Inspection Report

Property Address:
382 Lofton Rd NW
Atlanta GA 30309

Avalon Home Inspections Inc.

Date: 7/21/2020	Time: 09:30:00 AM	Report ID: 31236JK
Property: 382 Lofton Rd NW Atlanta GA 30309	Customer: Bethany Seewoester	Real Estate Professional: Cathryn Weldon Keller Williams (Atlanta) InTown

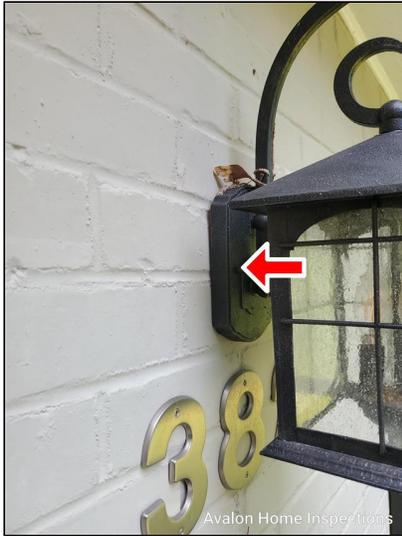
2.8 Item 1(Picture)

The light fixtures at the front, rear and right side of home are missing sealant to protect connections from corrosion. Electrical issues are considered a hazard until repaired. A qualified licensed electrical contractor should perform repairs that involve wiring.

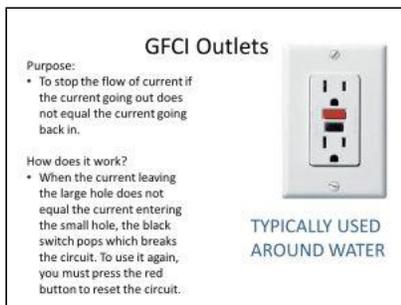
3.8 Item 1(Picture)

At least one GFCI (Ground Fault Circuit Interrupter) outlet at the kitchen is loose in the wall and needs to be secured properly. Electrical issues are considered a hazard until repaired. A qualified licensed electrical contractor should perform repairs that involve wiring.

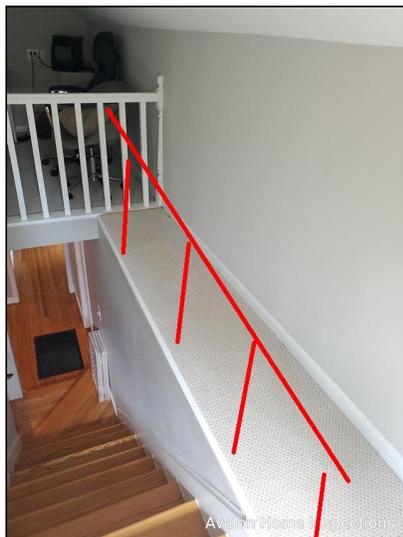
4.3.D Item 1(Picture)

The guard rail is missing. A fall or injury could occur if not corrected. A qualified contractor should repair or replace as needed.

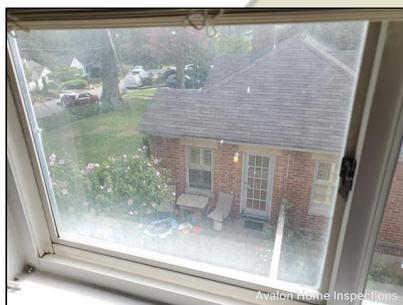
4.5.D Item 1(Picture)

(2) One window is cracked at glass pane at the bonus room. Cracked glass should be replaced to prevent injury or damage. A qualified person should repair or replace as needed.

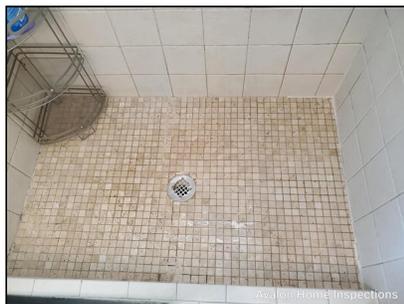
5.5.A Item 1(Picture)

(2) The tile wall is missing grout(caulk or silicone is not recommended) at inside corners of shower pan (floor perimeter) at the master bath. Repairs are needed. A qualified contractor should inspect and repair as needed.

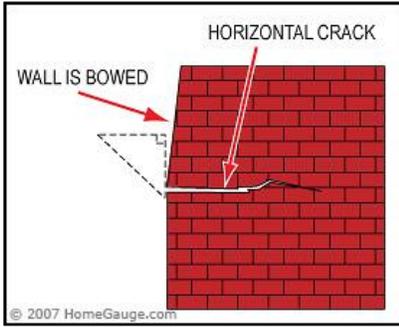
6.1 Item 1(Picture)

Structural crack in wall at the right side (facing front). The appearance of settlement crack is large enough for concern. Recommend a "Structural Engineer" to inspect.

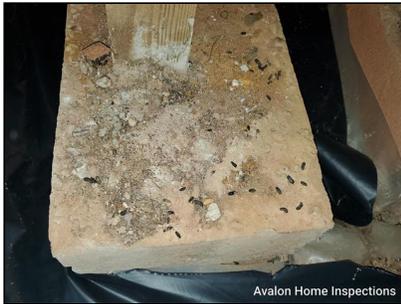
6.2 Item 1(Picture)

(1) Rodent droppings noted in crawlspace. A treatment may be needed. A qualified pest contractor should correct as needed.

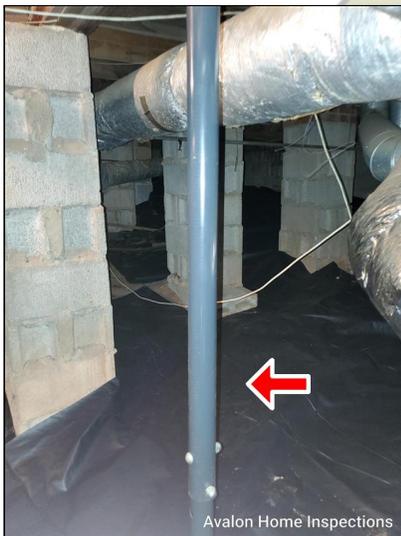
6.3 Item 1(Picture)

The steel jackpost(s) appears to work but are considered temporary supports in the crawlspace. Repairs are needed. A qualified licensed general contractor should inspect further and repair as needed.

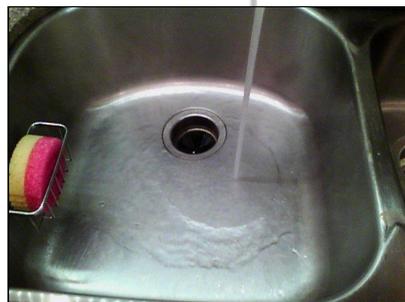
7.2 Item 3(Picture)

(3) The hot water temperature was greater than 125 degrees Fahrenheit. This is a safety hazard due to the risk of scalding. The thermostat should be adjusted so the water temperature doesn't exceed 125 degrees. If the water heater is powered by electricity, a qualified person should perform the adjustment, since covers that expose energized equipment normally need to be removed.

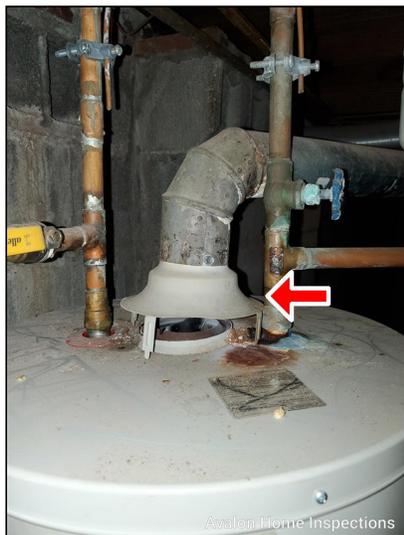
7.2 Item 5(Picture)

(4) The draft hood for water heater is loose or not secured. This is a safety issue and should be repaired. I recommend a qualified licensed heat contractor inspect further and repair as needed.

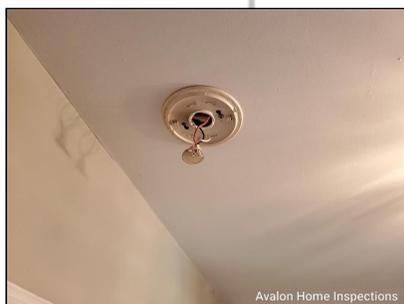
8.7 Item 1(Picture)

(2) The smoke detector has been disconnected intentionally at the common hallway to bedrooms. Without a working smoke detector in your home you have no first alert to a possible fire. I recommend repair or replace as needed using a qualified person.

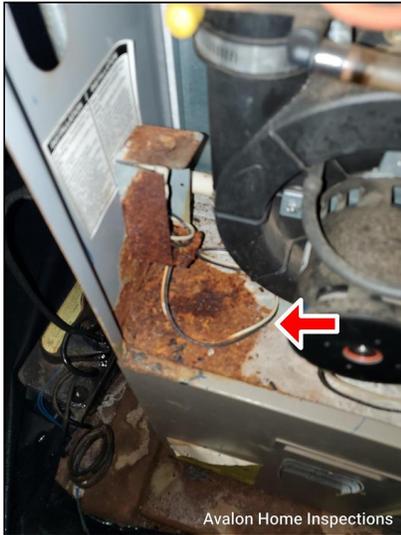
9.0 Item 2(Picture)

(2) The gas furnace will fire, but carbon deposits on burners or jets and rust within furnace indicate the need to service. A more thorough inspection by a qualified contractor is needed. A qualified HVAC person should inspect further and repair or replace as needed.

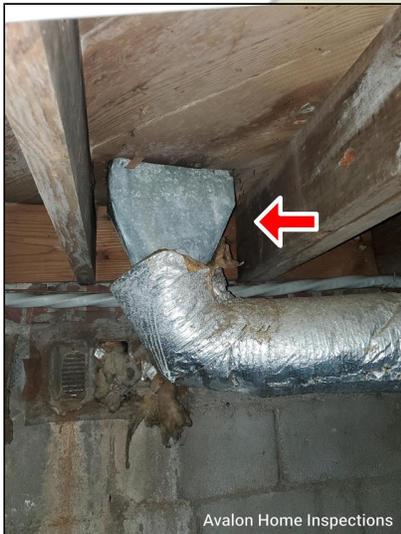
9.3 Item 1(Picture)

(2) The supply duct pipe boots are not insulated to subfloor in the crawlspace. This is causing condensation(sweating). A licensed HVAC contractor should inspect and correct as needed.

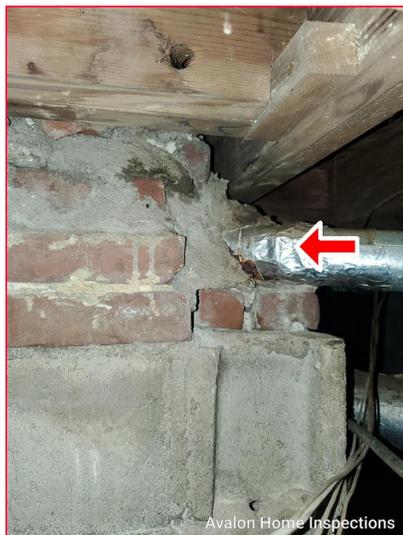
9.6 Item 1(Picture)

The vent pipe for water heater terminates in a clay liner and/or brick chase. This can be safety issue and should be further evaluated by a licensed HVAC contractor. I recommend a qualified licensed heat contractor inspect further and repair as needed.

Chase should be scoped by a qualified heat contractor to determine if liner is safe to use.

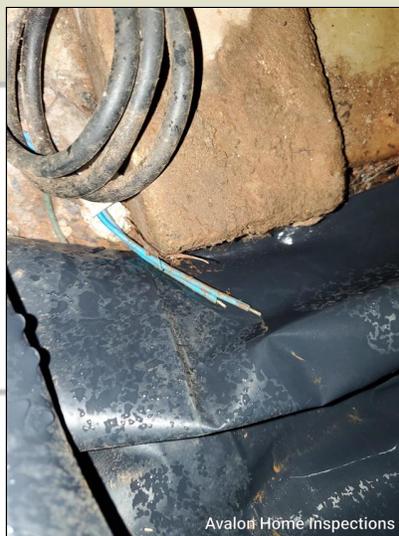
9.10 Item 3(Picture)

(3) The condensation pump's float switch is not connected to HVAC unit. Leaks can cause damage to unit or home. A qualified HVAC person should inspect further and repair or replace as needed.

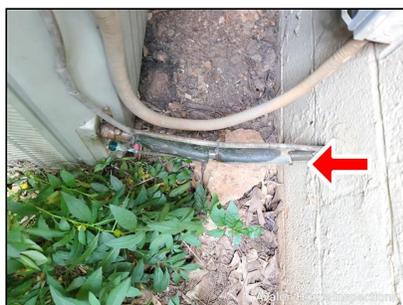
9.10 Item 9(Picture)

(7) The evaporator coil box is missing grommet where compressor lines enter at air handler inside. Missing grommets can cause energy loss and condensation. A licensed HVAC contractor should service or repair unit. A grommet can be installed or unit can be sealed with silicone.

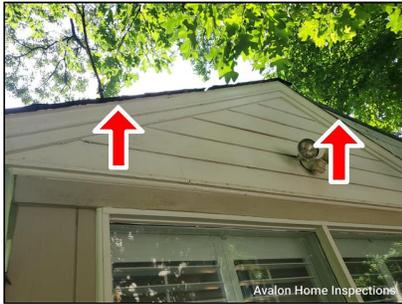
1.1 Item 4(Picture)

- i (2) The metal drip edge is missing along rake/eaves. Moisture or water could leak in to attic when raining. A qualified roofing contractor should inspect and repair as needed.

Recent changes in code require installation of drip edge flashing when roof is replaced. This change is not retroactive on shingles installed prior to 2012.. This also supports edge of roof shingles and covers the "builder gap" between fascia board and roof sheathing.

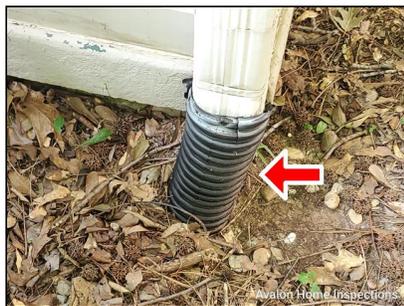
1.4 Item 3(Picture)

(2) The below ground drain lines for downspouts are old and I am unable to determine if drains will function properly.

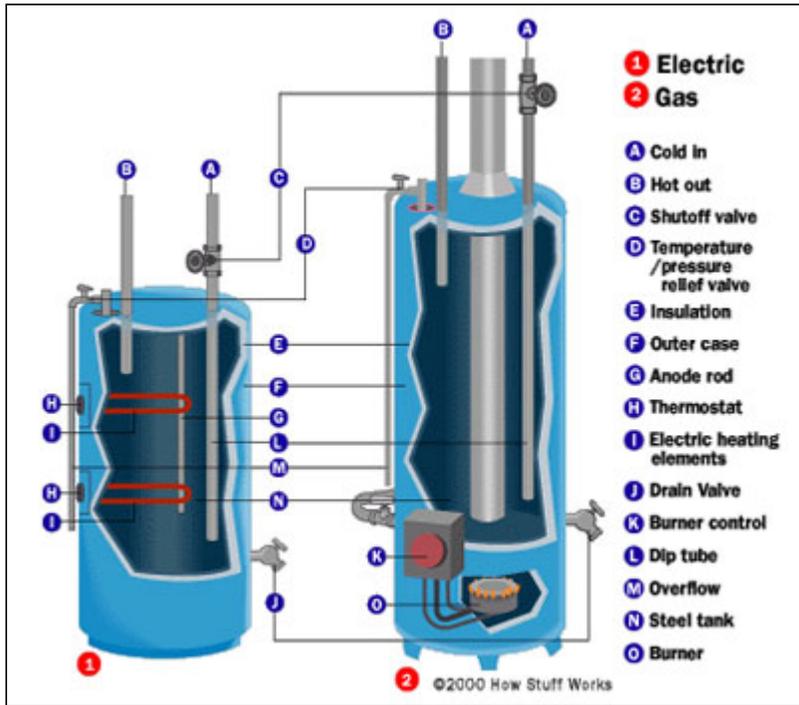
7.2 Item 1(Picture)

i (1) Average useful lifespan of water heater in Georgia is 14 Years. If water heater is over this age, buyer should budget for replacement. This is FYI.

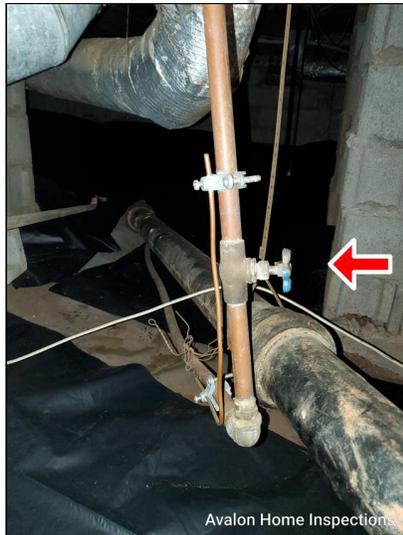
7.3 Item 1(Picture)

i The main shut off is the blue knob/lever located in the crawlspace. This is for your information.

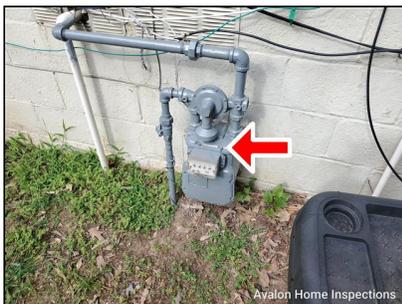
7.5 Item 1(Picture)

i The main fuel shut off is at gas meter outside.

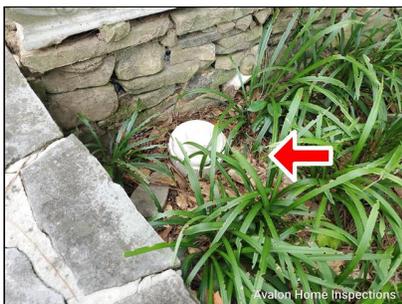
7.7 Item 1(Picture)

i Waste line cleanout is located at the front of home(picture)

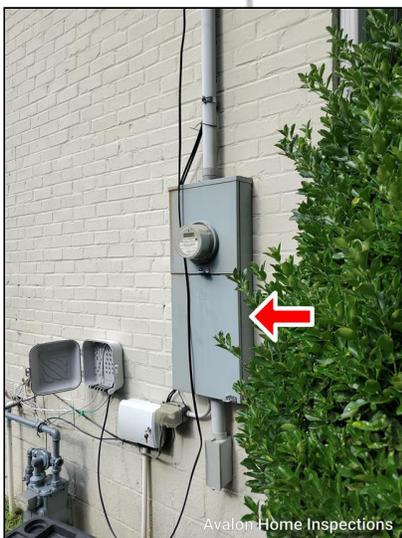
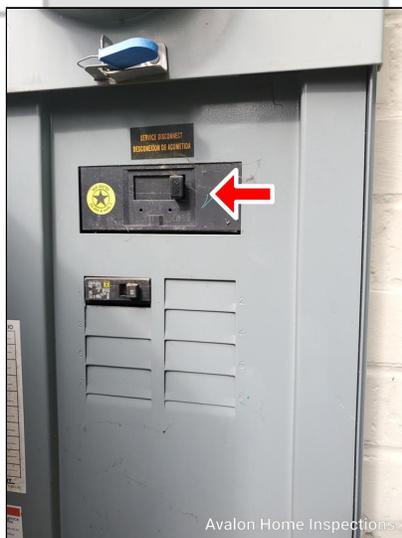
i The main panel box is located at the living room. However, the main disconnect (shut-off) is outside at meter base panel (for your information).

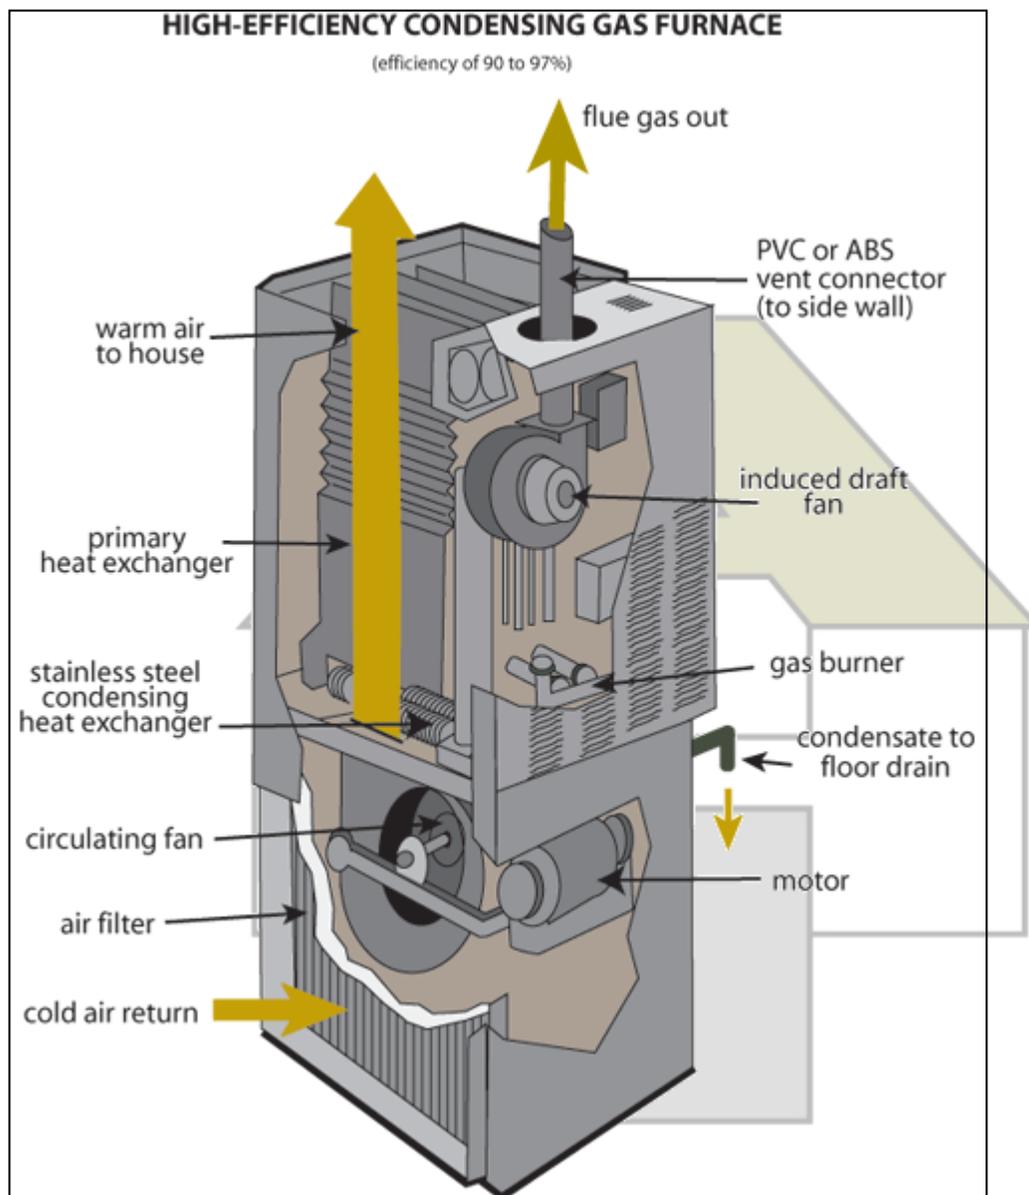
9.0 Item 1(Picture)

- (1) Average lifespan of gas furnace in Georgia is 25 Years. If unit is above this age, buyer should budget for replacement. This is FYI.

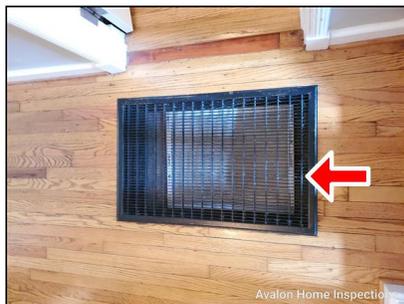
9.4 Item 1(Picture)

- Filter location(picture) in the hallway.

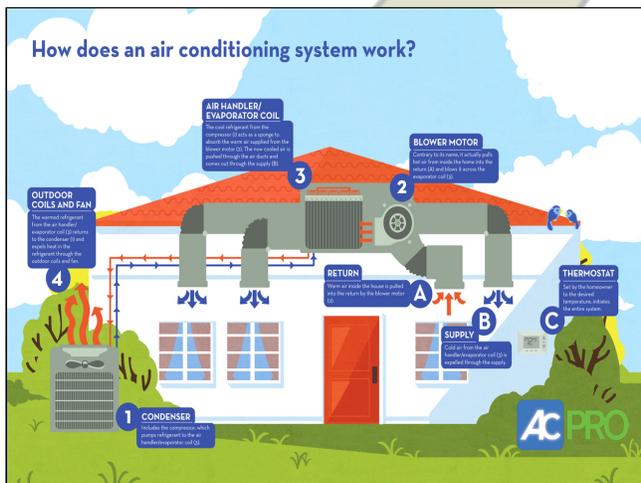
9.10 Item 1(Picture)

(1) Average lifespan of Air Conditioner in Georgia is 15 Years.If unit is above this age, buyer should budget for replacement. This is FYI.

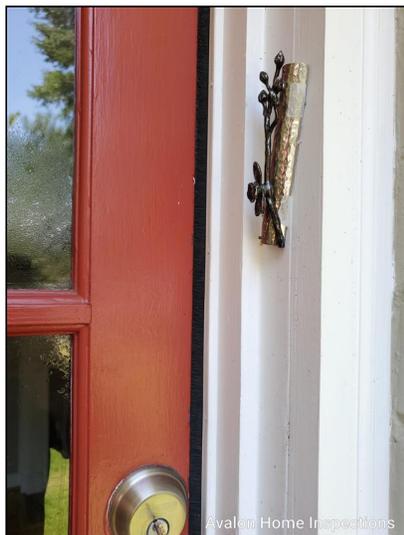
2.1 Item 1(Picture)

(2) The entry door at the front of home rubs at jamb when closing. This is a small repair. A qualified contractor should inspect and repair as needed.

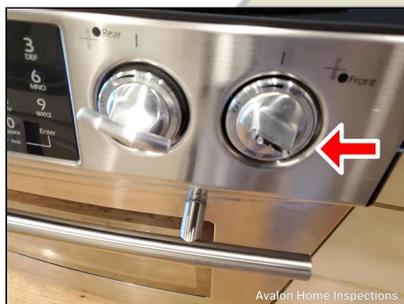
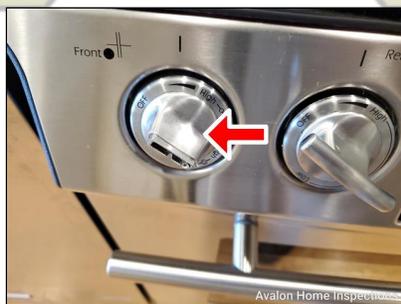
Two knobs are damaged at the range. Repairs are needed.

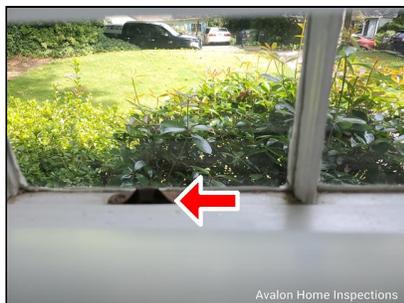
4.5.A Item 1(Picture)

One window is damaged at handle or lock hardware at the living room. This can cause some heat loss in winter and loss of cool air in summer if not corrected. A qualified contractor should inspect and repair as needed.

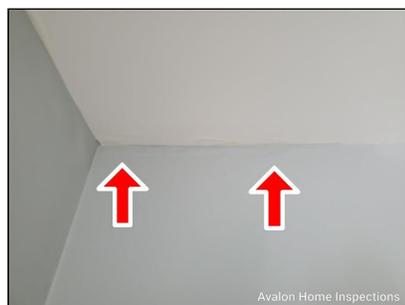
4.0.B Item 1(Picture)

The sheetrock on the ceiling reveals a light stain which appears from a water leak. Stain appears old in the guest bedroom. The moisture meter was used and it did not indicate an active leak. I recommend prep and paint using a qualified contractor.

Keep in mind moisture dries out of finished material (sheetrock, wood, etc.) between attic and stained area quickly due to the heat of an attic. False readings on moisture meters and thermal imaging cameras can occur if lack of adequate rain in the last few days has occurred. Please confirm with seller that leak has been evaluated and/or corrected.

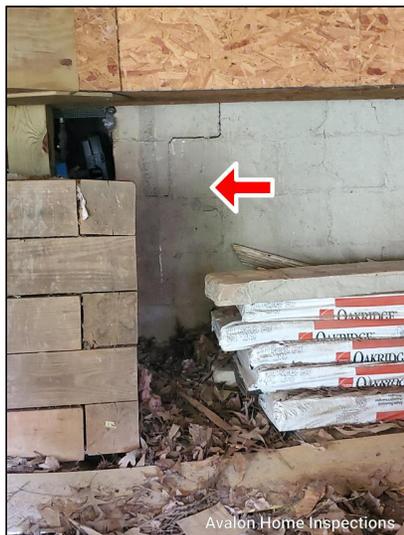
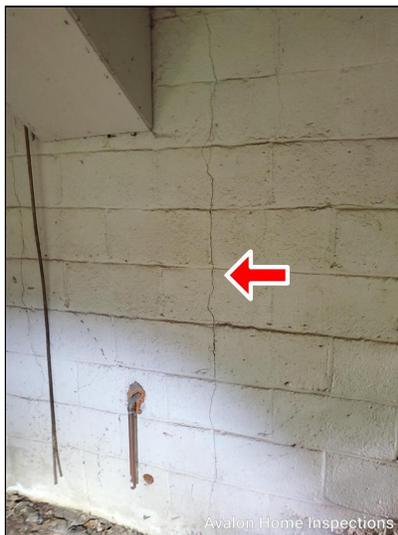
Typical shrinkage/expansion cracks at the foundation wall. Typical shrinkage/expansion cracks can be sealed and may need to be re-sealed periodically. This is FYI. Small cracks in masonry will sometimes appear as a house ages. These cracks are not structural in nature and are a result of shrinkage and/or settlement. Cracks should be sealed as a precaution to prevent rainwater penetration. During a prolonged or significant rain this can result in moisture intrusion over time and may not always be visible during the home inspection. Minor preventive maintenance can help to eliminate this.

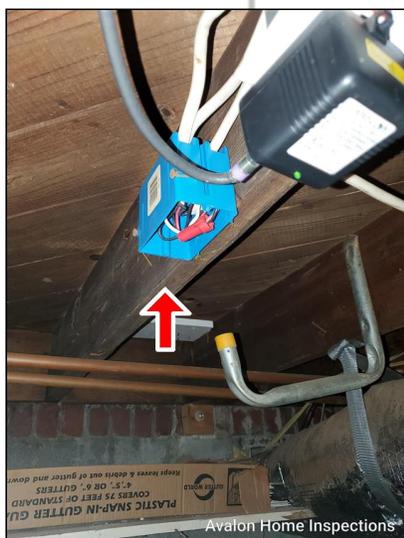
8.3 Item 1(Picture)

Several junction boxes in the crawlspace need cover plates. This is a small repair.

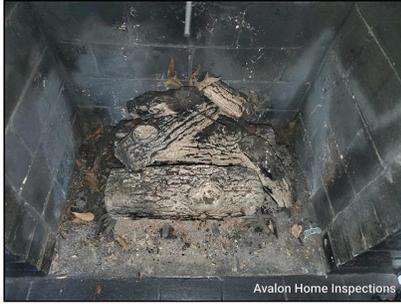
9.8 Item 1(Picture)

The black soot build-up indicates that Gas Fire logs do not appear to be arranged or positioned according to manufacturer's specs. If logs are not positioned correctly, carbon monoxide can be produced.

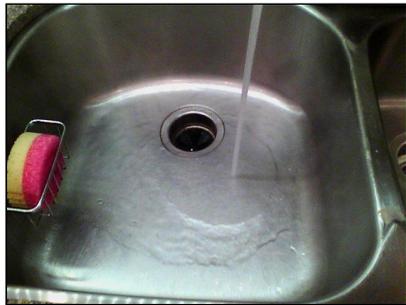
7.2 Item 3(Picture)

(3) The hot water temperature was greater than 125 degrees Fahrenheit. This is a safety hazard due to the risk of scalding. The thermostat should be adjusted so the water temperature doesn't exceed 125 degrees. If the water heater is powered by electricity, a qualified person should perform the adjustment, since covers that expose energized equipment normally need to be removed.

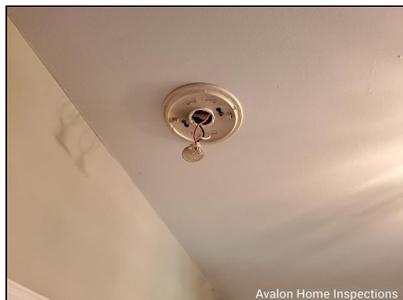
8.7 Item 1(Picture)

(2) The smoke detector has been disconnected intentionally at the common hallway to bedrooms. Without a working smoke detector in your home you have no first alert to a possible fire. I recommend repair or replace as needed using a qualified person.

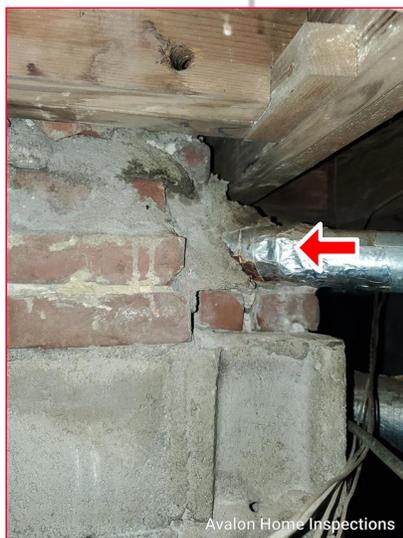
9.6 Item 1(Picture)

The vent pipe for water heater terminates in a clay liner and/or brick chase. This can be safety issue and should be further evaluated by a licensed HVAC contractor. I recommend a qualified licensed heat contractor inspect further and repair as needed.

Chase should be scoped by a qualified heat contractor to determine if liner is safe to use.
