HOME INSPECTION REPORT

300 Saddlebrook Drive, Roswell, GA 30075

Date of Inspection: 6/30/2020 Time: 1:30 PM

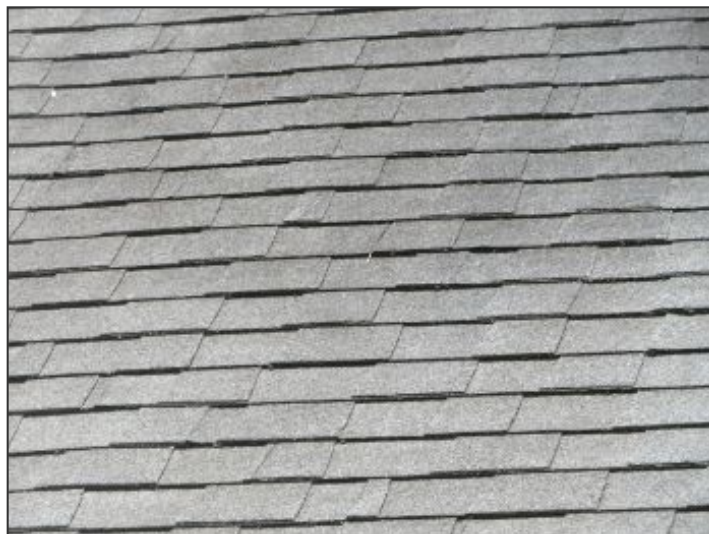
This roof has architectural or profile shingles; this attractive and slightly more expensive shingle is a significant upgrade from traditional roof shingles. It also has a longer warranty period of 25-35 years and should provide an extended lifespan when compared to traditional roof shingles. This type of shingle also performs better in storms and when exposed to hail.

Architectural roof shingles present

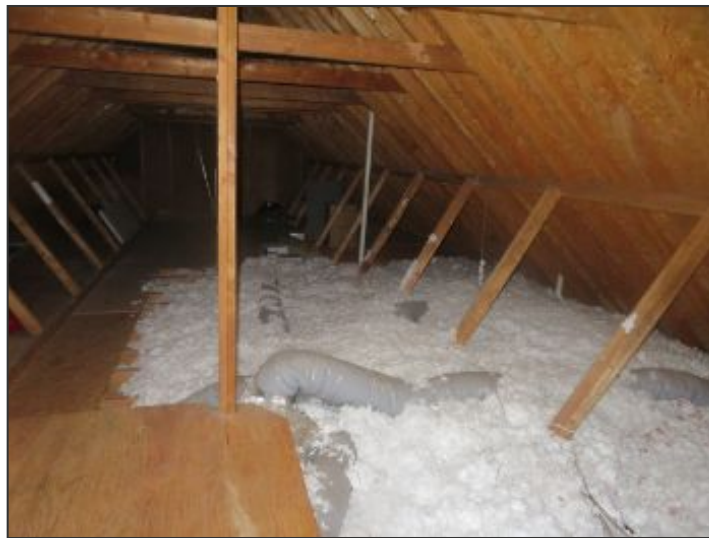
• Conventional framing is present in the attic and consists of 2 x 6 roof rafters and 2 x 8 ceiling joists spaced 16 inches on center. The roof decking has been framed with oriented strand board (OSB).

• The attic and roof framing appears serviceable during this limited inspection, no concerns were noted.

Attic framing and insulation looks good

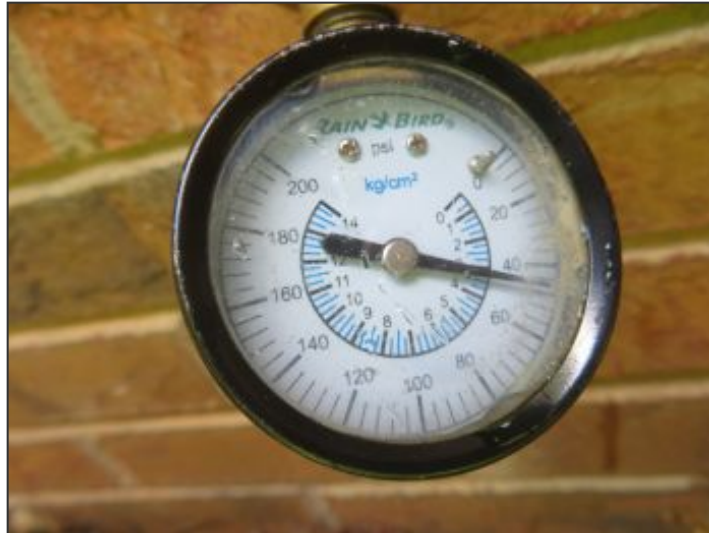
- The supply piping appears to be serviceable, no concerns were noted except as mentioned below. A water pressure reading was taken at the rear hose bib and was found to be normal at 50 PSI.

Water pressure normal - 50 PSI

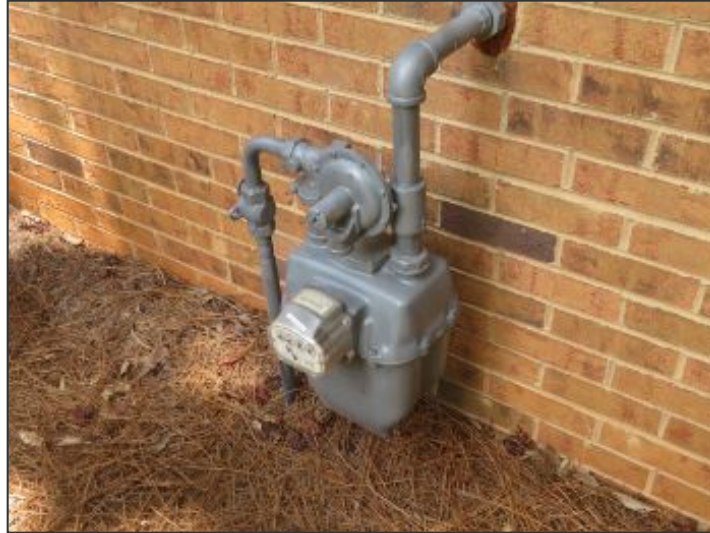
- The gas meter is located at the left side exterior wall and appears serviceable; no concerns were found. (NOTE: The gas lines inside the walls, ceilings and floors are not fully visible for inspection and could not be evaluated).

Gas meter at left exterior

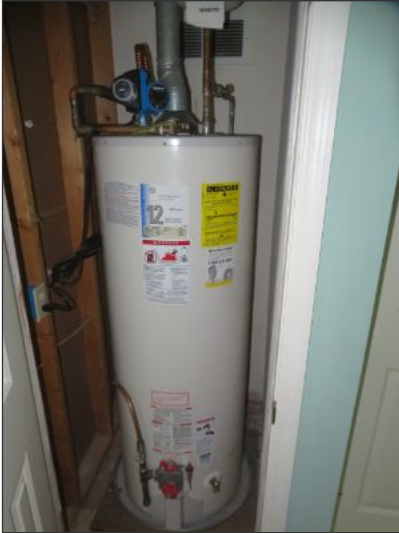
Gas water heater in bedroom closet

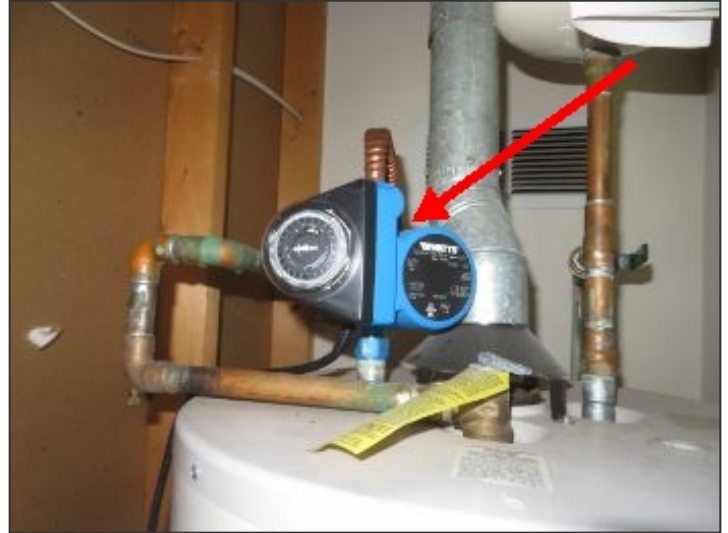
Recirculating pump at water heater

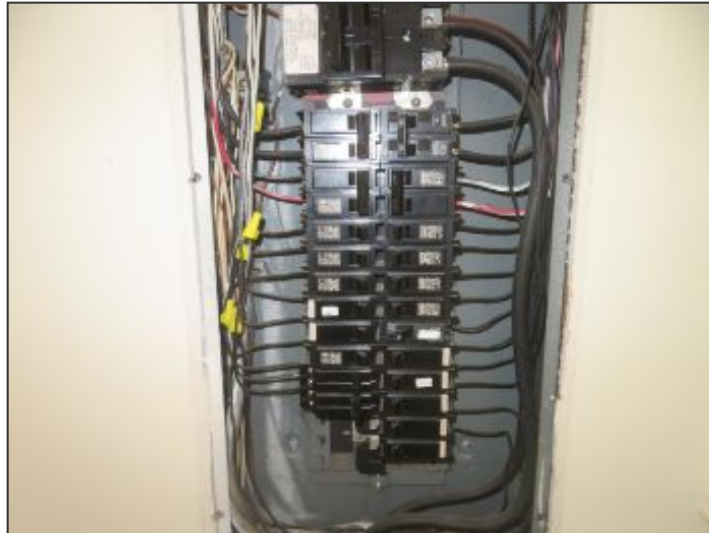
- The main panel is located in the laundry room . Circuit breakers are present. The main panel box appears serviceable during a limited visual inspection inside the panel; no concerns were found.

Main electrical panel looks good

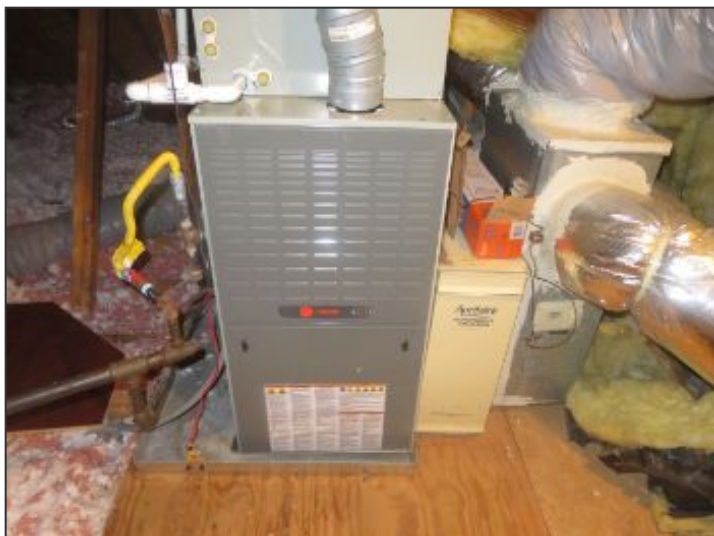
Gas furnace in attic

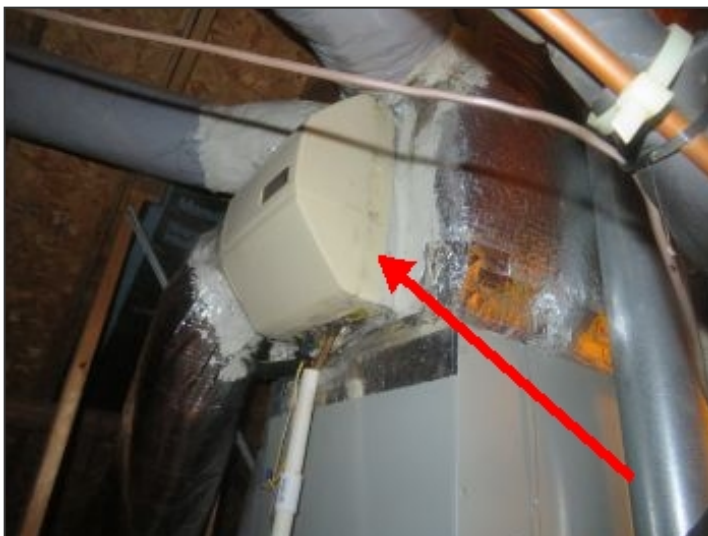
• A humidifier is present at this HVAC system. Because humidifiers are not within the scope of this inspection, it is recommended that further evaluation of the humidifier be conducted by a professional HVAC contractor to check for maintenance and cleaning needs.

Humidifier not within scope of inspection

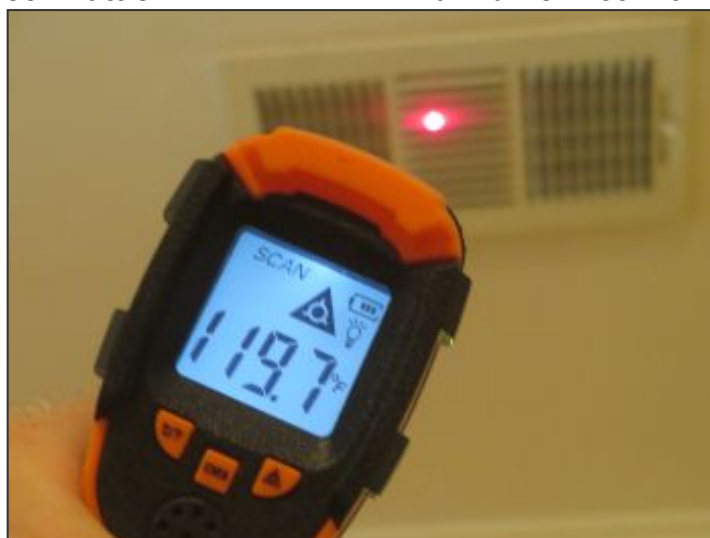
Gas furnace heating normally - 119 degrees

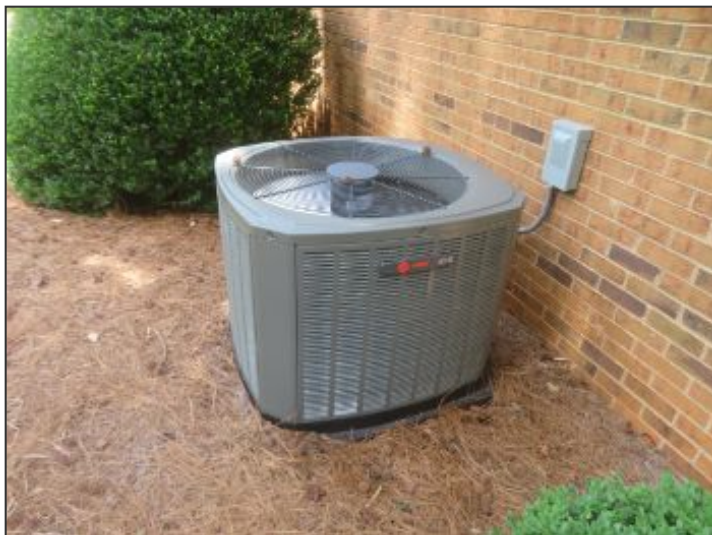
1. **This air conditioner has a 13 SEER rating (Seasonal Energy Efficiency Ratio). This 13 SEER system should be approximately 25% - 30% more efficient to operate than previous air conditioners that had a 10 SEER minimum rating. This means that it will cost approximately 25% - 30% less to cool your home, a significant energy savings. The 13 SEER minimum rating requirement began in January 2006.**
2. **This AC unit includes the newer refrigerant, R410-A, which is more environmentally friendly.**

AC unit at exterior

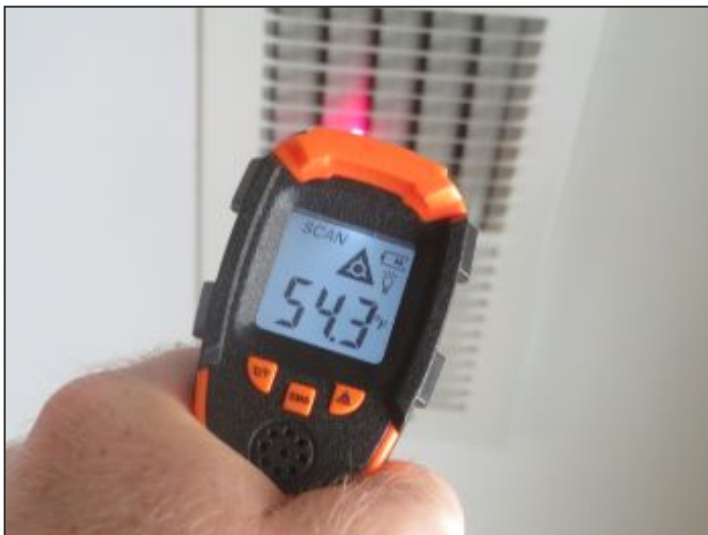
AC cooling normally - 54 degrees

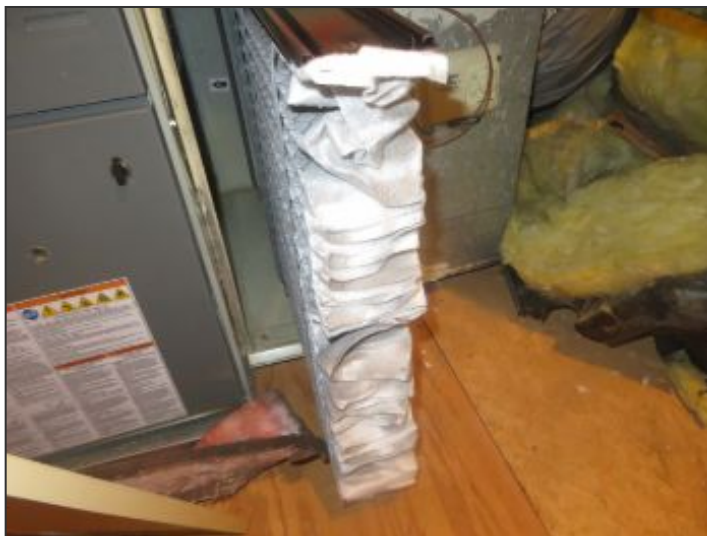
• A good quality 4" media filter that is designed to remove more impurities from the conditioned air. This type of filter is often changed every 4-6 months and is more expensive than a traditional one inch filter.

Good quality media filter present
