Property Inspection Report

Property address: **820 Deerfield Township Way
Alpharetta GA 30004-0913**

Inspection date: **Thursday, September 3, 2020**

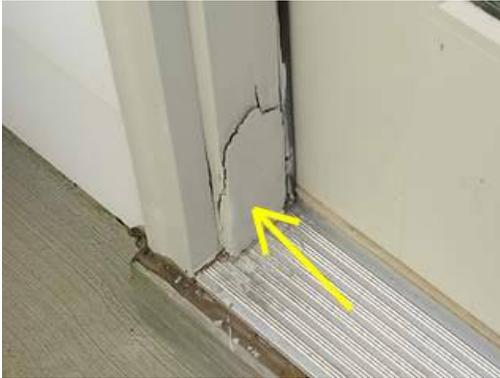
Photo 4-2

Exterior trim appears to be damaged in one or more areas. Recommend having a qualified contractor evaluate and make any necessary repairs.

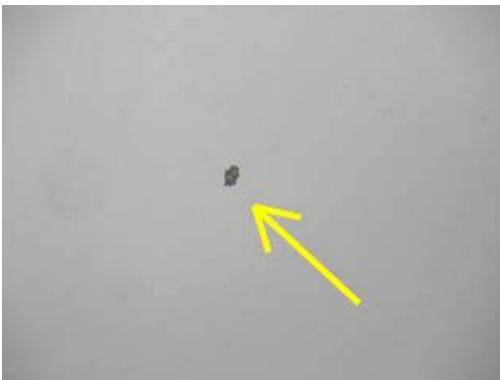
Photo 5-2

Siding is damaged and/or deteriorated in one or more areas. A qualified contractor should evaluate and make repairs and/or replace siding as necessary.

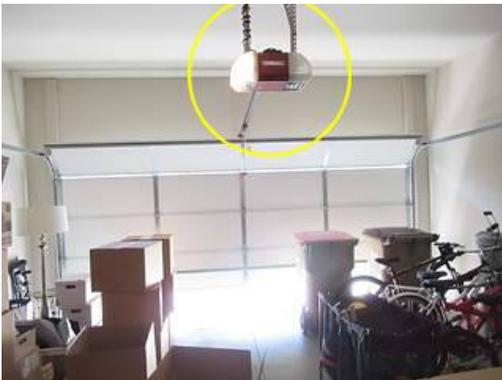
Photo 13-1

13) **i** Garage door opener appeared functional at time of inspection.

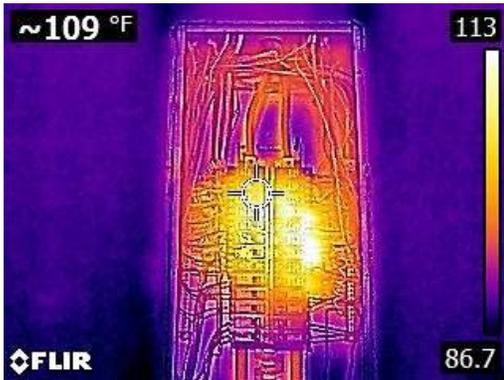
Photo 17-1

General picture of service panel. The basic infrared scan showed no abnormal anomalies at the time of the inspection.

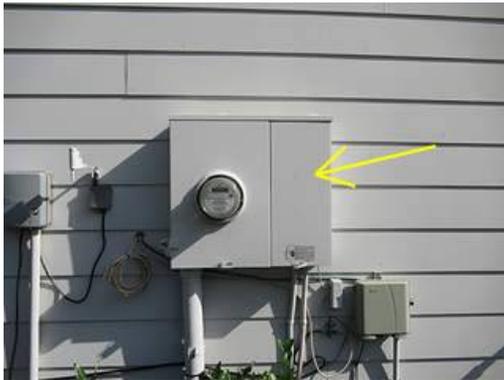
Photo 18-1

Location of the main service disconnect.

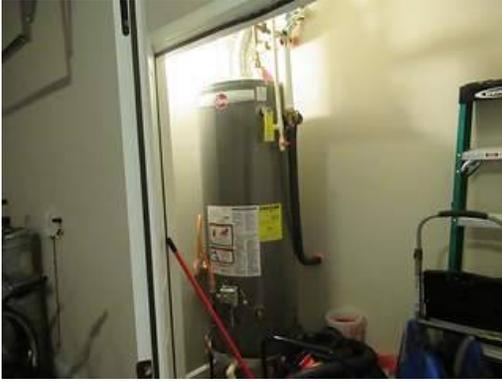
Photo 20-1

The water heater was checked and appears to be functional.

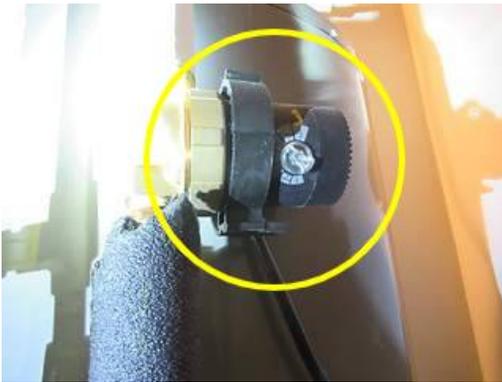
Photo 21-1

21) **i** A circulating pump is installed for the hot water supply. It is intended to make hot water immediately available when faucets are turned on. Timers are typically integrated with these pumps, and should be configured so water circulates only at desired times for better energy efficiency. The client(s) should familiarize themselves with the timer's operation and configure it as needed.

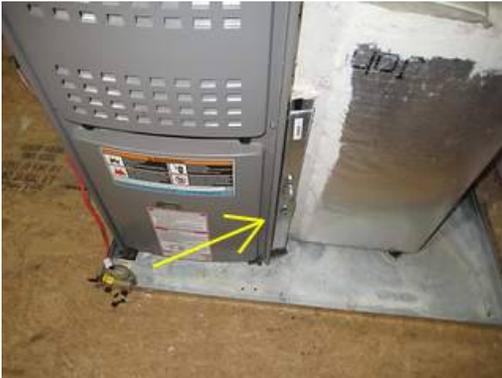
Photo 23-1

23) 🗝️ Air handler filter(s) should be checked monthly in the future and replaced or washed as necessary.

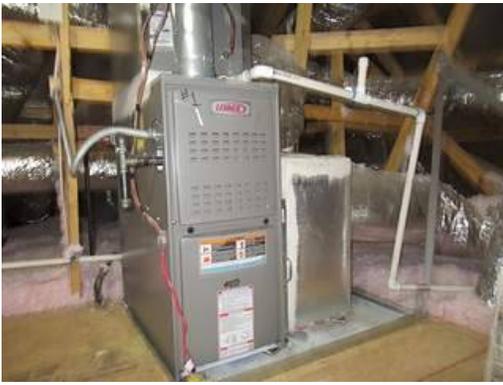
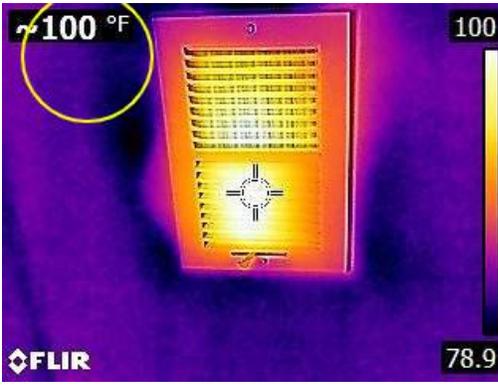
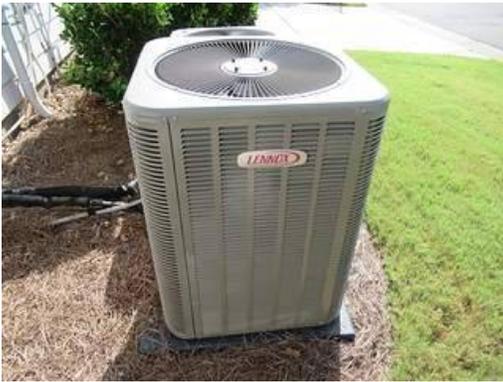
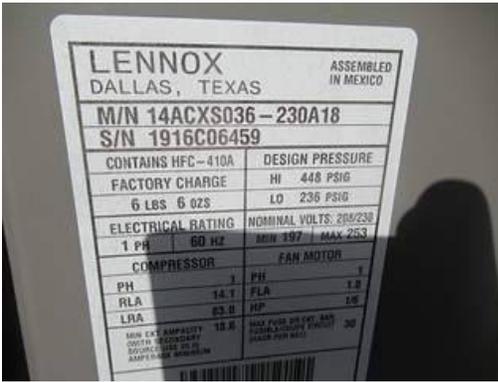
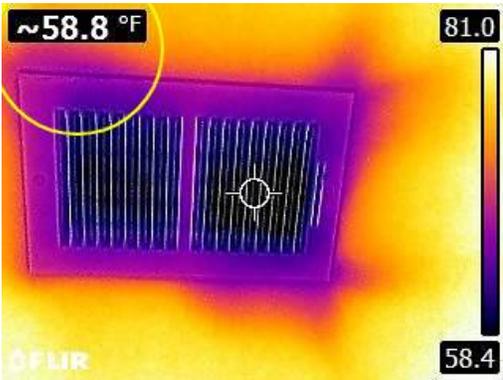
25) 📌 The main floor heating and air conditioning system was checked and appears to be functional at the time of the inspection.

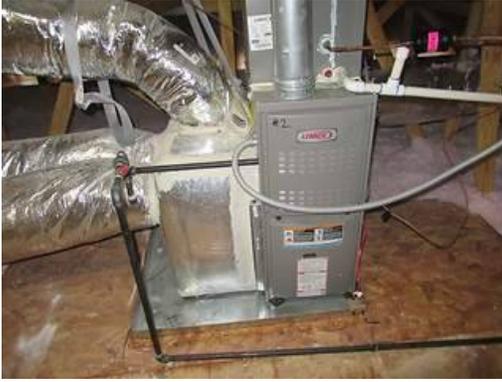
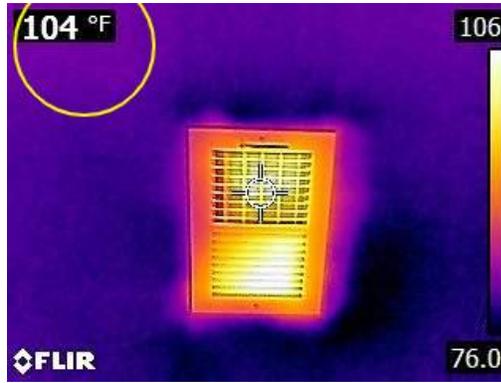
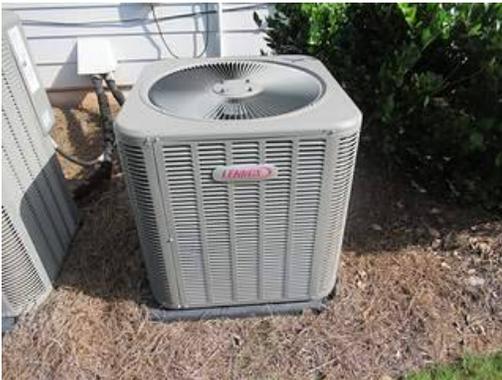
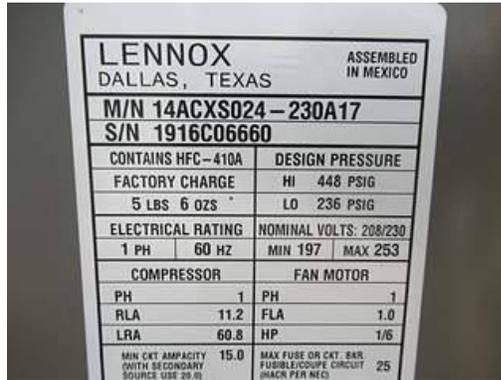
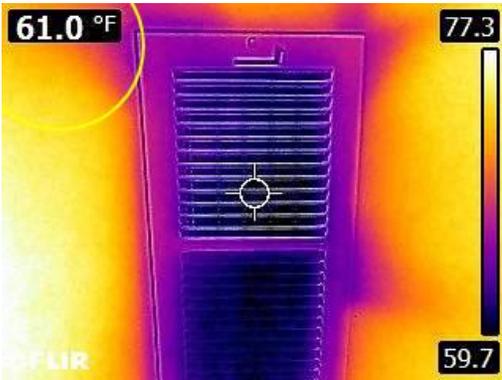
- 28) **i** The upstairs heating and air conditioning system was checked and appears to be functional at the time of the inspection.

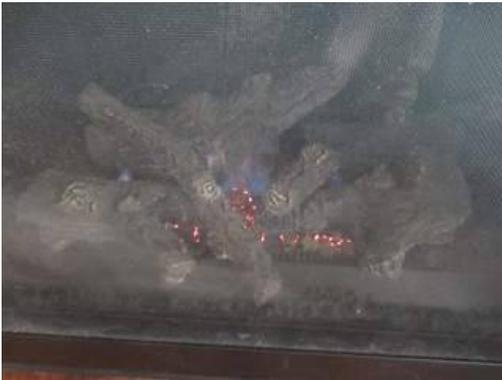
Photo 34-1

34) i The gas fireplace appeared functional at the time of the inspection.

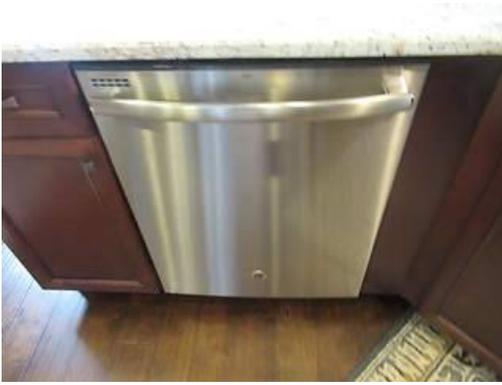
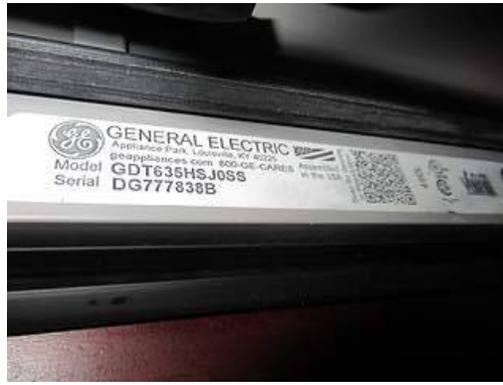
35) i The dishwasher was checked and appears to be functional.

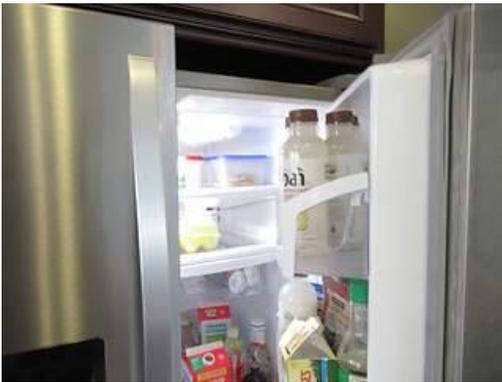
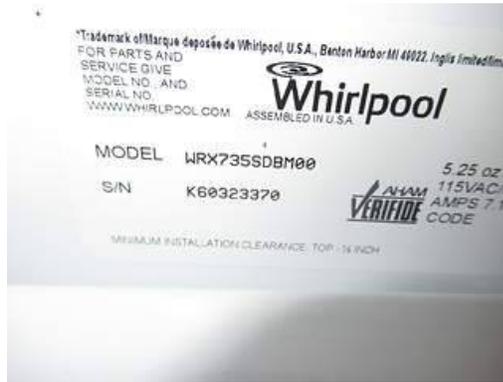
The refrigerator was checked and appears to be functional.

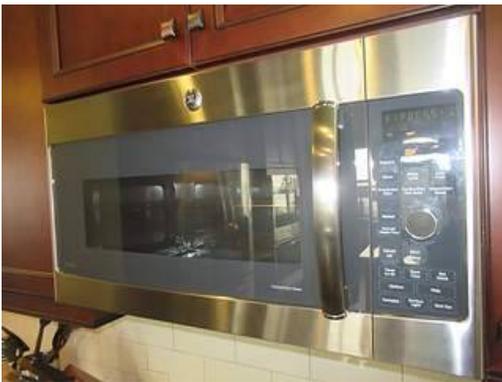
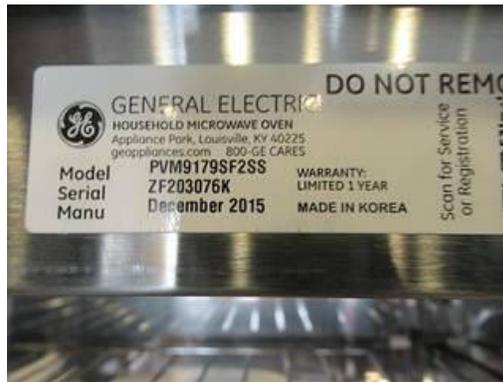
The microwave was checked and appears to be functional.

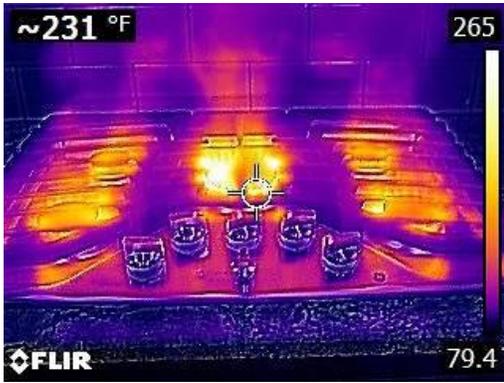
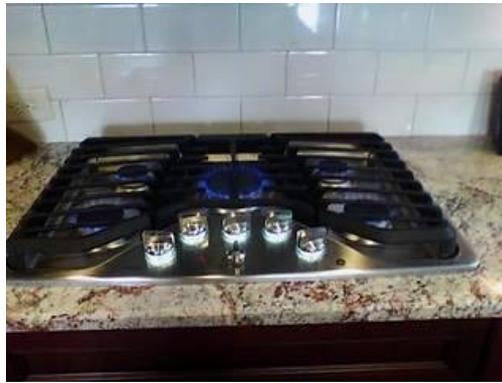
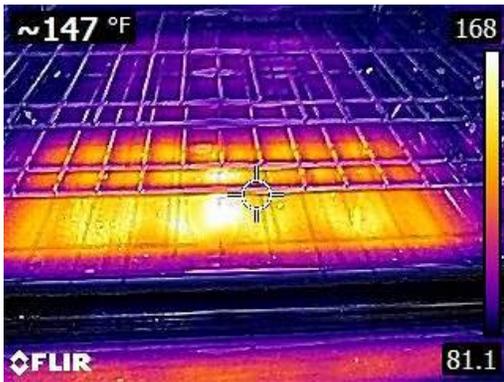
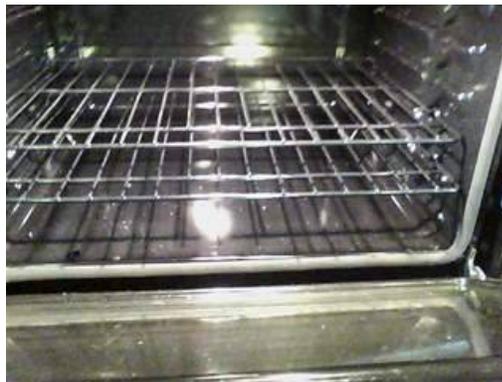
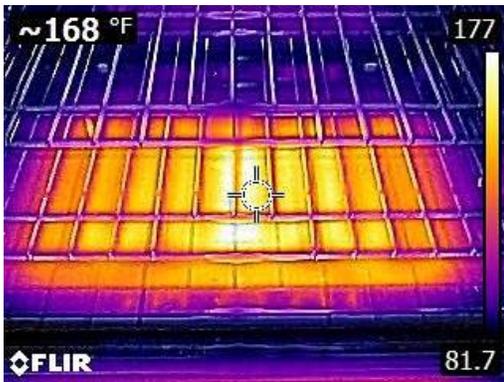
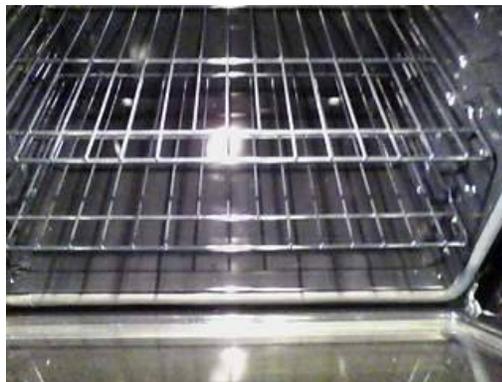
The range/oven was checked and appears to be functional.

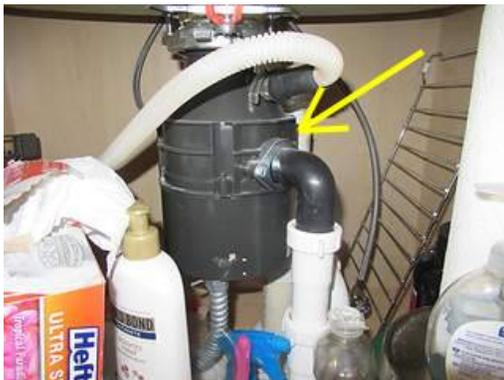
Photo 39-1

Food disposal appeared functional at time of inspection.

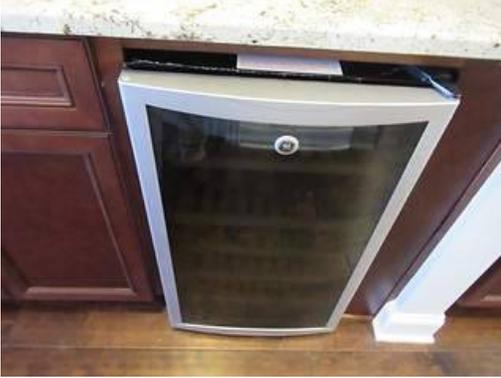
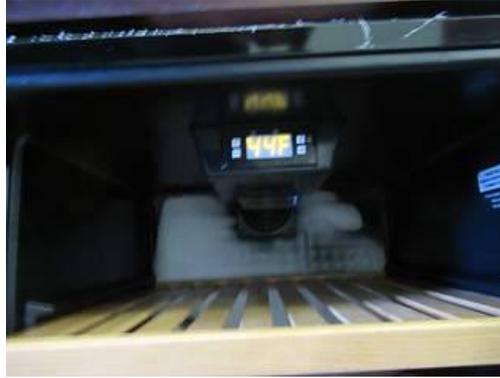
The wine refrigerator was functional at the time of the inspection.

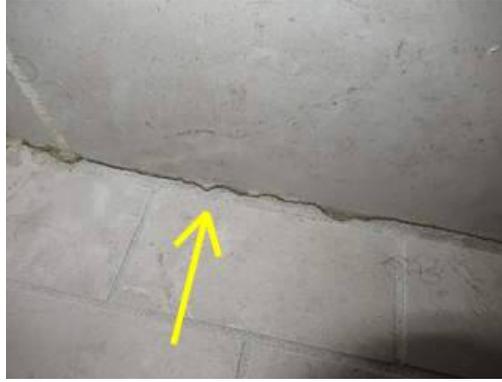
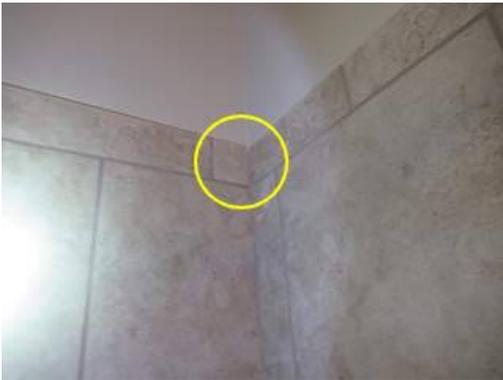
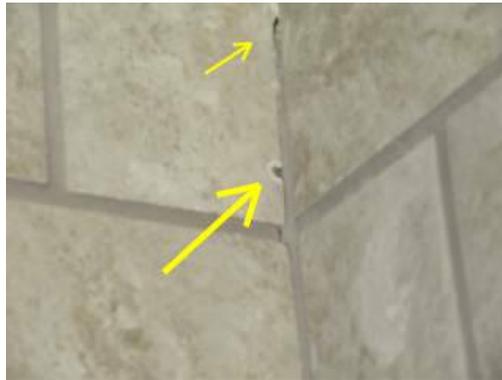
Tile and/or grout in one or more showers is damaged and/or deteriorated. For example, deteriorated or missing grout, cracked, missing or loose tiles, etc. A qualified contractor should evaluate and repair tile and/or grout as necessary.

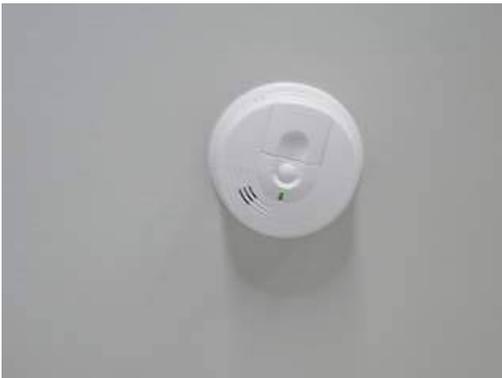
Photo 45-1

Batteries in all the smoke alarms should be replaced after taking occupancy, and twice annually in the future. "Chirping" noises emitted from smoke alarms typically indicate that batteries need replacing.

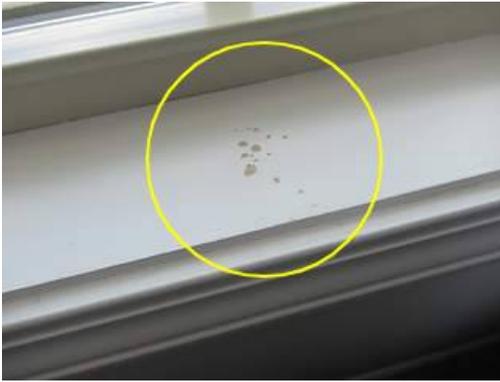
Photo 46-2

Trim is damaged and/or deteriorated in one or more areas. Recommend having a qualified contractor replace or repair trim as necessary.

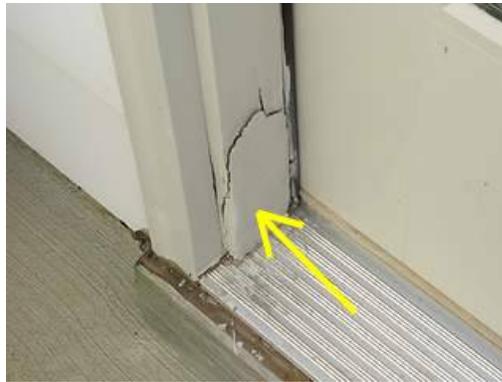
Photo 4-2

Exterior trim appears to be damaged in one or more areas. Recommend having a qualified contractor evaluate and make any necessary repairs.

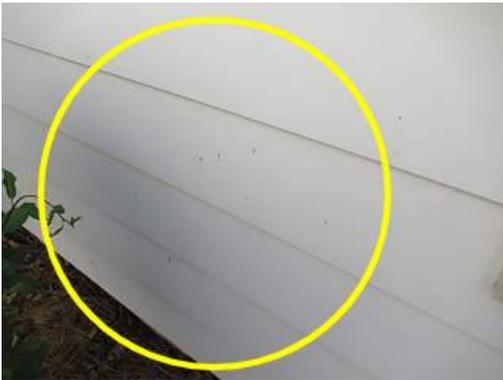
Photo 5-3

Siding is damaged and/or deteriorated in one or more areas. A qualified contractor should evaluate and make repairs and/or replace siding as necessary.

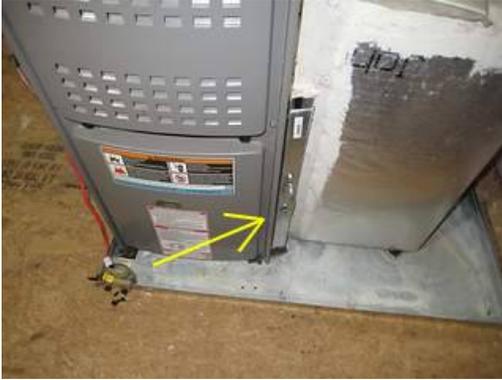
Photo 23-1

Air handler filter(s) should be checked monthly in the future and replaced or washed as necessary.

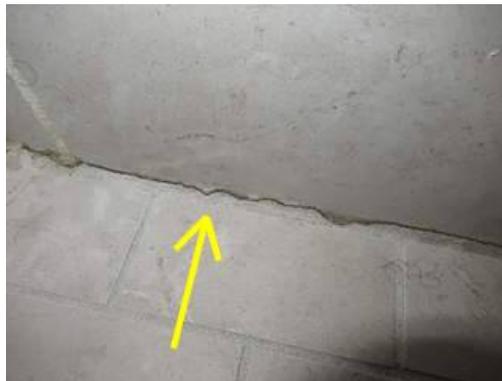
Photo 42-2

Tile and/or grout in one or more showers is damaged and/or deteriorated. For example, deteriorated or missing grout, cracked, missing or loose tiles, etc. A qualified contractor should evaluate and repair tile and/or grout as necessary.

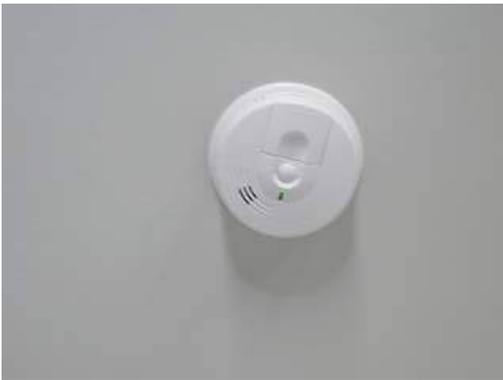
Photo 45-1

Batteries in all the smoke alarms should be replaced after taking occupancy, and twice annually in the future. "Chirping" noises emitted from smoke alarms typically indicate that batteries need replacing.

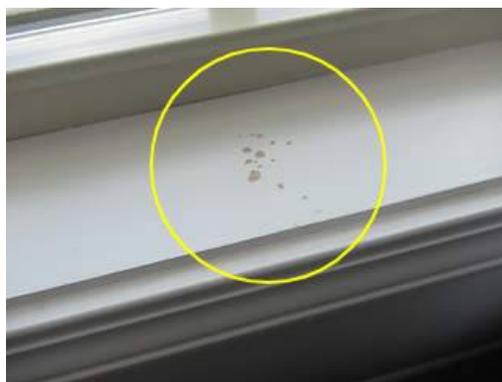
Photo 46-2

Trim is damaged and/or deteriorated in one or more areas. Recommend having a qualified contractor replace or repair trim as necessary.
