**House Smart**

**860 Longstone Landing  
Alpharetta GA 30022**

Client(s): Koller  
Inspection Date: 9/10/2020  
Inspector: Keith Cook , ASHI 202558

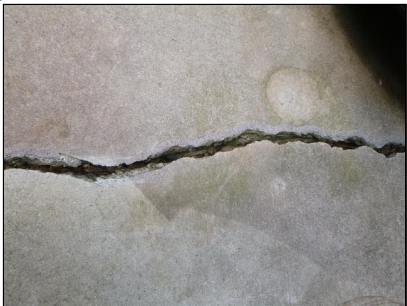
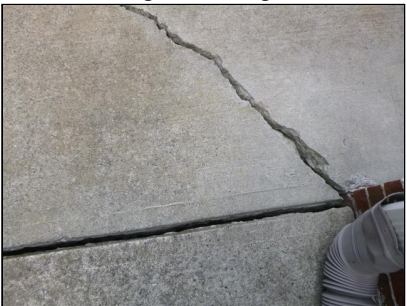
- ❌ 2. **MAJOR DEFECT:** Settling of the concrete surfaces observed. Repair can consist of either mud-jacking (injecting concrete under the slab to raise it) or replacement. Recommend having professionally repaired to raise surface back to or at least near the original position and reduce chances of continued settling occurring if not addressed.

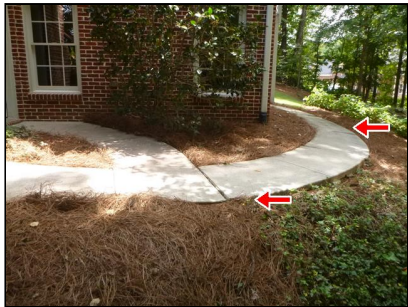
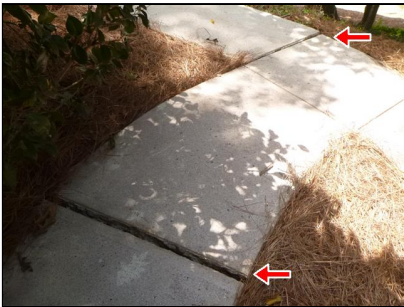
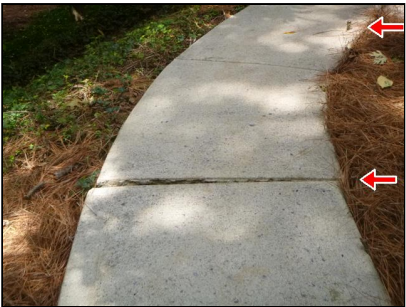
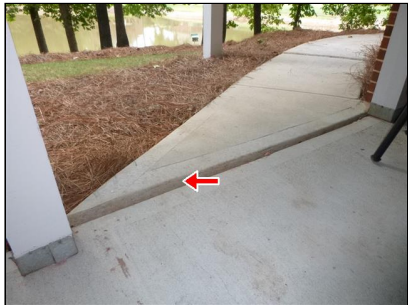
- ❌ 3. **SAFETY / HEALTH:** Settling of the concrete surfaces observed. Repair can consist of either mud-jacking (injecting concrete under the slab to raise it) or replacement. Recommend having professionally repaired to raise surface back to or at least near the original position and reduce chances of continued settling occurring if not addressed.

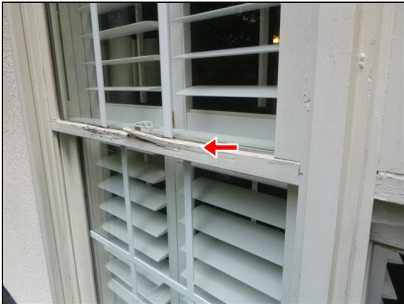
Item 4 - Picture 2

- ✖ 4. **SERVICE / REPAIR:** Window sash of Bedroom facing driveway side is damaged beyond point of repair and recommend having replaced.

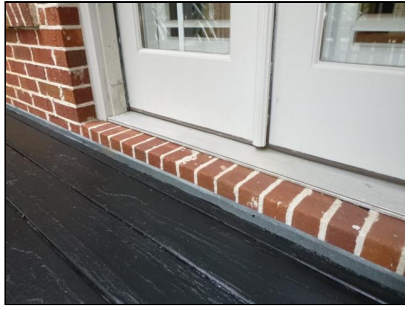
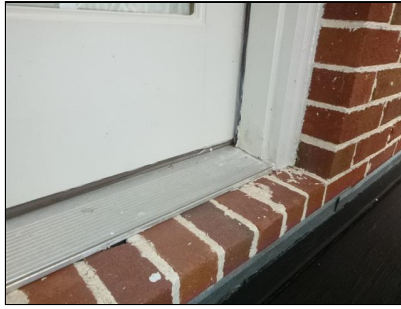
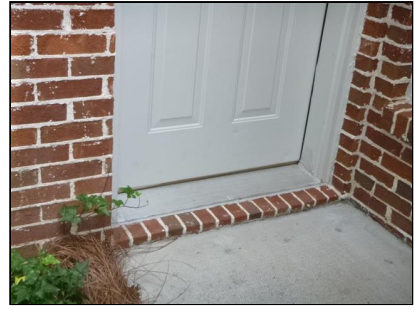
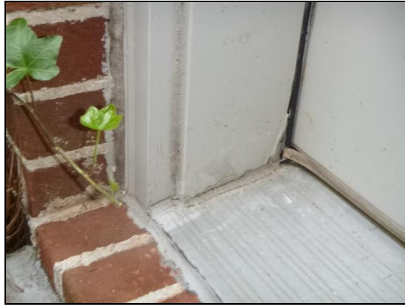
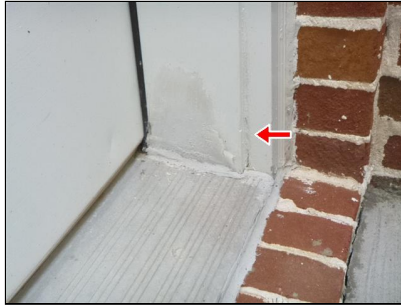
- ✖ 5. **SERVICE / REPAIR:** Recommend having repairs improved and better protected to avoid getting worse outside Master doors to deck. ALSO, Door to exterior storage room.

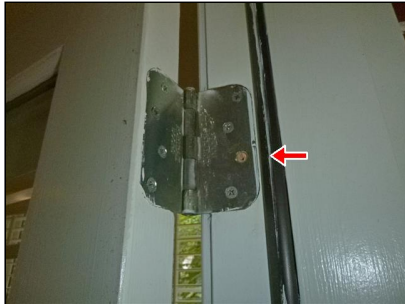
Item 6 - Picture 1

- ❌ 6. **SERVICE / REPAIR:** Screws found missing/stripped/damaged on door which can cause door to sag leading to sticking and failure to latch. Have proper size screw provided, hole modified to secure into door/jamb and installed to secure assembly in opening at Door to Deck from Master.

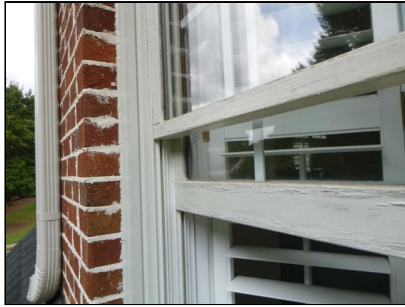
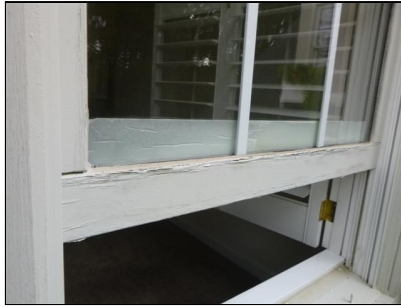
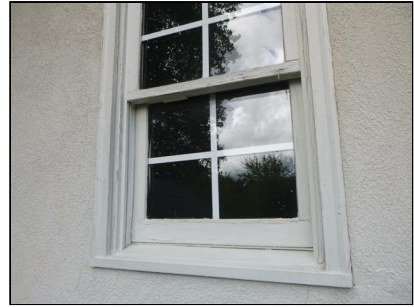
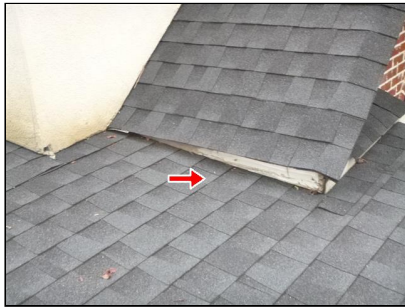
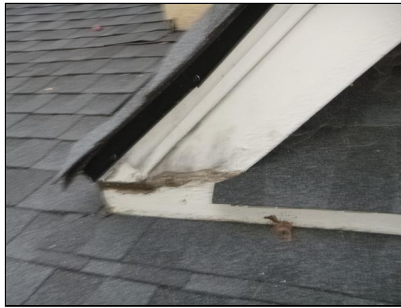
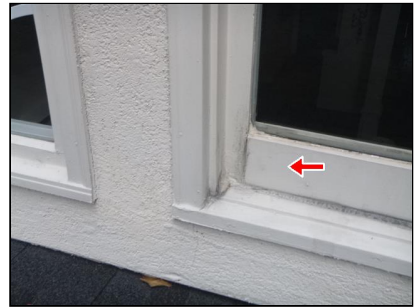
- ❌ 7. **SERVICE / REPAIR:** Paint on the window trim found in weathered condition. Sand, prime bare wood, caulk and paint to prevent moisture damage to the affected areas.

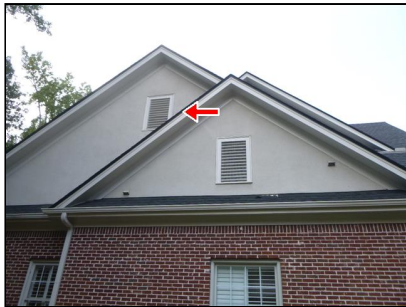
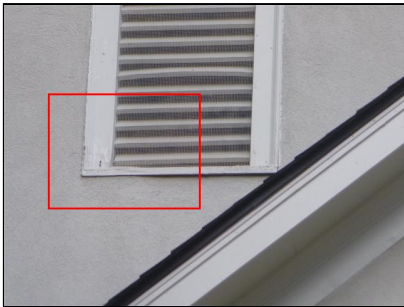
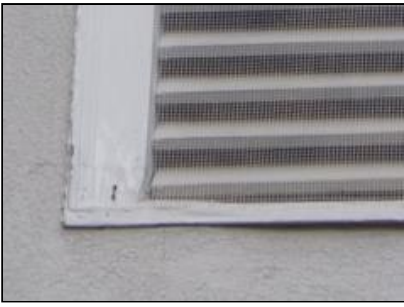
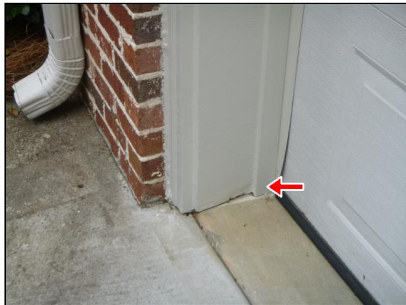
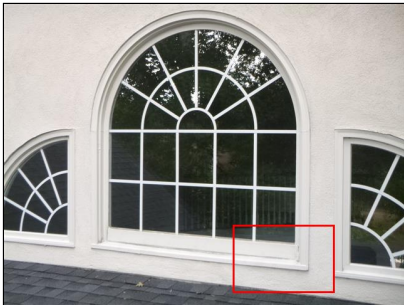
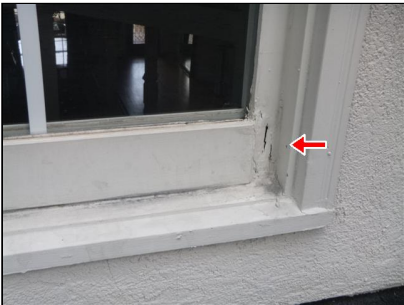
- ✘ 8. **SERVICE / REPAIR:** Rot developing in Corner of Gable vent on side of house, Bottom corner of garage door opening, Lower corner of upper Family room window (built up panel installed at bottom of sash). Replacements of affected materials is considered the best solution for long term performance of repair and plastic moldings are available for even better protection - [Contractor should review for additional damage and probe where suspect to insure that all damage is identified and replaced]. Fillers are discouraged but are commonly used in repairs of smaller areas where replacement would be difficult. Fillers should be done by experienced tradesmen and warrantee for a reasonable length of time. Work area should be primed, caulked and painted to match existing finishes.

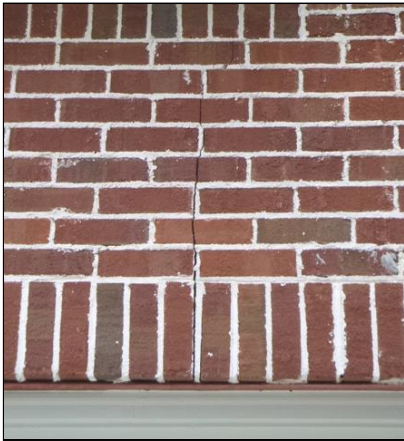
Item 9 - Picture 2

9. **SERVICE / REPAIR:** Hairline crack in brick veneer above garage door opening. Although structural deflection or settling exceeded the tolerance of brick, not significant at this point and likely to be the extent of failure. Repointing or sealing could be done but in many cases looks worse than leaving alone and not likely to be a significant problem if not sealed.

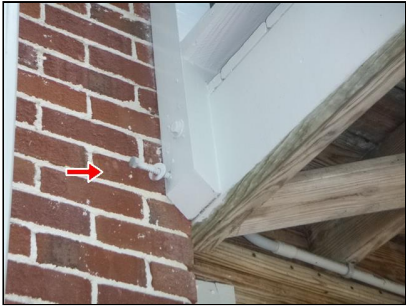
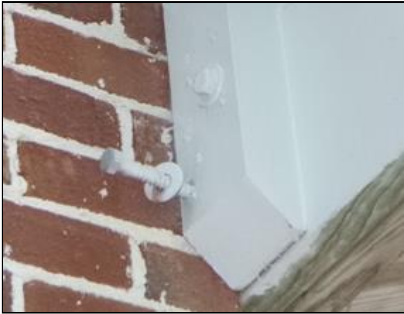
10. **SERVICE / REPAIR:** One deck rail bolts not tightened. Have corrected.

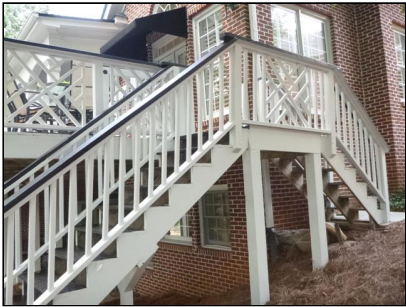
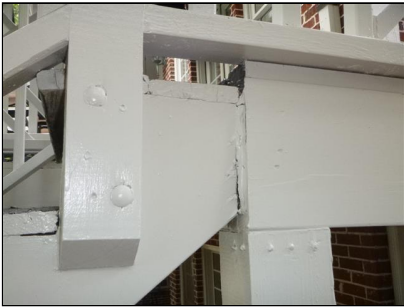
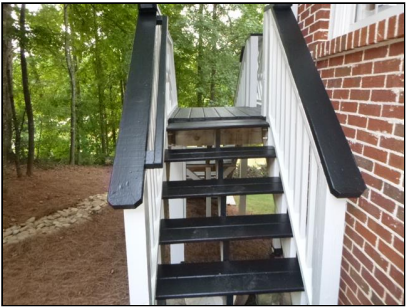
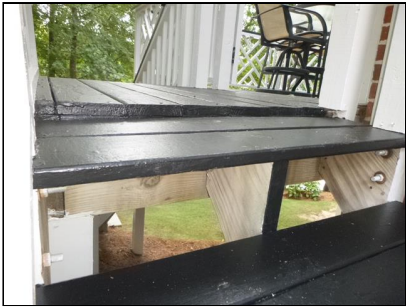
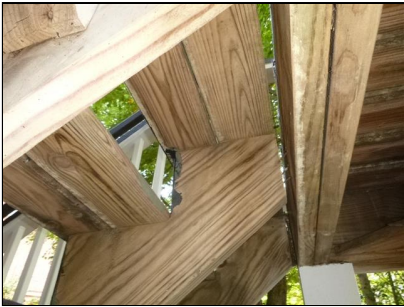
11. **SAFETY / HEALTH:** Side set of stairs from landing extension has settled at the bottom of stairs, between stairs and landing and landing itself. With all the different components, suspect that taking down and rebuilding will be the best option. Consult with contractors for ideas and estimates.

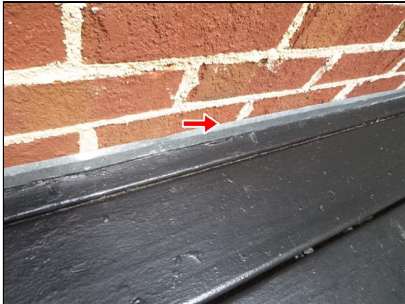
Item 13 - Picture 2

13. **SERVICE / REPAIR:** Deck flashing does not extend into brick veneer and is not sealed at intersection with brick. This can allow moisture behind flashing, which is meant to prevent moisture entry between siding and deck band at house. Seal with silicone caulk.

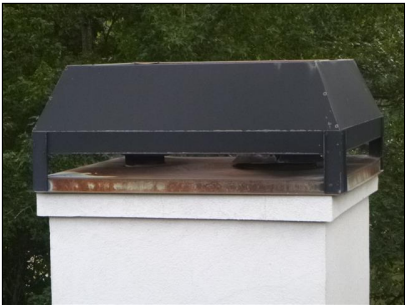
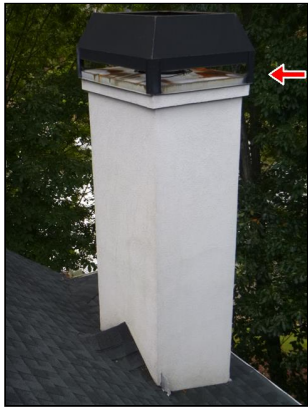
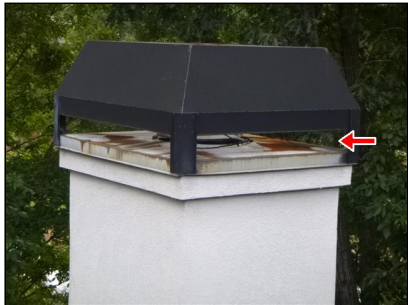
14. **SERVICE / REPAIR:** Rusting noted in cap of both chimneys. Clean and paint with rust inhibitor to prevent future rust through. Also clean and seal cap ring around flue to prevent leaking into chase.

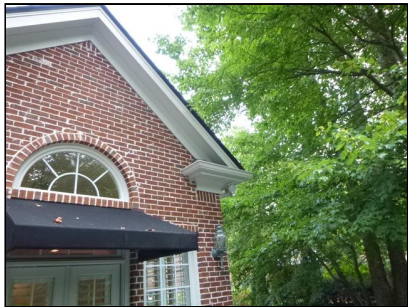
Item 15 - Picture 1

15. **SERVICE / REPAIR:** Trees overhanging or near roof area and would recommend having kept trimmed back to reduce possible damage from wind and to reduce access avenues for climbing pests to roof level.

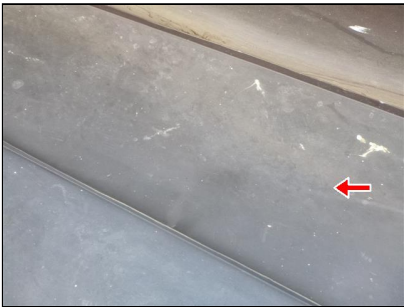
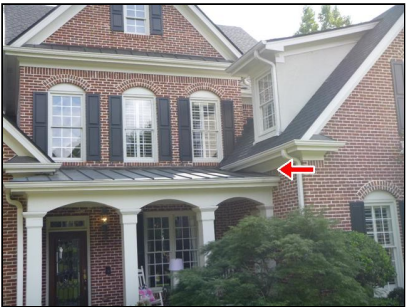
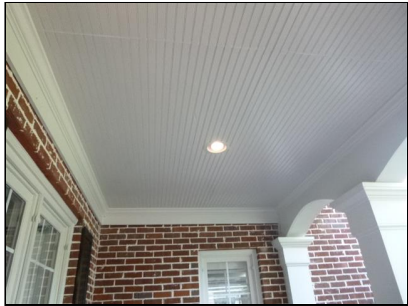
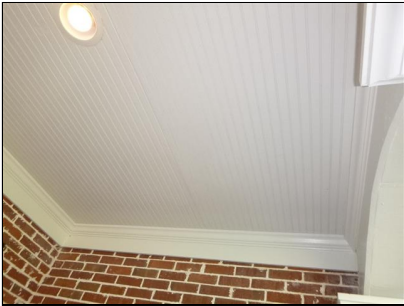
- ❌ 16. **SERVICE / REPAIR:** Metal roof on front porch found to be very soft in area next to Bonus dormer. Expect that roof deck has deteriorated from a leak but ceiling below has only slight damage. There may be a bright side that it's not actively leaking when raining BUT, if someone steps in the wrong spot much heavier than me, the metal may do more than just flex. Recommend having reviewed and repaired for best long term performance.

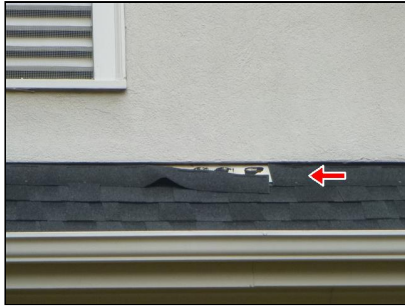
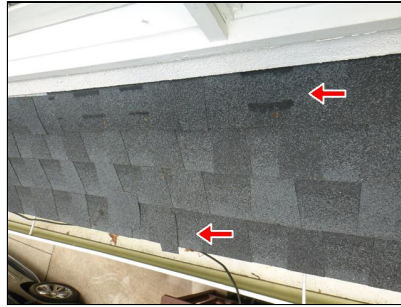
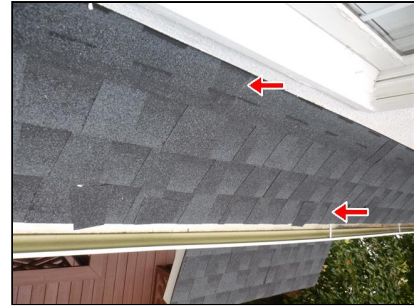
- ❌ 17. **SERVICE / REPAIR:** Accent roofing details found slipped on both sides of house. Recommend having repaired.

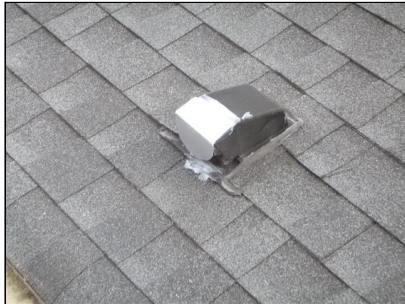
Item 18 - Picture 1

- ✘ 18. **SERVICE / REPAIR:** Exhaust hood above Garage end has a flap installed. Seek disclosure and consider having removed to avoid blocking air flow.

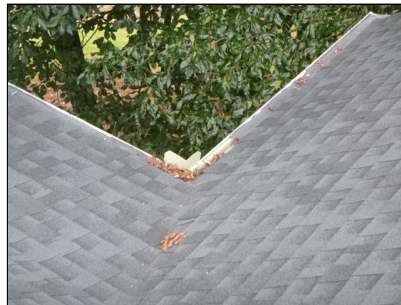
Item 19 - Picture 2

- ✘ 19. **SERVICE / REPAIR:** Its the time of year when the leaves are beginning to fall and gutters will need to be cleaned either now or soon. Gutters need to be cleared as much as twice a year to insure that proper drainage is made away from foundation and out of eaveline.

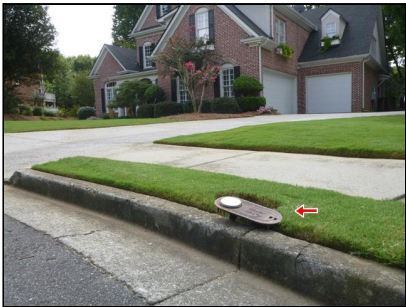
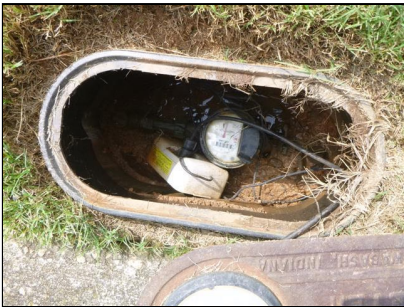
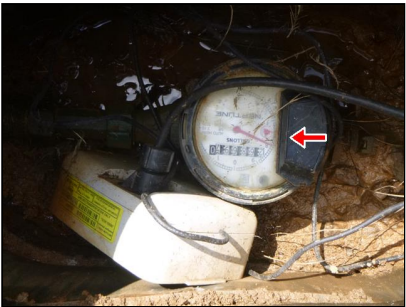
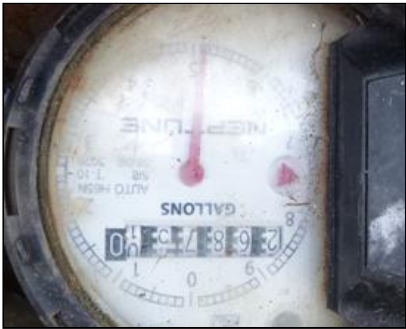
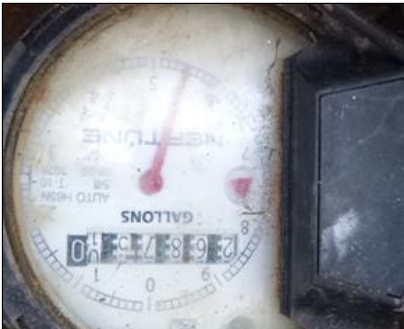
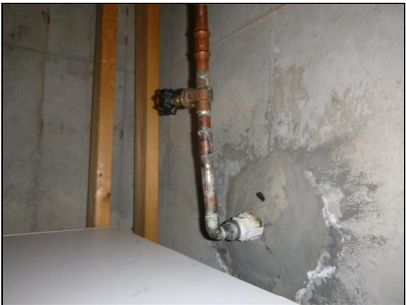
- ✘ 20. **SERVICE / REPAIR:** In reviewing the water meter, there was movement in the usage readout indicating water running/seepage either within home or underground (checked multiple times). Water movement sound noted in basement at main cut off. Have plumber confirm findings and investigate problem. Be prepared to make repairs or replacements to prevent higher water bills.

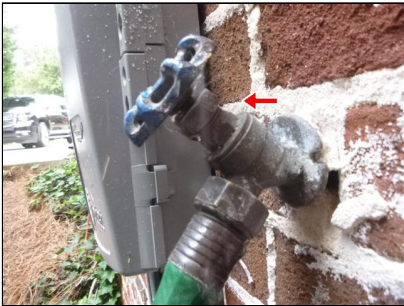
Item 21 - Picture 2

21. **SERVICE / REPAIR:** Hose bibb found to drip from handle when turned on. Have valve corrected to avoid leaking onto ground by foundation when using.

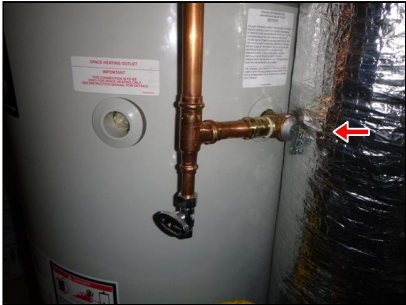
Item 22 - Picture 1

22. **SAFETY / HEALTH:** The temperature pressure relief valve has a rusted or frozen center valve stem. This may prevent the valve from operating as desired to reduce dangerous pressure within the heater. This is a potential safety issue. Recommend a licensed plumber to correct. **NOTE:** T/P drain line from water heater has a drain equipped as required and should be checked and cleared of water periodically. Be prepared to collect water from drain valve. Keeping line dry helps reduce potential of rusting and freeze up of safety valve.

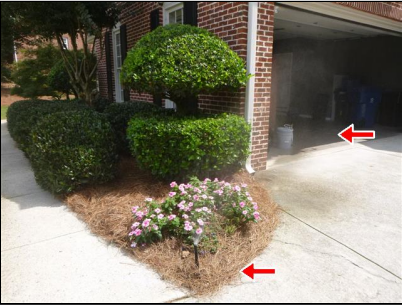
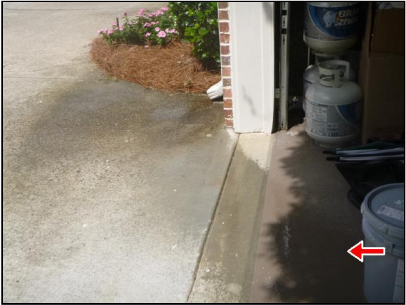
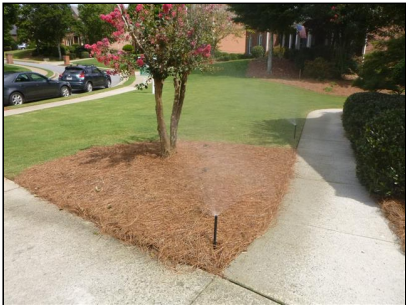
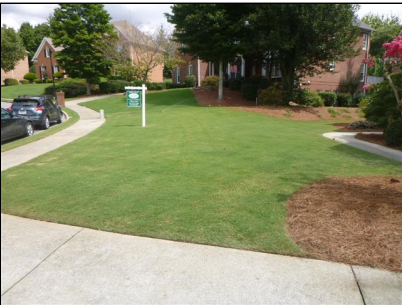
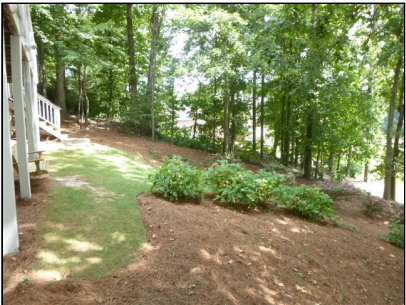
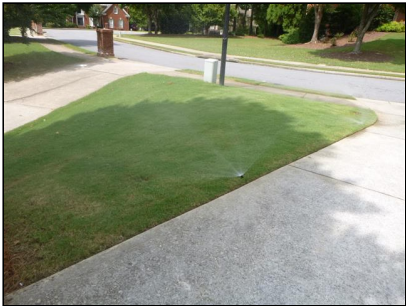
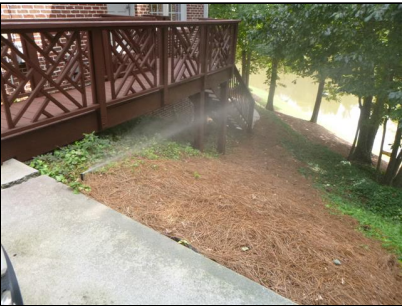
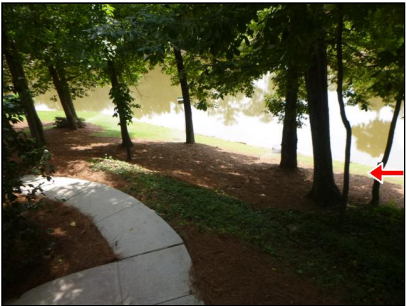
23. **SERVICE / REPAIR:** Various defects found in lawn sprinkler system such as Heads found spraying the house, and should be thoroughly reviewed and repaired as necessary to operate as designed. Recommend having seller demonstrate specific features of this system including cut off valve (usually in the lawn near the street), winterizing procedures and location of solenoids.

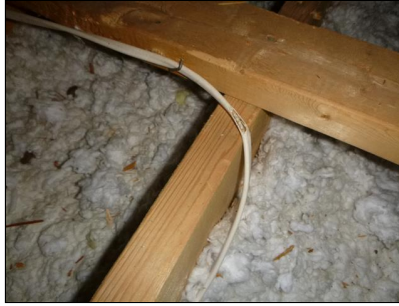
Item 24 - Picture 2

- ❌ 24. **SAFETY / HEALTH:** Electrical circuits in attic found to have been damaged by rodents mainly on the lower attic master side. Exposed circuits have the potential of arcing that produces heat. Proper repair includes replacing wiring of same size and type through extent of damage and providing splice connections enclosed in junction box. (Consult electrician for proper and safe repair process). Electrical tape only advised for minor damage closely reviewed on outer insulating sheathing.

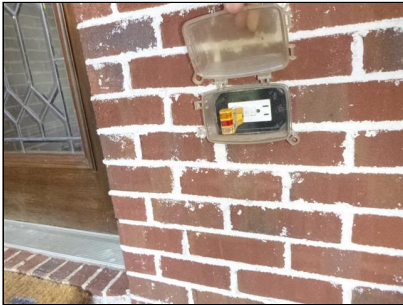
Item 25 - Picture 1

- ❌ 25. **SAFETY / HEALTH:** GFCI receptacle measured dead at Front porch and would not reset. All other resets throughout property were checked to verify reset and would recommend having electrician review and correct as necessary.

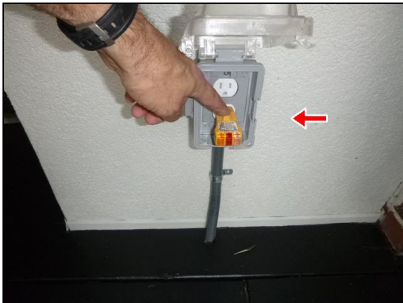
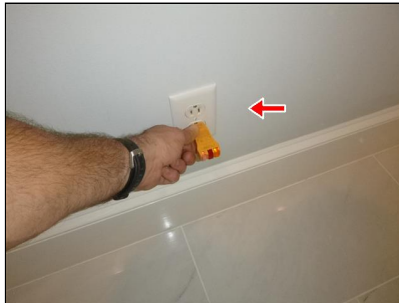
- ❌ 26. **SAFETY / HEALTH:** GFCI protection is missing at Deck, Master bathroom wall. GFCI (ground fault circuit interrupter) protected devices required to be installed at this/these location(s) when originally built for protection from electrical shock. Have corrected by qualified electrician.

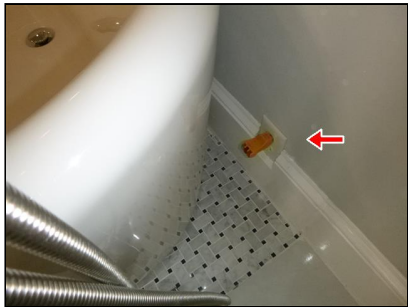
Item 27 - Picture 1

- ❌ 27. **SERVICE / REPAIR:** Inoperable receptacles observed at Master tub (tempered) and Master closet front. Recommend a licensed electrician to evaluate the condition and correct for compliance.

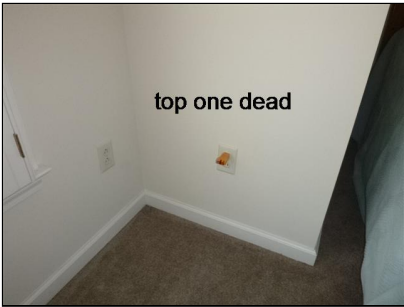
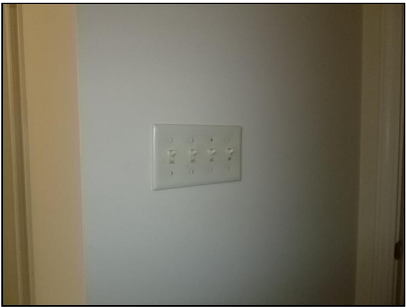
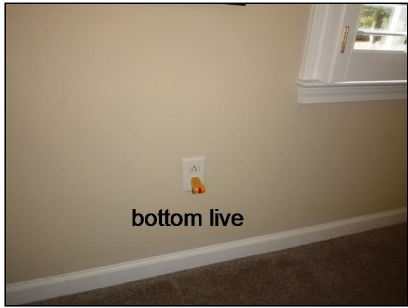
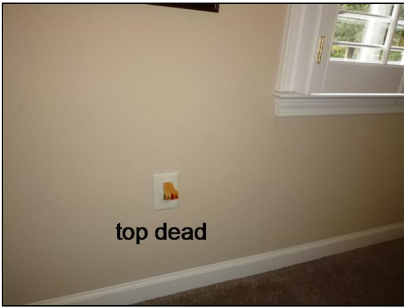
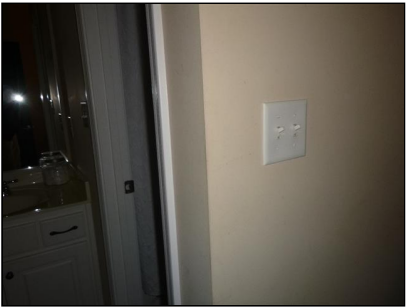
28. **GENERAL NOTE:** Receptacles in at least two of upstairs bedrooms has one half live and the other one dead. Often found in switched devices but not wired that way.

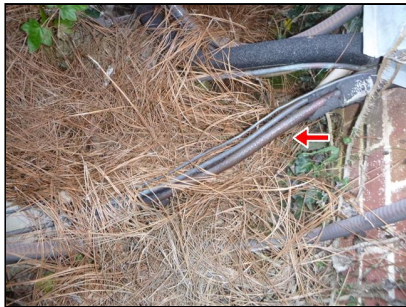
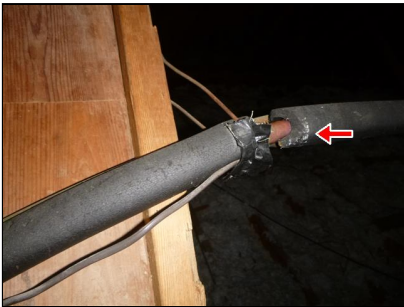
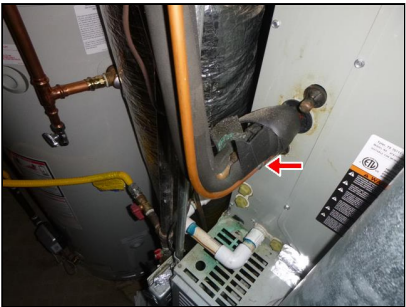
36. **SERVICE / REPAIR:** Refrigerant line insulation is damaged / missing. Replace and repair to prevent condensation and energy loss during operation.

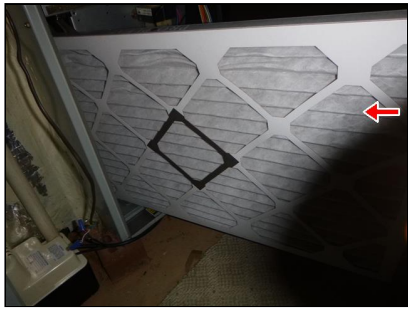
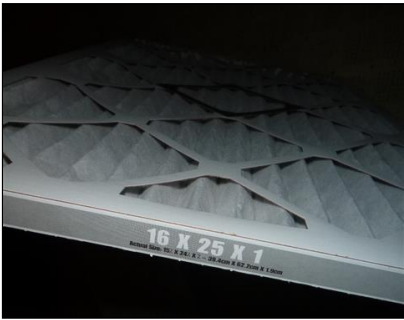
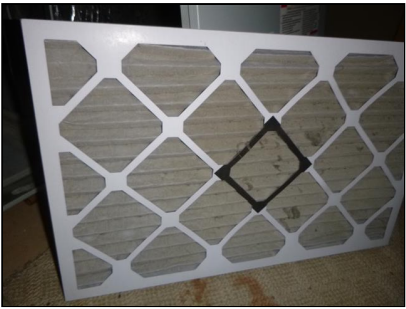
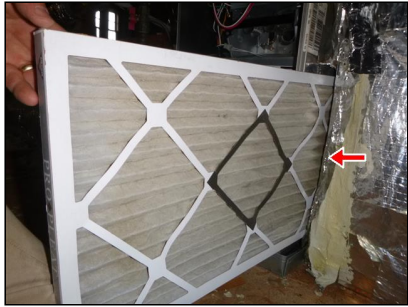
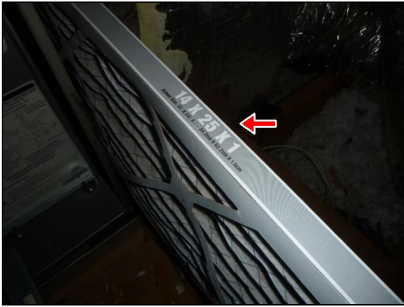
39. **SERVICE / REPAIR:** Filters dirty and should be replaced now and every 2 to 3 months at all three units. Size for units are (2) 16 x 25 x 1, 14 x 25 x 1.

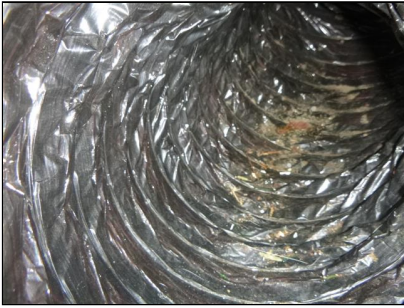
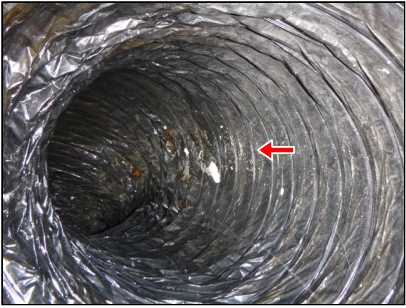
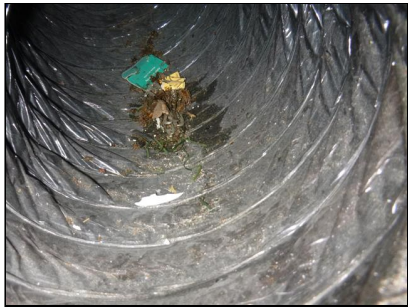
- ❌ 40. **SAFETY / HEALTH:** Debris within floor registers is limited but would recommend having vacuumed to reduce spread of dust during system operation. Although duct cleaning is available professionally, would at least have shop vacuumed to reduce dust.

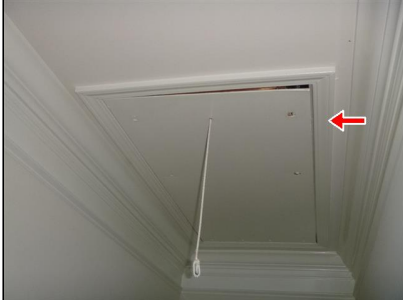
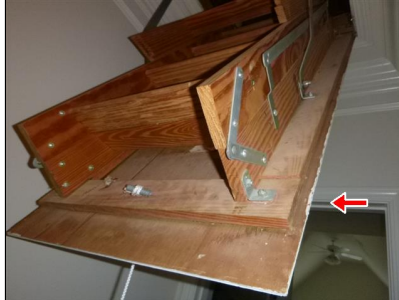
- ❌ 41. **SAFETY / HEALTH:** The pull down stairs to attic is damaged, fails to close completely and is possibly beyond the point of repair. Have reviewed by carpenter and repaired OR replaced as necessary to provide normal and safe ascent to attic level for storage purposes.

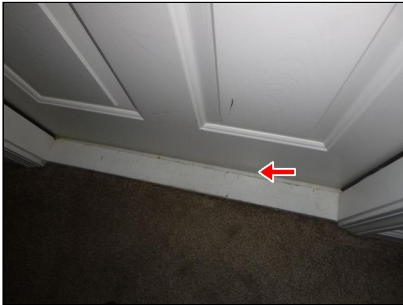
Item 42 - Picture 1

- ❌ 42. **SERVICE / REPAIR:** Door(s) to attic is/are not insulated and less effective in preventing heat loss. Missing insulation on one at upstairs bedroom. Recommend having an effort made to make more energy efficient between conditioned and unconditioned spaces.

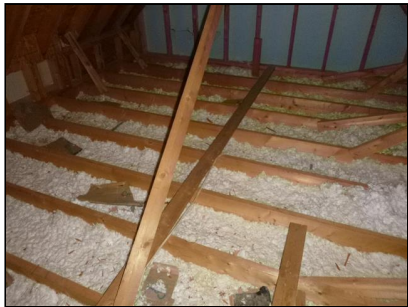
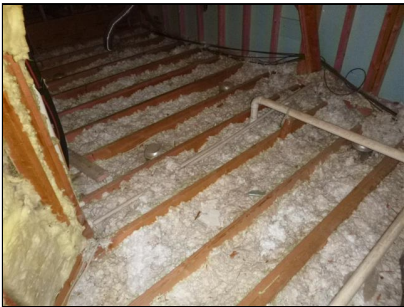
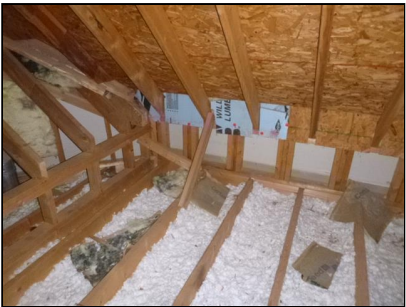
- ❌ 43. **SERVICE / REPAIR:** Insulation matted and value reduced by animal activity and trails in attic. Insulation value should be restored by matted conditions to at least amount required when built. The code has listed R-30 as the bench mark to achieve for nearly the last 20 years.

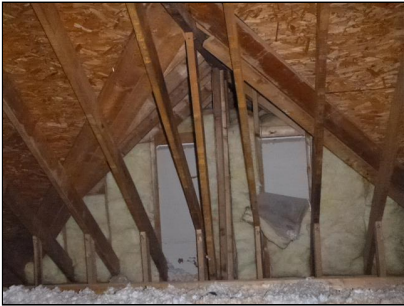
Item 44 - Picture 2

- ❌ 44. **SERVICE / REPAIR:** Insulation between studs in framed wall is missing / out of place at many locations around attic spaces. Recommend insulation be restored with vapor barrier toward heated space to meet required energy conservation.

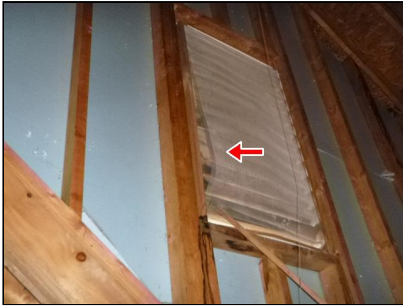
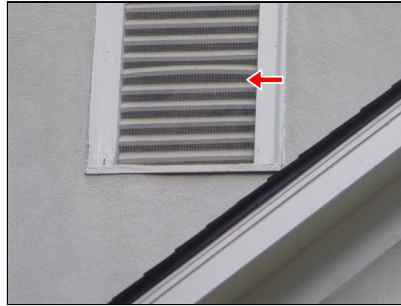
- ❌ 46. **SERVICE / REPAIR:** Damaged attic vent screens observed. Repairs are necessary to prevent pest entry. Replace any screens that have hole or tears. NOTE: There is hardware cloth installed over louvers seen from outside.

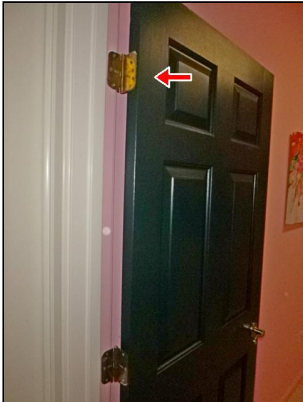
Item 47 - Picture 1

- ❌ 47. **SERVICE / REPAIR:** Screws in hinges at Laundry found to be stripped (failed to tighten with screw driver). Have modified to provide adequate holding to door casing which could result in further damage under normal use.

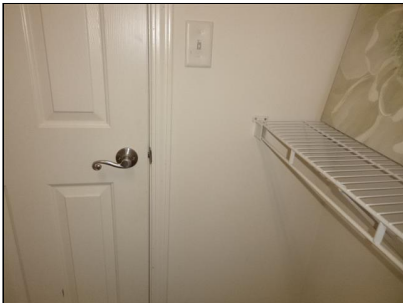
Item 48 - Picture 1

- ❌ 48. **SERVICE / REPAIR:** Adjust or modify door assembly to latch when closed at Front Middle Bedroom closet.

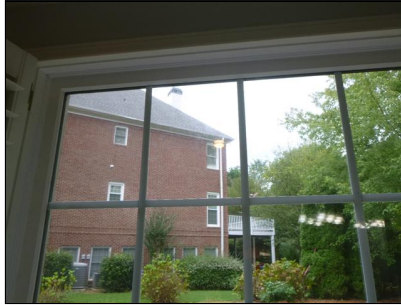
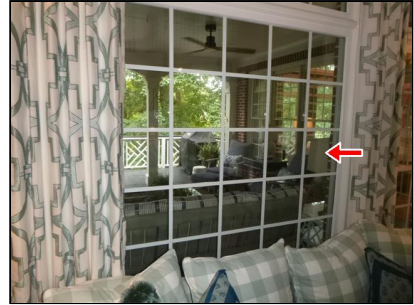
- ❌ 49. **MAJOR DEFECT:** Condensation and / or hazing was noted between insulated window panes. - Location: 1-2) Master tub, 3) Family room picture window, 4) Keeping room transoms - The thermopane insulated glass has lost its vacuum seal and may eventually completely cloud over. Broken seals also reduce the original insulation value of the window. (Dirty windows should be cleaned to assure that conditions do not exist in other units and

were not obvious at time of inspection.) Recommend replacement of all damaged windows listed plus any others throughout house that may be identified by glass service.

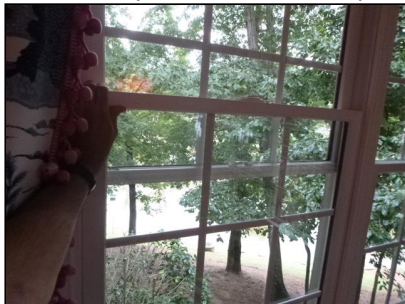
Item 51 - Picture 1

- ❌ 51. **SERVICE / REPAIR:** The counter balance device(s) installed in window sash located at Breakfast do not function correctly to keep in raised position when opened - effectively causing sash to be unbalanced or to drop when raised. Repair unit or have replaced for safety, especially if electing to open windows routinely.

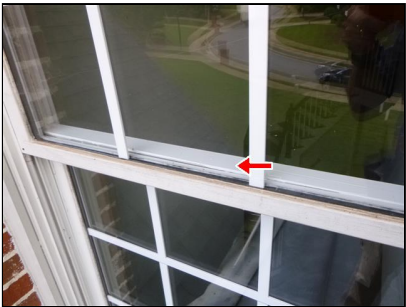
Item 52 - Picture 2

52. **SERVICE / REPAIR:** Recommend having damaged window latch replaced at Master bedroom. Recommend having latch installed at upper Foyer unit.

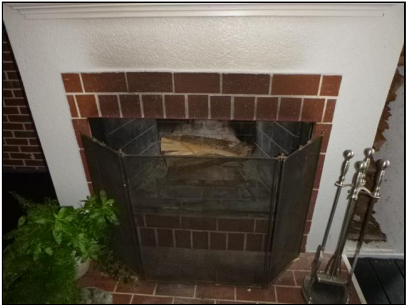
Item 54 - Picture 2

54. **SAFETY / HEALTH:** No permanent fireplace screen installed although a decorative one is in place. Must have some type screen provided when burning especially real wood. If screen is taken when seller, buyer should have one provided before using.

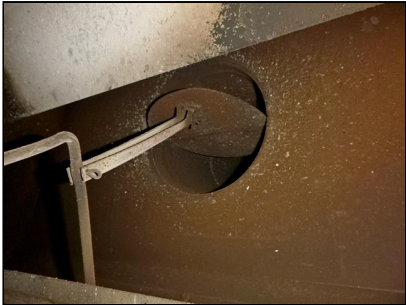
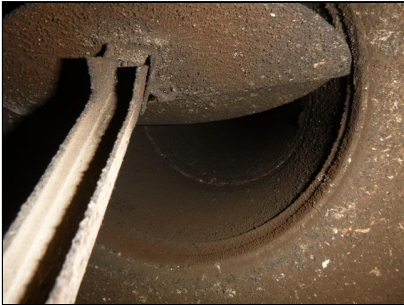
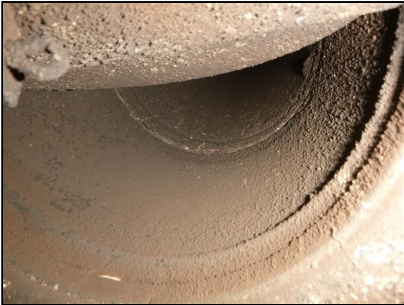
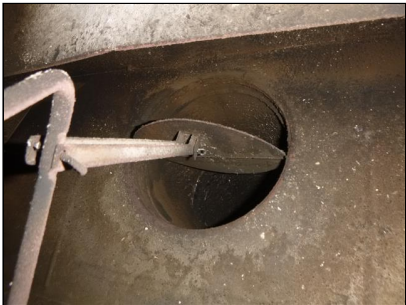
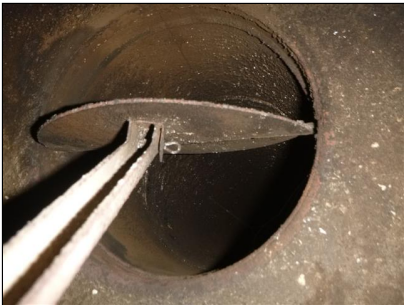
55. **SAFETY / HEALTH:** The chimney flue is dirty at Keeping room, Porch. Have a professional chimney sweep clean the flue for proper operation.

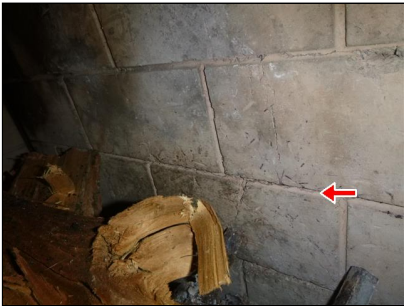
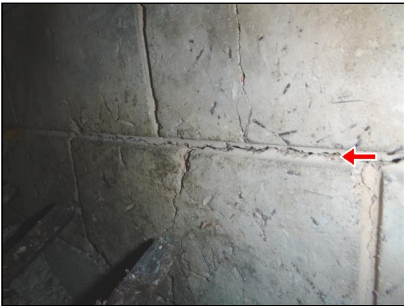
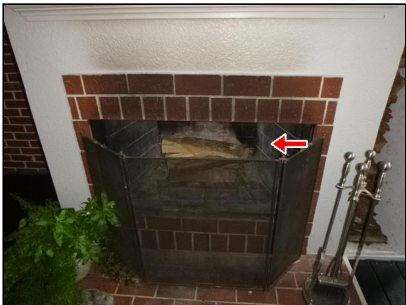
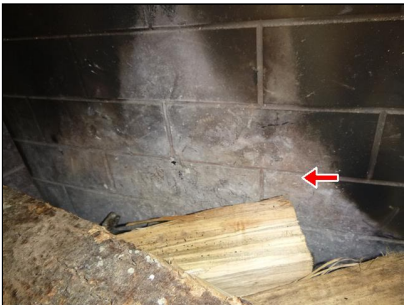
56. **SAFETY / HEALTH:** Firebrick panel in back wall of firebox has cracking at both wood burning fireplaces. Advise replacement of panel for safety to avoid panel falling apart during use.

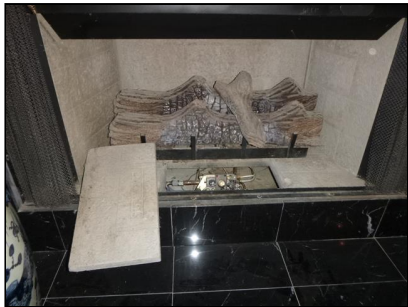
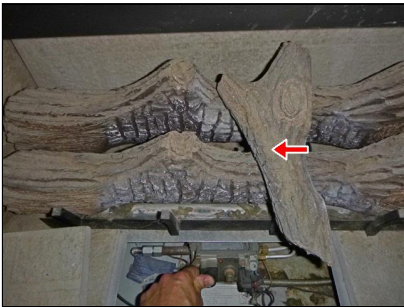
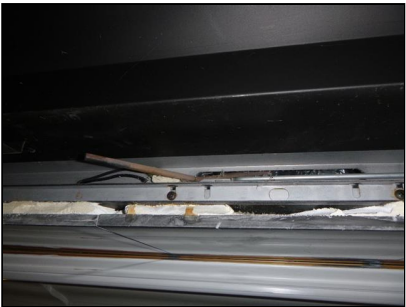
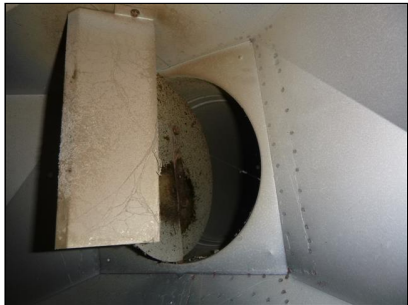
57. **SERVICE / REPAIR:** Could get the pilot to light but would not stay on after thermocouple is warmed up. Have reviewed by fireplace service technician and repaired to operate properly.

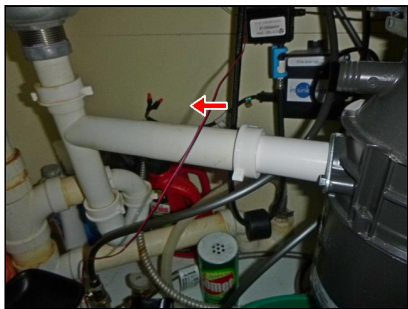
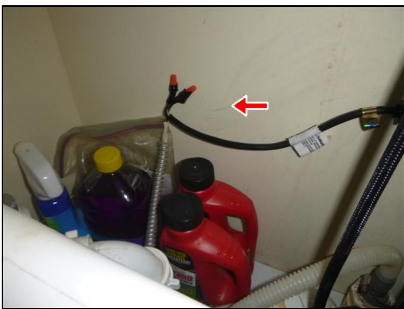
59. **SERVICE / REPAIR:** Conduit installed on disposal wiring under sink found to have a threaded connection outside of junction box. Have corrected for safety.

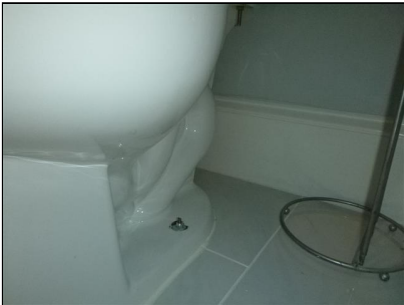
Item 60 - Picture 2

- ❌ 60. **SERVICE / REPAIR:** The toilet base bolts are missing caps on toilet located at Master bathroom. Have installed where missing to protect metal from corrosion.

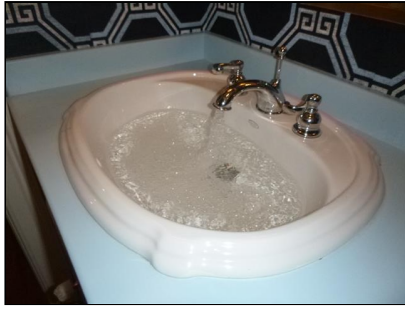
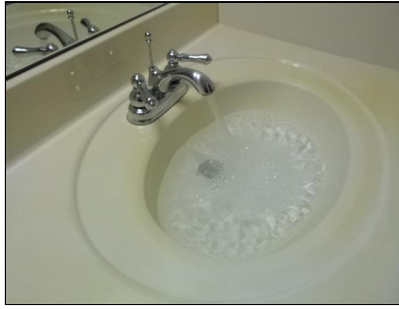
- ❌ 62. **SERVICE / REPAIR:** Aerator in faucet of 1) Half bathroom, 2) Jack & Jill bathroom sink missing and should be replaced to operate as designed and avoid wasting water.

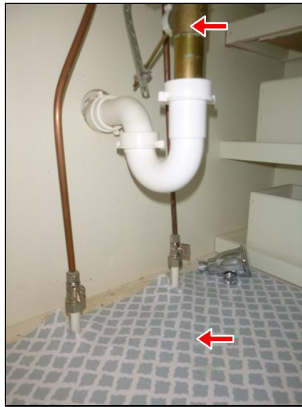
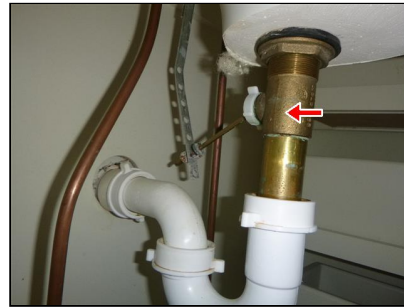
- ❌ 63. **SERVICE / REPAIR:** Drain assembly found to leak below Upstairs private bathroom sink when filled with water and then drained. Recommend a licensed plumber to correct.

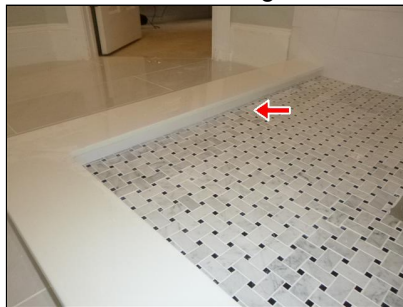
Item 64 - Picture 2

- ❌ 64. **SERVICE / REPAIR:** The glass enclosure for the shower is not installed at time of this inspection at the Master bathroom. Verify conditions once installed confirming that tempered glass is used and that assembly has been adequately sealed from the inside to resist leaking outside of enclosure. Seal opening in grout below threshold.

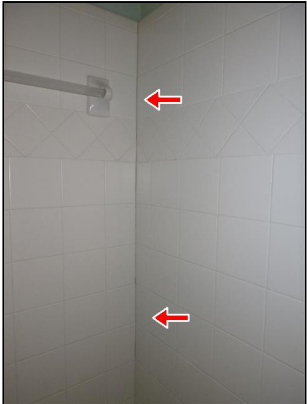
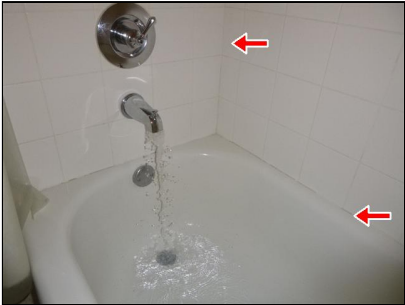
- ❌ 65. **SERVICE / REPAIR:** Caulk and / or regrout tile corner joints in tub and shower areas including intersection to floor tile. Open cracks can allow moisture intrusion which can weaken tile conditions. IRC Section P2705 Installation #3, water tight where contact with walls.

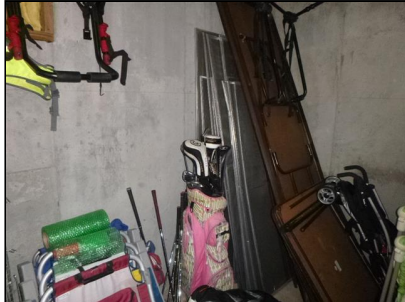
Item 66 - Picture 1

66. **GENERAL NOTE:** Storage noted in basement limits the ability to survey all areas. Recommend having space reviewed prior to closing to verify that conditions look normal.

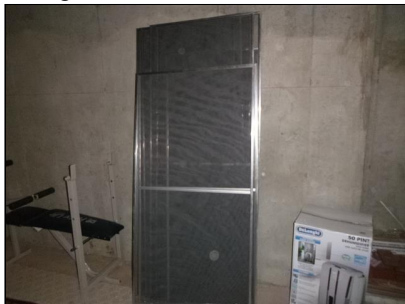
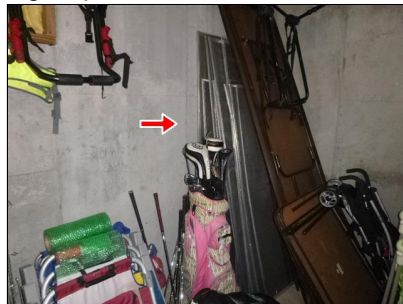
68. **GENERAL NOTE:** Screens found stored at time of inspection. Correct number and correct sizes including which one goes where not determined during inspection.

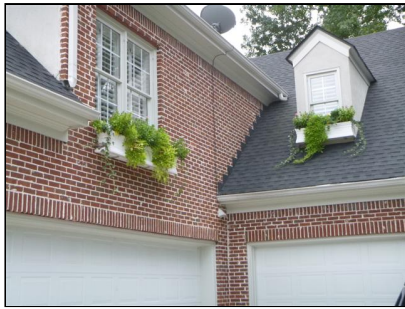
Item 69 - Picture 1

69. **GENERAL NOTE:** Window plant boxes have an attractive appeal but can hide moisture damage. Consider a look without them.

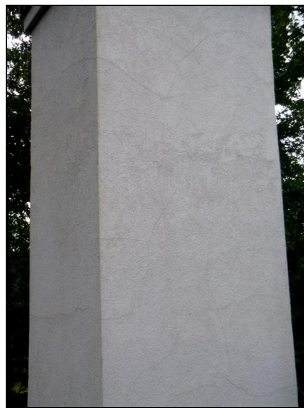
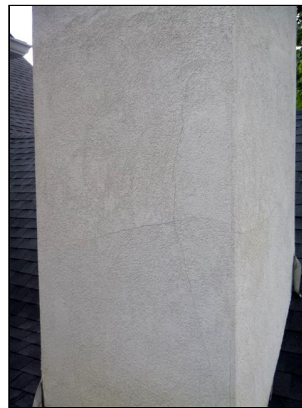
70. **GENERAL NOTE:** Common stucco cracks observed. Because stucco is a concrete-like material some cracking is certain and is not considered significant. Periodic application of a sealant to the cracks is recommended to prevent water entry.

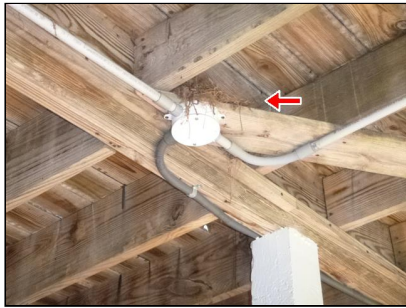
Item 73 - Picture 1

73. **GENERAL NOTE:** Bird nest on top of structures of deck. Consider having deterrent added to limit that habitat.

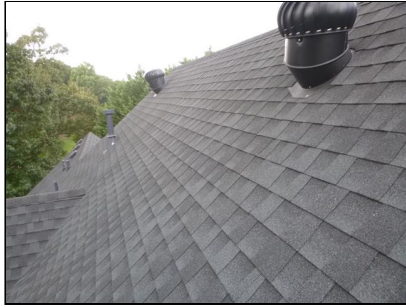
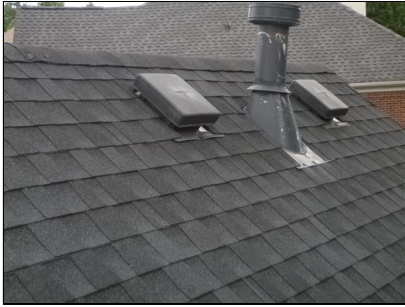
74. **GENERAL NOTE:** The roof covering is in the first third of its predicted life span.

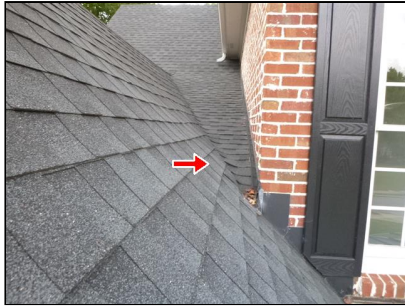
Item 75 - Picture 1

75. **GENERAL NOTE:** Dead valley and low slope cricket configurations are prone to catching leaves and other debris. Expect to clear routinely to avoid potential leaking conditions.

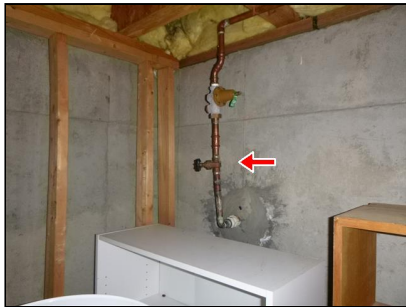
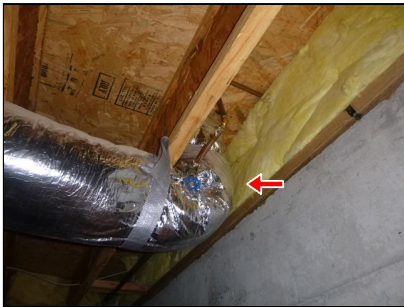
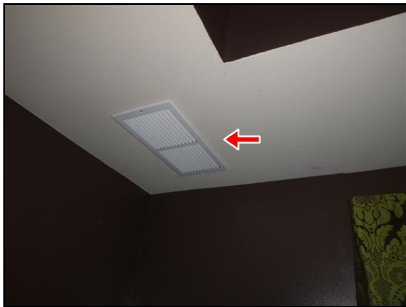
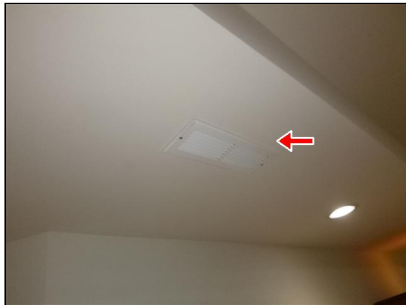
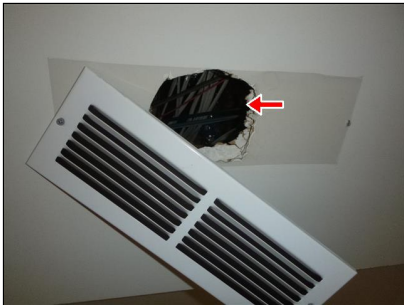
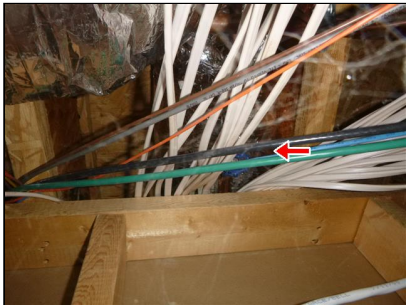
78. **GENERAL NOTE:** The main water shut off is located front wall of basement. The exterior hose bibb shut off valves are located To the right of main cut off, Basement through access grills on ceiling. Recommend turning off the exterior hose bibbs in the winter and draining the lines to reduce chances of freeze damage to exposed piping. (Recommend having main and exterior cut offs labeled to insure accurate servicing or winterizing - IPC 606.4)

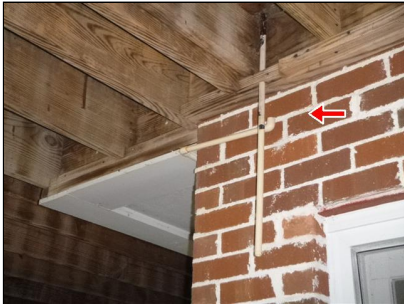
Item 79 - Picture 2

79. **GENERAL NOTE:** Exterior spigot had been run to deck level but appears to have been taken apart. Recommend having removed.

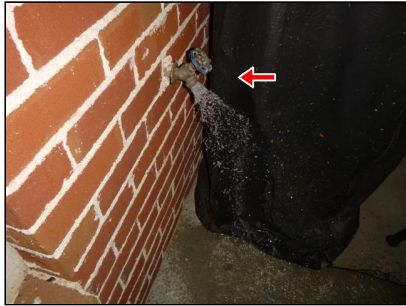
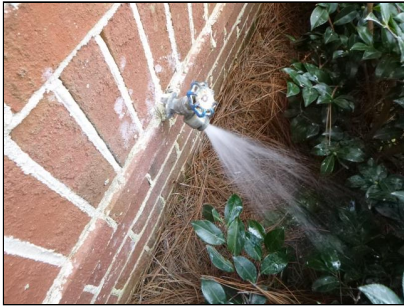
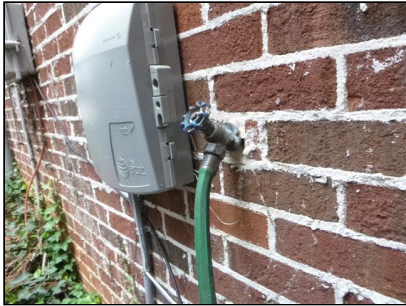
80. **GENERAL NOTE:** The exterior faucets should be shut off on the interior of the building during coldest months to avoid freezing which can lead to burst pipes.

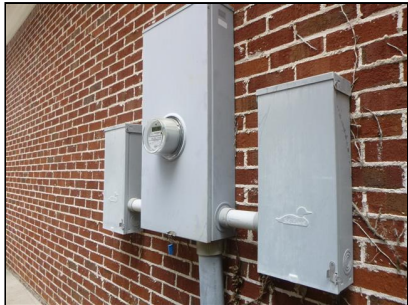
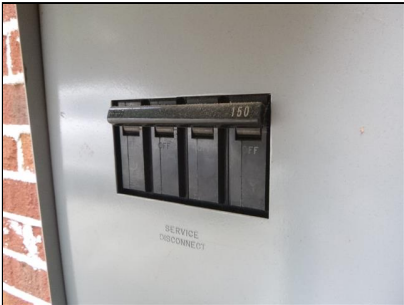
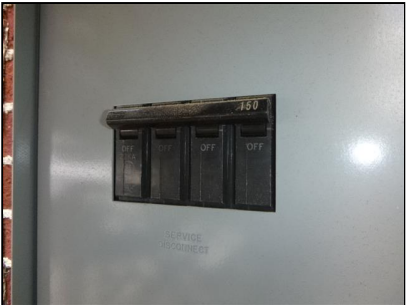
81. **GENERAL NOTE:** Main disconnect is located near meter outside. Cover often fitted with light weight hasp but most people do not have locked.
