**House Smart**

**860 Longstone Landing  
Alpharetta GA 30022**

Client(s): Koller  
Inspection Date: 9/10/2020  
Inspector: Keith Cook , ASHI 202558

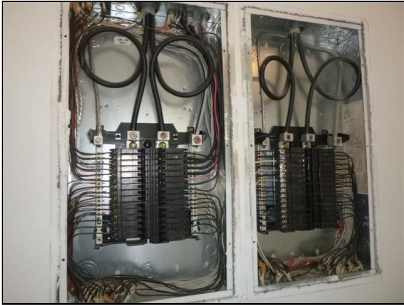
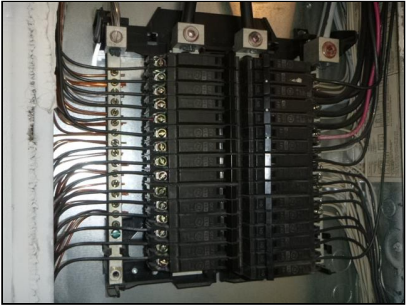
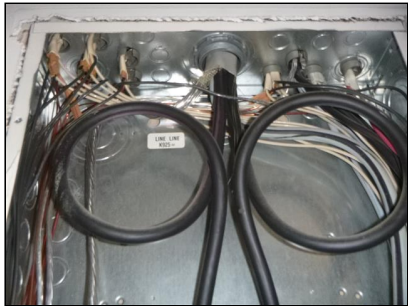
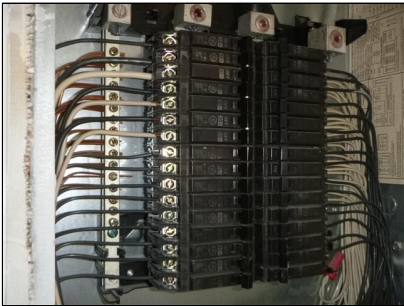
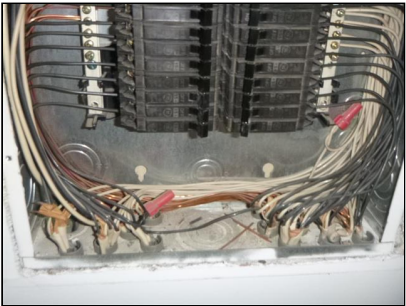
82. **GENERAL NOTE:** The interior of the electrical panel was observed and appears normal.

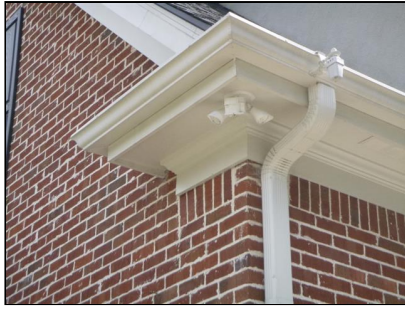
Item 84 - Picture 1

84. **GENERAL NOTE:** Motion sensor / photo cell type light fixtures observed on the exterior. These lights should be verified after dark. Unable to test at time of inspection.

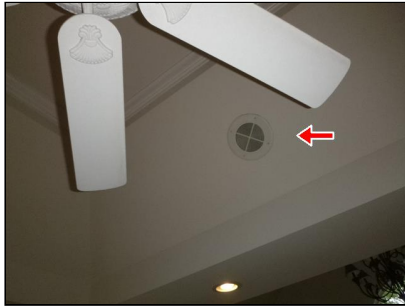
Item 85 - Picture 1

85. **GENERAL NOTE:** Speaker/wiring installed within home is not reviewed in terms of continuity or to test sound systems. Seek disclosure from seller on information pertaining to the prewiring of locations.

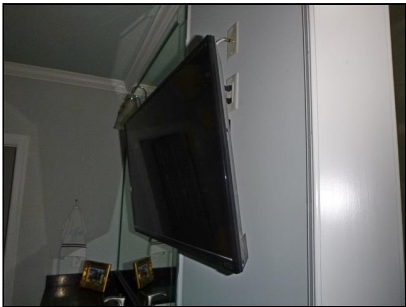
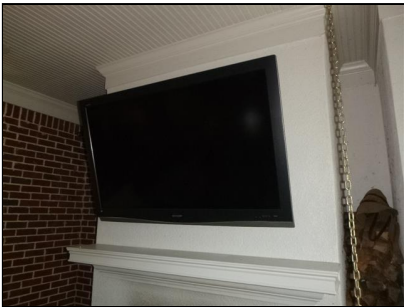
87. **GENERAL NOTE:** Media equipment (if left with property) is beyond the scope of inspection and should have information left with buyer and/or demonstrations made available to orient buyer with equipment that may have special features. If not remaining with property, wall mountings will leave holes that will require repair. Expectations should be agreed upon between buyer and seller.

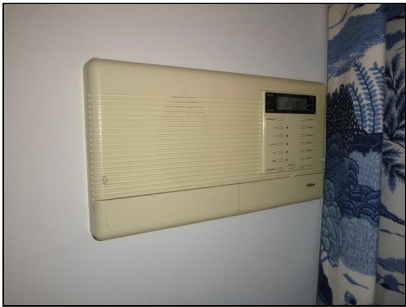
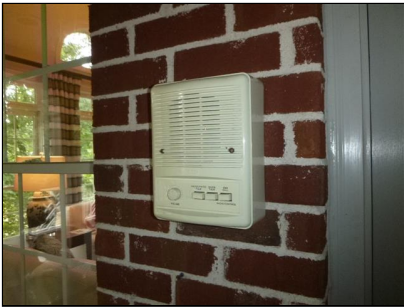
88. **GENERAL NOTE:** Intercom system located throughout home but reliability should not be expected. This type of equipment is prone to problems.

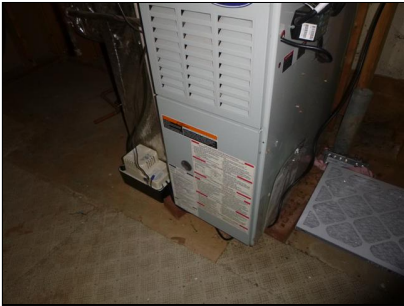
Item 89 - Picture 2

89. **GENERAL NOTE:** Today's requirements for HVAC systems is to install units in pans on basement level where condensate drainage failure could result in flooding finished areas. Consider some form of moisture detection for safety of finished if pan is not provided.

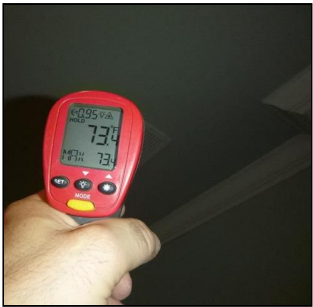
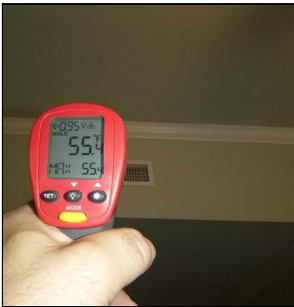
90. **GENERAL NOTE:** Temperature difference measured: 18 -21 degrees, Satisfactory

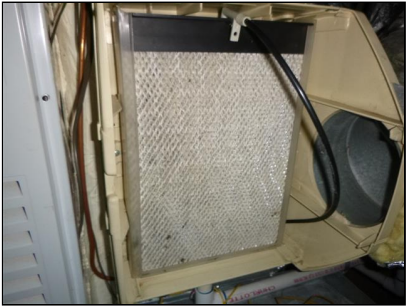
Item 92 - Picture 2

92. **GENERAL NOTE:** Routinely service humidifier for sanitary conditions of unit if electing to use. Media can become dirty allowing fungal growth on damp surfaces. Expect to replace periodically.

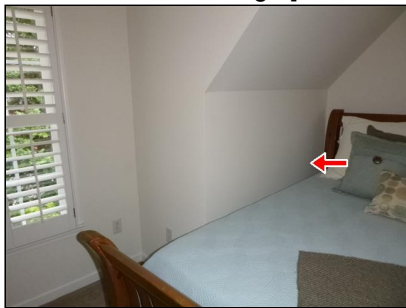
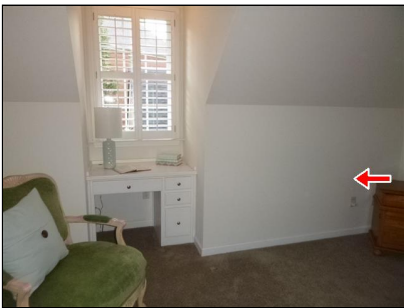
95. **GENERAL NOTE:** There are short attic spaces that do not have access provided. Conditions of framing, roof and insulation cannot be verified. Although not likely to have been required when originally built, would recommend having openings made including doors to close if electing to confirm conditions. [Often spaces can be used for limited storage.]

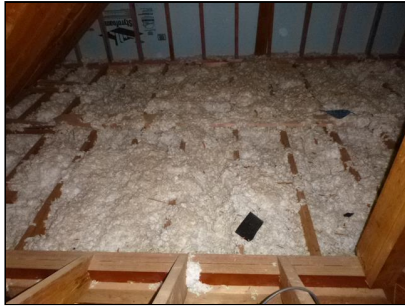
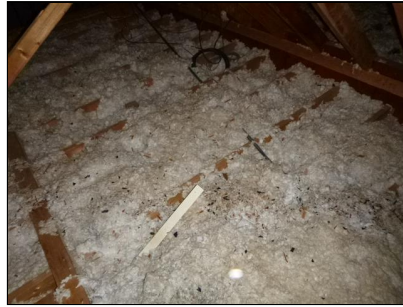
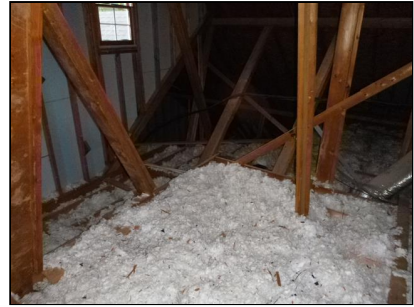
96. **GENERAL NOTE:** Conditions of attic insulation is good for some of areas surveyed.

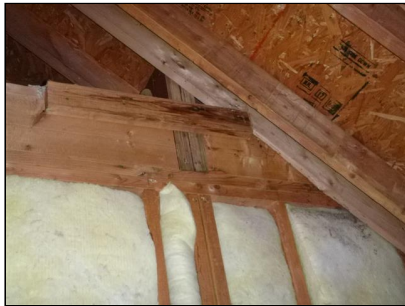
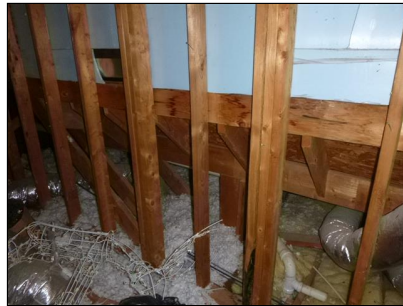
97. **GENERAL NOTE:** Staining found in roof deck and framing are believed to be from problems that occurred prior to the roof replacements or repaired. Recommend having monitored during periods of heavy rain to insure that conditions are not active and would require repair.

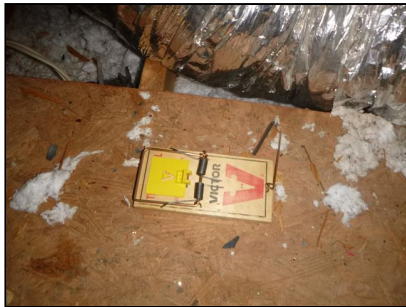
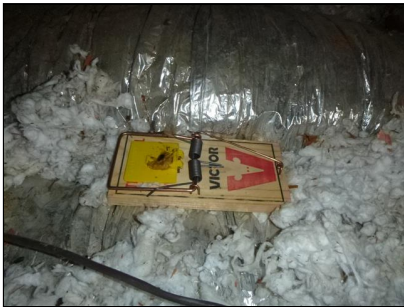
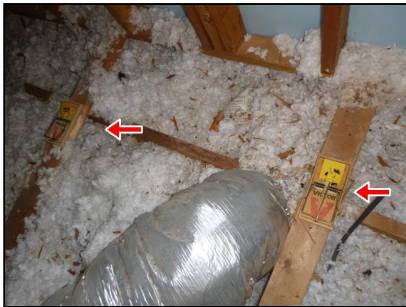
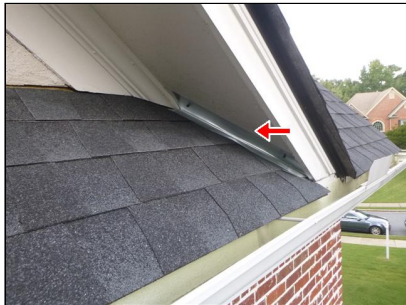
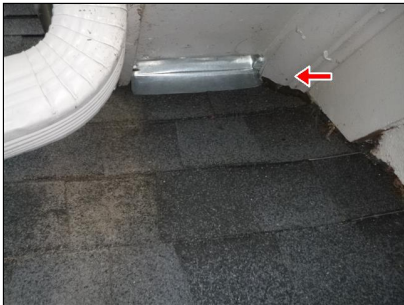
98. **GENERAL NOTE:** Appears to have had efforts made to eliminate pest entry into attic spaces. Seek disclosure from seller on this for future reference and have warrantee information provided if available. Traps found in upper attic are two tripped and two set below window front. All empty.

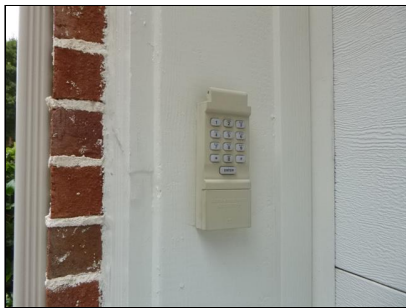
Item 99 - Picture 1

99. **GENERAL NOTE:** Remote keypad mounted outside of garage provides a method for opening the garage with security of a code. This code number should be provided to buyer or have reprogrammed per manufacturers instructions.

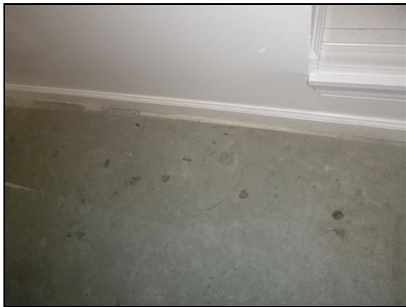
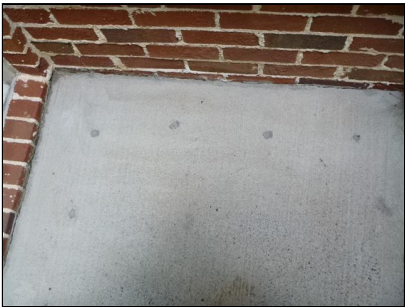
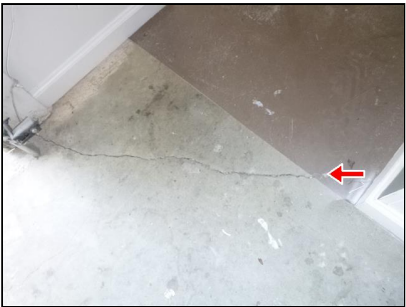
- Floor**
100. **GENERAL NOTE:** Drill holes in slab of garage generally from previous termite treatment. Unable to verify when this was done and would recommend seeking disclosure from seller for future reference. **ALSO:** Common cracks observed in the concrete surfaces. These are expected and are not generally considered significant. Monitor conditions that should not exceed 1/4 inches width or significant differential settlement.

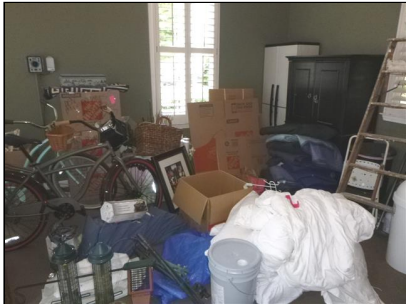
Item 101 - Picture 1

101. **GENERAL NOTE:** Due to personal objects stored in the garage not all areas were visible. Verification of all conditions by the seller is necessary.

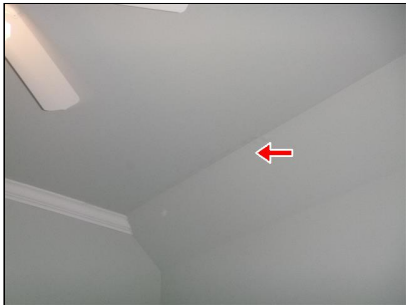
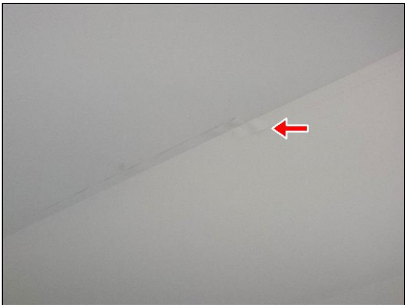
102. **GENERAL NOTE:** There are cosmetic blemishes in drywall such as cracking, exposed tape, nail pops, etc... These are commonly resurfaced prior to repainting to help improve the appearances.

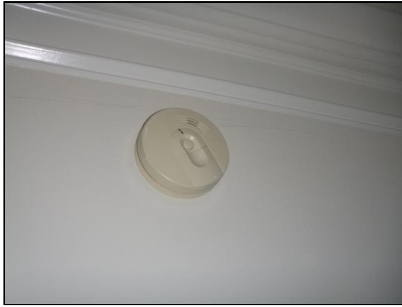
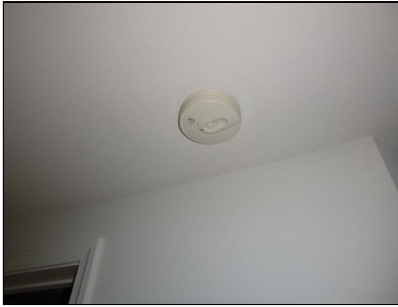
103. **RECOMMENDED UPGRADE:** Older model smoke detector observed. Manufacturers recommend the replacement of smoke detectors every ten years due to the declining sensitivity of the internal sensors. Consider the combination device that includes CO detection for added safety.

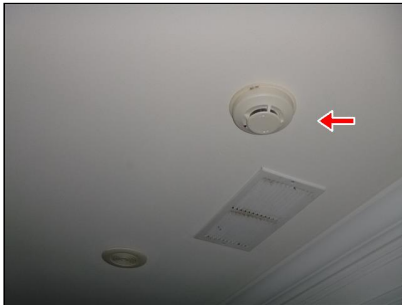
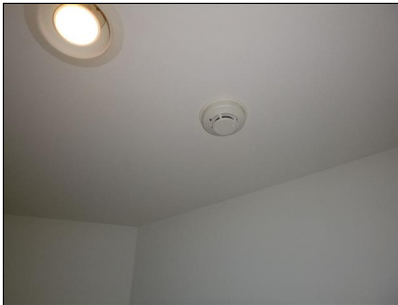
104. **GENERAL NOTE:** Some of smoke detectors within home are type commonly used with security system and would not function if security system is not powered up. If security system is not monitored or powered, be sure that the other detectors are operational.

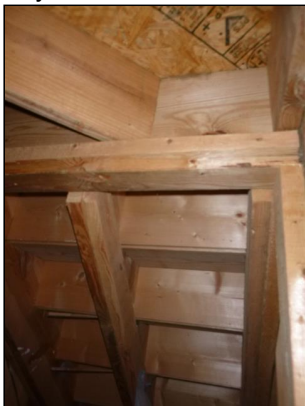
Item 105 - Picture 1

105. **GENERAL NOTE:** Storage areas below stairways are currently required to be finished with at least 1/2 inch drywall installed to all exposed wood surfaces for fire safety. Additionally, no flammable materials should be stored there to avoid resulting in losing primary exiting path during a fire. Another option is to seal off area to prevent access. Although this may not have been a requirement when built or enforced by local authorities, buyers should consider this as a safety upgrade.

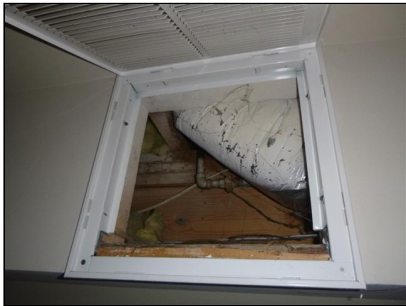
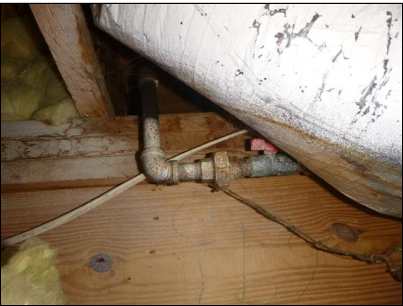
107. **GENERAL NOTE:** Remote access to gas valve for fireplace on porch.

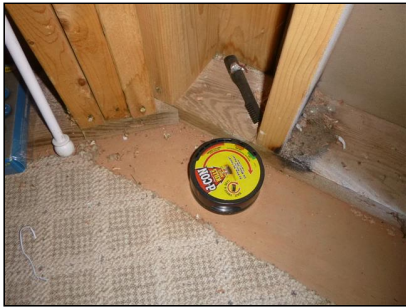
Item 108 - Picture 1

108. **GENERAL NOTE:** Pest control noted in basement. Seek disclosure on history of issues.

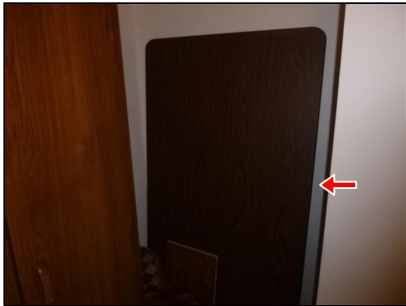
Item 109 - Picture 1

109. **GENERAL NOTE:** Grill behind table in Basement closet. Seek disclosure as to purpose.

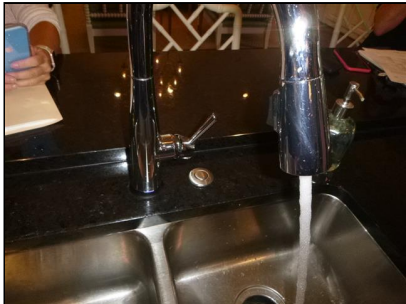
Item 110 - Picture 1

110. **GENERAL NOTE:** Kitchen sink has a system that permits operation without use of faucet valve. Styles are either touch or touchless activated and operate through batteries in cabinet below. If batteries die, faucet will not operate.

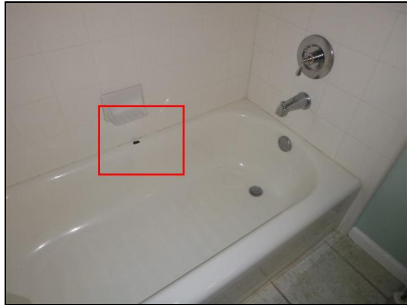
Item 111 - Picture 1

111. **GENERAL NOTE:** Chip(s) noted in tub finish at Upstairs private bathroom can be and are recommended to be repaired by tub restoration company.

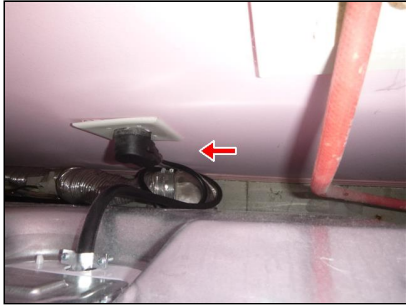
Item 112 - Picture 1

112. **GENERAL NOTE:** Dryer energy supply is 4 prong electrical only.

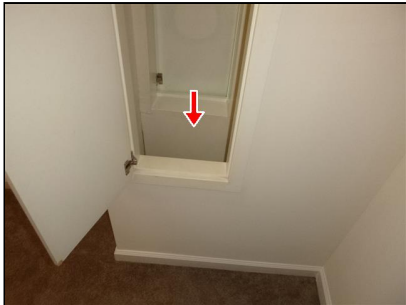
Item 114 - Picture 1

114. **GENERAL NOTE:** Laundry chute from upstairs. Should be cautious with children and their desire to see what will go through the chute.
