Inspection Report

956 McDonald Rd
Dahlonega GA 30533

Superior Home Inspections

Date: 9/11/2020	Time: 10:00 AM	Report ID: 091120
Property: 956 McDonald Rd Dahlonega GA 30533	Customer: Anthony Wasilewski

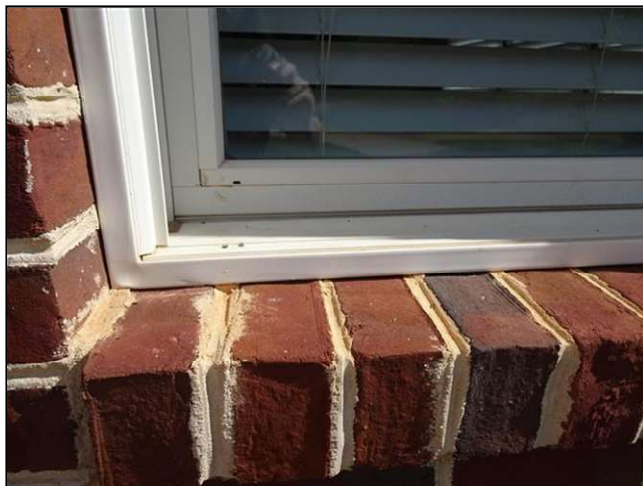
2.2 Item 2(Picture)

Windows need sealant/caulking where missing at edge trim where it meets brick cladding. Deterioration, leaks, and energy loss may occur if not corrected. Recommend repair as needed by qualified contractor.

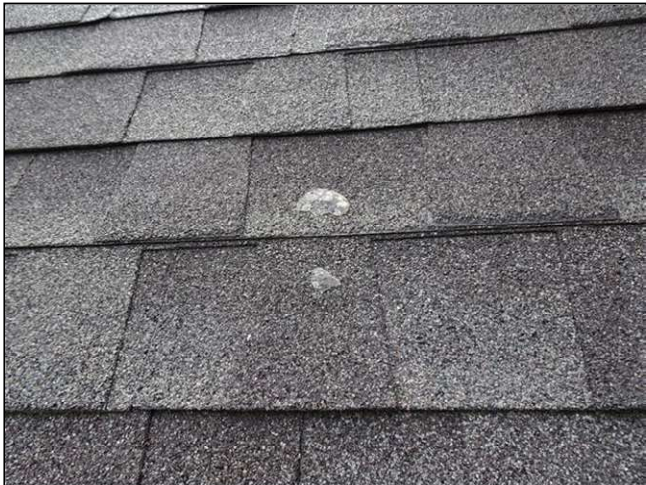
3.0 Item 2(Picture)

Roof shingles had evidence of wear, notably front sides. There was granule loss and wear with fiberglass mat being exposed. Additionally there were multiple areas of nail pops, lifted shingles or nail holes. Recommend further evaluation by a qualified roof contractor for corrections, repairs or replacement.

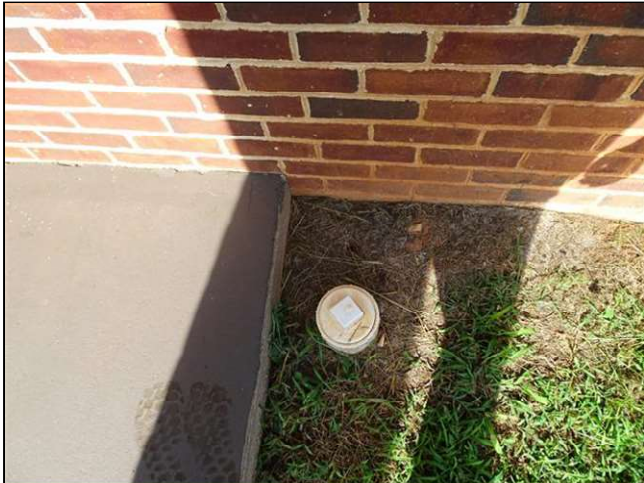
4.0 Item 1(Picture)

(1) This home has an apparent septic tank system. I do not inspect septic tanks or their components. Recommend asking current owner for supporting documentation or service records. It is recommended to have the tank/components evaluated and pumped every 5 years approximately. There is a sewer clean-out at rear yard.

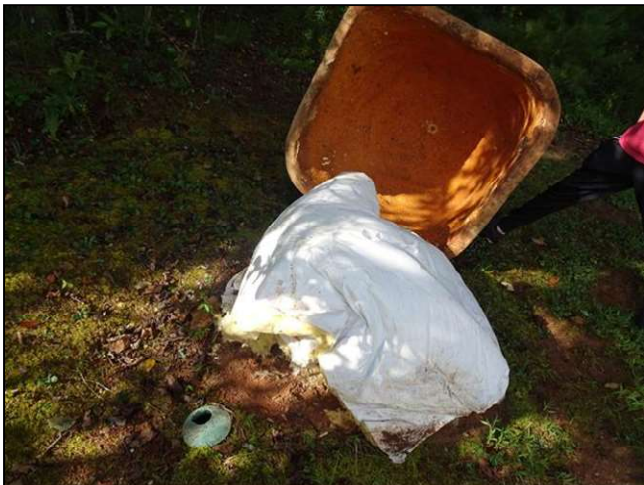
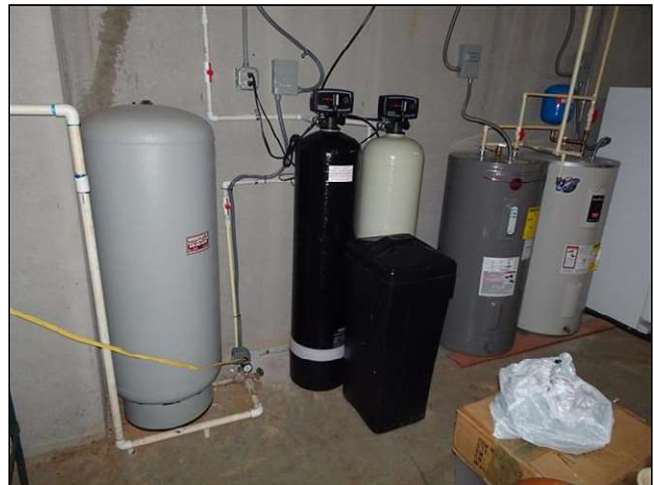
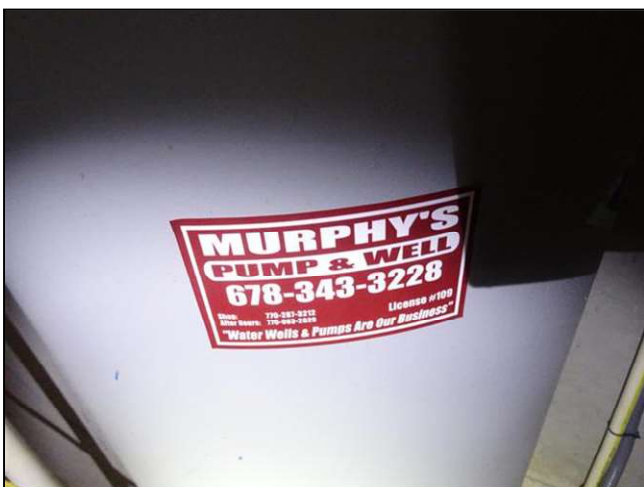
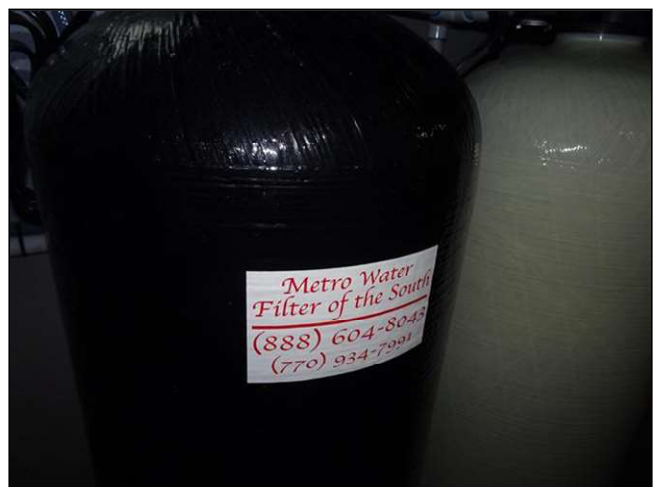
(1) This home has an apparent well system. I do not inspect well systems or components. Home has a water filtration system as well. I recommend having a licensed well contractor evaluate along with bacteria (water quality) testing.

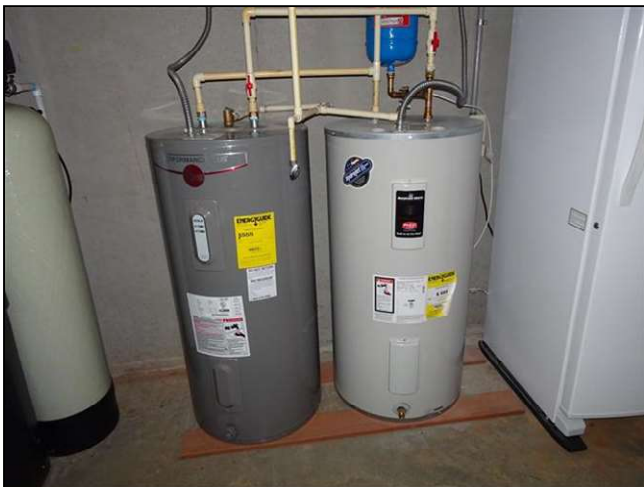
4.2 Item 1(Picture)

There are two electric fired tank water heaters. Both are approximately 4 years old. Both were functional at time of inspection.

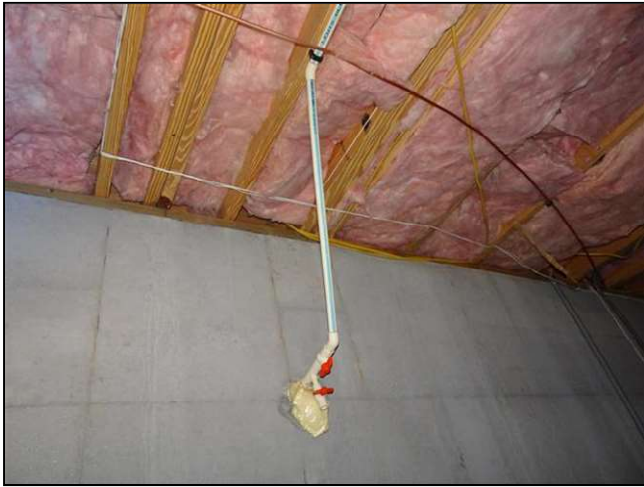
4.3 Item 1(Picture)

Located in the basement.

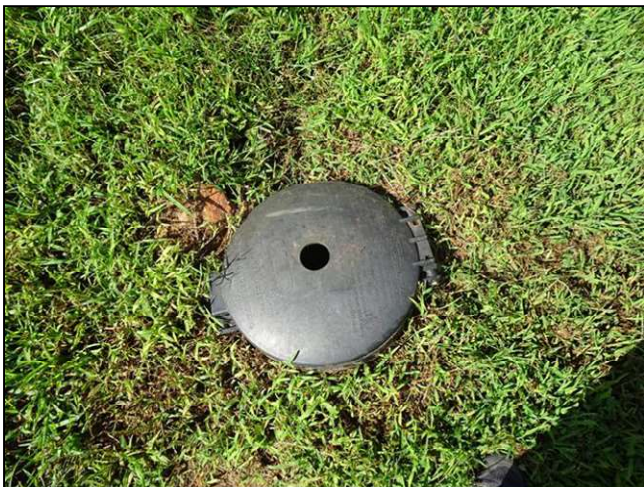
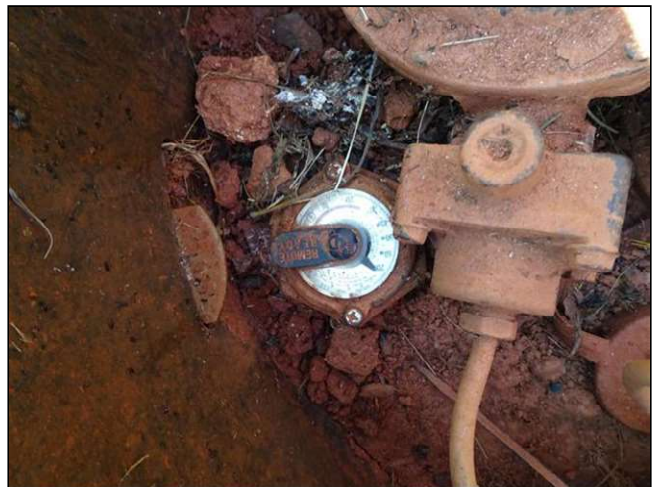
Located at rear yard at tank. There is a buried LP tank at rear yard. I do not inspect septic tanks or their components. Recommend asking current owner if tank is owned or leased. Recommend evaluation by a licensed gas contractor as needed.

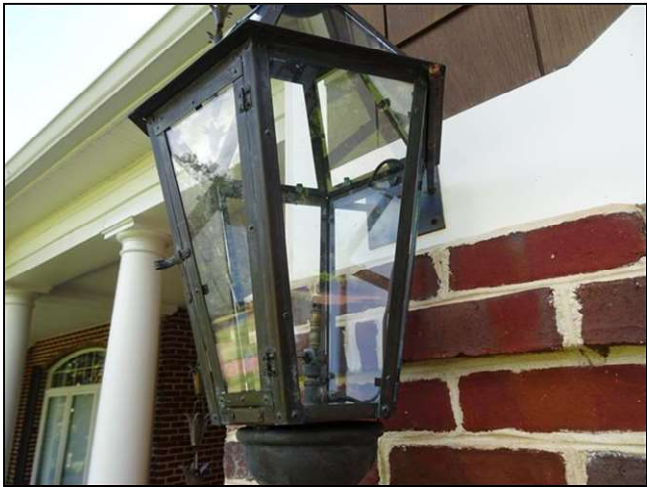
4.5 Item 1(Picture)

There are gas lighting fixtures at front of home. I did not function test these. Recommend asking current owner how they are controlled and if functional.

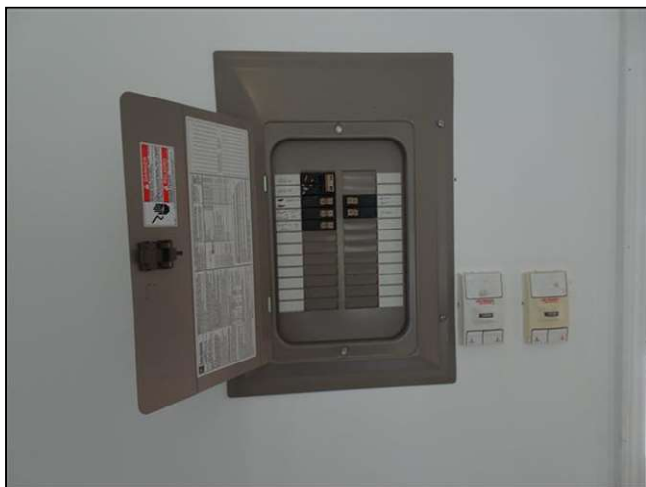
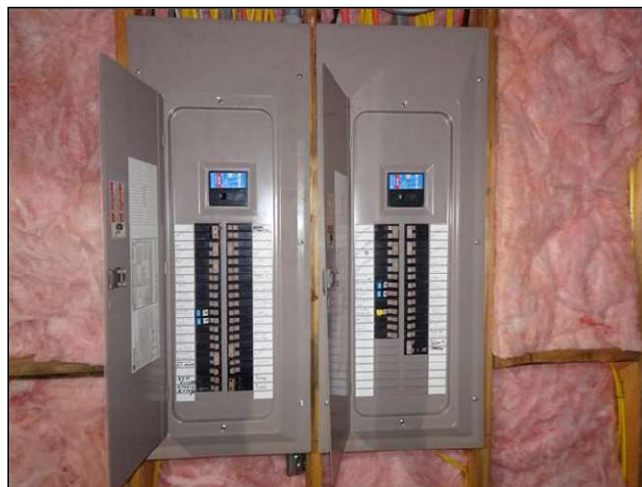
There are two electrical service panels in the basement and one panel at the garage. This is for your information.

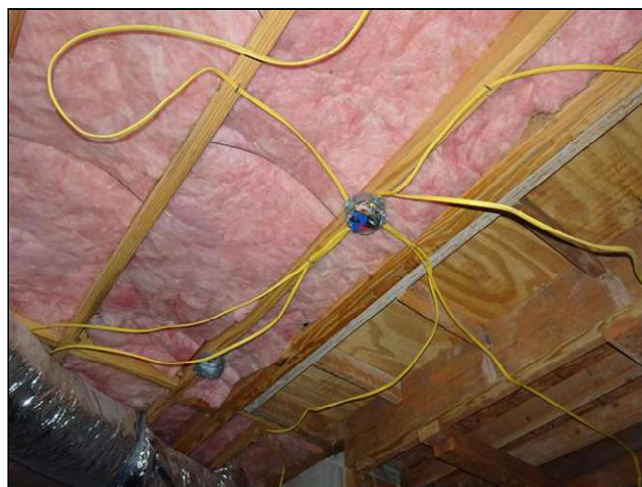
5.3 Item 2(Picture)

J-boxes in basement at a few areas need cover plates. Recommend correction by a qualified electrician.

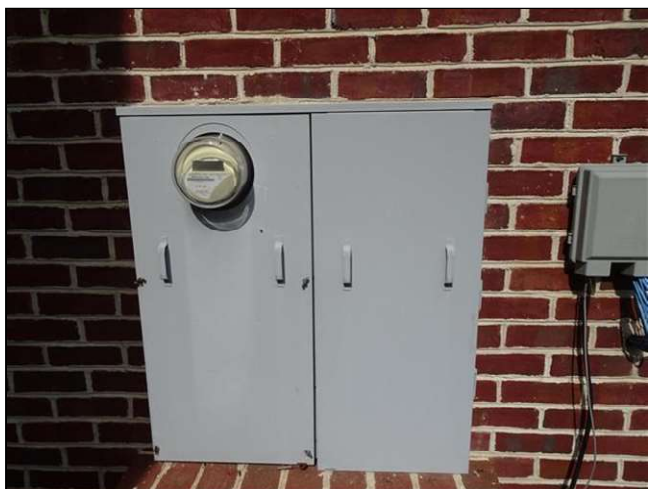
5.6 Item 1(Picture)

Main electrical service panels are located at basement. However, main disconnect (shut-off) is outside at meter base panel (for your information).

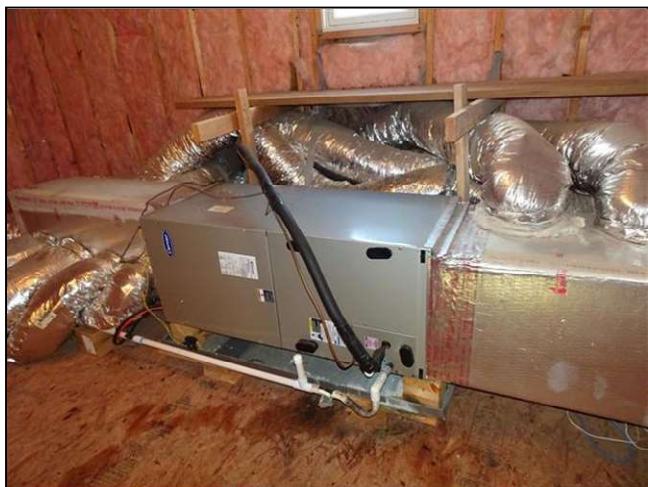
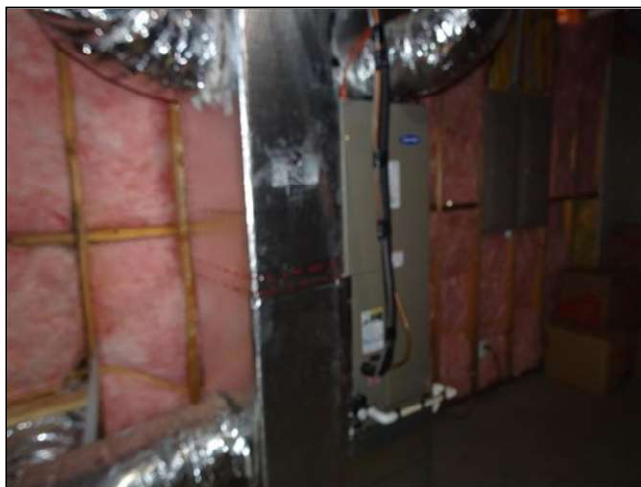
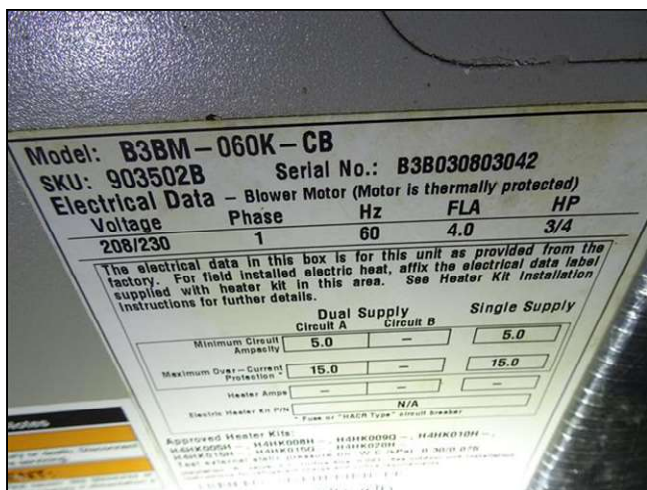
There are 3 HVAC systems. One in upper attic is approximately 7 years old. Other basement units are approximately 3 and 16 years old. Average expected useful life span of HVAC units are 10-20 years. All were functional at time of inspection.

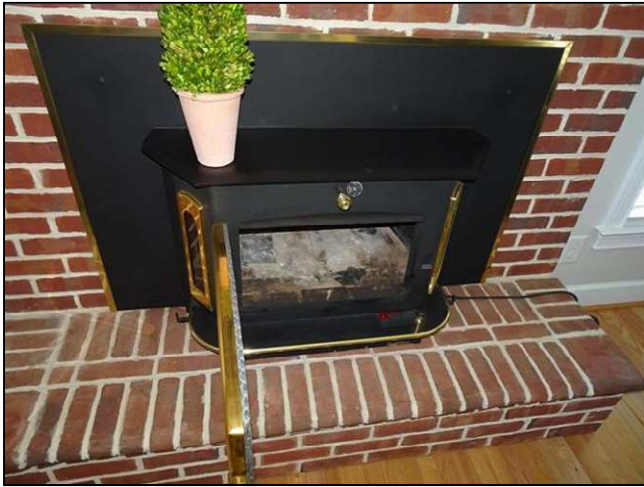
6.4 Item 1(Picture)

I do not inspect wood stove burners. Recommend evaluate by a qualified chimney sweep.

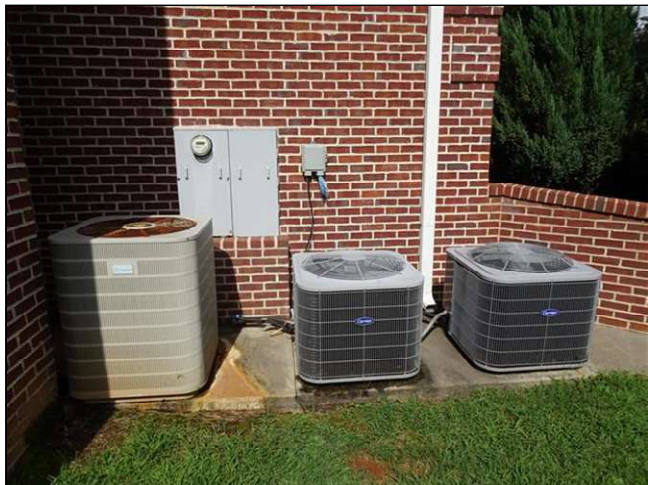
7.0 Item 1(Picture)

There are 3 AC condenser units. Ages are 3,7 and 16 years old. Average expected useful life span of HVAC units are 10-20 years. Units were functional at time of inspection.

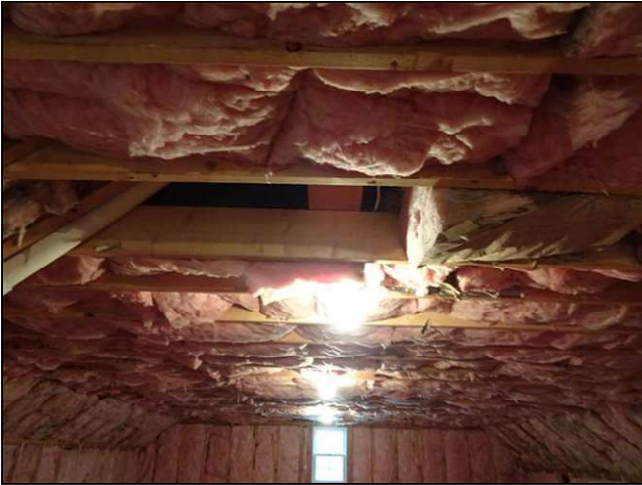
9.0 Item 3(Picture)

A few pieces of insulation were fallen or loose in attic. Recommend secure by a qualified contractor.
