<http://www.lunspro.com>
inspections@lunspro.com
(770) 483-2808
5174 McGinnis Ferry Rd #136
Alpharetta, GA 30005
Inspector: Britt Baker
Inspector's email: britt.baker@lunspro.com
Inspector's phone: (678) 230-9011

Summary

Client(s): Dane Hinton
Property address: 3035 Roxburgh Dr
Roswell GA 30076
Inspection date: Saturday, August 15, 2020

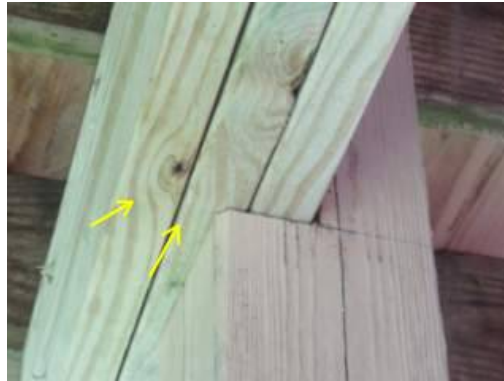
Photo 4-2

One or more wood support beams are properly supported by a support post. This is a safety issue. Recommend a qualified contractor evaluate and make the necessary repairs.

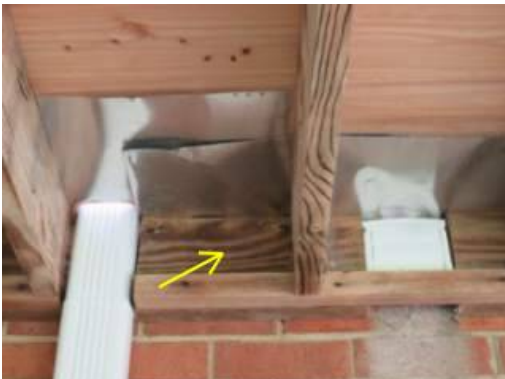
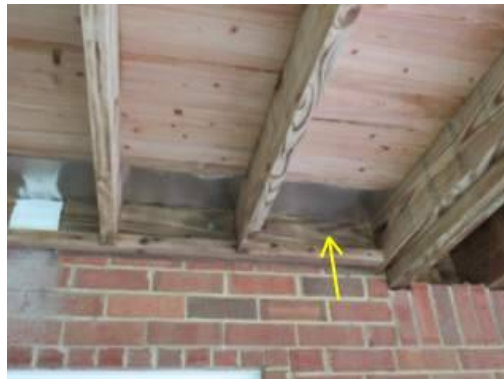
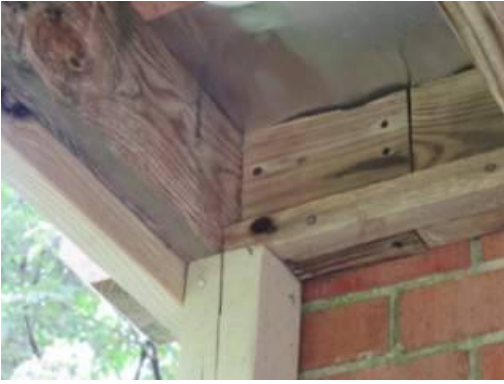
There are not enough lag bolts or carriage bolts attaching the ledger board to the house. This poses a significant safety hazard since the ledger board(s) may separate from the structure, causing the deck(s) to collapse. A qualified contractor should install lag screws or bolts as per standard building practices to securely attach the ledger board(s) to the structure. For more information on installing deck ledger boards visit:

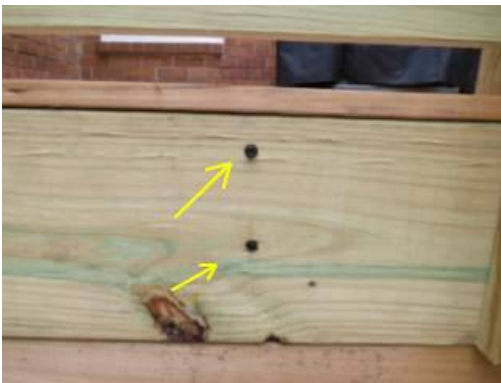
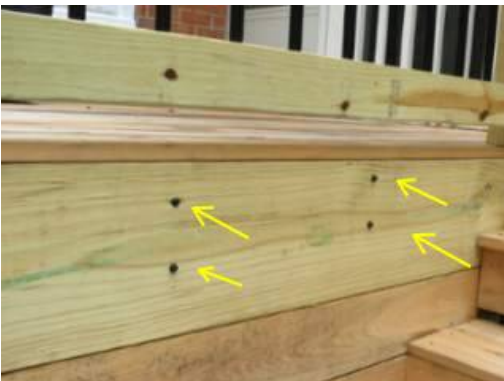
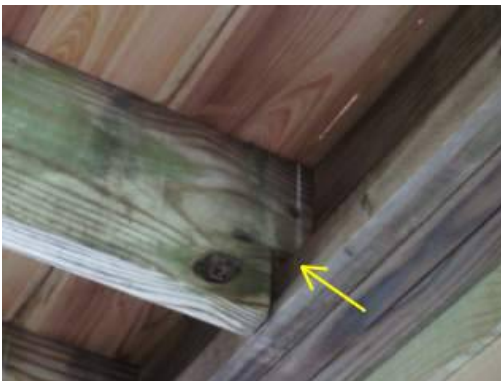
Joists for one or more decks, balconies or porches were fastened to ledger boards and/or perimeter joists with wood blocking and common nails rather than joist hangers and approved (Teco) nails. This was a common practice in the past but it is now considered unsafe due to the risk of such structures separating from the main building. It is a potential safety hazard. Modern standards call for a ledger board to be installed with 1/2 inch lag screws or bolts into solid backing, and brackets such as [Simpson Strong Tie DTT2 brackets and threaded rod](http://www.simpsonstrongtie.com/Products/Decking/Deck-Joist-Connectors.aspx), connecting interior and exterior joists. Joists should be fastened to ledger boards with correctly sized joist hangers. Recommend that a qualified contractor repair per standard building practices. For more information, visit: <http://www.reporthost.com/?LB>

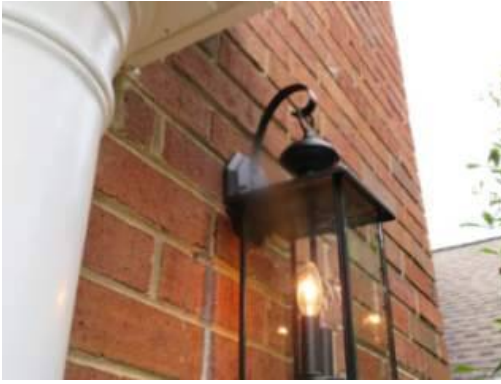
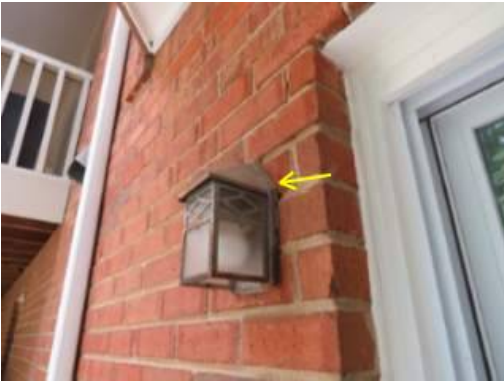
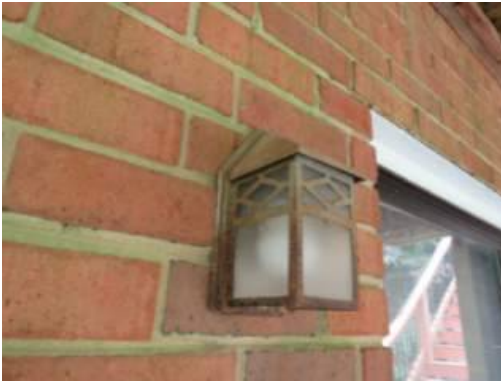
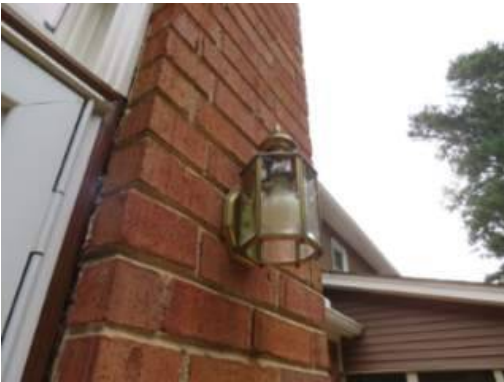
9) 🛠️🔌 One or more wall-mounted exterior light fixtures have wiring that's subject to water intrusion due to caulk not being installed around the light fixture's back plate. Caulk should be applied around the perimeter of back plates where missing. A gap should be left at the bottom for condensation to drain out.

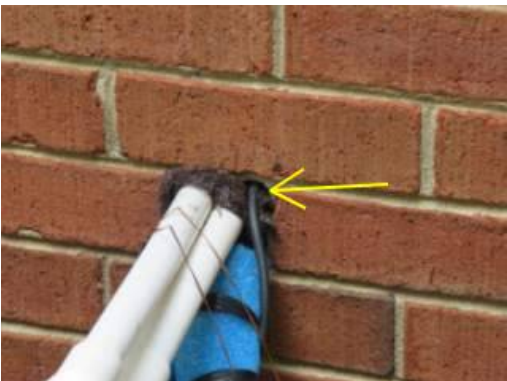
Photo 13-2

Gaps exist at one or more openings around the exterior, such as those where outside faucets, refrigerant lines, and/or gas supply pipes penetrate the exterior. Gaps should be sealed as necessary to prevent moisture intrusion and entry by vermin.

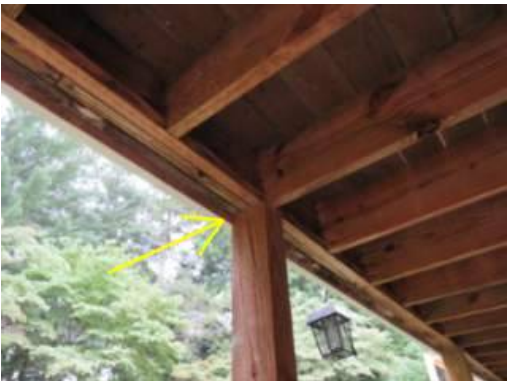
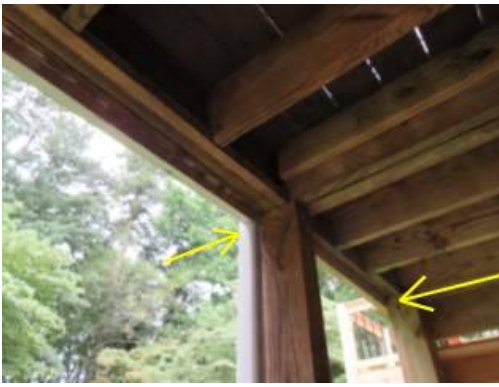
One or more deck or porch beams were not positively secured to the support posts below. Deck or porch beams are commonly connected to support posts by "toenailing," which is inadequate. Decks and porches are subject to movement under live loads and require a positive connection between their support posts and beams. Recommend that a qualified contractor repair per standard building practices. For example, by installing metal plates, plywood gussets or dimensional lumber to connect posts and beams.

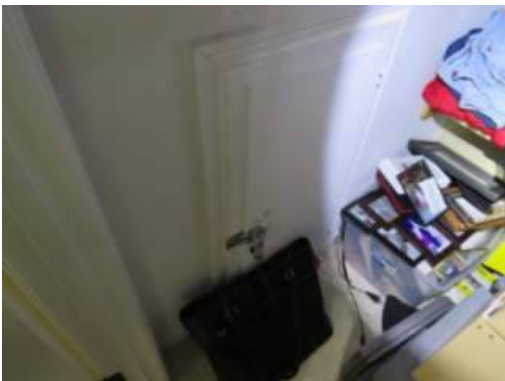
Photo 93-1

In the closet located in the second floor office. There is a access point that is locked shut. This section of the attic is excluded from the report.
