Inspection Report for Lindsey and George Evagoras

Property Address: 135 Ludwell Court, Alpharetta, GA

Atlanta Elite Home Inspection

9/8/2020

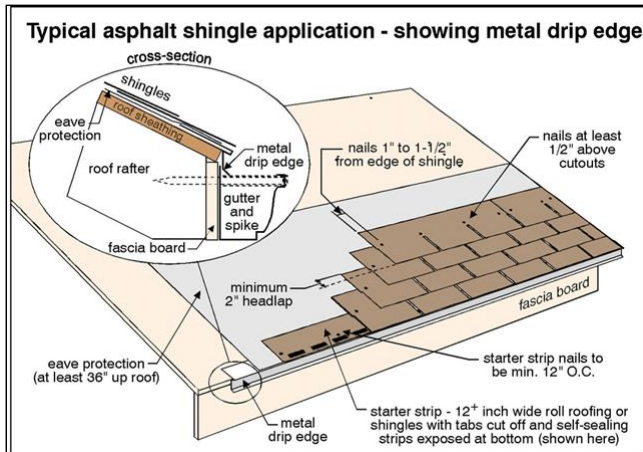
Improve: A drip edge flashing should be installed around the perimeter of the roof to ensure that water drains from the roof directly into the gutters. This flashing also helps protect the roof sheathing from damage at the eave.

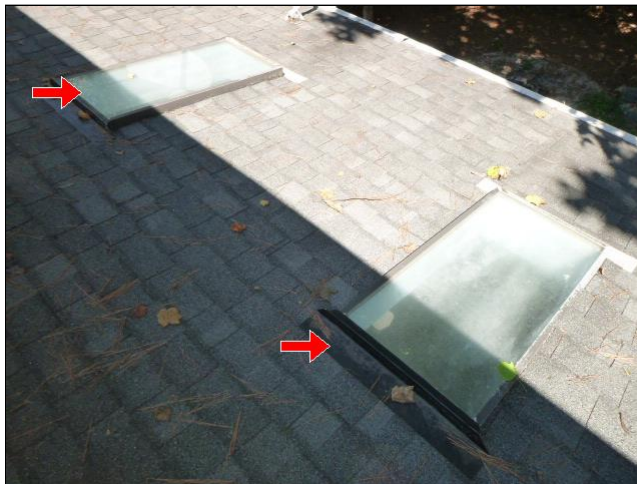
Monitor: The flashing components at the skylights should be carefully monitored, as these areas are extremely vulnerable to leakage.

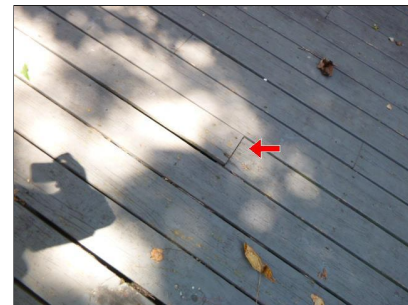
Loose Deck Boards

Loose and warped deck boards should be re-secured to the joists with wood screws for a better and longer lasting attachment.

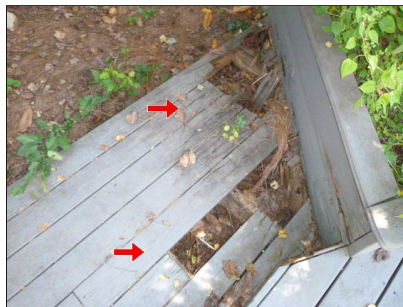
Deck Rot

Signs of rot were observed in the floor boards/joists of the deck structure. All damaged members should be replaced or otherwise re-supported with new wood. Following repair of the damaged areas, proper staining and weather protection of the wood and control of water from roof or surface runoff can avoid further damage.

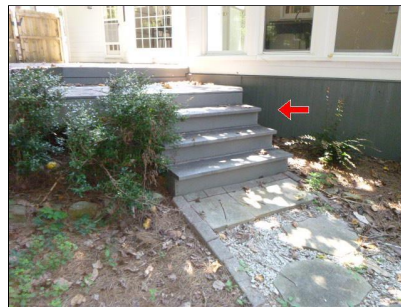
Railing Needed

Railings should be provided for deck stairs to prevent tripping hazards.

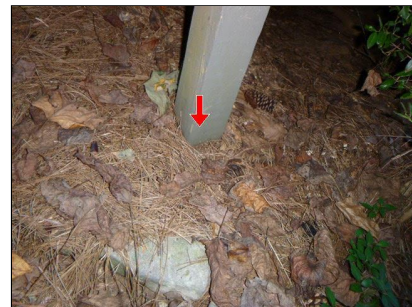
Posts in Contact with Soil

The grade is in contact with the base of the support wood posts for the deck and sunroom, which can cause moisture and termite damage in the future. Recent studies have shown that even pressure treated wood can rot over time due to constant contact with the soil. Make sure the footings for the posts are in place and extend at least 2" above the ground to keep the bottoms of the posts dry and free from soil contact.

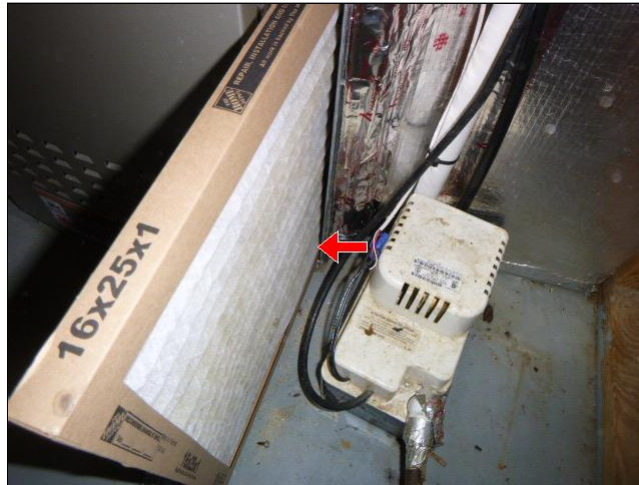
Repair, Safety Issue: The heating systems should be serviced and cleaned by a qualified HVAC service company before closing (no recent service stickers were noted). The heat exchangers should be checked for cracks. The gas venting system should also be checked for proper safety. The dirty air filter(s) should be checked and replaced

as needed. Manufacturers recommend servicing of all furnaces before each heating season as required for proper safety and function. Check with the seller concerning all previous service records.

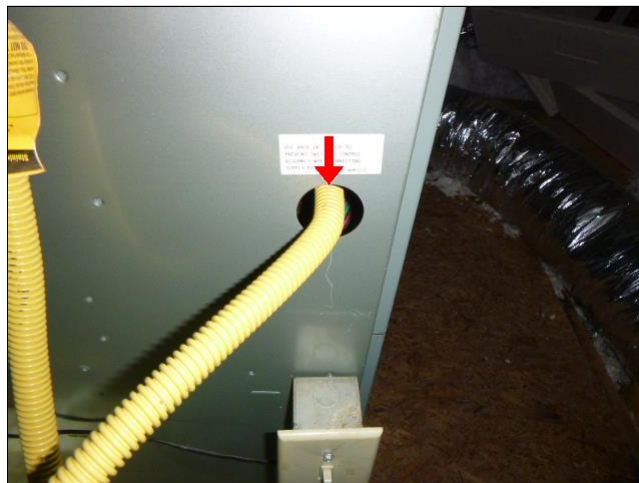
Repair, Safety Issue: The gas supply line serving the upstairs furnace is flexible piping which passes through the outer case of the furnace without protection. This piping runs the risk of being damaged by the edge of the casing and should be replaced with rigid pipe or otherwise protected to prevent future leaks. A drip leg would also be required here.

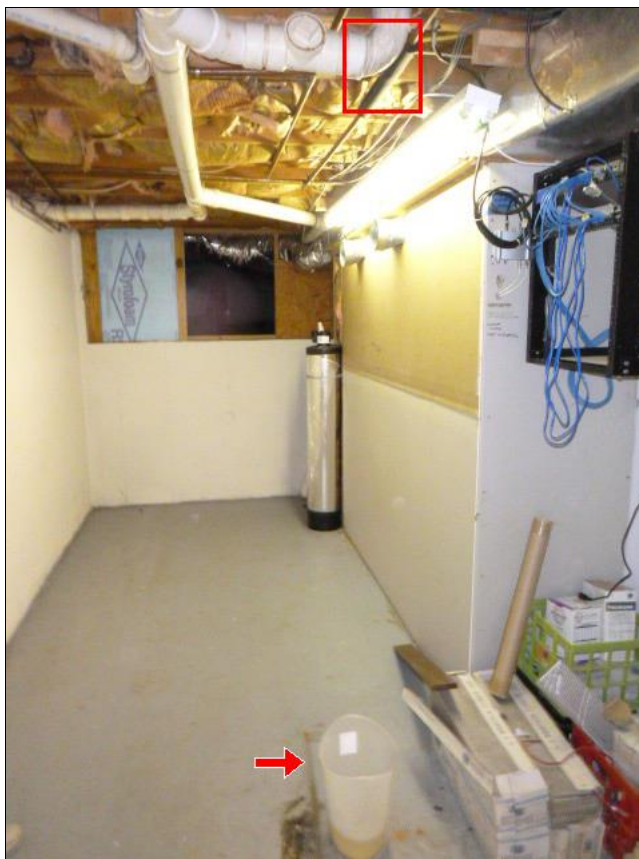
Repair: *The waste piping at the rear basement is leaking. The plumber should check all piping and connections in the area and make repairs as necessary.*

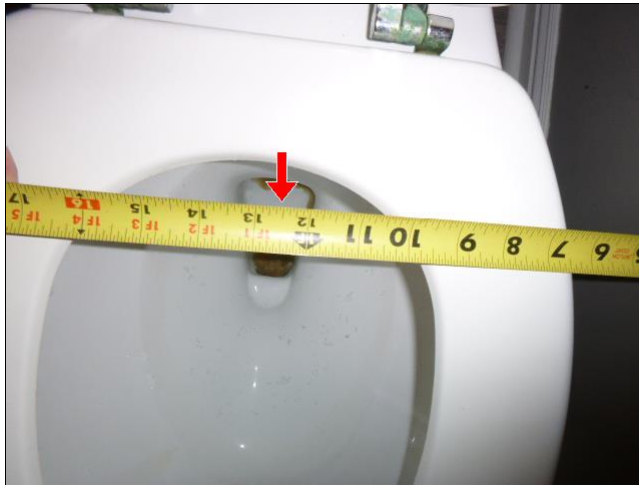
Repair: The toilet in the powder room was loose and needs repair. Have the wax ring checked for leaks and the toilet properly bolted to the floor.

Improve: Toilets should have a minimum clearance of 15" to adjacent walls (measured to the centerline of the fixture) and minimum of 21" clearance at the front (measured to the front edge of the fixture). The toilet in the master bathroom does not meet this requirement (too close to wall) and should be repositioned for proper function and access.

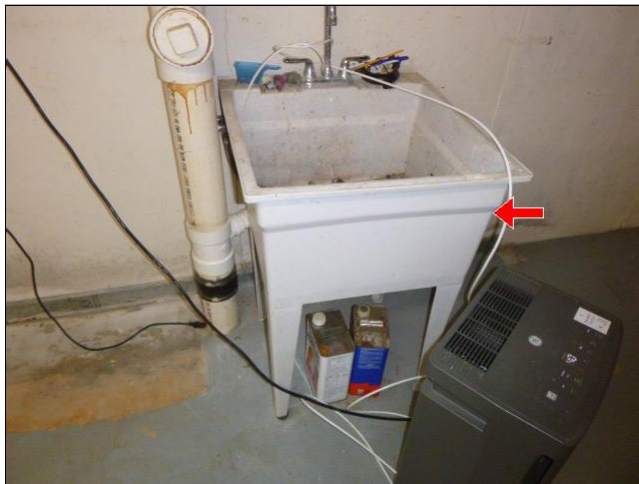
Repair: The basement utility sink was draining slowly indicating that an obstruction may exist or the sink stopper needs adjustment. Have the stopper adjusted and then check the P-trap and drain line for blockages and clear as needed.

Repair: The free standing sink in the basement is loose and should be properly attached to the floor to prevent the loosening of the piping connections, which can cause leaks in the future.

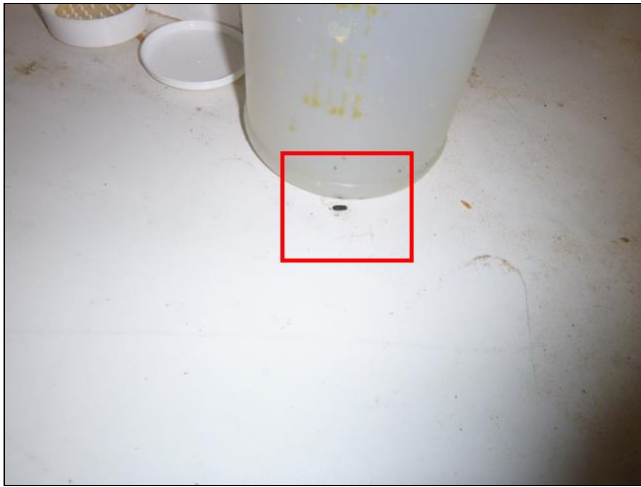
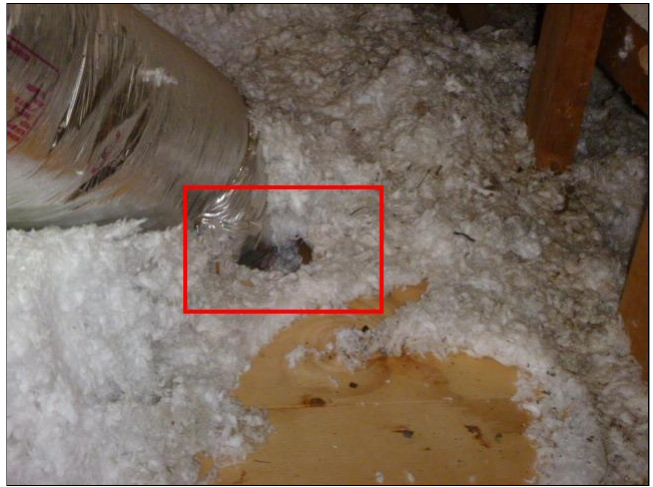
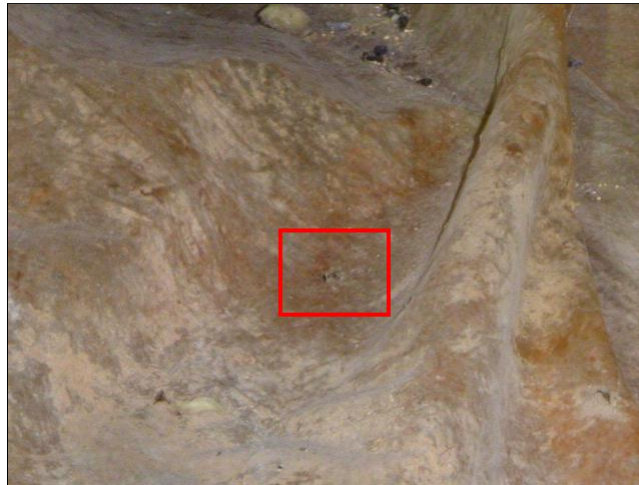
Monitor, Possible Repair, Safety Issue: *There is evidence of past rodent activity in the attic, basement and crawlspace as evidenced by droppings and/or disheveled insulation. A pest control specialist should be consulted to eliminate future activity. All outside openings into the structure should be covered with screen wire or otherwise sealed. All damaged insulation should be removed and replaced as needed. Consult with the seller concerning remedies taken to address this condition. Rodents can damage electrical wiring and other building components and can create unhealthy conditions within the home.*

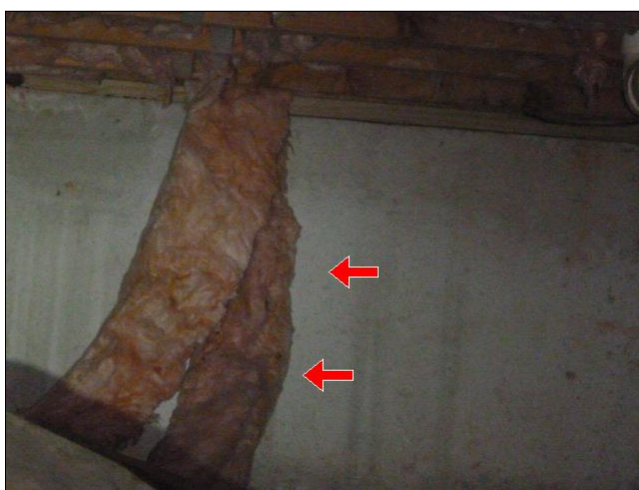
Repair: *Loose or damaged insulation in the floor above the crawl space should be re-installed or replaced altogether and then re-secured with straps. Installing a netting or mesh below the insulation would also serve to keep the insulation in place and protect it from damage.*

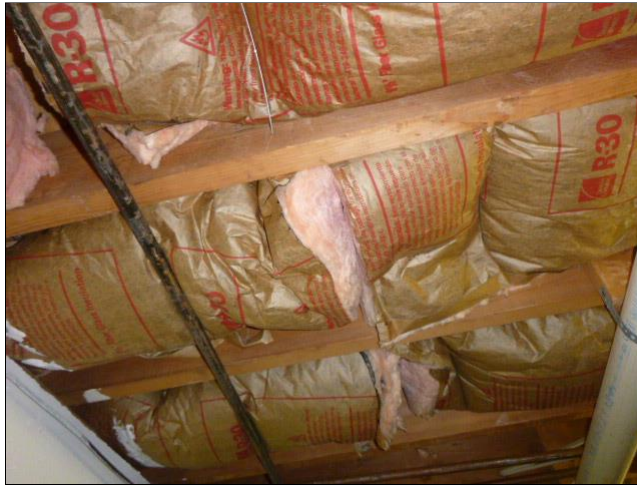
Repair, Safety Issue: The insulation batts in the basement are installed with the paper vapor barrier exposed, which presents a fire hazard (see label on facing). The insulation should be either turned around so that the vapor barrier is not exposed or covered with an approved product (e.g. sheetrock). Otherwise, the insulation should be replaced with a product that does not have a paper backing (e.g. "unfaced" material).

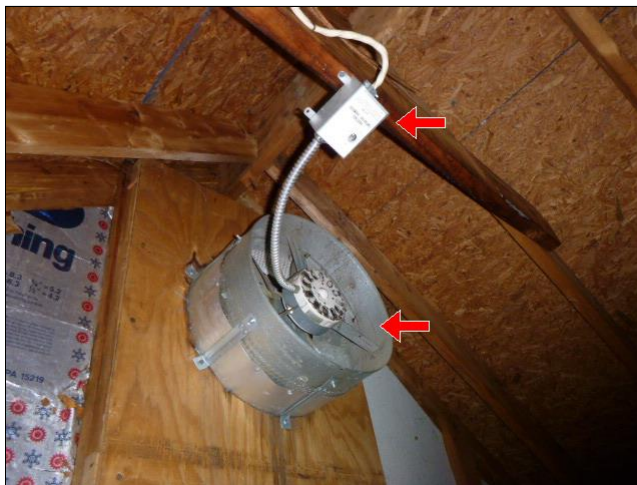
Monitor, Possible Repair: The power ventilator in the attic was not running at the time of the inspection (temperature in the attic was over 100 degrees) which means that it is either inoperative or the thermostat needs adjustment. The thermostat(s) were out of reach for proper testing. Have these checked for proper operation and settings and repair as necessary for proper ventilation of the attic. The thermostats should be relocated to a more accessible location, preferably near the stairs/scuttle hole.

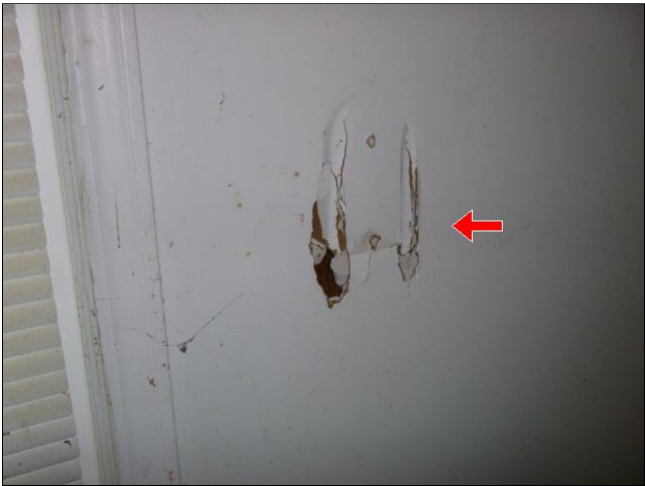
Repair: Damage and/or holes were noted in the walls of the garage, which should be repaired and repainted.

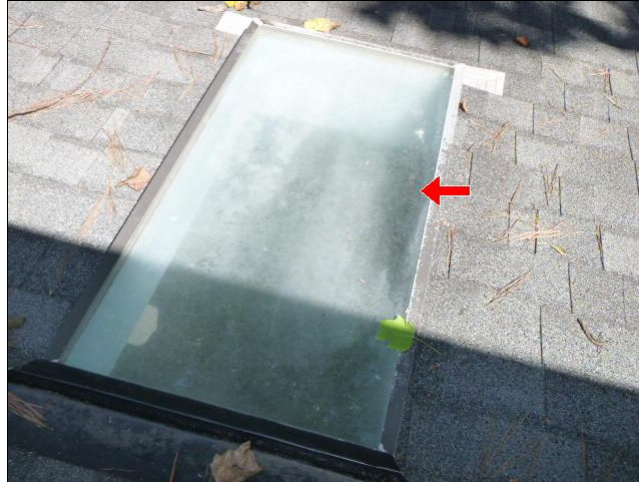
Monitor, Possible Repair: The sunroom skylights have either fogged over or need cleaning . They should be cleaned so the condition of the glass can be determined. Broken seals in insulated glass causes condensation between the panes of glass. This "fogging" of the glass is primarily a cosmetic concern, however, if this has occurred, the glass should be replaced for improved visibility.

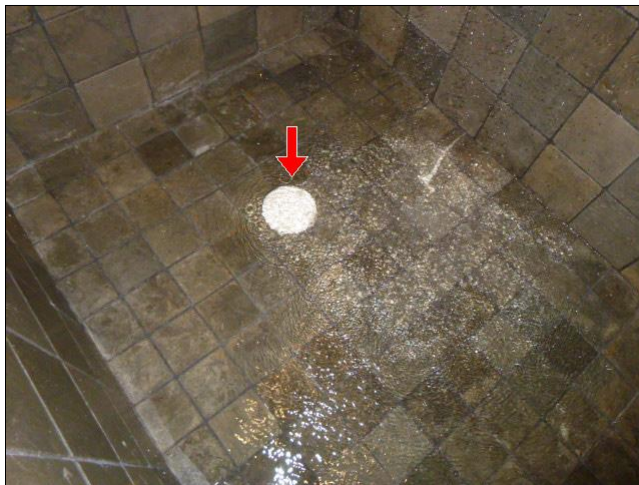
Monitor: The shower stall located in the master bathroom was tested with a standing water test (drain line plugged and the stall filled with water to a depth of 1" - 2") to determine if leaks might be present in the shower pan. While no evidence of leakage was noted at the time of the inspection, this does not preclude that leakage will be experienced in the future. Leakage that may be occurring may not be evident until the day after the inspection. The ceilings/floor system below the shower should be monitored for future leakage and the pan repaired or replaced as needed.

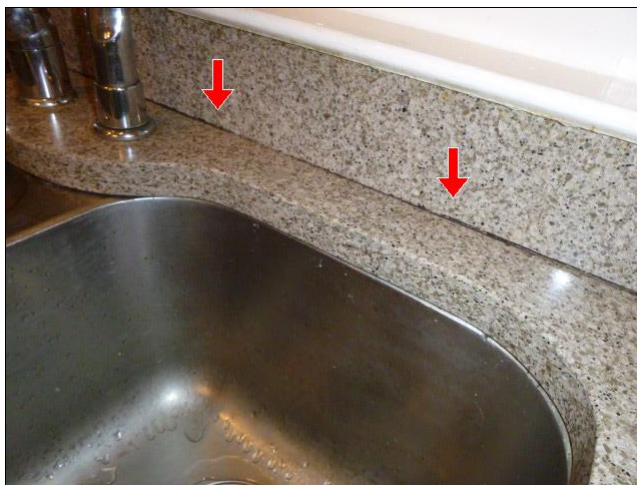
Improve: The backsplash at the kitchen counters needs caulking and sealing to prevent moisture intrusion into the walls, especially around the sink.

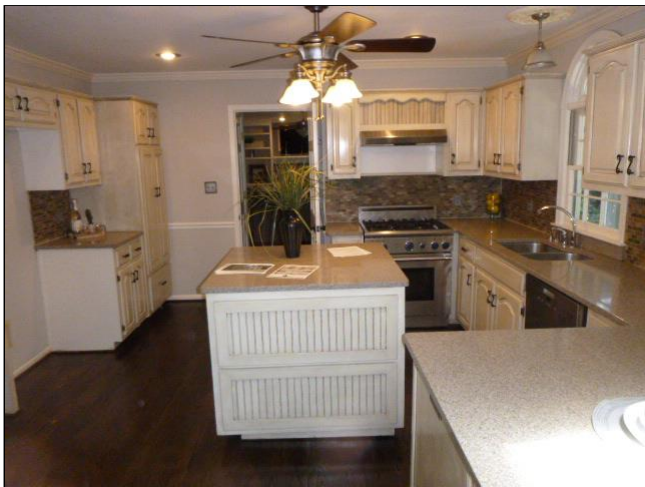
Kitchen

The kitchen appliances are considered to be in generally good condition. Most appliances that were tested responded satisfactorily.

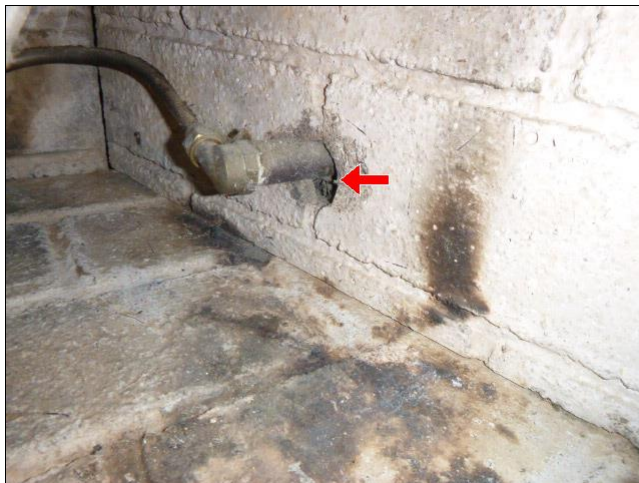
***Repair, Safety Issue:** The gas piping at the fireplace should be grouted and sealed where it passes through the outside walls of the fire chamber to prevent embers from contacting wood framing. All other openings and gaps at the hearth and surround materials should also be grouted and sealed to the metal facing of the fireplace.*

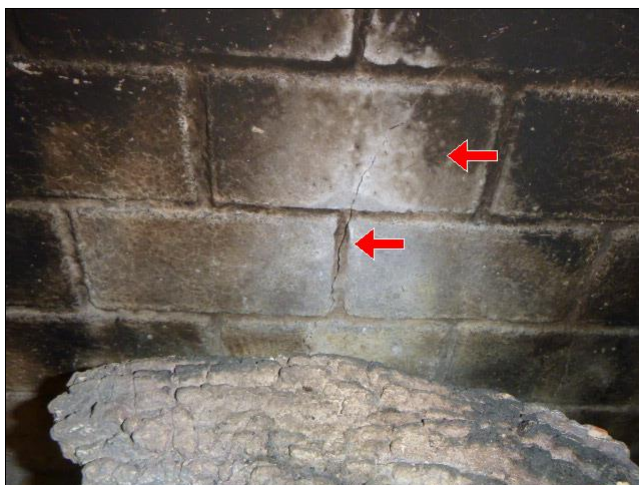
Repair, Safety Issue: All open joints and cracks in the firebox and flues should be grouted and sealed with fire clay to prevent the chance of embers from coming in contact with wood framing.
