Your Inspection Report

3180 Lynwood Drive
Atlanta, GA 30319

INSPECTION DATE:
Wednesday, September 16, 2020

RE: Report No. 35642
3180 Lynwood Drive
Atlanta, GA
30319

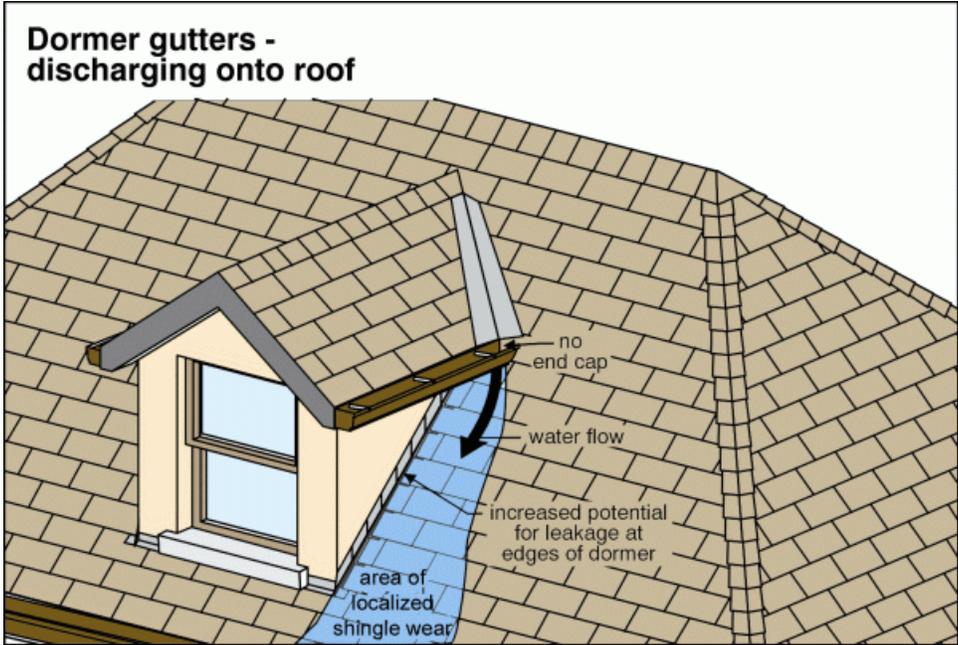
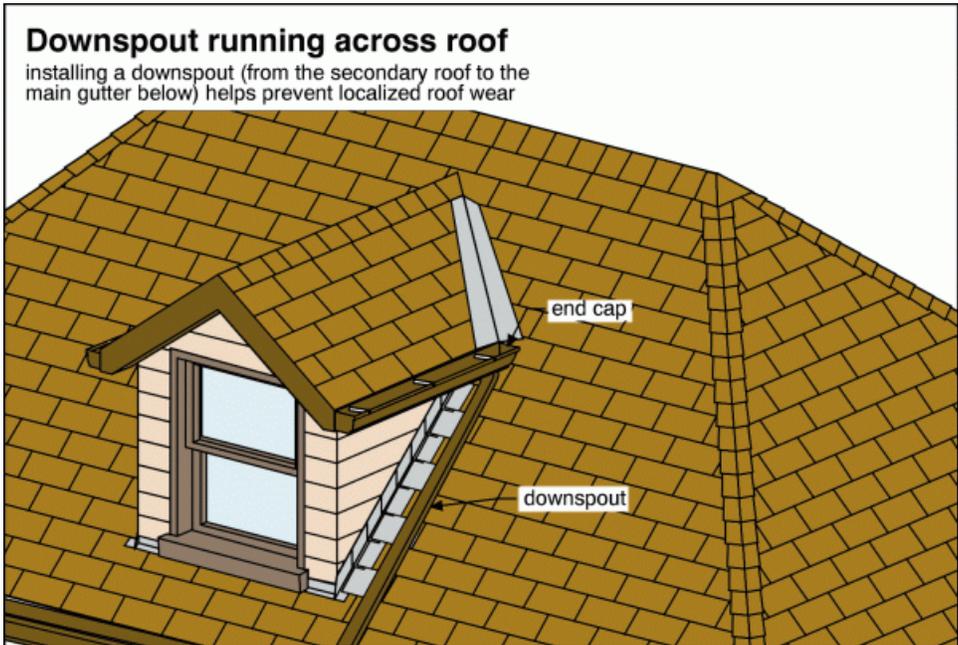
1. **Condition:** • Discharging onto roof covering

Time: Immediate

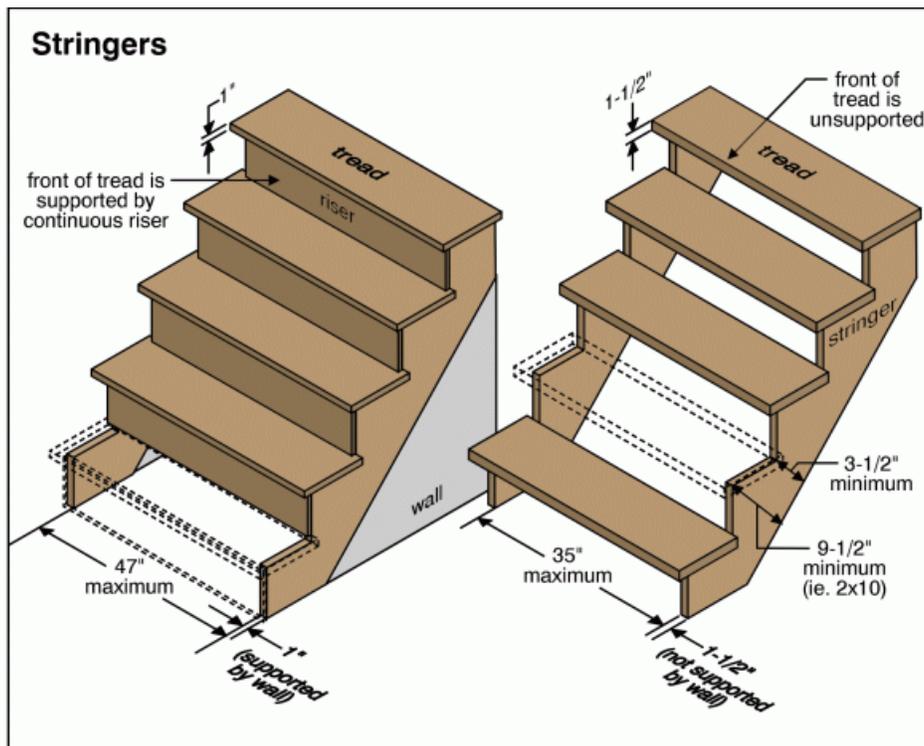
19. Poor Bearing at top or bottom of stair...

6. Condition: • Poor Bearing at top or bottom of stair stringer

Cost: Depends on the preferred remedy of repair

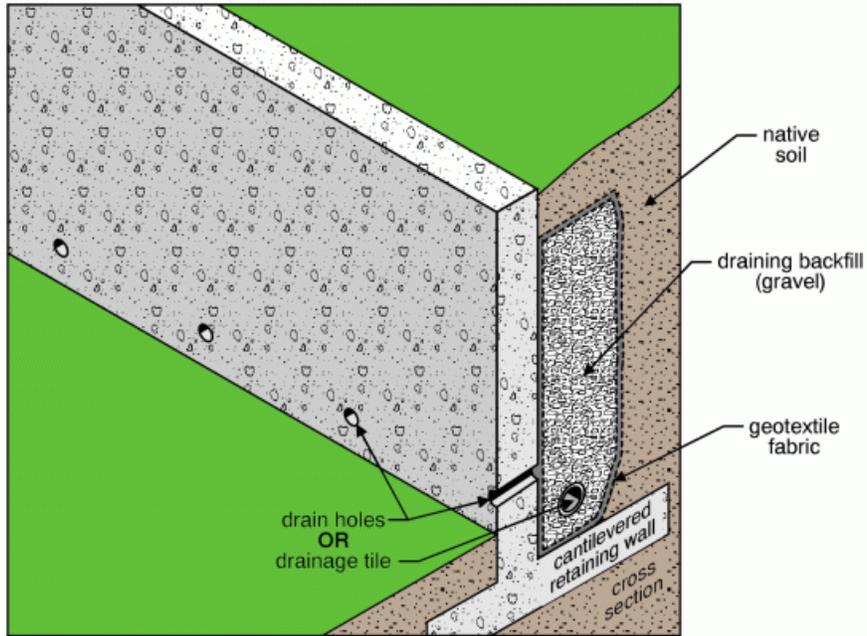
23. Drainage system for retaining wall is missing
