Atlanta Property Inspections, Inc. HOME INSPECTION REPORT

130 Lambdin Lane, Alpharetta, GA 30022

Inspection prepared for: Nancy Aranson

Date of Inspection: 9/26/2020 Time: 28 Years Old (1992)

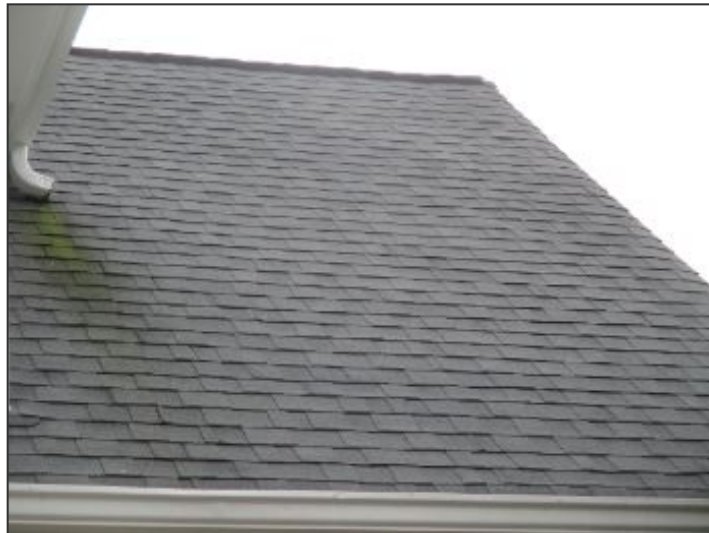
• Metal roofing is present at the small living room accent roof.

• **ROOF INSPECTION ACCESS:** The roof was viewed and inspected from the ground with binoculars.

Architectural shingles present

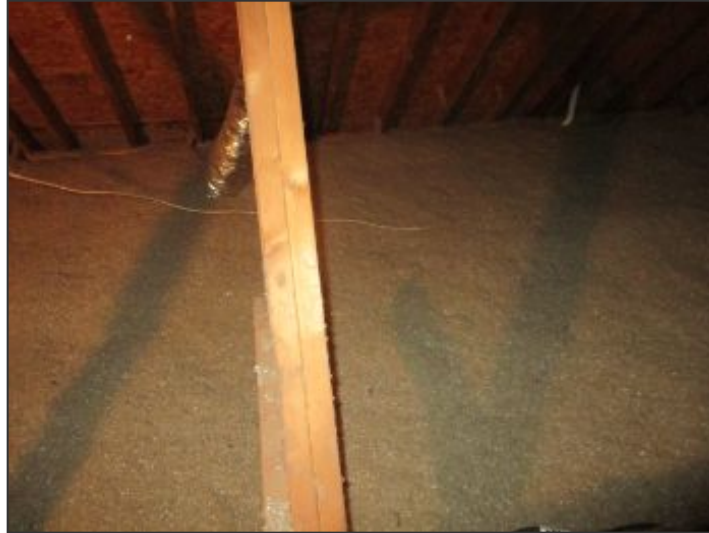
• **Cellulose** Blown In Insulation; 8.5 inches of depth or about R-30. The attic insulation appears serviceable, no concerns were noted.

Insulation coverage in attic looks good

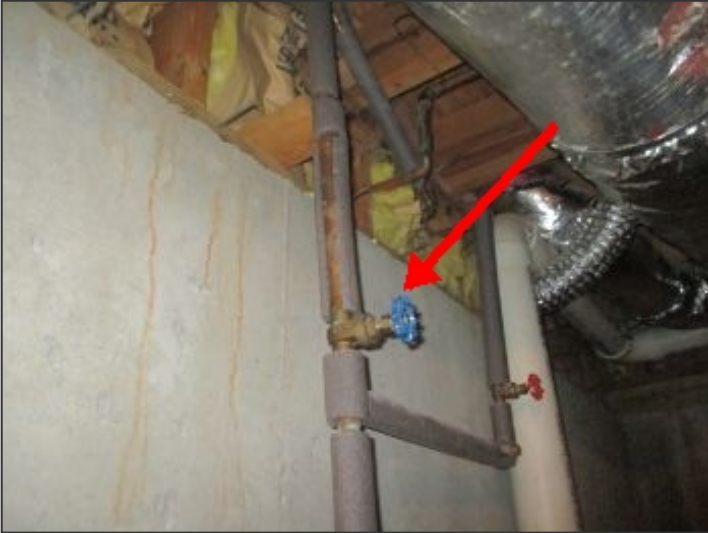
Main plumbing supply cut off valve

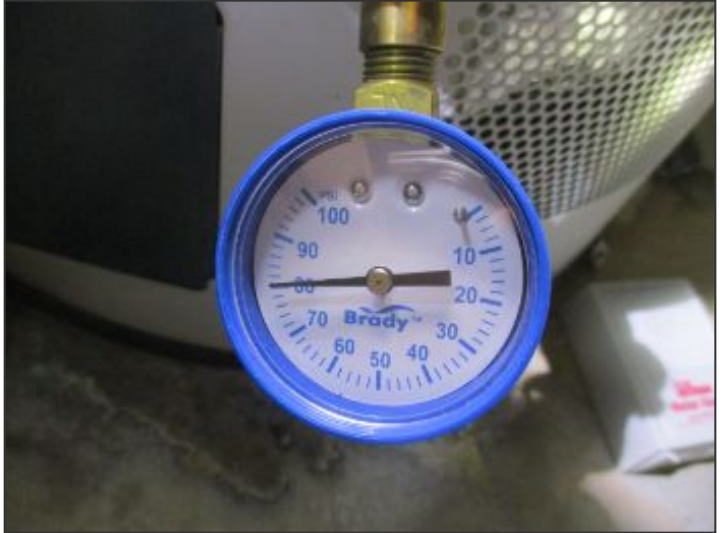
• The supply piping appears to be serviceable, no concerns were noted. A water pressure reading was taken at the water heater and was found to be normal at 80 PSI.

80 PSI normal at water heater

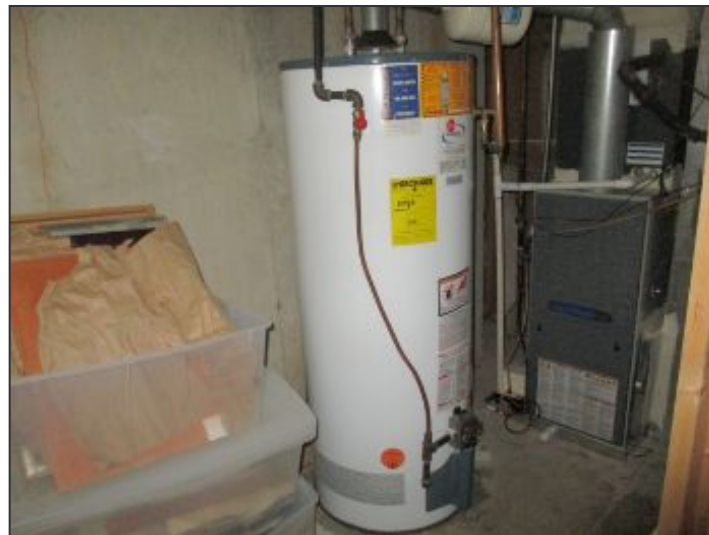
A thermal **expansion tank / valve is present on the cold water line and appears serviceable.**

Water heater located in basement

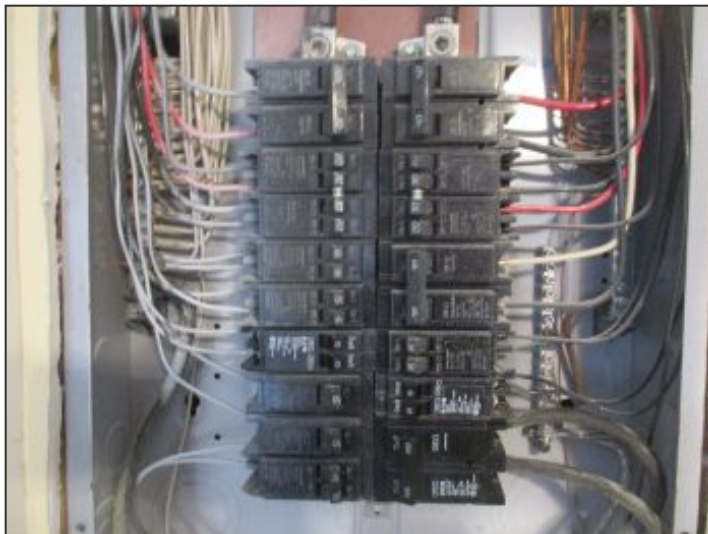
• The main panel is located in the basement . Circuit breakers are present. The main panel box appears serviceable during a limited visual inspection inside the panel; no concerns were found.

Main electrical panel in basement

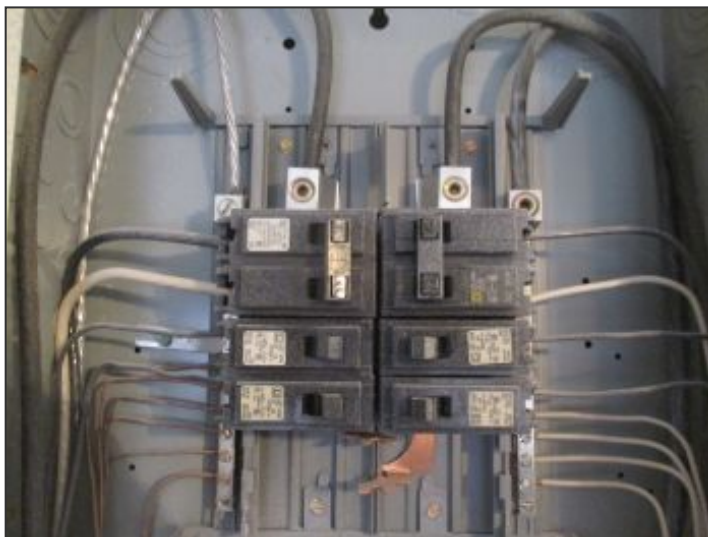
- A 100 amp subpanel is located in the basement.
- The subpanel appears to be serviceable, no concerns were noted.

Subpanel located in basement

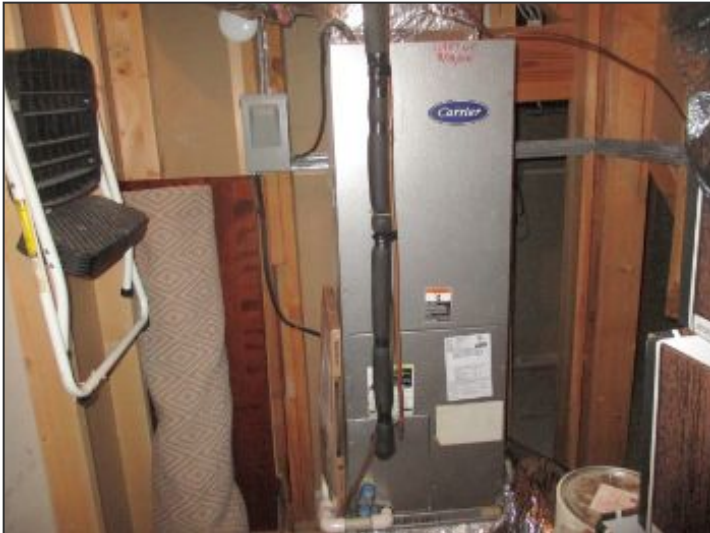
Unable to operate, fully test, and inspect this heating system - the heat pump would not come on or respond to normal thermostat controls during the inspection. This inspection is limited to a visual inspection only and is not complete. Further evaluation is advised by a professional HVAC contractor to determine the full scope of repair needs.

Due to the advanced age of this heating system, client should budget for replacement soon which is expected to be a major expense. Based on industry standards, the heating system appears to be at the end of its normal expected lifespan of 15 - 20 years.

Heating system located in basement - 2000

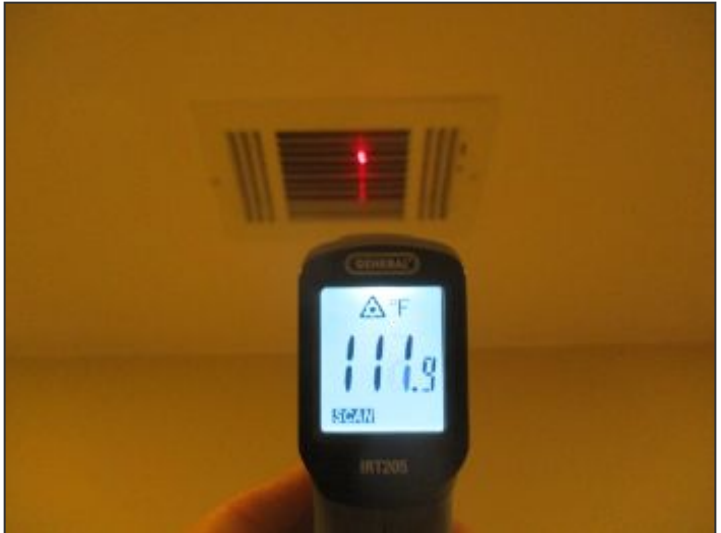
Normal temps at basement heat strips

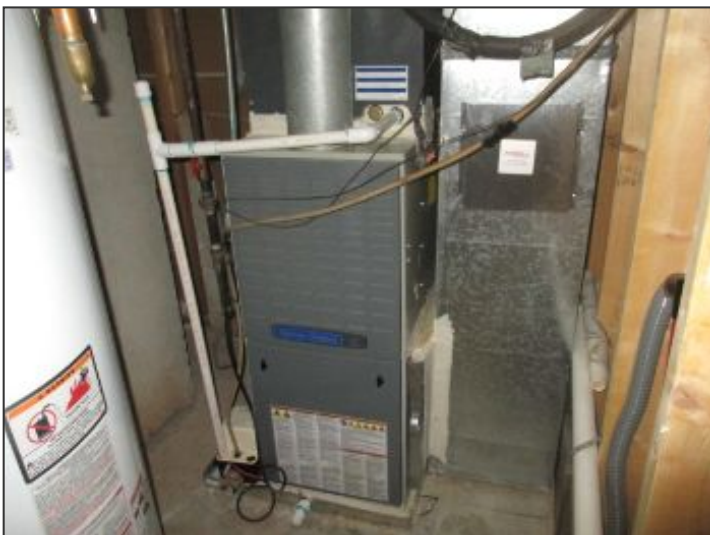
• **The heating system appears serviceable; the heating system was operated and was found to be functioning normally during a limited visual inspection, no significant concerns were noted. Continue to maintain the system and have it serviced regularly.**

First floor furnace located in basement - 2012

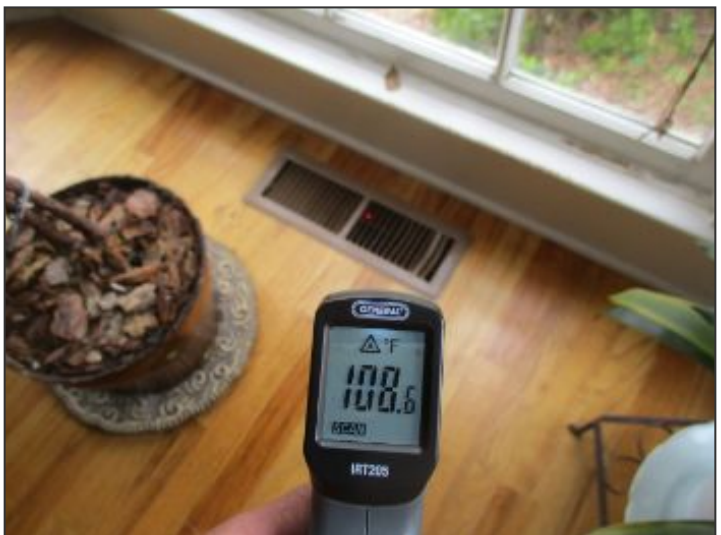
Normal temps at first floor furnace

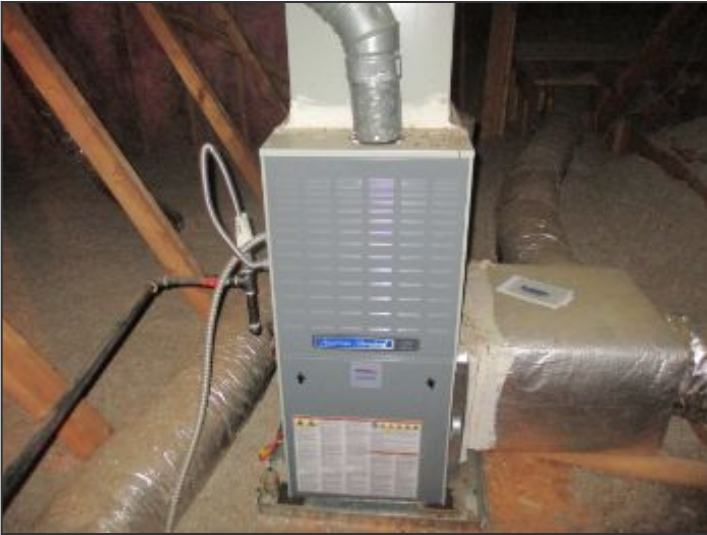
- **The heating system appears serviceable; the heating system was operated and was found to be functioning normally during a limited visual inspection, no significant concerns were noted. Continue to maintain the system and have it serviced regularly.**

Second floor furnace located in attic - 2012

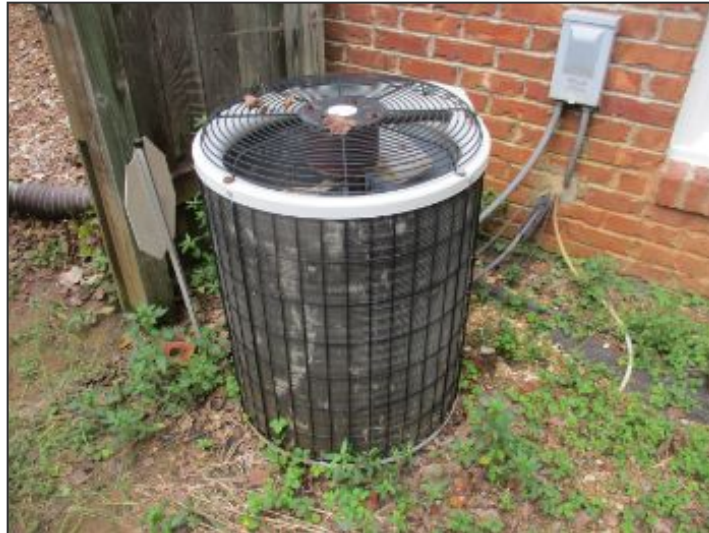
Page 47	AC UNIT 1:	<p>• AC UNIT INOPERATIVE: We are unable to operate, fully test, and inspect this air conditioning system - the exterior unit would not come on or respond to normal thermostat controls during testing. This inspection is limited to a visual inspection only and is not complete. Further evaluation is advised by a professional HVAC contractor to determine the full scope of repair / replacement needs and costs.</p> <p>• AGING EQUIPMENT - BUDGET FOR REPLACEMENT: Due to the advanced age of this AC unit, client should budget for replacement soon which is expected to be a major expense. Based on the available manufacturing date on the equipment, the AC unit is at or past the normal expected lifespan of 12-15 years.</p> <p>Consider these cost saving strategies when replacing HVAC equipment:</p> <p>1. MANUFACTURERS REBATES: Check for current rebates from manufacturers on models that may be discontinued or that have higher energy ratings: Carrier Rebates: http://www.carrier.com/homecomfort/en/us/rebates-and-financing/ Lennox Rebates: http://m.lennox.com/promotions/national.asp Trane Rebates: http://www.trane.com/residential/en/buying-a-trane/savings-and-offers.html York Rebates: http://york.com/residential/promotions-savings/default.aspx</p> <p>2. UTILITY COMPANY REBATES: Check for rebates or incentives from your local power company or gas provider - many offer rebates for higher efficiency equipment</p> <p>3. TIME OF INSTALLATION: Wait to have your equipment to be installed in the fall or spring when HVAC contractors are not as busy and ask for an off season discount.</p> <p>4. GET MULTIPLE QUOTES: Always get more than one quote before making your decision - prices can vary widely from one company to another.</p>

Basement A/C unit - 2000

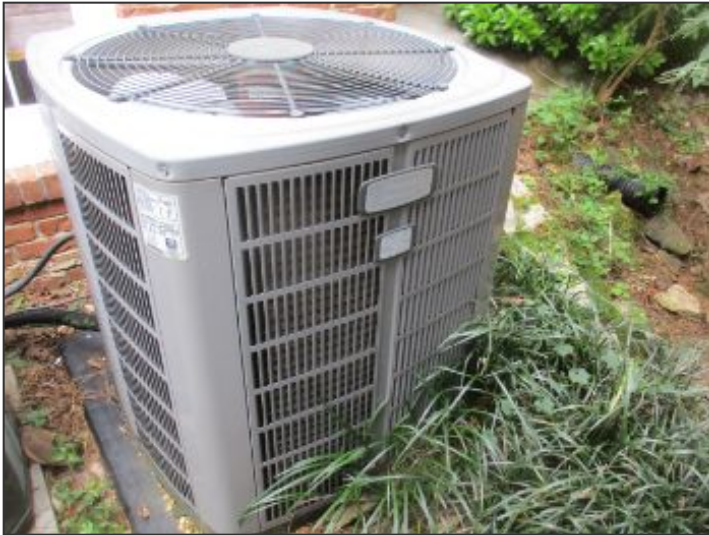
Due to the advanced age of this AC unit, client should budget for replacement soon which is expected to be a major expense. Based on the available manufacturing date on the equipment, the AC unit is at or past the normal expected lifespan of 12-15 years.

High efficiency first floor A/C unit - 2007

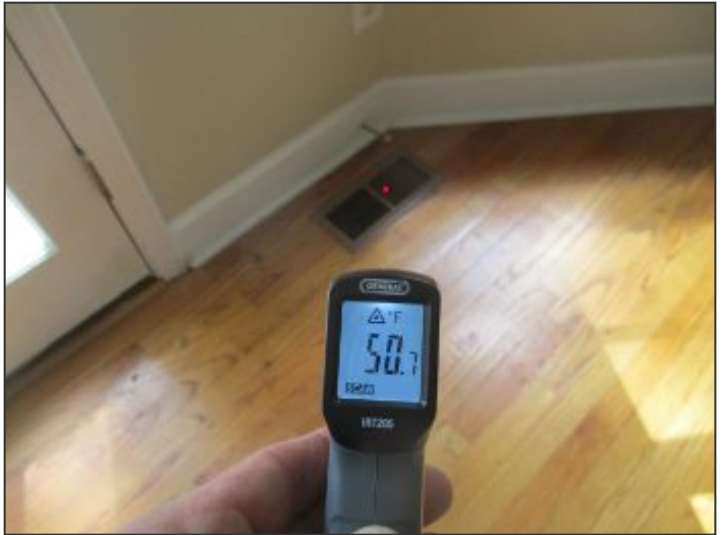
Normal temps at first floor A/C unit

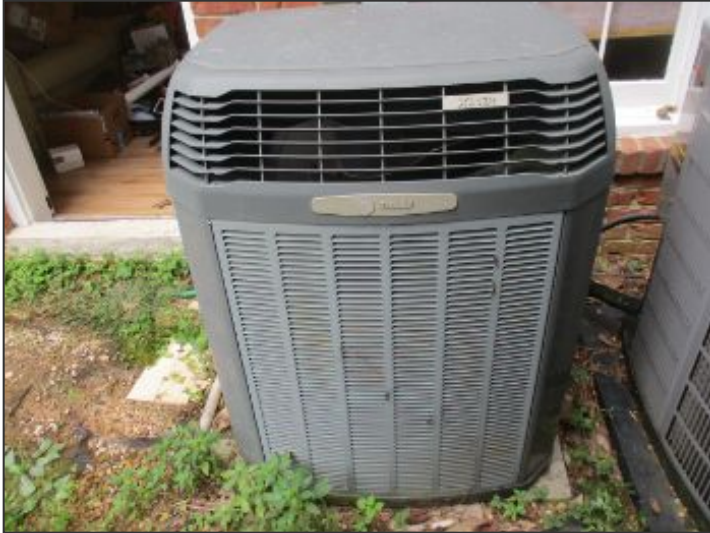
Due to the advanced age of this AC unit, client should budget for replacement soon which is expected to be a major expense. Based on the available manufacturing date on the equipment, the AC unit is at or past the normal expected lifespan of 12-15 years.

High efficiency second floor A/C unit - 2003

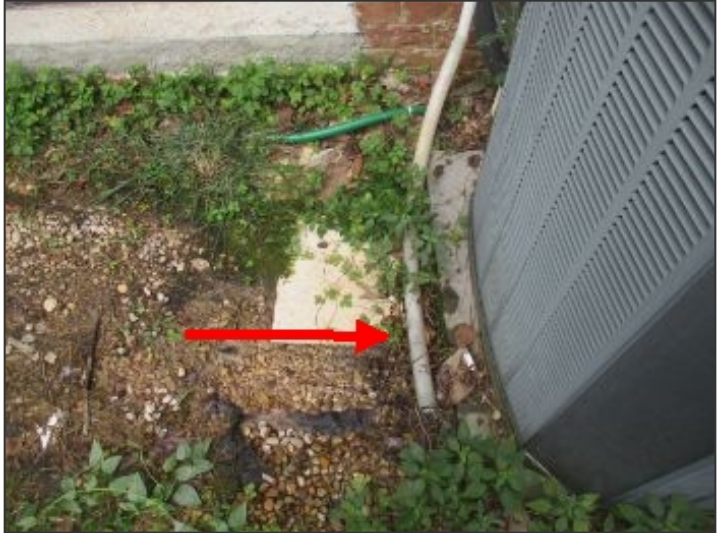
Good condensate drain extensions
