House Smart

**4980 Hidden Branches Circle
Dunwoody GA 30338**

Client(s): Schnitzer
Inspection Date: 8/5/2020
Inspector: Keith Cook , ASHI 202558

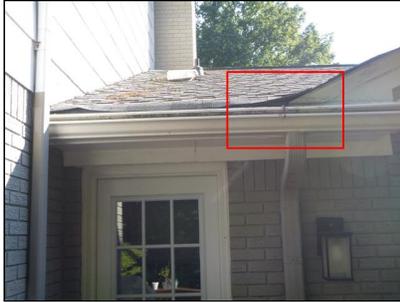
Item 4 - Picture 1

- ❌ 4. **SERVICE / REPAIR:** Openings found near roof level at time of inspection. Openings exist at bottom of valleys where roofing curves up on inside corner. ALSO, Opening where roof flashing intersects chimney. Have modified

to be within the 1/4 inch maximum limit for ventilation and to reduce chances of pest intrusions. IRC Section R806.1. Pest control services refer to this as an exclusion process.

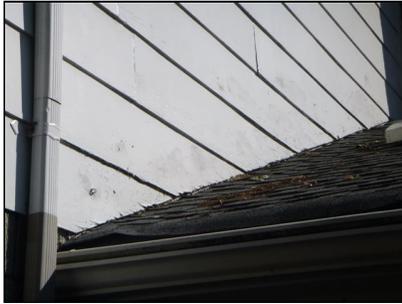
Item 6 - Picture 1

- ❌ 6. **SERVICE / REPAIR:** Lap siding in contact with roof found to be delaminating and moisture damaged. Siding cut on an angle is not usually painted and more vulnerable to moisture exposure. Siding manufacturer's typically require as much as 2 inch clearance to protect. Recommend either having affected siding replaced or have modified by trimming back siding and installing a trim band parallel to roof. Flashing is critical with this detail.

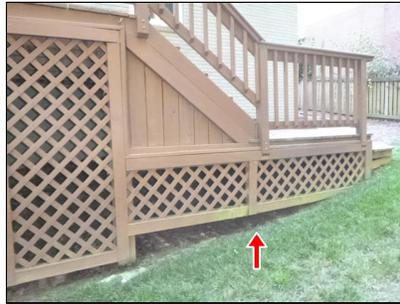
Item 7 - Picture 2

- ☒ 7. **SERVICE / REPAIR:** Load of stairs should be transferred to the ground by support post added point where intersecting. Include new footing. Stringers should have blocking added to support head ends of lumber.

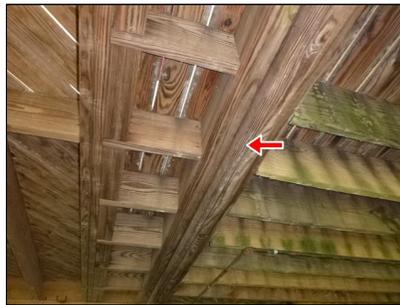
Item 8 - Picture 2

- ☒ 8. **SAFETY / HEALTH:** Uneven deck flooring just outside of screen porch area. Framing transition below likely to have caused issue. Recommend having modified to limit potential for tripping. Little awkward to have deck flooring and framing run in the same direction in that one location.

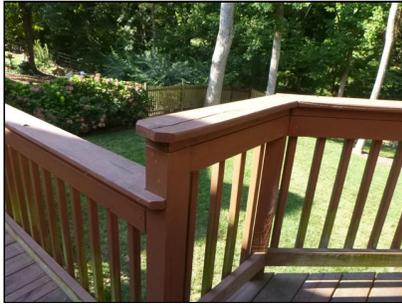
Item 9 - Picture 1

- ☒ 9. **SAFETY / HEALTH:** Guardrail found loose and is not safe as installed primarily at top of railing. Recommend that a deck contractor evaluate and stabilize as needed.

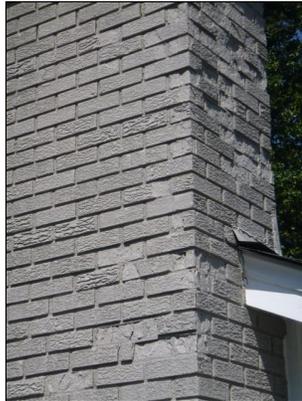
Item 10 - Picture 2

- ❌ 10. **SERVICE / REPAIR:** Spalling of bricks noted in chimney above roof surface with potential for continued deterioration. Recommend having mason or other contractor experienced with this issue to review and make necessary modification to brick surfaces (already painted at least once) or provide alternate resurfacing technique to make assembly better protected. Flaking brick surface can continue to get wet and freeze in winter causing more damage.

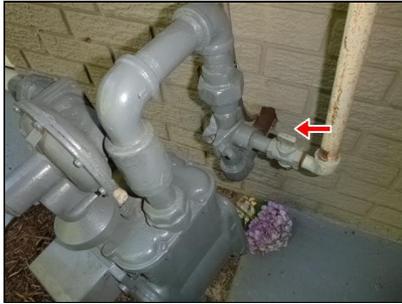
Item 11 - Picture 1

- ❌ 11. **SERVICE / REPAIR:** Paint rusty gas line at meter outside as required by 95 CABO Section 2608.3 or IRC Section G2414.8 (404.8) which lists corrosion resistant material used for gas line outside. Have cleaned and painted with rust inhibitor to prevent further oxidation. **ALSO:** Penetrations of siding not sealed at: Gas line. Seal to prevent moisture and insect access.

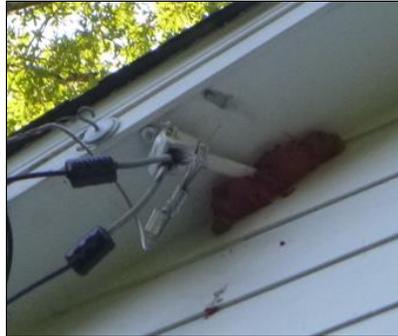
Item 12 - Picture 2

- ❌ 12. **SERVICE / REPAIR:** Expandable foam sealant observed at power line penetration of rake soffit. This product is not manufactured for exterior use and is not intended as a moisture barrier. Repairs are necessary to prevent sunlight from breaking down the foam and allowing water entry. Recommend foam be removed and replaced with appropriate calking material or have foam cleaned and painted to reduce UV damage.

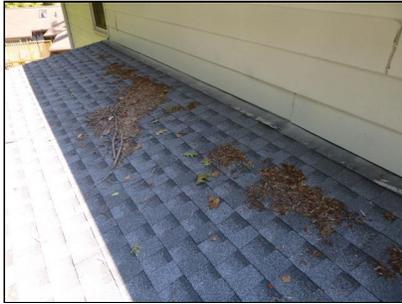
Item 14 - Picture 1

- ❌ 14. **SERVICE / REPAIR:** Organic debris (leaves, sticks, moss, algae, etc) present on the roof covering. Removal of all debris is recommended to prolong the life of the roof.

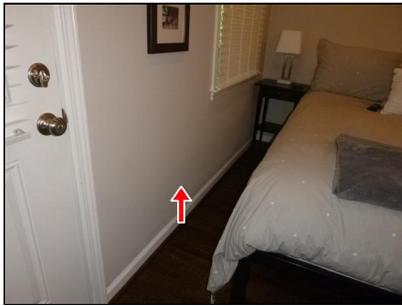
Item 27 - Picture 1 Basement

- ❌ 27. **SERVICE / REPAIR:** Not all of the habitable rooms have a sufficient number of receptacles and/or within spacing limits. Current standards state there should be a receptacle on any wall two feet or wider, with spacing not to exceed six feet to openings or wall ends. Recommend a licensed electrician to evaluate the condition and correct for compliance.

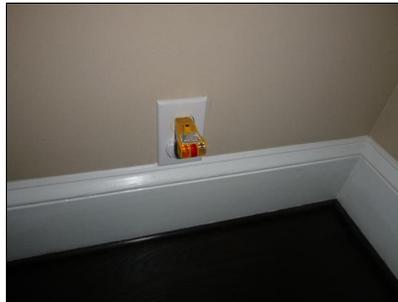
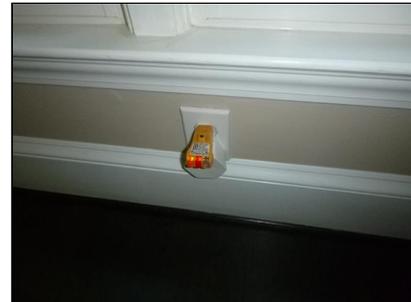
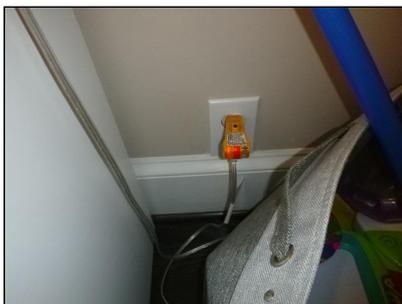
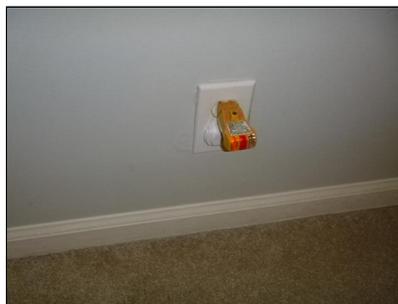
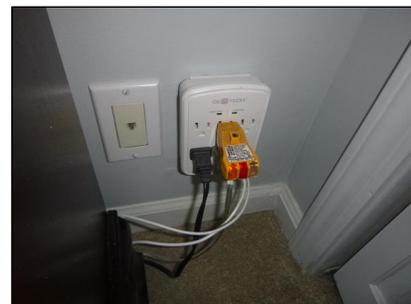
- ❌ 28. **SAFETY / HEALTH:** Reverse polarity at receptacle observed at Living Room, Dining, Master bedroom. This is a somewhat common error in wiring where the hot (black wire) and neutral (white wire) are reversed. With a series of devices incorrect, looking for and correcting the one error made will usually correct every other device downstream. Recommend having electrician review and address to insure that repairs are done properly.

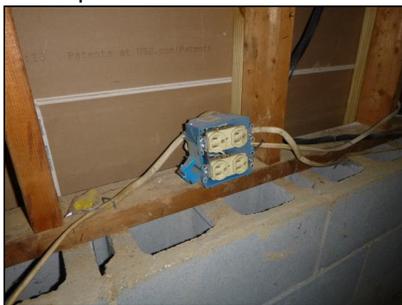
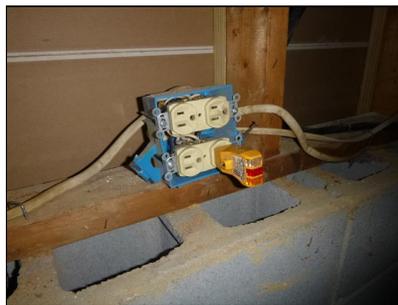
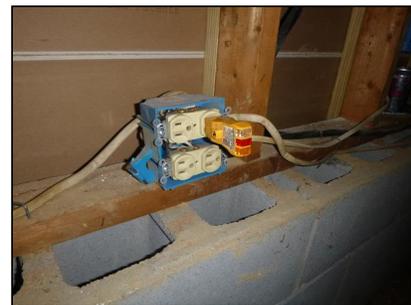
- ❌ 29. **SAFETY / HEALTH:** Include correcting reverse polarity reading on device located in Crawlspace rear and install cover plate.

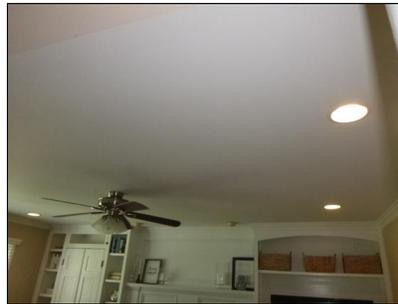
Item 31 - Picture 2

- ❌ 31. **SERVICE / REPAIR:** Dimmer device does not dim lights of Family room cans. Device should be repaired / replaced to operate as intended.

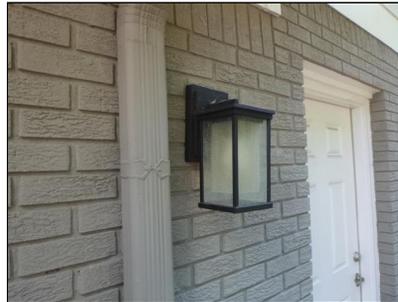
Item 32 - Picture 2

- ❌ 32. **SERVICE / REPAIR:** Inoperable lights observed at the time of inspection at: 1) Basement shower, 2) Deck sconce. Replace bulbs and verify that the fixture is operational. If not, consult an electrician for repairs.

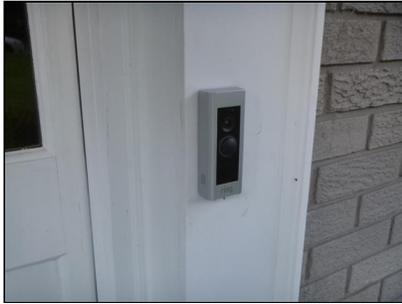
Item 33 - Picture 1

- ❌ 33. **SERVICE / REPAIR:** Door bell operates through an app and should either be given information on transferring to new owner OR have device removed and restore the standard door bell system.

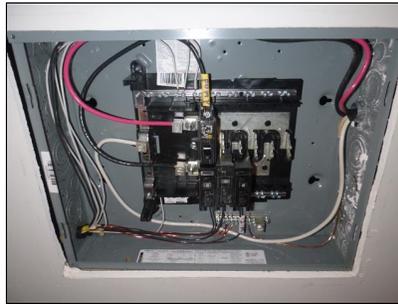
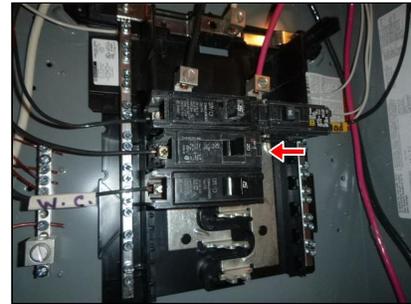
- ❌ 34. **SAFETY / HEALTH:** There are different breaker manufacturer types within panel box and found to be uneven suggesting different types of mountings. Recommend having reviewed by electrician and replaced to be of proper type to insure safety in use. Different manufacturers have different mountings and are not universal. Panel box is a Square D and Mismatched Breakers are Siemens. NEC 110-3b

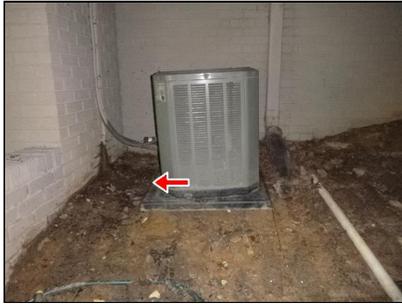
Item 36 - Picture 1

- ❌ 36. **SERVICE / REPAIR:** The condensation drain line terminates next to the building. This will release a considerable amount of water next to the foundation. Recommend the drain line be extended to terminate at least three feet from the foundation and beyond the A/C condensation units. This is also to reduce conducive conditions for termites.

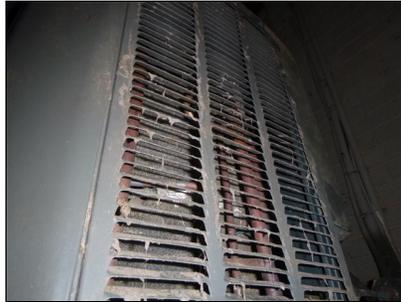
Item 37 - Picture 2

- ❌ 37. **SERVICE / REPAIR:** Dryer vent terminates behind A/C unit which is not advised due to heat, lint and potential chemical reaction of coil with harsh detergents. Advise relocating either vent or A/C unit to protect system. (10 feet clearance is general rule for separation.) If no relocation is done, the next best thing to have fins of unit cleaned routinely and avoid drying clothes during the heat of the day in the summer.

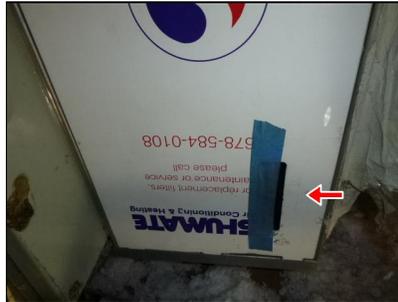
Item 40 - Picture 2

- ❌ 40. **SERVICE / REPAIR:** Filter cover at attic unit is taped closed. This works but would recommend having latching devices repaired. Have opening in panel cover sealed better.

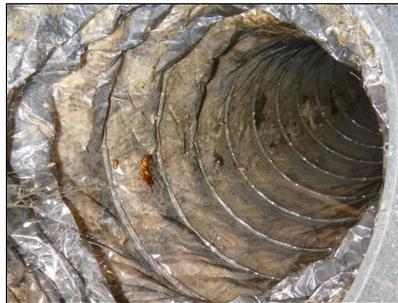
Item 41 - Picture 2

- ❌ 41. **SAFETY / HEALTH:** Debris within floor registers is limited but would recommend having vacuumed to reduce spread of dust during system operation. Although duct cleaning is available professionally, would at least have shop vacuumed to reduce dust.

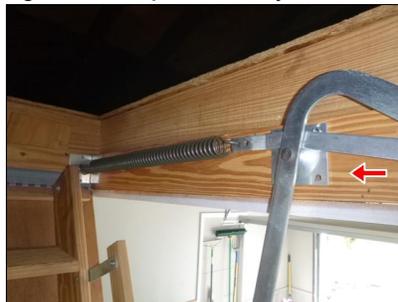
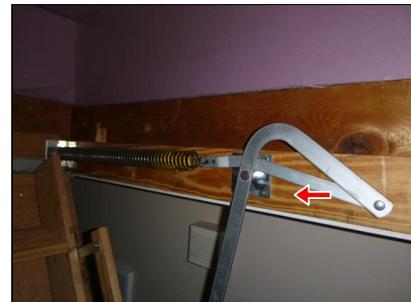
- ❌ 42. **SERVICE / REPAIR:** The pull down ladder leading to the attic area is not secured to the framing correctly. Add nails to all openings in metal mounting brackets provided by manufacture.

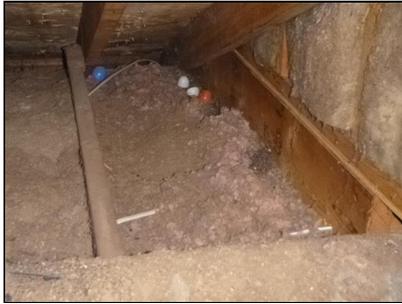
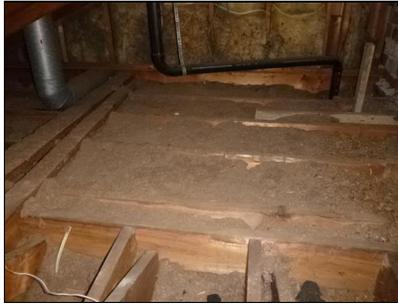
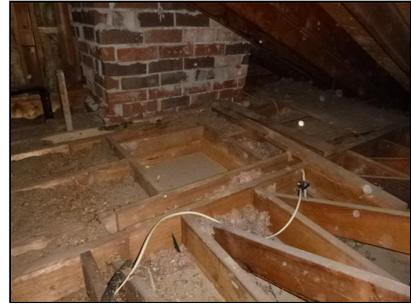
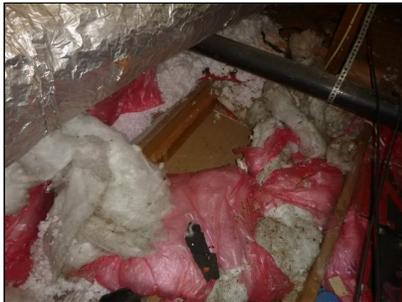
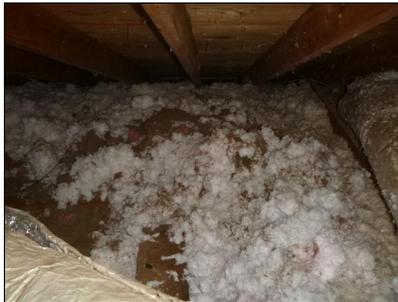
- ❌ 43. **SERVICE / REPAIR:** Thin / missing insulation noted between ceiling joists in attic above Laundry/Storage and Upstairs hallway. Recommend insulation be installed to provide required thermal protection.

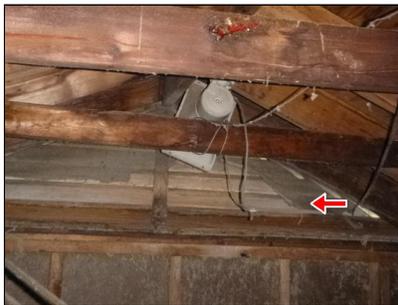
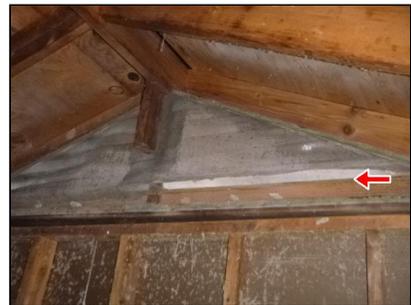
- ☒ 44. **SERVICE / REPAIR:** Damaged attic vent screens observed. Repairs are necessary to prevent pest entry. Replace any screens that have hole or tears. NOTE: Hardware cloth installed on outside of vents but would permit wasp sized pests.

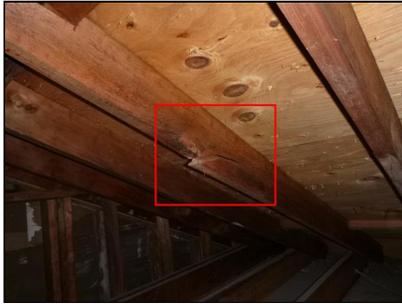
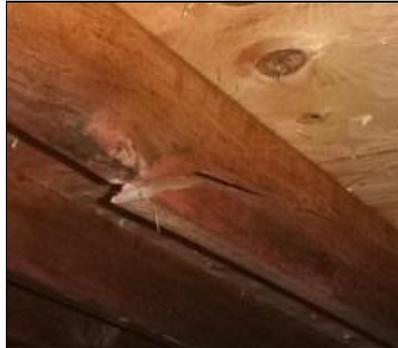
- ☒ 45. **SERVICE / REPAIR:** Cracked rafter in Garage attic. Recommend having sistered reinforcing done to strengthen weakened condition.

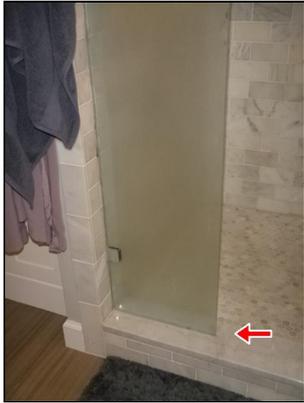
Item 57 - Picture 1

- ❌ 57. **SERVICE / REPAIR:** Fixed glass panel to Master shower is loose at bottom and should be secured better to limit potential for damage.

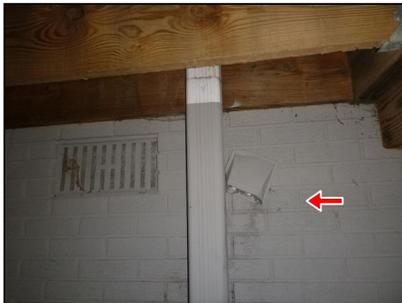
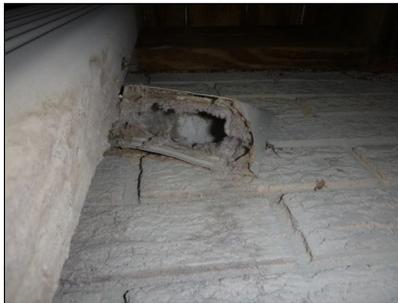
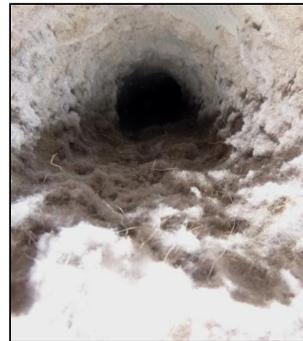
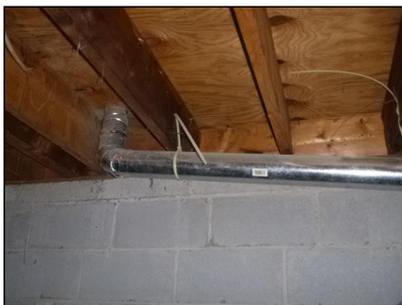
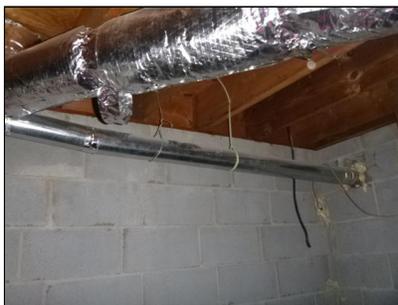
- 58. **SAFETY / HEALTH:** The dryer exhaust line has a significant amount of lint visible from the hood location outside. Have the line cleaned for maximum efficiency and safety.

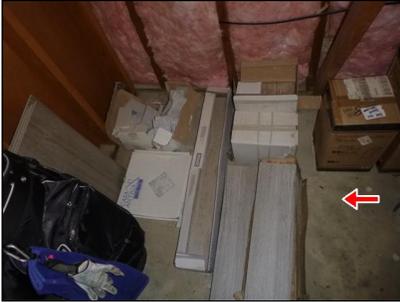
Item 60 - Picture 1

- ☒ 60. **GENERAL NOTE:** Builder materials found stored in Basement area. Verify locations that materials were used (paint, tile, grout, etc...) and if remaining with property for buyer's future use.

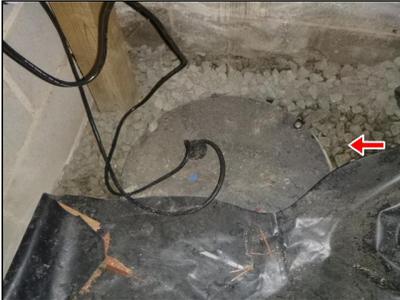
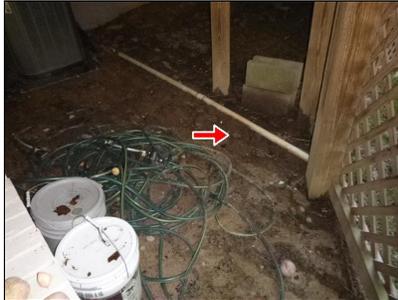
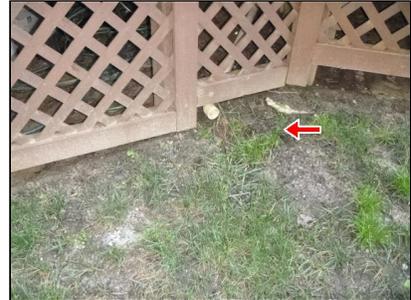
- ☒ 61. **GENERAL NOTE:** Crawspace equipped with a sump pump and drainage system to the unit. Verify if warranties exist from seller. Seek disclosure on maintenance of equipment for buyer's use.

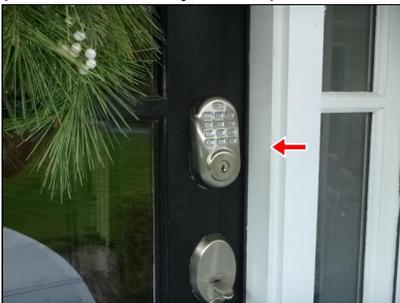
Item 62 - Picture 1

- ☒ 62. **GENERAL NOTE:** Door with keypad lock feature found and should have code and reprogramming information provided for buyer to operate.

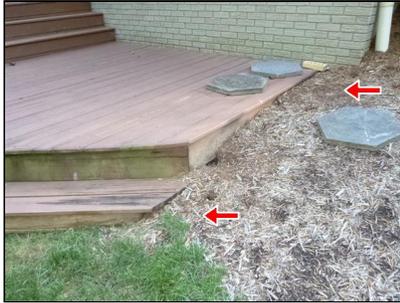
Item 63 - Picture 1

63. **GENERAL NOTE:** Significant ground contact of deck framing and/or very low clearance. This reduces visual early detection of termite travels and is typically excluded from termite company bond on property. Removal may not be practical or desired but should be aware of the potential consequences.

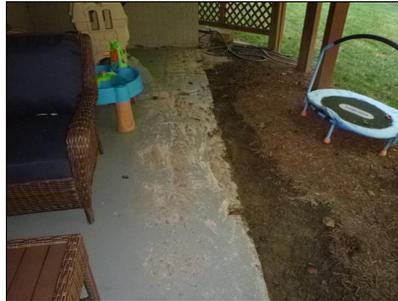
Item 64 - Picture 2

64. **GENERAL NOTE:** Very wet conditions below deck above retaining wall and onto patio. Possibly conditions that occurred after very heavy rain on Monday. Verify conditions are not routine.

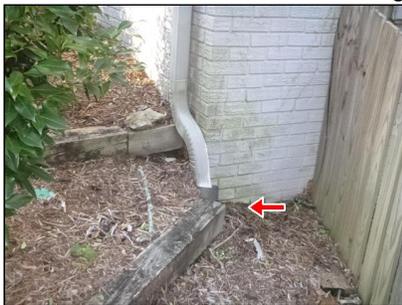
Item 66 - Picture 1

66. **GENERAL NOTE:** Underground water collection and dispersion for the gutters noted. Because the system is underground we are not able to inspect the drainage or determine its effectiveness. Seek disclosure on where lines terminate and monitor during rains to insure adequate drainage. Have cleared if found blocked.

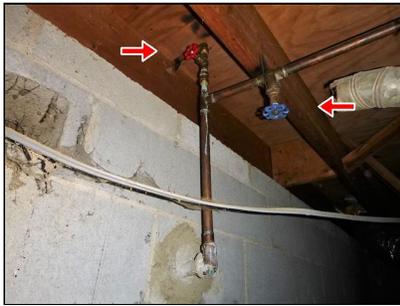
Item 67 - Picture 1

67. **GENERAL NOTE:** The main water shut off is located front wall of basement. The exterior hose bibb shut off valves are located Above main cut off. Verify location of spigot cut off for rear spigot. Recommend turning off the exterior hose bibbs in the winter and draining the lines to reduce chances of freeze damage to exposed piping. (Recommend having main and exterior cut offs labeled to insure accurate servicing or winterizing - IPC 606.4)

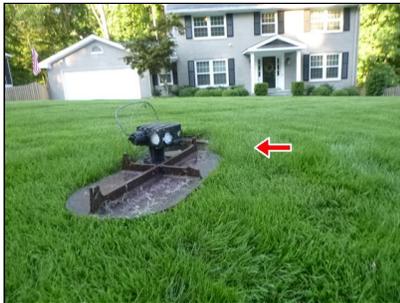
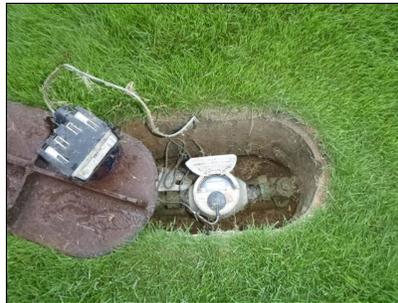
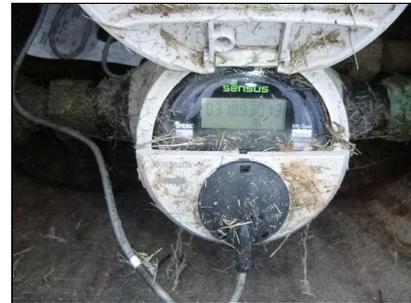
68. **GENERAL NOTE:** Upon arrival, found the water service meter and monitored dials and indicators for water flow. There was no indication of water usage. This is a solid indicator that, prior to entering the home, there are no leaks in the water service or supply line plumbing.

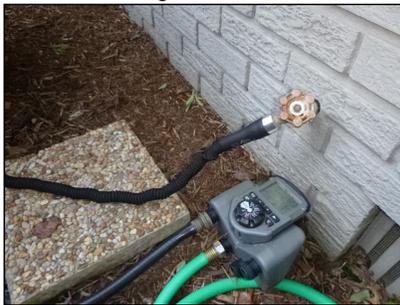
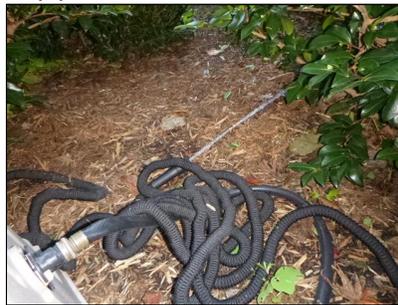
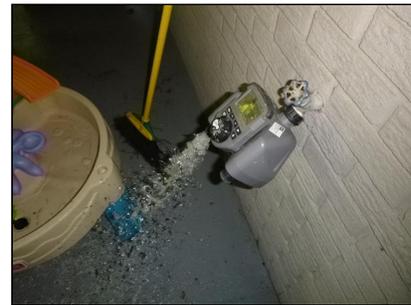
69. **GENERAL NOTE:** The exterior faucets should be shut off on the interior of the building during coldest months to avoid freezing which can lead to burst pipes.

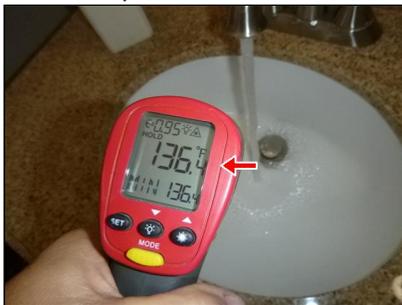
Item 71 - Picture 1

71. **SAFETY / HEALTH:** The water heater thermostat is currently set near or at highest mark and should be turned down to initial setting for safety in normal use. Typically initial setting should produce approximately 120 degree water temperatures.

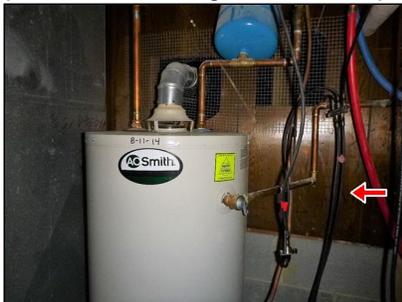
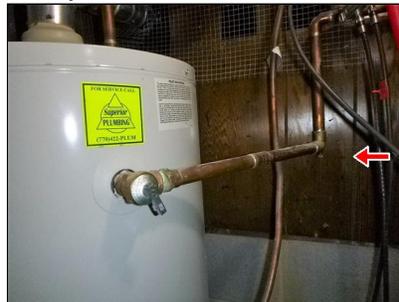
72. **GENERAL NOTE:** T/P drain line from water heater has a drain equipped as required and should be checked and cleared of water periodically. Be prepared to collect water from drain valve. Keeping line dry helps reduce potential of rusting and freeze up of safety valve.

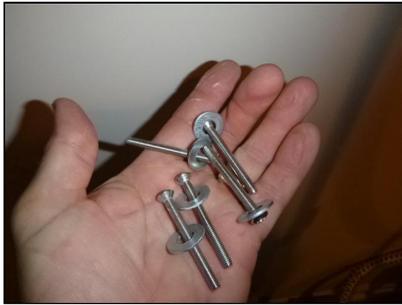
Item 74 - Picture 1

74. **GENERAL NOTE:** Extra long screws provided are difficult to line up to serve as presently installed.

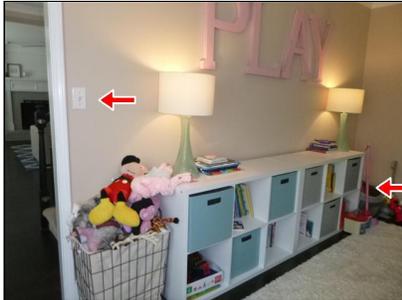
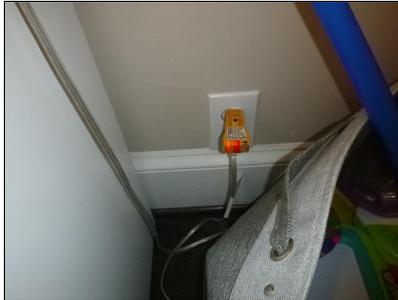
75. **GENERAL NOTE:** Switch located in Living Room found to operate part of receptacle located within the room to allow for switching on a lamp when entering.

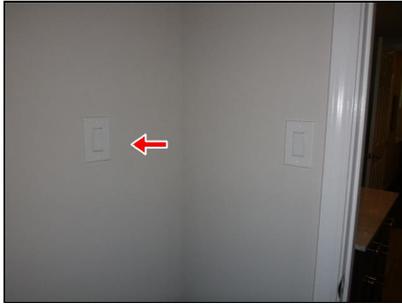
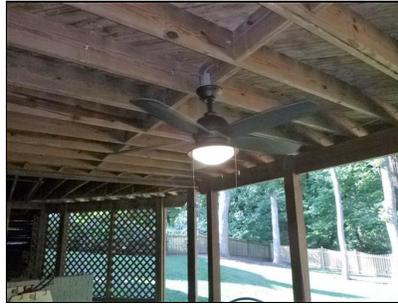
76. **GENERAL NOTE:** Switch in Basement closet provides power to ceiling fan below porch.

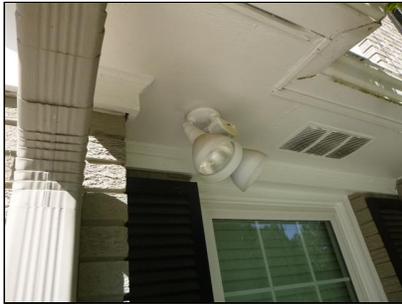
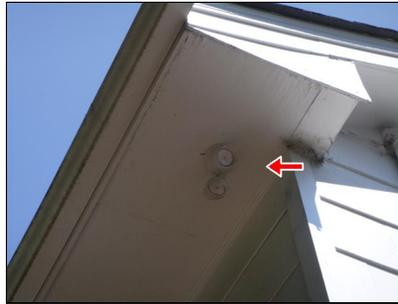
77. **GENERAL NOTE:** Motion sensor / photo cell type light fixtures observed on the exterior. These lights should be verified after dark. Unable to test at time of inspection.

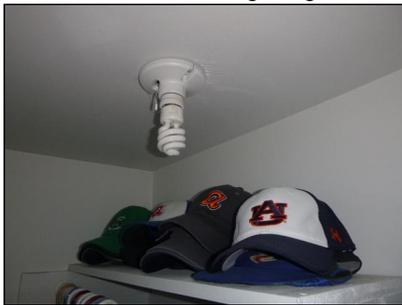
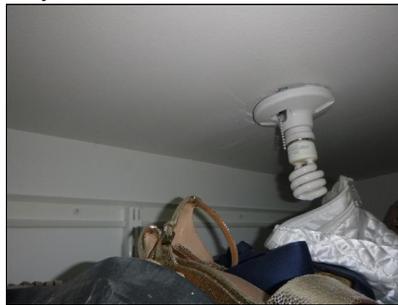
78. **GENERAL NOTE:** Incandescent lights in closets located above or near shelves are a safety concern in the event storage materials fall against hot bulbs. Options are to eliminate or relocate fixtures there or install cooler compact fluorescent bulbs if lighting is necessary.

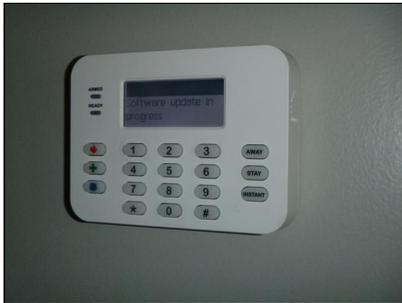
Item 80 - Picture 1

80. **GENERAL NOTE:** House is fitted with security system and appears currently functional. There is no extensive testing done to system during home inspection. Contact a provider to review system if electing to make operational and monitored.

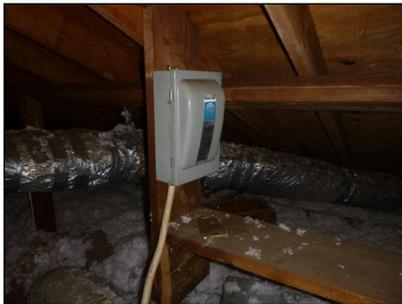
Item 81 - Picture 1

81. **GENERAL NOTES:** Unused electrical located in attic. Possibly run for electric heating in the past.

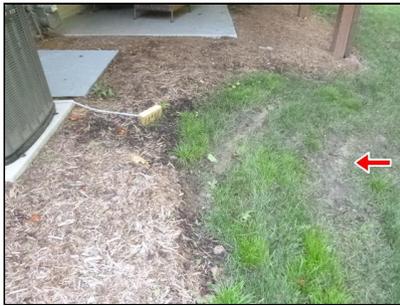
Item 82 - Picture 1

82. **GENERAL NOTE:** Damp conditions in ground by A/C units will be common during hottest times of the year as humidity that was in the home is drained back outside. Efforts to drain further away or manage could be reviewed and corrected by landscaper if electing to reduce moisture in yard. One option to reduce dampness by A/C units is to create a dry well filled with rock to permit added surface area for water to percolate into. Have utility search made before digging.

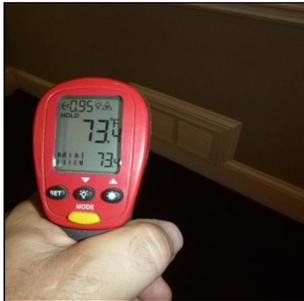
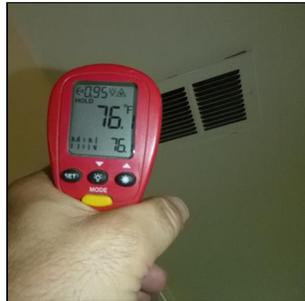
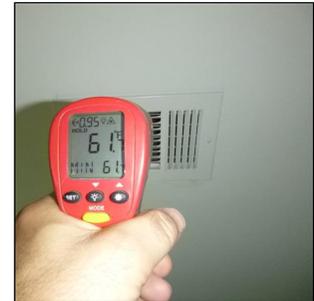
83. **GENERAL NOTE:** Temperature difference measured: 15 - 17 degrees, Satisfactory

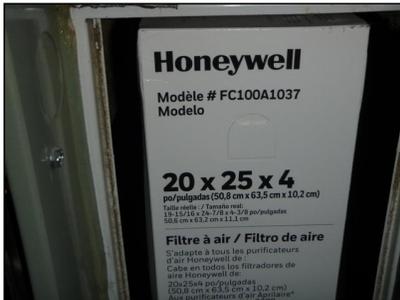
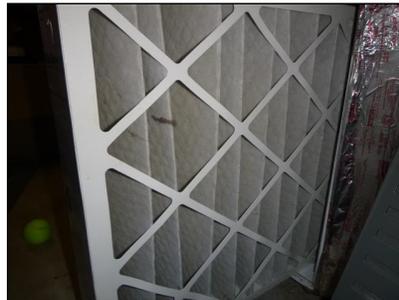
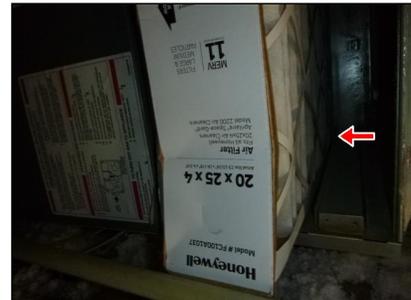
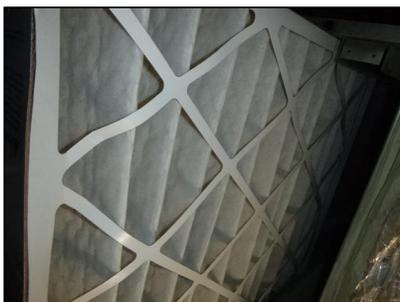
84. **GENERAL NOTE:** Expandable filter or extra thick media types have an extended period of replacement schedule. Verify last replacement and have media replaced with new one at proper time. Size/type filter(s) is/are 20 x 25 x 4.

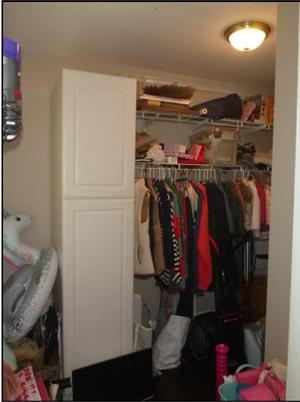
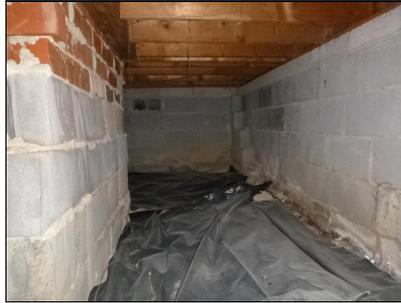
85. **GENERAL NOTE:** No supply found installed to serve storage closet behind fireplace and whereas it is not technically required, they are often found installed to avoid having assume outside temperatures especially if door remains closed much of the time. Consider having upgraded to serve space. Access from crawlspace is available.

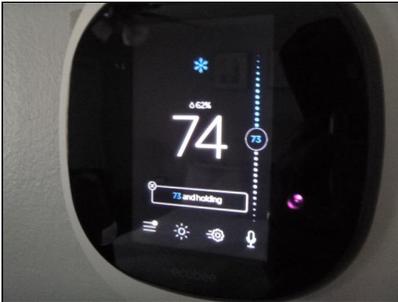
Item 86 - Picture 1

86. **GENERAL NOTE:** Thermostats are a type that uses homes WiFi to program and change settings from a phone app. Seek information from seller if available.

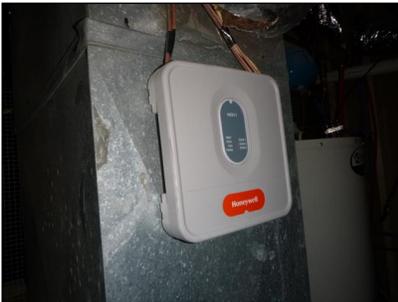
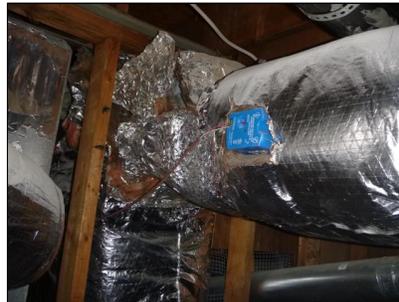
87. **GENERAL NOTE:** This home has electronic dampers run through two thermostats to help balance main and upstairs levels.

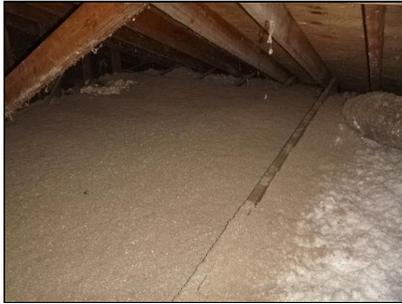
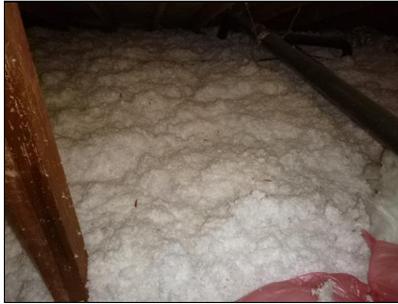
88. **GENERAL NOTE:** Conditions of attic insulation is good for the much of areas surveyed.

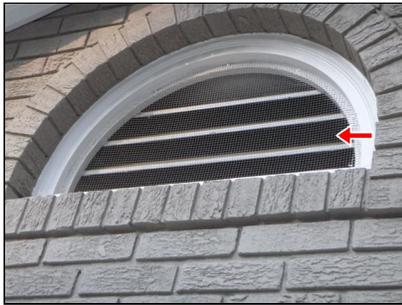
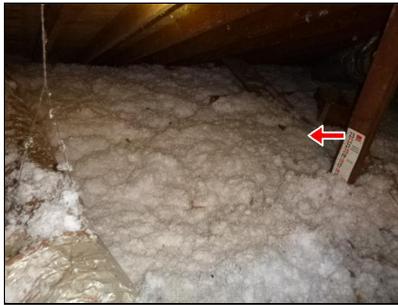
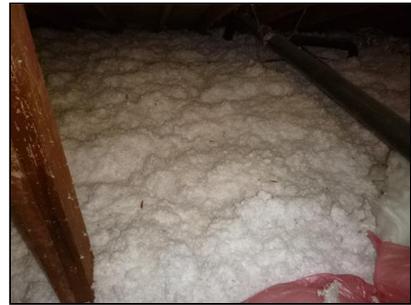
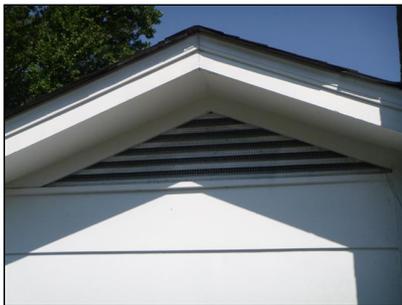
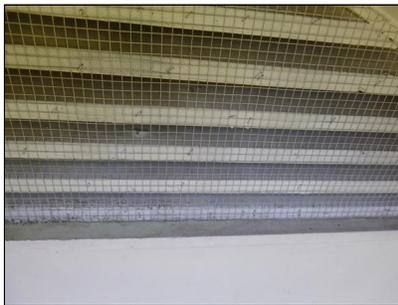
89. **GENERAL NOTE:** Appears to have had efforts made to eliminate pest entry into attic spaces. Seek disclosure from seller on this for future reference and have warrantee information provided if available. Trails in insulation from pest activities in attic.

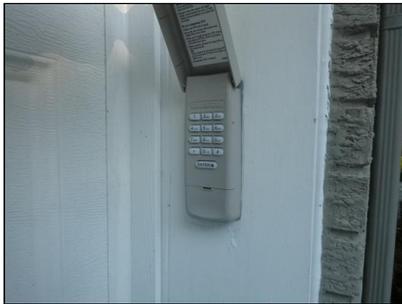
Item 91 - Picture 1

91. **GENERAL NOTE:** Remote keypad mounted outside of garage provides a method for opening the garage with security of a code. This code number should be provided to buyer or have reprogrammed per manufacturers instructions.

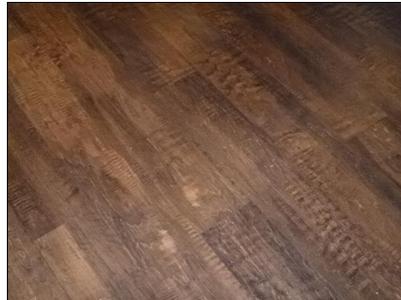
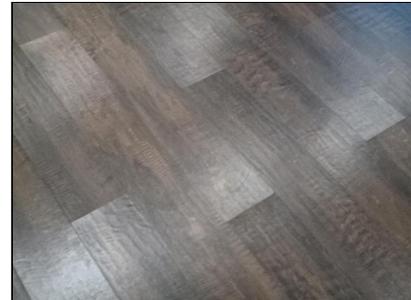
92. **GENERAL NOTE:** Basement flooring appears to have been affected by elevated moisture. Possibly prior to sump pump installation but cannot confirm how well it will perform over time.

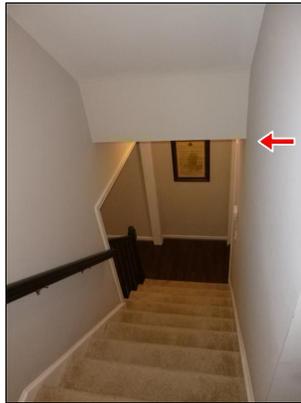
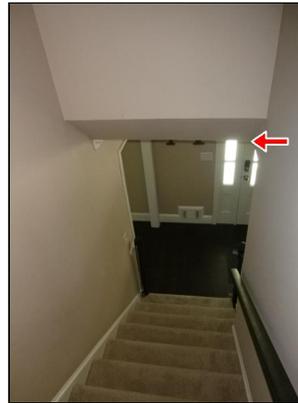
94. **GENERAL NOTE:** Headroom less than 6 feet 8 inches in stairway from Basement and from Foyer as measured along plane of leading edge of steps as denoted in code publications. The height measured around 6'-0" and 6'-6" by the measurement definition. Not usually easy to modify due to structural conditions. Aside from obvious condition in taller persons, may contribute to difficulty in moving larger pieces of furniture.

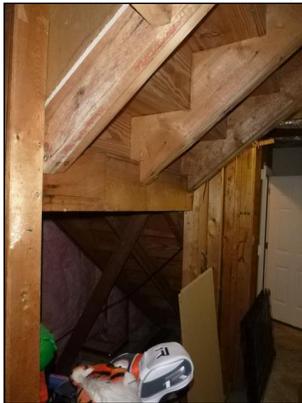
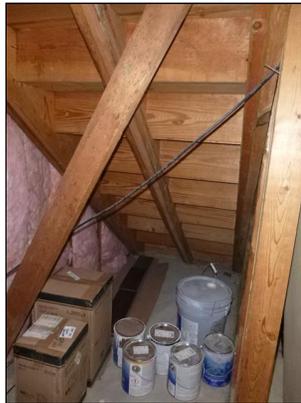
95. **GENERAL NOTE:** Storage areas below stairways are currently required to be finished with at least 1/2 inch drywall installed to all exposed wood surfaces for fire safety. Additionally, no flammable materials should be stored there to avoid resulting in losing primary exiting path during a fire. Although this may not have been a requirement when built or enforced by local authorities, buyers should consider this as a safety upgrade.

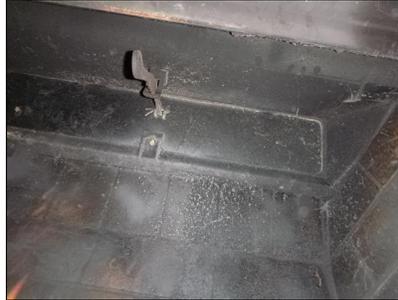
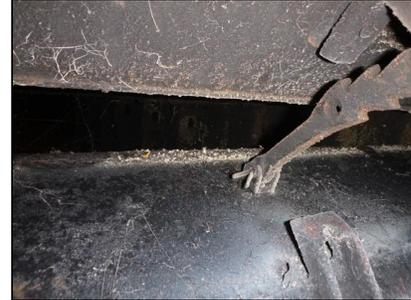
96. **GENERAL NOTE:** The fireplace located at Family room is presently set up with artificial gas log set and was tested. Dampers are required to have clamps installed to prevent fully closing (Damper clamp not installed on damper within this fireplace). This manufacturer required clamp is for safety since exhaust gases contain carbon monoxide. (Partially open dampers often responsible for drafts during winter months and clamp could be removed at owner's discretion.) [If electing to convert back to burning real wood, the present burner mechanism will have to be replaced with cast iron burner because artificial burners cannot withstand the heat and abuse of real wood fires.]

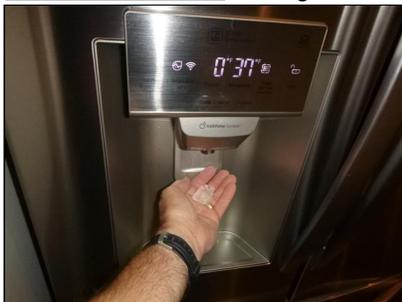
Item 98 - Picture 1

98. **GENERAL NOTE:** Refrigerator though door dispenser functional when tested.

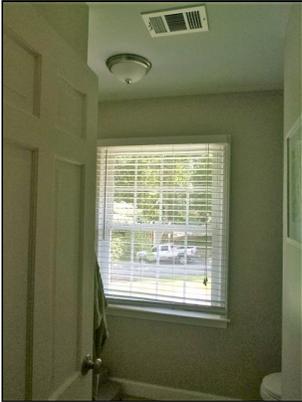
Item 99 - Picture 1

99. **RECOMMENDED UPGRADE:** The bathroom(s) have operable windows which are approved for ventilation requirements. Exhaust fans can be installed in bathrooms where attic exists above, if electing to have a more practical solution to removing humidify as an upgrade.

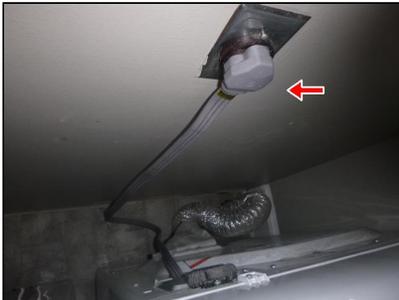
Item 100 - Picture 1

100. **GENERAL NOTE:** This laundry has a 3 prong receptacle to serve the dryer. If you have a newer dryer, they now have a 4 prong plug. Most common remedy is to have cord replaced on dryer to meet the hook up needs. NOTE: If ground and neutral are combined within 3 prong, the safer solution would be to convert to 4 prong to avoid a parallel current flow back to the panel through the ground.
