SafeHarbor Inspection Group

Building Inspection Report

229 Kirkwood Rd NE

Atlanta GA 30317

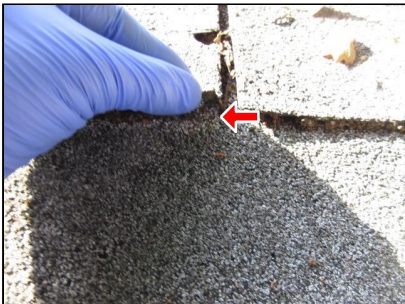
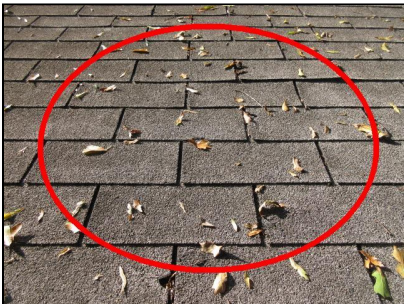
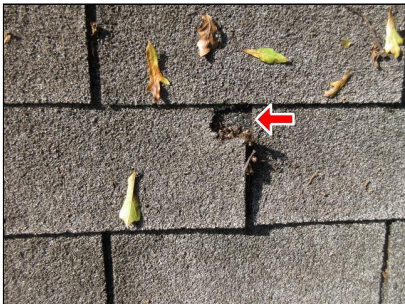
Concern: Overall, the roofing is nearing the end of its useful life as indicated by brittle and curling shingles. The roof should be monitored closely for leaks and budgeted for replacement in the very near future. Recommend removing all previous layers of roofing material and replacing all old flashings when the roof is replaced. Replace all damaged sections of roof decking as needed.

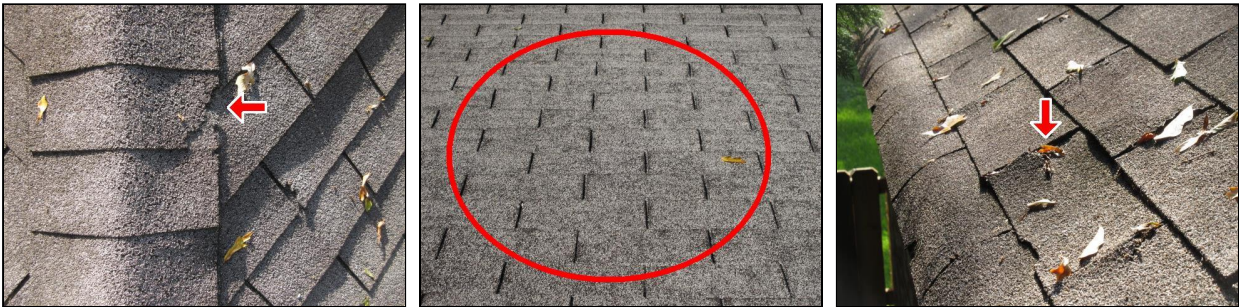
Monitor, Possible Repair: Signs of previous leaks were noted in the roof framing (e.g. at the rear shed). Consult with the seller concerning the history of all leakage encountered in the roofing system and previous repairs performed to correct these conditions. If these repairs have not been made, a qualified roofer should investigate the flashing and shingles in the area(s) and make repairs as necessary. All flashing and roofing components should be monitored in the future for further leakage and repaired as necessary.

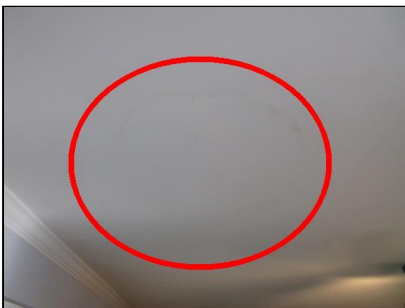
Living Room Ceiling

Monitor: Signs of previous roofing repairs were noted at the rear roof above the laundry area, and at the front roof above the living room. Consult with seller to determine the nature of these repairs and the history of all roof leakage encountered in the roofing system.

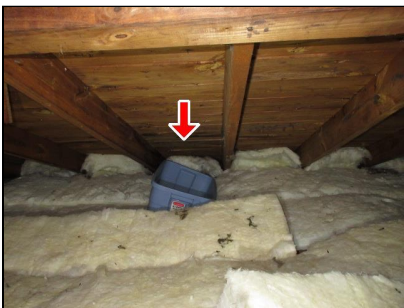
Bucket Noted (Empty) Above Stain in Living Room

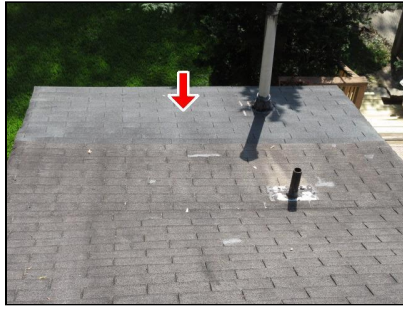
Rear Roof Above Laundry Room
(Newer Shingles Noted)

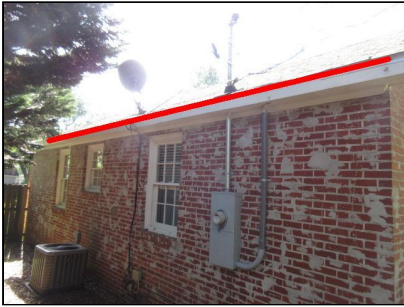
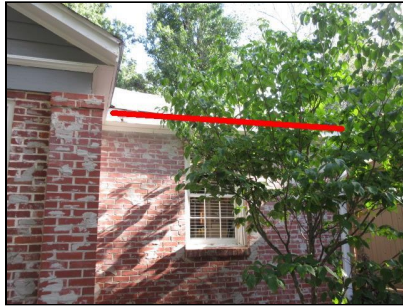
Improve: It is recommended that gutters and downspouts be installed at the sides and rear roof to avoid spilling roof runoff around the building, which is a potential source of water entry or water damage. The downspouts should be piped away from the foundation so that they discharge water at least ten (10) feet from the house to prevent moisture infiltration into the crawlspace. Storm water should be encouraged to flow away from the building at the point of discharge.

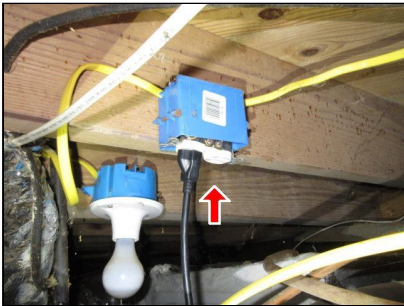
Repair, Safety Issue: Missing outlet and switch cover plates as noted in the rear shed and in the crawlspace (next to furnace) should be replaced as needed to avoid a shock hazard.

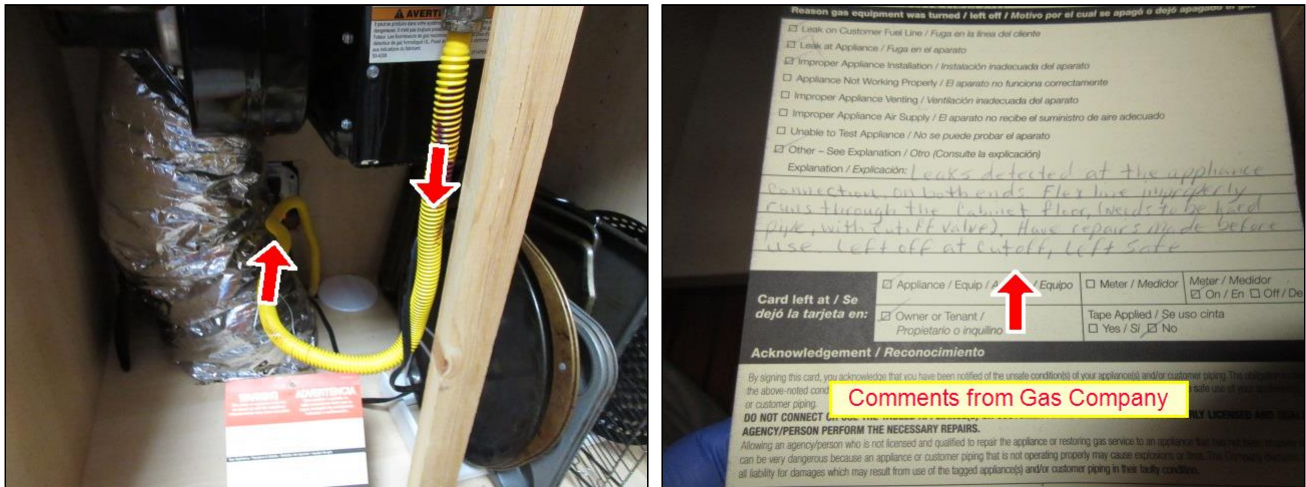
Repair, Safety Issue: The gas supply line serving the cooktop is flexible piping which passes through the cabinetry without protection. This piping runs the risk of being damaged by the edge of the cabinet and should be replaced with rigid pipe or otherwise protected to prevent future leaks.

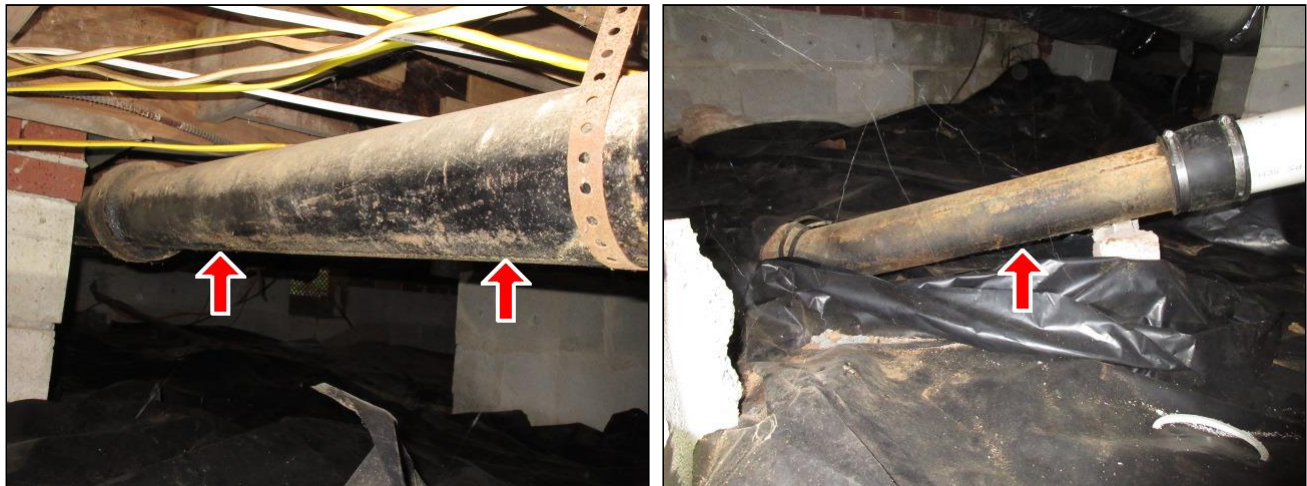
Monitor, Future Repair: Old cast iron waste piping components as noted will need replacement in the future to prevent blockages in the lines and leakage at the joints. If the old cast iron piping remains underground to

the main sewer outfall, consider having a plumber check the line before closing for potential blockages and/or damage.

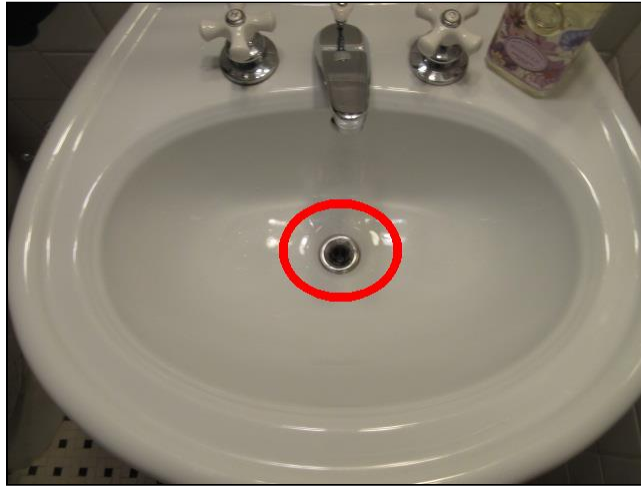
Repair: The sink stopper located in the bathroom is missing and needs repair or replacement altogether.

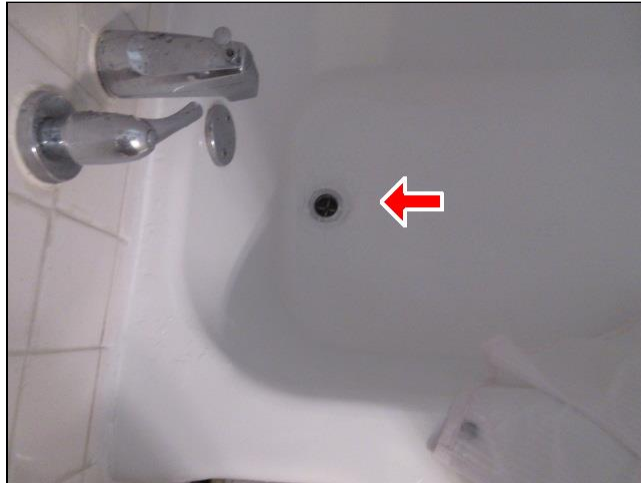
Repair: The tub stopper in the bathroom is missing and needs repair or replacement altogether.

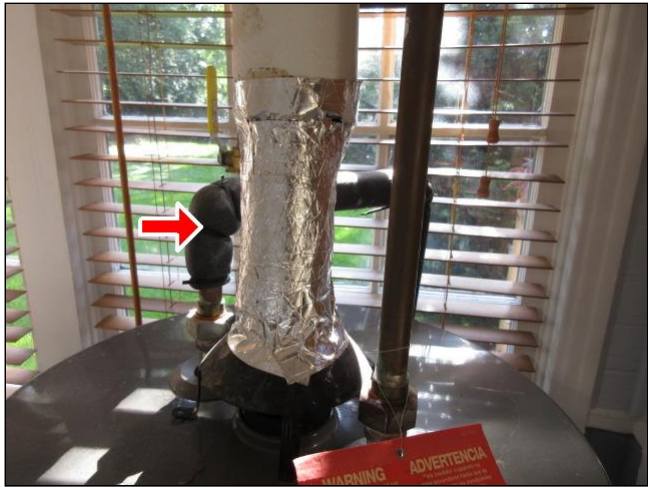
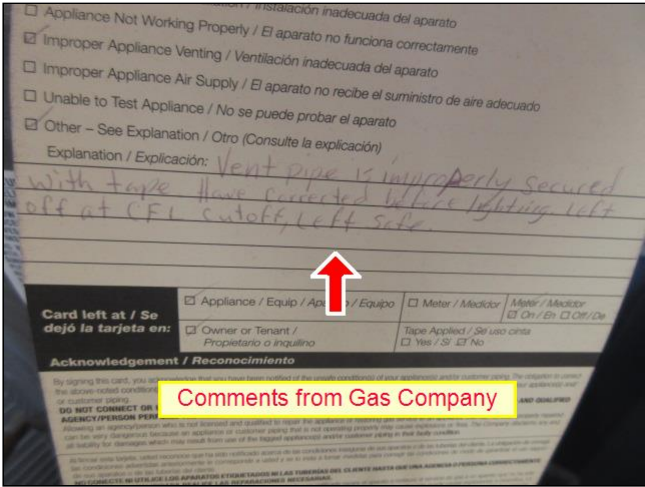
Repair, Safety Issue: For enhanced safety, it is recommended that the improper connections at the water heater venting system be improved by properly sealing and securing the joints with screws as opposed to foil as noted.

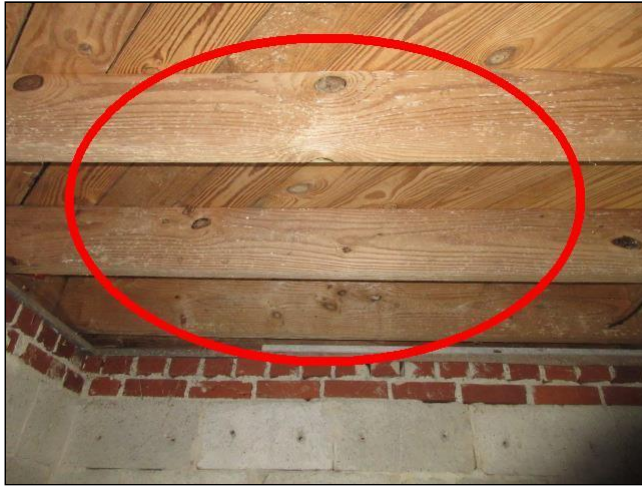
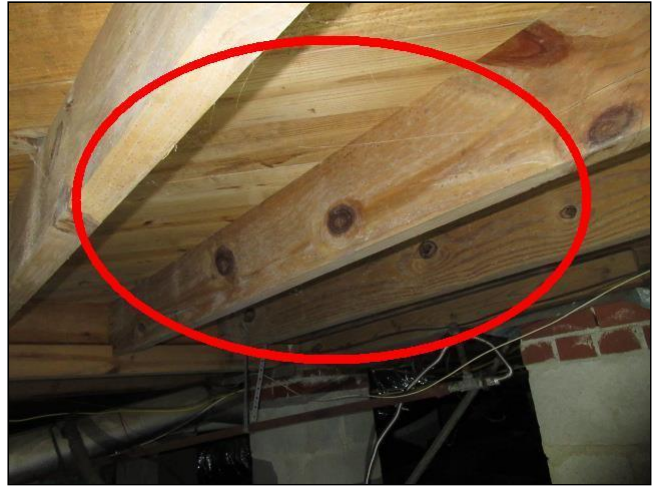
Possible Repair, Safety Issue: Slight indications of possible mold and/or mildew growth were noted on the joists in the crawlspace which can promote bacteria causing agents to infiltrate living areas. Proper ventilation and storm water control (see "Roofing" and "Exterior" Sections) will help control humidity and reduce the potential for mildew, rot, and termite infestations. If this condition is a health concern for occupants, consider engaging an indoor air specialist for further evaluation. A mold assessment is not included in this inspection.

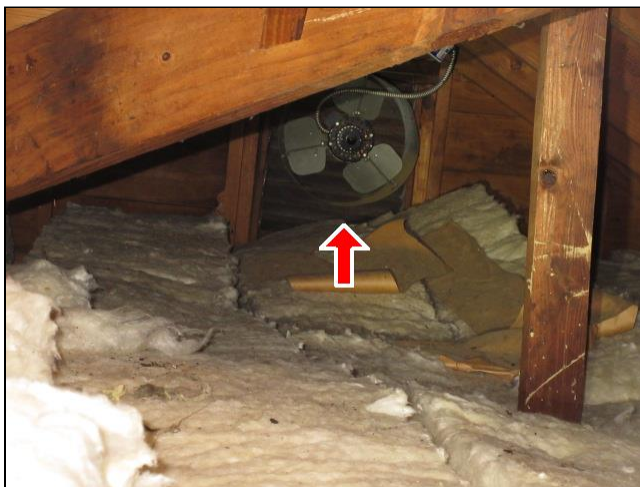
Improve: The power ventilator in the right side attic could not be tested due to unreachable thermostats. The thermostats should be relocated to a more accessible location, preferably near the stairs/scuttle hole. They should then be tested for proper operation and adequate ventilation of the attic.

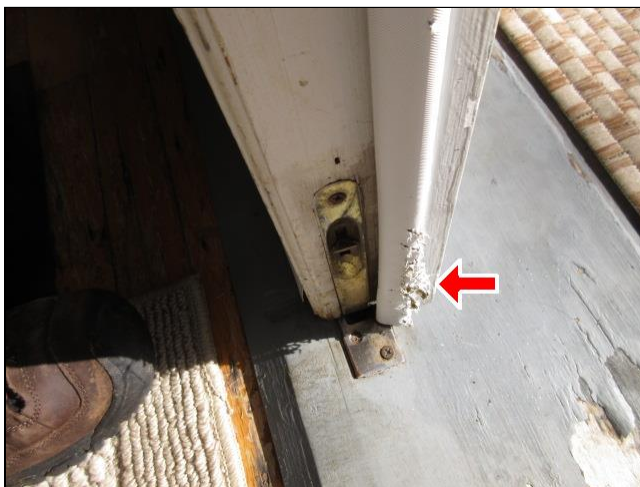
Repair: The weatherstripping as noted at the rear door is damaged and should be repaired or replaced as needed to limit outside air infiltration into conditioned areas.

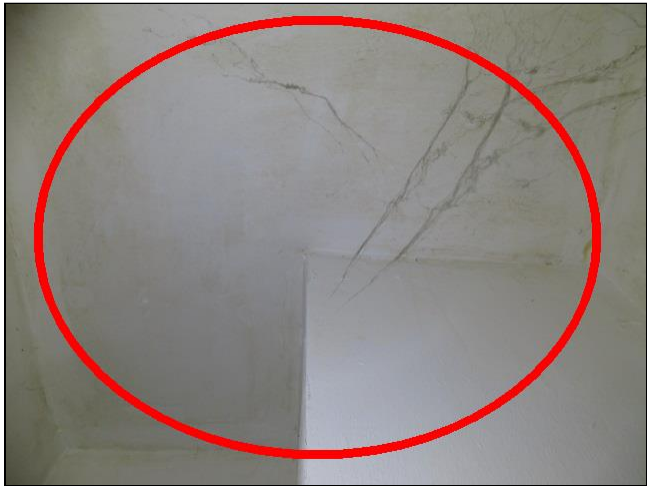
Repair, Safety Issue: Evidence of possible mold and mildew was noted in the kitchen closet. Bacteria growth within the house contaminates indoor air quality could pose a health risk. Recommend having an indoor air quality specialist evaluate these conditions and make recommendations as necessary. These areas may need cleaning with a fungicide or otherwise sanitized. All damp and damaged sheetrock should be replaced as needed. The source of the moisture should be eliminated to prevent further growth. The identification and testing for mold growth is not a part of this inspection.

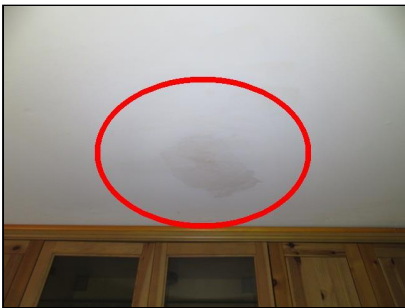
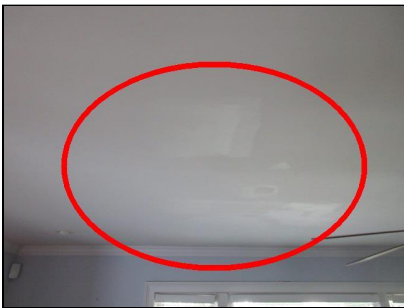
Monitor: Evidence of previous patching and repairs was detected at the living room, rear bedroom and kitchen. Consult with the seller concerning the nature of these repairs and monitor for future activity.

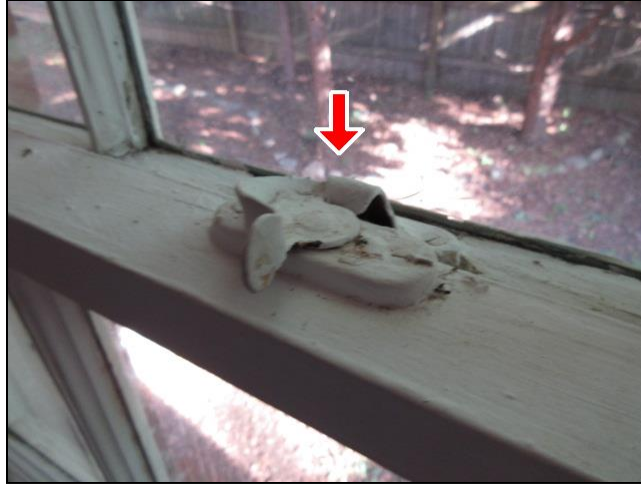
Repair: Inoperative window latches as noted in the rear bedroom should be repaired or replaced for proper locking of the windows.

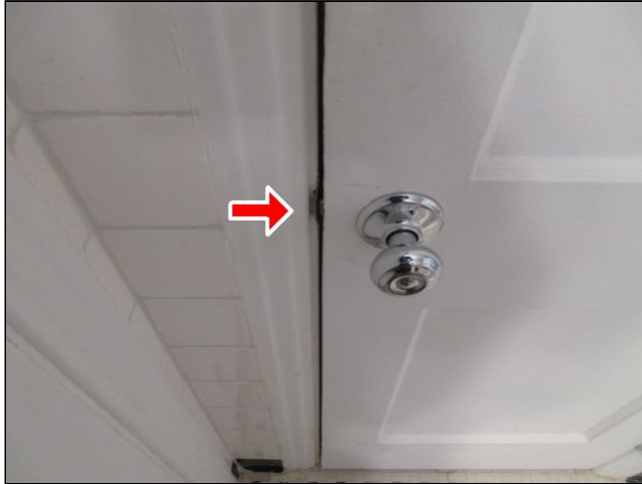
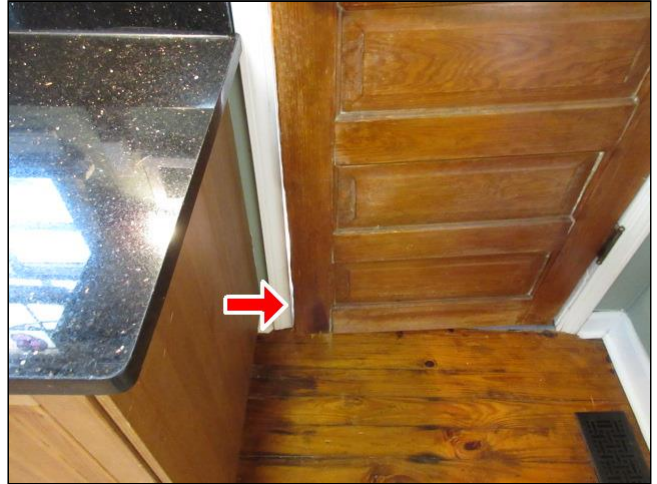
Repair: Doors should be trimmed or the hardware adjusted as necessary to latch and close properly as noted at the bathroom closet and laundry room.

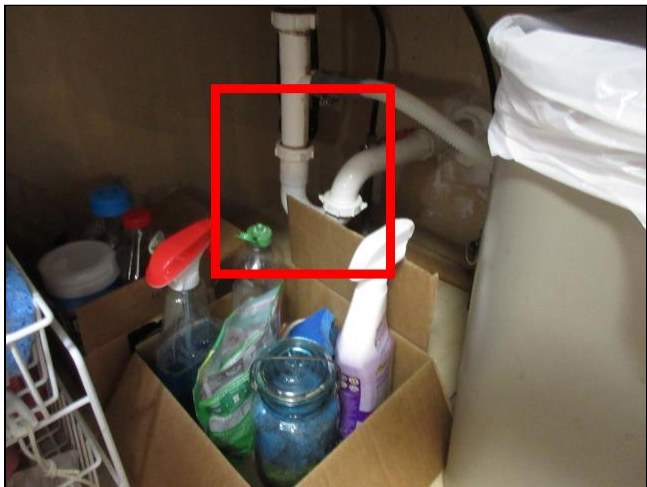
Improve: Recommend the installation of a disposal at the kitchen sink for proper disposal of food debris.

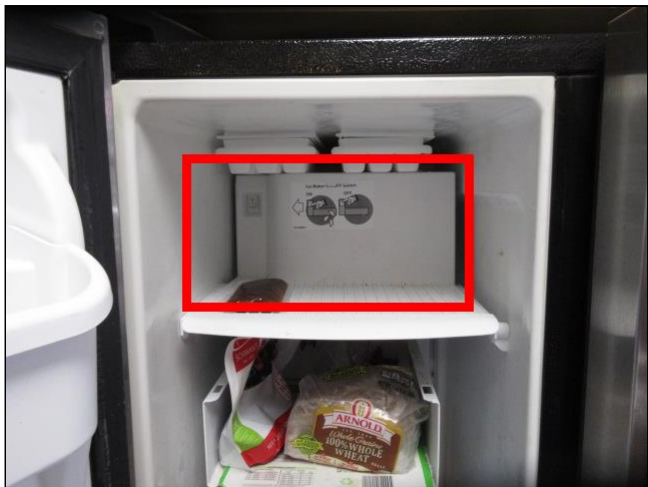
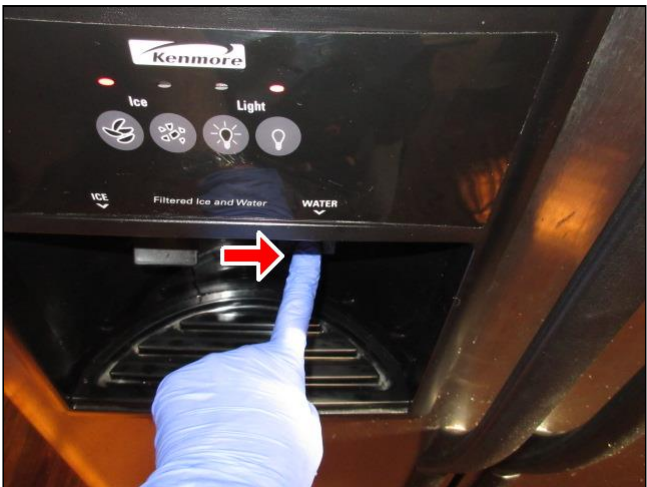
Monitor, Possible Repair: The ice maker and water dispenser in the refrigerator is either turned off or non-operable. Consult with the seller concerning its status, as the unit may need repair.

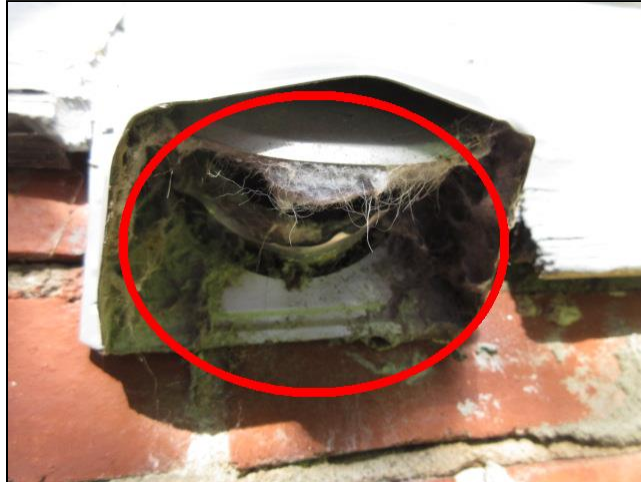
Repair, Safety Issue: The clothes dryer exhaust vent pipe appears clogged with lint and should be cleaned. Blocked piping can cause damage and possible fires at the dryer element.
