Welch Engineering  
1345 BridgeMill Avenue  
Canton, Georgia 30114

# Residential Inspection

120 Colton Crest Drive  
Johns Creek, Georgia 30005

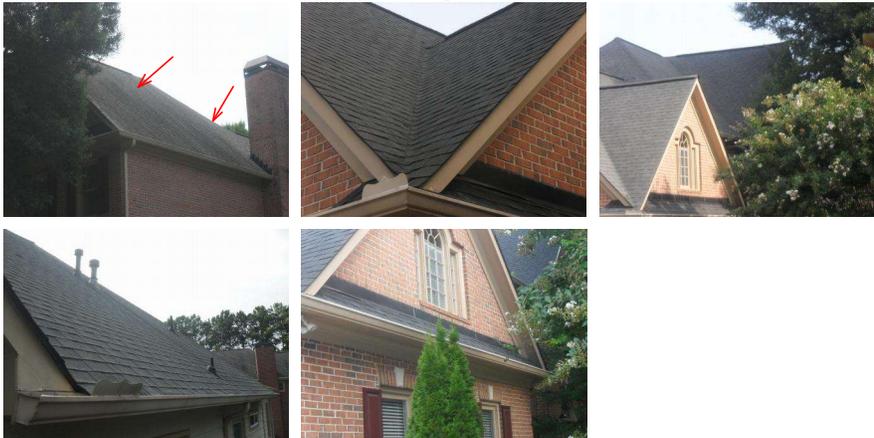
1. Method of Inspection: On roof, Binoculars, Windows from above, Attic  
2.      Unable to Inspect: 15% Due to the height and steep slope of the roof some of the roofed areas were not accessible.  
3.      Material: Architectural shingles Stains on right side roof

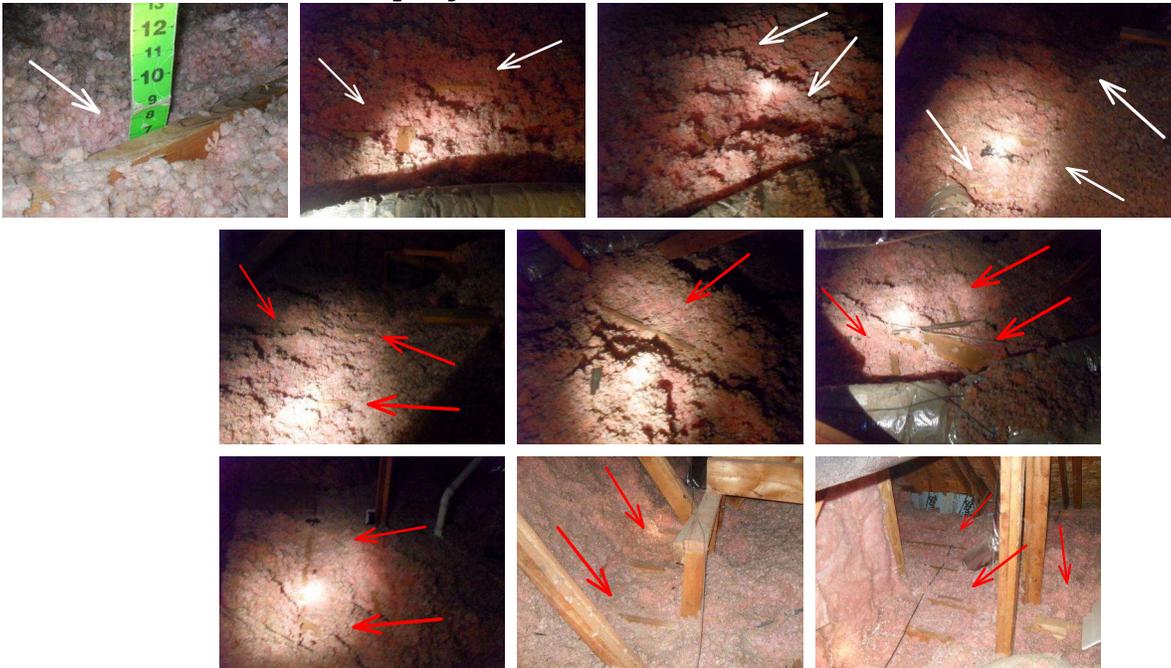
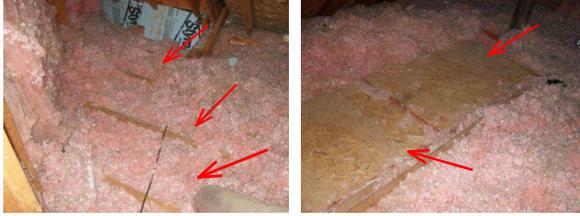
11. **Above main structure Attic Insulation Depth:** 0 - 12" The attic insulation has been walked through, moved and compressed from its uniform 12" depth for R-30. Plywood has been laid on top of loose fill reducing the R-value. See photos. The joist are about 7" high so if the attic joist are visible, about 5" of insulation is missing. It is recommended that a qualified insulation contractor evaluate the attic insulation and install additional loose fill insulation to equal R-30 and post certificate certifying R-30.

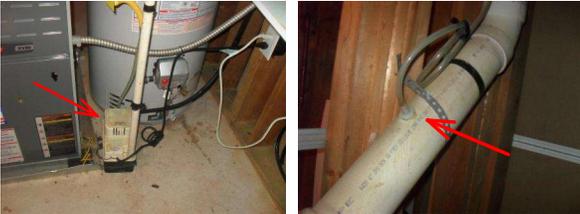
14. **Right side of house - forward unit AC System Condensate Removal:** Electric pump with clear plastic tubing Condensate being improperly emptied into plumbing pipe. Not allowed because sewer gas can enter conditioned air when pump not in use. Safety hazard. A licensed and qualified HVAC contractor is recommended to evaluate and provide estimated/recommendation for needed repair.

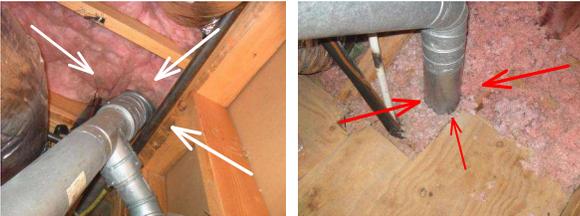
Attic insulation must be separated from a flue vent by a distance of 1" for class B double wall vent. If the insulation in the attic is 12" deep the shield should be at least 14" long, totally isolating the flue pipe from attic insulation.

Safety/fire hazard. Recommend an insulating shield be installed & ensure at least 1" clearance from combustibles

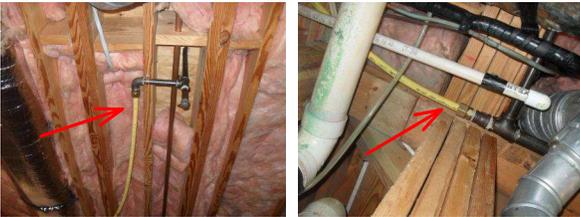
18. **Gas Service Lines:** Steel pipe, Flexible connector, Yellow CSST Yellow CSST tubing was used to run gas to kitchen, which has not been bonded as required by code & manufactures installation instructions. The thin wall tubing can burn through from nearby lightning strikes if tubing is not properly bonded causing house fire. Appears gas line was not run with required permit or city inspection. See [www.csstfacts.org](http://www.csstfacts.org), [csstsafety.com](http://csstsafety.com) & Georgia Fuel Gas Code Section 310.1.1 for additional information. According to manufacturer, this tubing may only installed by a qualified installer who has completed installation certification. If this tubing is installed improperly, fire, explosion, or asphyxiation may result, according to product label. Installation and bonding instructions, and local codes must be strictly followed. See [Homeflex.com](http://Homeflex.com). Does not appear tubing was installed by a licensed or certified plumber. It is recommended that a qualified & licensed plumbing/HVAC contractor evaluate & provide estimate/recommendation for needed repairs that comply with manufacturer's instructions & State Fuel Gas Code
