Report: 1000-ambrose-ave home inspection

1000 Ambrose Ave
Alpharetta, GA 30022

October 6, 2020

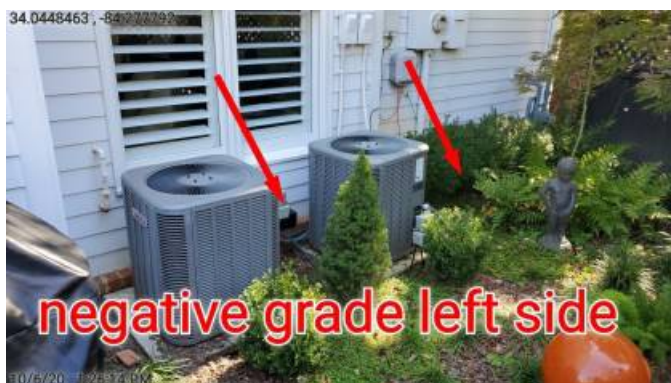
2.5 Site: ☐ ☐ ☒ ☐ Grade at the foundation is negative at the right side of the home and left side of the home. Correction is recommended. Pitch slope of soils away from foundation. Slope should fall away from the foundation at a minimum of 1/2 inch per foot and extend at least 10 feet away from the foundation

Ground was in contact with the siding on the right side of the home. Grade should be 6 inches below any wood / siding materials. Concrete should be 2 inches below any wood / siding materials. This condition may be conducive to termites and water entry into the home.

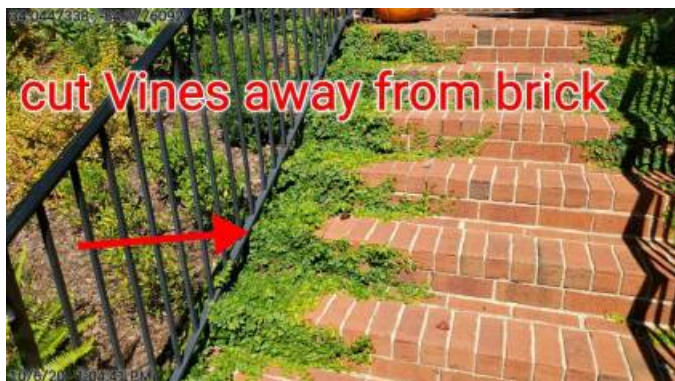
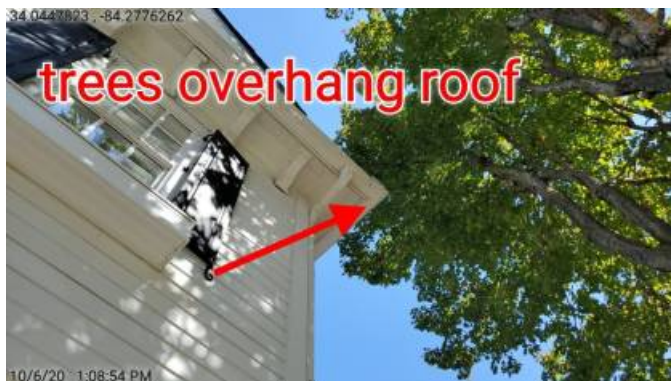
Trees are seen overhanging the homes roof. This can cause premature aging to the roof shingle and damage to the gutters over time. Recommend cutting the trees back so the limbs do not over hang the roof.

Vines are growing up the front porch steps. Recommend cutting back the vines as this can cause deterioration to the brick surface.

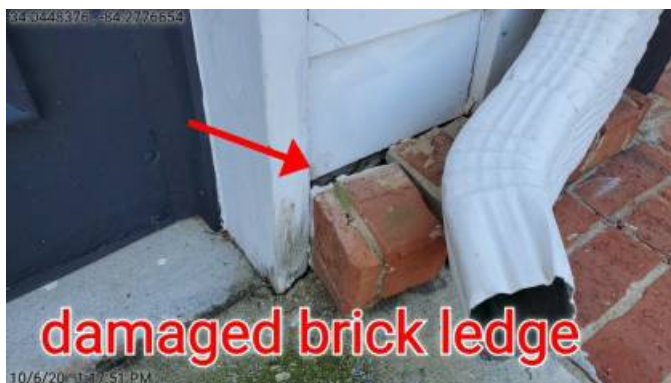
The brick ledge to the right of the garage door is damaged and loose. Recommend Repairs by a licensed brick mason.

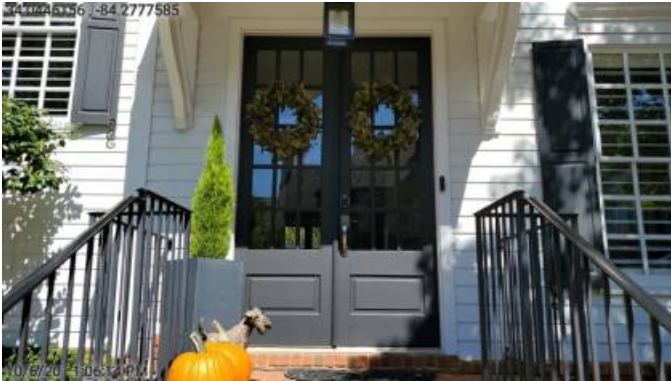
The door sticks or rubs in the door jamb. Recommend adjustments to the door and / or jamb for proper operation of the door.

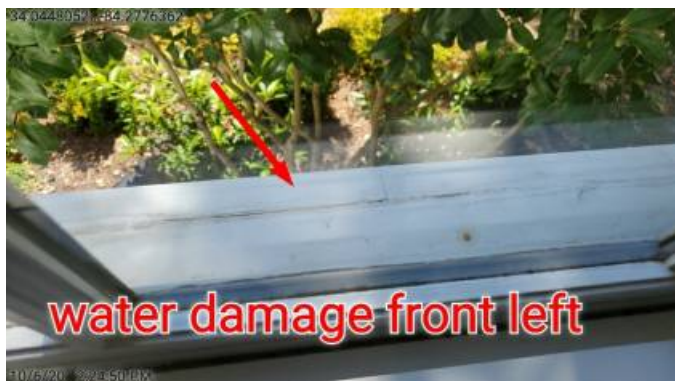
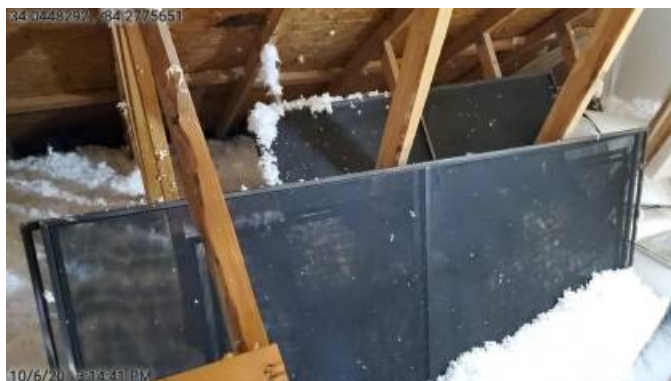
Water damage was noted to the windows at the front left wall. Recommend repair / replacement to all damaged wood. In most cases the wood rot has only affected the brick mould and the window sill but In some cases the wood frame on the window is damaged and the window may need to be replaced.

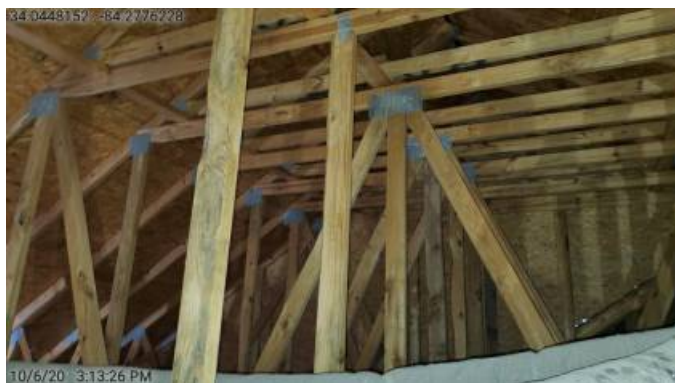
4.12 Structure Condition: ☐ ☐ ☒ ☐ Repairs were noted to at least two trusses in the attic space around the first floor furnace. The repair on one section of the truss is loose and no longer effective. Recommend new Repairs by a licensed framing contractor.

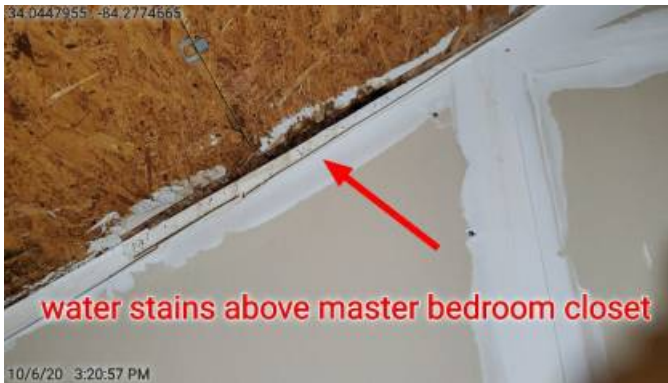
Water stains above the master bedroom closet correspond with the repairs and staining on the ceiling of the same closet. All areas were tested with a moisture meter and showed no moisture at the time of the inspection. Recommend inquiring with the current homeowners as to the nature of any previous repairs and

any warranty that may transfer to the new owners.

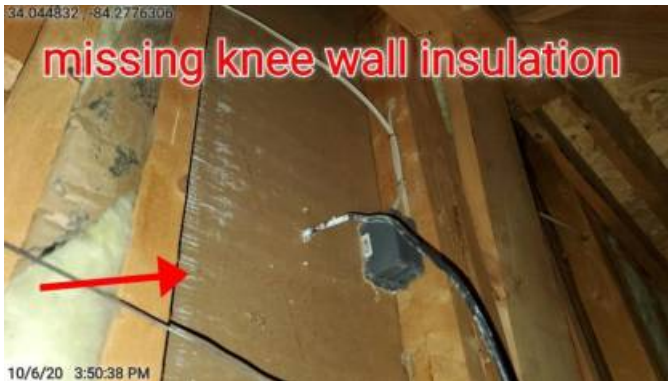
Loose and missing insulation batts were noted at one or more of the attic knee walls in the garage attic space. Recommend securing / replacing the missing batts for improved efficiencies in the attic.

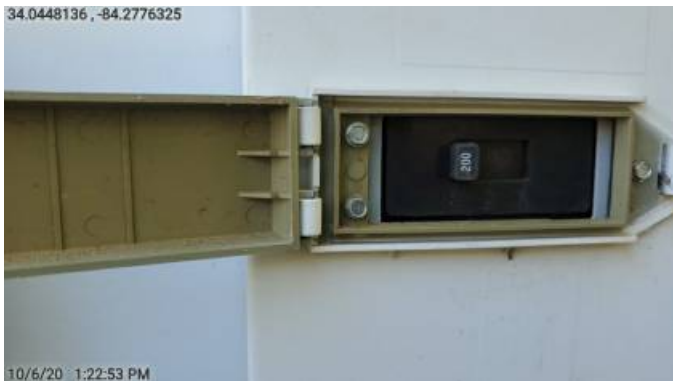
5.4 Main Circuit Rating And Service Disconnect:

☒ ☐ ☐ ☐ Main Circuit Sizing: 200 amps.
 Located at the exterior of building.

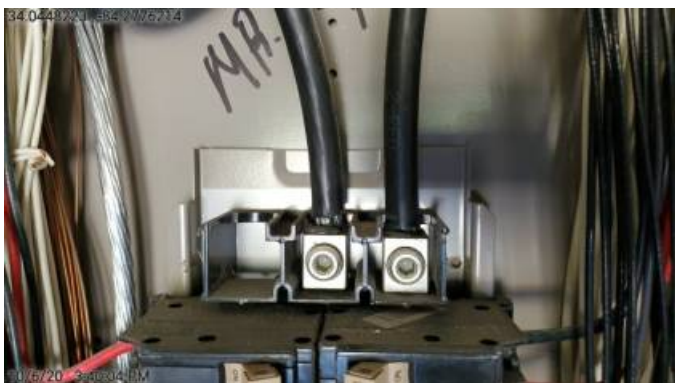
5.5 Entrance Cable Size:

☒ ☐ ☐ ☐ 4/0 Aluminum
 Anti-oxidant paste has been applied.

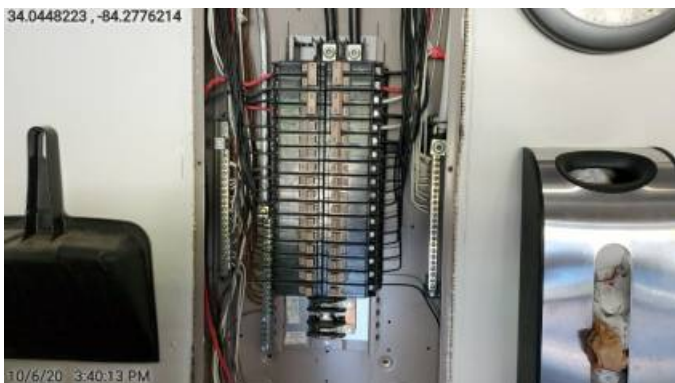
5.6 Main Panel Observations:

Circuit and wire sizing correct so far as visible.

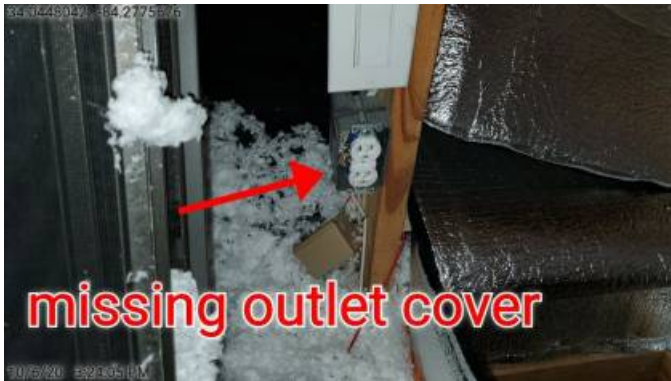
5.21 Attic & Insulation:	<input type="checkbox"/>	<input checked="" type="checkbox"/>	<input type="checkbox"/>	<input type="checkbox"/>
--------------------------	--------------------------	-------------------------------------	--------------------------	--------------------------

One or more outlet covers in the attic are damaged or missing. Recommend replacing the covers as a safety concern.

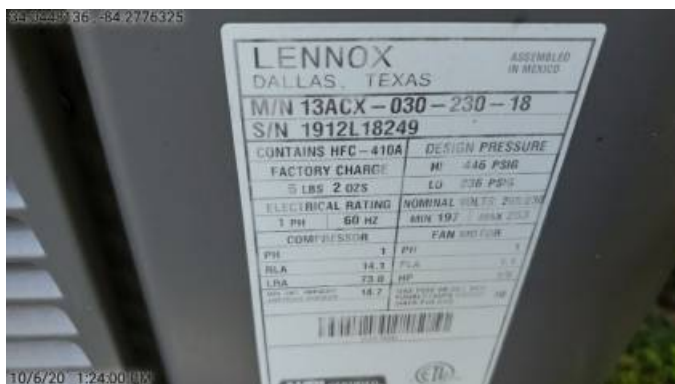
6.3 Capacity / Approx. Age: ☐ OK ☐ MM ☐ RR ☒ IS 2.5 Tons, Max Fuse: 30 amps, Brand: Lennox brand

Manufacture Date: 2012

Typical life span of an electric AC compressor is approximately 15 years.

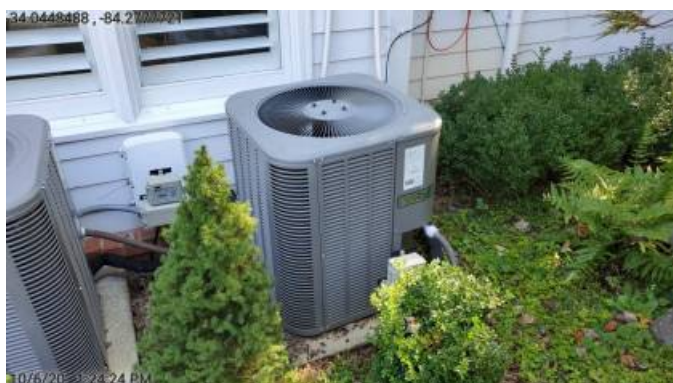
6.5 System Condition:

Unit is not producing an adequate air temperature drop.
 Recommend further evaluation and repairs by a qualified HVAC technician.

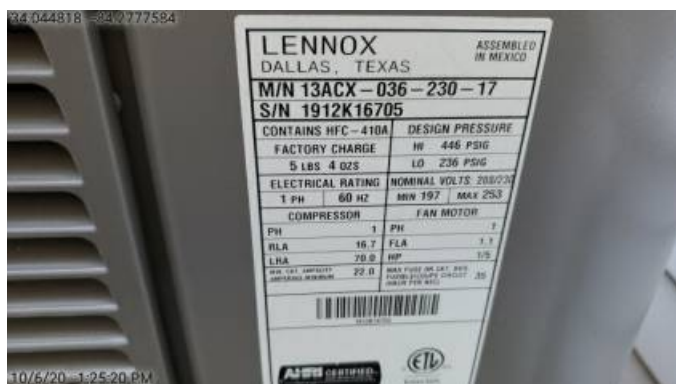
Manufacture Date: 2012

Typical life span of an electric AC compressor is approximately 15 years.

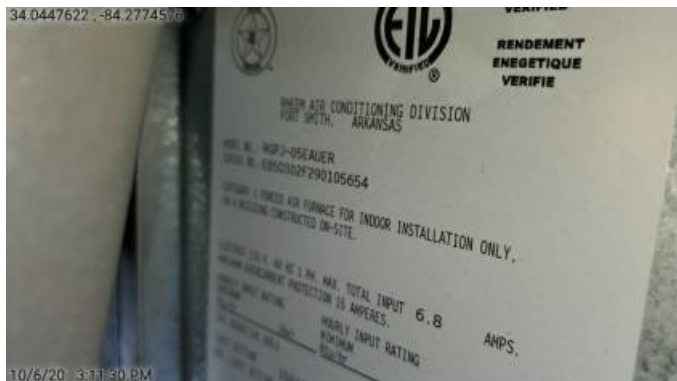
Manufacture Date- 2001.

The typical service life for a forced air natural gas furnace / heat pump is 18 - 20 years. The heating system is approaching the design life. The system is more likely to fail the nearer it approaches design life. Recommend general maintenance and service checkups going forward to extend the life of the existing heating system.

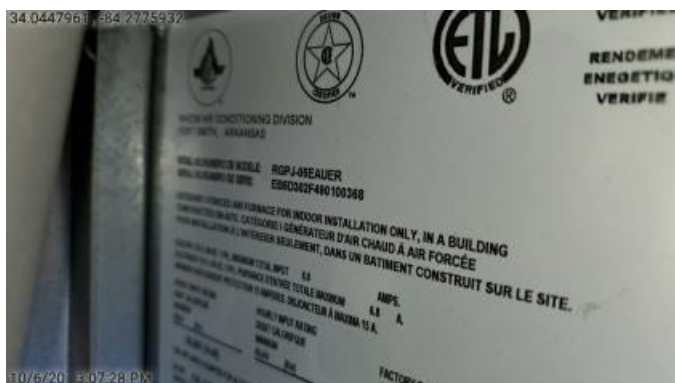
Manufacture Date- 2001.

The typical service life for a forced air natural gas furnace / heat pump is 18 - 20 years. The heating system is approaching the design life. The system is more likely to fail the nearer it approaches design life. Recommend general maintenance and service checkups going forward to extend the life of the existing heating system.

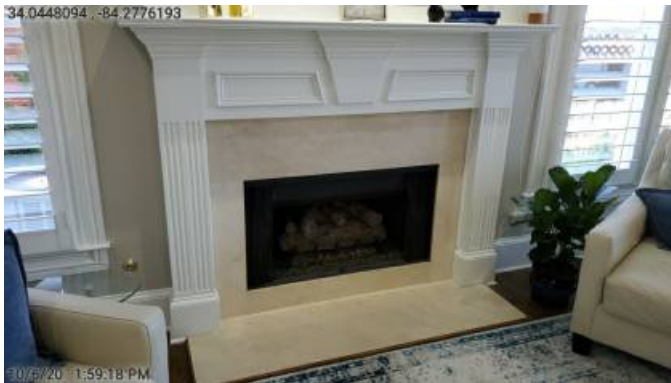
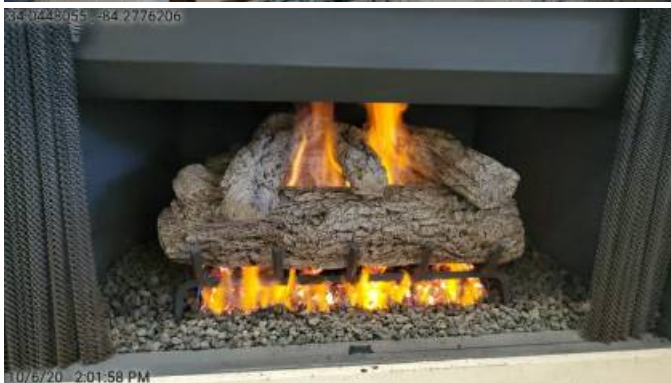
6.33 Family Room:

Water staining was noted at the top of the firebox around the flue. This may be an indication of water leakage around the flue and chimney cap. Recommend a licensed chimney specialist further evaluate and make any repairs necessary to the chimney cap to help prevent future water penetration.

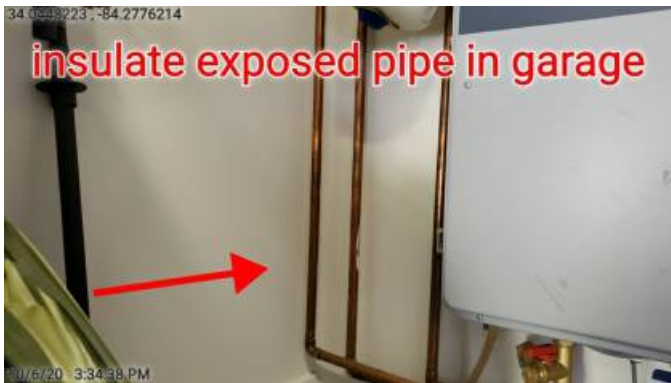
7.6 Condition:

The majority of the exposed pipe in the garage is not insulated. Recommend insulating the pipes to help prevent freezing.

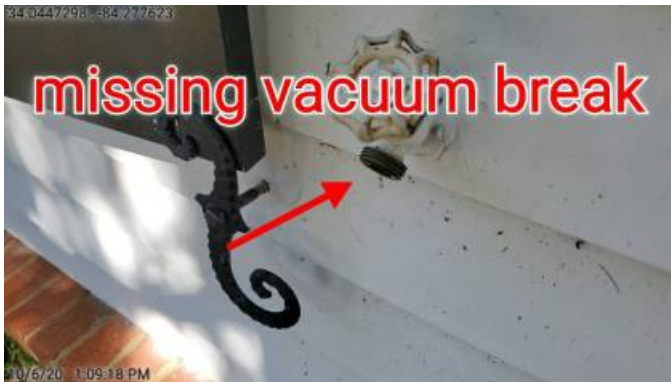
7.9 General:	<input type="checkbox"/>	<input checked="" type="checkbox"/>	<input type="checkbox"/>	<input type="checkbox"/>	There is at least one hose bib missing the vacuum break (backflow device).
--------------	--------------------------	-------------------------------------	--------------------------	--------------------------	--

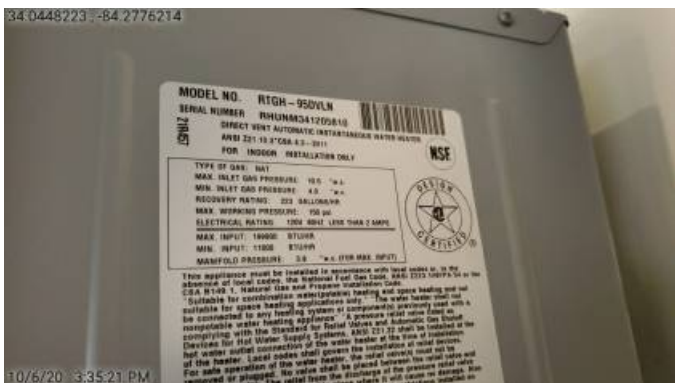
Manufactured In: 2012

The average life span of a tankless water heater is 20 years. Tankless water heaters require regular maintenance. Check with your owners manual for suggested maintenance and intervals.

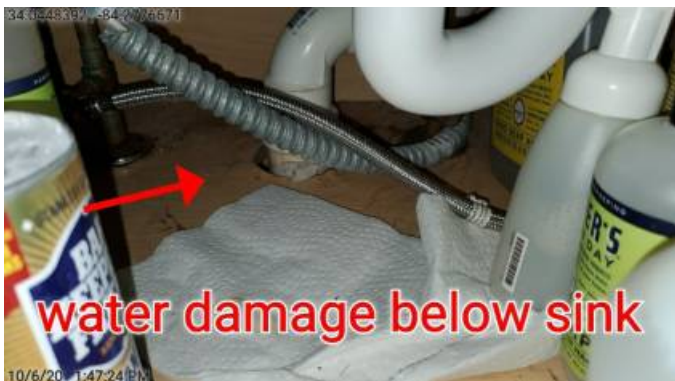
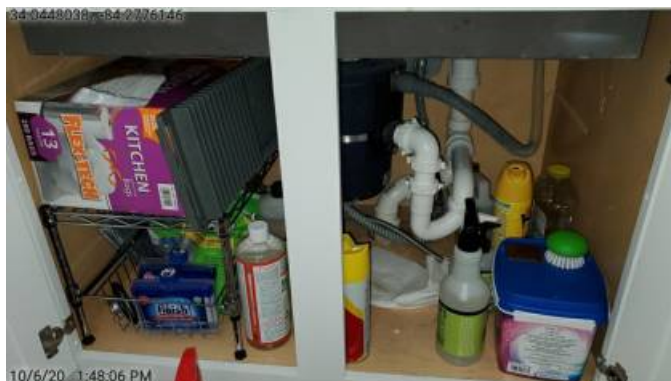
View was blocked by stored items.

Water damage was noted to the cabinet floor below the sink. This is from a previous or ongoing water leak below the sink. Recommend repairs to the cabinet after the source of the moisture has been corrected if there is an active water issue.

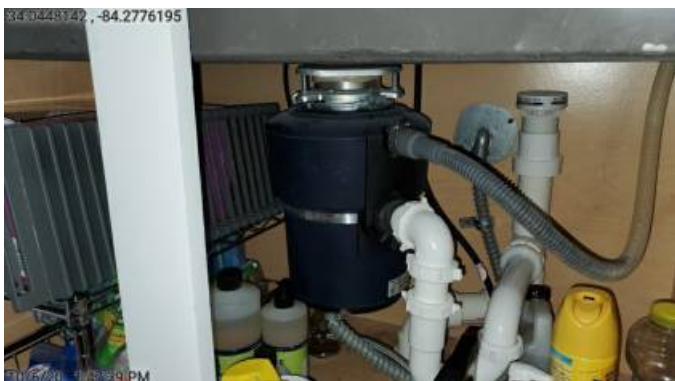
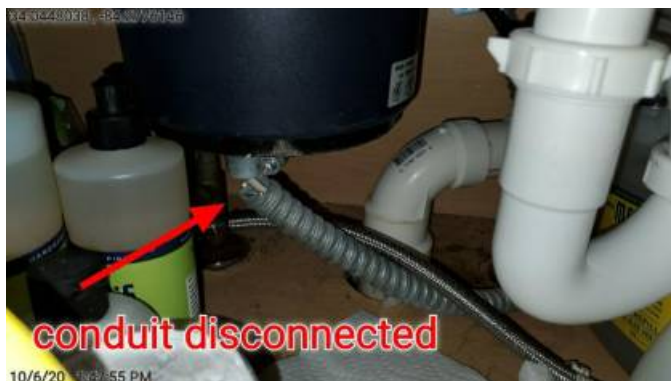
8.5 Garbage Disposal:

The conduit on the wiring is disconnected or damaged at the base of the garbage disposal. This condition could cut through the exposed wiring. Recommend a certified electrician re-attach the conduit correctly to the disposal.

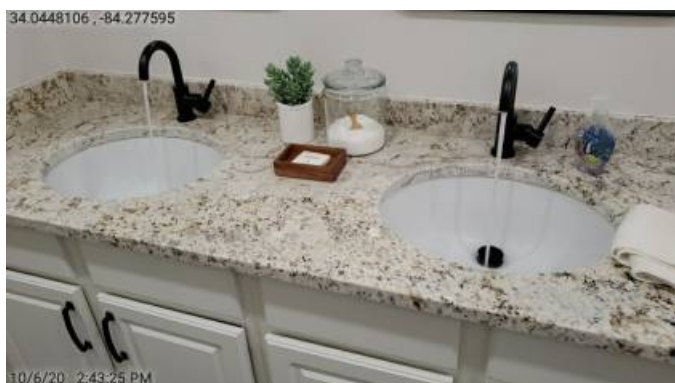
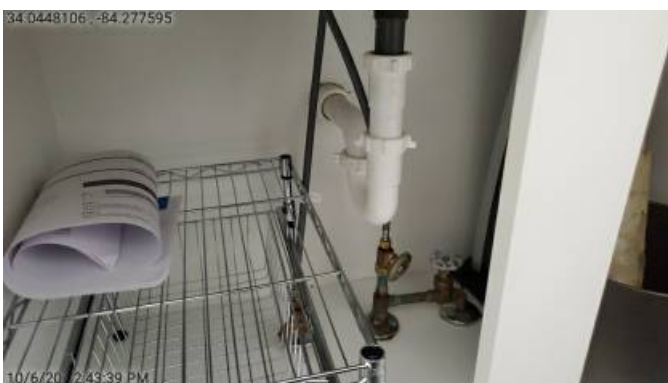
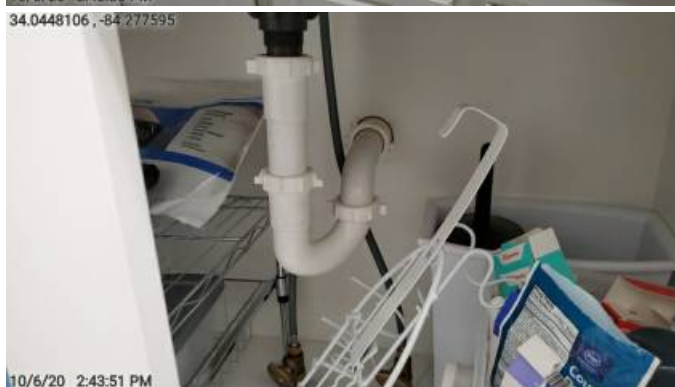
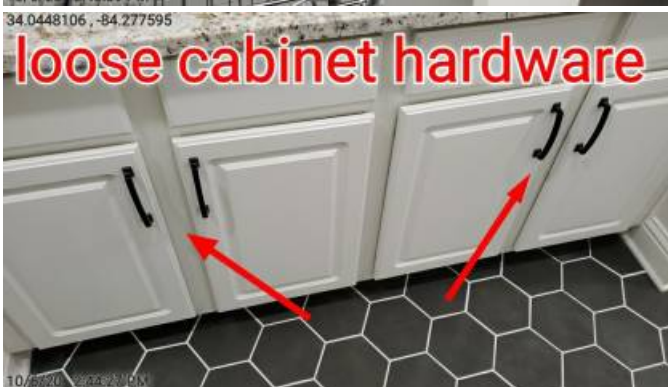
9.2 Second Floor Bath:

Loose hardware was noted on one or more of the doors and / or drawers in the room. Hardware noted may include hinges, knobs, pulls, slides, among other things. Recommend all hardware be properly secured and ensure proper operation of the hardware once secured.

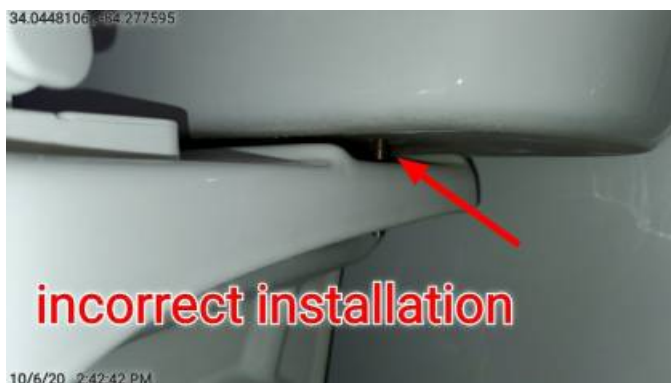
9.5 Second Floor Bath:

Toilet tank is loose at the toilet bowl. Tighten as needed. Leakage may occur at the bolts between the tank and bowl is they are loose. New gaskets may be necessary.

The tank was installed incorrectly. The tank Hardware is missing the nut and washer directly below the tank. Recommend reinstalling the tanks buy a licensed plumbing contractor.

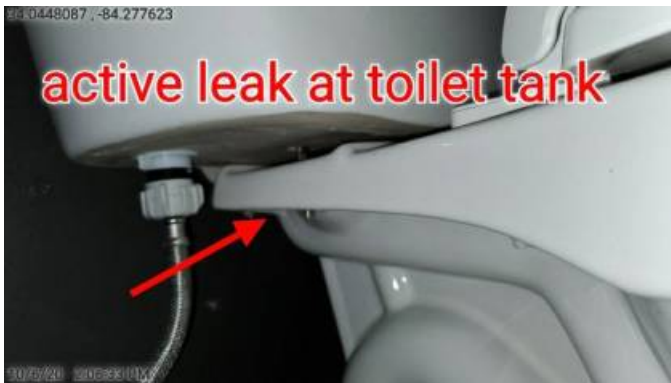
9.6 1/2 Bath:

Toilet tank is loose at the toilet bowl. Tighten as needed. Leakage may occur at the bolts between the tank and bowl is they are loose. New gaskets may be necessary.

There is a leak where the toilet tank meets the toilet bowl. Recommend Repairs by a licensed plumbing contractor.

The tank was installed incorrectly. The tank Hardware is missing the nut and washer directly below the tank. Recommend reinstalling the tanks buy a licensed plumbing contractor.

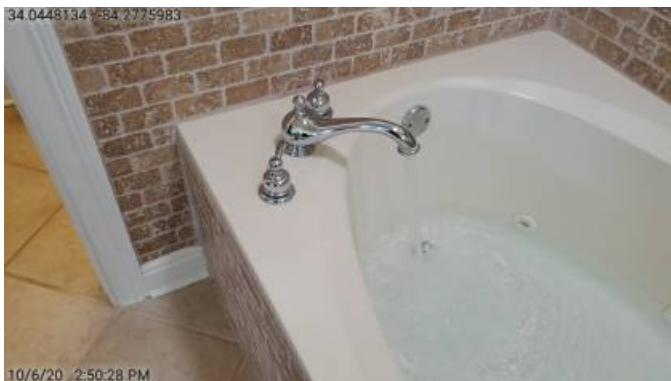
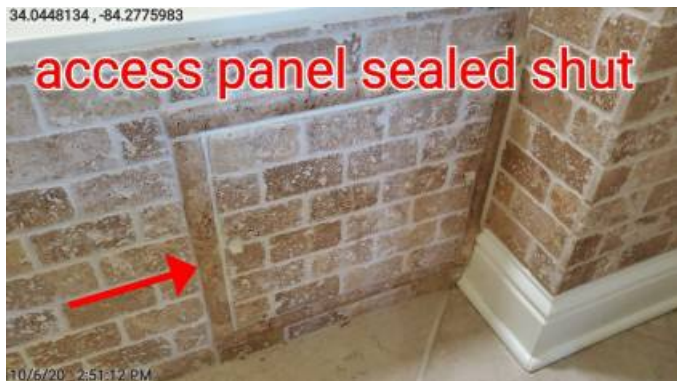
9.7 Master Bath:

The access panel to the jacuzzi motor under the tub has been sealed shut in one way or another. Access to the motor is required. Recommend making the panel accessible for servicing of the motor below the tub.

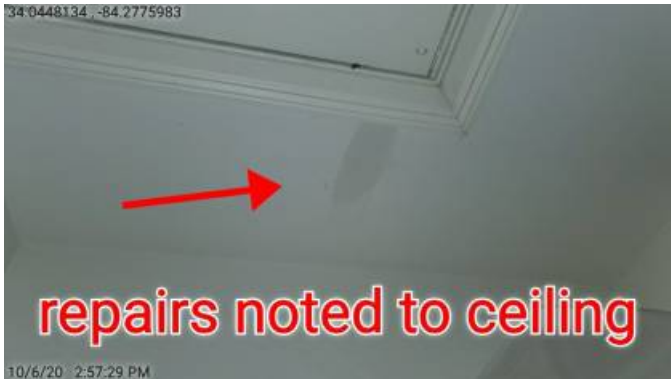
Repairs noted to the ceiling in this room. Recommend inquiring with the current homeowners as to the nature of the repairs and monitor condition.

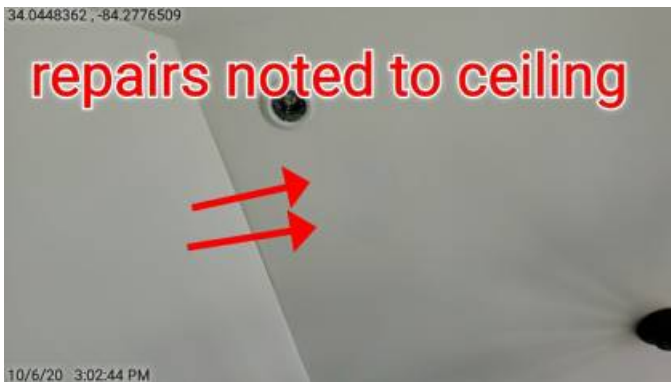
10.9 Master Bedroom:

Repairs noted to the ceiling in this room. Recommend inquiring with the current homeowners as to the nature of the repairs and monitor condition.

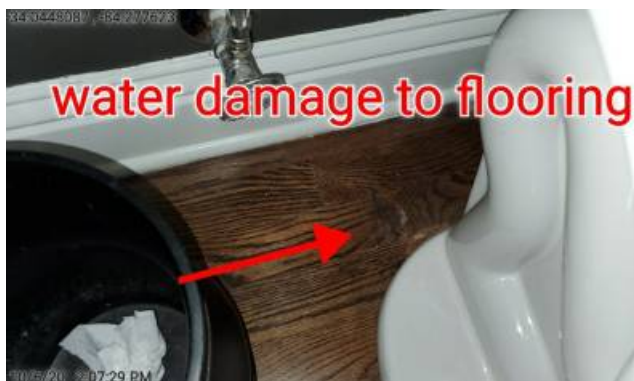
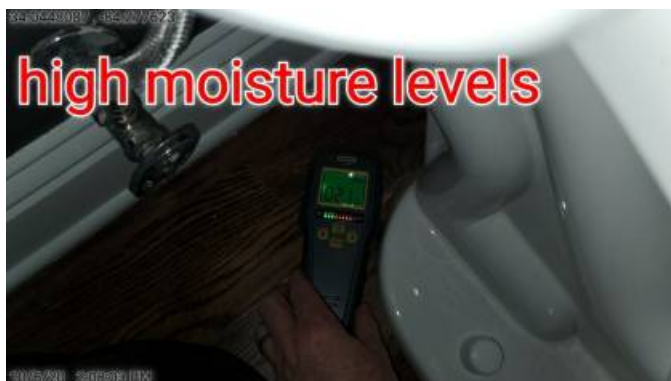
Water stains were noted around the toilet on the floor. Moisture levels were noted to be high in the area which may indicate a leak at the toilet. Recommend repairs to the flooring after the leak at the toilet has been addressed.

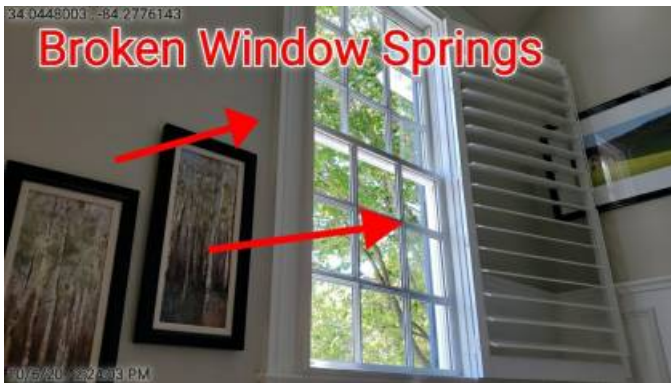
10.12 Entry / Foyer / Hall:

The thermal seal is broken on one or more of the windows in the room or hall. Although it is keeping the elements out, it has a clouded appearance. This condition will worsen. Replacement of the window may be necessary at some point in the future.

The spring or slide that holds the window in the up position is nonfunctional or damaged in some way. It needs to be replaced or repaired for proper operation of the window.

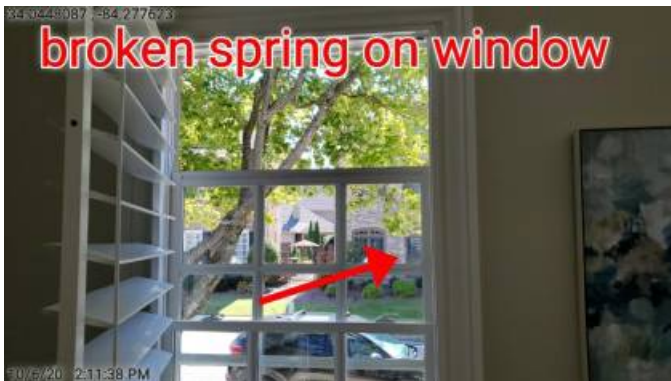
The spring or slide that holds the window in the up position is nonfunctional or damaged in some way. It needs to be replaced or repaired for proper operation of the window.

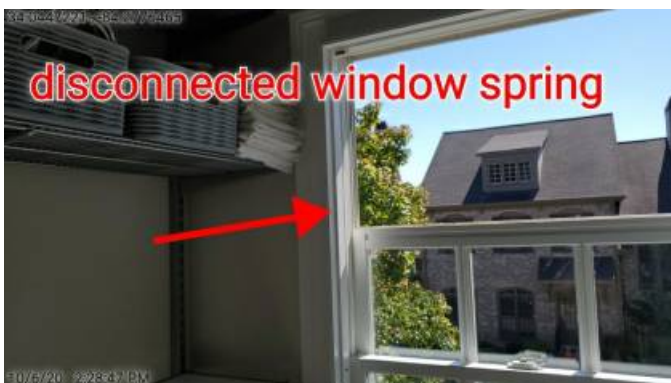
10.14 Laundry:

The spring or slide that holds the window in the up position is nonfunctional or damaged in some way. It needs to be replaced or repaired for proper operation of the window.

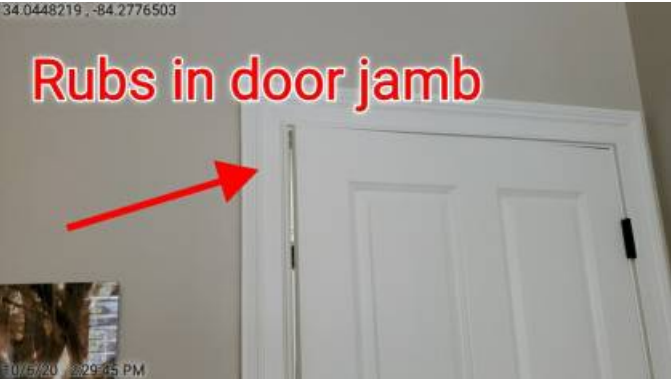
OK	MM	RR	IS	
10.15 Front Left Bedroom:	<input type="checkbox"/>	<input checked="" type="checkbox"/>	<input type="checkbox"/>	<input type="checkbox"/>	Doors rub or stick in the jamb due to slight settlement around the area or loose hardware. Recommend adjusting the door / jamb for proper operation.

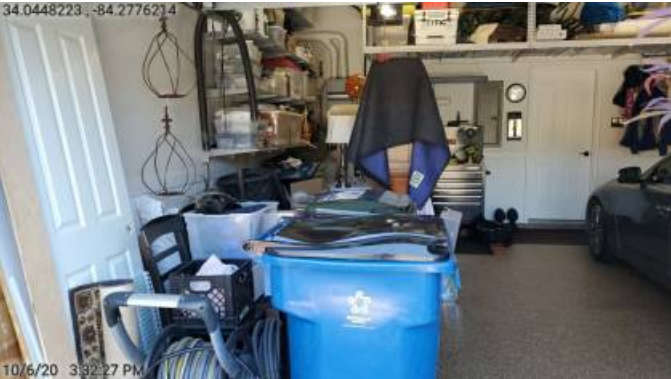
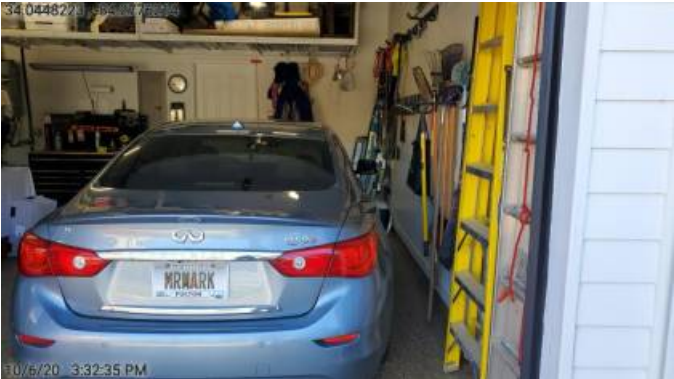
10.16 Garage Walls, Floors, & Ceilings:	<input type="checkbox"/>	<input type="checkbox"/>	<input type="checkbox"/>	<input type="checkbox"/>	Limited visibility due to storage along the walls.
---	--------------------------	--------------------------	--------------------------	--------------------------	--

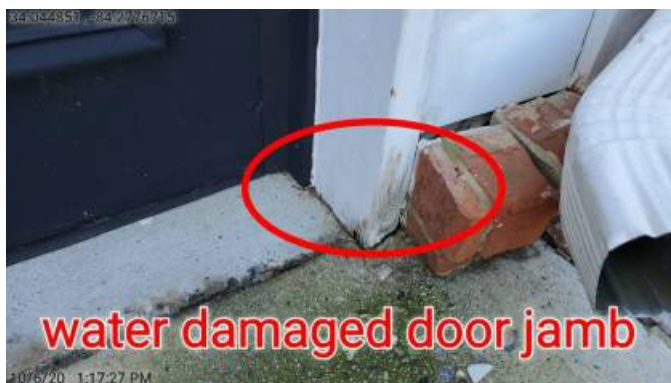
Water damage noted around the base of one or more of the garage door jams. Recommend repairs or replacement to the affected material.

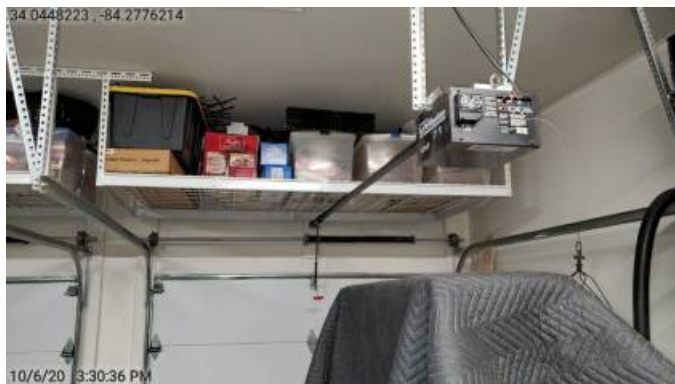
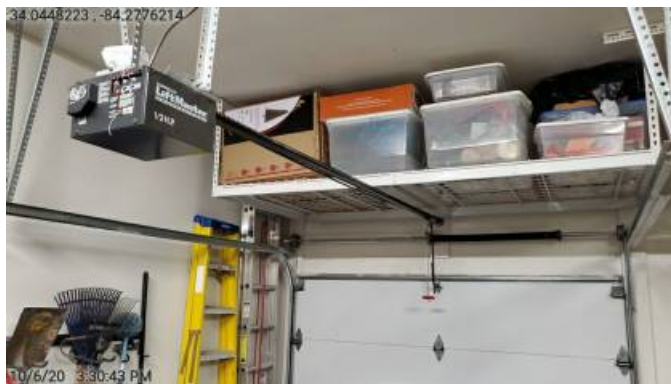
12.3 Automatic Opener:

The automatic door opener was operational at the time of the inspection.

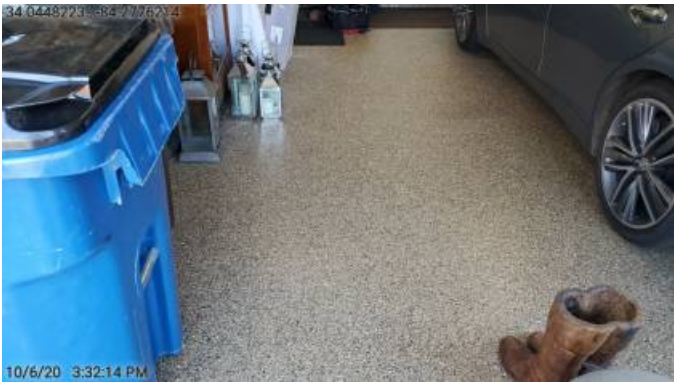
12.5 Slab Condition:

General condition appears serviceable

Floor is not fully visible due to a covering or stored items in the garage.
