Inspection Report

Property Address:
1575 Spinnaker Dr
Alpharetta GA 30005

Champia Real Estate Inspection, LLC

Date: 10/9/2020	Time: 02:00:00 PM	Report ID: 42821
Property: 1575 Spinnaker Dr Alpharetta GA 30005	Customer: Alexis Seton	Real Estate Professional: Kim Rowe Chapman Hall (Atlanta)

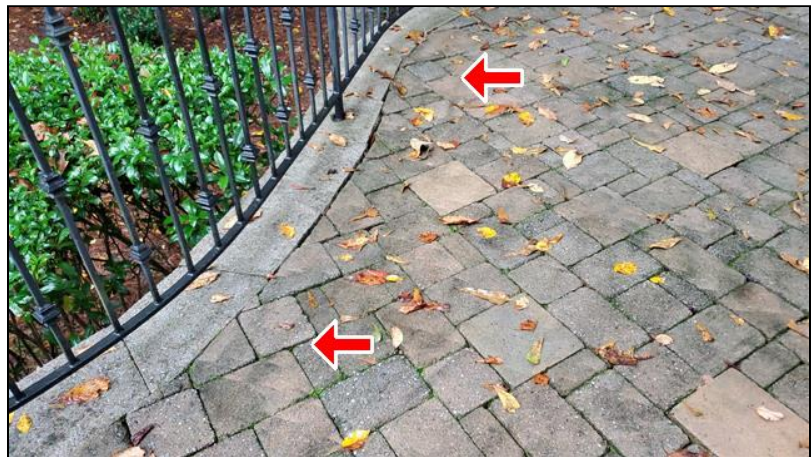
1.4 rear patio

1.4 Signs of erosion noted at rear brick patio and front porch. Repair as necessary to avoid further damage. Recommend consult with a licensed general contractor for further information. Refer to images for specific locations.

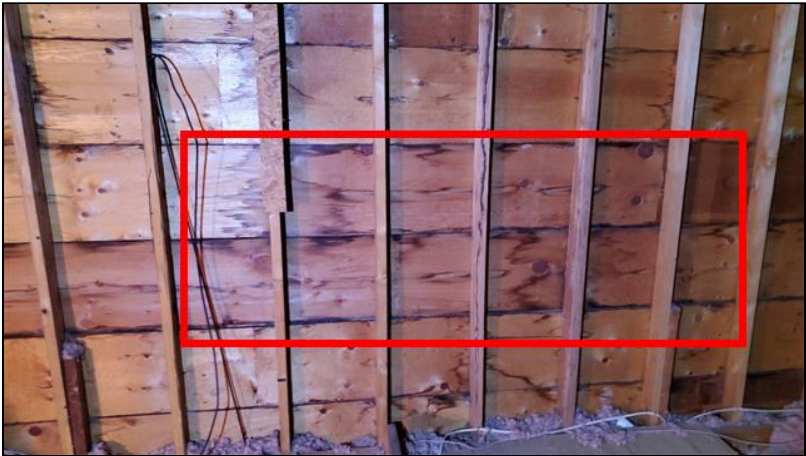
3.1 left

3.1 (1) Signs of moisture entry noted at front right and left in attic. Recommend further evaluation by a qualified roof contractor.

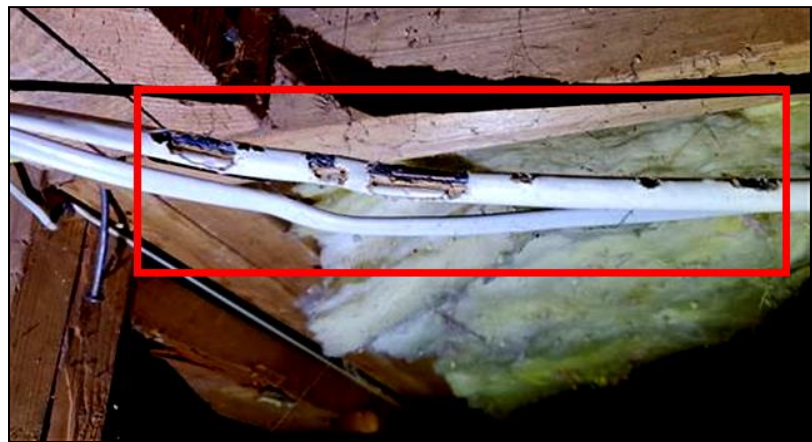
3.4 attic

3.4 Signs of animal activity noted in the attic (tracks, burrow holes). Recommend to consult with a qualified pest and wildlife exclusion contractor.

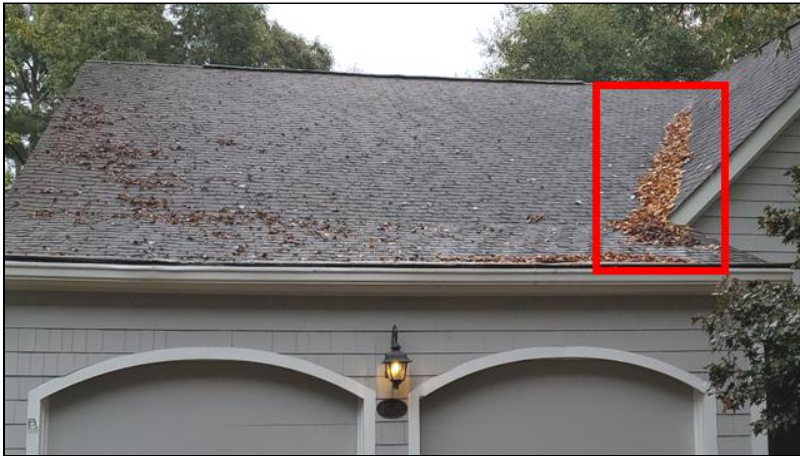
3.5 front

3.5 Accumulation of organic debris (i.e. leaves) noted at numerous areas on the roof. Recommend frequent cleaning/as necessary to avoid moisture entry. Recommend consult with a qualified landscape contractor for further information.

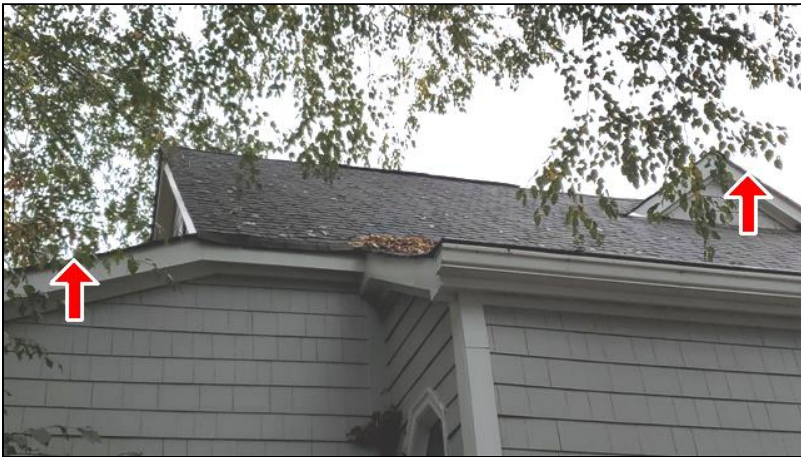
3.6 right

3.6 Missing drip flashing noted at roof lines. NOTE: Drip flashing should be installed at roof-to-facia intersections to protect the facia. Recommend consult with a qualified roof contractor for further information.

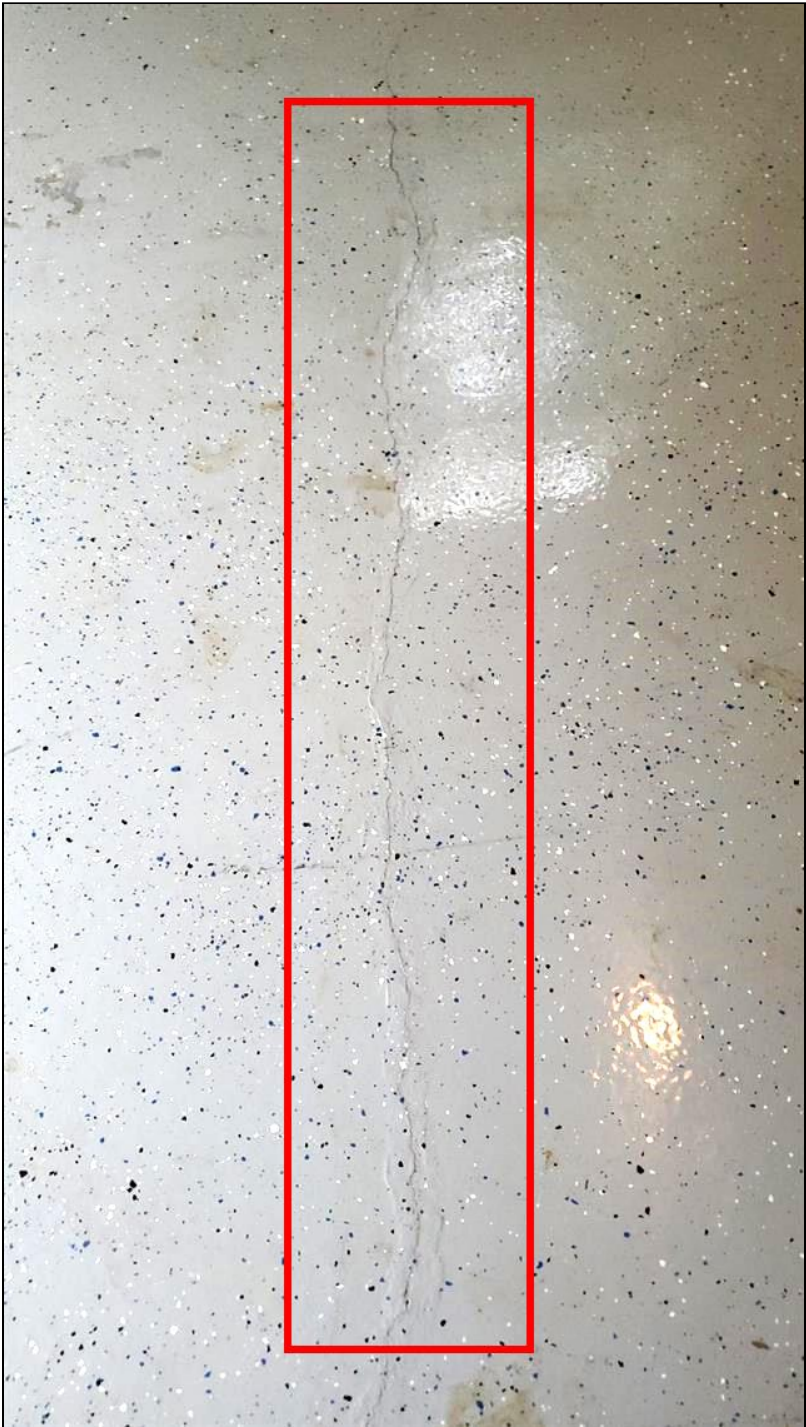
4.2 garage

4.2 Damage/Cracks/Sagging noted at garage flooring. Recommend further evaluation by a qualified structural contractor.

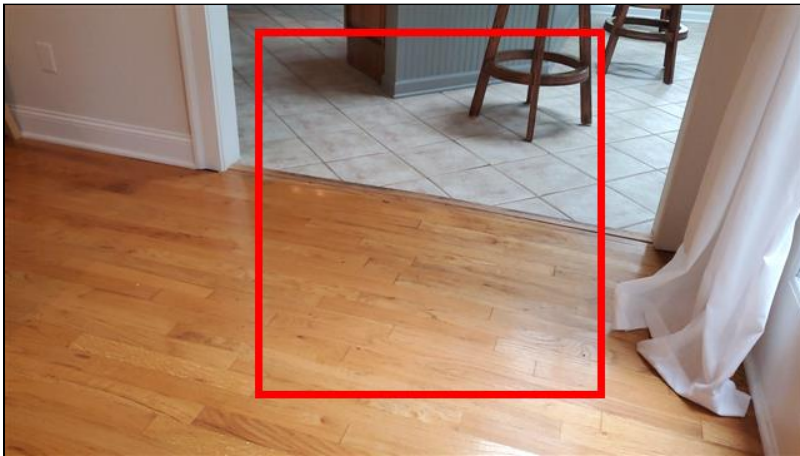
5.2 1st floor family room/kitchen

5.2 (1) NOTE: Uneven flooring noted at 1st floor family room to kitchen and dining room. Recommend consult with seller for further information. NOTE: Recommend consult with a licensed structural contractor for further information.

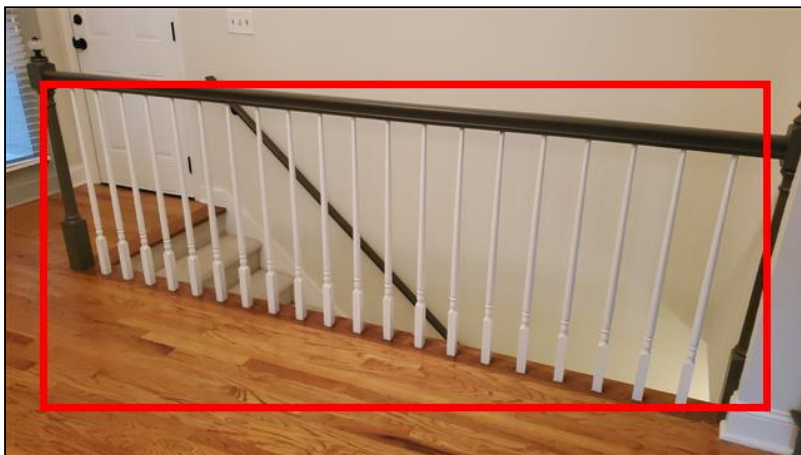
5.3 1st floor stairs

5.3 Balusters spaced too wide noted at 1st floor guard rails. NOTE: Balusters at guard rails should not be spaced wider than 4" apart. Adjust as necessary to improve safety. Recommend consult with a licensed general contractor for further information.

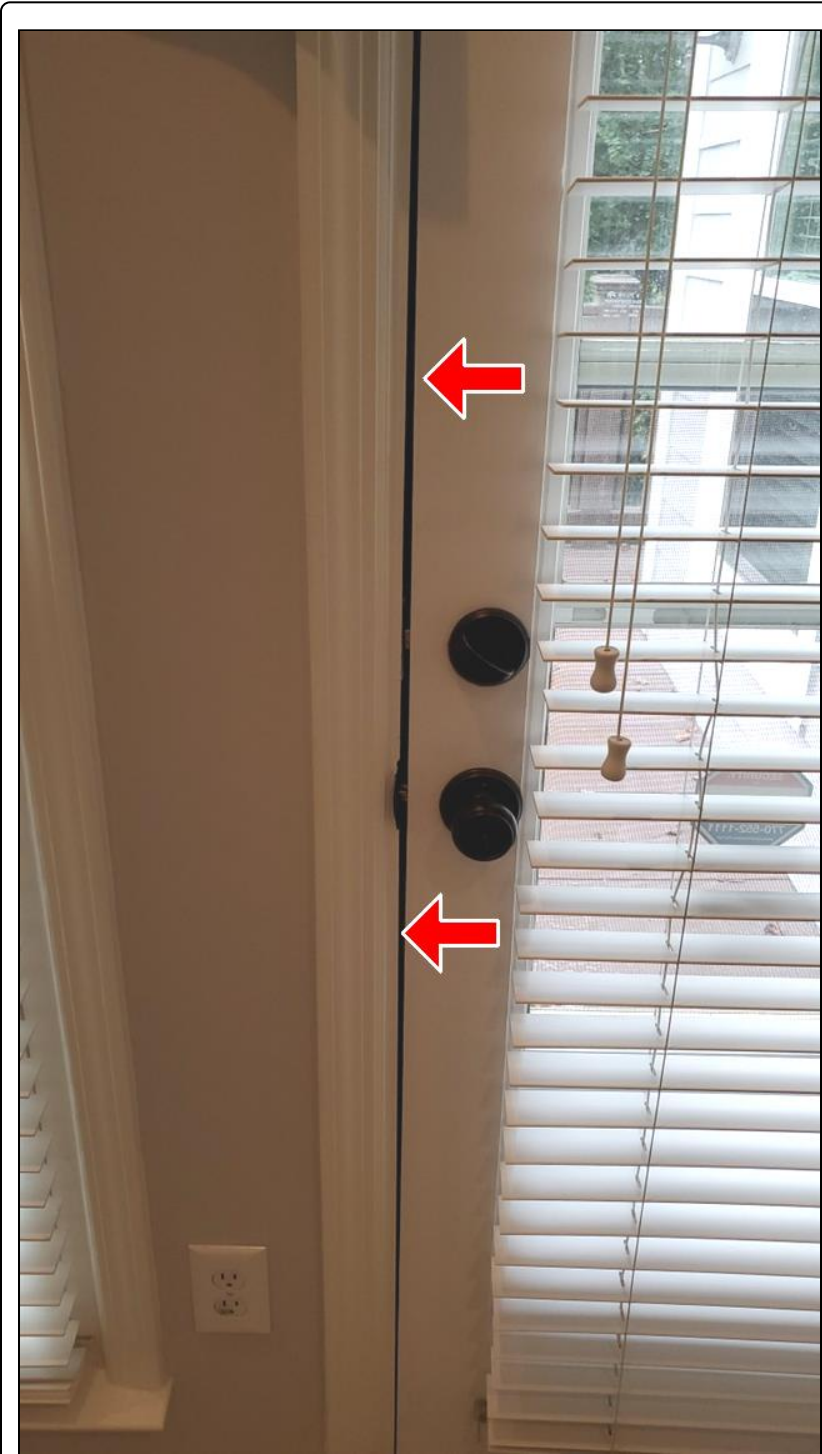
5.4 1st floor mstr bdrm

5.4 (1) Uneven/Gap noted at 1st floor master bedroom door. Repair/Adjust as necessary to ensure proper operations.

5.4 (4) NOTE: Recommend consult with a qualified door contractor for all attention and repairs.

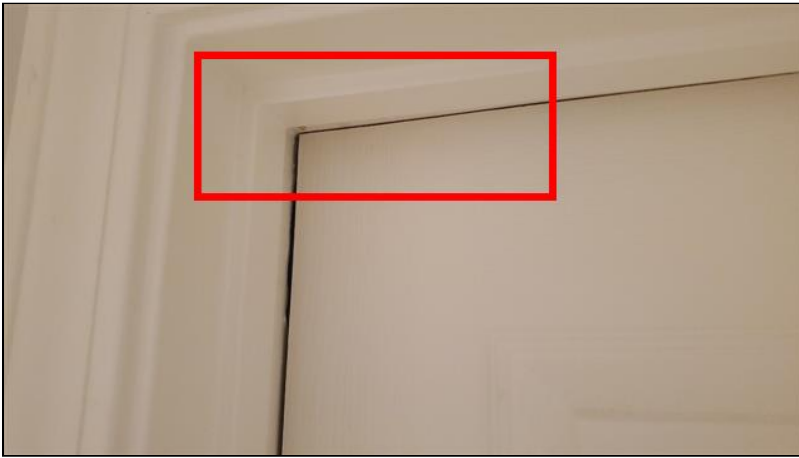
5.4 bsmt left rear room

5.4 (2) Doors at basement left bedrooms bind. Adjust as necessary to ensure proper operations.

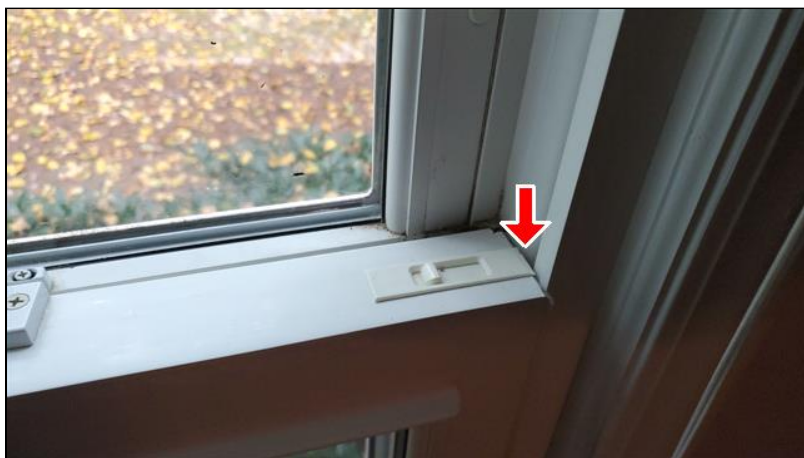
5.5 1st floor front bedroom

5.5 (1) Damaged tilt feature noted at several windows. Repair/Replace as necessary ensure proper operations. Refer to images for specific locations. Recommend further evaluation by a licensed window contractor.

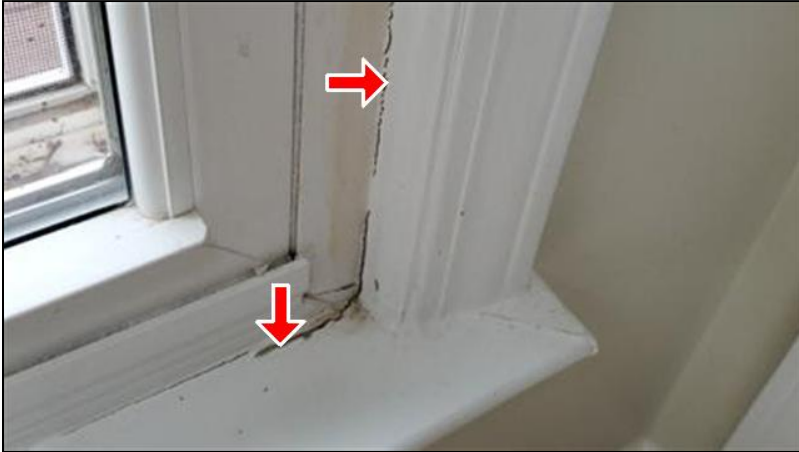
5.5 kitchen breakfast

5.5 (2) Gaps/Separation noted at several window sills. Repair/Seal/Paint as necessary to avoid further damage and improve thermal envelope

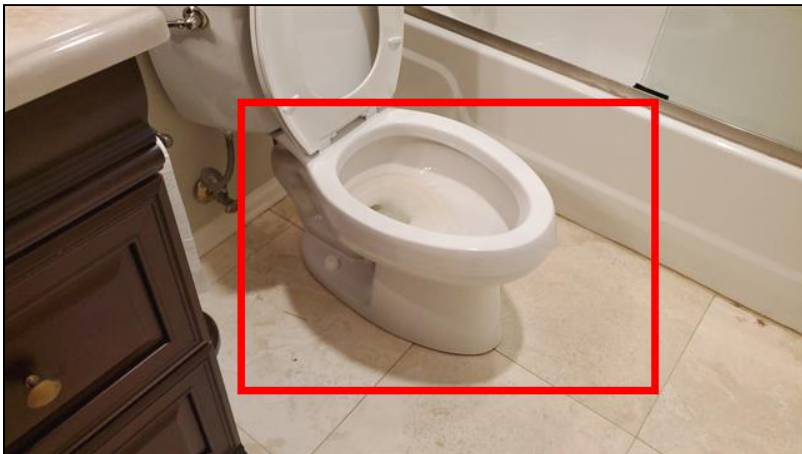
7.6 1st floor hallway lavatory

7.6 (1) Loose toilet bowl noted at 1st floor and basement lavatory. Reset toilet bowl with approved sealing material (i.e. wax ring) and secure as necessary.

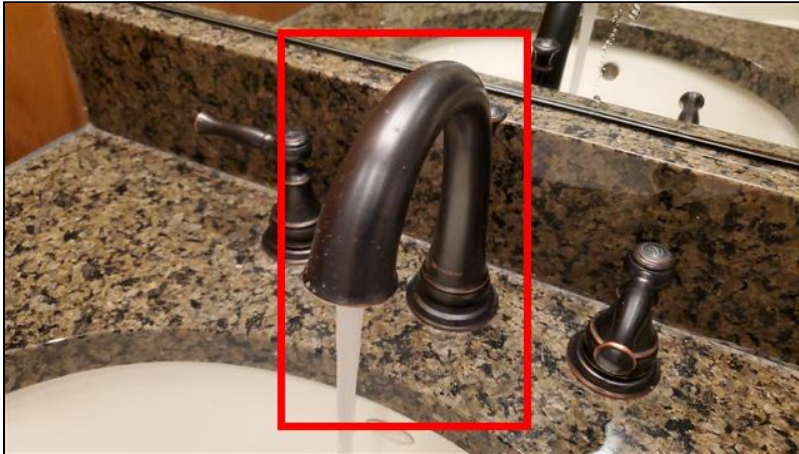
7.6 1st floor mstr lavatory sinks

7.6 (4) Loose faucets noted at 1st floor master lavatory sinks. Repair/Secure as necessary to ensure proper operations.

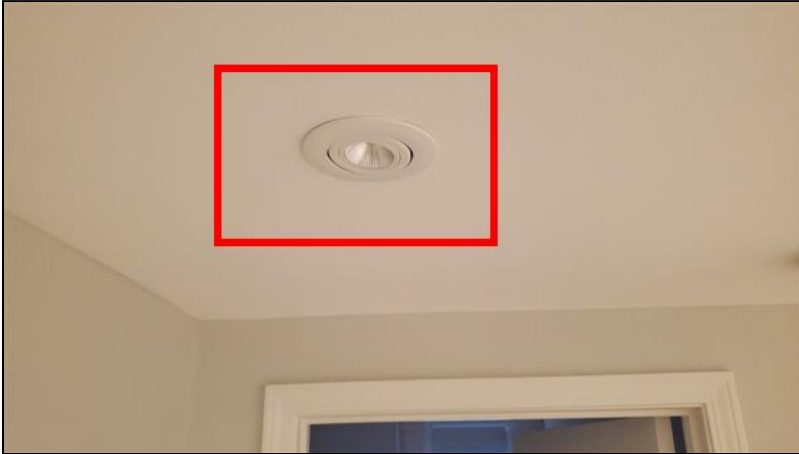
8.4 bsmt open area

8.4 (1) Light fixtures at several locations did not operate. Refer to images for typical locations. Check light bulbs/ evaluate circuits. Replace/repair where necessary.

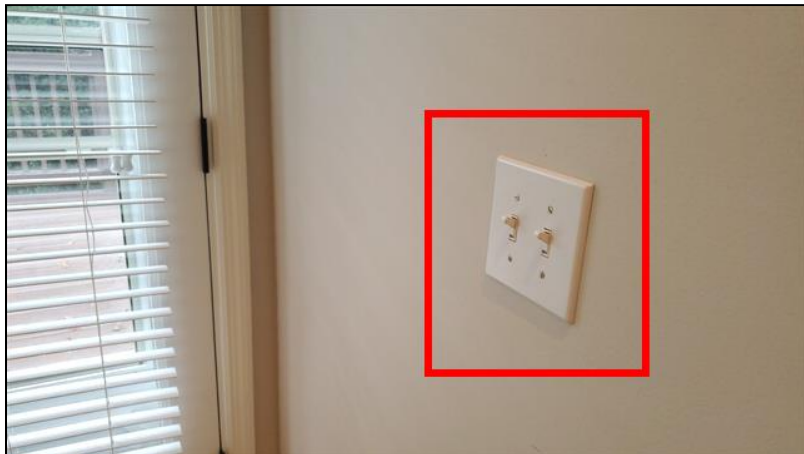
8.4 1st floor mstr bdrm

8.4 (2) Functionality of numerous light switches were not readily determined or apparent. Recommend to consult with owner for explanation/clarification.

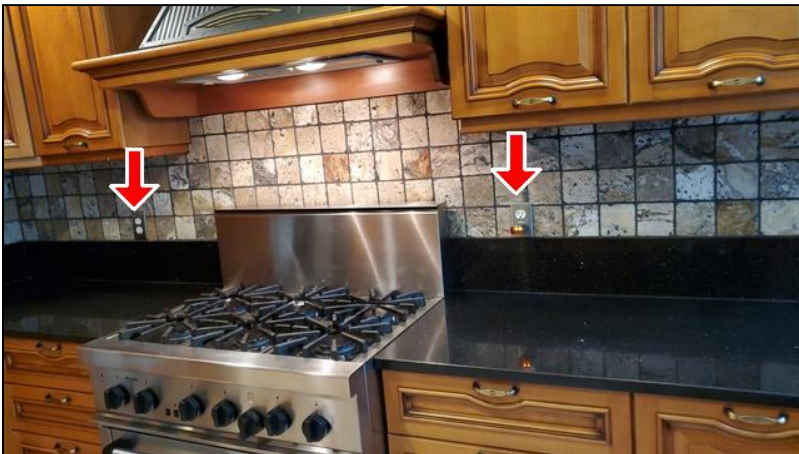
8.6 kitchen

8.6 (1) GFCI-protection missing at kitchen counters receptacles. Recommend to upgrade receptacles and install GFCI (and AFCI, as applicable)-protection at required locations. Consult with a licensed electrical contractor for further evaluation.
