# Building Inspection Report

9375 Scott Rd, Roswell, GA 30076

9/11/2020

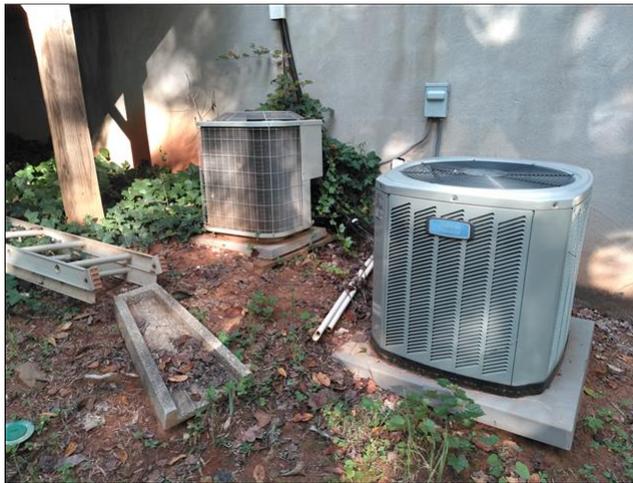
AC Units

The outdoor A/C condensing units appear to be approximately 7 and 9 years old based on the serial numbers. The typical life for such components is 12-15 years based on proper maintenance scheduling. Upon testing in the air conditioning mode, a normal temperature drop (between 12 to 15 degree differential) at the closest supply register was observed. This suggests that the system is operating properly. Servicing and repairs are recommended for the air conditioning (and heating) components, which should be performed by a qualified heating and air conditioning service company.

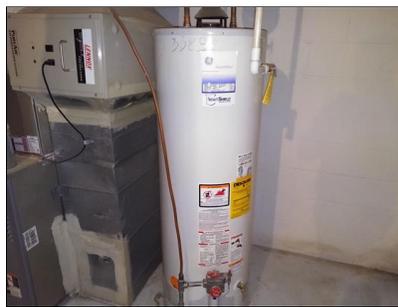
Water Heater

Overall, the plumbing system is in generally good condition with minor repairs/improvements recommended. No visible signs of active leakage were noted in the plumbing system. Some of the plumbing fixtures within the home have been upgraded, which improves the function of the fixtures while reducing maintenance. The older toilets have been replaced with newer 1.6 gpf tanks to reduce water consumption. The water volume supplied to the fixtures is reasonably good. A typical drop in flow was experienced when two fixtures were operated simultaneously. The water pressure of 60 psi was in the normal range (typical is 40-80 psi). The water heater is an older unit (15 years old). As the typical life expectancy of water heaters is 8 to 12 years, this unit should be budgeted for replacement in the near future.
