Inspection Report

1745 Hawk View Ct
Cumming GA 30041

Dana Inspection Services, Inc.

Date: 10/15/2020	Time: 01:00:00 PM	Report ID: 101520TC11
Property: 1745 Hawk View Ct Cumming GA 30041	Customer: Seamus McGrath	Real Estate Professional: ann-marie Sharp keller williams

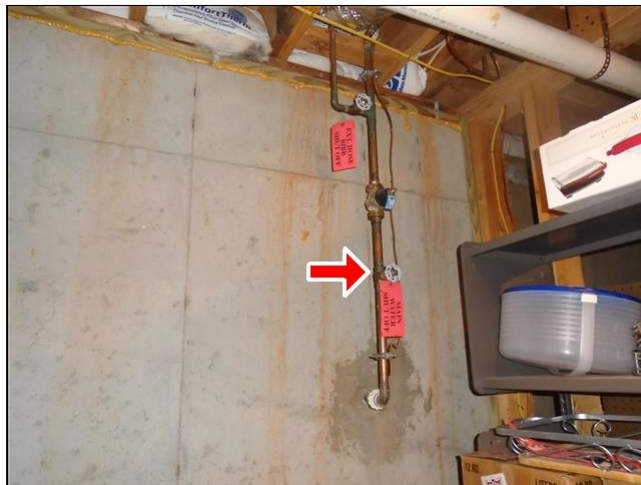
Basement mechanical room

The water service main shut off valve is located at the front right wall of the basement.

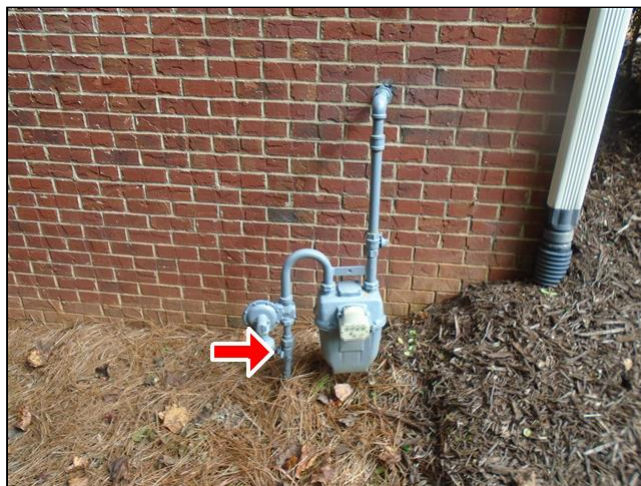
Left side of house

The main fuel shut off is at the gas meter outside.

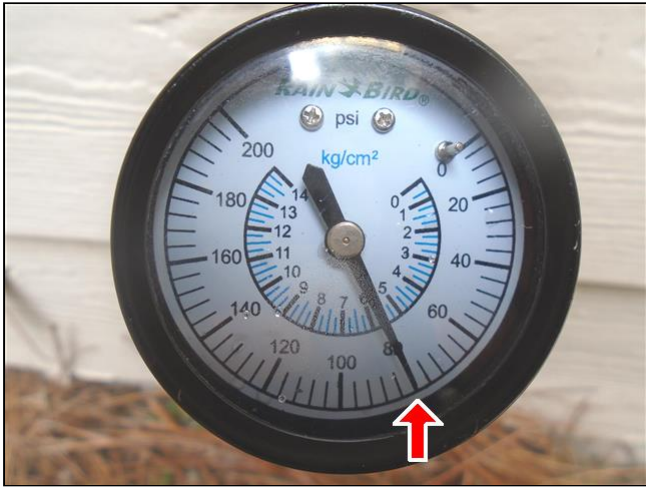
Rear hose bibb

The whole home water pressure was tested at the rear hose bibb and found to be approximately 80 psi. Pressures between 40 - 80 psi are considered acceptable for residential use.

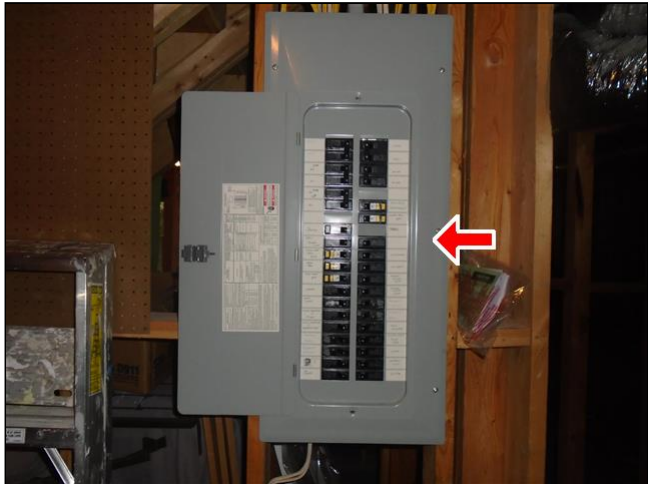
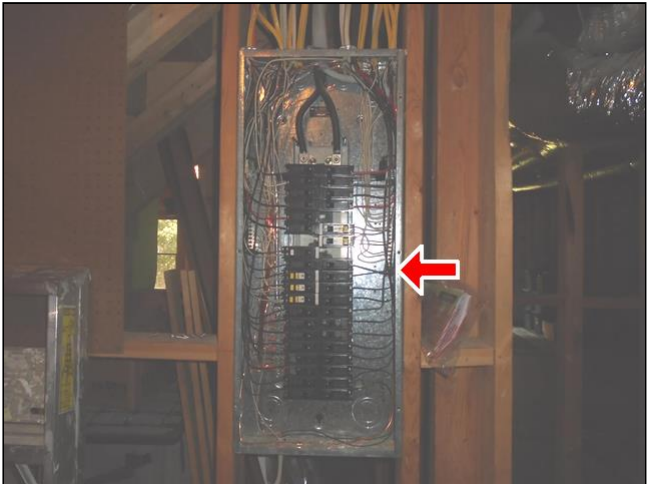
The electrical service main distribution panel is located in the basement mechanical room. The service main breaker is located on the right side of the house, below the meter.
