The Cornerstone Inspection Group

Building Inspection Report

2170 Country Ridge Road, Alpharetta, Georgia 30004

9/15/2020

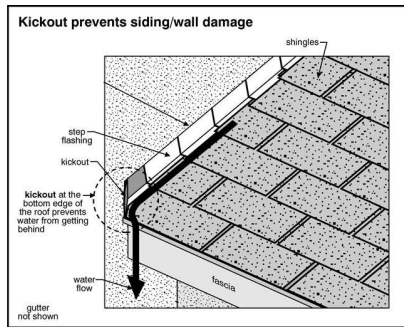
2.1 Item 1(Picture) Flashing Detail

Repair: No "kick-out" flashing was noted at the intersection of the gutters and side walls as noted at the rear, which is needed to prevent moisture intrusion into the wall system. This should be installed at all required locations by a qualified contractor as needed for proper protection (see illustration below for details).

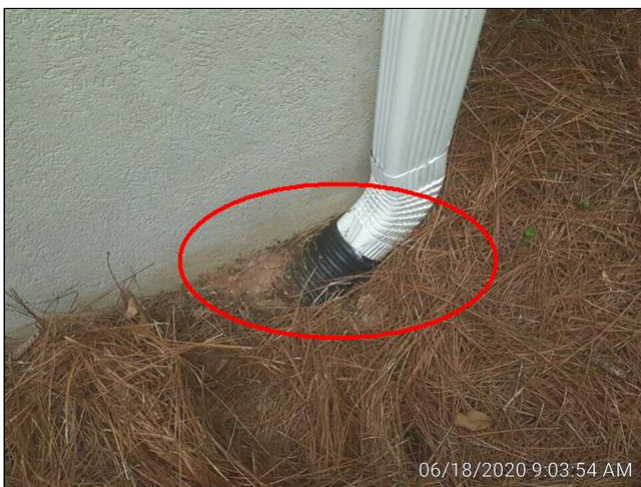
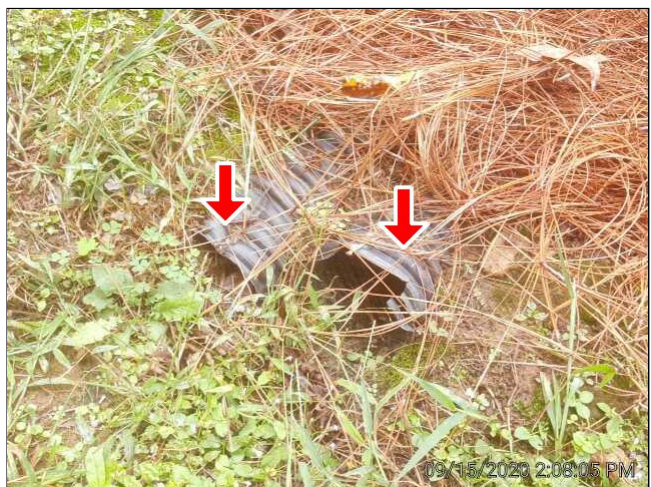
Repair: The gutters and downspouts require cleaning and realignment by a qualified gutter contractor to avoid spilling roof runoff around the building and into the cornice - a potential source of water entry and damage. Debris should also be removed from the roofing to reduce the risk of leaks and early roof wear. All leaks and joints in the gutters should be caulked and sealed. All loose gutter nails should be re-driven into the fascia

Improve: Recommend covering the gutters with heavy duty screens or gutter helmets to avoid future congestion of the gutters with leaves and debris.

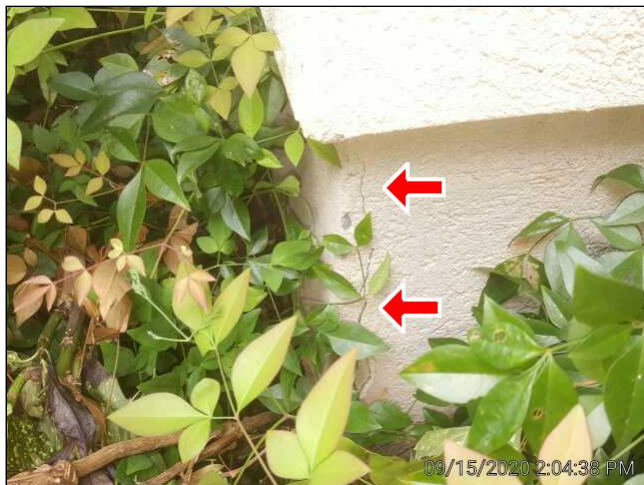
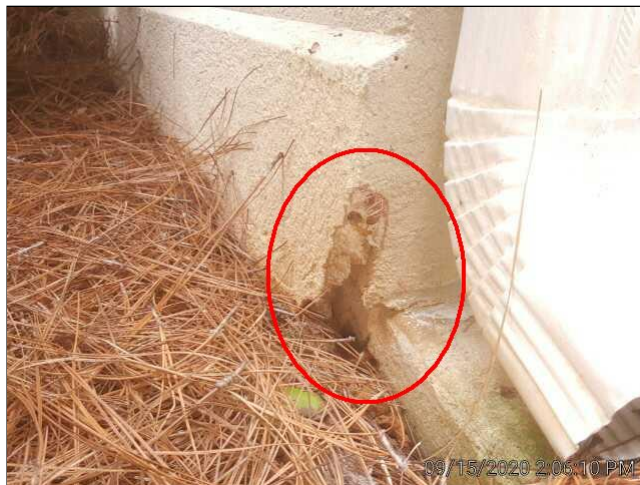
3.3 Item 1(Picture) right front corner

Repair: Damage to exterior stucco wall as noted to the left of the garage entry should be repaired as needed by a qualified contractor to prevent moisture intrusion and possible damage to the wall structure.

Monitor, Improve: Minor cracks in the stucco exterior were noted in some areas. While this type of cracking is somewhat typical for a house of this age, the stucco should be monitored for further cracking and addressed as needed. Consider having the entire stucco veneer painted with an "Elastomeric" paint for improved sealing and protection of the stucco.

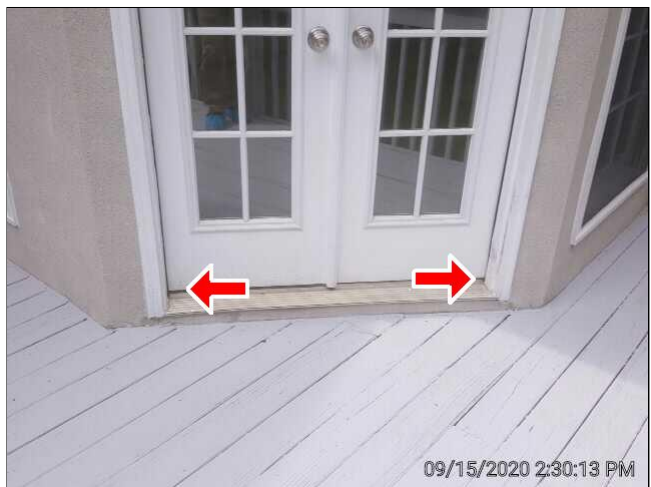
3.4 Item 4(Picture)

Repair: The framing at the bottom of the french doors at the deck are damaged and need repair. Following repair of the damaged areas (which should be combined with exterior painting) proper maintenance of the windows and doors and control of water from roof or surface runoff can avoid further damage.

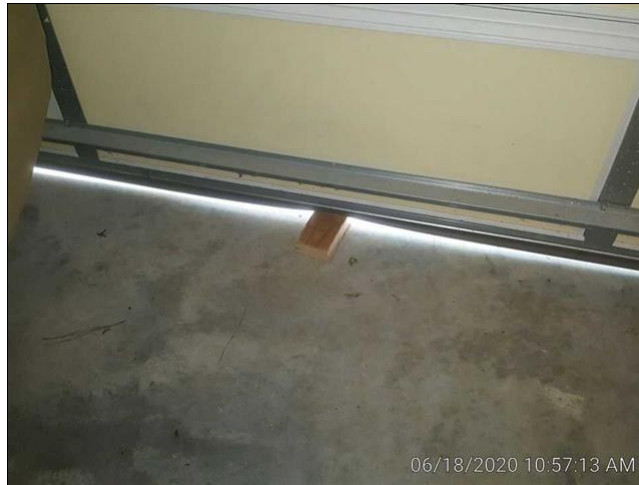
3.5 Item 1(Picture)

Improve: The garage door weatherstripping is damaged and should be repaired to limit moisture and rodent intrusion into the garage.

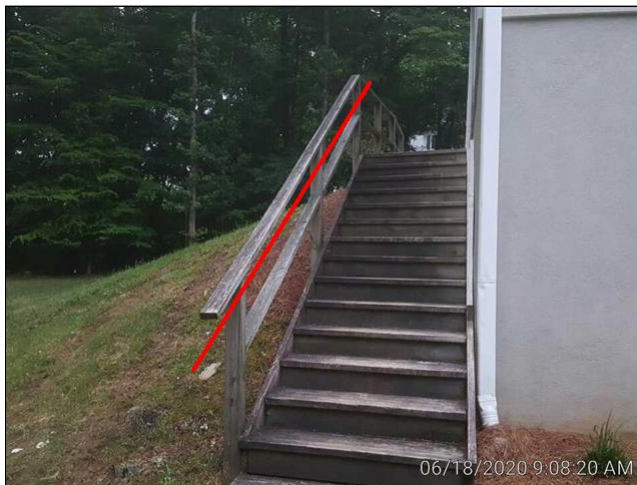
3.7 Item 1(Picture)

Improve, Safety Issue: The openings in the railing as noted are more than allowed by current safety standards for child safety (max. 4" spacings allowed). It is recommended that this be corrected as needed for improved safety.

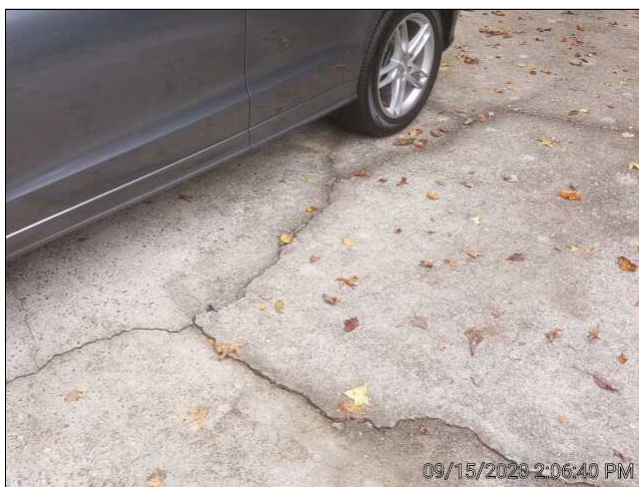
3.8 Item 1(Picture)

Monitor, Future Repair: *The driveway has heaved and cracked in some areas and will need repair or replacement in the future.*

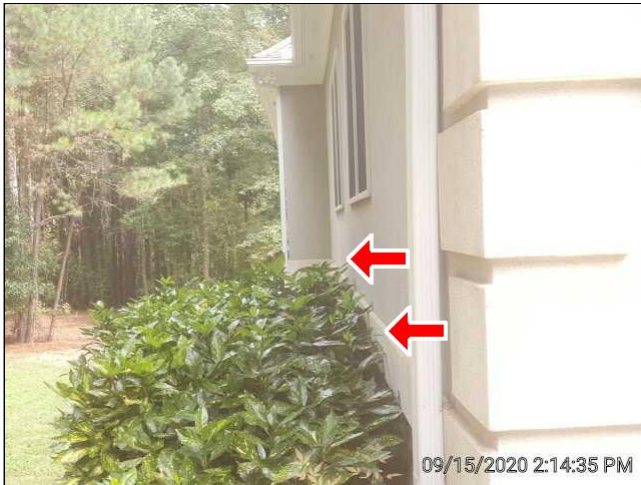
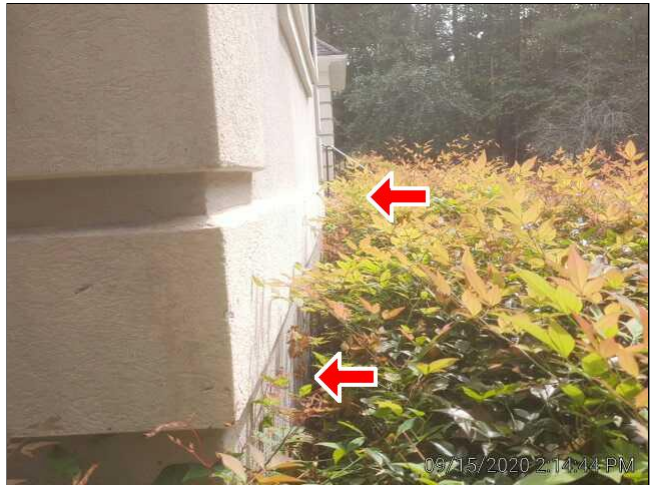
Improve: The shrubbery and vegetation growing near exterior walls should be kept trimmed away from siding, window trims, and the eaves to reduce risk of insect and water damage. Overhanging tree branches should be cut back to prevent future damage to the roofing and gutters and to prevent rodent infestations into the attic.

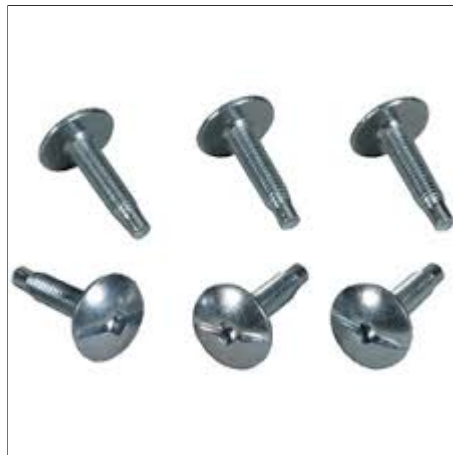
4.2 Item 6(Picture) Panel screws

Improve: Missing screws (4) as noted at the front panel cover of the main electrical panel should be replaced for proper securing of the cover. All screws attaching the panel cover should be blunt headed to prevent possible damage to the wiring.

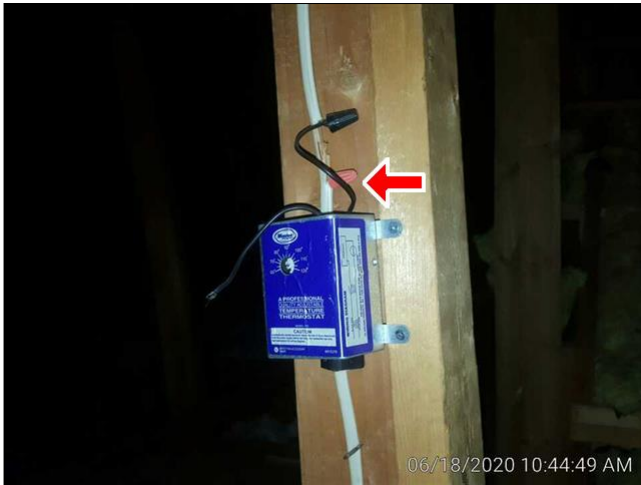
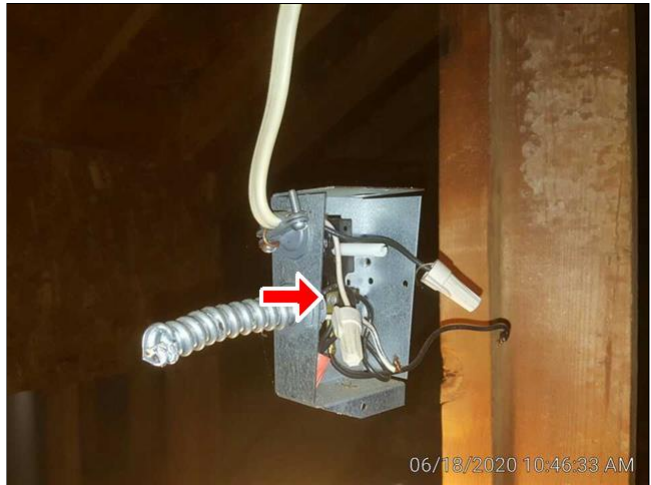
Repair: Abandoned, **LIVE** wiring as noted in the attic should be repaired as necessary. The ends of the wires should be properly terminated with wire nuts and installed inside junction boxes fitted with cover plates to minimize shock and fire hazards. Otherwise the wiring should be disconnected in the panel box and removed altogether.

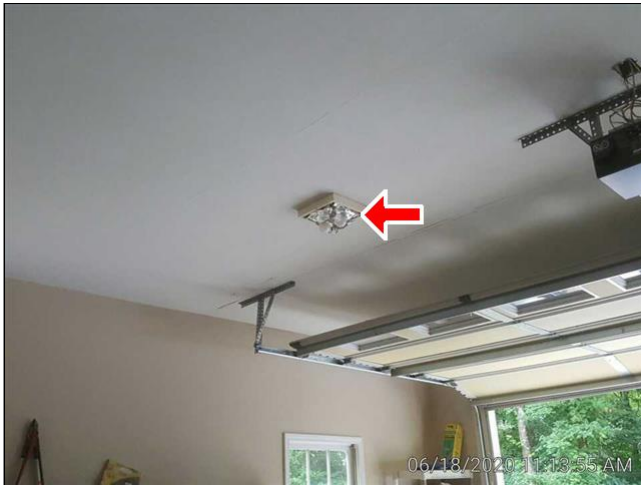
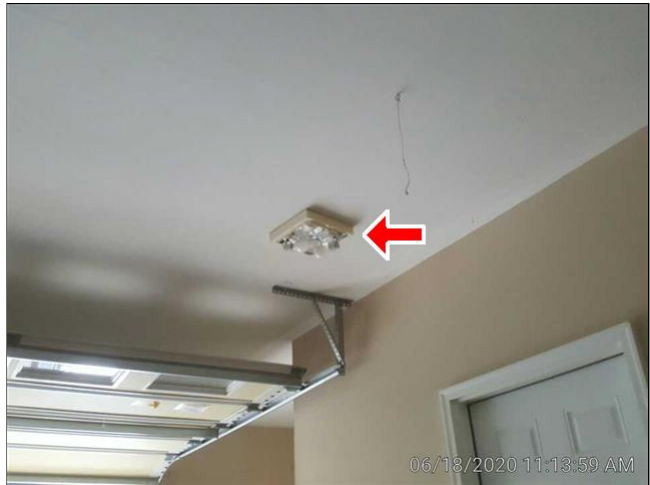
Improve: Missing light covers (2) as noted in the garage should be replaced for proper protection of the bulb(s).

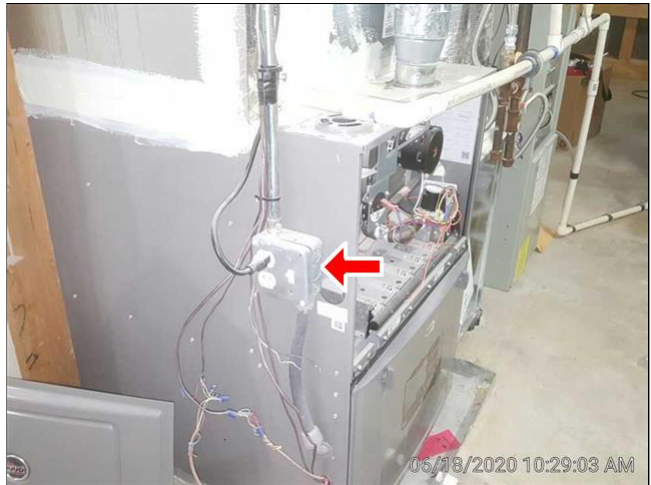
6.0 Item 4(Picture)

Improve: Recommend labeling the furnace shut-off switches (switch closest to the furnace) to prevent someone from shutting off the furnace by accident.

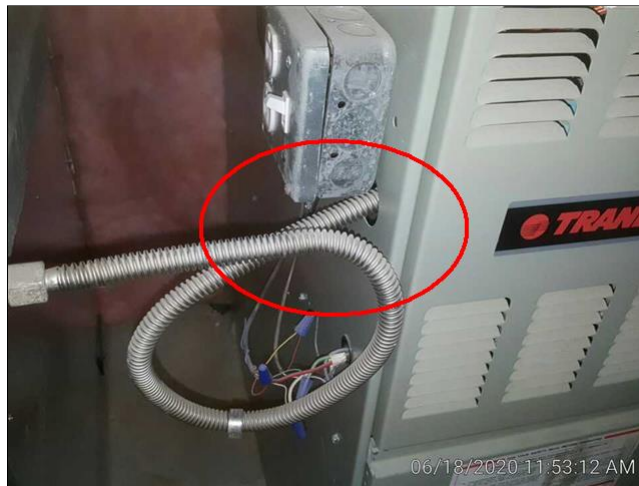
6.1 Item 1(Picture)

Repair, Safety Issue: The gas supply line serving the **TRANE** furnace is flexible piping which passes through the outer case of the furnace without protection. This piping runs the risk of being damaged by the edge of the casing and should be replaced with rigid pipe or otherwise protected to prevent future leaks. A drip leg would also be required here.

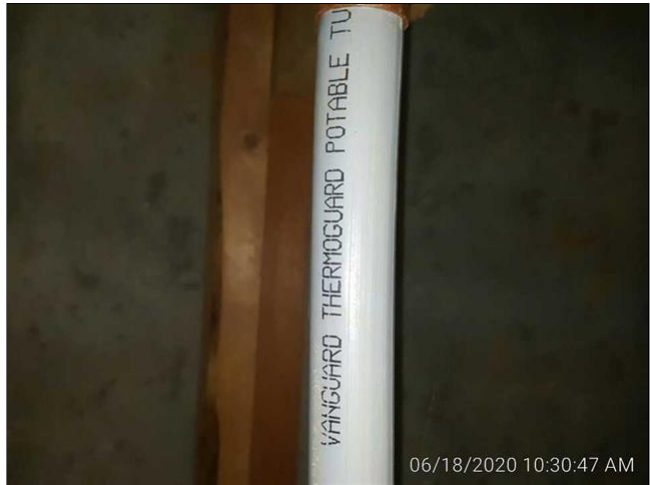
7.1 Item 2(Picture)

Concern: The water service line at the front right in the basement to the street appears to be polybutylene, which has had problems with bursting in the past. Have a plumber assess this condition to determine if replacement of the service line is needed.

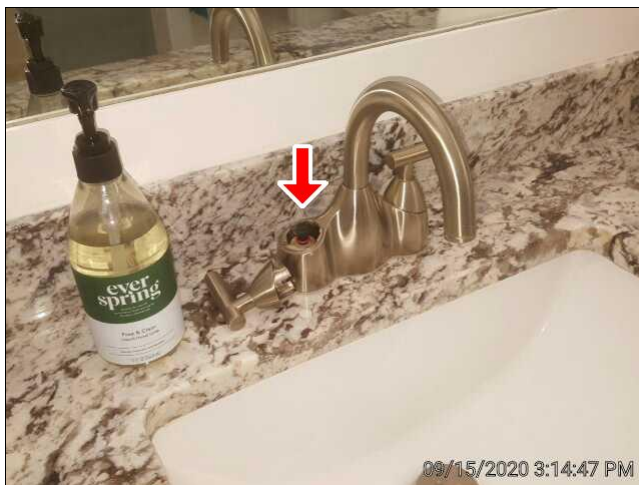
7.4 Item 1(Picture)

Repair: Loose plumbing faucets and handles as noted in the master bath should be tightened for proper operation and to prevent leaks in the piping.

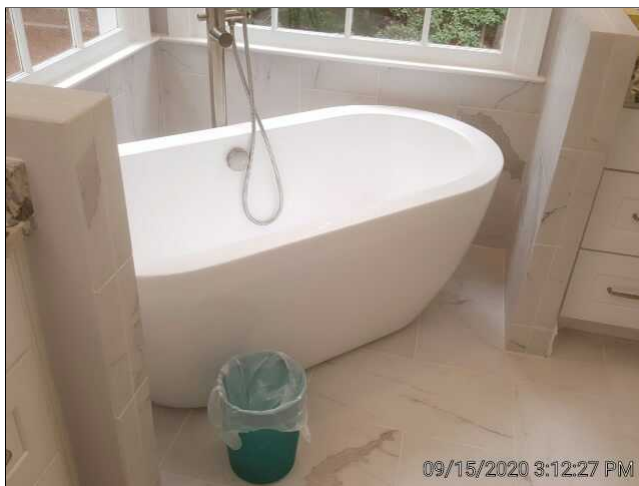
7.5 Item 1(Picture)

Repair: The tub in the master bathroom is loose at the floor. This condition may cause future leaks in the piping. The tub should be properly secured to prevent movement and damage to pipes under the tub.

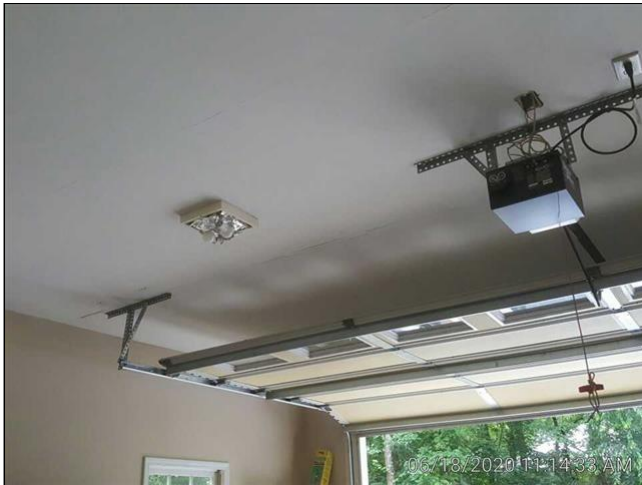
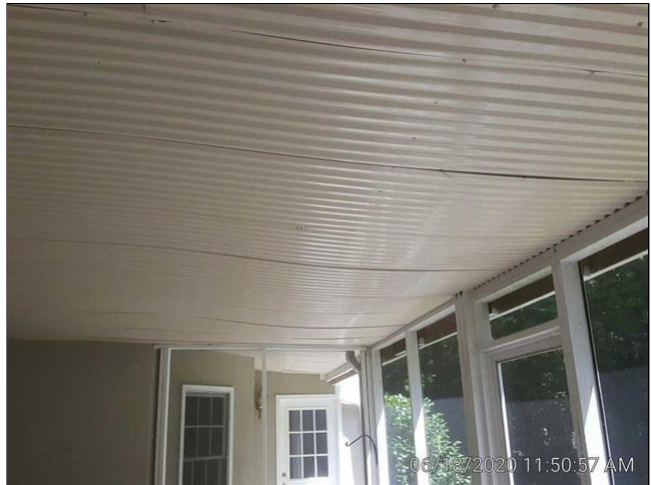
Repair: There were indications that some areas of the sheetrock ceilings were pulling away from the ceiling joists and were beginning to sag, especially as noted and the garage. All sagging sheetrock should be screwed to the joists to prevent further movement. The screw heads will need patching, caulking, and repainting.

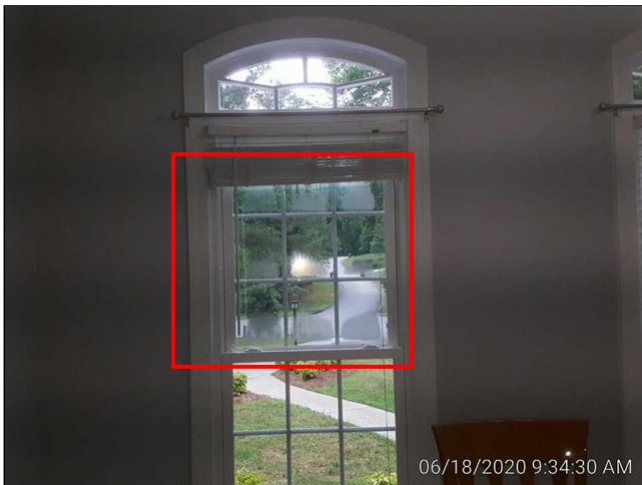
9.2 Item 1(Picture) dining room

Repair: "Fogged" glass was noted, which should be replaced. This condition is typically caused by damaged seals around the perimeter of the insulated glass, which in turn allows condensation to develop between the panes. All damaged glass panels in this area should be replaced by a qualified glass replacement contractor to prevent further moisture damage to wood components and for proper visibility through the glass. The contractor should inspect all other insulated panels in the house for additional condensation that may be occurring in the glass. Other windows may be fogged but cannot be positively determined until the glass is cleaned.

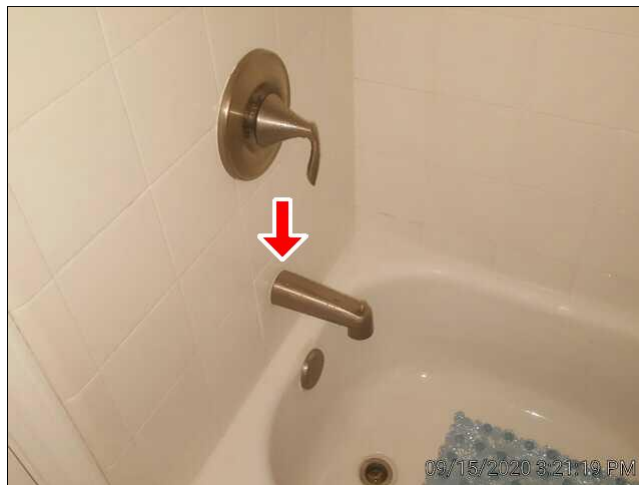
9.4 Item 1(Picture)

Improve: The escutcheon plates and tub spouts in the bath and shower surrounds need caulking and sealing to prevent moisture intrusion behind the wall which can cause structural damage. All open joints in the tile should also be caulked and sealed. Make sure escutcheon plates under the sinks are in place and also caulked to prevent moisture intrusion into the cabinets.

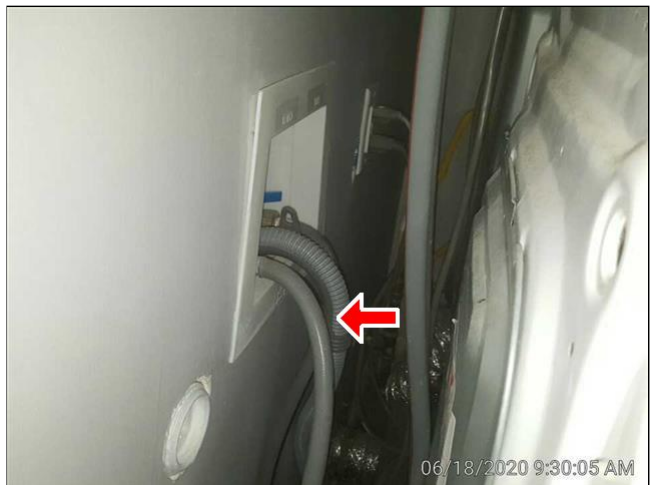
10.6 Item 2(Picture)

Improve: Recommend installing a metal or more durable composite overflow pan (rather than plastic) that is connected to a drain line under the washing machine to prevent damage to interior finishes from possible leaks at the washing machine. A better solution would be to install a tiled floor with a curb and floor drain. Otherwise, a leak detection system should be used. Also recommend installing metal braided hoses for the water connections for added protection.

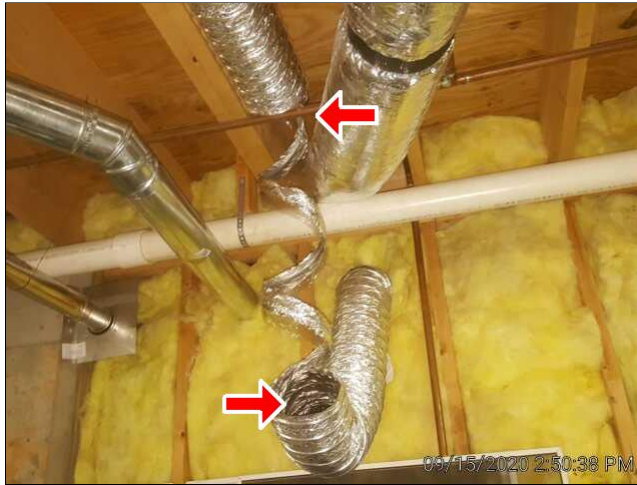
10.7 Item 1(Picture)

Repair: The cooktop exhaust piping as noted in the basement is damaged and needs repair to vent the exhaust to the exterior.
