Atlanta Property Inspections HOME INSPECTION REPORT

9610 Rod Road, Alpharetta, GA 30022

Inspection prepared for: Nick Alexander

Date of Inspection: 9/29/2020 Time: 1:30 PM

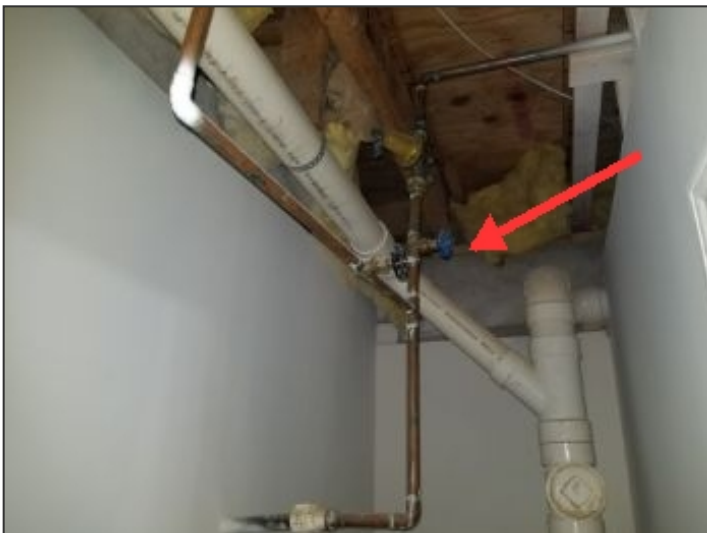
Main water cut-off handle located at front foundation wall

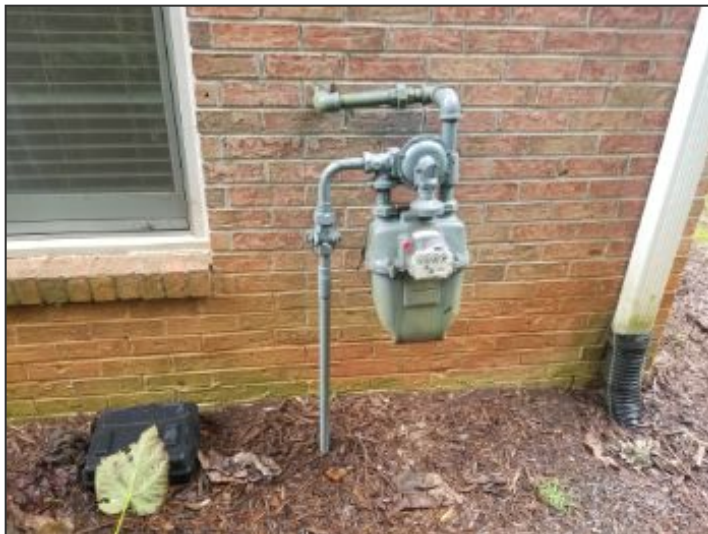
• The gas meter is located at the right side wall exterior wall and appears serviceable; the main gas shutoff valve is located at the exterior meter; no concerns were found. (NOTE: The gas lines inside the walls, ceilings and floors are not fully visible for inspection and could not be evaluated).

Gas meter located at right side wall

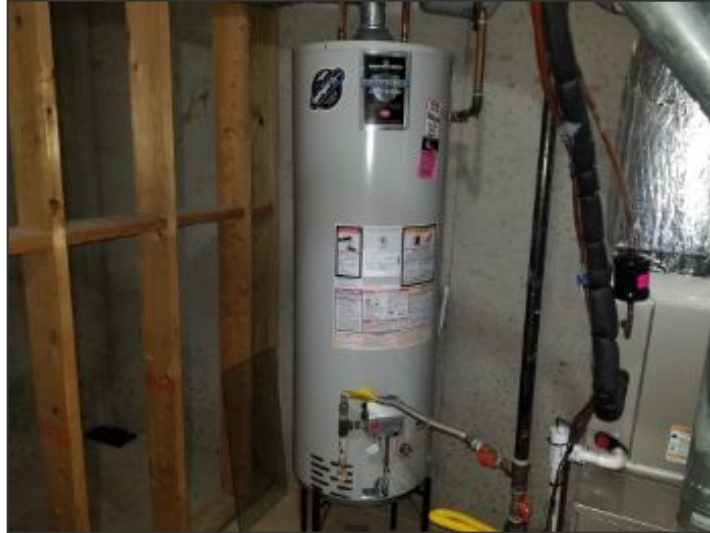
• This home has a single 50 gallon water heater that is too small for this large home. Based on the square footage and the number of bedroom and bathrooms, this home should have more than one single water heater tank, or a larger tank. Based on these conditions, installation of another water heater tank is recommended to meet the hot water demands of the home.

Water heater located in basement

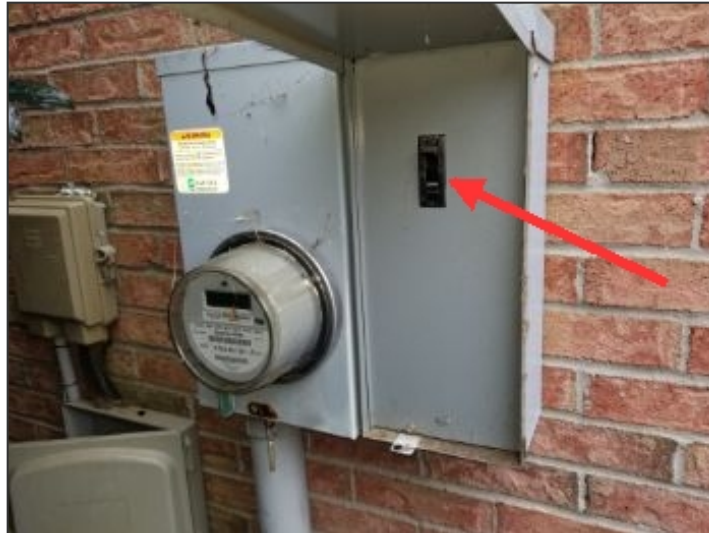
• A 200 amp main breaker is present at the exterior meter location; appears serviceable, no concerns were noted.

Main electrical disconnect at exterior meter

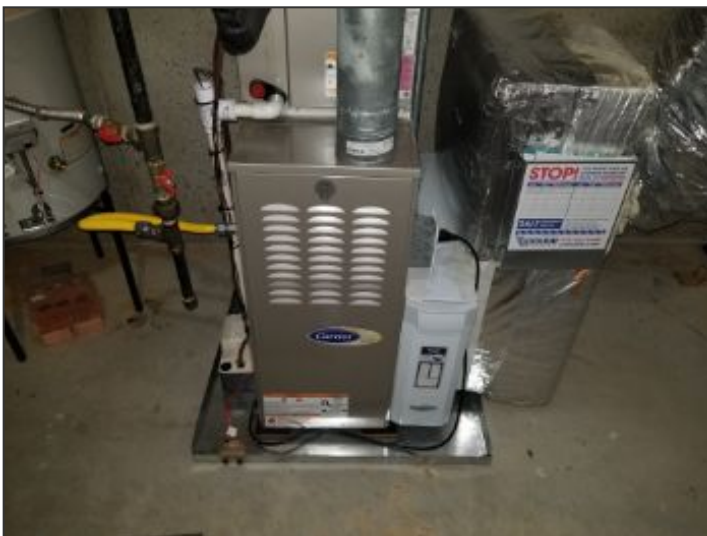
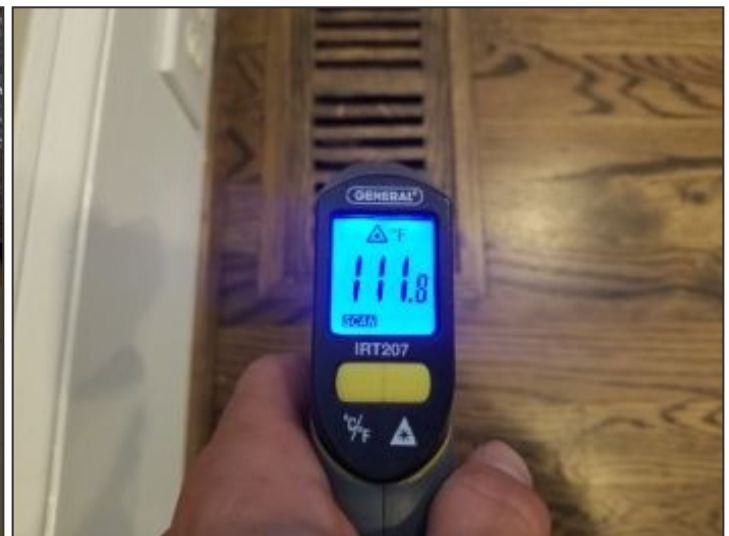
• **The heating system appears serviceable; the heating system was operated and was found to be functioning normally during a limited visual inspection, all readily openable panels were opened; no significant concerns were noted. Continue to maintain the system and have it serviced regularly.**

Good temps during testing of main floor furnace

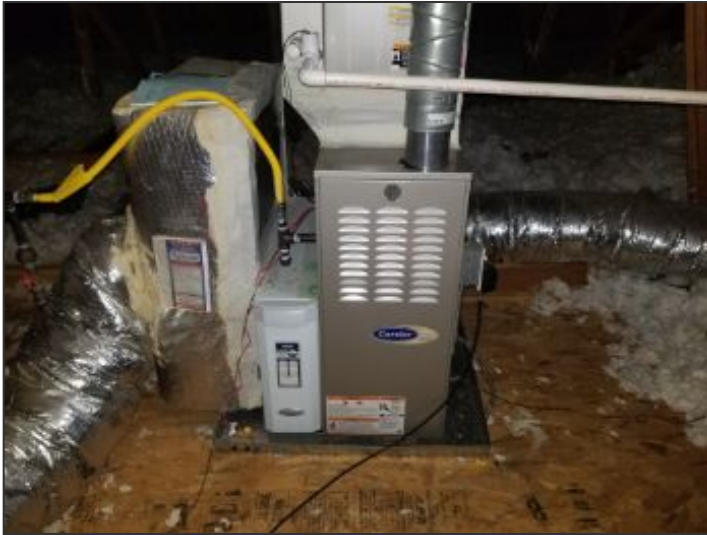
Second floor furnace located in attic

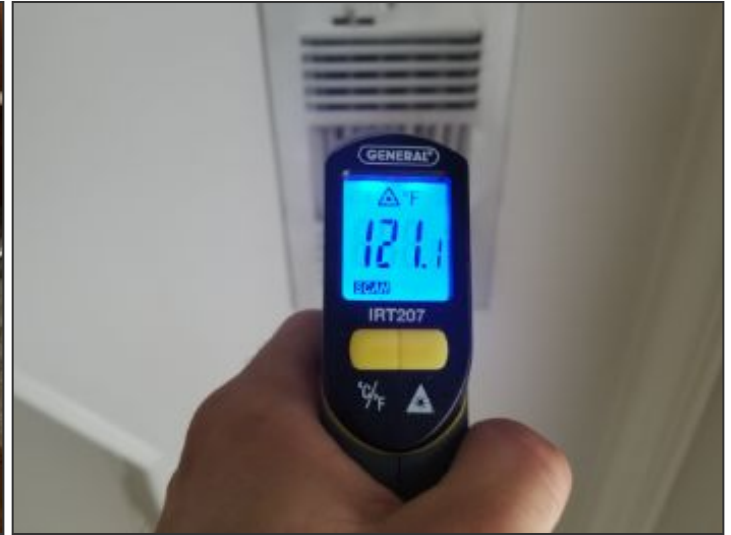
- **The heating system appears serviceable; the heating system was operated and was found to be functioning normally during a limited visual inspection, no significant concerns were noted. Continue to maintain the system and have it serviced regularly.**

Good temps during testing of second floor furnace

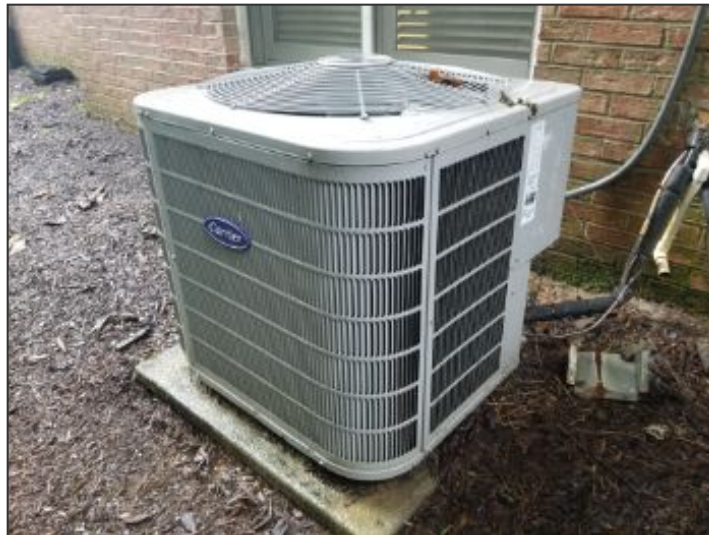
We are unable to inspect the cooling system due to cold weather. The outside temperatures have dropped below 60 degrees during the day or during the previous overnight hours. Due to concerns regarding possible damage to the unit, the air conditioner was not operated and could not be fully inspected during this cold weather inspection. This inspection is limited to a visual inspection and a quick start up to insure the unit is functional.

Main floor AC unit

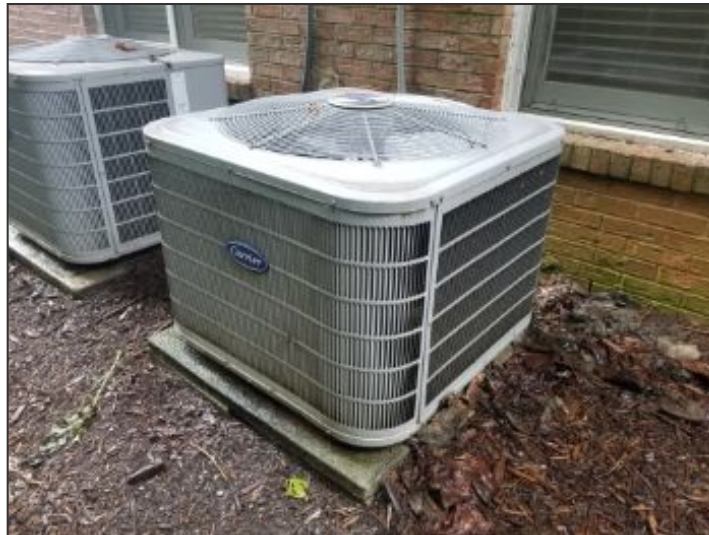
We are unable to inspect the cooling system due to cold weather. The outside temperatures have dropped below 60 degrees during the day or during the previous overnight hours. Due to concerns regarding possible damage to the unit, the air conditioner was not operated and could not be fully inspected during this cold weather inspection. This inspection is limited to a visual inspection and a quick start up to insure the unit is functional.

Second floor AC unit

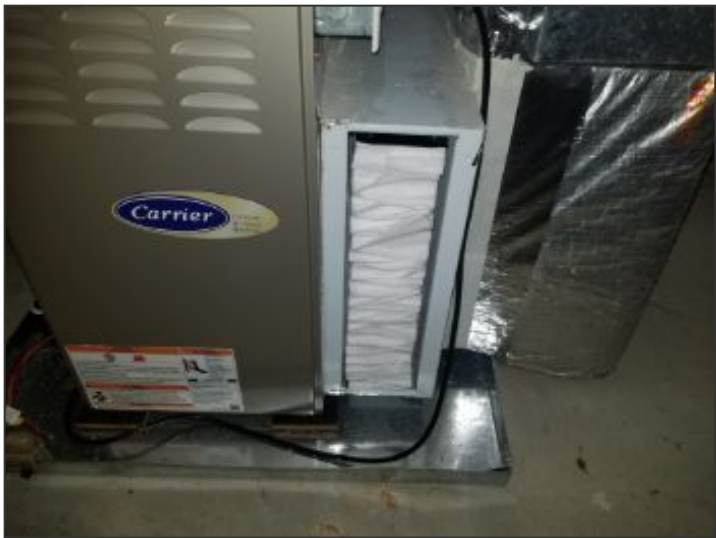
• **The filters appear serviceable. No concerns were noted. Client is encouraged to change the filters regularly. Regular filter changing helps to maintain clean HVAC equipment, cleaner air ducts, and reduced dirt and dust inside the home. Consider using good quality filters. Good filter choices include a pleated filter or larger media filter that provides more surface area for improved air cleaning. Look for filters with a higher micro-particle performance rating (800 and up), and a higher MERV rating (Minimum Efficiency Reporting Value - 8 to 10 and up).**

Media filters present at HVAC systems
