Home Inspection Report

90 Foxridge Ct
Marietta, GA 30067

INSPECTION REPORT SUMMARY

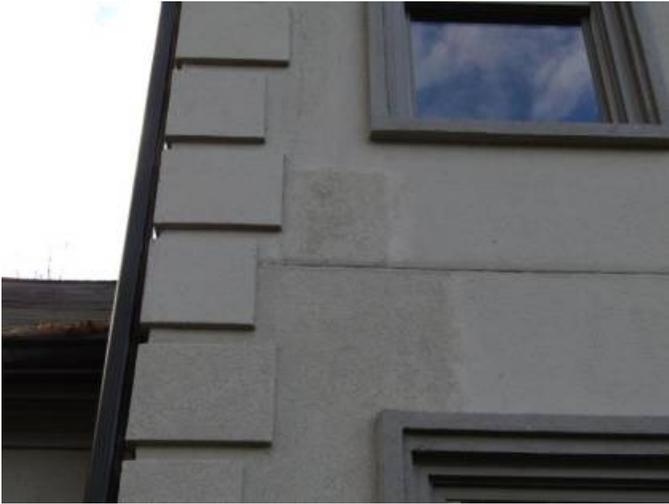
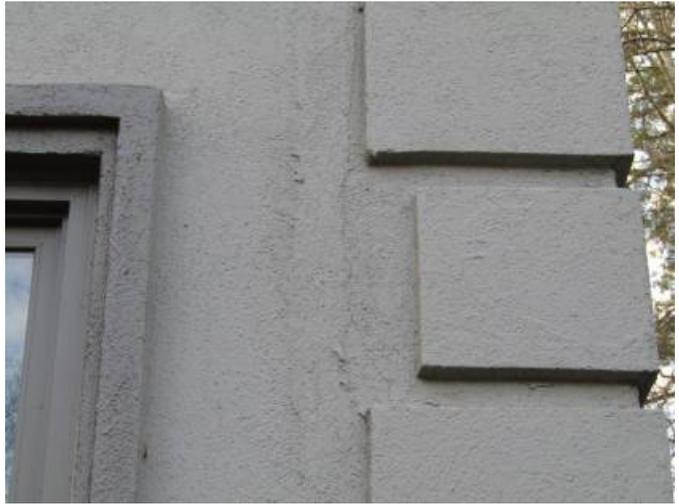
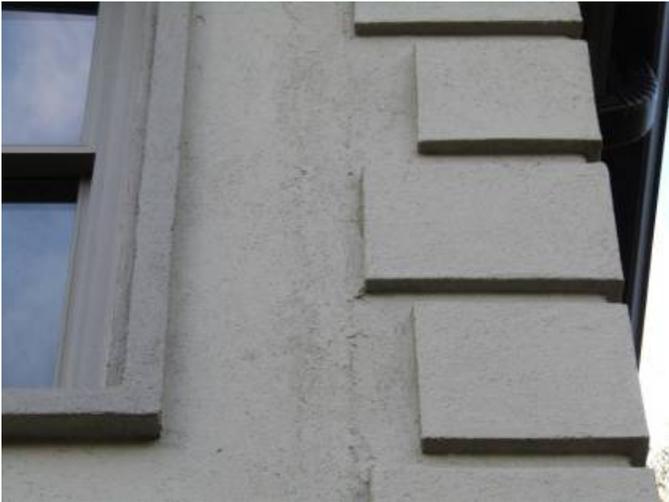
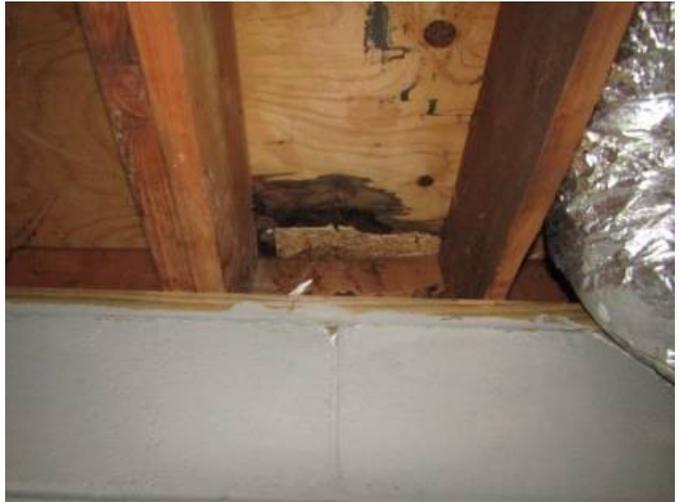
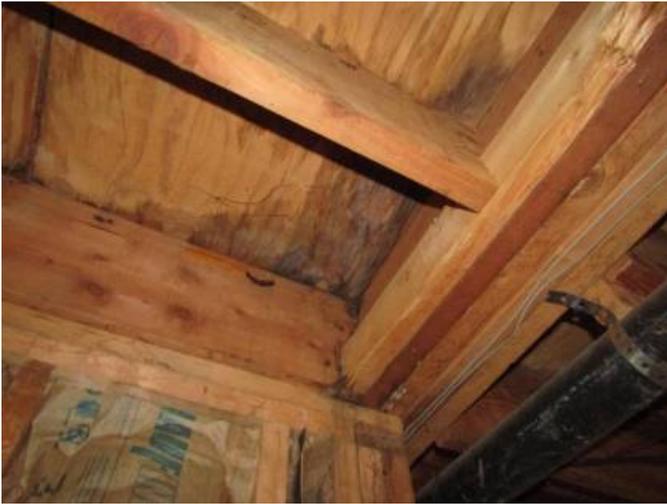
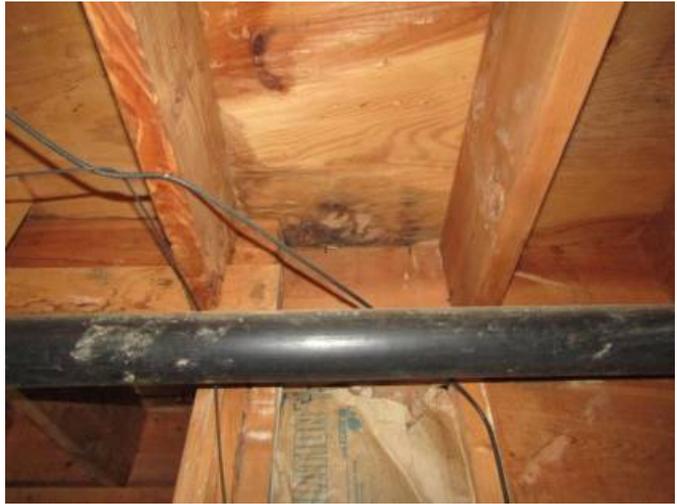
3. - The foam board behind the stucco siding is in contact with the ground on the rear of the chimney.
 - Some of the joints where wood trim meets the stucco siding have gaps in the caulk.
 - There is not a flashing above the garage door trim.
 - Repairs were noted at several areas of the stucco siding.
 - There are water stains on the basement ceiling at several locations.

the garage door trim is deteriorating

Not all locations are listed here or are shown below. Recommend having the stucco siding evaluated by a qualified stucco contractor or stucco inspector. Repair and seal as needed.

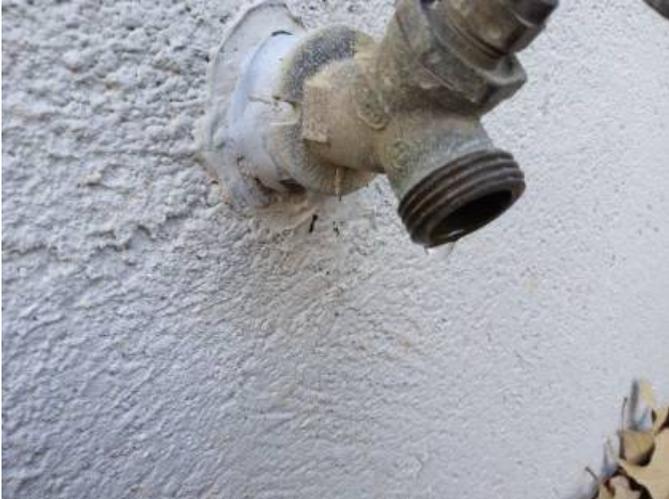
Exterior Faucets: **Action** - The exterior faucet on the front of the home leaks, it will not shut off completely.
- The exterior faucet on the rear of the home leaks at the valve stem when the faucet is turned on.

Attention - During the winter, it is recommended to shut off the water supply to the exterior faucets and install insulating covers over the faucets to help prevent freeze damage to the faucet or piping.

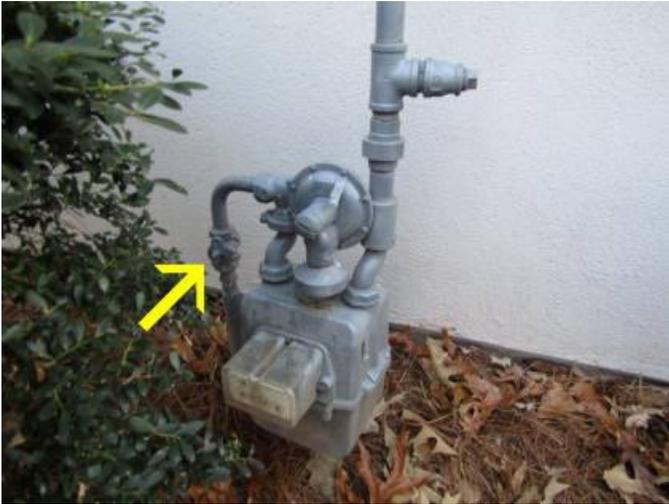
Piping Condition: **Action** - There is not a sediment trap on the gas line for the upstairs furnace. A sediment trap is required to help prevent clogging of the gas regulator.
- There is a gas leak at the gas meter on the exterior of the home. Repair by a licensed plumber is recommended.
