Inspection Report

**Property Address:
554 Vinings Estate Dr SE
Mableton GA 30126**

Inspector: Brandon Williams

**Residential Inspector of America
3276 Buford Drive, Ste. 104-306
Buford, GA 30519
770.476.4963**

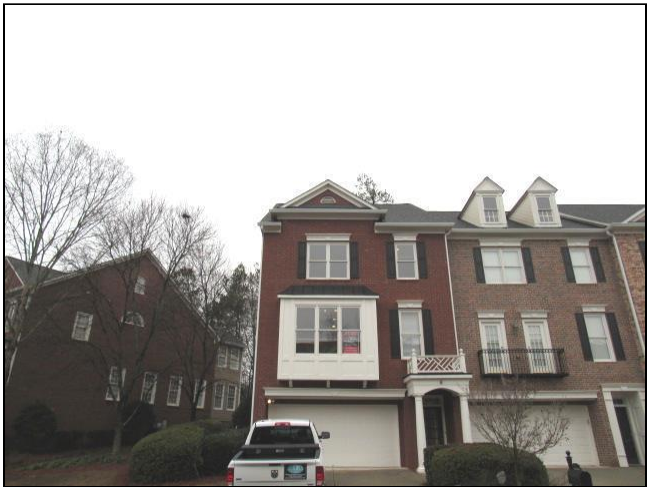
1.0 Item 1(Picture)

These are photos of the home taken from different angles and are not intended to show any defects.

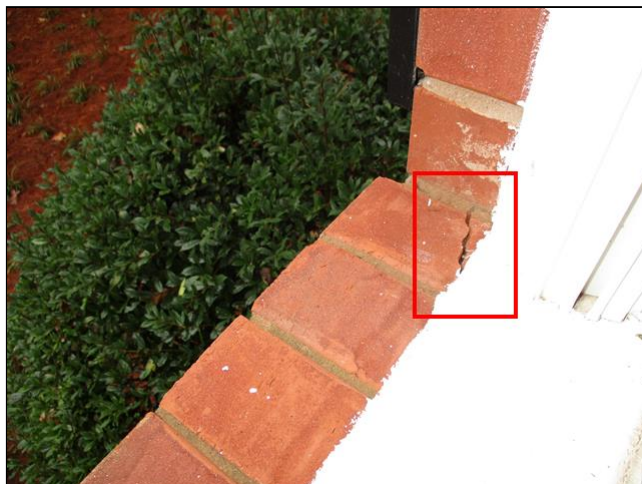
1.1 Item 5(Picture)

(2) Cracks found in the brick veneer/sill at several windows around the home. See photos for examples. Have a brick mason evaluate brick window sill areas and make all repairs/replacements as needed

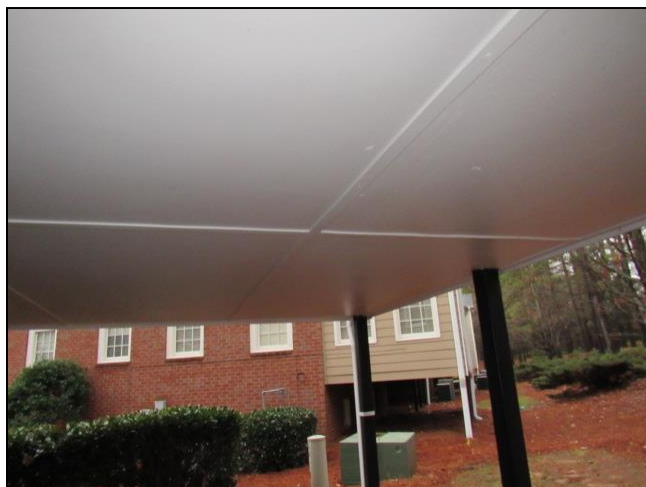
1.4 Item 2(Picture)

(3) Under side of rear sunroom/sitting room is covered with a finish material, so the framing could not be inspected, and the attachment method could not be verified.

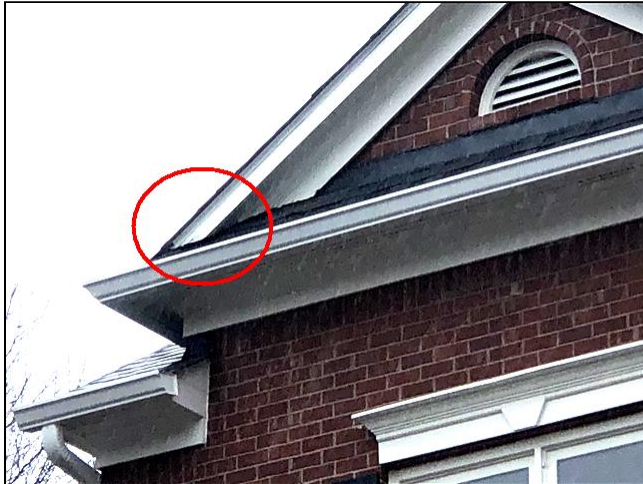
1.6 Item 3(Picture)

Water damage found on soffit and fascia trim at two areas at the front of the home. See photos for locations. Have contractor evaluate all soffit/fascia and have all damaged wood replaced.

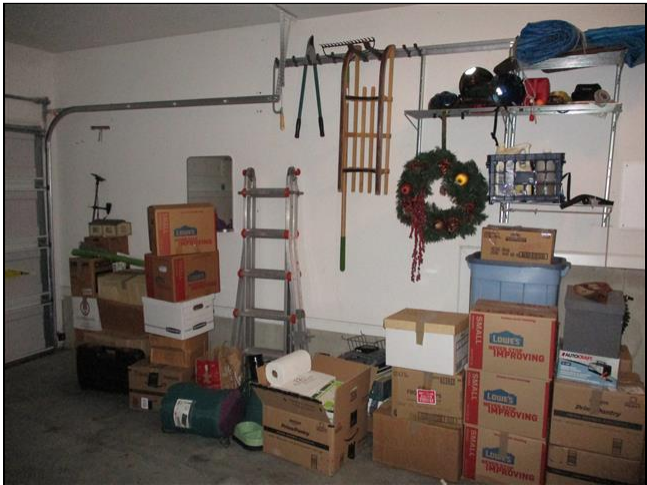
2.1 Item 1(Picture)

The garage inspection was limited due to stored items being in the garage at the time of the inspection.

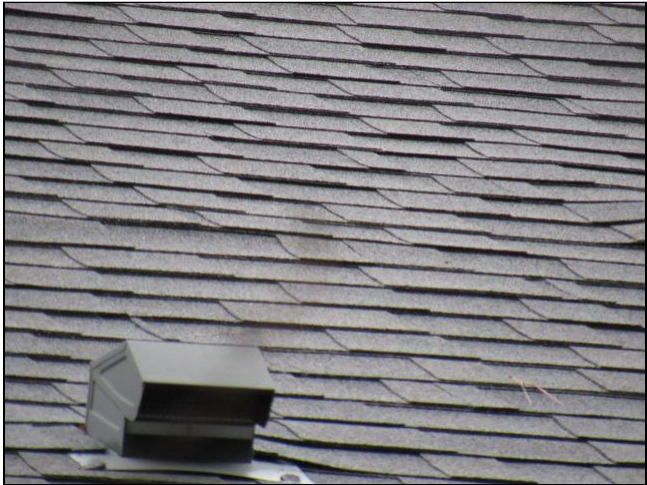
4.0 Item 1(Picture)

Shingles on the roof are the 4 tab architectural type with a life expectancy of about 20-25 years (depending on conditions) and the shingles were in good condition at the time of the inspection

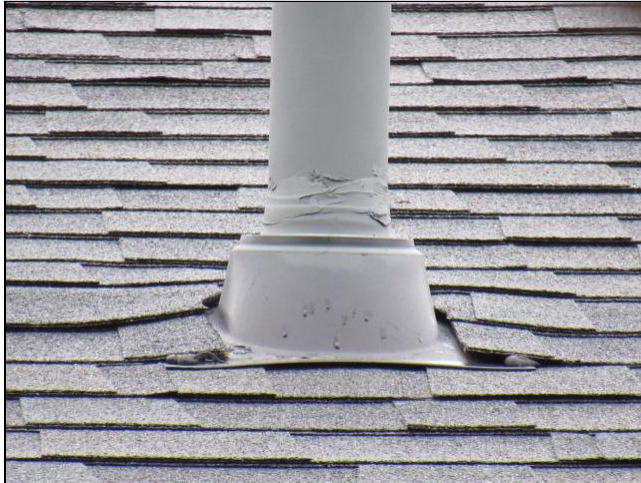
4.2 Item 1(Picture)

Boot flashing around plumbing vents on the roof are ok now, but these last about 5-7 years before needing replacement. They crack and split and allow rain water to leak into attic.

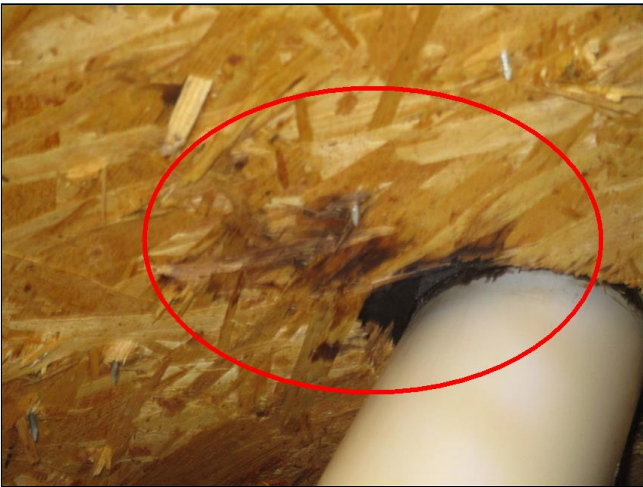
4.4 Item 4(Picture)

Water stains and possible slight damage noted in the roof decking in the front right corner of the attic and at both rear plumbing vents. Roofer will need to evaluate roof and ensure that it is water tight. Even though these areas may not have been wet during the inspection, it is possible that outdoor and weather conditions could cause leaks to become active again. See photo(s) for examples of location(s).

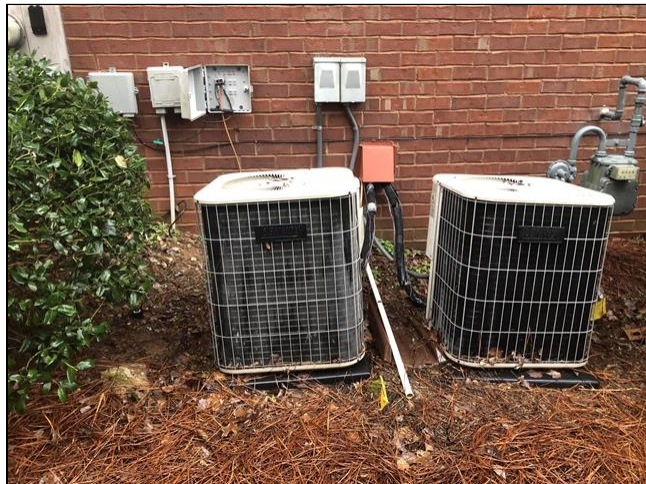
6.7 Item 2(Picture)

🔧 (3) Have outside a/c units leveled. They are listing to one side due to settlement/soil erosion.

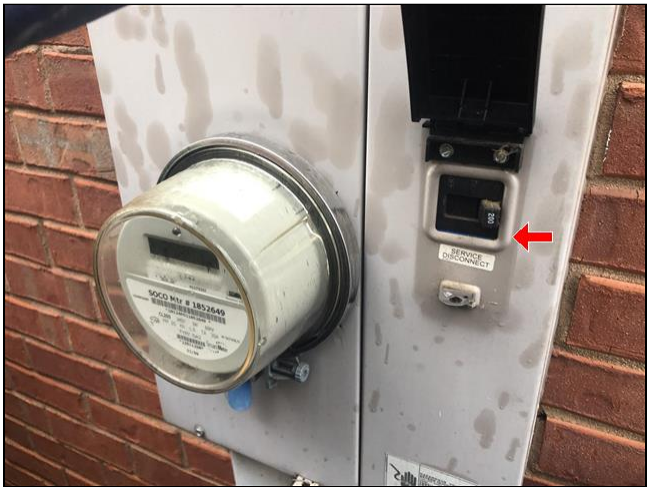
7.0 Item 1(Picture)

Main electrical disconnect location.

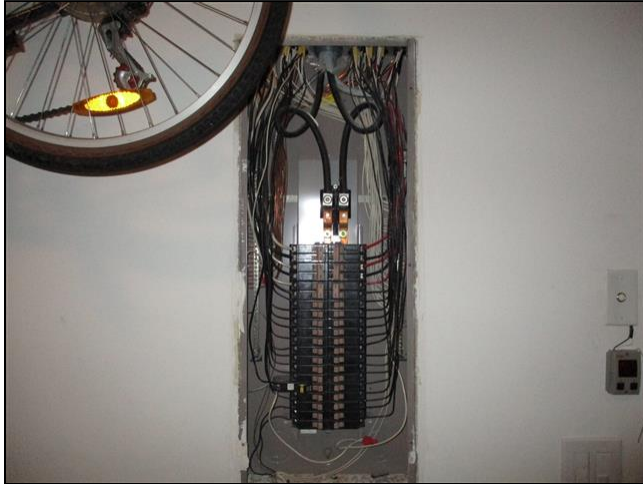
7.2 Item 1(Picture)

View of panel. Panel was inspected for function (not code compliance) and building codes and standards have changed over the years.

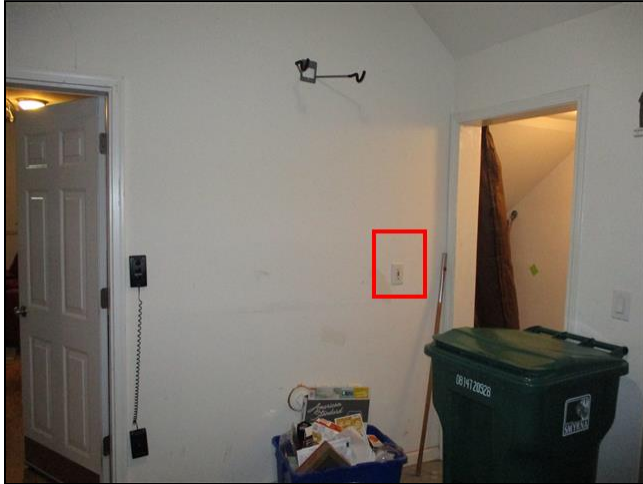
7.6 Item 1(Picture)

All bathroom gfci outlets reset at the garage gfci outlet on the rear right wall seen in photo. This is for your information only

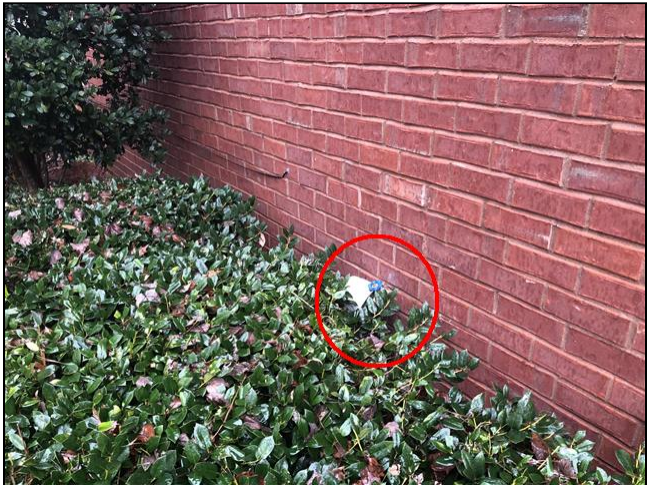
8.1 Item 1(Picture)

(1) Left side exterior hose bibb was not accessible to test for operation, leaks, or water pressure due to thick vegetation blocking access. Have any concerns resolved prior to closing

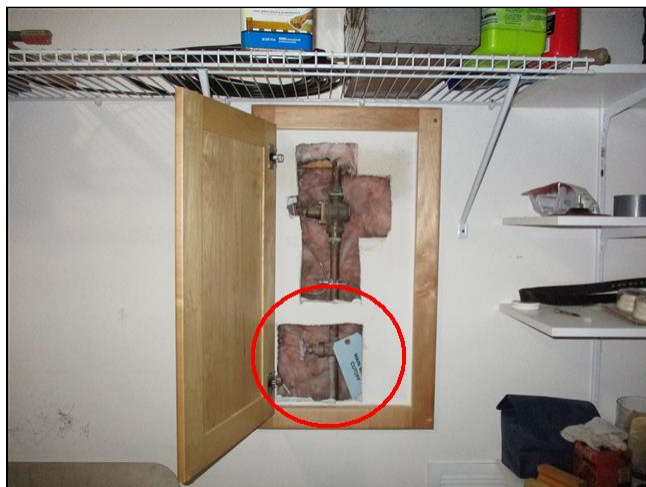
8.4 Item 1(Picture)

(1) The main water shut off is located in the garage.

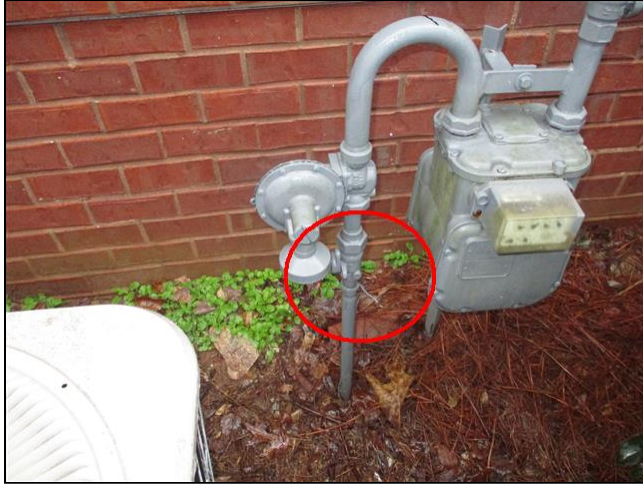
8.6 Item 1(Picture)

The main gas shut off is located at the meter.

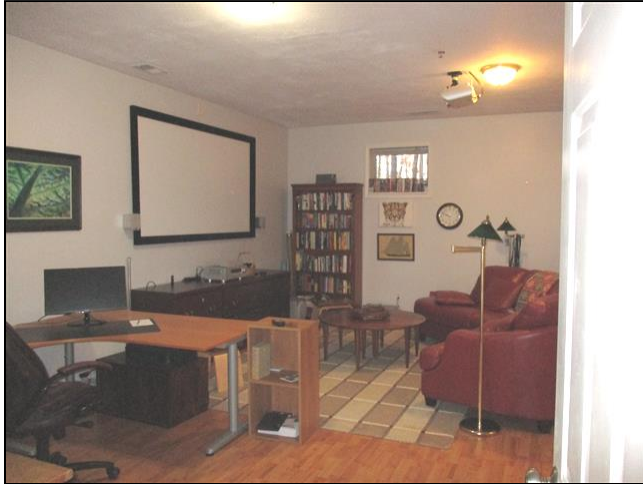
9.1 Item 1(Picture)

Most of the walls and ceilings in the finished basement are covered and structural members are not visible. No obvious problems discovered. Condition of all framing members not seen is not known.
