## HOME INSPECTION

01/13/20

5477 Woodsong Trail  
Dunwoody, GA 30338

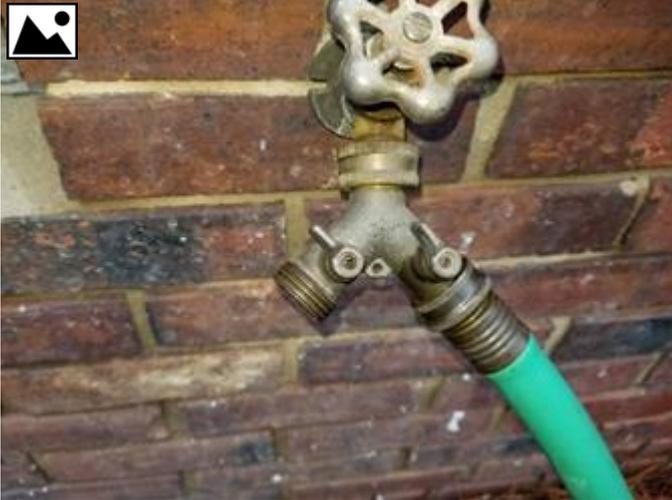
- 23 The hose faucet is missing an anti-siphon device, which is designed to prevent contaminated water from entering house's potable water supply. This is a safety concern. **Location:** Multiple Locations. *Install an anti-siphon device.* [45](#)

**Location** Multiple Locations

**Action** *Install an anti-siphon device.*
