**BPG Inspection Services**

**5390 Glenbrooke Trail  
Dunwoody GA 30338**

Client(s): Mulrane  
Inspection Date: 1/3/2020  
Inspector: Kevin Carey ,

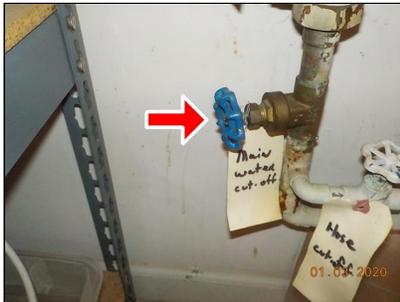
24. **GENERAL NOTE:** The main water shut off valve is **located next to the water heater.**

The main water shut off valve is located next to the water heater.

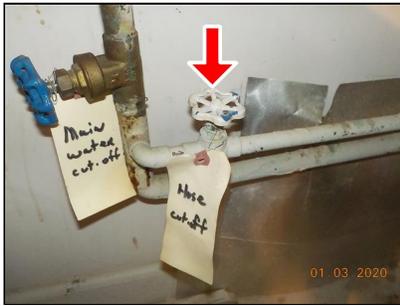
Right side hose bibb shut off valve

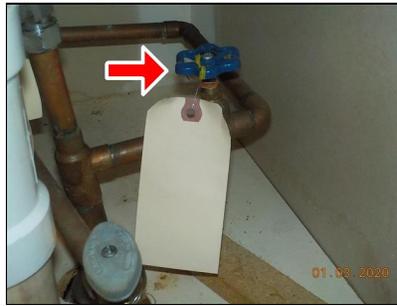
Left side hose bibb shut off valve

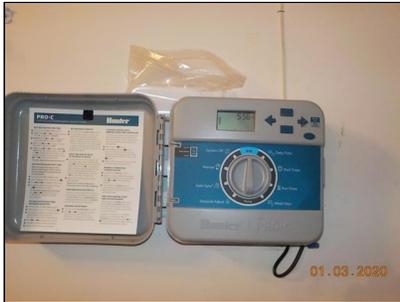
27. **GENERAL NOTE:** The underground sprinkler system was not tested and is not included in the scope of our inspection. Working condition should be verified by the seller.

The underground sprinkler system was not tested

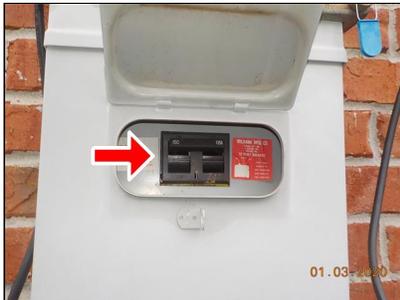
28. **GENERAL NOTE:** The main electrical disconnect is **located at the meter.**

The main electrical disconnect is located at the meter.

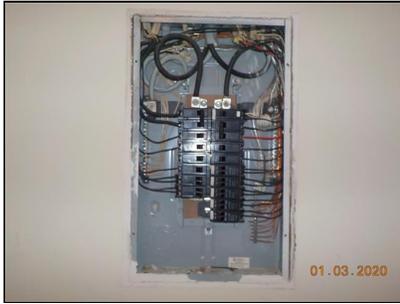
The electrical panel cover was removed and the wiring inspected.

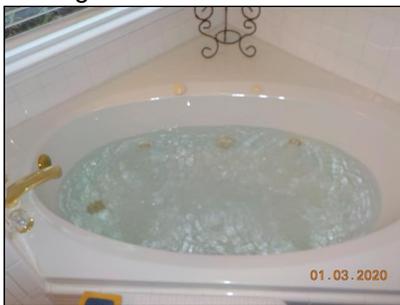
- 37. **GENERAL NOTE:** Filled and operated the whirlpool tub for at least 10 minutes. There were no indications of leaking from access available or below unit.

Filled and operated the whirlpool tub for at least 10 minutes.
