# Property Re Inspection Report

Property address: **7060 Amberleigh Way  
Duluth GA 30097**

Inspection date: **Wednesday, January 8, 2020**

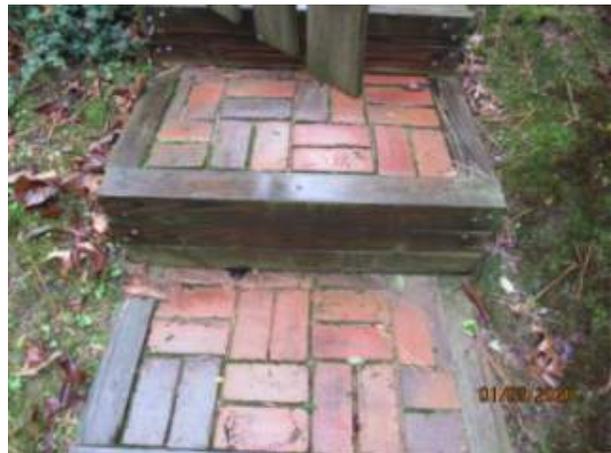
**Photo 4-2**

Risers for stairs at one or more locations were higher than 7 3/4 inches and posed a fall or trip hazard. Risers should be 7 3/4 inches or shorter. At a minimum, be aware of this hazard, especially when guests who are not familiar with the stairs are present. Recommend that a qualified contractor repair per standard building practices.

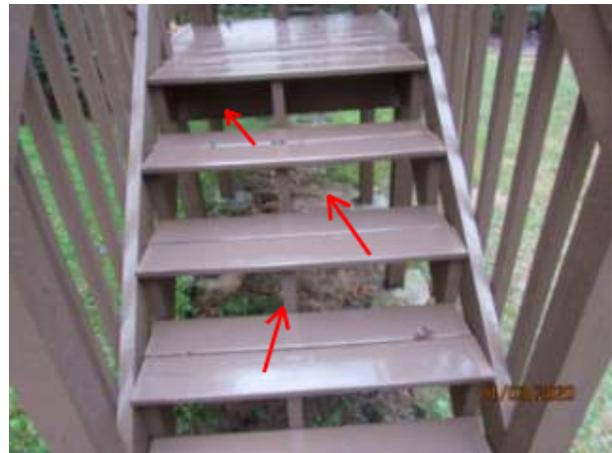
**Photo 5-2**

Large gaps at stair risers were found. This is a potential safety hazard for children (e.g. falling, getting stuck in gaps). Recommend that a qualified contractor repair as necessary to eliminate large gaps in stairs at elevations over 30 inches high. For example, by installing boards for risers.

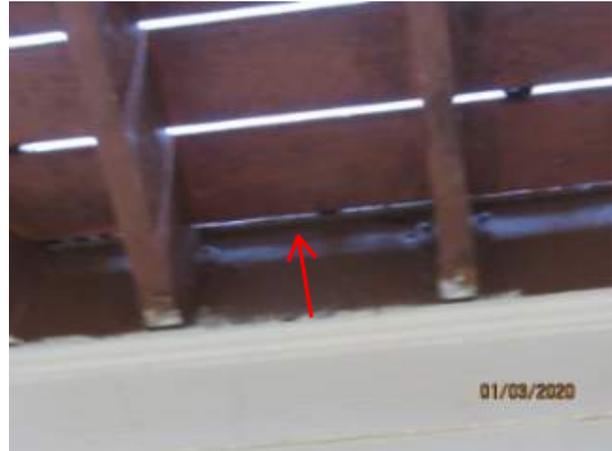
**Photo 6-2**

6) 🛠️💧 Flashing appeared to be missing from above one or more deck or porch ledger boards, or could not be verified. Missing flashing at this location can cause moisture to accumulate between the ledger boards and the building. Fungal rot may occur in this area and cause the ledger board fasteners to fail. The deck may separate from the building in this event. This is a potential safety hazard. Recommend that a qualified contractor install flashing above ledger boards per standard building practices. For more information, visit: <http://www.reporthost.com/?LB>  
<http://www.reporthost.com/?SD>

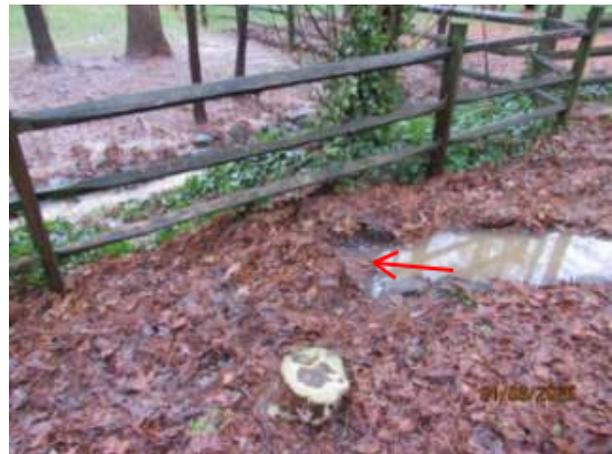
**Photo 7-2**

7) 🛠️📍 Located in the rear of the property is a culvert drain for the storm drains. The path that the water takes to the creek is clogged with debris causing the water to back up. Recommend a qualified contractor evaluate and make the necessary repairs.

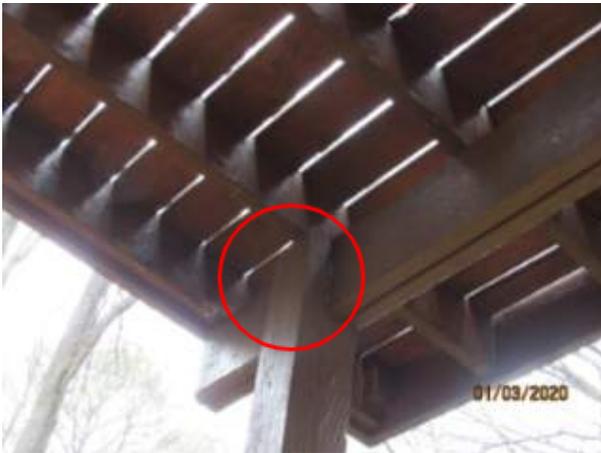
**Photo 8-3**

8) 🛠️📍 The support beams for the deck sit on top of a cut out in the 6x6. There are no carriage bolts or lag bolts securing the beams to the post. Recommend a qualified contractor evaluate and make the necessary repairs.

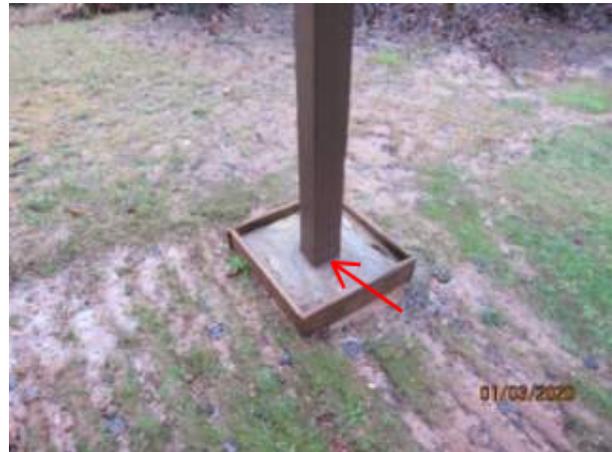
**Photo 11-2**

**11)** 🛠️💧 Wooden support posts for the deck or porch were resting directly on concrete piers or footings below. Water may wick up into the support post ends and result in elevated levels of moisture in the wooden support post ends. This is a conducive condition for wood-destroying organisms. Support posts should rest in metal brackets above concrete piers or footings, or should be separated from the concrete below by impervious membranes such as composition shingle scraps. Even if posts are made of treated wood the cut ends may not have been field-treated, leaving little or no preservative at the post center. Recommend that a qualified contractor repair per standard building practices. For example, by installing composition shingle scraps between the posts and the concrete below.

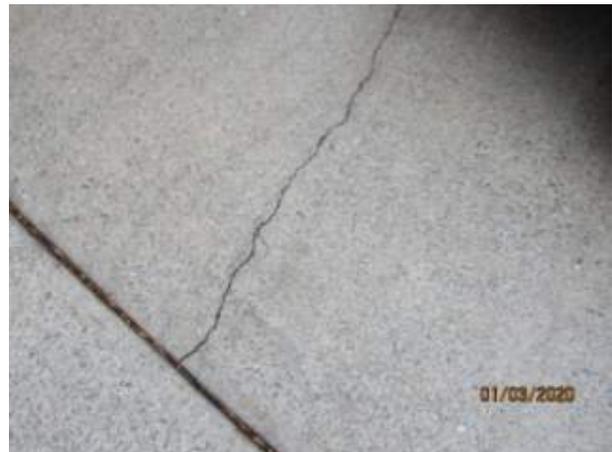
**Photo 13-2**

Minor deterioration (e.g. cracks, holes, settlement, heaving) was found in the driveway, but no trip hazards were found. The client may wish to have repairs made for cosmetic reasons.

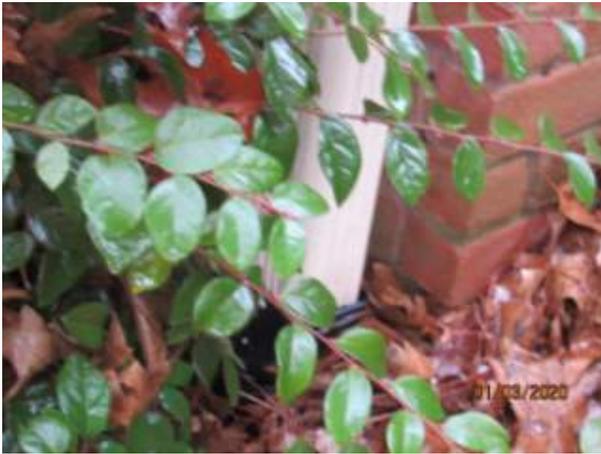
**Photo 32-1**

**32)** 🏠 ⓘ Downspouts that discharge below grade level should be monitored. If they are ever suspected to be clogged or disconnected below grade, they should be reoriented to discharge out and away from the building.

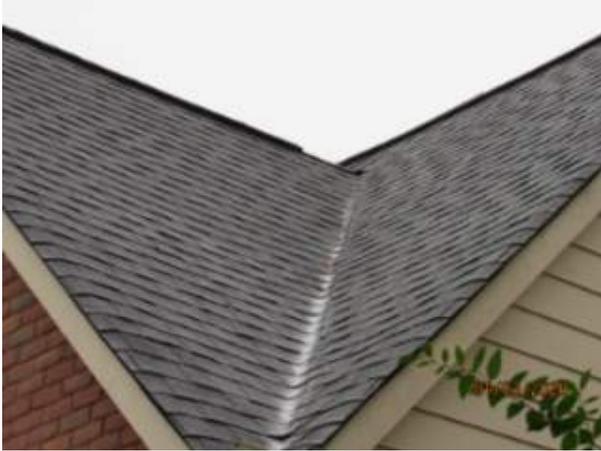
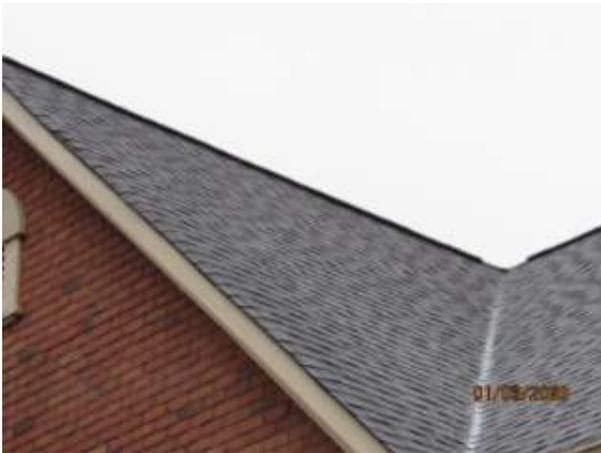
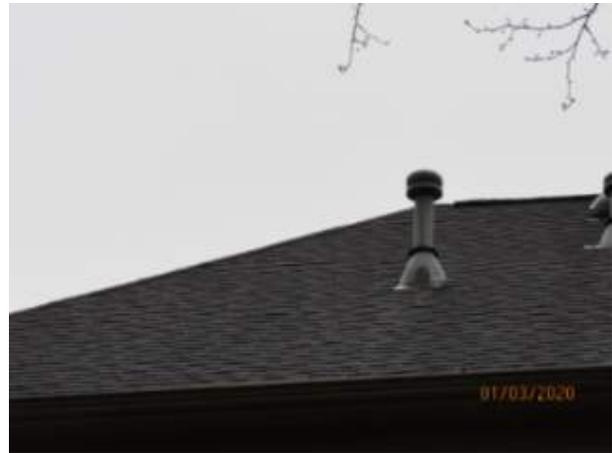
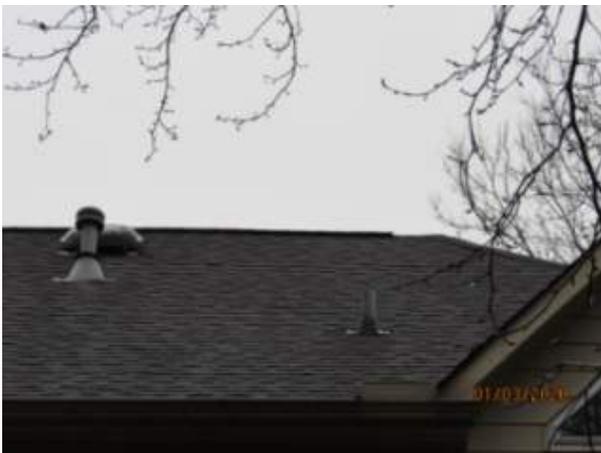
**35)** General pictures of the roof

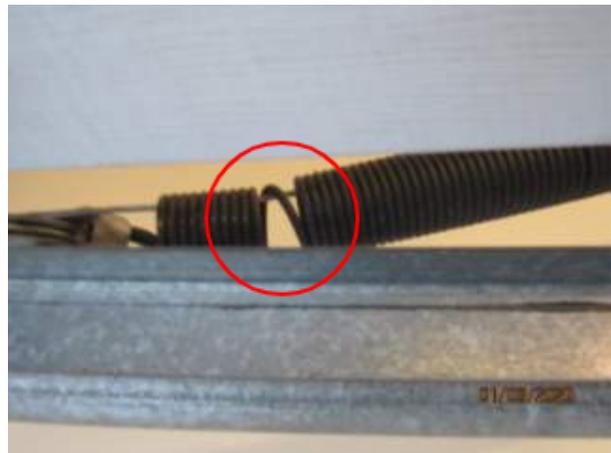
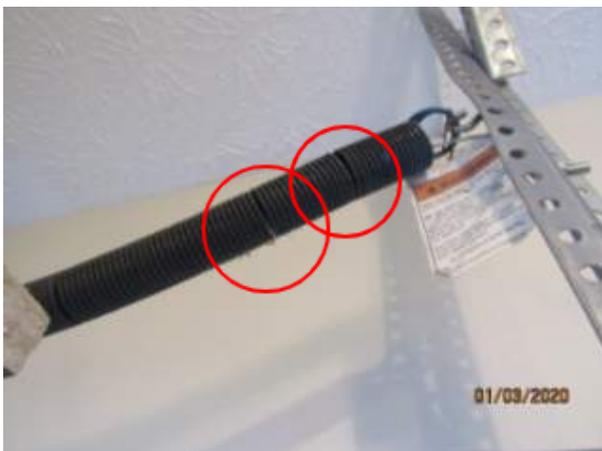
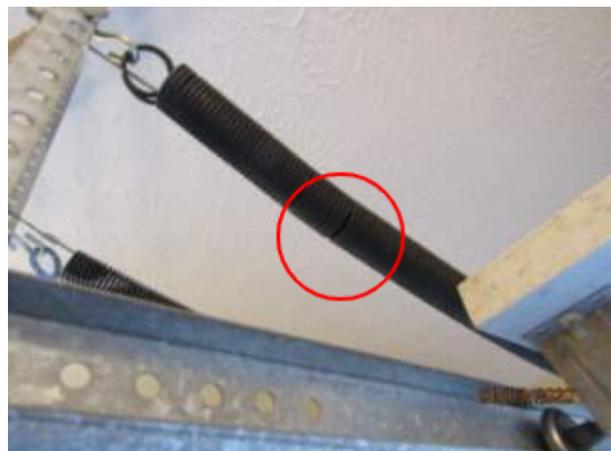
**36)** 🚑🔧📄 One or more extension springs supporting garage vehicle door(s) were stretched. This is an indication that the spring(s) have been weakened. Stretched extension springs are a potential safety hazard in the event that they break. The vehicle door could fall shut or a spring could strike someone nearby when it breaks. Recommend that a qualified contractor replace stretched extension springs.

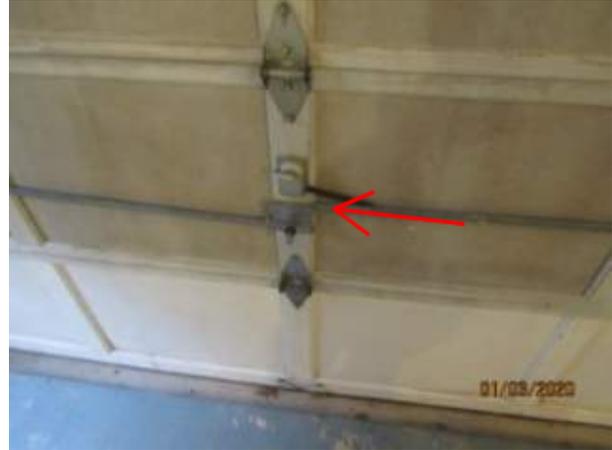
**Photo 38-2**

One or more garage vehicle doors had an automatic opener installed, and the manual lock mechanism on the door hadn't been permanently disabled. The automatic opener can be damaged, or injury can occur if the automatic door opener is operated with the manual lock engaged. A qualified person should disable or remove the lock mechanism per standard building practices.

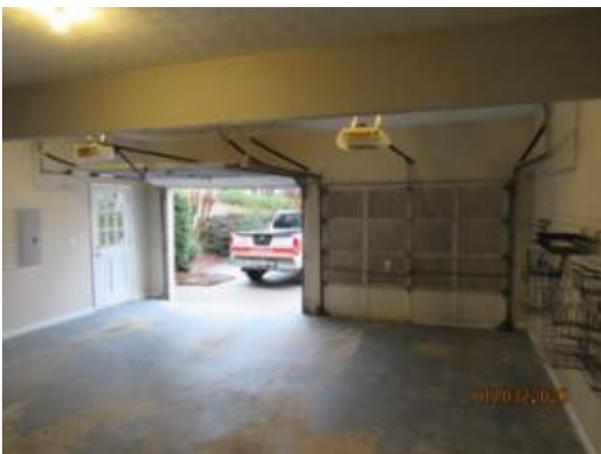
**Photo 42-1**

**42)** General pictures of the garage/carport

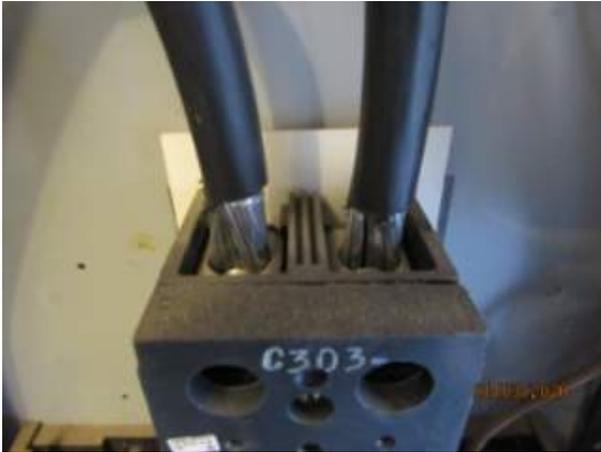
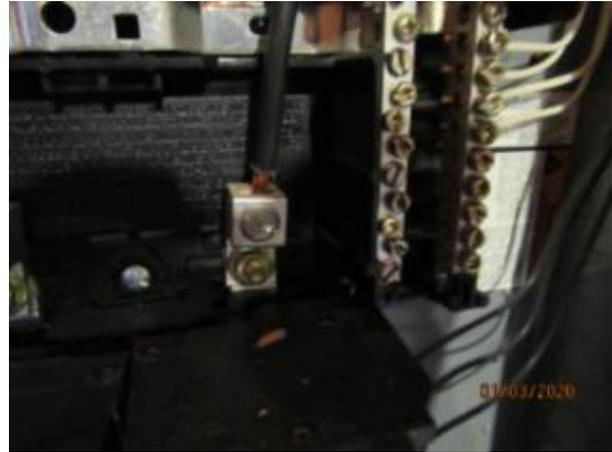
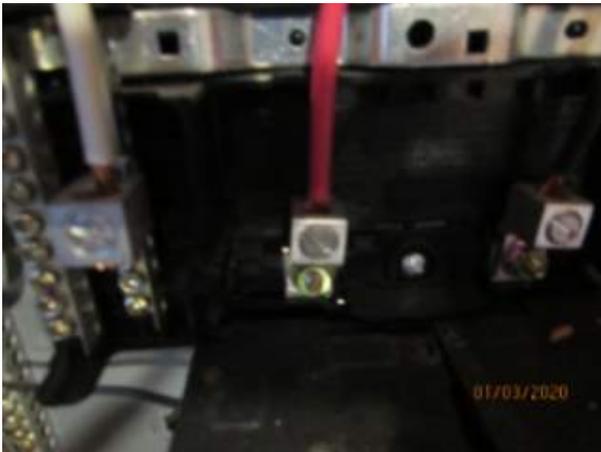
43) 🛠️🔍📄 One or more connections with aluminum wires in panel #A and B lacked anti-oxidant paste. Oxidation usually occurs without it, and may result in poor connections, overheating, and possibly fires. A qualified electrician should evaluate and apply anti-oxidant paste as necessary.

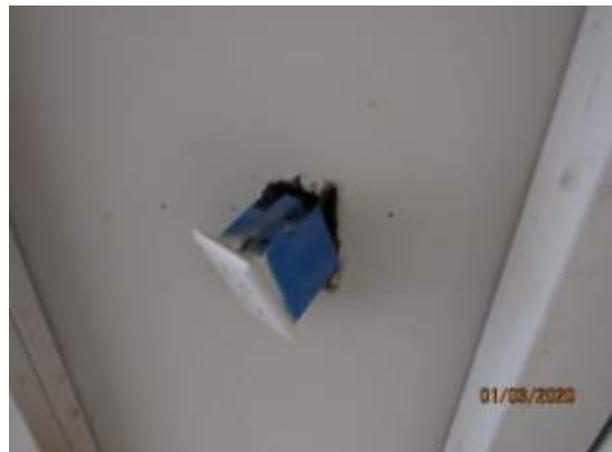
**Photo 47-2**

One or more electric receptacles (outlets) and/or the boxes in which they were installed were loose and/or not securely anchored. Wire conductors can be damaged due to repeated movement and/or tension on wires, or insulation can be damaged. This is a shock and fire hazard. Recommend that a qualified electrician repair as necessary.

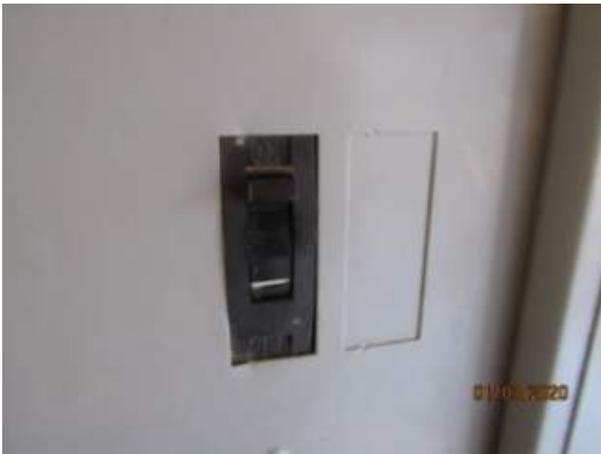
**Photo 53-1**

Location of main shut off:

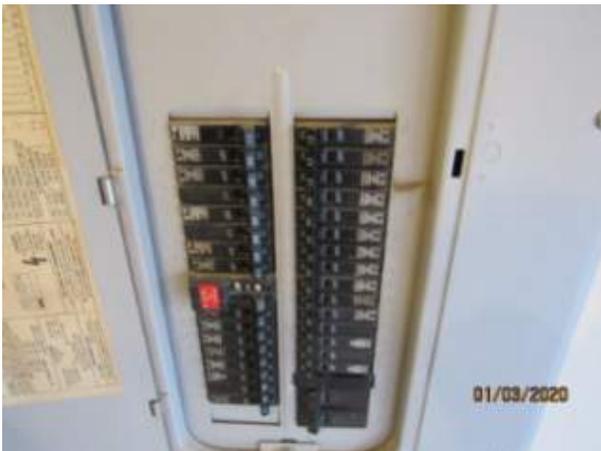
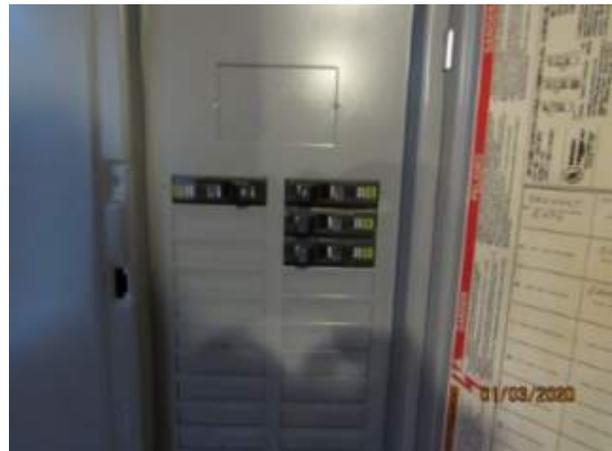
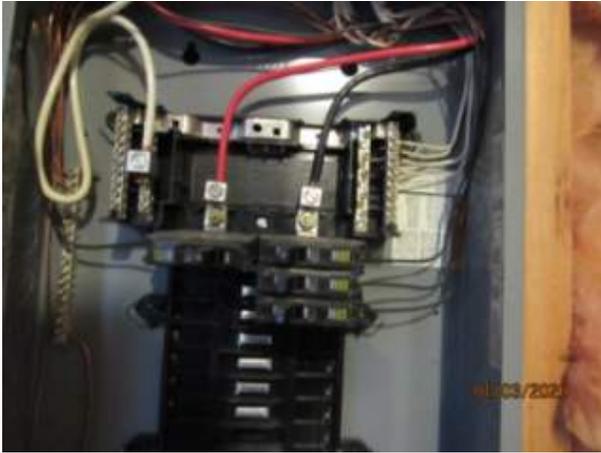
54) General pictures of service panel(s).

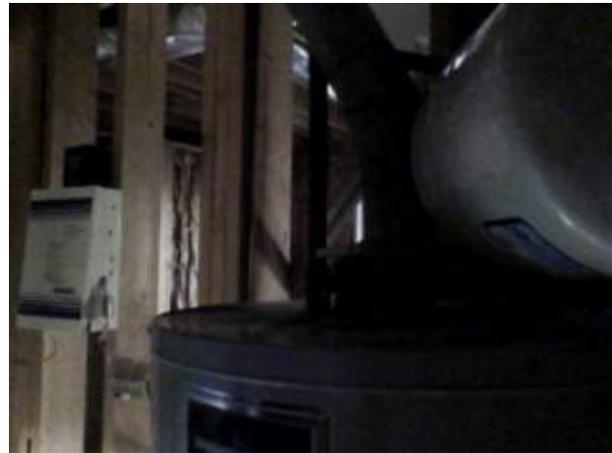
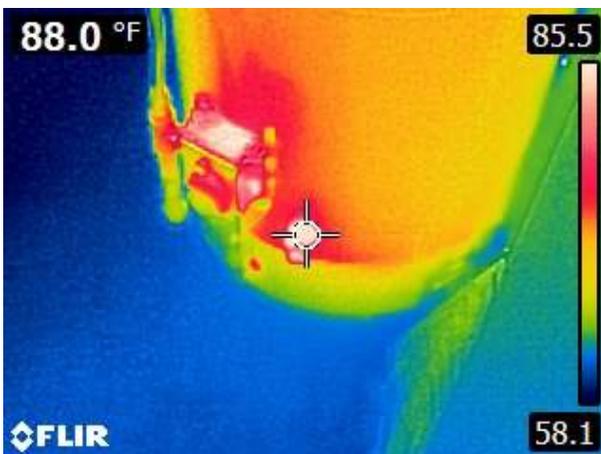
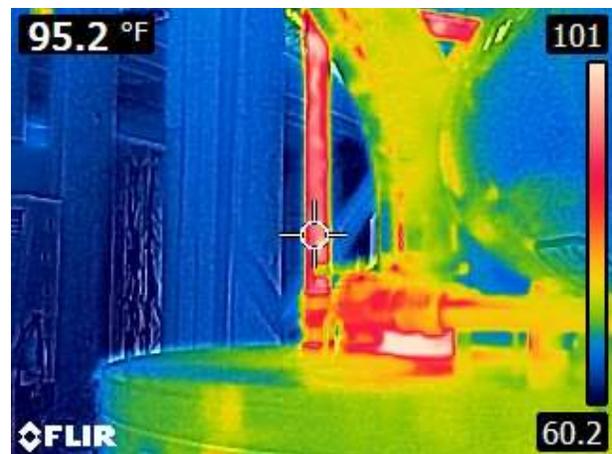
60) **i** General pictures of the water heater using infrared.

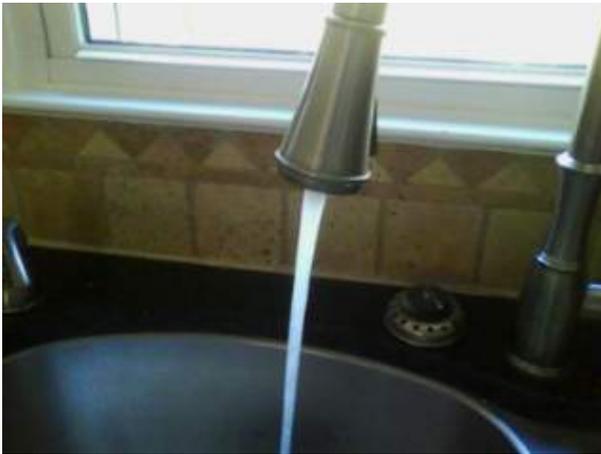
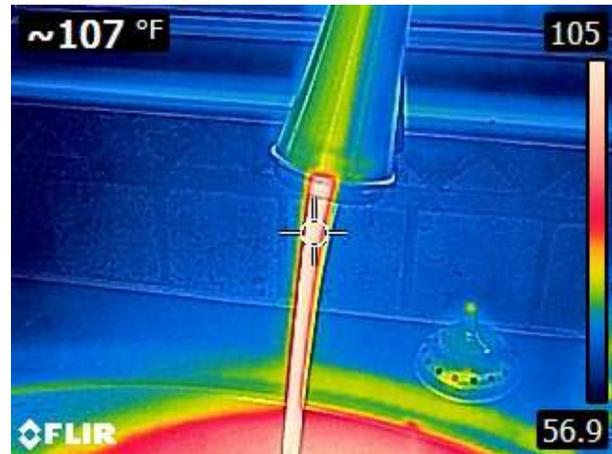
General pictures of water temperature using infrared.

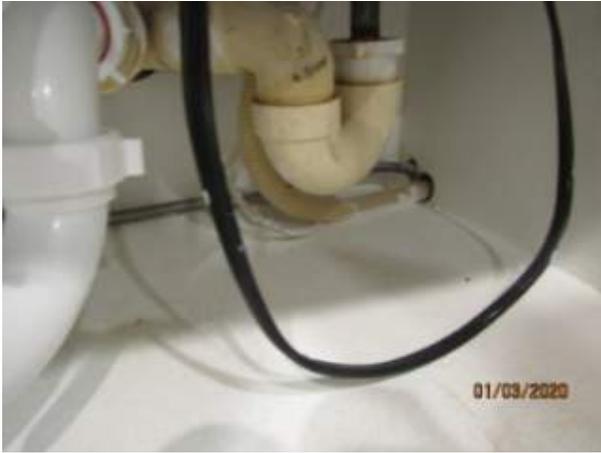
**Photo 62-1**

No high loop or air gap was visible for the dishwasher drain. A high loop is created by routing the drain line up to the bottom surface of the counter top above and securely fastening it to that surface. An air gap is a device that makes the drain line non-continuous. Both of these prevent waste-water backflow from entering the dishwasher, and possibly flooding out of the dishwasher if/when a siphon occurs. Some newer dishwashers have these devices built in. The client should try to determine if these devices are built in to this brand and model of dishwasher (e.g. review installation instructions). If not, or if this cannot be determined, then recommend that a qualified contractor install a high loop and air gap per standard building practices.

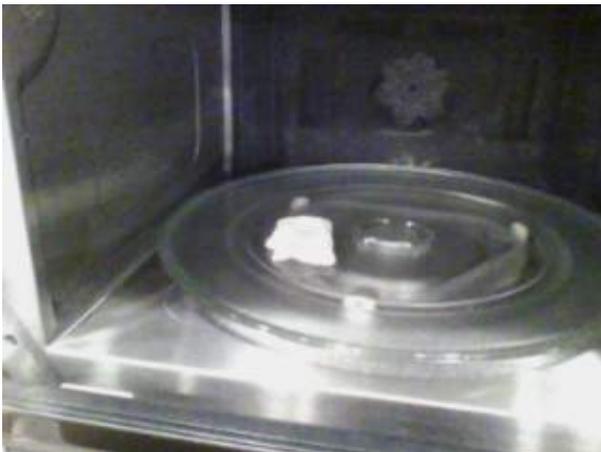
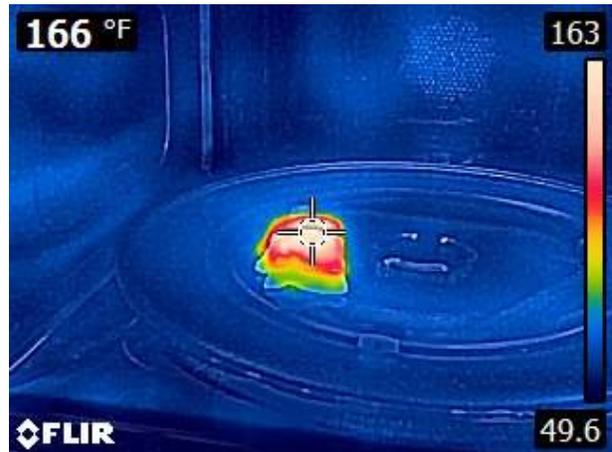
Microwave appeared to be heating at the time of inspection.

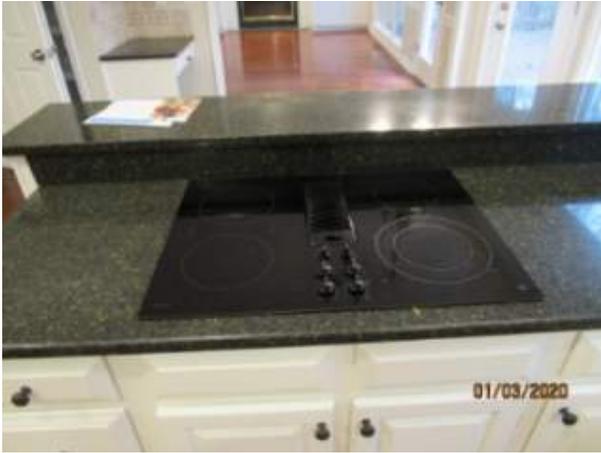
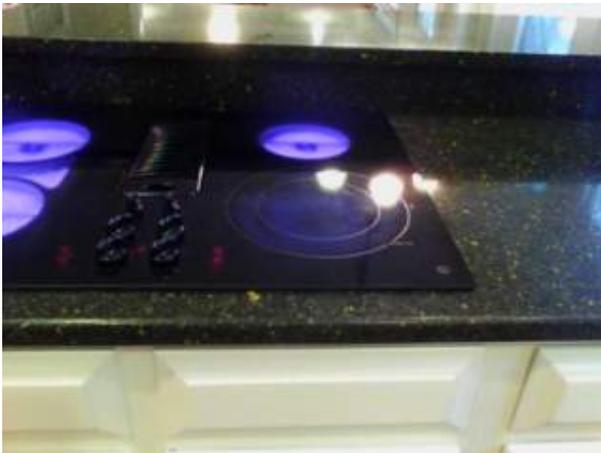
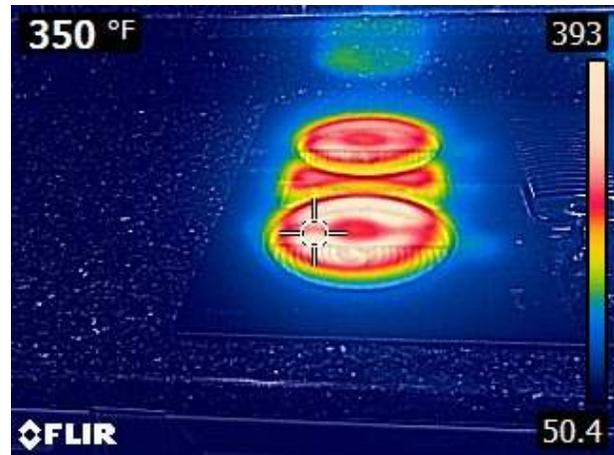
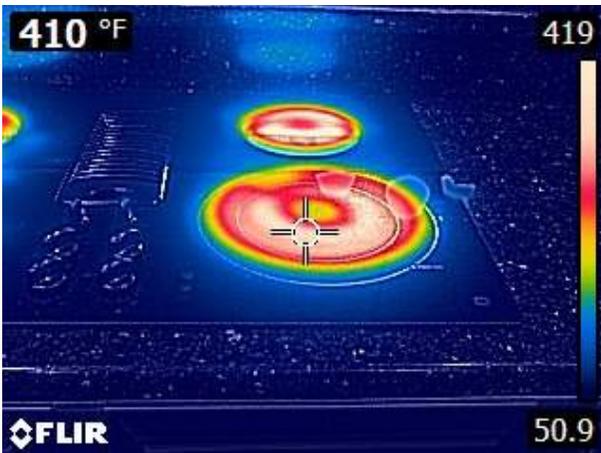
Stove top appeared to be heating at time of inspection

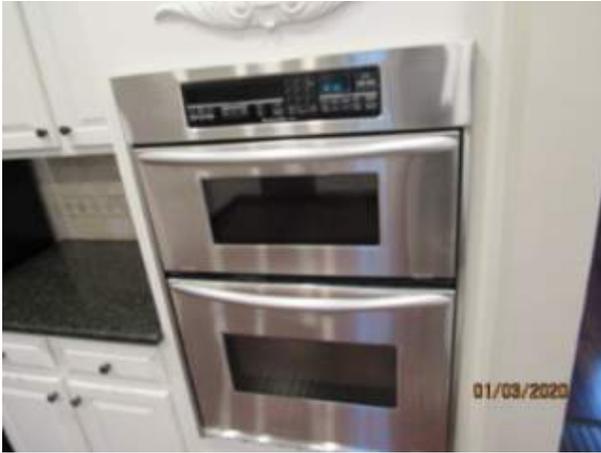
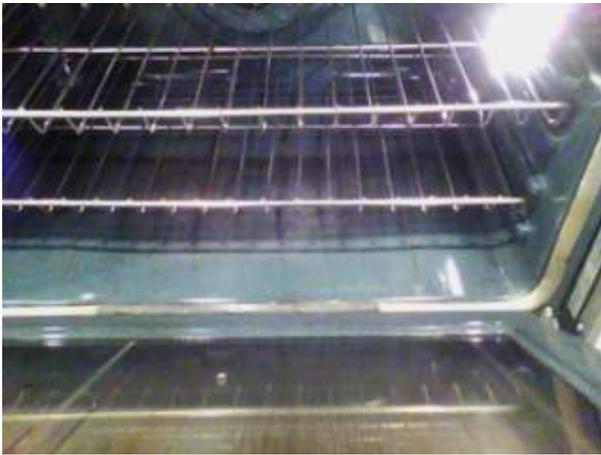
Oven(s) appeared to be heating at time of inspection

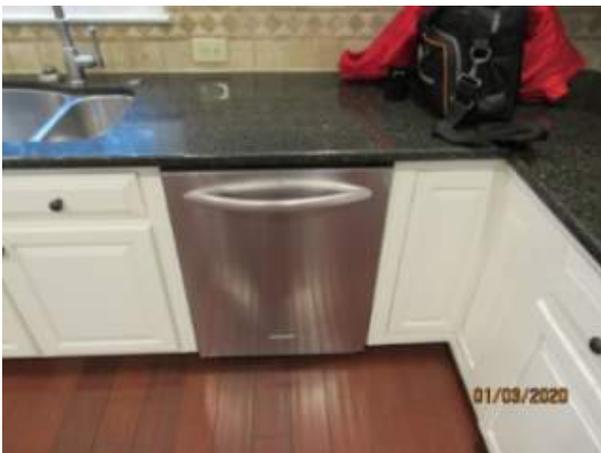
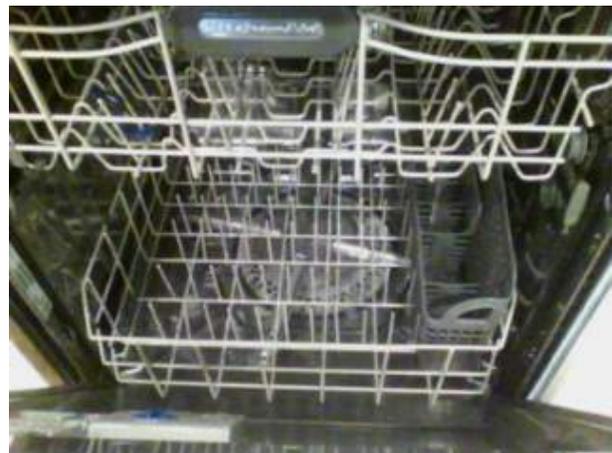
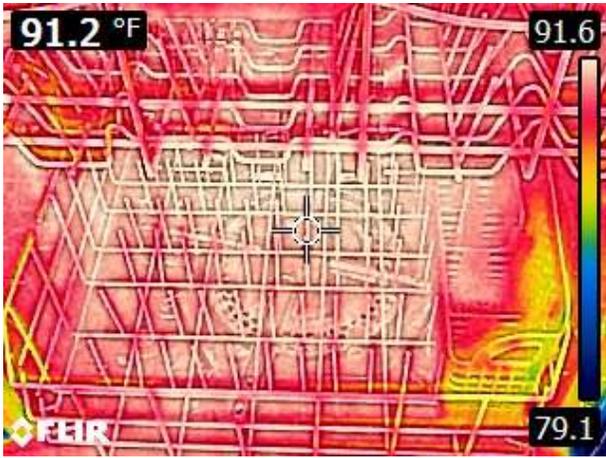
Dishwasher appeared to be functional at the time of the inspection.

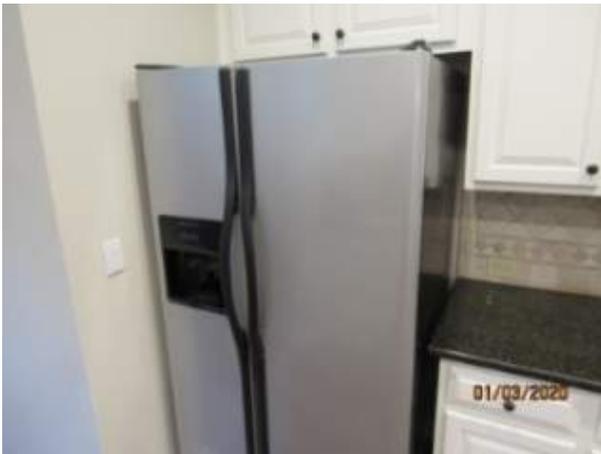
Photo 68-1

Refrigerator appeared to be working at time of the inspection.

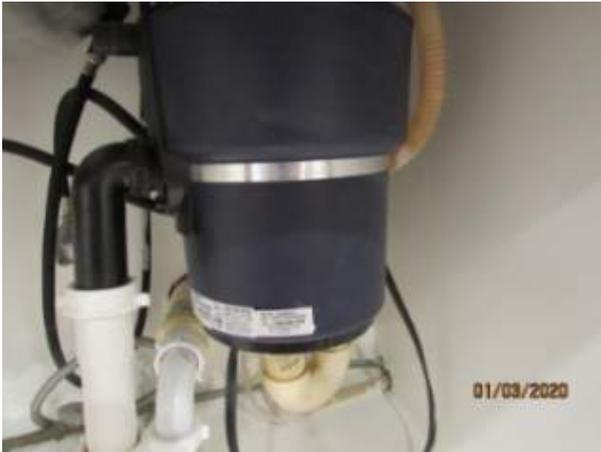
Photo 69-1

General picture of the garbage disposal.

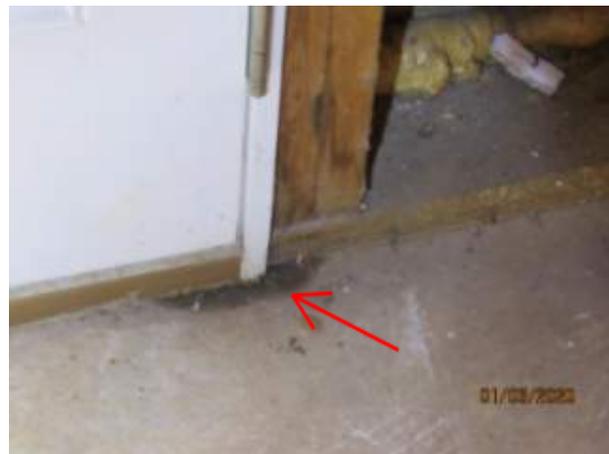
**Photo 71-2**

**71)** 🛠️🔍📍💧 Standing water was found in one or more sections of the basement. Accumulated water is a conducive condition for wood-destroying organisms and should not be present in the basement. A qualified contractor who specializes in drainage issues should evaluate and repair as necessary. Typical repairs for preventing water from accumulating in basements include:

- Repairing, installing or improving rain run-off systems (gutters, downspouts and extensions or drain lines)
- Improving perimeter grading
- Repairing, installing or improving underground footing and/or curtain drains

Ideally, water should not enter basements, but if water must be controlled after it enters the basement, then typical repairs include installing a sump pump.

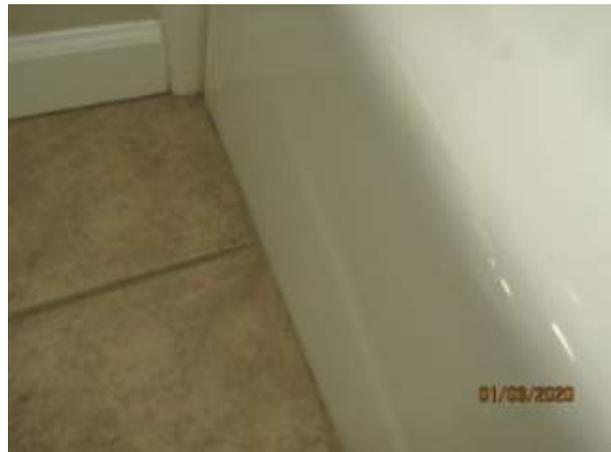
**Photo 79-2**

**79)** 🛠️ ⓘ 💧 Gaps, no caulk, or substandard caulking were found between the bathtub and the floor at location(s) #B. Water may penetrate these areas and cause damage. Recommend that a qualified person re-caulk or install caulking as necessary.

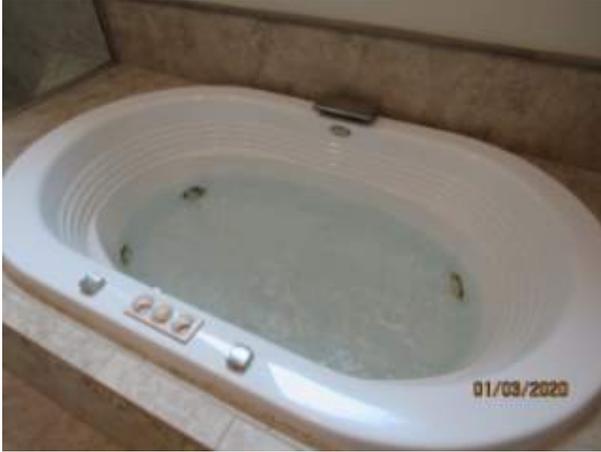
**Photo 82-1**

82) 📌 Jetted tub appeared to be operable at the time of inspection.

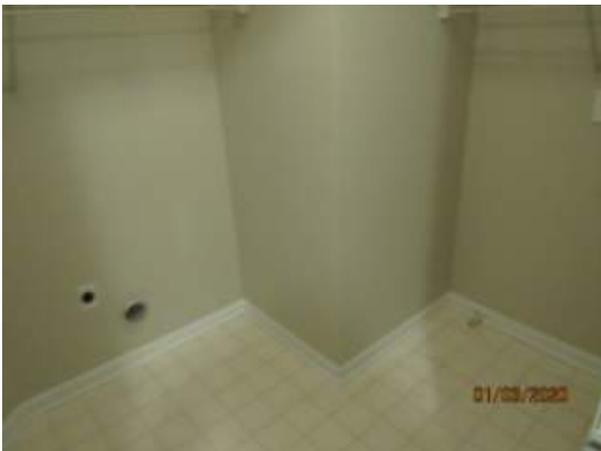
**Photo 83-1**

83) 📌 General picture of the laundry room.

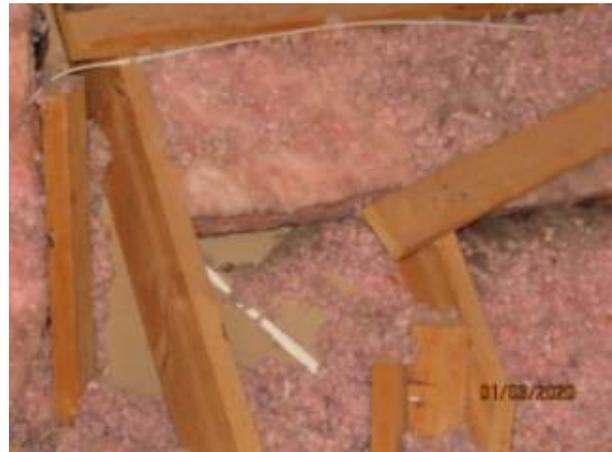
**Photo 87-2**

One or more attic access hatches or doors were not insulated, or had substandard insulation. Weatherstripping was also missing or substandard. Recommend installing weatherstripping and insulation per current standards at hatches or doors for better energy efficiency. For more information, visit: <http://www.reporthost.com/?ATTACC>

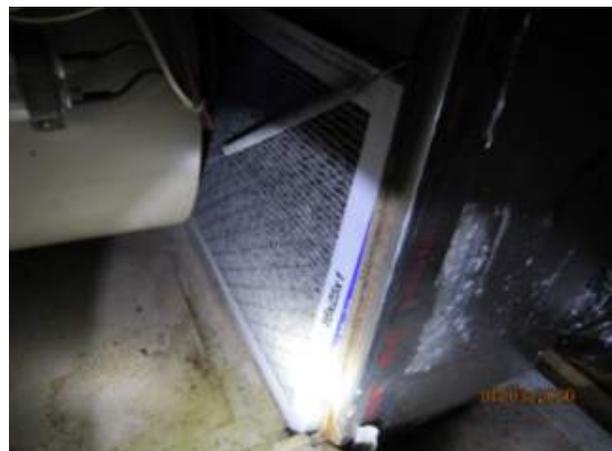
**Photo 92-2**

**92)** 🛠️📄📌📍 Recommend replacing or washing HVAC filters upon taking occupancy depending on the type of filters installed. Regardless of the type, recommend checking filters monthly in the future and replacing or washing them as necessary. How frequently they need replacing or washing depends on the type and quality of the filter, how the system is configured (e.g. always on vs. "Auto"), and on environmental factors (e.g. pets, smoking, frequency of house cleaning, number of occupants, the season).

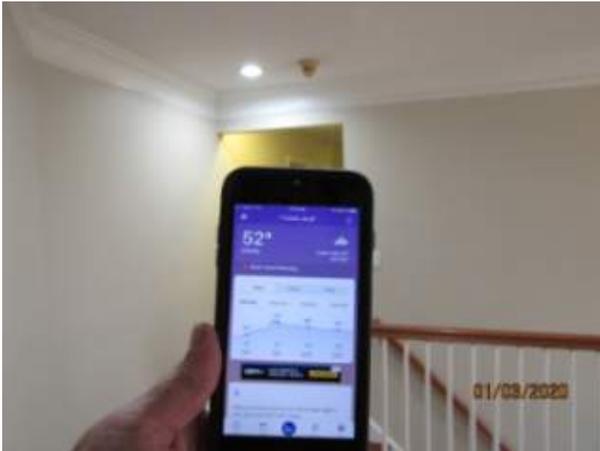
**Photo 94-1**

The outdoor air temperature was below 65 degrees Fahrenheit during the inspection. Air conditioning systems can be damaged if operated during such low temperatures. Because of this, the inspector was unable to operate and fully evaluate the cooling system. Client should consider having the A/C units further evaluated by a qualified HVAC contractor to determine if units will cool properly during a warmer climate.

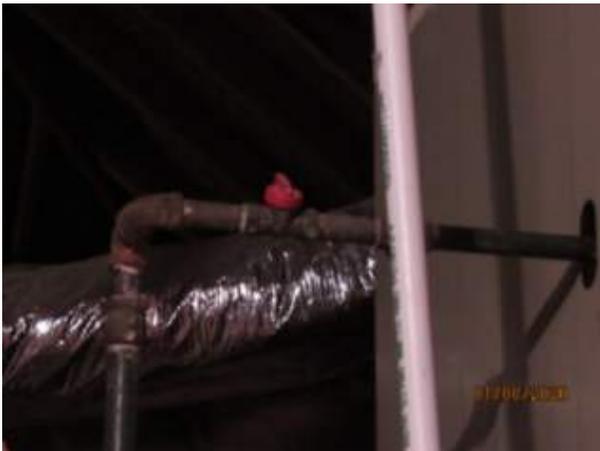
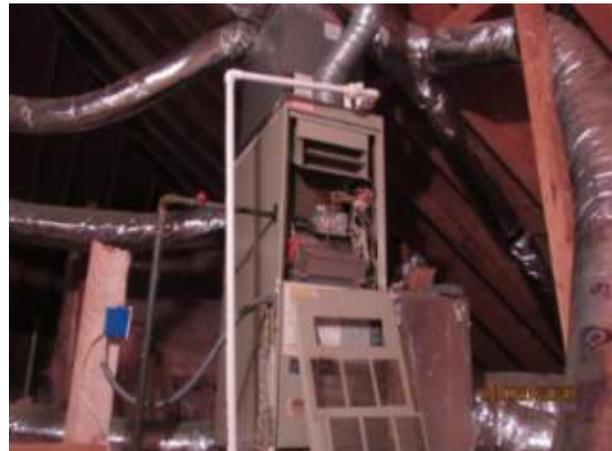
The furnace heating system was not fully evaluated because the gas supply was off. Recommend that a full evaluation be made by a qualified person when conditions have been corrected so the system is operable. Note that the inspector does not operate shut-off valves, pilot lights or circuit breakers, or any controls other than normal controls (thermostat).

Cover to the furnace was laying next to the unit.

Location Attic

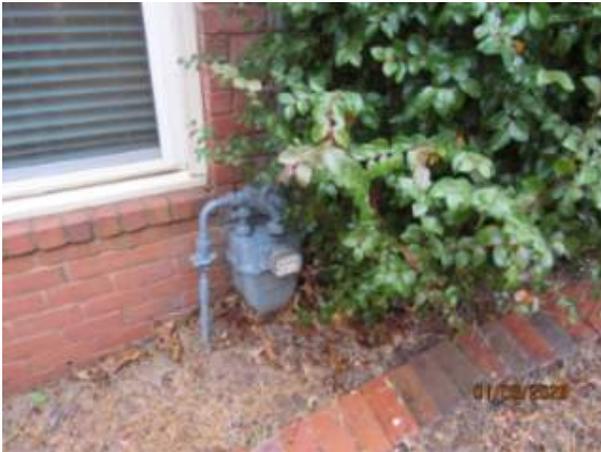
**Photo 107-1**

Location of gas shut off/meter:

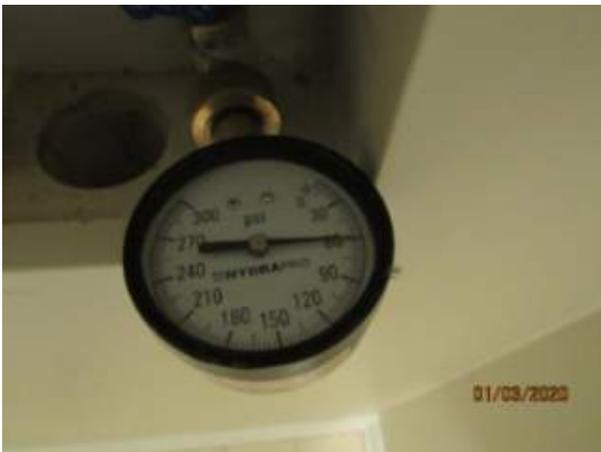
**Photo 108-1**

General picture of water pressure.

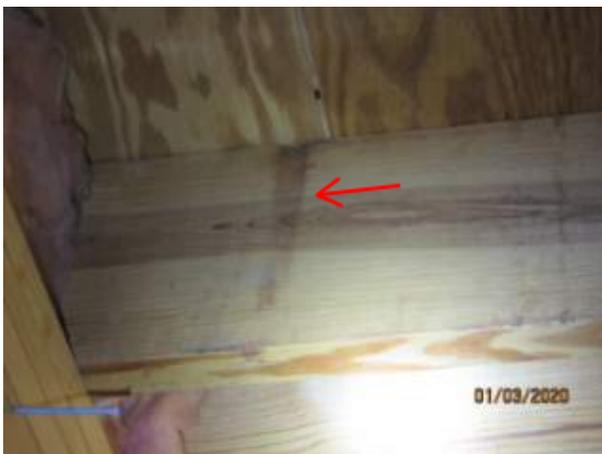
**Photo 109-1**

There appears to be biological growth suspected to be mold in several areas. Mold is caused by trapped moisture.

This inspection does not include mold testing, sampling or inspecting. Therefore, this comment is just a recommendation to have it further evaluated.
