**Report:** 2225-blackheath-trce home inspection

# **Confidential Inspection Report**

## **2225 Blackheath Trce**

**January 9, 2020**

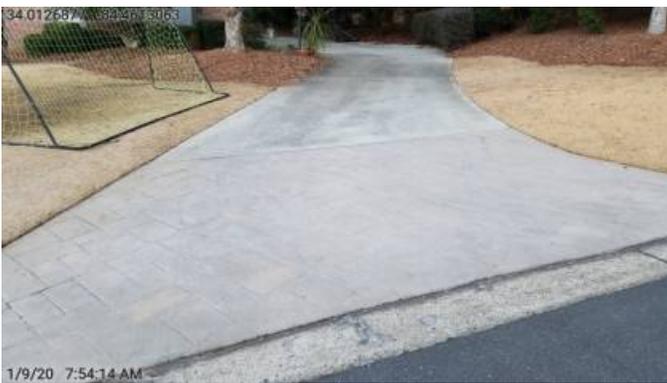
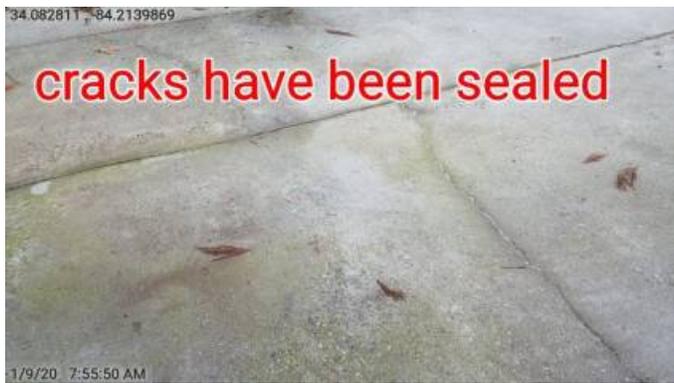
2.1 Driveway: OK MM RR IS  
    The driveway is constructed of: Concrete

Cracks noted are typical. Typical cracks include normal shrinkage of the concrete. Recommend applying a sealant or seal all cracks to prolong service life of the driveway.

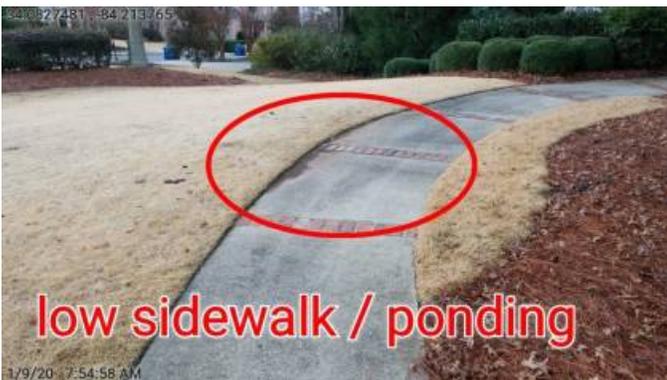
2.2 Walks:     Poor drainage is noted where the elevation of the walk way is below that of the adjacent ground which may cause water to pond on the walk way surface.

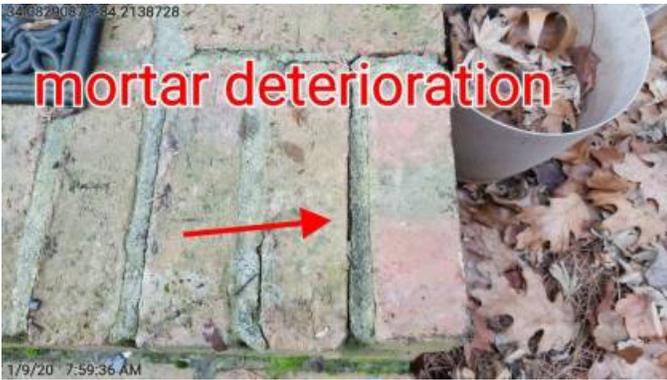
2.5 Exterior Steps: Side Of Home

Mortar deterioration was noted at the steps. Recommend tuck pointing the bricks / stone to help prevent further water penetration and deterioration.

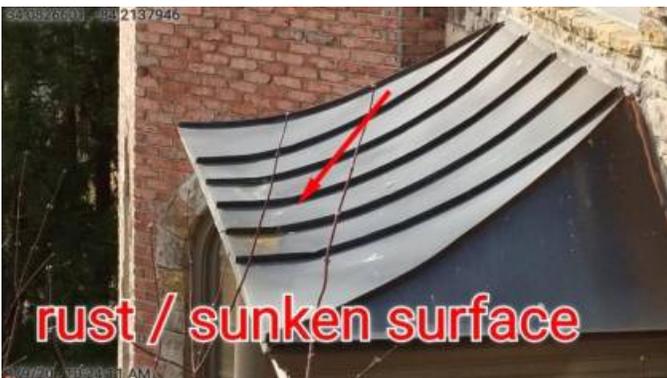
2.7 Cover / Roof:  OK  MM  RR  IS

1. A portion of the front porch metal roof is sunken which prevents complete Watershed from the roof surface. Rust is forming in the sunken areas as a result. Recommend treating the surface of the roof to help prevent further rust and dress the slope to provide for proper Watershed from the roof.

A portion of the front porch metal roof is sunken which prevents complete Watershed from the roof surface. Rust is forming in the sunken areas as a result. Recommend treating the surface of the roof to help prevent further rust and dress the slope to provide for proper Watershed from the roof.

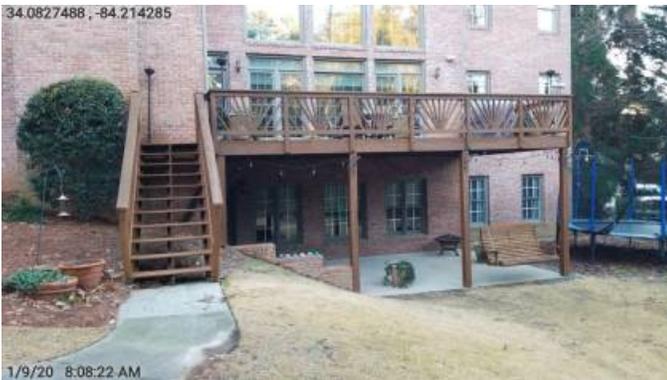
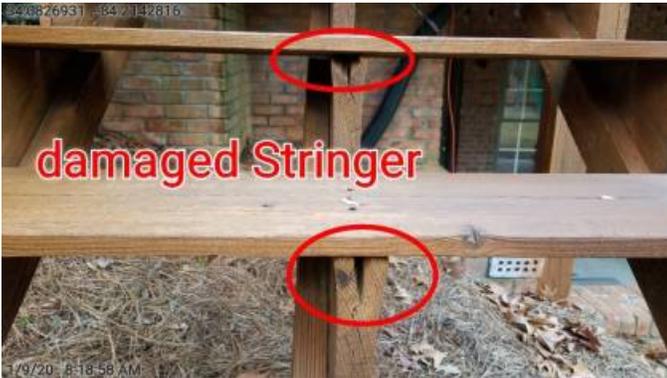
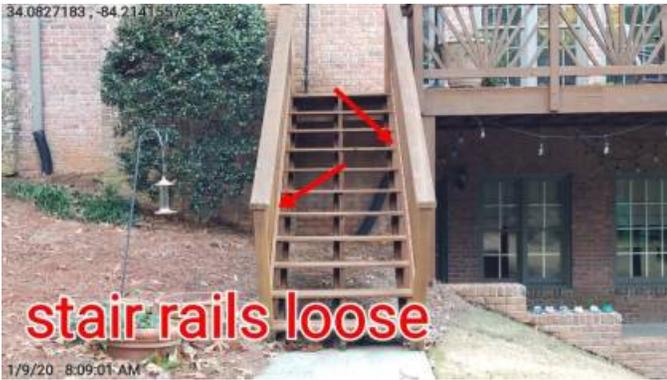
The surface and handrails of the deck are weathered. Recommend treating or re-staining the wood to help prolong the life of the deck.

Damage was noted to one or more sections of the stair stringer. This is an immediate safety hazard as the deck stair treads maybe come loose or unbalanced. Recommend immediate repairs or replacement of the damaged stringers.

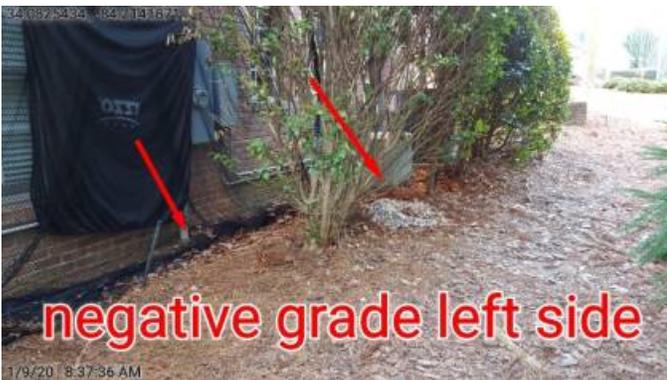
2.9 Site:

3. Grade at the foundation is negative at the left side of the home and front wall of the home. Correction is recommended. Pitch slope of soils away from foundation. Slope should fall away from the foundation at a minimum of 1/2 inch per foot and extend at least 10 feet away from the foundation

Grade at the foundation is negative at the left side of the home and front wall of the home. Correction is recommended. Pitch slope of soils away from foundation. Slope should fall away from the foundation at a minimum of 1/2 inch per foot and extend at least 10 feet away from the foundation

**R401.3 Drainage** - Surface drainage shall be diverted to a storm sewer conveyance or other approved point of collection that does not create a hazard. Lots shall be graded to drain surface water away from foundation walls. The grade shall fall a minimum of 6 inches (152 mm) within the first 10 feet (3048 mm).

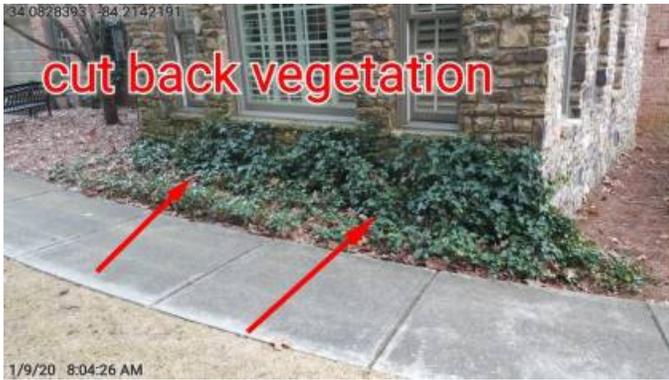
2.10 Condition:

Vines are growing up one or more of the walls on the home. Recommend cutting back the vines as this can cause deterioration to the siding surface.

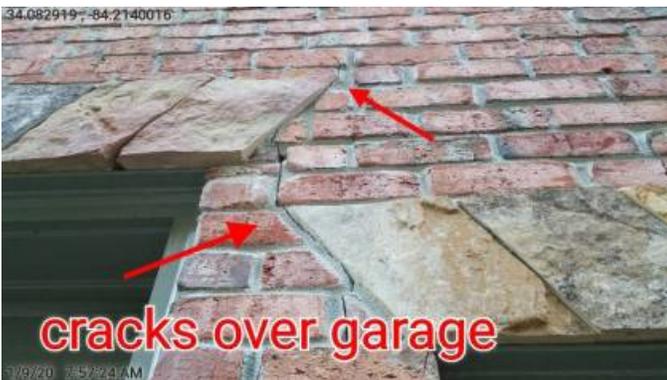
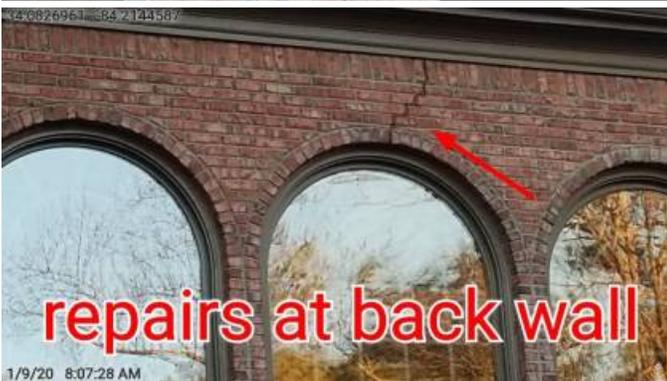
3.2 Materials & Condition:

There was cracking noted in the siding above the garage door. This may be due to settlement of the home and / or relaxing of the support lintel. Recommend further evaluation and repairs by a licensed brick mason and monitor condition.

Repairs were noted to The Brick over the arched windows on the back of the home. The crack appears to be continuing separating after the repairs which would indicate continued settlement. Recommend inquiring with the current homeowners as to the nature of repairs and any warranties that may transfer to the new owners.

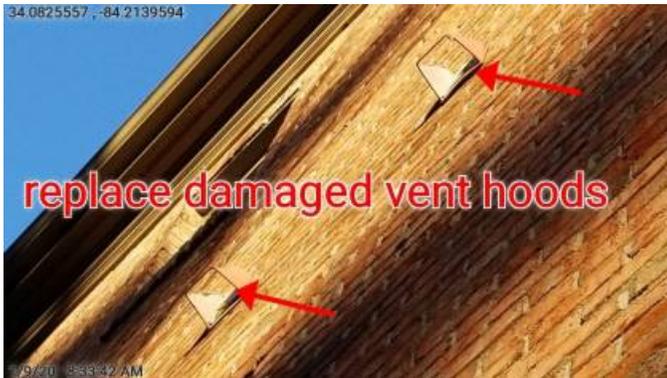
3.3 Flashing & Trim:  OK  MM  RR  IS

The two left side bathroom vent hoods are damaged and allowing water to enter behind the brick veneer. Recommend replacing both of the damaged vent hoods.

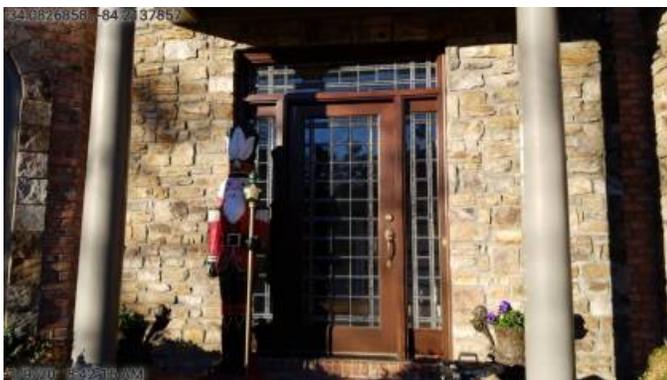
The door sticks or rubs in the door jamb. Recommend adjustments to the door and / or jamb for proper operation of the door.

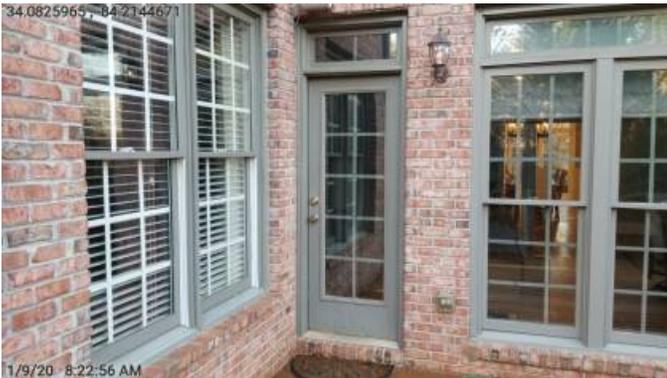
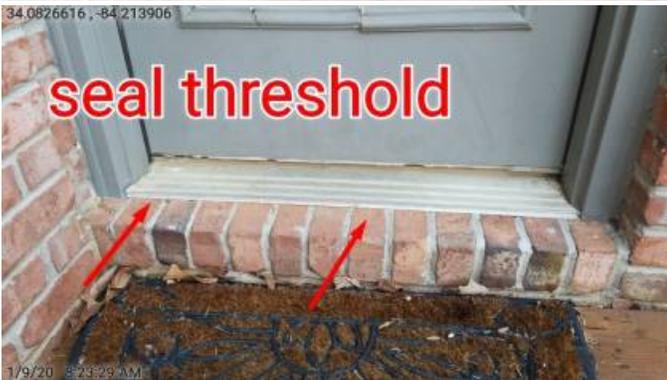
**Rear Entry Door Above Deck:**

The door skin / trim is punctured or broken. It is no longer performing as intended.

The threshold is not sealed at the base of the door. Seal / caulk the base of the front door to help prevent water penetration.

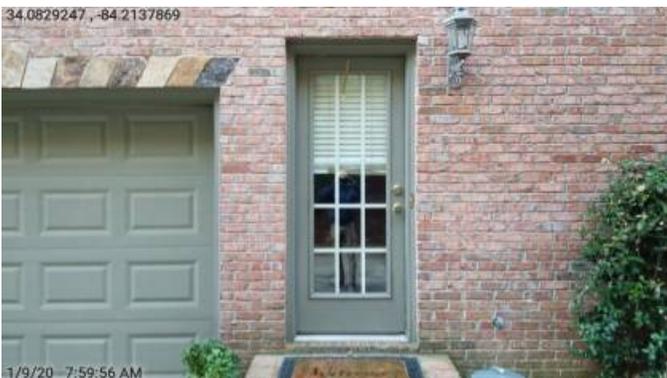
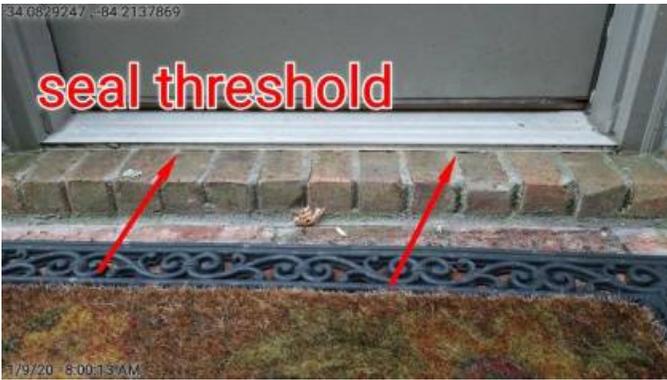
**Right Side Door:**

Water damage was noted at the lower portion of the doorframe. Recommend repairs to the soft spots and repaint to seal the trim and jamb.

The threshold is not sealed at the base of the door. Seal / caulk the base of the front door to help prevent water penetration.

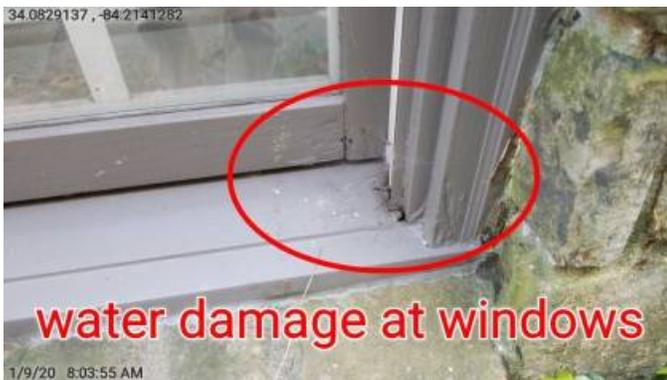
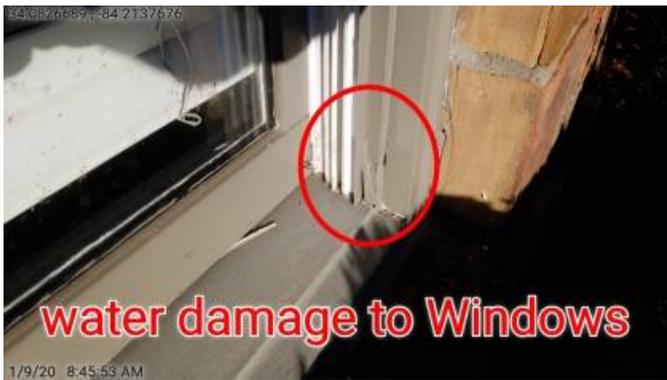
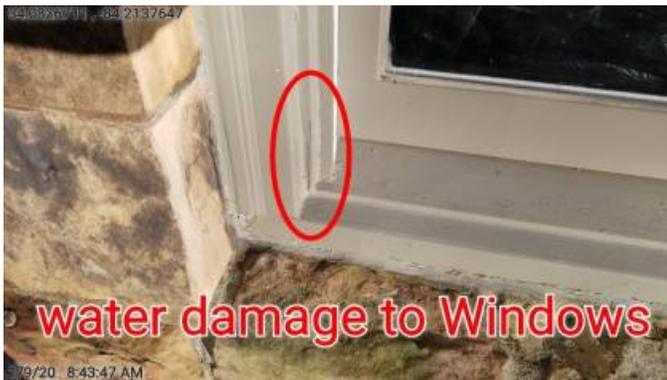
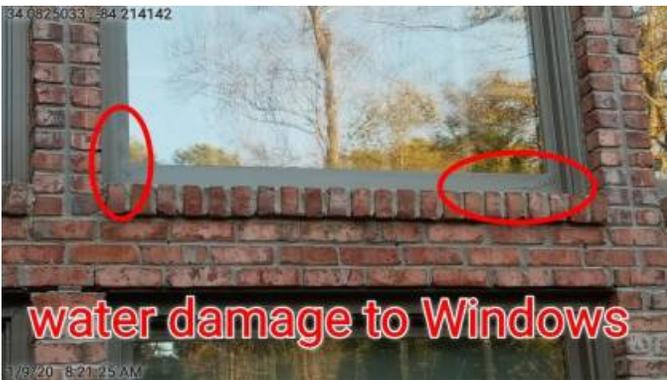
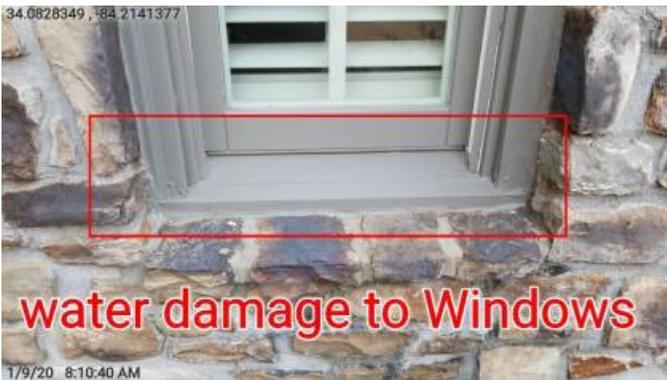
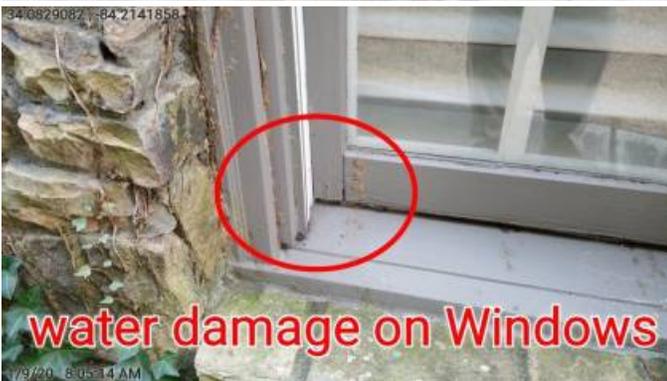
8. Water damage was noted on one or more window(s) around the home. Recommend a licensed contractor repair or replace **all** damaged sections of the windows and / or trim as necessary.

The windows on the brick walls were not caulked or the caulking is deteriorated where the windows are no longer sealed to the brick wall. Recommend caulking around the perimeter of the windows where the window meets the brick to help prevent water penetration.

Water damage noted to one or more shutters around the windows. Recommend repairs or replacement of all affected window shutters.

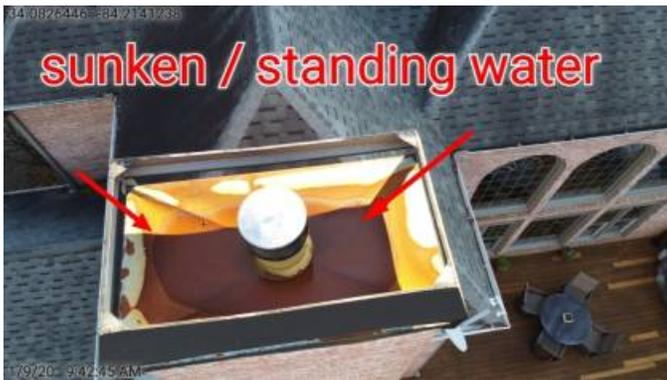
3.16 Chimney Cap:  OK  MM  RR  IS

9. The metal cap is sunken, allowing water to pond on the cap. This allows water to leak down the side of the metal flue. Recommend a chimney contractor repair or replace the sunken cap to properly shed the water from the top of the chimney.

Standing water was noted on the top of the chimney cap due to an indentation in the metal. This will cause rusting and possible failure over time. Recommend adjusting the pitch on the cap to promote water flow off of the cap.

The metal cap is sunken, allowing water to pond on the cap. This allows water to leak down the side of the metal flue. Recommend a chimney contractor repair or replace the sunken cap to properly shed the water from the top of the chimney.

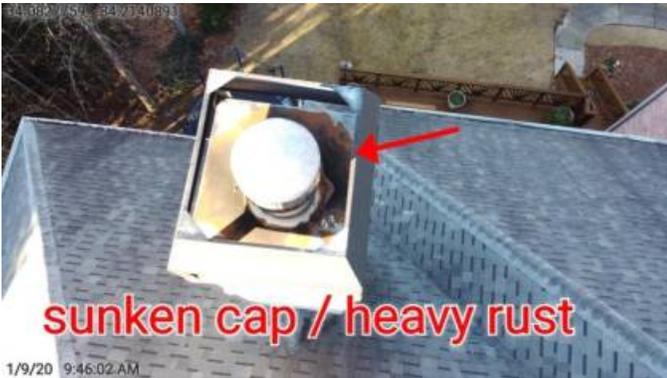
3.21 Chimney Cap:

The chimney cap is heavily rusted. This may indicate standing water (improper slope) and normal aging of the metal cap. This condition is conducive to water leaking into the chimney. Recommend treating the metal cap with an anti corrosive paint to halt the rusting process and ensure there is a proper slope on the cap for correct water management.

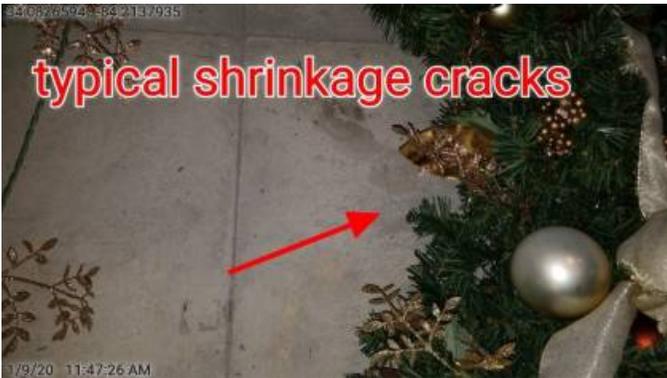
4.2 Foundation Walls:     Foundation wall materials are poured concrete.

Shrinkage cracking was noted on at least one wall. Shrinkage cracking is the result of moisture in the concrete walls evaporating and shrinking. This generally is not a cause for concern as all concrete shrinks. Should any of these cracks begin to grow, then further attention and evaluation would be recommended.

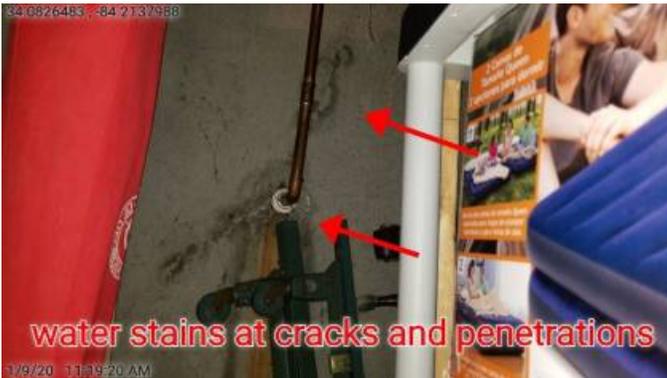
4.3 Moisture:

Staining was observed: Efflorescence and water staining can be seen penetrating one or more cracks or penetrations in the basement and / or crawlspace. Recommend addressing all water management issues around the foundation perimeter to help prevent further water penetration. Further evaluation and repairs may be necessary by a water proofing company. Water seepage may recur in the future. The best defense against water seepage is good drainage of soils near the foundation wall..

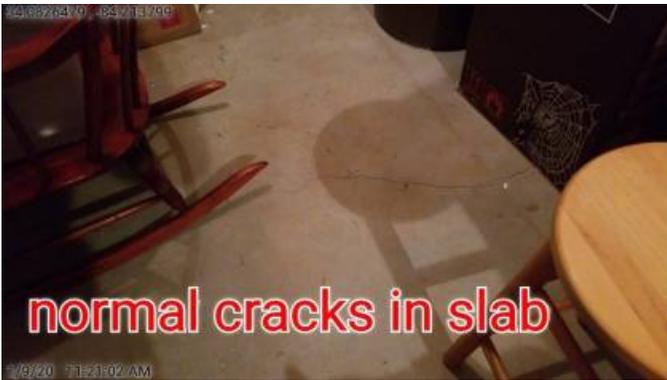
4.5 Floor:

Normal shrinkage cracks were noted in the slab floor. Unless otherwise noted, the cracks appeared to be nothing more than curing cracks. Monitor condition.

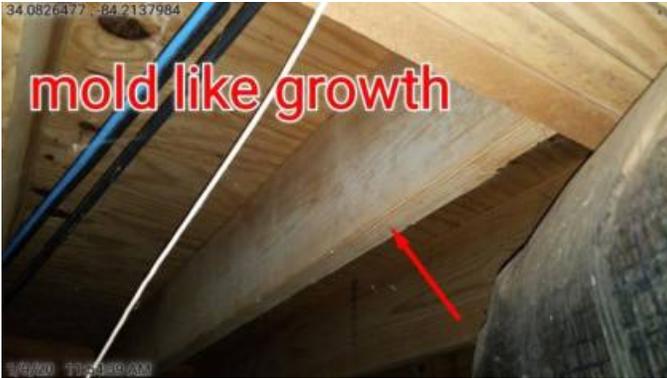
4.8 Moisture:

Mold like growth was noted on the wood framing below the floor and or on the walls in the basement / crawlspace area. This can affect air quality in the home and is normally a result of high moisture levels in the basement / crawlspace. Recommend a mold remediation company treat all affected framing and surfaces.

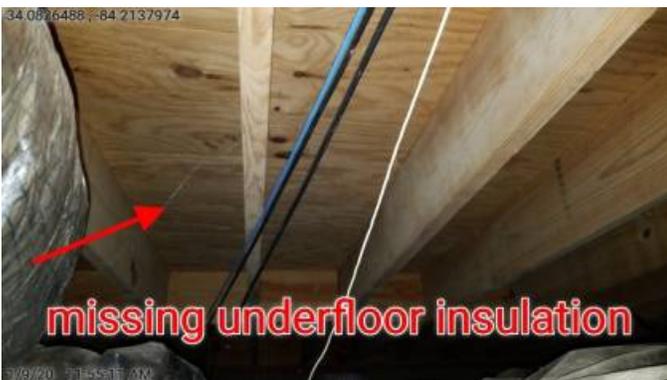
4.10 In Unfinished Areas:

No under floor insulation exists. Under floor insulation is recommend to help improve the homes efficiencies.

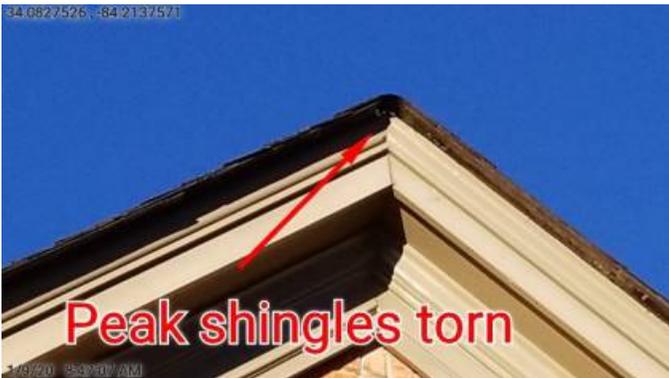
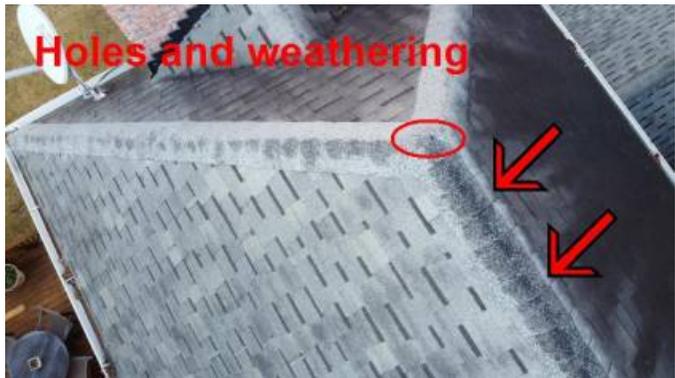
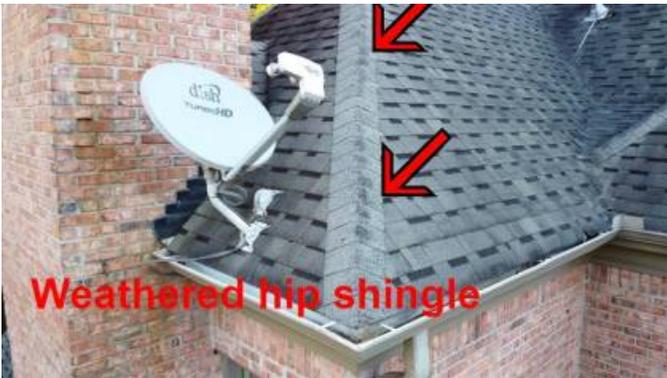
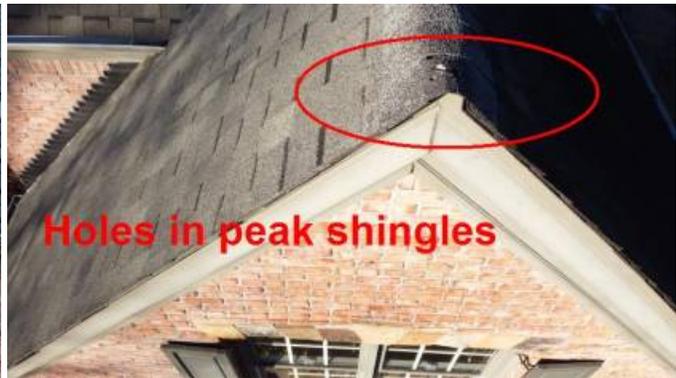
5.4 Roof Covering Condition:

The shingles at the gable ends of the roof ridges are torn. Recommend repairs / replacement of the affected shingles.

Although the roof shingle is a 30 year shingle, the hip and ridge shingles are only 20 year shingles. As a result, these shingles are beyond their design life and showing significant granular loss, tears, and holes in the ends of the ridges. Recommend a licensed roofing contractor replace the hip and ridge shingles to help prevent leaks and further damage.

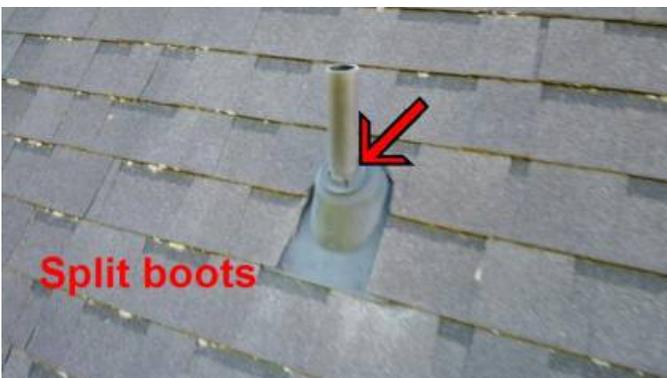
There are exposed nail heads on the top nailed shingles and flashing. Recommend caulking / sealing all exposed nail heads on the roof surface.

The plumbing boots are cracked or deteriorated around the plumbing vents. This is a common cause for roof leaks. Recommend replacing the vent boots.

Rusty flashing is noted. Recommend treating the rusted flashing with an anti corrosion paint to help prevent further rusting and leakage.

Rust and leaks noted on the direct vent stack on the right side above the master bedroom fireplace. Recommend sealing the flashing and corrosion proofing the flue.

There is at least one satellite dish installed on the roof. Bolting the satellite dish to the roof creates a condition conducive to leaks. Regular maintenance will be required to help ensure the attachment point remains water tight. Monitor condition.

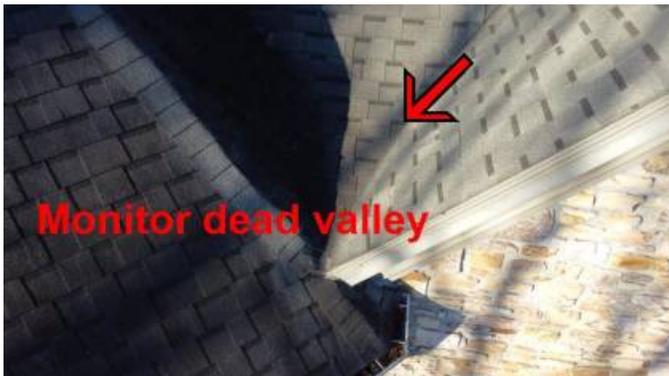
The dead Valley located above the garage or other areas of the roof will be prone to the accumulation of leaves and debris. These areas are also prone to leaks due to the debris buildup. Recommend regular general maintenance going forward in this area to help prevent water back up under the shingles. Monitor closely.

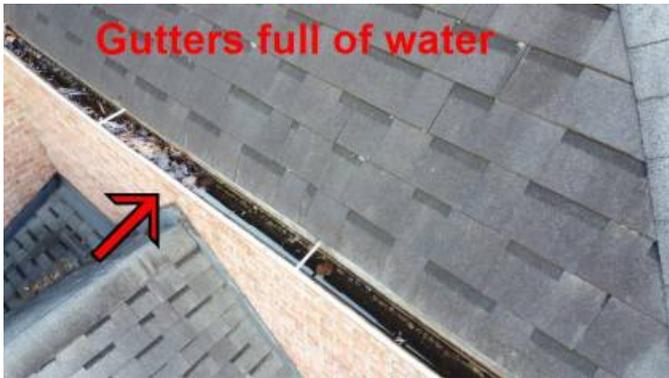
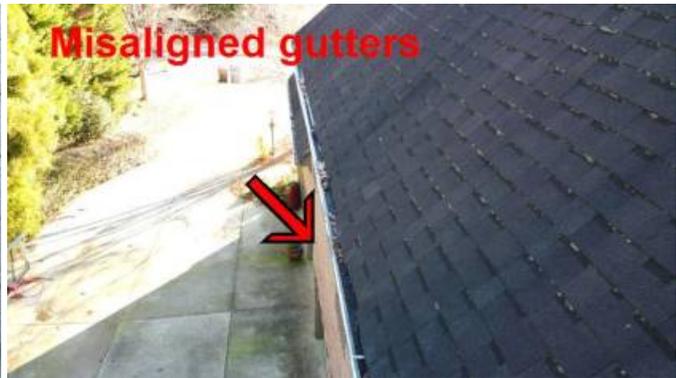
5.10 Type & Condition:

Leaves and debris are built up in the gutter causing the gutters to overflow. Recommend cleaning the gutters on a regular basis. Leaves and Debris in the gutters may conceal rust in the bottom of the gutters.

Gutter is sloped improperly and holding water at one or more elevations around the home. Recommend a licensed gutter contractor re-align the affected gutters to promote water flow to the downspouts and prevent the water over running the gutter system.

There are one or more gutter pins loose around the perimeter of the gutters on the home. This may lead to misaligned gutter and gutter damage. Recommend securing all gutter pins to help ensure a proper slope on the gutters.

Based on the general condition of the gutters at the time of inspection we recommend a qualified gutter contractor perform a routine gutter maintenance on the gutter system. This should include clearing the gutters of debris, properly aligning and securing gutters for correct water flow, sealing all gutters seams, and extending all gutters downspouts where necessary.

Subsurface drains noted, but Not Tested. Blockage by leaves, debris, and roots are common in buried drains. Blockage below ground cannot be visually identified. Recommend having all gutters cleaned on a regular basis including servicing the buried drains to ensure proper water flow away from the foundation. Buried drains are not part of this inspection.

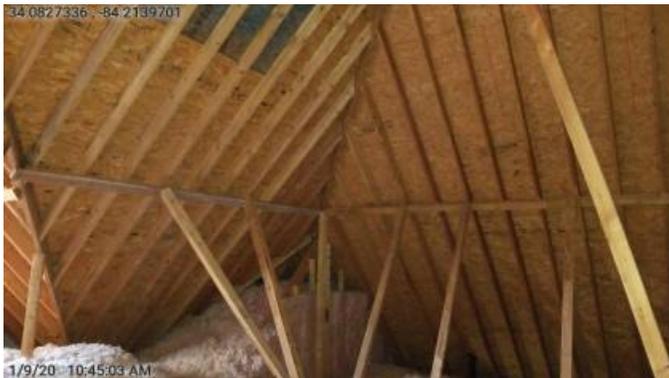
The builder did not install ply clips during installation, which may result in sagging at the joints of the sheathing.

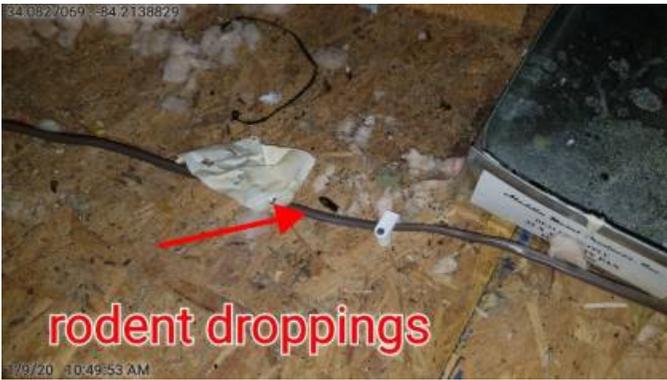
5.14 Wild Life:

There are signs of current or previous squirrels / rodents / pests living in the attic. Recommend employing the services of a pest management service to rid the attic of animals.

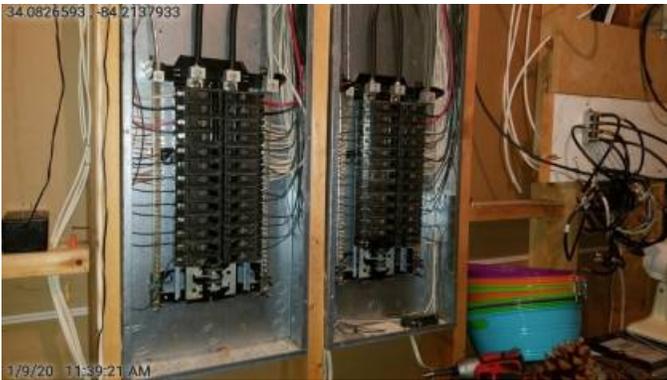
6.6 Main Panel Observations: OK  MM  RR  IS

More than one neutral wire in the panel has been connected to a single termination screw where only one wire should be connected. Recommend a licensed electrician install each neutral wire on a dedicated terminal screw. **Please reference NEC 408.41**

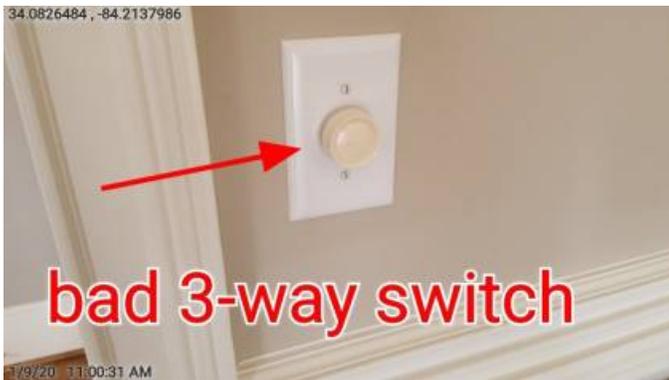
The three way switch in this room is not functional. You should be able to turn the light on and off at either switch. Recommend a licensed electrician re-wire the circuit to operate properly.

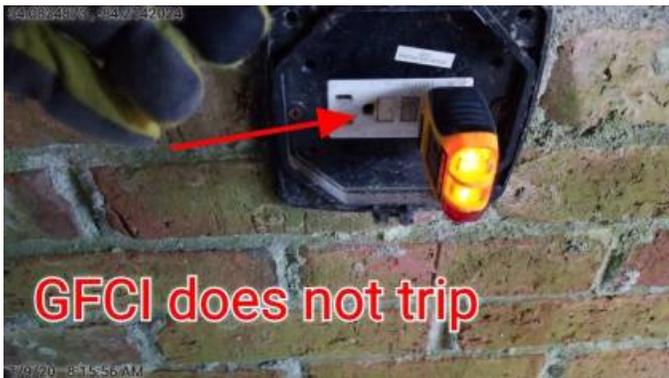
There is one or more outlet cover which is damaged. Recommend replacing the affected exterior outlet covers to protect the electrical outlet from the elements.

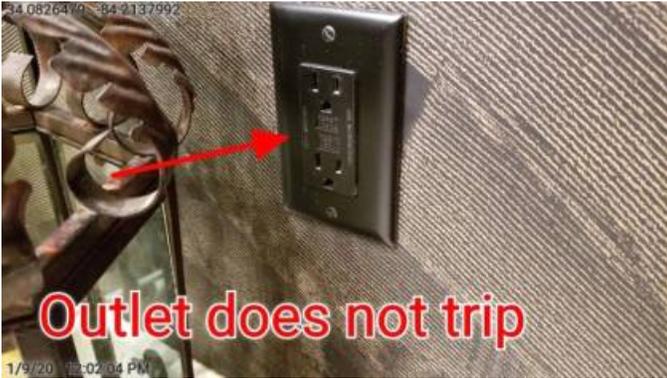
6.23 Basement Bath:	<input type="checkbox"/>	<input type="checkbox"/>	<input checked="" type="checkbox"/>	<input type="checkbox"/>	GFCI was not operational. Recommend a licensed electrician re-wire or replace the affected outlets.

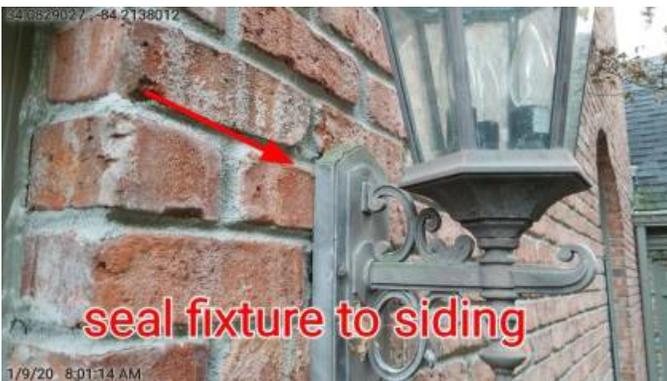
6.24 Exterior Walls:

The exterior light fixtures are not caulked / sealed to the home allowing water to run behind the fixture and siding. Recommend caulking around the light fixtures to prevent water penetration.

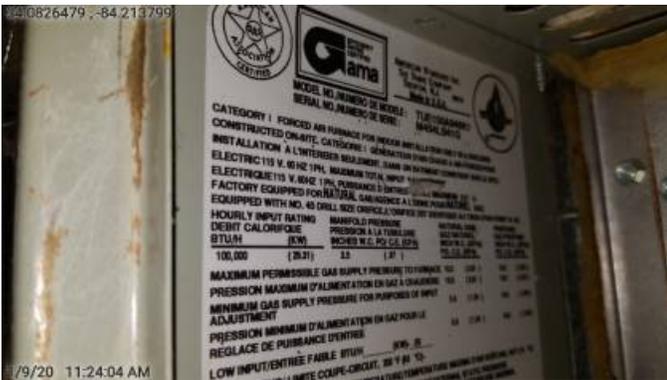
7.3 Capacity / Approx. Age:  OK  MM  RR  IS Mid efficiency furnace, Brand: Trane brand  
 Manufacture Date- 1997.

The typical service life for a forced air natural gas furnace / heat pump is 18 - 20 years. The advanced age and / or condition of this unit is such that you will likely need to replace it in the near future.

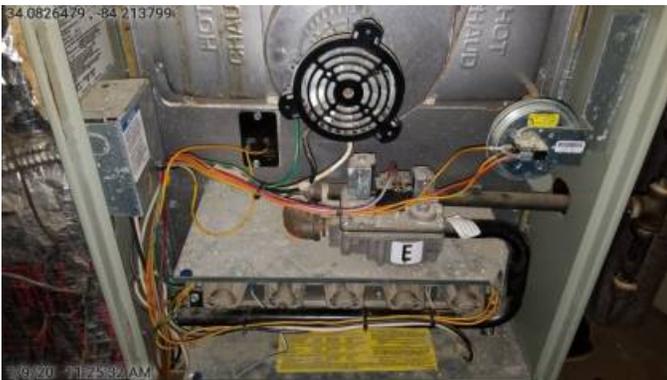
7.4 General Operation & Cabinet:  OK  MM  RR  IS No condensate overflow pan is provided. The possibility of damage to building materials from condensation formation or leakage is present below the blower unit .

Furnace is an older unit that has a very limited service life.

The system lacks general maintenance. Suggest cleaning / servicing burner compartment, blower motor, evaporator coil, pilot light, vent system and burners. Clear / service all condensation lines. Additionally, we recommend cleaning the duct work for improved indoor air quality.

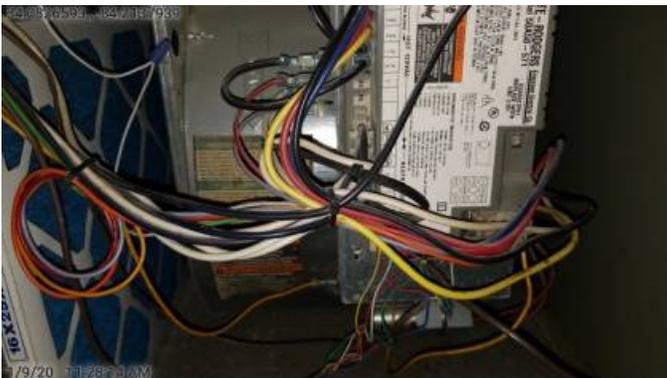
System lacks cleaning. Fan compartment is dirty. Recommend an HVAC technician service / clean the unit for improved efficiencies.

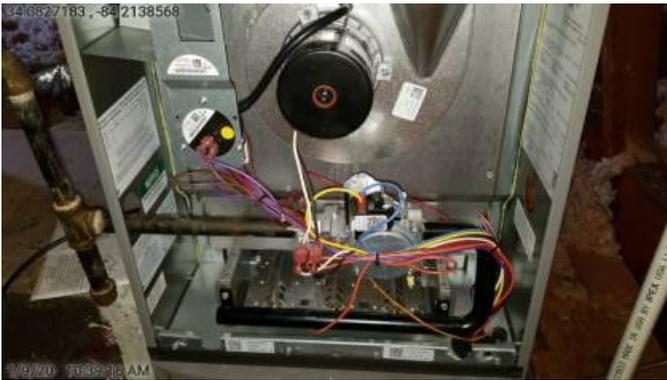
Missing the junction box and / or junction box cover located inside the burner compartment. All wire splices should be enclosed in an appropriate junction box. Recommend repairs by a licensed electrician.

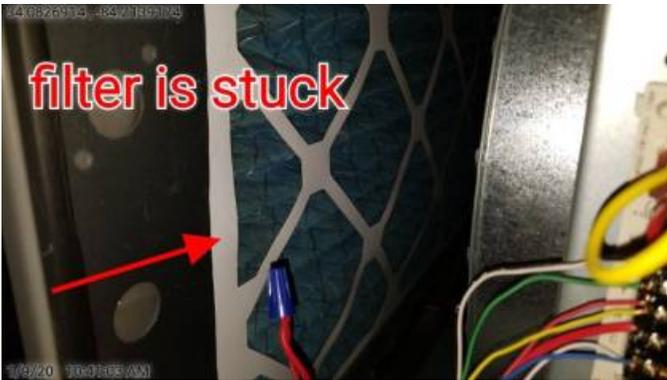
The filter is stuck in the HVAC system. Recommend removing the stuck filter and replacing with the appropriate size. Adjustments to the filter cabinet may be necessary.

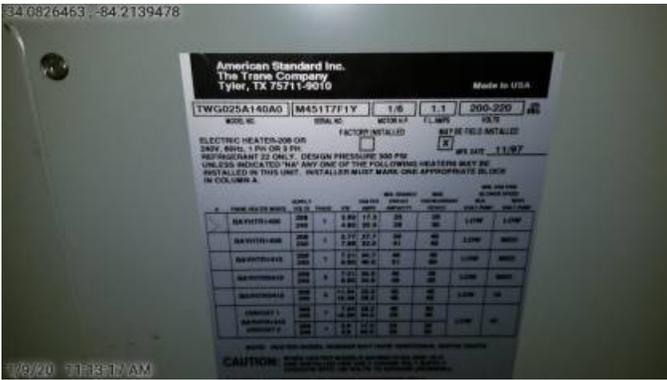
Manufacture Date- 1997.

The typical service life for a forced air natural gas furnace / heat pump is 18 - 20 years. The advanced age and / or condition of this unit is such that you will likely need to replace it in the near future.

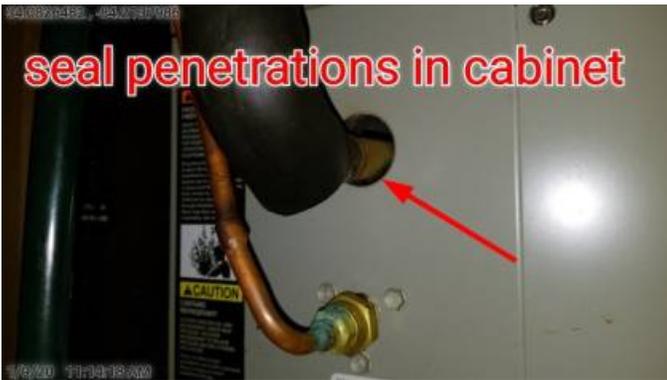
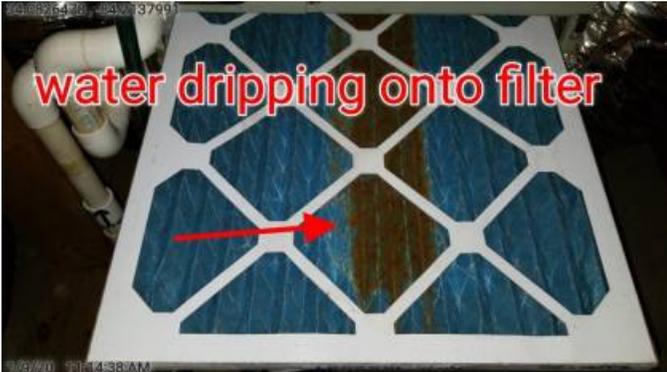
7.24 General Operation & Cabinet:  OK  MM  RR  IS

No condensate overflow pan is provided. The possibility of damage to building materials from condensation formation or leakage is present below the blower unit .

Recommend sealing around the penetrations in the cabinet to help prevent air leakage and improve the efficiency of the unit.

There is evidence of water dripping down through the basement air handler has the filter at the bottom of the system is water-stained. This would be a symptom of a condensation backup or problem with the evaporator coil. Recommend further evaluation and Repairs by a licensed HVAC technician.

Furnace is an older unit that has a very limited service life.

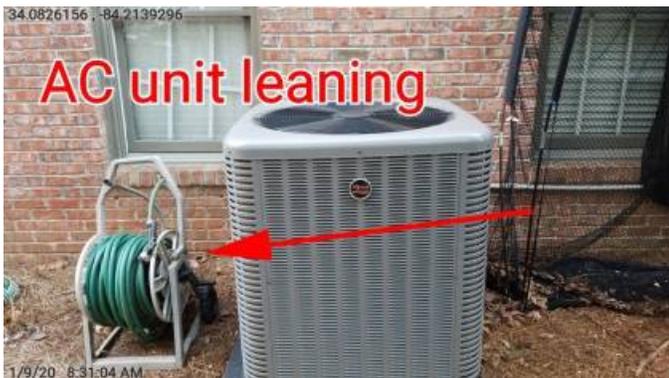
7.32 System Condition:

The unit is leaning due to erosion around the base of the AC pad. Recommend leveling the unit for efficient operation.

The insulation on the refrigerant lines that runs through the attic space is damaged and or missing in sections. Recommend repairing all breaks in the line set insulation to prevent condensation from dripping onto the ceilings below.

It is suspected that the insulation on the refrigerant line is damaged inside the wall where it travels from the attic to the left side wall. This is evidenced by water staining on the wall in the back left first floor bedroom. Recommend further evaluation and repairs by a licensed HVAC technician.

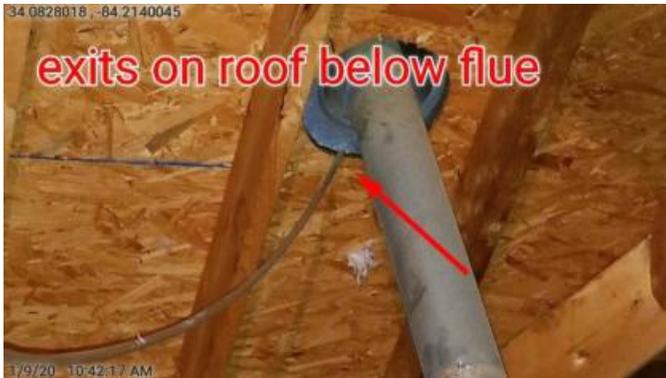
7.33 Condensate Line: OK MM RR IS

The condensation from the attic unit is pumped to a penetration in the roof around the dryer vent. This is an improper installation as the flexible condensation line may be pinched underneath the flashing, preventing the water to discharge correctly. This may result in water backing up into the attic. Recommend a licensed HVAC technician properly route the condensation line to the exterior of the home in an appropriate manner.

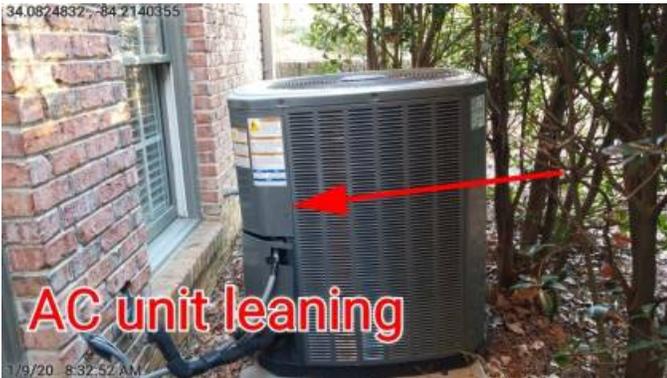
7.37 System Condition:                   OK   MM   RR   IS

The unit is leaning due to erosion around the base of the AC pad. Recommend leveling the unit for efficient operation.

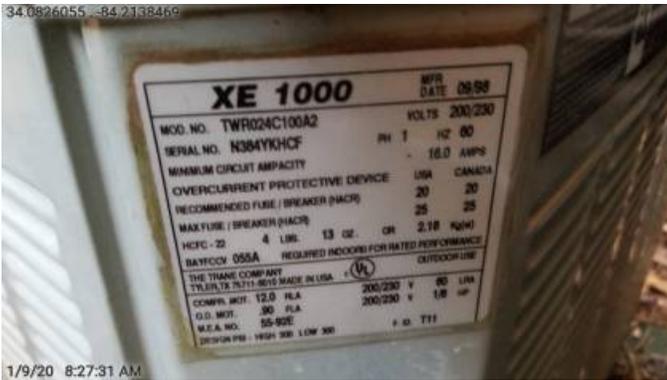
2.0 Tons, Max Fuse: 25 amps, Brand, Trane brand, Manufacture Date- 1998.

Typical life span of an electric AC compressor is approximately 15 years. This unit is beyond its intended design life. Budget for replacement in the near future.

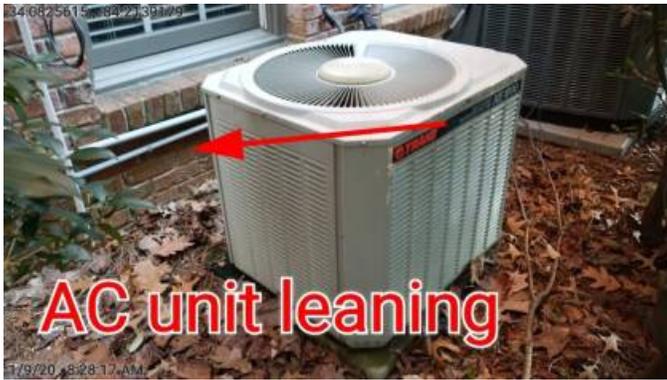
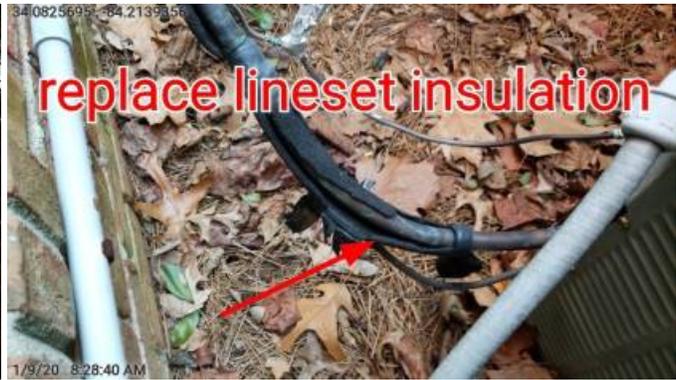
7.42 System Condition:

The unit is leaning due to erosion around the base of the AC pad. Recommend leveling the unit for efficient operation.

The insulation on the exterior refrigerant lines is deteriorating. Recommend replacing the insulation.

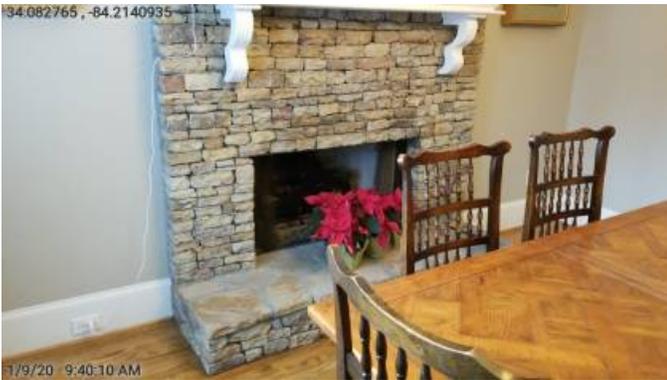
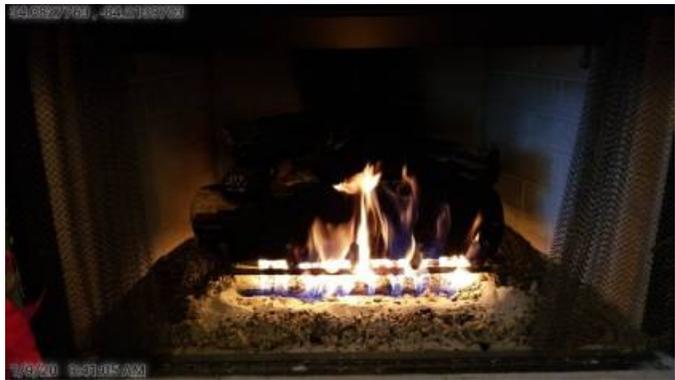
7.47 Master Bedroom:                           The fireplace is a factory made prefabricated metal installation.  
 Fuel Type: Gas - The fireplace is designed to use gas fuel only and the gas is vented through a direct vent.  
 Water staining was noted at the top of the firebox around the flue. This may be an indication of water leakage around the flue and chimney cap. Recommend a licensed chimney specialist further evaluate and make any repairs necessary to the chimney cap to help prevent future water penetration.  
 The tilt up door to the starter is difficult to operate between the two stone sides of the fireplace. Minor modifications may be necessary for proper operation.

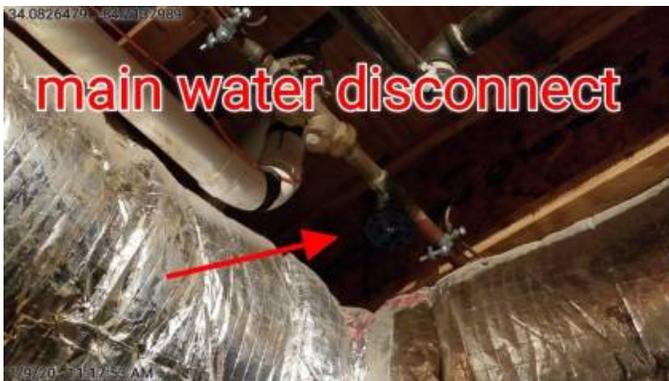
| 8.1 Shut Off: | <input checked="" type="checkbox"/> | <input type="checkbox"/> | <input type="checkbox"/> | <input type="checkbox"/> | Water meter is located in the front yard. |
| | | | | | Main shutoff valve is located in the basement |

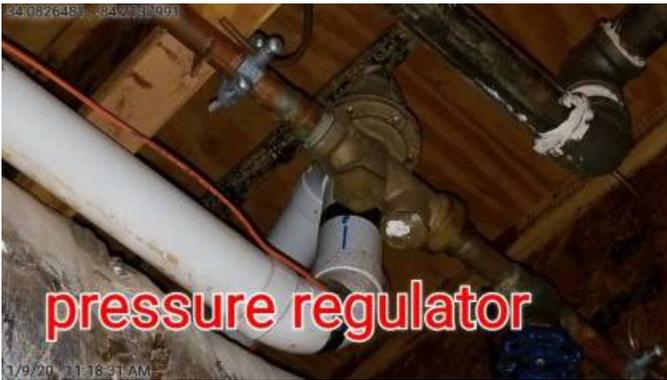
8.3 Pressure Regulator:      OK   MM   RR   IS

There is a water pressure regulator valve correctly installed. This allows adjustment of the incoming water pressure.

Water pressure was over 80 pounds per square inch and is considered excessive. Recommend adjusting the pressure on the system to below the 80 pound maximum. This may require the adjustment of the pressure regulator or replacement of a defective pressure regulator.

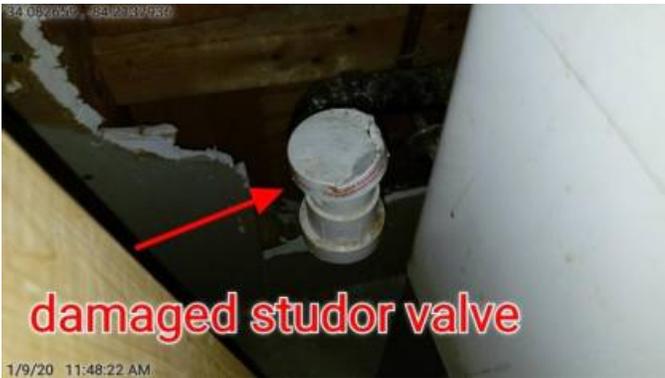
There is a damaged Studor valve to the left of the basement sink. Recommend a licensed plumbing contractor replace the damaged valve.

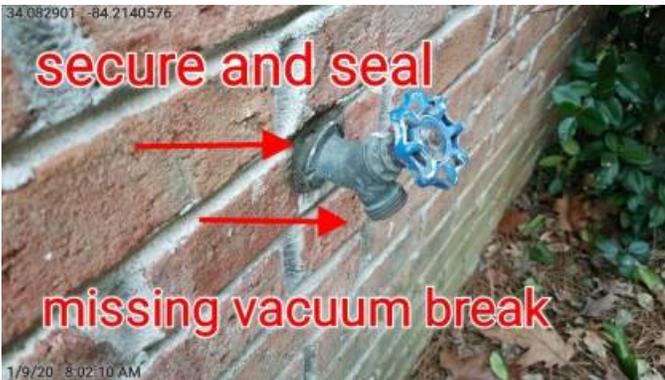
8.9 General:     There is at least one hose bib missing the vacuum break (backflow device).  
There are gaps noted around one or more of the water faucets around the exterior of the home. Recommend securing and sealing the faucet to the wall to prevent water penetration behind the siding system.

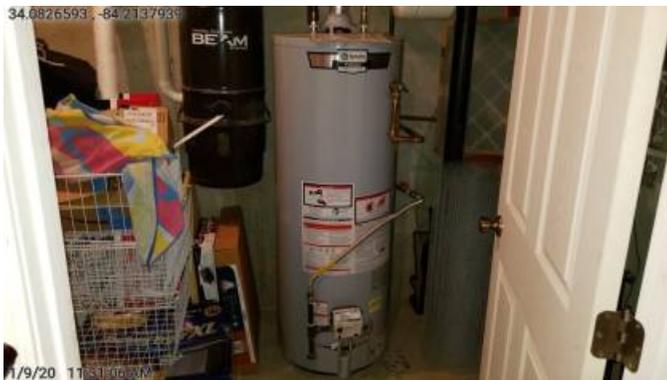
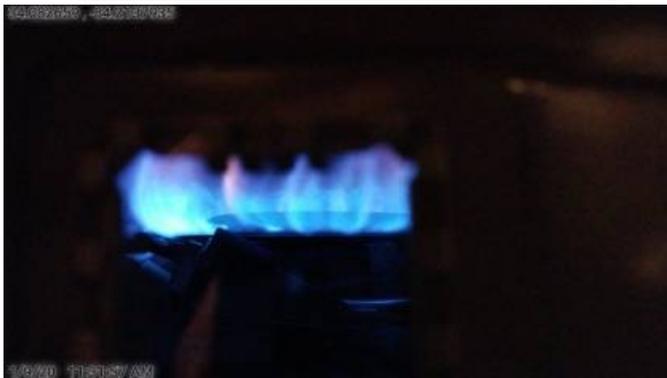
8.12 Condition:

The water heater is missing the overflow pan below the unit. Recommend installing an overflow pan in case of a leak on the water heater or other plumbing emergency.

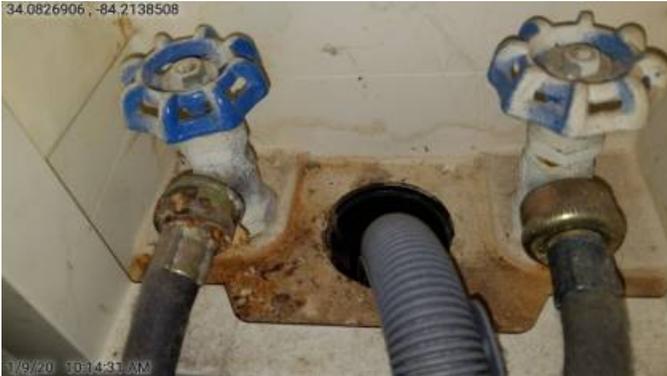
8.18 Laundry: OK MM RR IS

There is a connection box installed in the wall with both hot and cold water and a drain pipe. The drain pipe was not flood tested.

Previous leak noted. Monitor condition.
