**Report:** 2225-blackheath-trce home inspection

# **Confidential Inspection Report**

## **2225 Blackheath Trce**

**January 9, 2020**

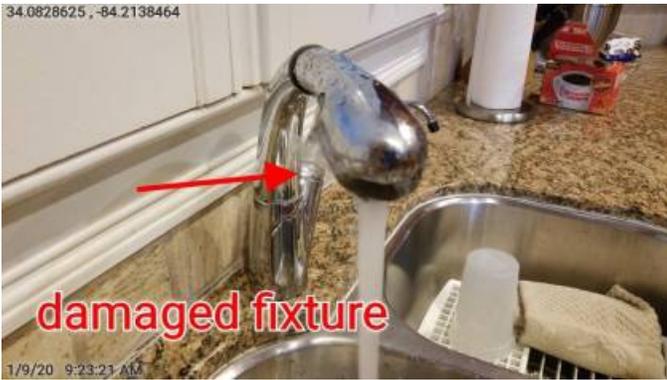
9.3 Kitchen Sink Fixture & Lines: OK MM RR IS  
    The kitchen faucet is damaged and leaking around the sprayer head. Recommend a licensed plumbing contractor replace the fixture.

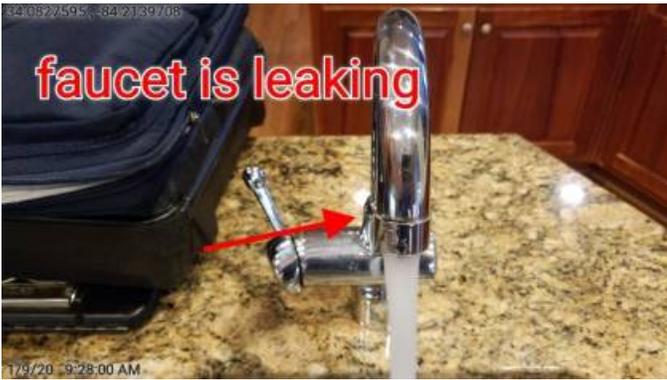
9.4 Kitchen Sink Fixture & Lines: *Kitchen Island*

There is a small leak at the faucet spout. Recommended Repairs by a licensed plumbing contractor.

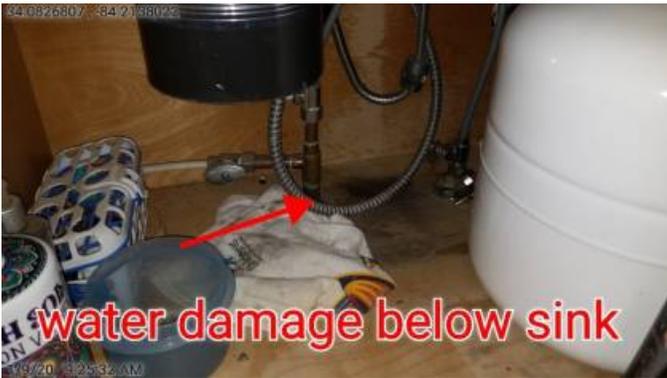
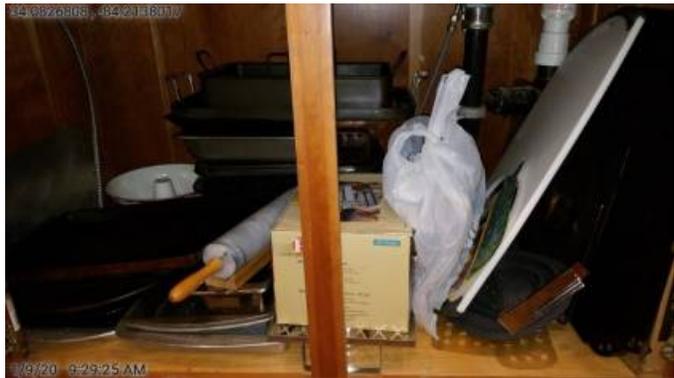
9.7 Kitchen Sink Cabinet /  
Countertop:

Water damage was noted to the cabinet floor below the sink. This is from a previous or ongoing water leak below the sink.

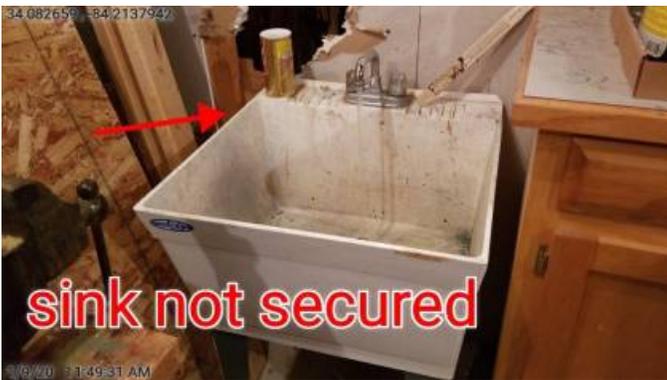
OK	MM	RR	IS	
10.1 Basement:	<input type="checkbox"/>	<input checked="" type="checkbox"/>	<input type="checkbox"/>	<input type="checkbox"/>	The sink or pedestal is not secured to the wall and / or floor. Recommend properly securing the sink to minimize movement which may lead to leaks in the future.

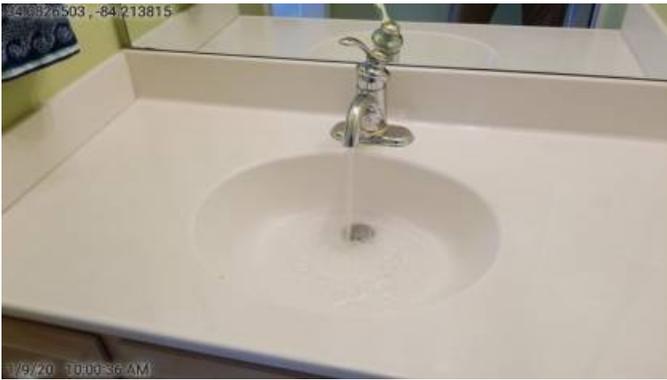
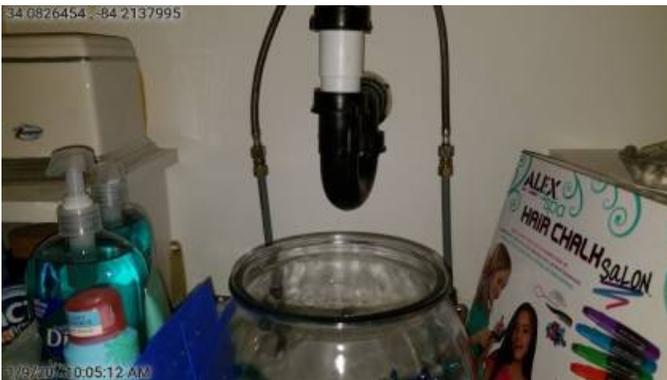
10.3 Jack & Jill Bath:

The stopper is missing in the sink. Recommend the stopper and all hardware be replaced for proper operation of the sink.

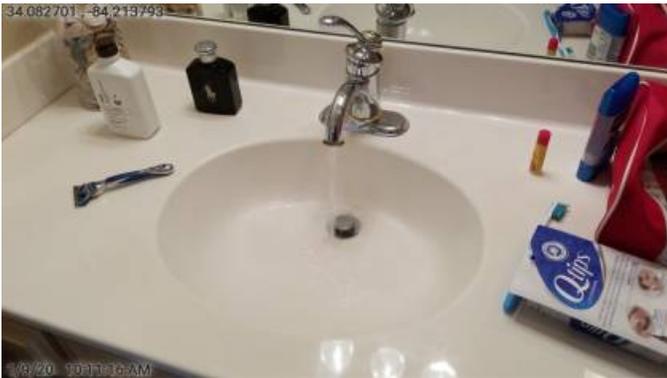
10.5 Guest Bath:

Recommend cleaning / clearing the faucet aerator for improved stream of water.

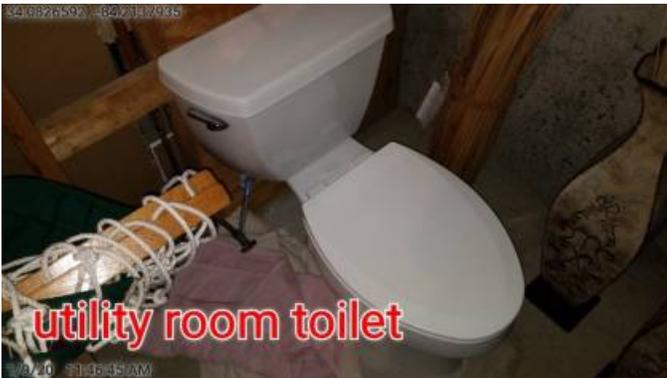
Water was off to the toilet installed in the utility room. Not tested for operation or drains.

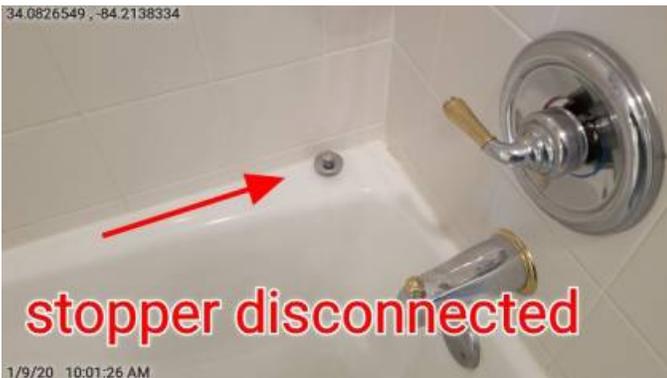
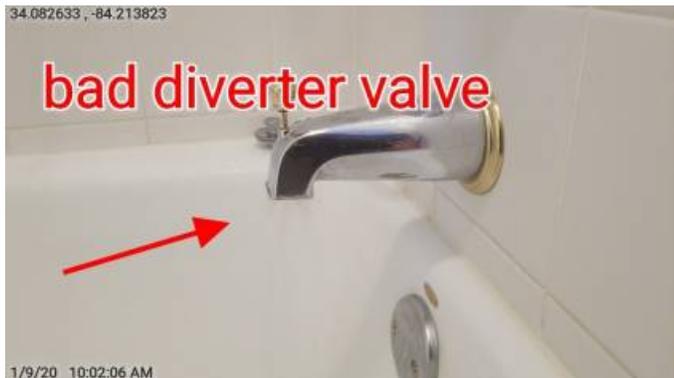
The diverter valve does not properly divert all the water to the shower head. Recommend a licensed plumber evaluate and make necessary repairs.

The stopper in the tub has been disconnected. Recommend re-installing the stopper for proper operation.

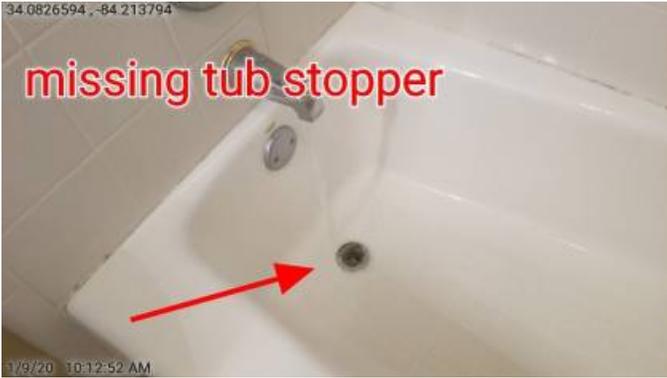
10.16 Guest Bath:

Missing the tub stopper. Recommend replacing the stopper with the properly sized tub stopper for proper operation.

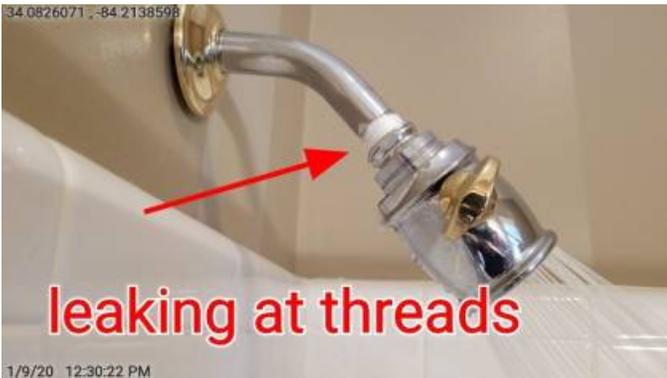
10.17 Guest Bath: First Floor

The shower head is leaking where the shower head screws onto the plumbing pipe. Recommend re-taping the threads to prevent further leaking.

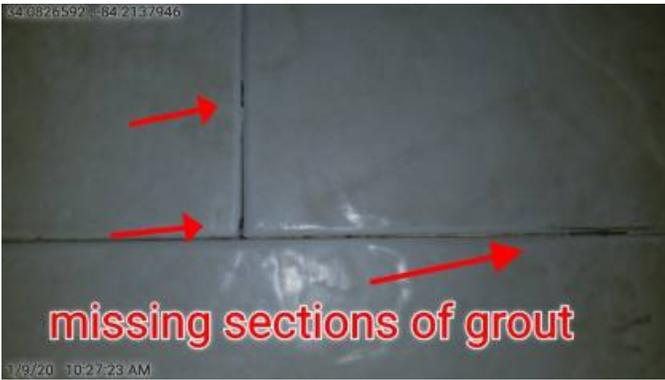
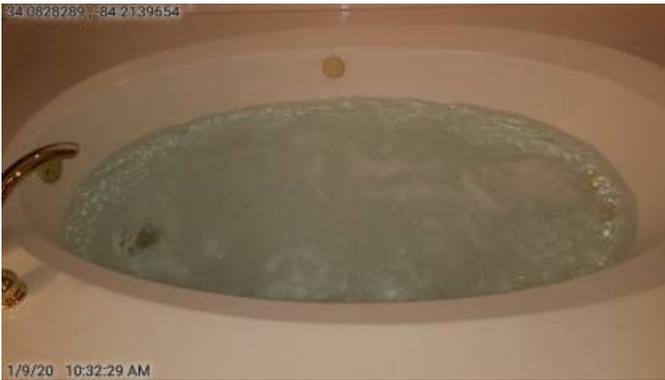
Missing sections of grout noted in the shower and / or bath surround. Recommend re-grouting to help prevent water penetration behind the shower surround.

Repairs were noted to the shower pan tile around the drain. Caulking is only a temporary repair and does not provide for a permanent solution. Recommend inquiring with the current homeowners as to the nature of the repairs and any previous leaks as a result of the shower pan condition prior to repairs.

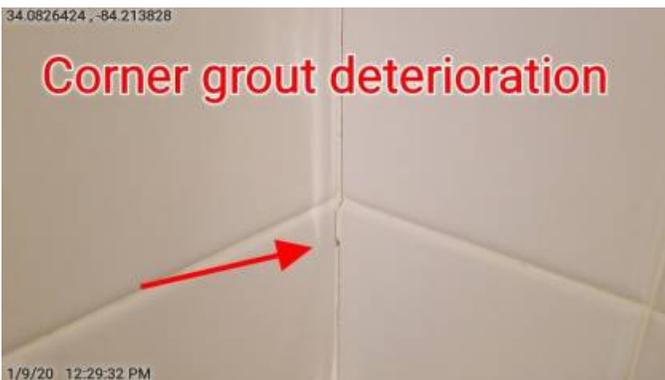
10.22 Guest Bath: First Floor

OK  MM  RR  IS  The grout in the corners of the shower is deteriorating. Recommend repairs / re-grouting to the corner.

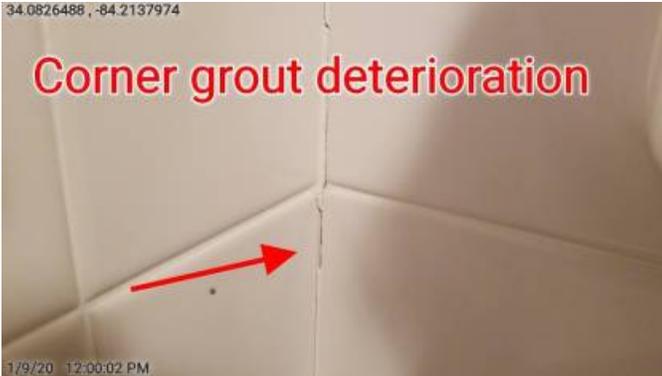
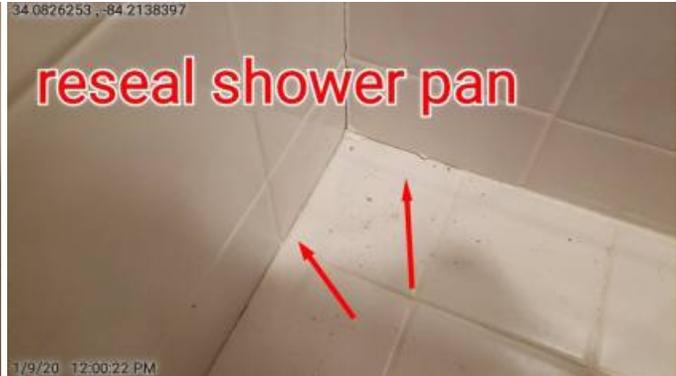
10.23 Basement Bath:

The grout in the corners of the shower is deteriorating. Recommend repairs / re-grouting to the corner.

The caulk / grout around the top perimeter of the shower pan is deteriorated and could lead to water leaks. Recommend caulking the perimeter of the shower pan to prevent future leaks.

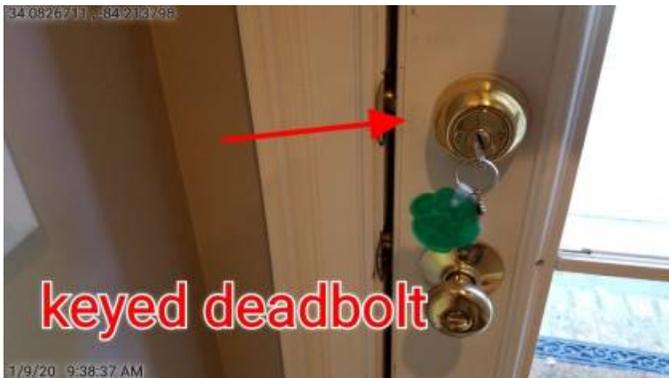
11.1 Overall Door Condition:      OK   MM   RR   IS

One or more exterior door(s) are double keyed meaning the dead bolt requires a key to unlock the door from inside the home. This is considered a safety hazard in the event of a fire when ease of exit is essential. Recommend installing lockable thumb turn dead bolts as a fire safety measure.

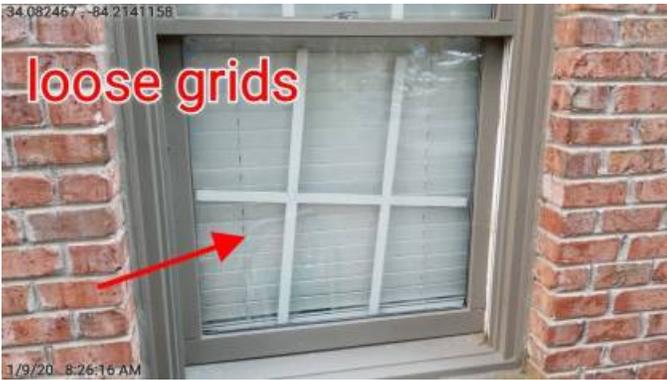
11.2 Overall General Type & Condition:

One or more of the plastic magnetic latches for the blinds is broken. Recommend replacing the magnetic latching Hardware.

Many of the decorative grids in the windows are loose or missing throughout the house.

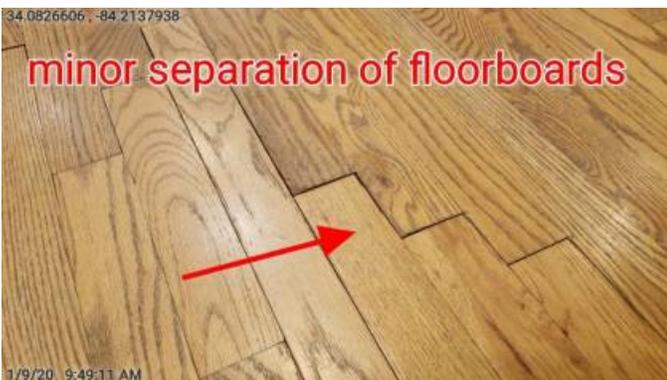
11.5 Kitchen Interiors:

Floorboards are separating where there appears to have been some repairs to the floor in the area around the interior door. Recommended inquiring with the current homeowners as to any previous repairs.

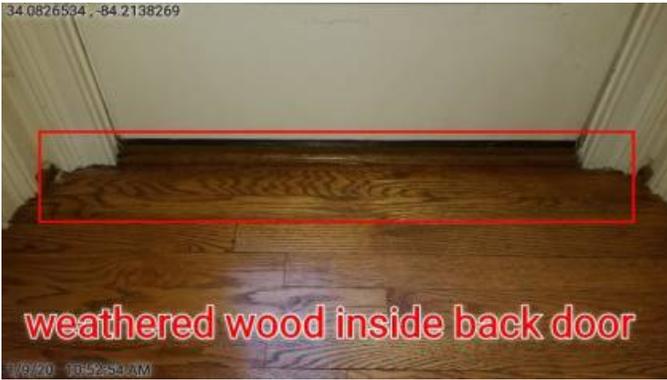
11.6 Family Room:

The flooring directly inside of the exterior door is weathered or water damaged from what appears to be water penetration below the door. Recommend sealing the door from the exterior to help prevent further water penetration and repairs if necessary to the flooring and framing in the area.

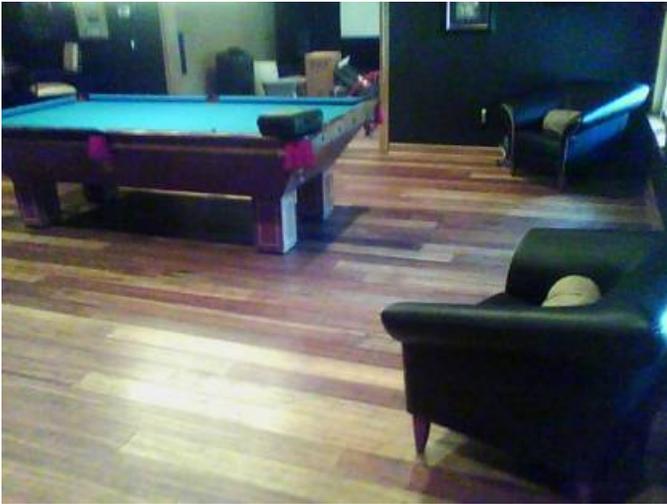
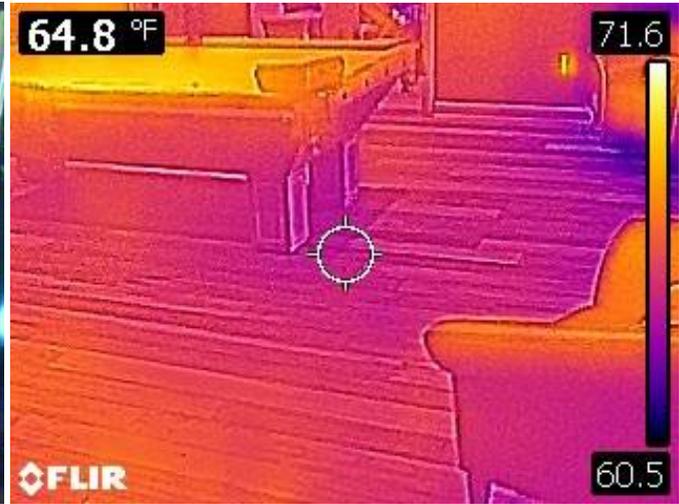
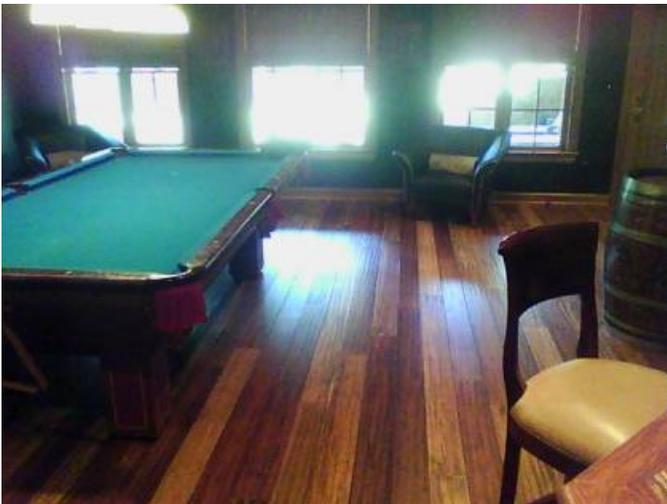
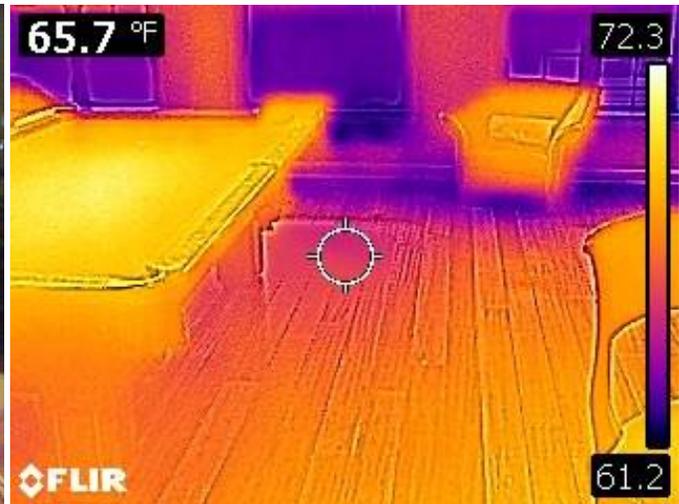
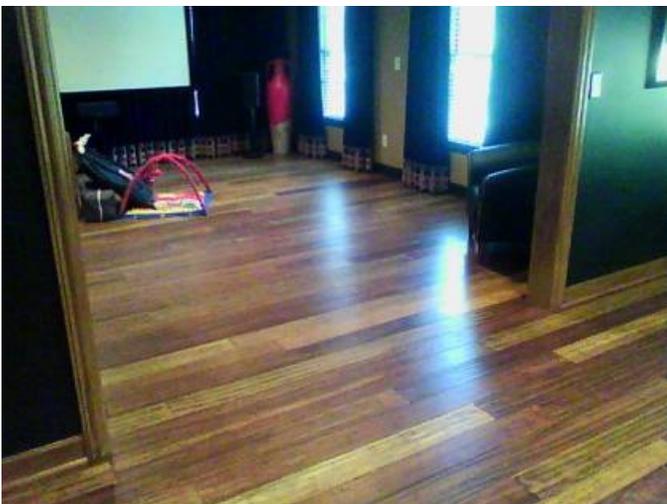
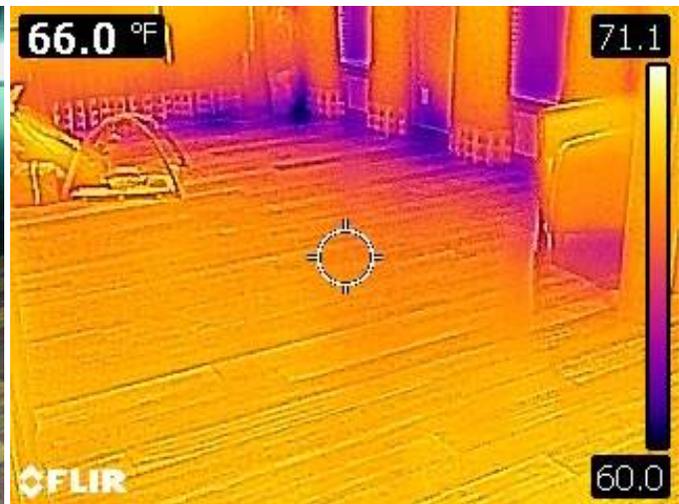
11.7 Bonus Room: Pool Room

There was a leak reported in the discloser statement in this room. The floors appear to be dry at the time of the inspection. Recommend addressing the water management at the gutters along the back of the home and the flashing at the back of the deck to help prevent future water penetration.

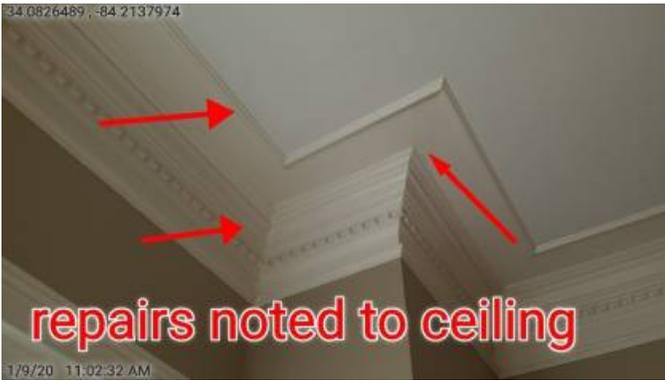
11.8 Dining Room:                       OK    MM    RR    IS

Repairs noted to the ceiling in this room. It appears there was a previous roof leak where the metal roof over the dining room windows separated from the exterior wall. Repairs were noted. Recommend inquiring with the current homeowners as to the nature of the repairs and monitor condition.

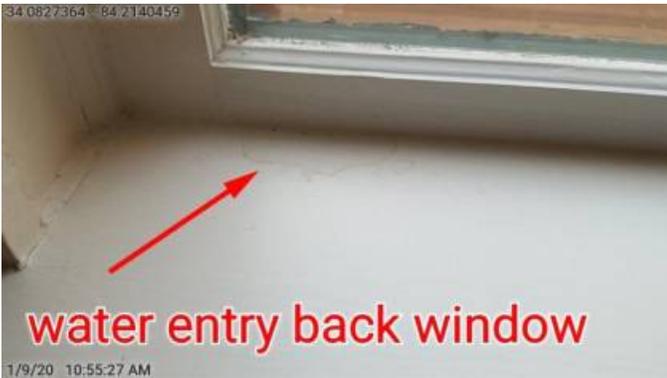
11.9 Family Room:

Water entry was noted around the lower portion of the window as evidenced by water staining or active standing water. Recommend sealing the window from the exterior to help prevent any further water penetration and monitor condition.

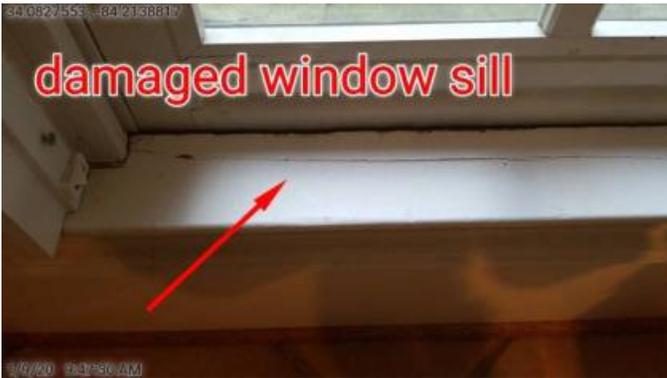
11.10 Keeping Room:      OK   MM   RR   IS

There was damage noted to the window sill. Recommend repairs or replacement to the affected sections of the sill.

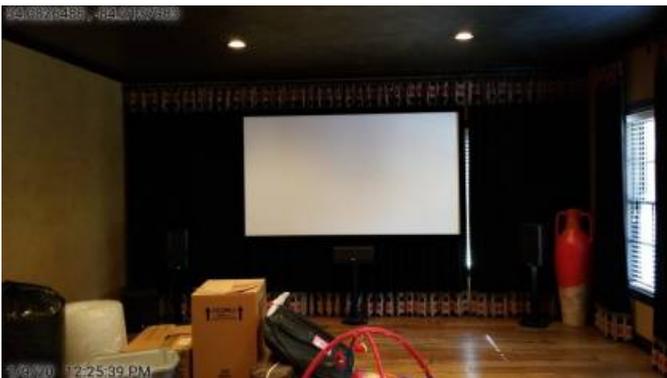
11.11 Theater Room

Windows not accessible due to movie screen.

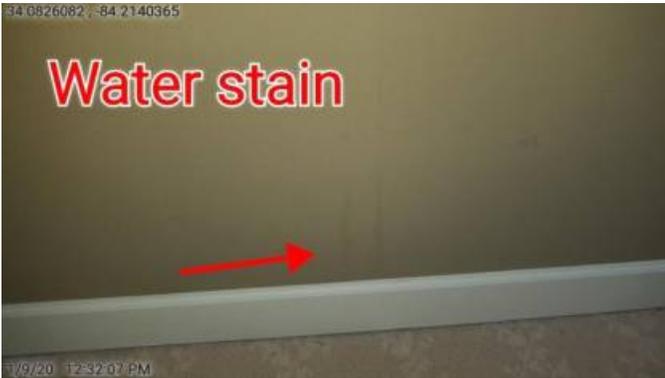
11.12 First Floor Bedroom:

Water stains were noted on the exterior wall of the room. The location would indicate a break on the insulation on the refrigerant line running from the attic to the outdoor air conditioner.

Recommend repairs to the insulation to help prevent further water staining or damage.

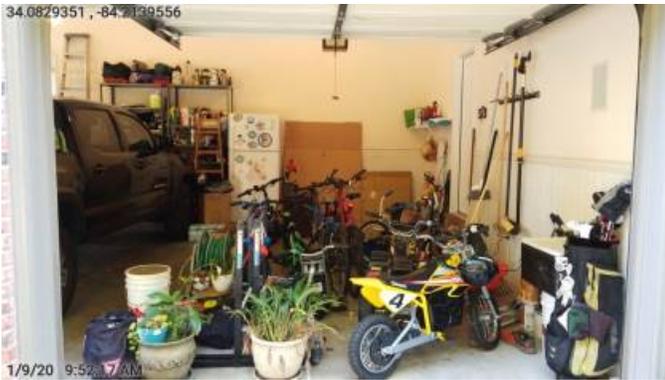
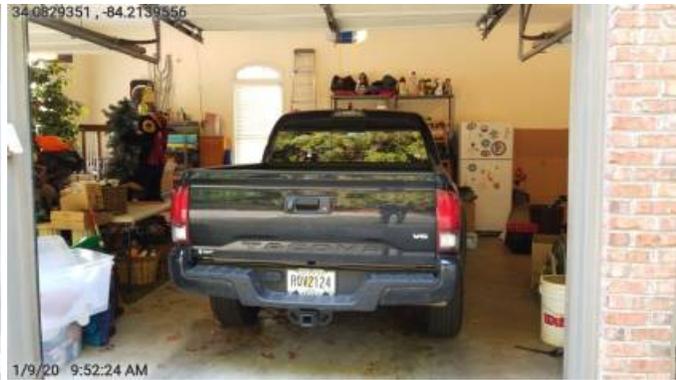
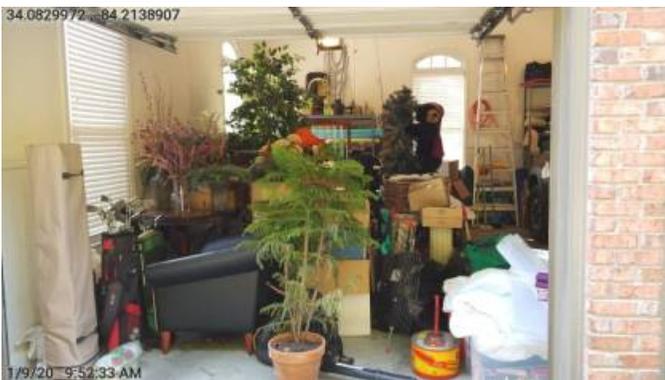
Limited visibility due to storage along the walls.

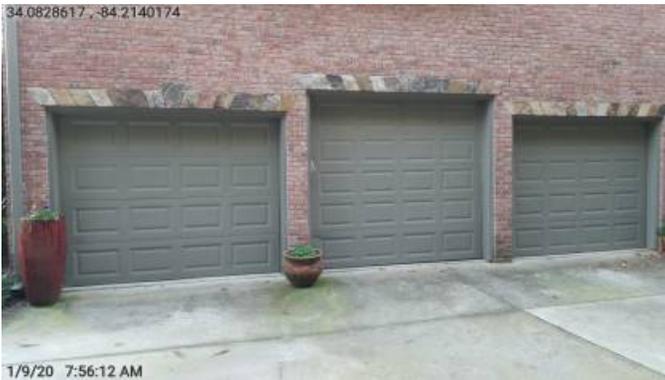
13.2 *Material - Condition:*      OK   MM   RR   IS  
            Doors are constructed of metal

Water damage noted around the base of one or more of the garage door jambs. Recommend repairs or replacement to the affected material.

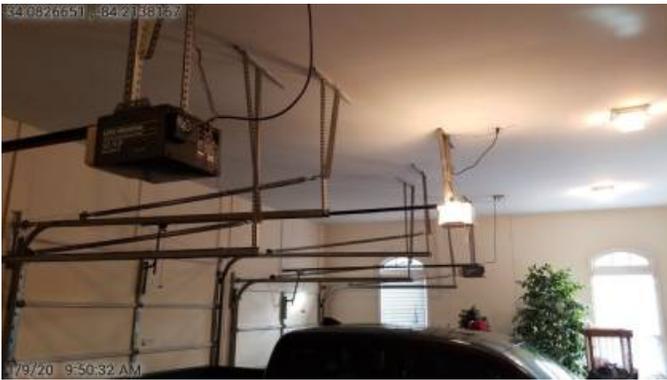
13.3 *Automatic Opener:*                  The automatic door opener was operational at the time of the inspection.

The auto reverse was not operational or missing the electric reverse sensors on the right side garage door directly adjacent to the interior of the home. Note: All overhead doors should have fully operational auto-reverse function as a safety precaution.

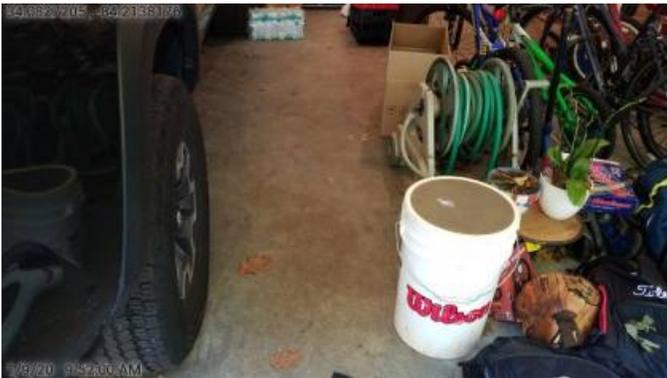
13.5 Slab Condition:

Typical cracks noted. Shrinkage cracks in all concrete is to be considered typical.

Floor is not fully visible due to a covering or stored items in the garage.
