Building Inspection Report

4047 Newhaven Circle, Atlanta, GA

Inspection Date:

1/21/2020

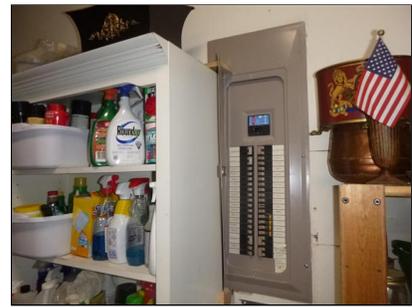
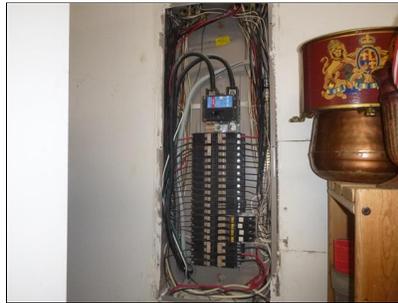
Main Panel in Garage

The size of the electrical service (200 amps) appears to be sufficient for typical electrical requirements. All 3-prong outlets that were tested were appropriately grounded. Ground fault circuit interrupter (GFCI) devices have been provided in some areas of the home. These devices are extremely valuable, as they offer an extra level of shock protection. All GFCI's that were tested responded properly. Smoke detectors were noted. These should be tested on a regular basis by the occupants (see instructions on the unit). In all, the electrical system appears to be in good condition, with minor repairs/improvements recommended, which should be performed by a licensed electrician. A surge protection device was noted in the main electrical panel (not tested). Consult with the seller concerning the proper operation and maintenance of this component.

10. **Repair:** Wiring in the main distribution panel that is doubled up on one circuit breaker (referred to as "double taps") should be separated unless the breaker is designed to accept two wires (circuit(s) marked with orange dots). Otherwise, each wiring circuit should be connected to a separate breaker to prevent poor connections at the breakers.

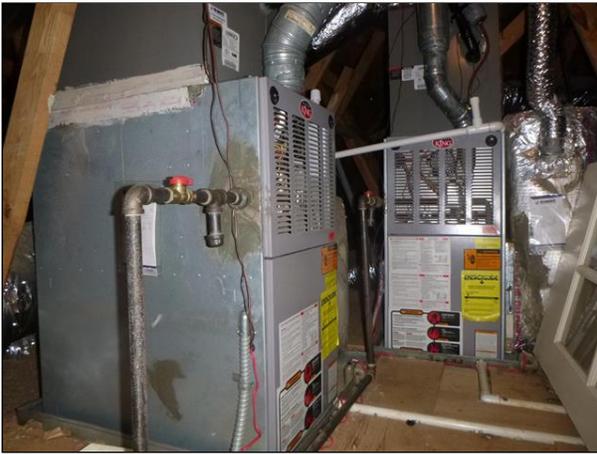
Furnaces in Attic

The furnaces appear to be approximately 18 years old based on the serial numbers. The typical life for units such as this is 15-20 years based on proper maintenance scheduling. The furnaces responded to normal operating controls at the time of the inspection. The heating system is controlled by a programmable "set back" thermostat. This type of thermostat, if set up correctly, helps reduce heating costs. The distribution of heat is divided into zones, allowing for greater ease of balancing heat flow. This system was recently inspected and serviced by a heating and air conditioning service company (as per service stickers on the unit). Please refer to this documentation concerning service and repairs performed and the condition of the equipment.

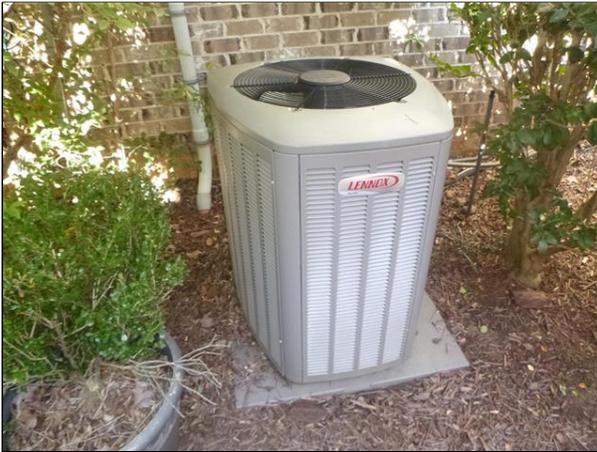
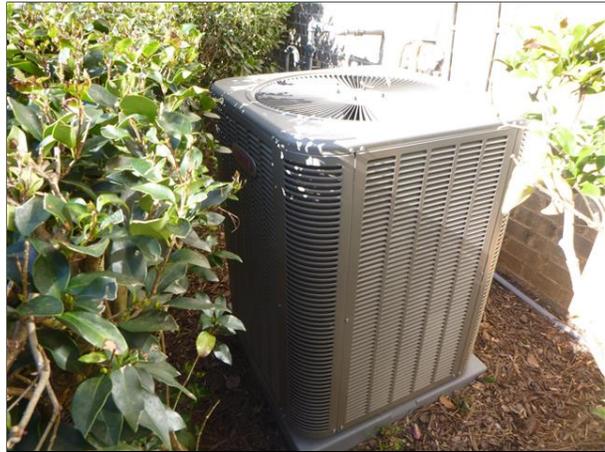
AC Unit at Right

The outdoor A/C condensing units appear to be approximately 2 & 7 years old based on the serial numbers. The typical life for such components is 12-15 years based on proper maintenance scheduling. Check with the seller concerning all prior service records for the heating and air conditioning equipment. The air conditioning system was not operated due to outdoor temperatures (see "Limitations" below). Recommend servicing and checking freon levels when warmer temperatures prevail this spring.

11. **Repair:** The maximum allowable breaker size for the outdoor A/C units as indicated on the label of the equipment are 30 amps while the breaker sizes at the panel box are 35 amps. All breakers should be checked for proper compatibility with the equipment they serve and changed out as necessary.

14. **Monitor, Repair:** Since the air conditioning system could not be tested (see below), it should be serviced and cleaned by a qualified HVAC service company for the next cooling season or before closing as temperatures allow. Freon levels and pressures should be checked as outdoor temperatures allow and the freon system tested for leakage. The air filters should be checked and replaced as needed.

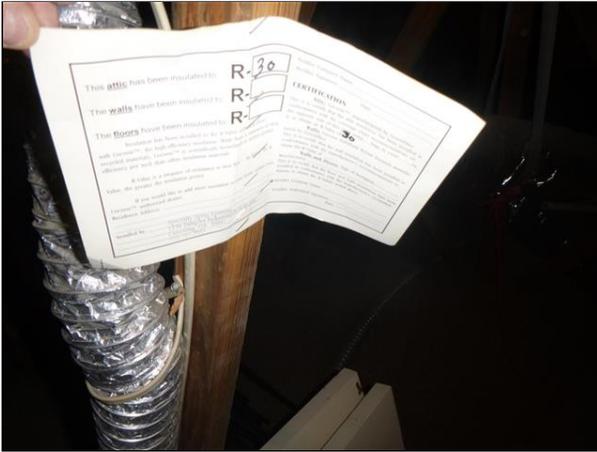
Certificate of Attic Insulation

The visible areas of the attic appear to be well insulated. The wall insulation was not visible. Ventilation of the attic areas appears to be adequate. Insulated windows and doors as noted help in preventing excessive heat gain and loss through these components. An insulation certificate certifying the insulation rating was noted in the attic.
