Atlanta Property Inspections

HOME INSPECTION REPORT

786 Gardenside Circle, Marietta, GA 30067
Inspection prepared for: Kayla Meyer
Date of Inspection: 1/24/2020 Time: 9:30 AM
Age of Home: 20 Years Old (2000) Size: 1600 SF
Weather: Overcast / Light Rain, Wet Soil, 45 - 50 Degrees

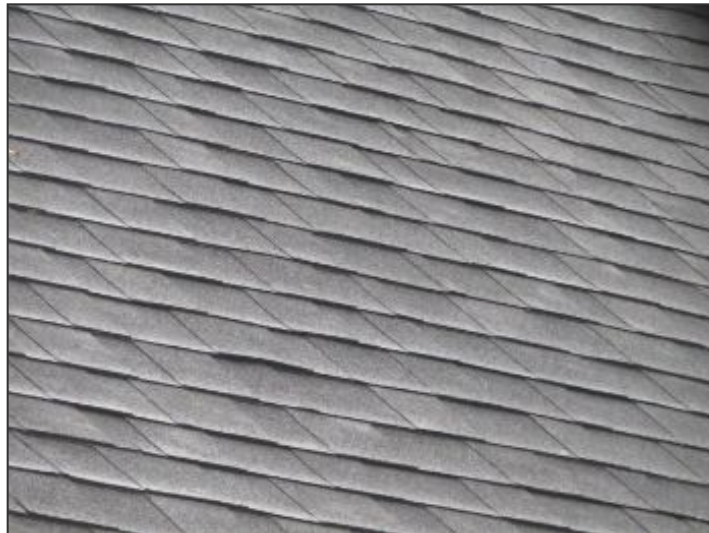
This roof has architectural or profile shingles; this attractive and slightly more expensive shingle is a significant upgrade from traditional roof shingles. It also has a longer warranty period of 25-35 years and should provide an extended lifespan when compared to traditional roof shingles. This type of shingle also performs better in storms and when exposed to hail.

Architectural roof shingles present

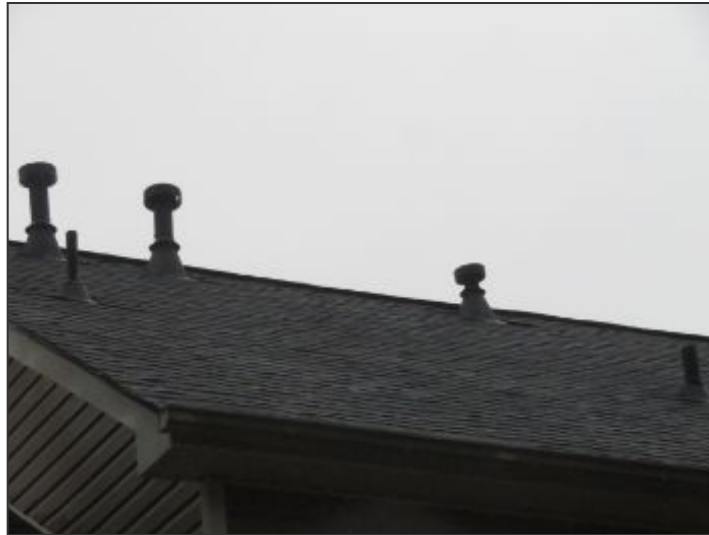
• **The roof appears serviceable and within its normal useful life. No concerns were noted with shingles, flashings and valleys. Continue to monitor the roof for any changes. Annual inspections are suggested, particularly after heavy storms and high winds.**

Rear roof surfaces look good

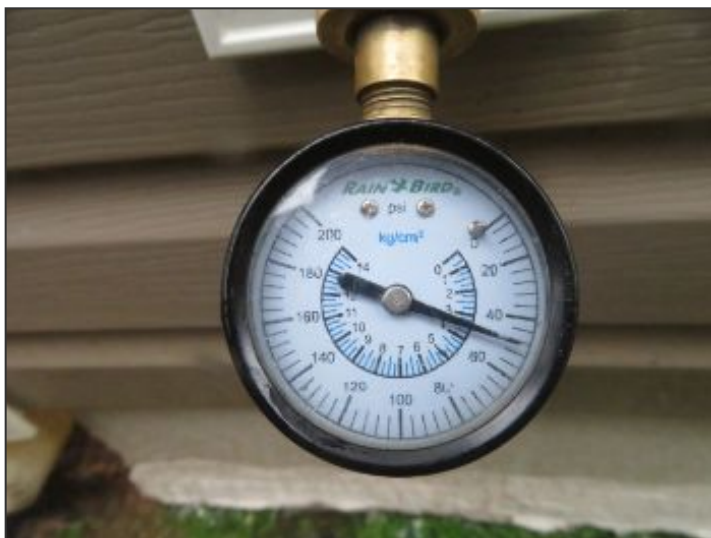
- The supply piping appears to be serviceable, no concerns were noted. A water pressure reading was taken at the rear hose bib and was found to be normal at 50 PSI.

Water pressure normal - 50 PSI

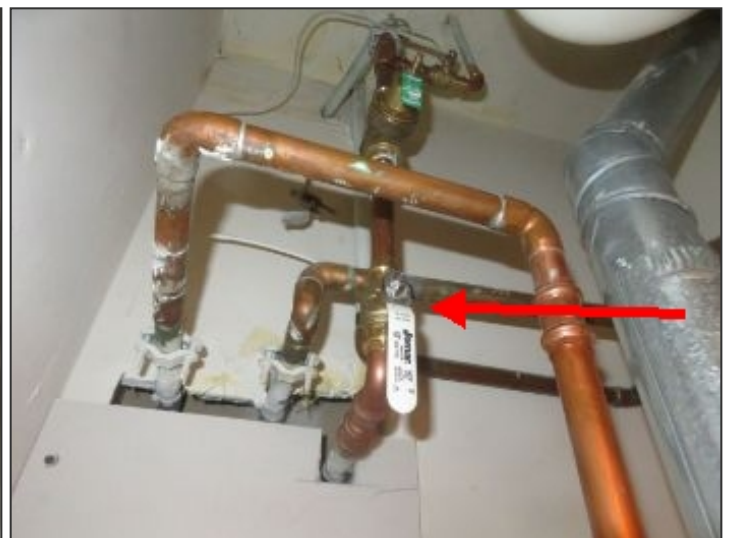
Main water cutoff above water heater

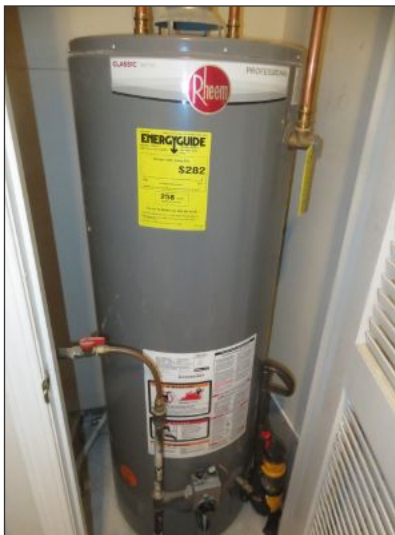
A thermal expansion tank / valve is present on the cold water line and appears serviceable.

Gas water heater in laundry room

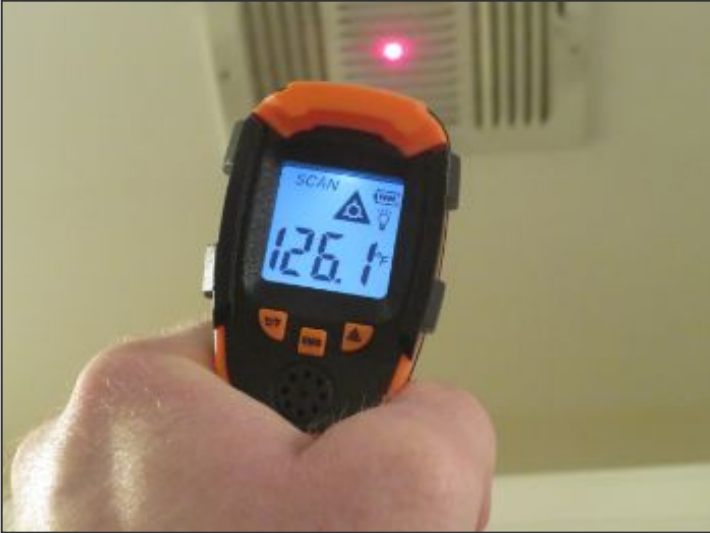
• **The heating system appears serviceable; the heating system was operated and was found to be functioning normally during a limited visual inspection, no significant concerns were noted. Continue to maintain the system and have it serviced regularly.**

Gas furnace heating normally - 126 degrees

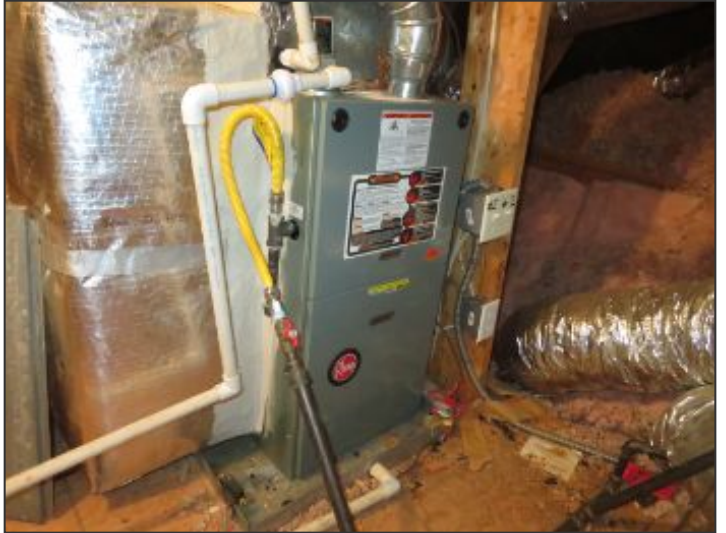
First floor gas furnace in attic

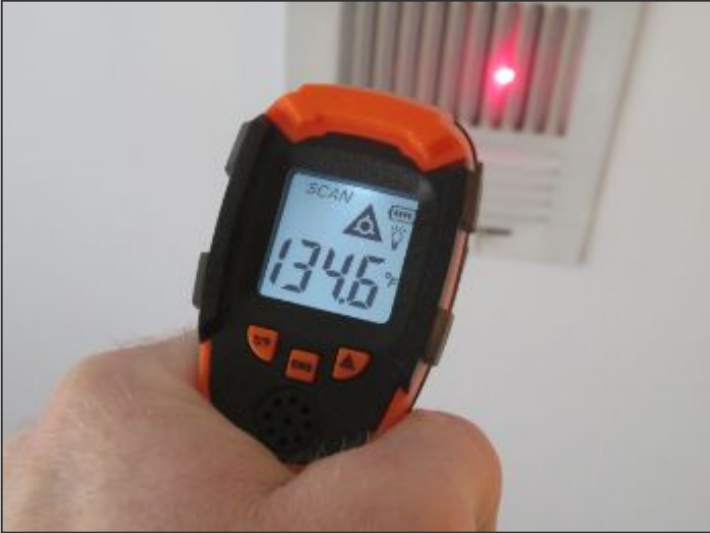
Gas furnace heating normally - 134 degrees

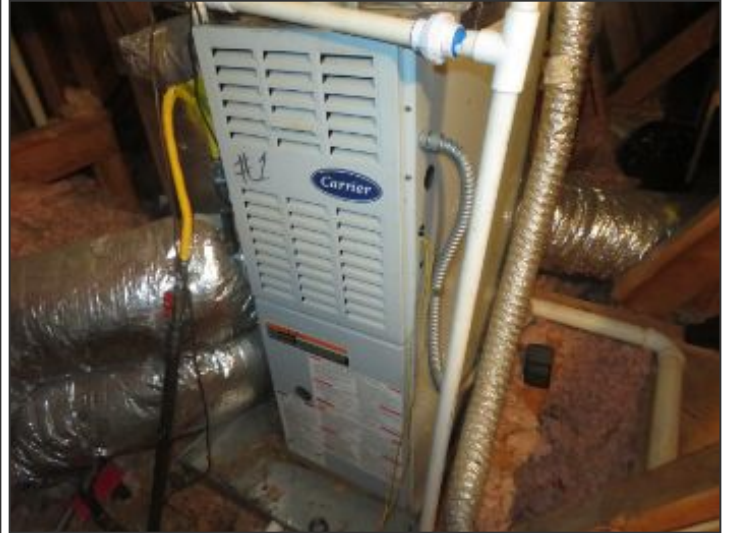
<p>Page 38</p>	<p>HEATING 2:</p>	<p>• AGING EQUIPMENT:</p> <p>HEAT EXCHANGER INSPECTION ADVISED: Due to the advanced age of the system, a full heat exchanger inspection is advised by a professional HVAC contractor and to provide written certification that the heat exchanger is in good working condition and is safe to operate. Additional heat exchanger inspections are advised each year for as long as this older furnace is in service.</p> <p>BUDGET FOR REPLACEMENT: Due to the advanced age of this heating system, client should budget for replacement soon which is expected to be a major expense. Based on the available manufacturing date on the equipment, the heating system is at or past the normal expected lifespan of 15-20 years.</p> <p>Consider these cost saving strategies when replacing HVAC equipment:</p> <p>1. MANUFACTURERS REBATES: Check for current rebates from manufacturers on models that may be discontinued or that have higher energy ratings: Carrier Rebates: http://www.carrier.com/homecomfort/en/us/rebates-and-financing/ Lennox Rebates: http://m.lennox.com/promotions/national.asp Trane Rebates: http://www.trane.com/residential/en/buying-a-trane/savings-and-offers.html York Rebates: http://york.com/residential/promotions-savings/default.aspx</p> <p>2. UTILITY COMPANY REBATES: Check for rebates or incentives from your local power company or gas provider - many offer rebates for higher efficiency equipment</p> <p>3. TIME OF INSTALLATION: Wait to have your equipment to be installed in the fall or spring when HVAC contractors are not as busy and ask for an off season discount.</p> <p>4. GET MULTIPLE QUOTES: Always get more than one quote before making your decision - prices can vary widely from one company to another.</p>

Second floor gas furnace in attic

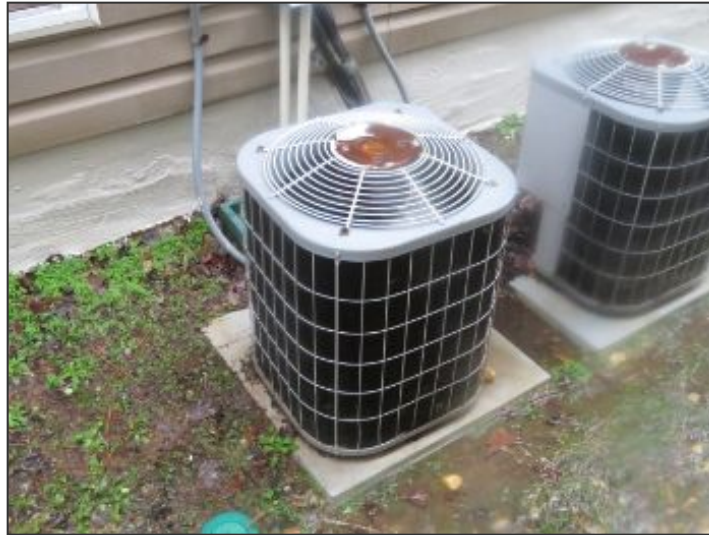
• AGING EQUIPMENT - BUDGET FOR REPLACEMENT:
 Due to the advanced age of this AC unit, client should budget for replacement soon which is expected to be a major expense. Based on the available manufacturing date on the equipment, the AC unit is at or past the normal expected lifespan of 12-15 years.

First floor AC unit
