AMENDMENT TO ADDRESS CONCERNS WITH PROPERTY AMENDMENT #1

Whereas, the undersigned parties have entered into a certain Agreement between _____
An Do, ~~Do~~ _____ (“Buyer”) and H Donald Snapp, Linda W. Snapp _____ (“Seller”), with
a Binding Agreement Date of 1/4/2020 for the purchase and sale of real property located at:
175 Stone Pond Lane, Johns Creek, Georgia
30022-8471 (“Agreement”).

Thank you for the opportunity to conduct a home inspection of the property listed above. We understand that the function of this report is to assist you in understanding the condition of the property to assist in making an informed purchase decision.

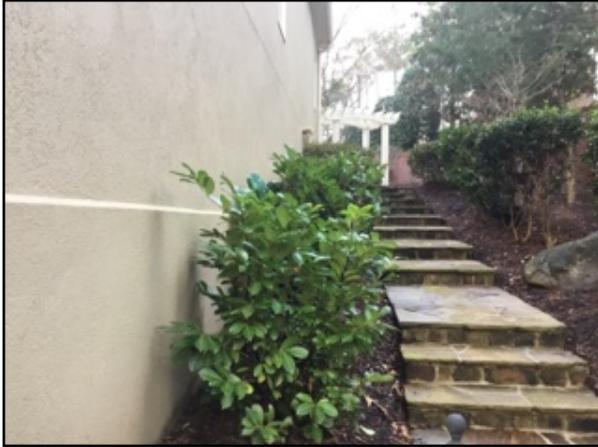
Figure 1-1

Repair: Tree branches should be trimmed away from the house to avoid damage to the building.

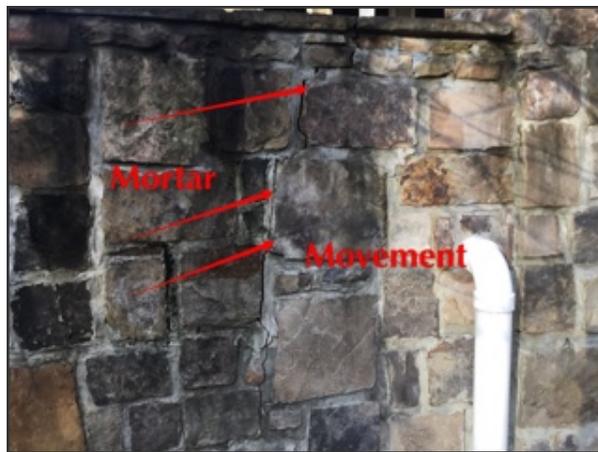
Figure 2-2

2) Monitor: The retaining wall shows evidence of movement. This condition should be monitored. It is impossible to determine the rate of movement during a one-time visit to the house. May desire to add mortar back where movement has concurred.

Monitor: The retaining wall shows evidence of movement. This condition should be monitored. It is impossible to determine the rate of movement during a one-time visit to the house. May desire to add mortar back where movement has concurred.

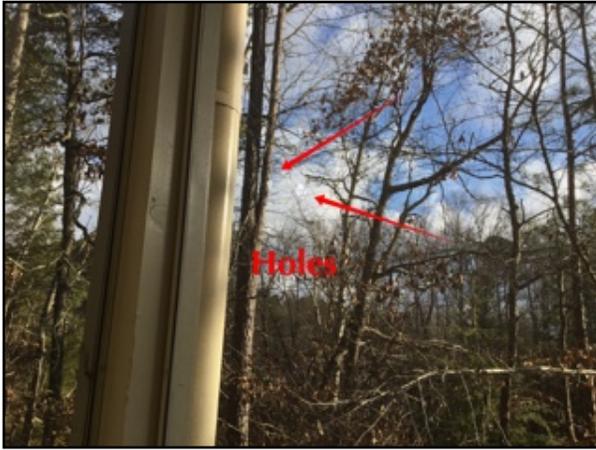
Figure 3-1

3) Screen on back porch has 2 small holes that need repair.

Screen on back porch has 2 small holes that need repair.

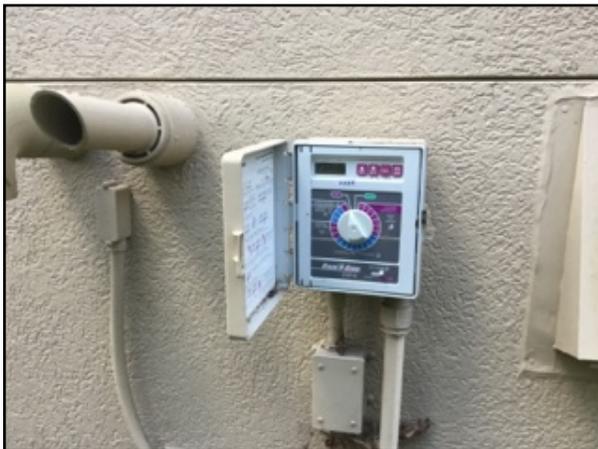
Figure 4-1

Monitor: The lawn irrigation system was not turned on (testing of the system is not within the scope of this inspection). Consider having the system fully tested by a lawn irrigation service company to make adjustments as necessary for a full coverage of all landscaping components. Make sure all heads next to the foundation are directed away from the structure to prevent damage to wood components and to prevent moisture infiltration into the basement/crawlspace.

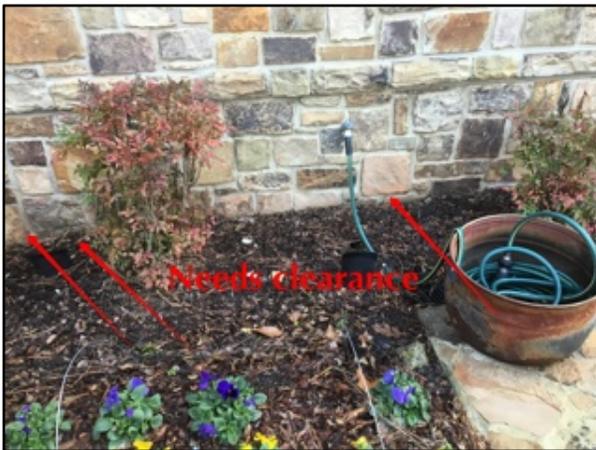
Figure 5-1

4) The concrete portion of your foundation has to be in contact with the ground, but all other materials must have adequate clearance. Wood siding, stucco, brick, vinyl, all siding should ideally have at least 6 to 8" clearance above the ground. This will allow product to weep moisture from behind walls and help create air flow. That was not the case in this property and should be done.

The concrete portion of your foundation has to be in contact with the ground, but all other materials must have adequate clearance. Wood siding, stucco, brick, vinyl, all siding should ideally have at least 6 to 8" clearance above the ground. This will allow product to weep moisture from behind walls and help create air flow. That was not the case in this property and should be done.

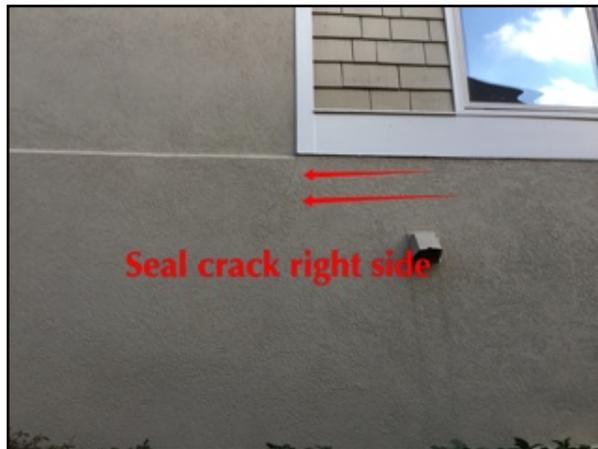
Figure 6-2

5) Cracks in stucco need sealed around perimeter of home.

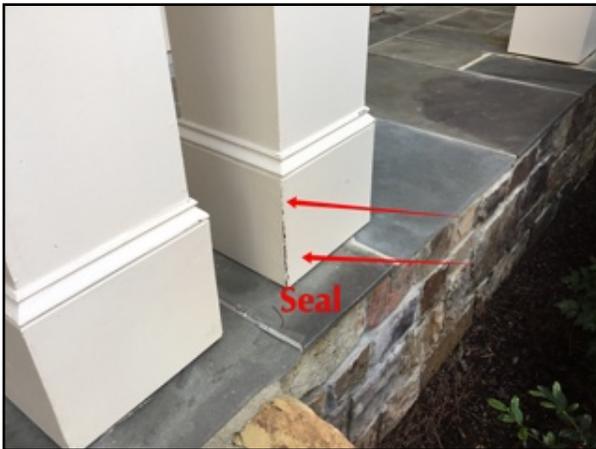
Figure 7-1

6) Column on front of home needs sealing to prevent rot.

Comment 7:
Column on front of home needs sealing to prevent rot.

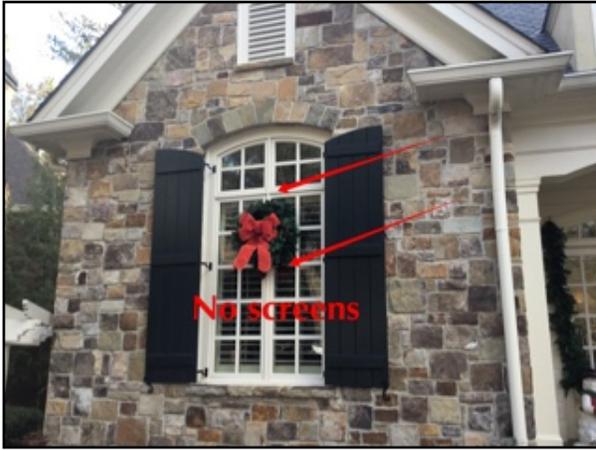
Figure 8-1

7) All screens missing on home. May ask seller where screens are.

All screens missing on home. May ask seller where screens are.

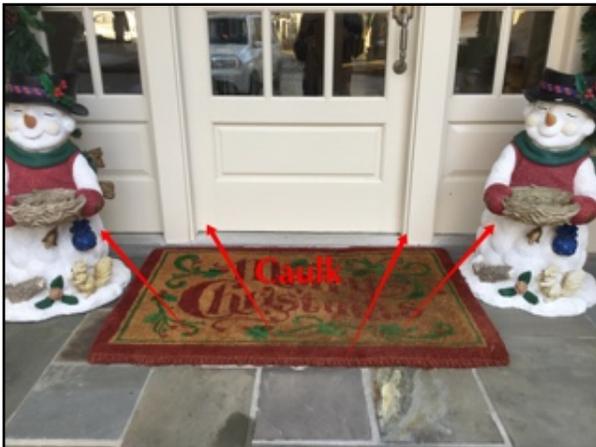
Figure 9-1

The exterior doors. in front and back of home needs caulking along top and bottom around threshold of exterior trim to avoid further water intrusion and rot of wood jambs.

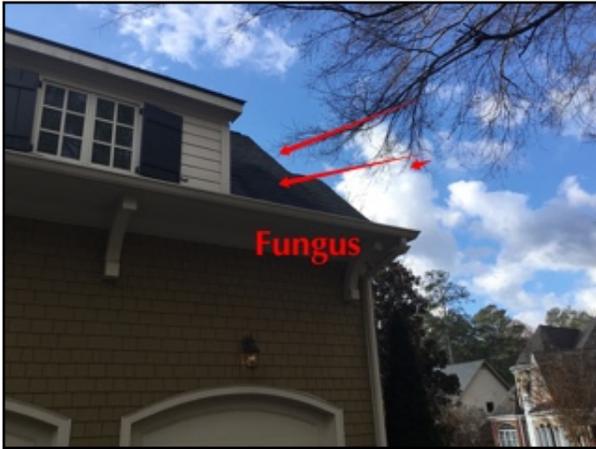
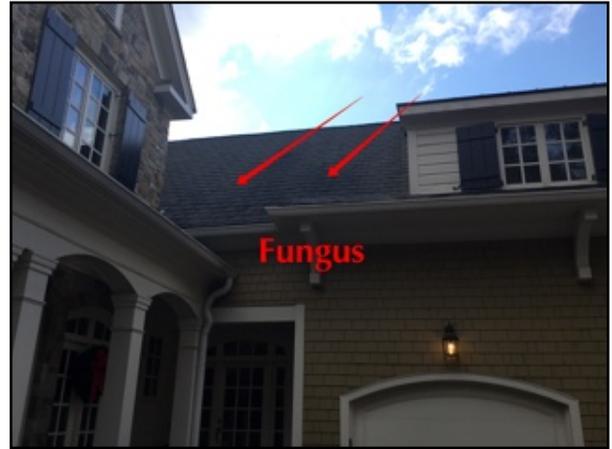
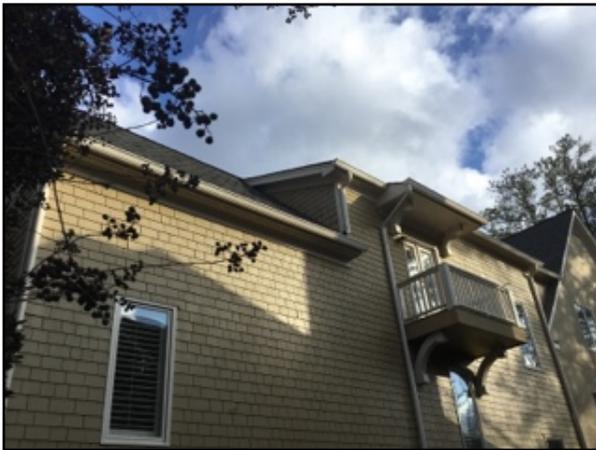
Improve: Some shingles as noted front and back are coated with a black substance which is algae. Algae is not uncommon and should have no appreciable effect on the longevity of the roofing material. Cleaning is possible and should be completed by a qualified contractor to prevent damage to the roof. Recommend that you have a professional roofing contractor look at roof to ensure that there is still plenty of longevity left in shingles. Overall they look good visually.

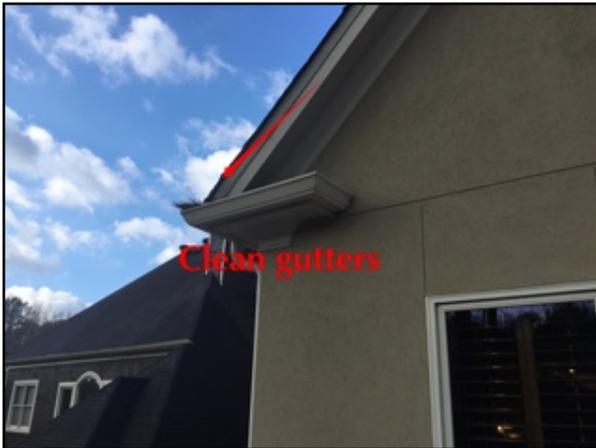
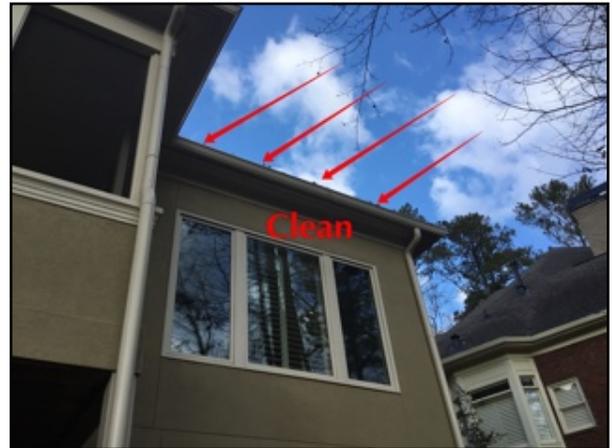
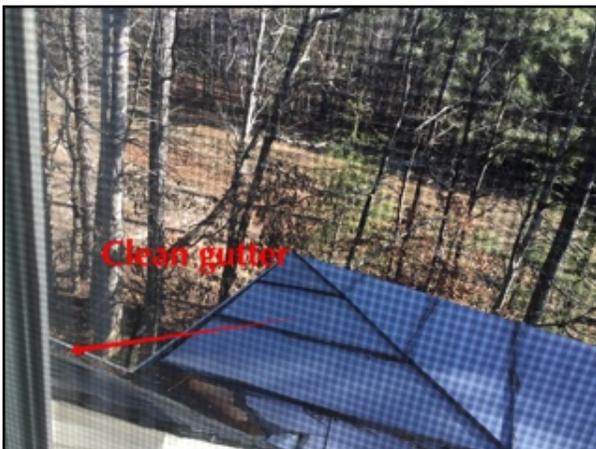
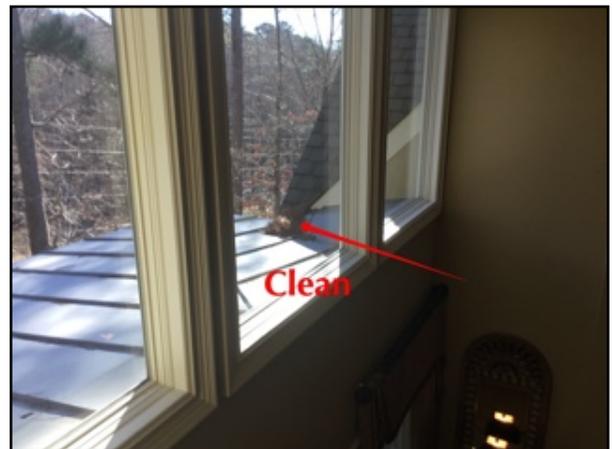
Repair: The gutters require cleaning to avoid spilling roof runoff around the building a potential source of water entry or water damage.

Improve: Covering the gutters with a protective mesh may help to avoid congestion with leaves and debris Gutter Damage.

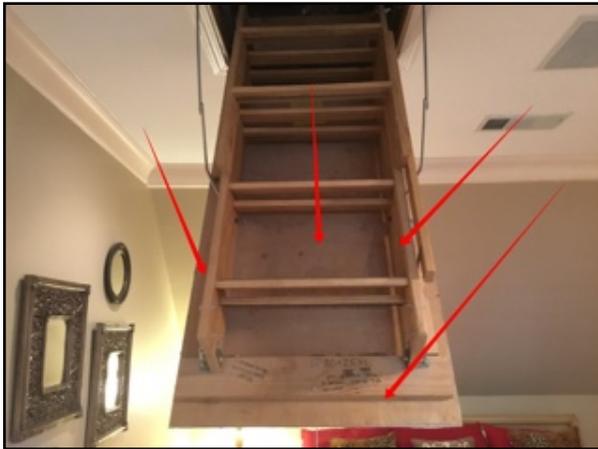
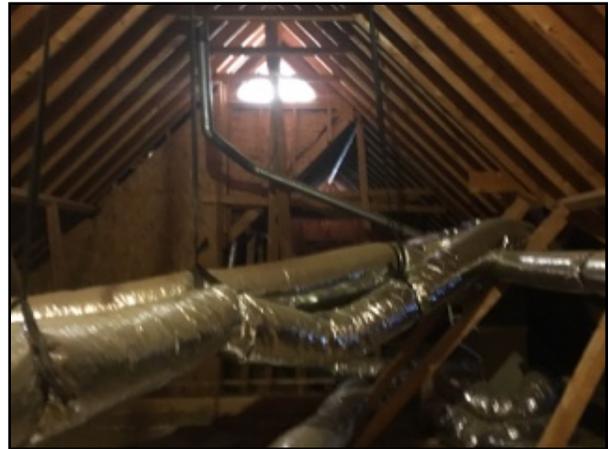
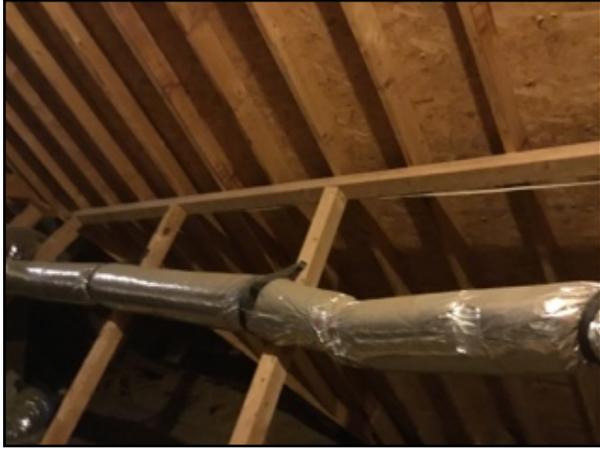
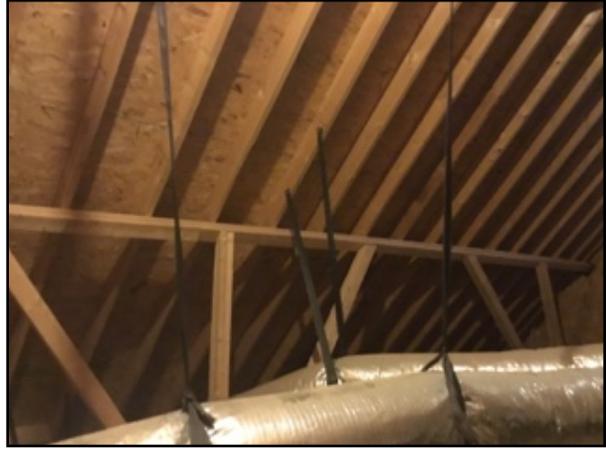
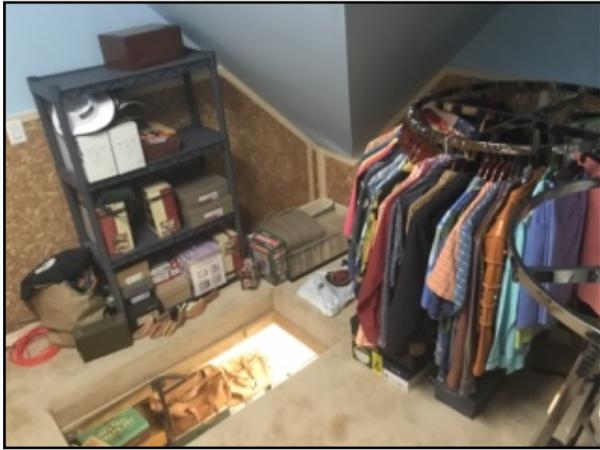
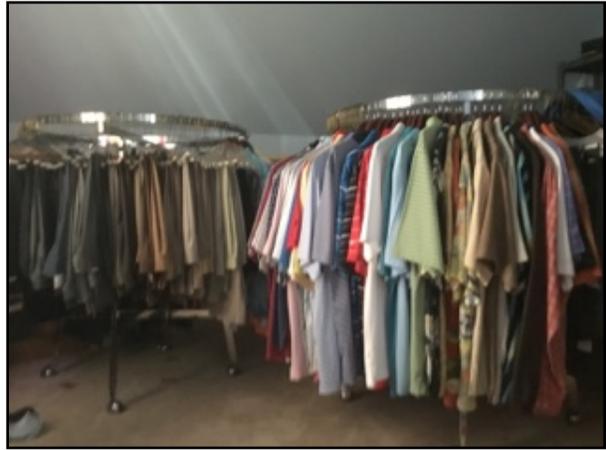
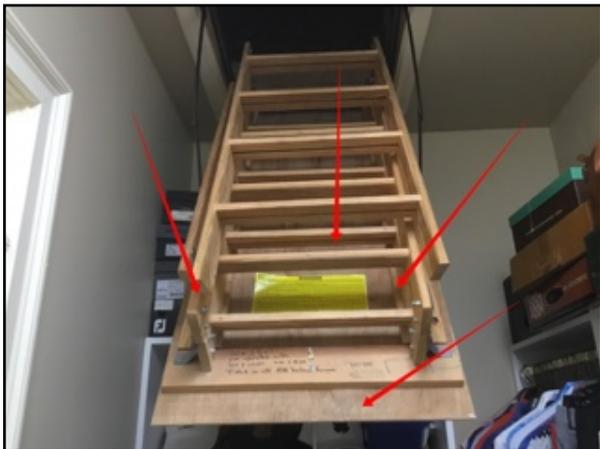
The pull-down attic access door should be insulated with foam board and weather stripped to limit unconditioned air infiltration into finished areas.

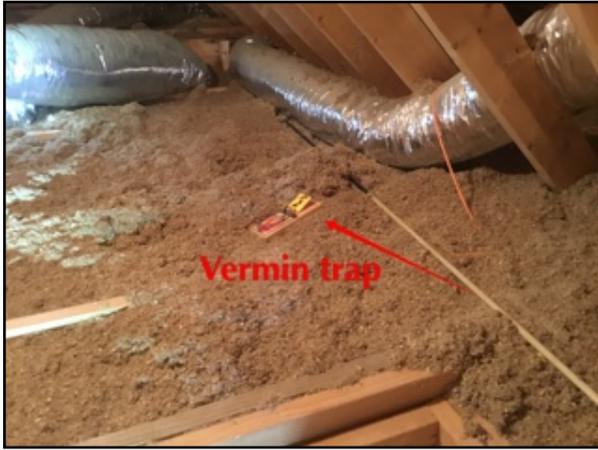
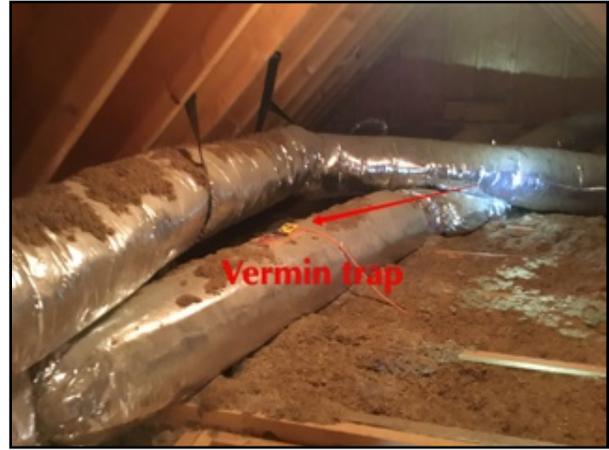
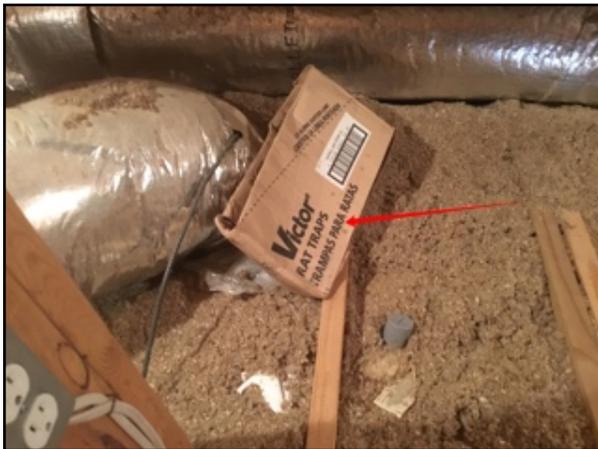
**Comment 17:**
Did see evidence of vermin traps. Ask seller if there is known problem.

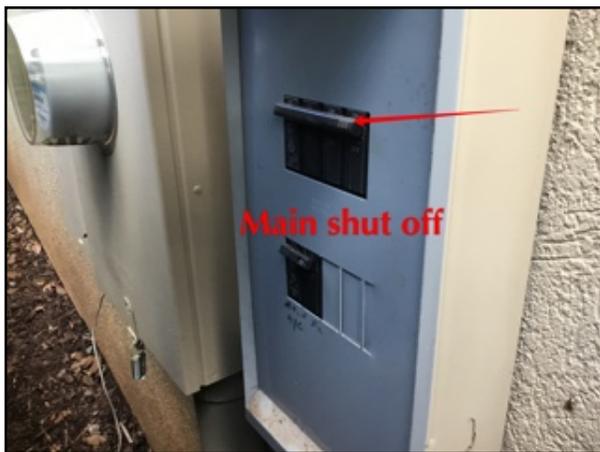
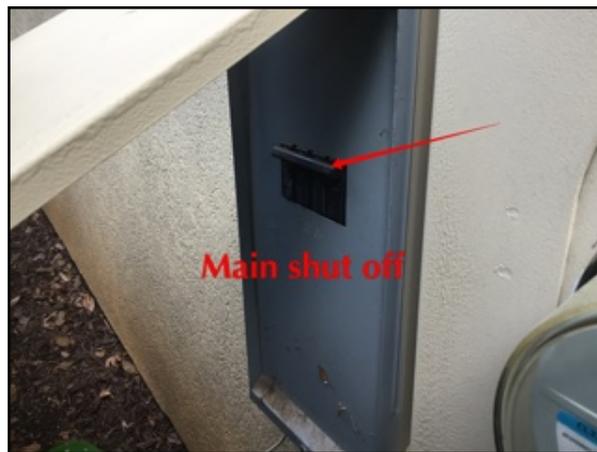
Comment 18:
Main electrical shut-off for home.

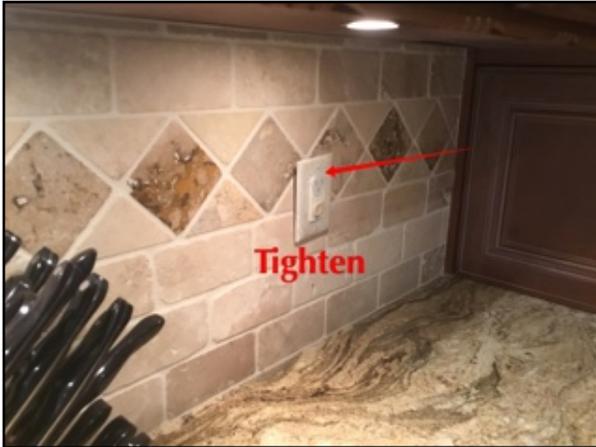
Figure 20-1

Comment 20:
Outlet under kitchen cabinets is loose and needs tightening.

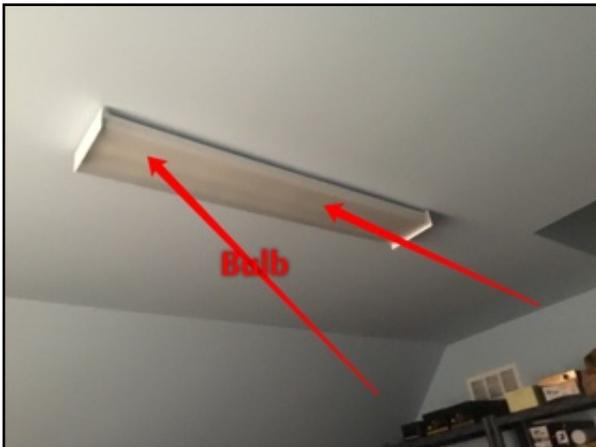
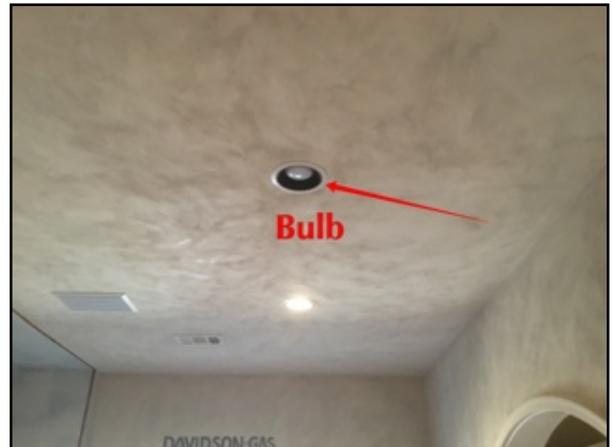
Comment 21:
Light in attic area of master closet, cam light in pool room, is inoperable. If not the bulb then further investigation would be required.

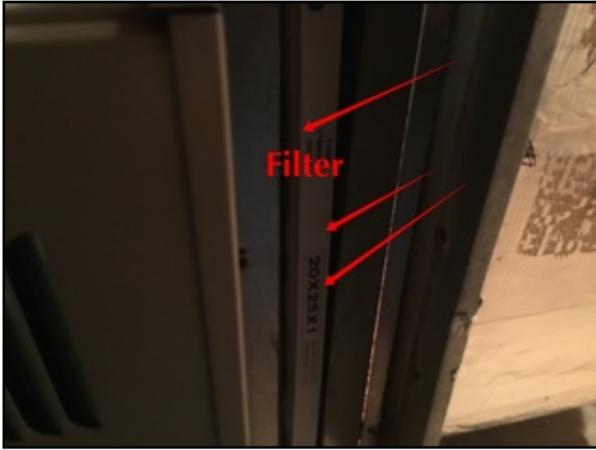
Figure 23-1

Comment 23:
Change filter at least once a quarter.

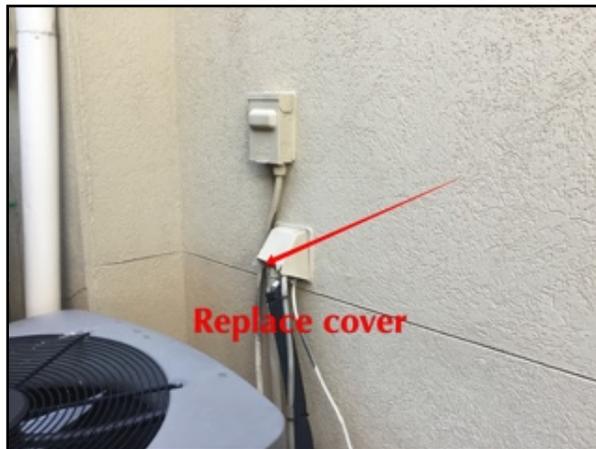
Figure 26-2

Vent covers for AC units are broke and should be replaced.

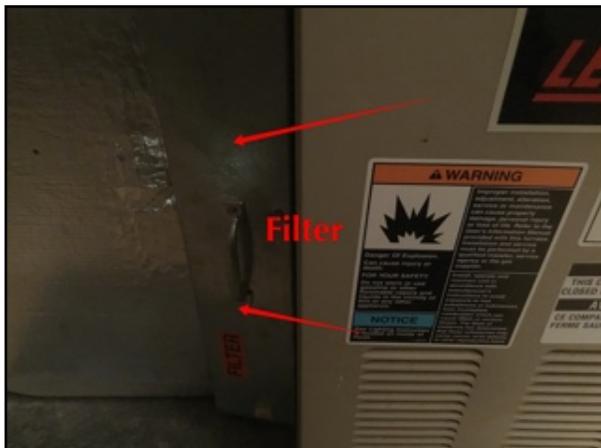
Figure 27-1

Comment 27:
Change filter at least once a quarter.

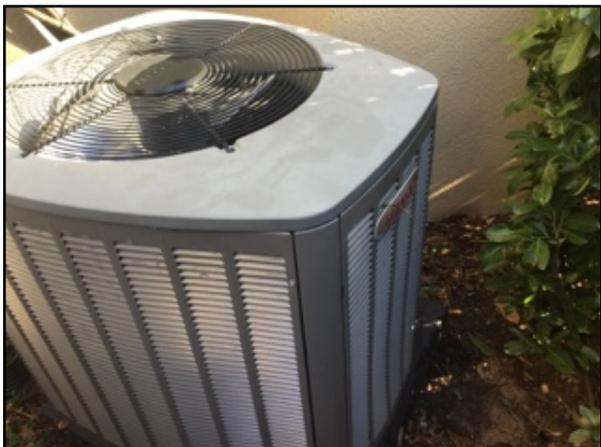
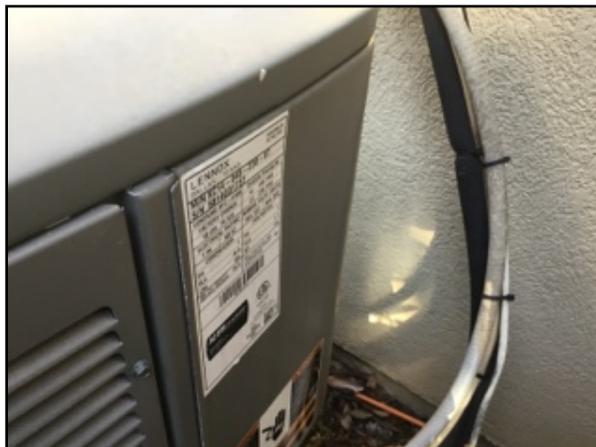
Repair: Damaged and or missing insulation on refrigerant lines should be repaired. These outside lines should be insulated all the way to the compressor unit to prevent loss of temperature in the lines.

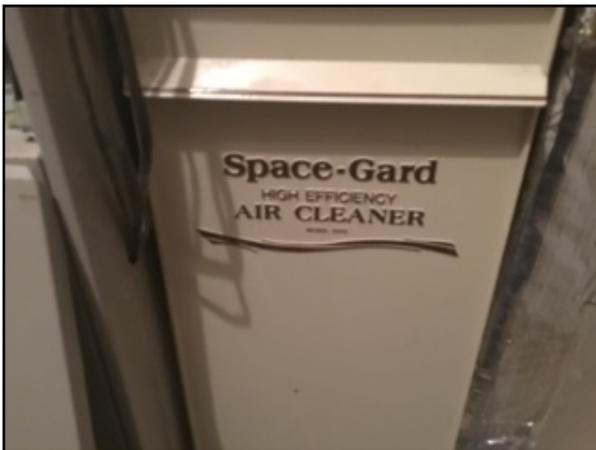
Figure 32-1

Change filter at least once a quarter.

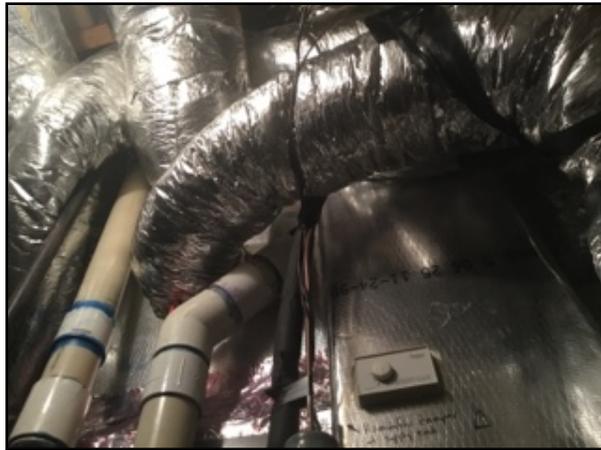
The furnace appears to be approximately 22 years old based on the serial number. The typical life for such a unit is 20-25 years based upon proper maintenance scheduling. The furnace responded to normal operating controls at the time of inspection. Adequate heating capacity is provided by the systems and heat distribution within the home is adequate.

Repair, Safety Issue: Given the age of the furnaces, recommend they be examined and serviced by a qualified HVAC service company. The heat exchangers should be checked for cracks, which can allow carbon monoxide poisoning to infiltrate the supply air. As dirt is the biggest enemy of a furnace (wastes fuel and drastically lower efficiency), cleaning of the filter systems, the blowers, and motors should be completed on an annual basis. Recommend a HVAC specialist evaluate all systems to ensure longevity of units.

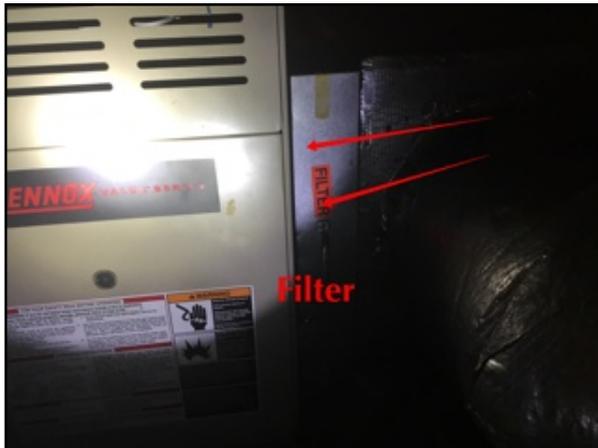
Figure 36-1

Comment 36:
Change filter at least once a quarter.

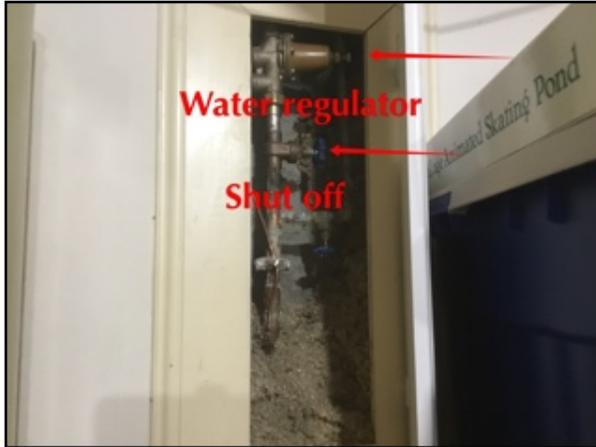
Figure 42-1

Main water shut off and water regulator on front wall of basement.

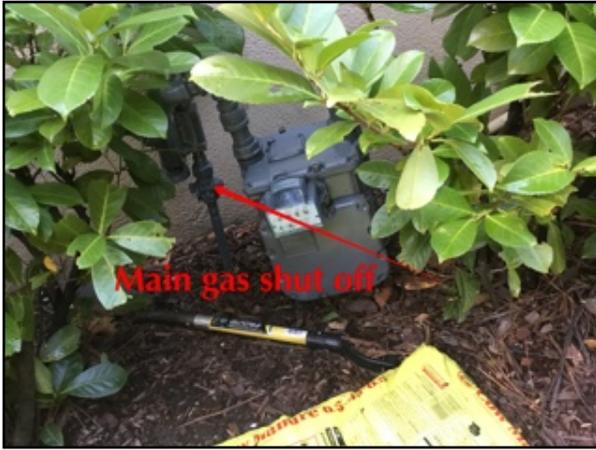
Figure 43-1

Comment 43:
Main gas shut off on left side of home.

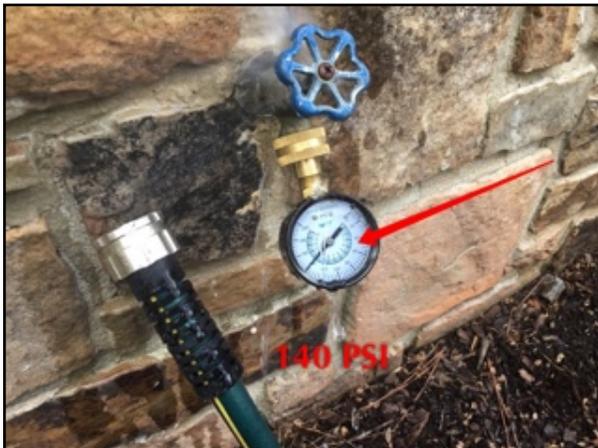
Figure 44-1

Repair: As the static water pressure of the supply plumbing system exceeds 80 pounds per square inch (psi), it would be wise to adjust or replace the existing pressure regulator. Otherwise, the plumbing system may be prone to leaks in piping, fittings or other equipment. Currently at 140 PSI too high

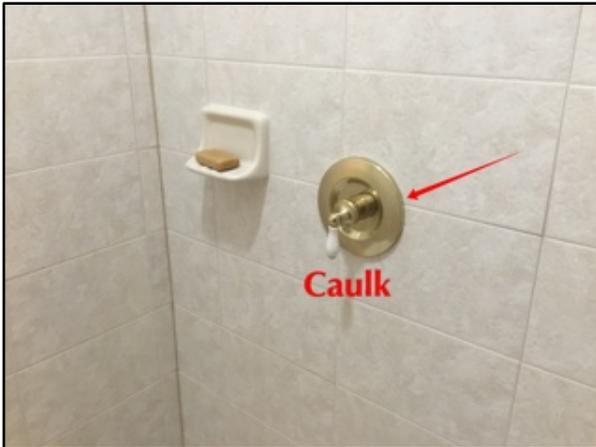
Figure 47-1

Comment 47:
Need caulking around faucet and water control to help prevent water intrusion behind walls.

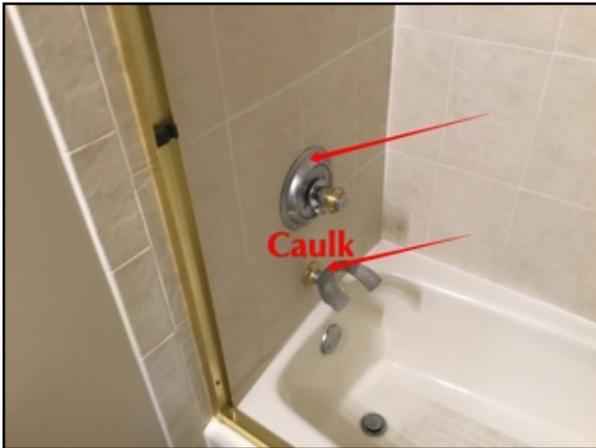
Figure 48-1

Need caulking around faucet and water control to help prevent water intrusion behind walls.

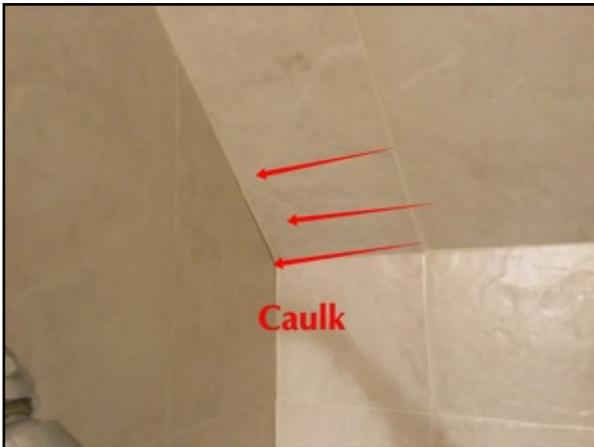
Figure 49-1

Additional mortar is needed in the corners of tile to prevent water intrusion behind walls.

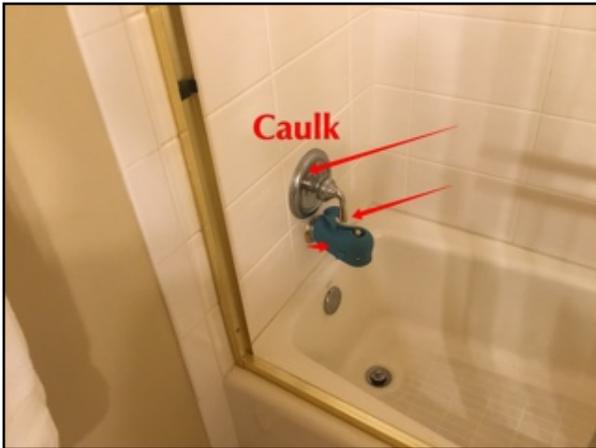
Figure 50-1

Need caulking around faucet and water control to help prevent water intrusion behind walls.

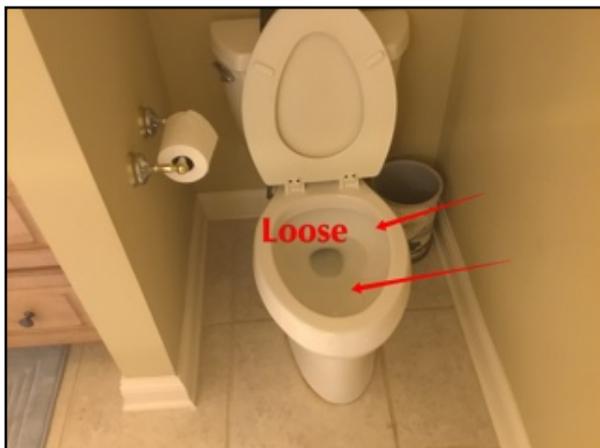
Figure 51-1

Low Rise Tank
Condition: Repair or Replace

Repair: The toilet is loose as noted in hallway bath which needs repair. Have the wax ring checked for leaks and the toilet properly bolted to the floor.

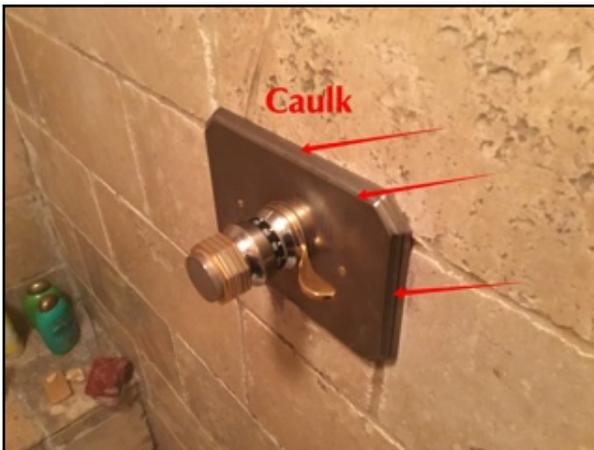
Figure 52-1

Stall
Condition: Repair or Replace

Need caulking around faucet and water control to help prevent water intrusion behind walls.

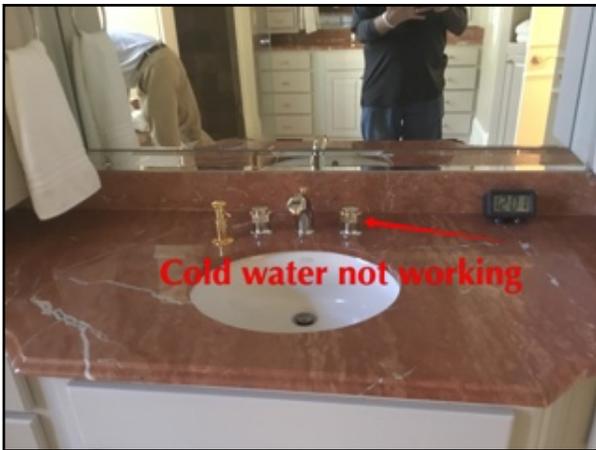
Figure 53-1

Condition: Repair or Replace

Sink on right side of master bath cold water not coming on. Further investigation required.

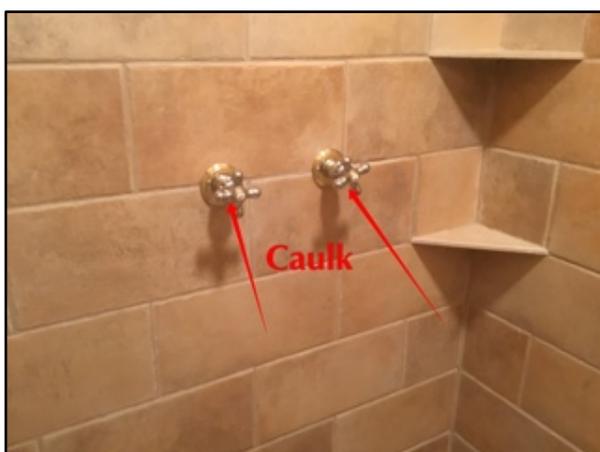
Figure 55-1

Basement Hallway Bath
Stall
Condition: Repair or Replace

Comment 55:
Need caulking around faucet and water control to help prevent water intrusion behind walls.

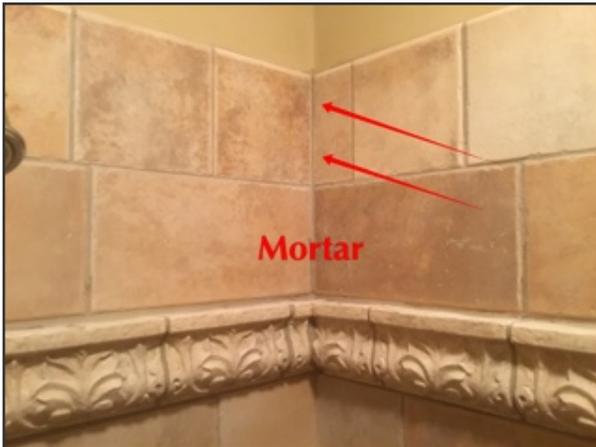
Figure 57-1

Condition: Repair or Replace

Additional mortar is needed in the corners of tile to prevent water intrusion behind walls.

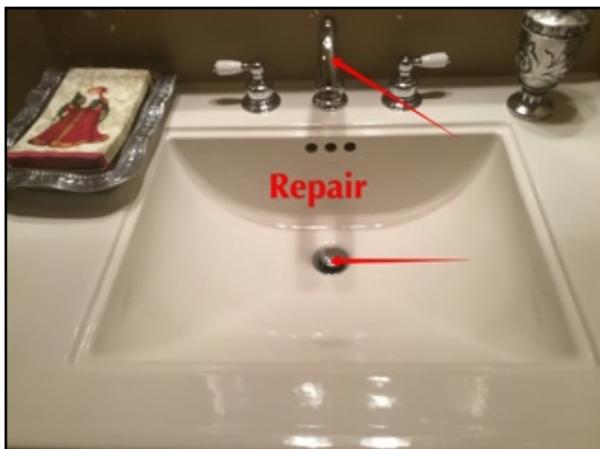
Figure 58-1

Condition: Repair or Replace

Comment 58:
Drain plug not working correctly. Needs repair.

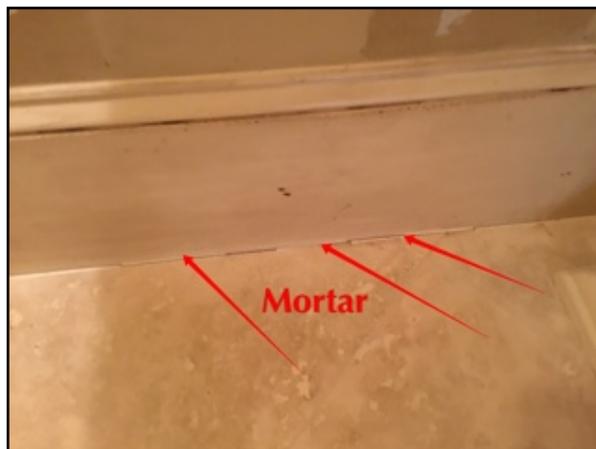
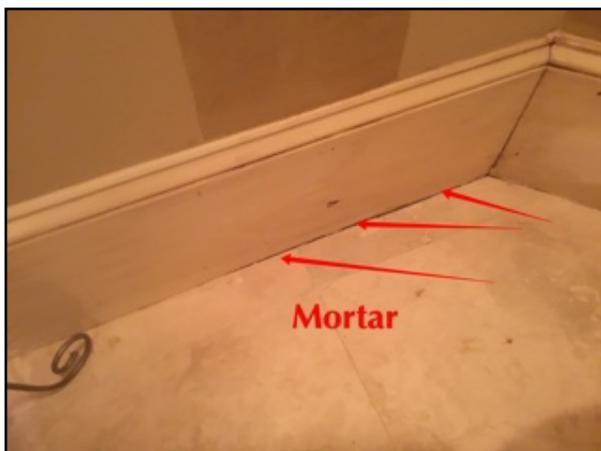
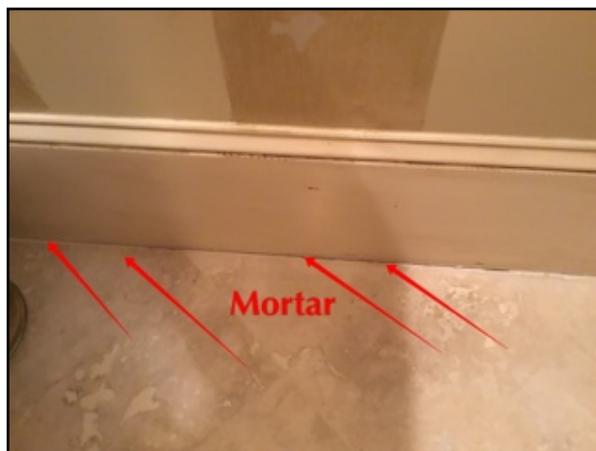
Condition: Repair or Replace

Where tile meets base trim needs repair as it needs additional mortar.

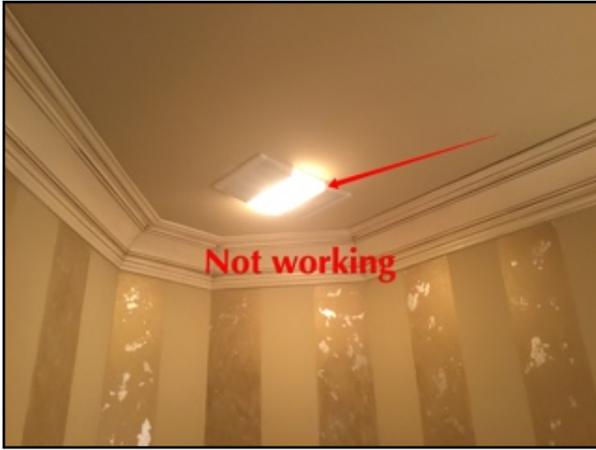
Figure 60-1

Condition: Further Evaluation Required

Ventilation fan not working. Further evaluation required and repaired.

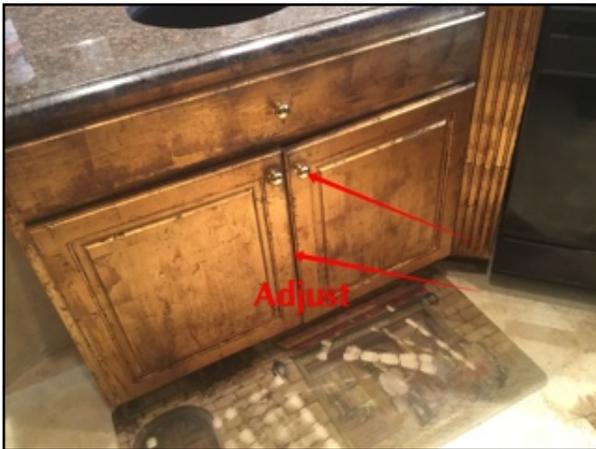
Figure 61-1

Condition: Marginal

Cabinet door in basement kitchen area needs adjustment.

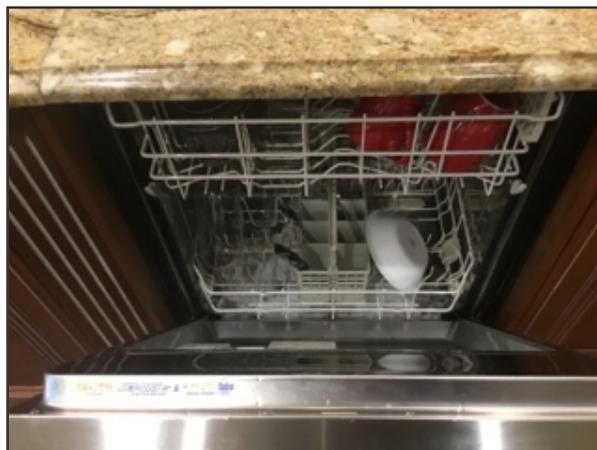
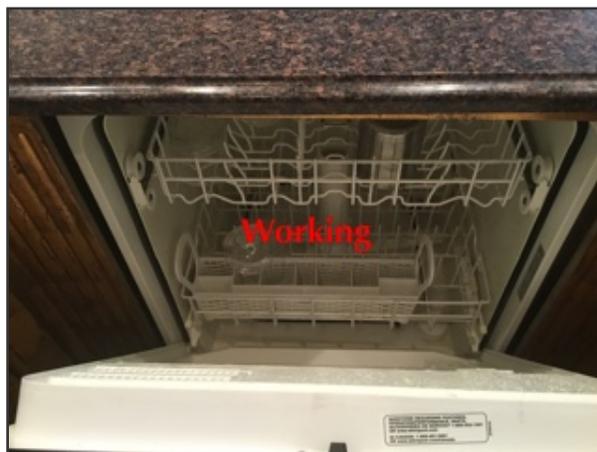
Bosch, Kenmore
Condition: Further Evaluation Required

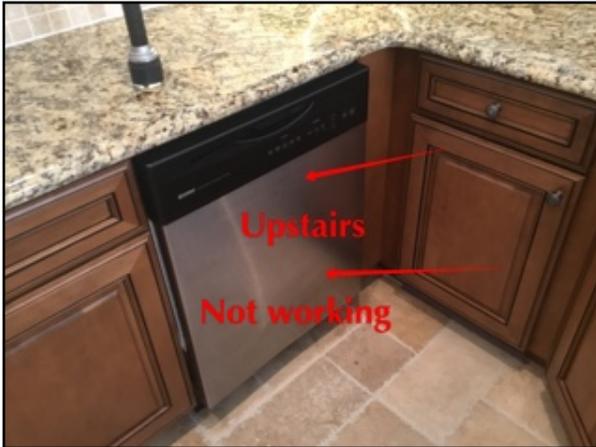
Figure 62-1

Comment 62:

Upstairs kitchen dishwasher was not working correctly at time of inspection. Further evaluation needed.

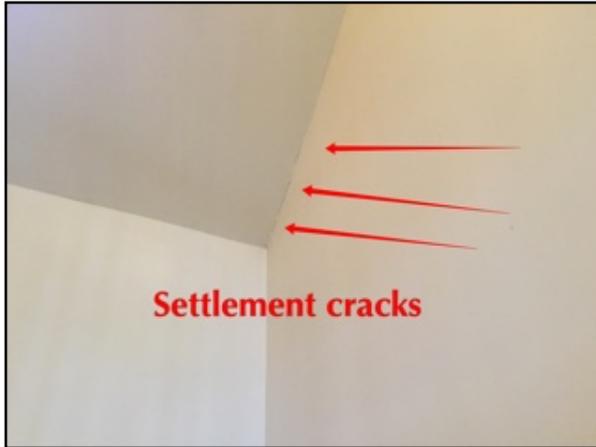
Figure 63-1

Monitor: Minor cracks were noted in the ceiling and/or walls of foyer. These are normally the result of the natural settlement process. In the absence of further cracking, repair should not be necessary (See Photo).

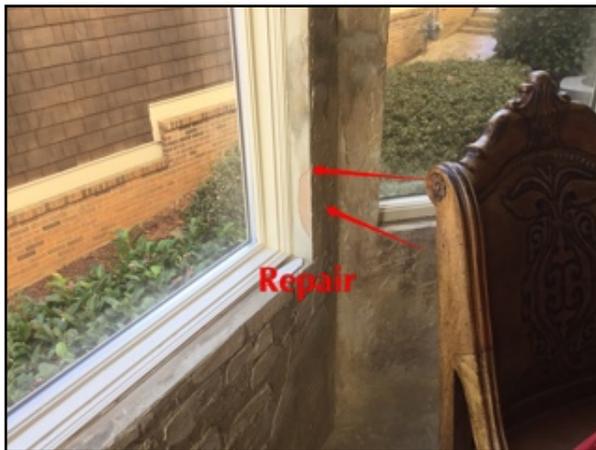
Figure 64-1

Comment 64:
Bay window down in basement area the mortar has come loose around window and needs repair.

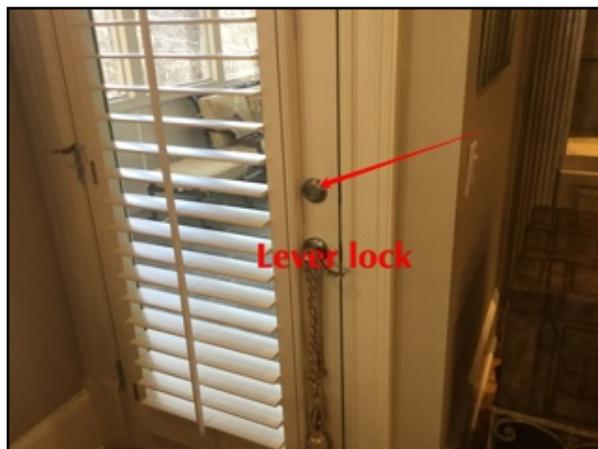
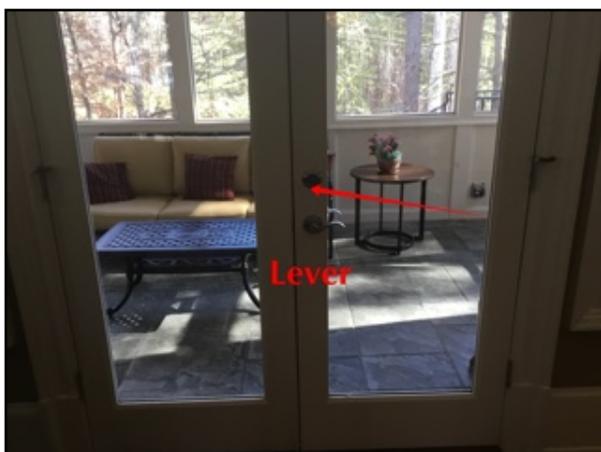
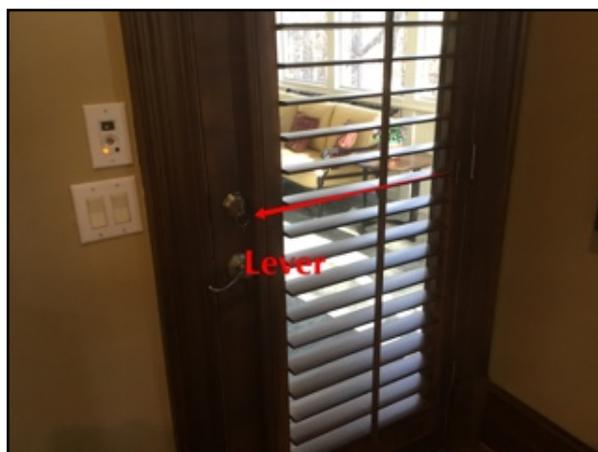
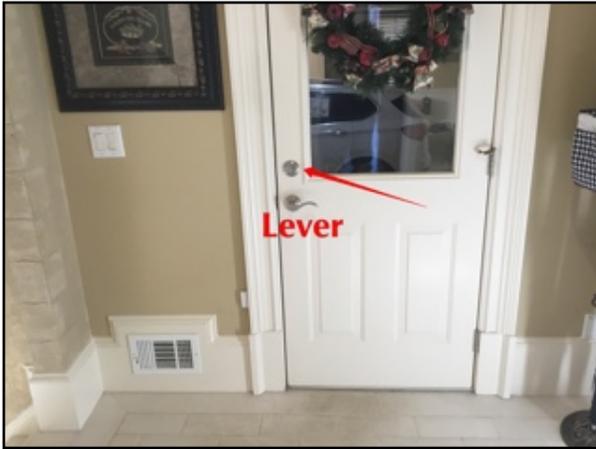
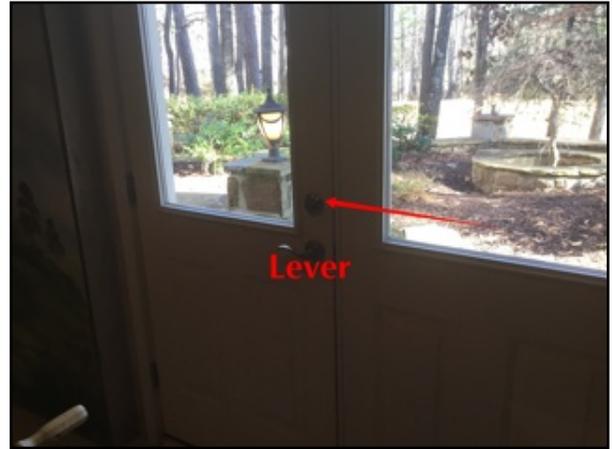
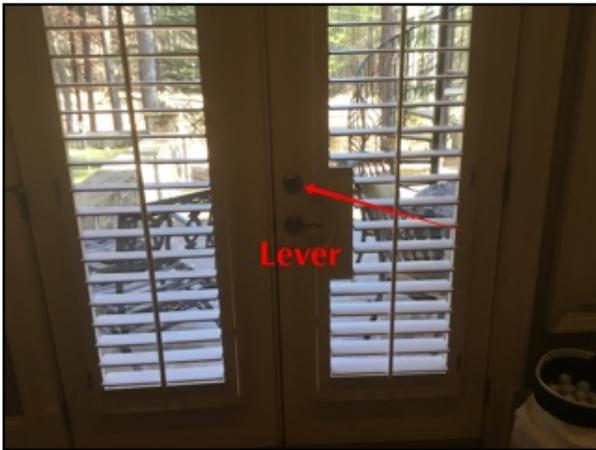
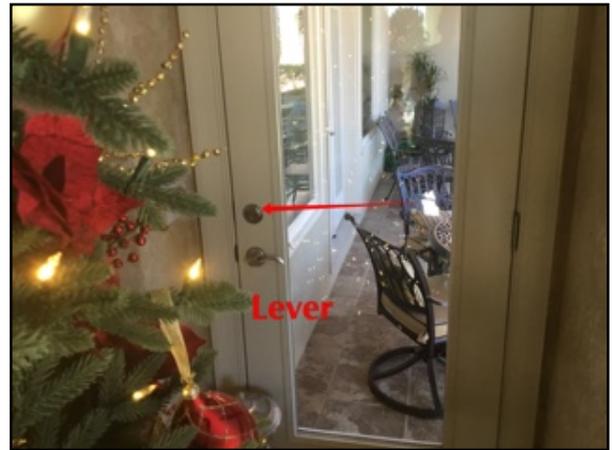
Improve, Safety Issue: Double keyed deadbolts were noted on the exterior doors, which is against current day codes for proper emergency egress from the home. Recommend replacing these with the type that have levers on the interior side.

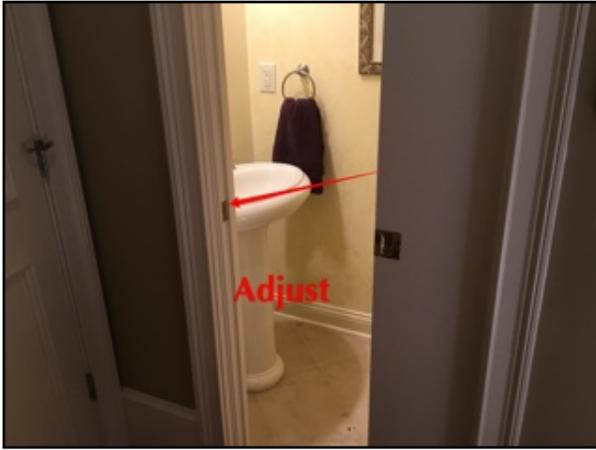
Figure 66-1

Comment 66:

Pocket door in upstairs 1/2 bath is not latching correctly. Adjustment needed.

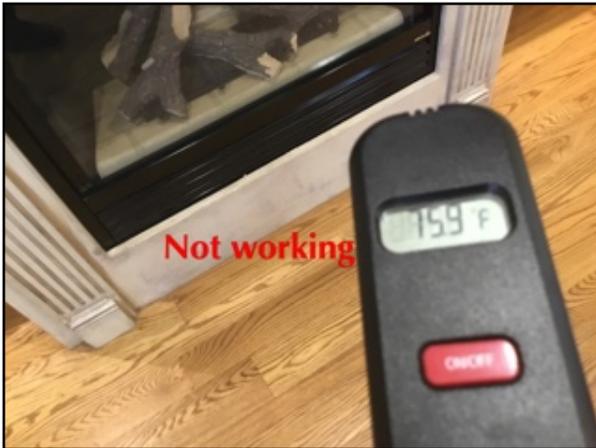
Figure 67-1

Comment 67:

Fireplace in master did not come on at time of inspection with remote. Ask seller if working. Or change out batteries.

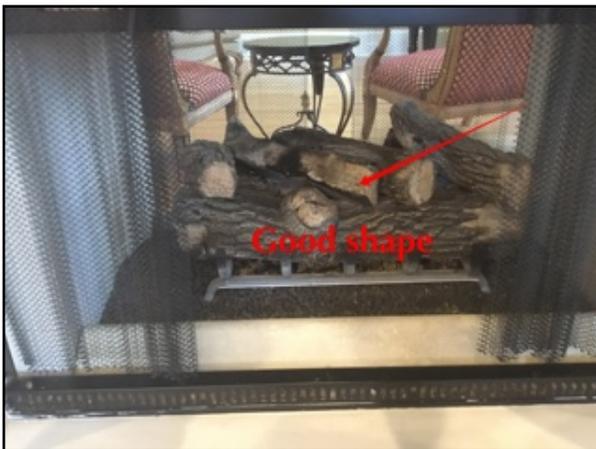
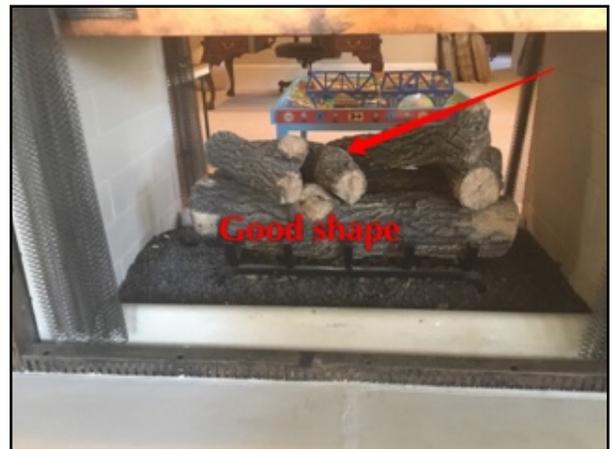
Comment 68:

Gas tested working.

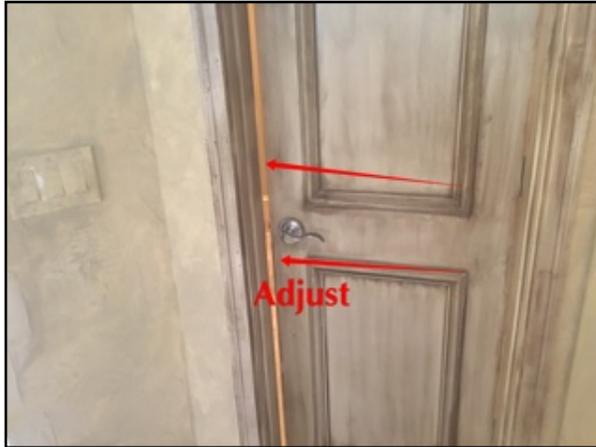
Figure 69-1

Comment 69:

Basement bathroom door not closing properly. Needs adjustment.

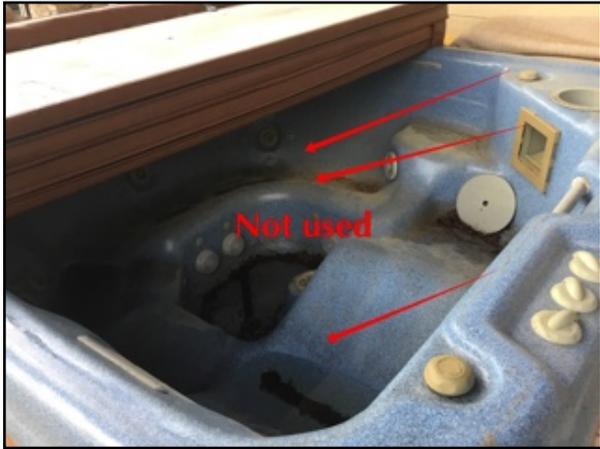
Figure 71-1

Comment 71:

Spa does not look like its been used in a while. Would need to speak with seller to see if it properly works.
