Atlanta Property Inspections, Inc.

HOME INSPECTION REPORT

712 Sandringham Drive, Alpharetta, GA 30004
Inspection prepared for: Hydi Kalmin
Date of Inspection: 1/9/2020 Time: 1:30 PM
Age of Home: 23 Years Old (1997) Size: 1630 SF
Weather: Sunny, 60 Degrees, Dry Soil

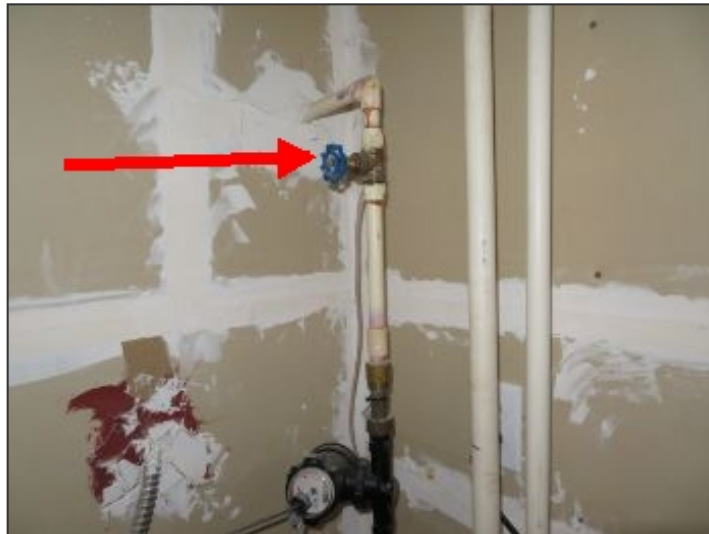
• The supply piping appears to be serviceable, no concerns were noted.

Main water cut off located near water heater

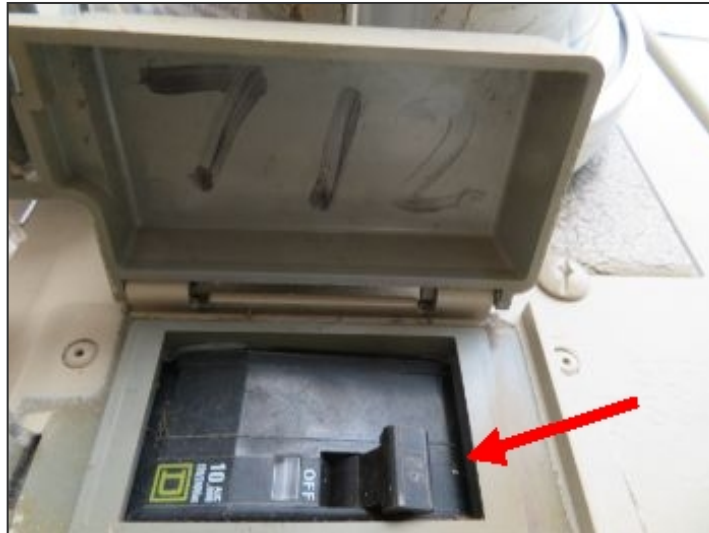
- **A 125 amp main breaker is present at the exterior meter location; appears serviceable, no concerns were noted.**

Main electrical cut off at exterior

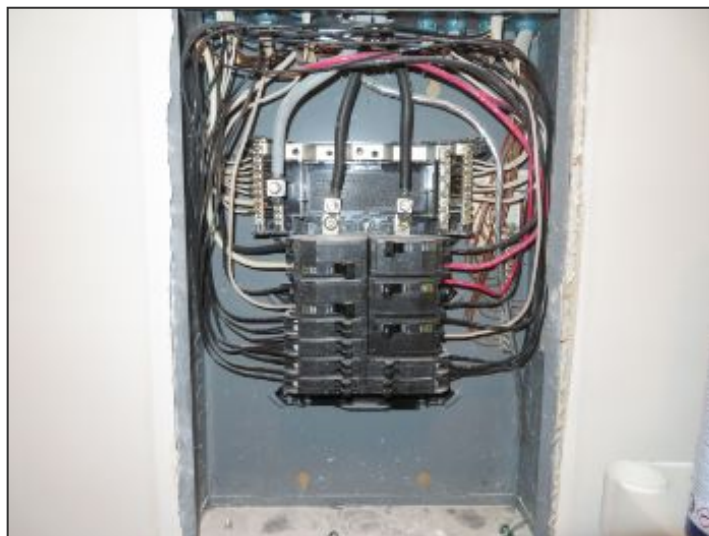
- **The main panel is located in the laundry room . Circuit breakers are present. The main panel box appears serviceable during a limited visual inspection inside the panel; no concerns were found.**

Interior view of main panel

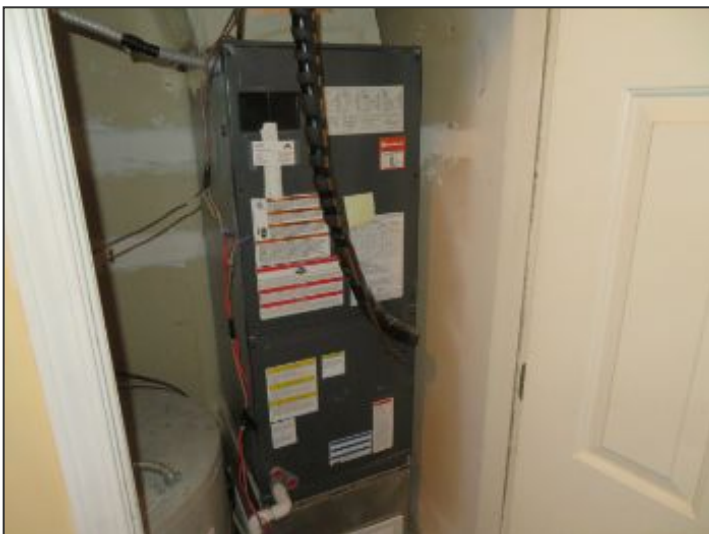
• The electric heating system appears serviceable; the heating system was operated in the heat pump cycle as well as the electric strip cycle and was found to be functioning normally during a limited visual inspection, no significant concerns were noted.

The heat pump was tested and produced heat at 103 degrees. The heat strips and heat pump were tested together and produced heat at 127 degrees. We recommend that you continue to maintain the system and have it serviced regularly, at least once per year for units over 5 years old.

Air handler located in hall closet

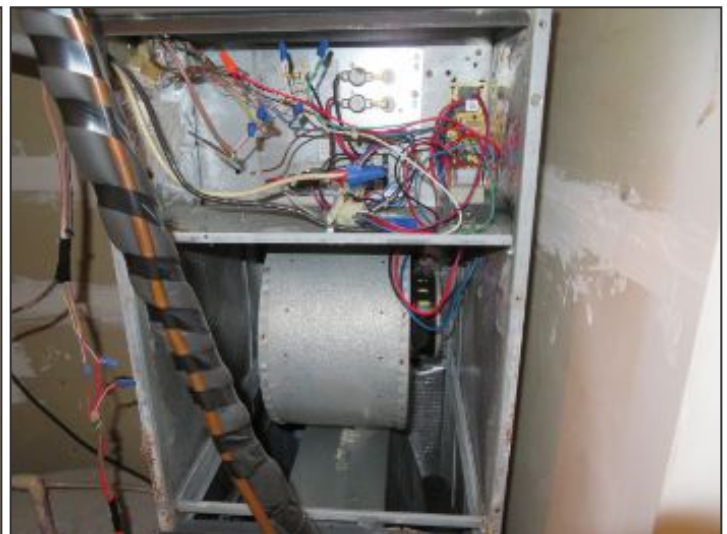
Interior view of air handler

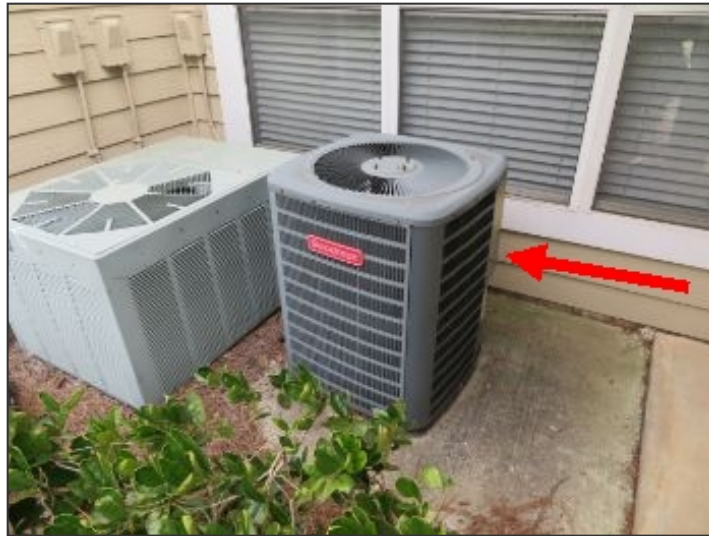
We are unable to inspect the cooling system due to cold weather. The outside temperatures have dropped below 60 degrees during the day or during the previous overnight hours. Due to concerns regarding possible damage to the unit, the air conditioner was not operated and could not be fully inspected during this cold weather inspection. This inspection is limited to a visual inspection and a quick start up to insure the unit is functional.

High efficiency AC unit

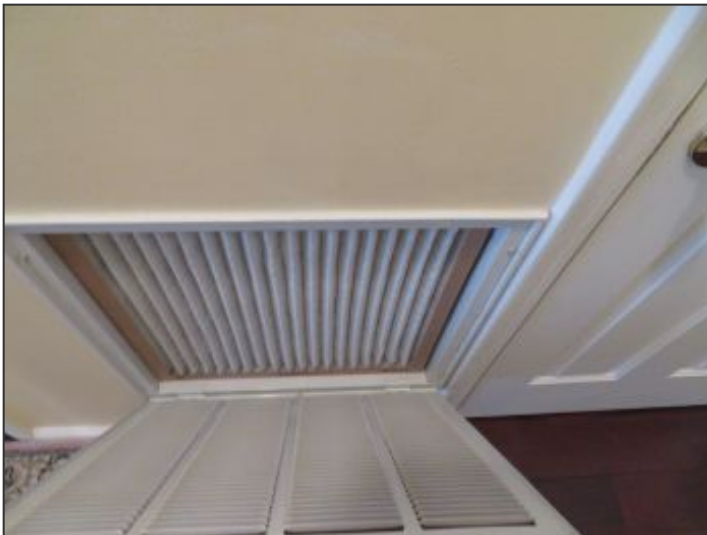
Location of wall filter

• The filters appear serviceable. No concerns were noted. Client is encouraged to change the filters regularly. Regular filter changing helps to maintain clean HVAC equipment, cleaner air ducts, and reduced dirt and dust inside the home. Consider using good quality filters. Good filter choices include a pleated filter or larger media filter that provides more surface area for improved air cleaning. Look for filters with a higher micro-particle performance rating (800 and up), and a higher MERV rating (Minimum Efficiency Reporting Value - 8 to 10 and up).
