Property Inspection Report

Property address: **6422 Vernon Woods Dr NE
Atlanta GA 30328**

Inspection date: **Saturday, February 1, 2020**

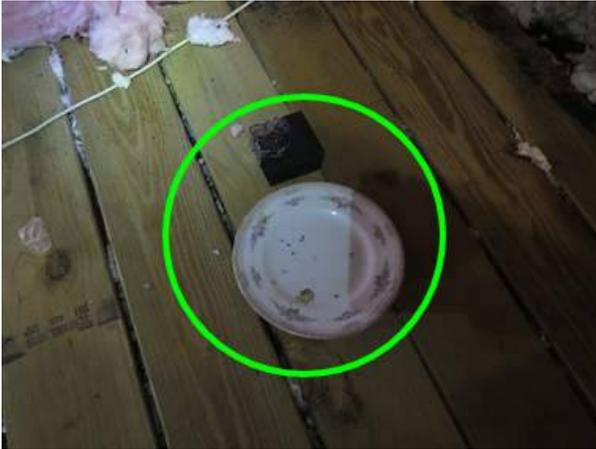
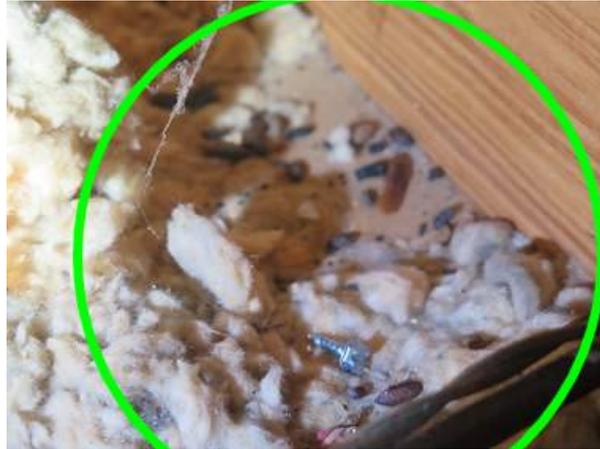
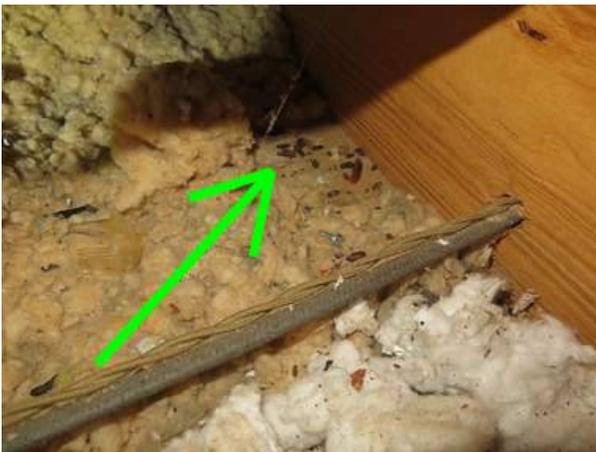
Evidence of rodent infestation was found in the form of feces, traps, poison and/or damaged insulation in the attic. Consult with the property owner about this. A qualified person should make repairs to seal openings in the structure, set traps, and clean rodent waste as necessary. Recommend following

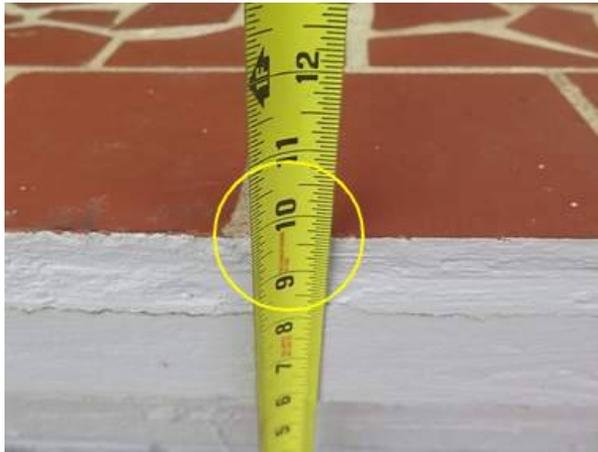
Photo 5-2

The risers for stairs at one or more locations varied in height and pose a fall or trip hazard. Risers within the same flight of stairs should vary by no more than 3/8 inch. At a minimum, be aware of this hazard, especially when guests who are not familiar with the stairs are present. Recommend that a qualified contractor repair per standard building practices.

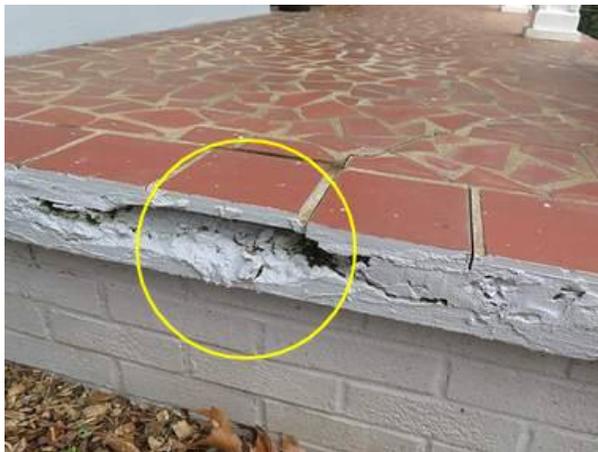
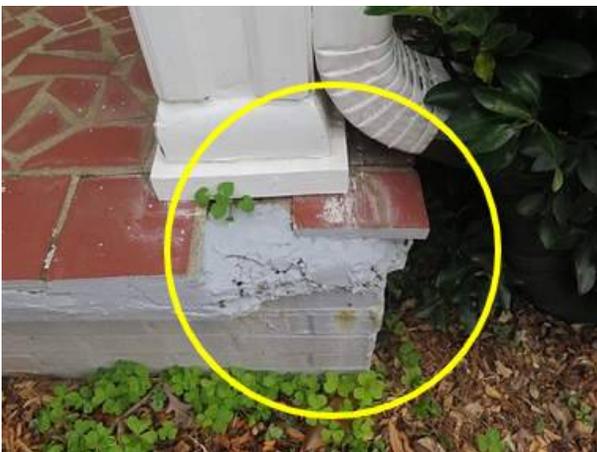
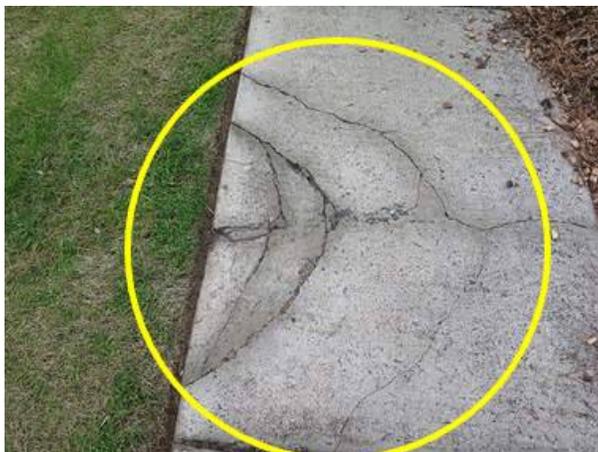
8) Cracks, holes, settlement, heaving and/or deterioration were found in sidewalks and/or patios. Recommend that qualified contractor repair as necessary.

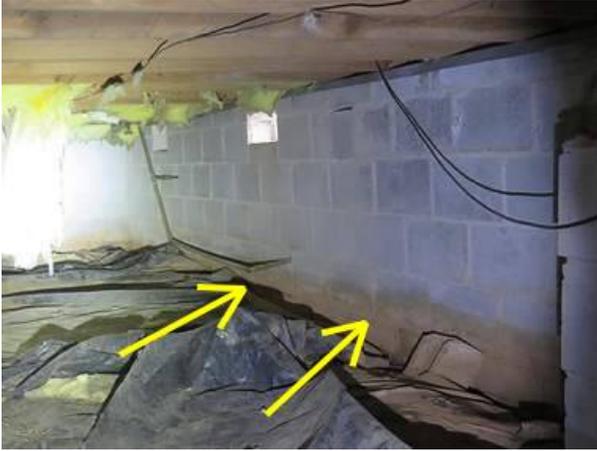
Photo 16-1

- Repairing, installing or improving rain run-off systems (gutters, downspouts and extensions or drain lines)
- Improving perimeter grading
- Repairing, installing or improving underground footing and/or curtain drains

Ideally, water should not enter crawl spaces, but if water must be controlled after it enters the crawl space, then typical repairs include installing trenches, gravity drains and/or sump pump(s) in the crawl space.

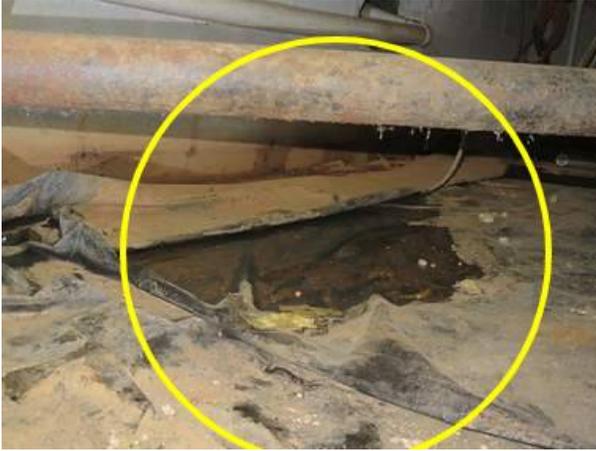
Photo 18-1

Typically such repairs include:

- Repairing, installing or improving underground footing and/or curtain drains
- Applying waterproof coatings to foundation walls
- Digging trenches in the crawl space to collect or divert water
- Installing sump pumps

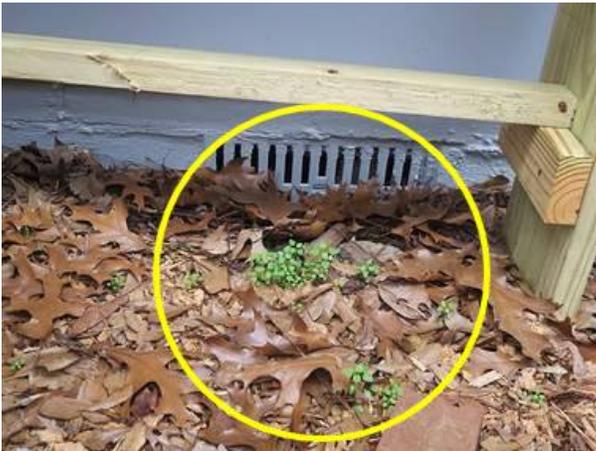
Photo 19-1

One or more crawl space vents were below grade, and either no wells were installed, or wells were substandard. Vent wells should be installed when vents are at or near grade to prevent debris from blocking vents and/or water from entering vents. This is a conducive condition for wood-destroying organisms. Recommend that a qualified person install, replace or repair vent wells per standard building practices.

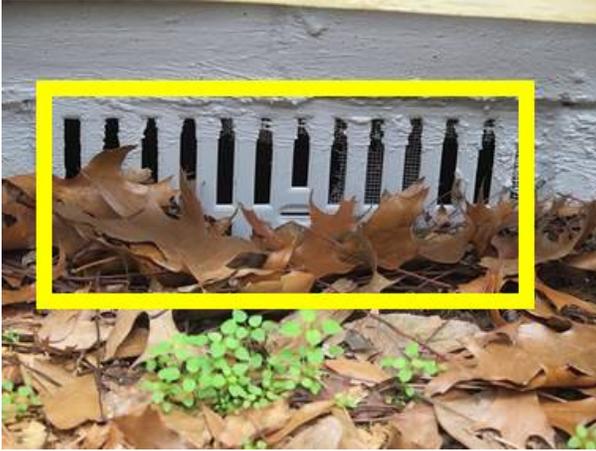
Photo 23-1

23) 🛠️🐭 The screens for one or more crawl space vents were damaged. Vermin or pets can enter the crawl space and nest, die and/or leave feces and urine. Vermin often damage under-floor insulation too. Recommend that a qualified person install or replace screens where necessary using 1/8-inch to 1/4-inch wire mesh.

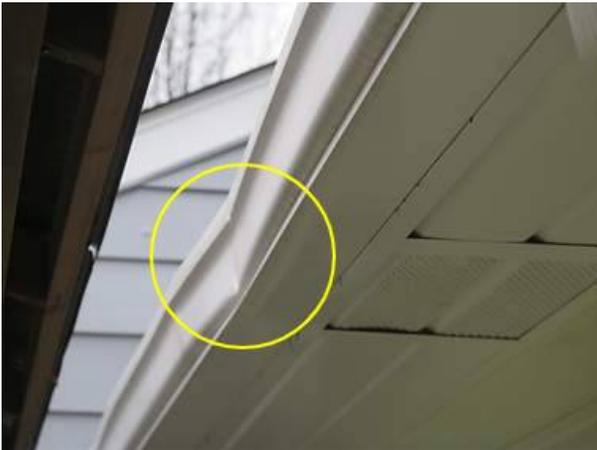
Photo 28-1

One or more gutters were damaged. Rainwater can come in contact with the building's exterior or accumulate around the building foundation as a result. This is a conducive condition for wood-destroying organisms. Recommend that a qualified person repair as necessary.

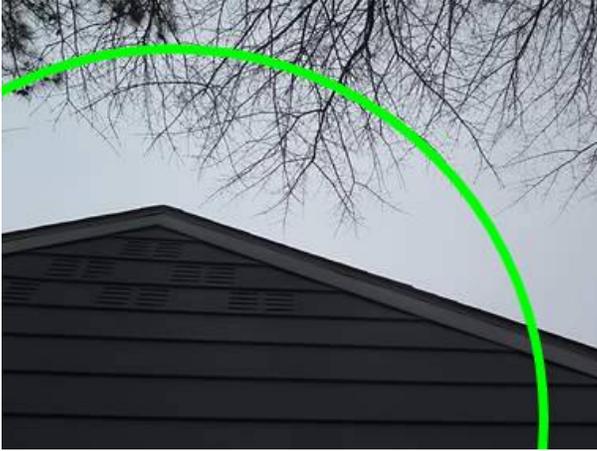
Photo 29-1

Vegetation such as trees, shrubs, and/or vines overhung the roof surface or were in contact with the roof edge. Organic debris such as leaves or needles are likely to accumulate in gutters and on the roof surface. Gutters can overflow and cause water to come in contact with the building exterior or water can accumulate around the foundation. This is a conducive condition for wood-destroying organisms. Vegetation in contact with the roof can damage the roof surface and/or the roof drainage system. Recommend pruning vegetation so as to not be in contact with the roof and to not overhang the roof surface. If vegetation is too tall then it should be pruned at least 10 feet above the roof surface.

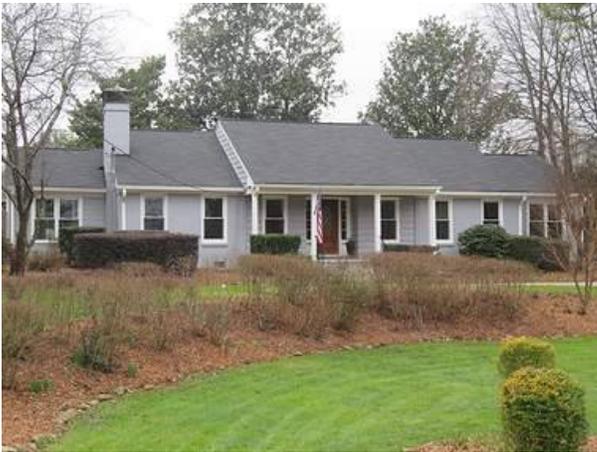
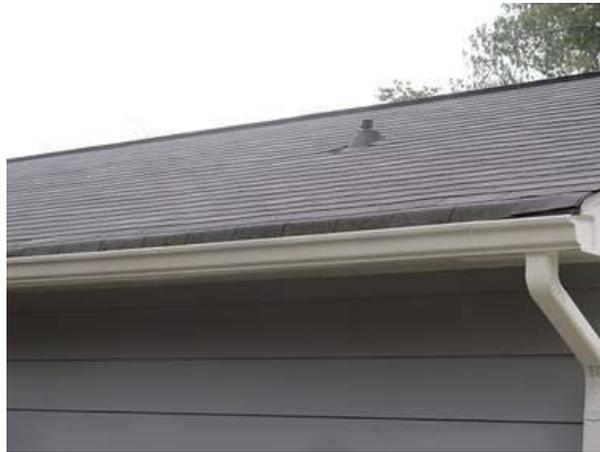
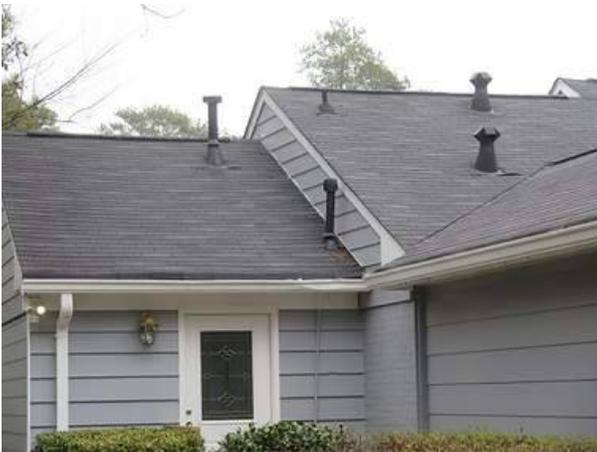
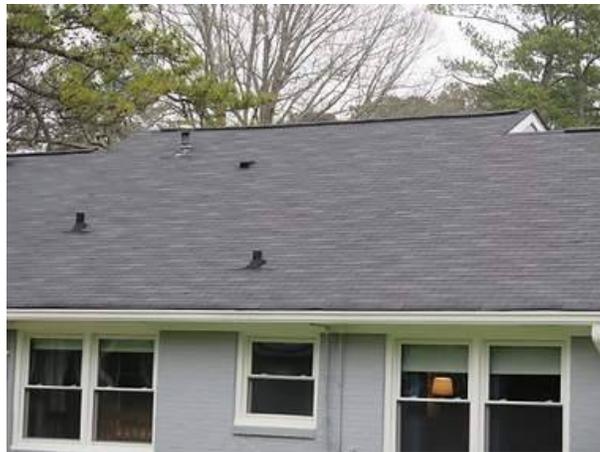
General photos of the roof surface.

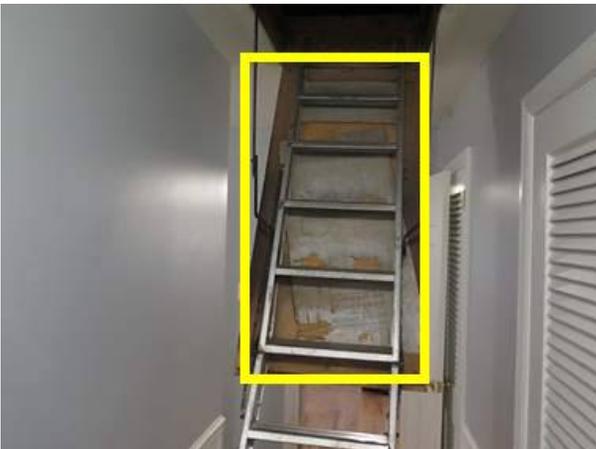
Photo 32-1

The pull-down attic stairs were not insulated. Typically, such stairs that are not insulated also do not have any weatherstripping installed. Recommend that a qualified person install insulation and weatherstripping per standard building practices for better energy efficiency. For more information, visit:

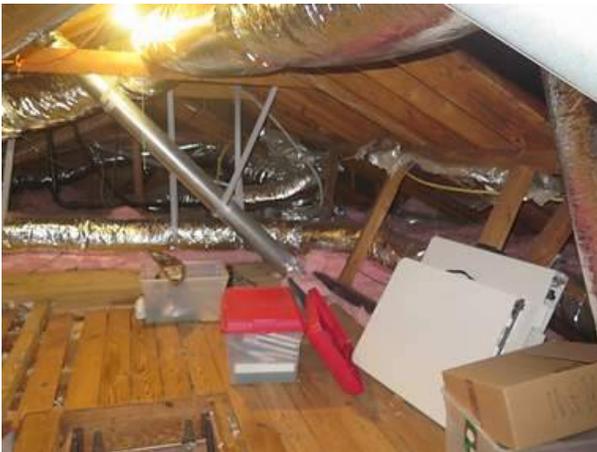
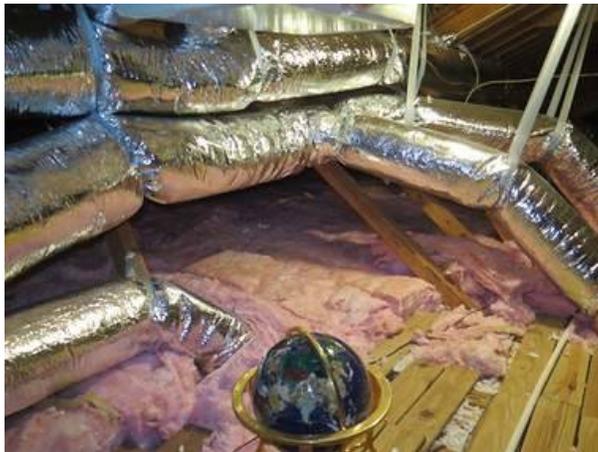
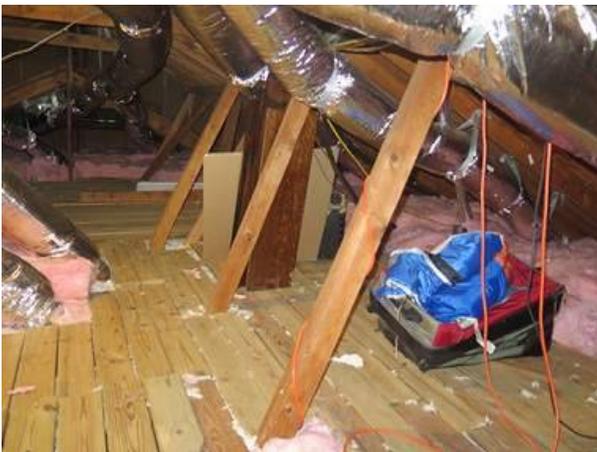
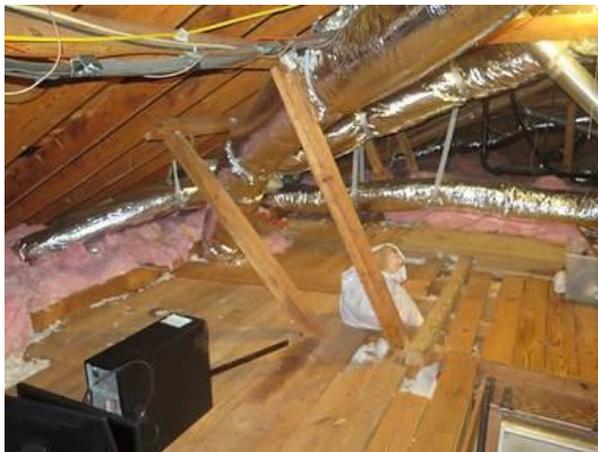
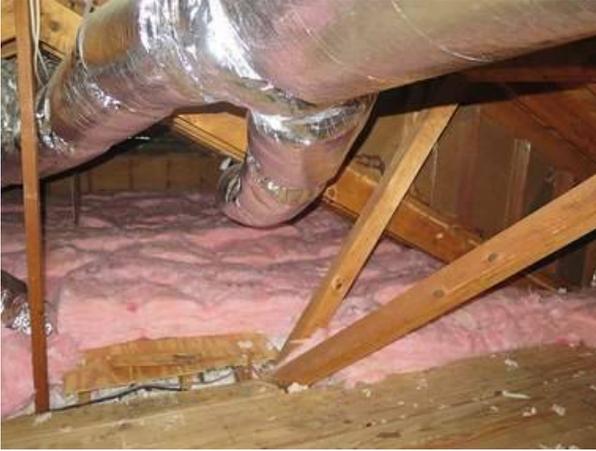
35) General photos of the attic area and roof structure. All attic areas and roof structures more than 15 feet from attic access point(s) #A were inaccessible due to possible damage to the insulation if traversed and/or ducts or pipes blocking. These areas were not evaluated and are excluded from the inspection.

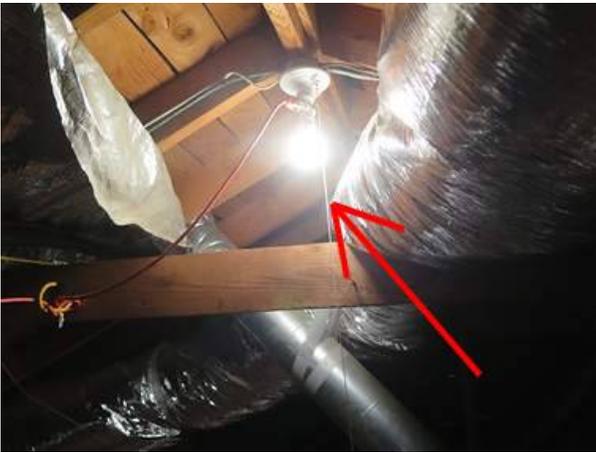
Photo 36-1

General photo of the attic light switch and location.

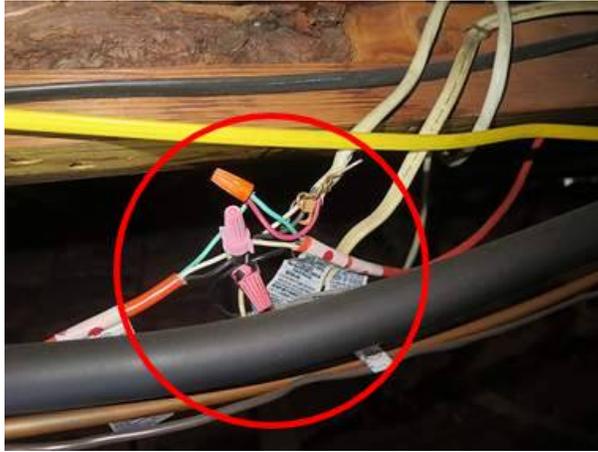
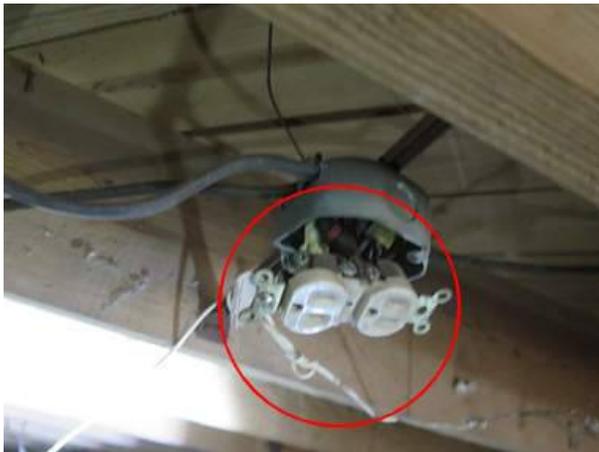
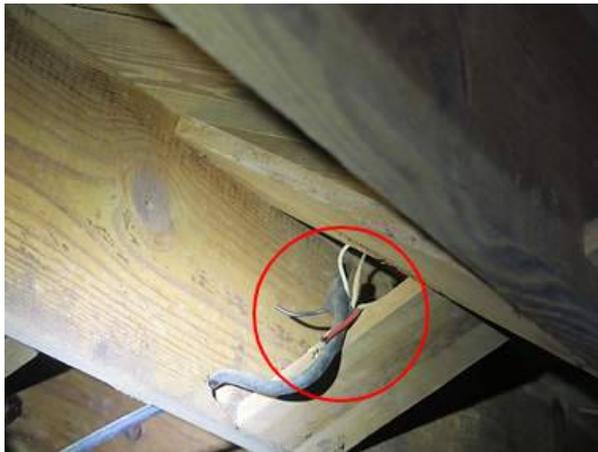
Substandard wiring was found at the attic and/or crawl space. For example, loose wiring, unterminated wires, exposed splices, missing or broken cover plates and/or loose boxes. This is a safety hazard. Recommend that a qualified electrician evaluate and repair as necessary and per standard building practices.

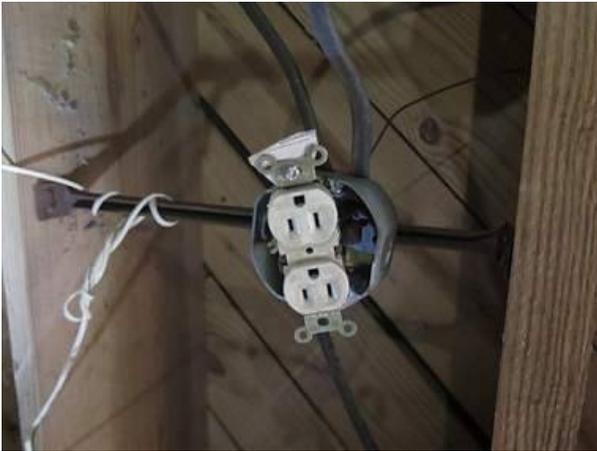
Photo 38-1

One or more electric receptacles at the crawl space had no visible ground fault circuit interrupter (GFCI) protection, or the inspector was unable to determine if GFCI protection was present. If not GFCI-protected, receptacles in wet areas pose a shock hazard. Recommend that a qualified electrician evaluate and install GFCI protection if necessary and per standard building practices. General guidelines for GFCI-protected receptacles include the following locations:

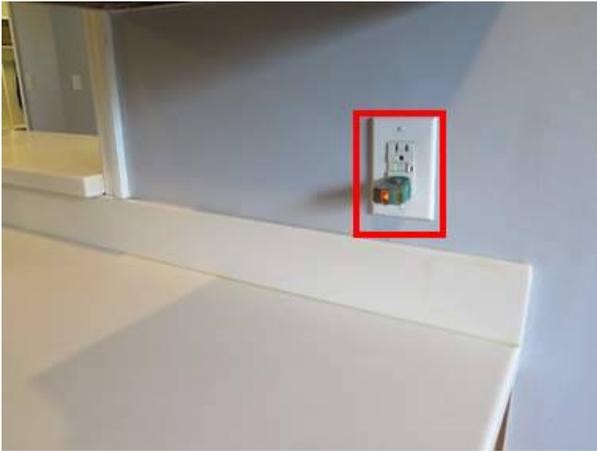
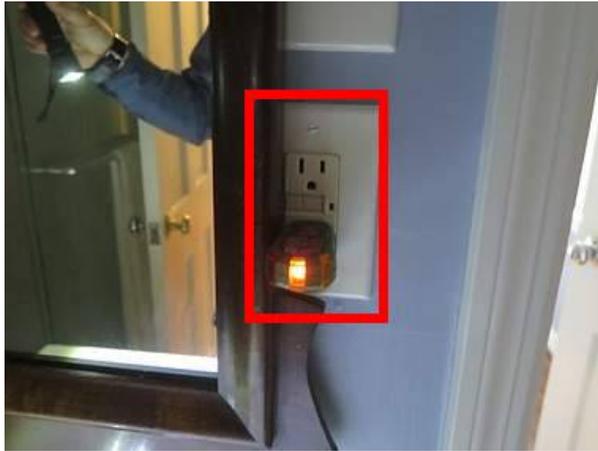
One or more ground fault circuit interrupter (GFCI) receptacles (outlets) wouldn't trip with a test instrument at the kitchen and/or bathroom(s). This is a potential shock hazard. Recommend that a qualified electrician evaluate and repair as necessary.

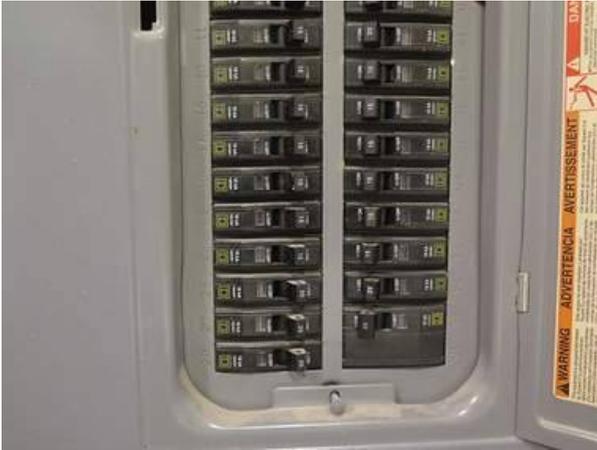
Photo 40-1

They're equipped with sophisticated electronics that can detect an arcing condition (like in a frayed lamp cord), which may not be detected by a standard circuit breaker until after a fire has started. AFCI protection is not just required for new construction; it's now also required where branch-circuit wiring is modified, replaced or extended into existing homes.

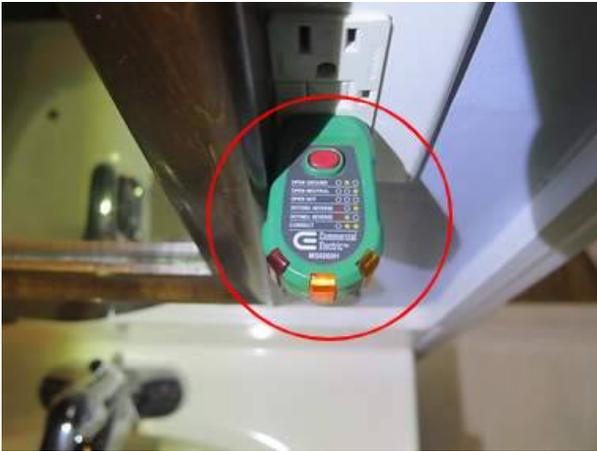
Photo 41-1

One or more ground fault circuit interrupter (GFCI) type receptacles (outlets) had an open ground. GFCI receptacles will work (trip) without a ground; but a 3-slot receptacle on an open ground circuit can result in appliances that require a ground can be used without one. This is a potential shock hazard. Recommend that a qualified electrician upgrade circuits that require GFCI protection (e.g. in wet areas) with grounded wiring per standard building practices.

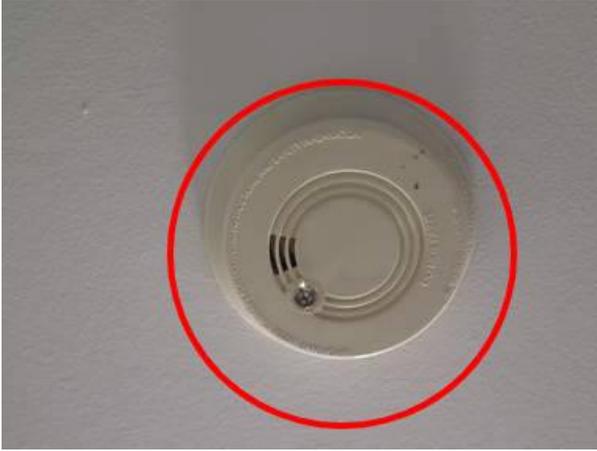
Photo 42-1

Smoke alarms were missing from one or more bedrooms. Additional smoke alarms should be installed as necessary so a functioning alarm exists in each hallway leading to bedrooms, in each bedroom, and on each level. For more information, visit:

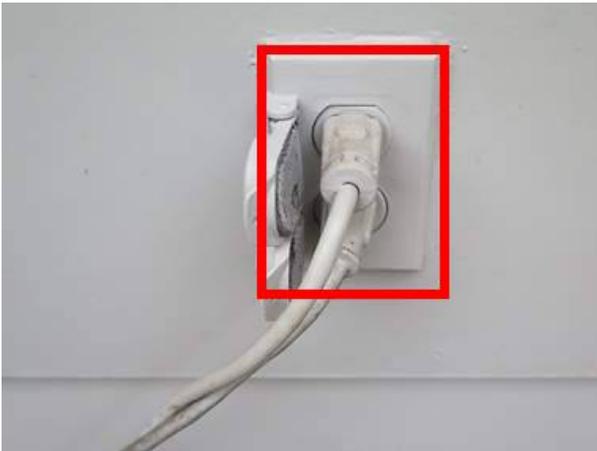
Photo 43-1

One or more exterior receptacle (outlet) covers were substandard or damaged. Outdoor outlets should have watertight covers that allow them to stay covered even with a cord plugged in. This is a potential shock hazard. Special weathertight outlets are required outdoors or where water may contact the outlet. Recommend that a qualified person replace covers where necessary.

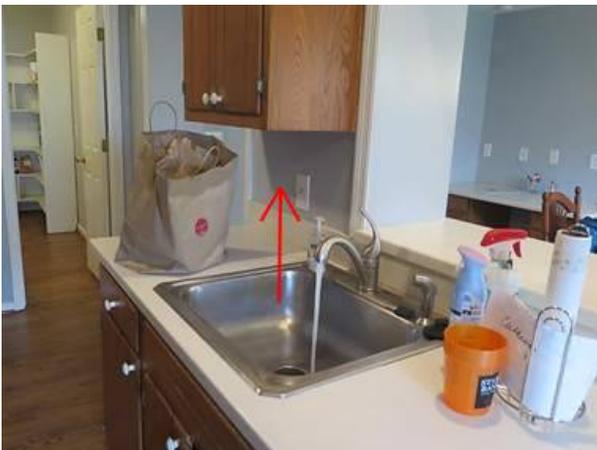
Photo 44-1

Few receptacles (outlets) were installed in one or more areas by modern standards. This can result in "octopus" wiring with extension cords, which is a fire hazard. In modern construction, electrical outlets should be located so that there is an outlet within six feet horizontally of any point along the wall (in finished living spaces). Translated, this means there should be an outlet every twelve feet along the wall. Above kitchen counters, modern codes require outlets spaced so that no point on the counter is more than two feet from a receptacle. Consult with a qualified electrician about upgrading circuits with additional receptacles per standard building practices.

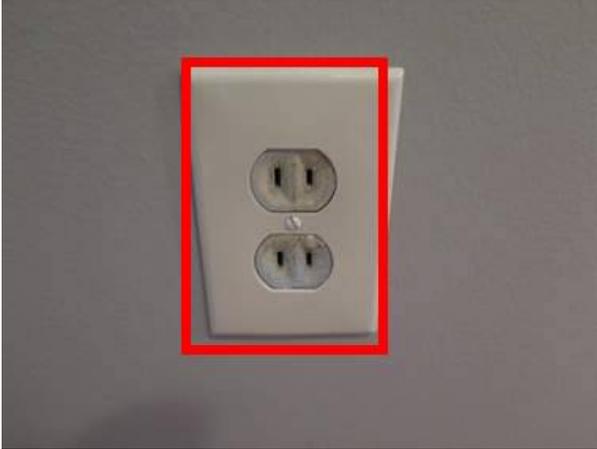
Photo 45-1

45) 🔍 2-slot receptacles (outlets) rather than 3-slot, grounded receptacles were installed in one or more areas. These do not have an equipment ground and are considered unsafe by today's standards. Appliances that require a ground should not be used with 2-slot receptacles. Examples of such appliances include computers and related hardware, refrigerators, freezers, portable air conditioners, clothes washers, aquarium pumps, and electrically operated gardening tools. The client should be aware of this limitation when planning use for various rooms, such as an office. Upgrading to grounded receptacles typically requires installing new wiring from the main service panel or sub-panel to the receptacle(s), in addition to replacing the receptacle(s). Consult with a qualified electrician about upgrading to 3-wire, grounded circuits.

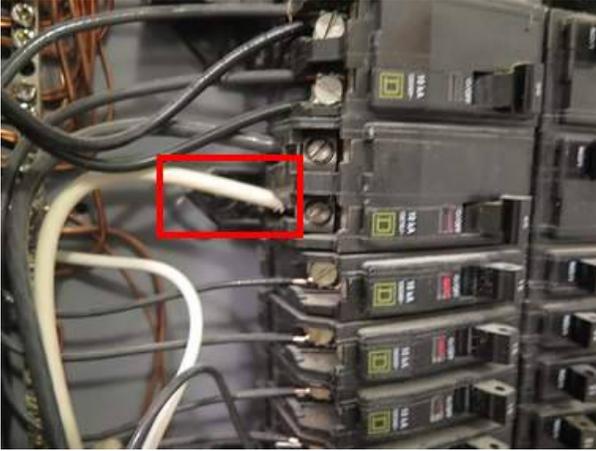
Photo 47-1

47) ⚡ One or more energized conductors in panel(s) # A had white, gray or green insulation. Insulation on energized conductors should be black or red in color to identify them as energized wires. Recommend that a qualified electrician re-identify wires per standard building practices. For example, by wrapping in black vinyl tape or marking with a black permanent marker.

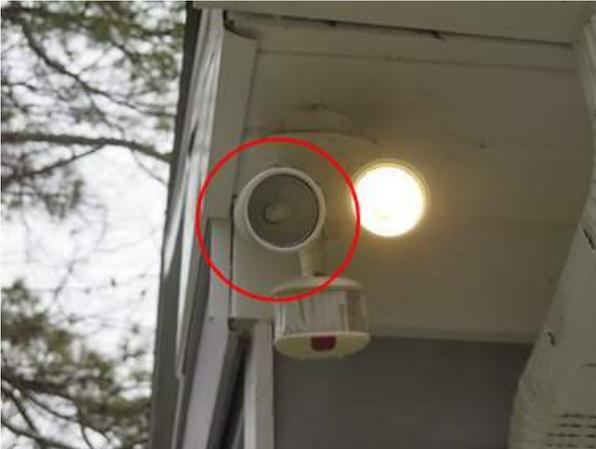
Photo 48-1

48) One or more light fixtures were inoperable (didn't turn on when nearby switches were operated). Recommend further evaluation by replacing bulbs and/or consulting with the property owner. If replacing bulbs doesn't work and/or no other switch(es) can be found, then recommend that a qualified electrician evaluate and repair or replace light fixtures as necessary.

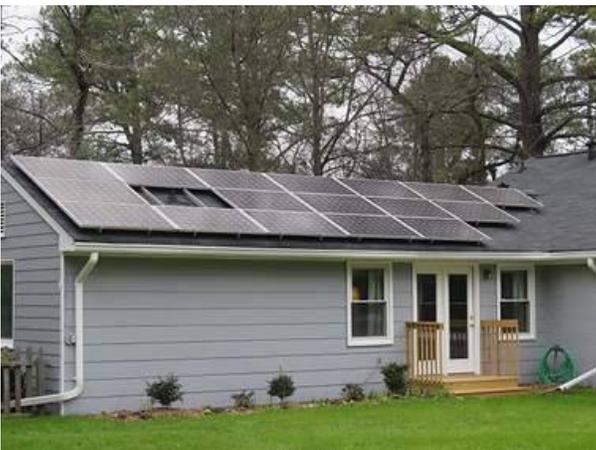
Photo 49-1

49) Equipment for a solar panel system was found. Solar panels, transfer switches, and any associated wiring are excluded from this inspection. Recommend that the client consults with the property owner or review documentation to familiarize themselves with the operation of this system.

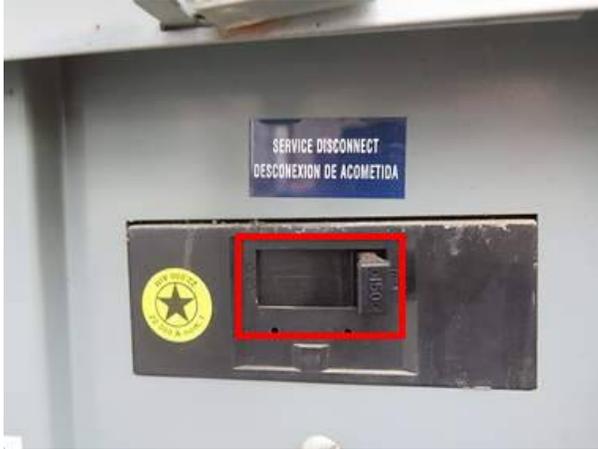
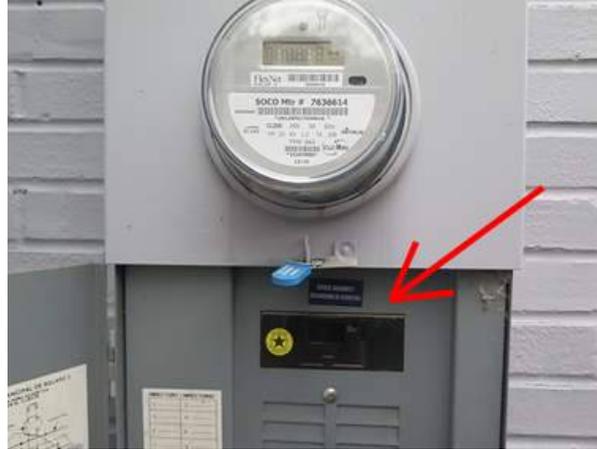
50) Photo of the main service switch located adjacent to the meter on the left side of the home.

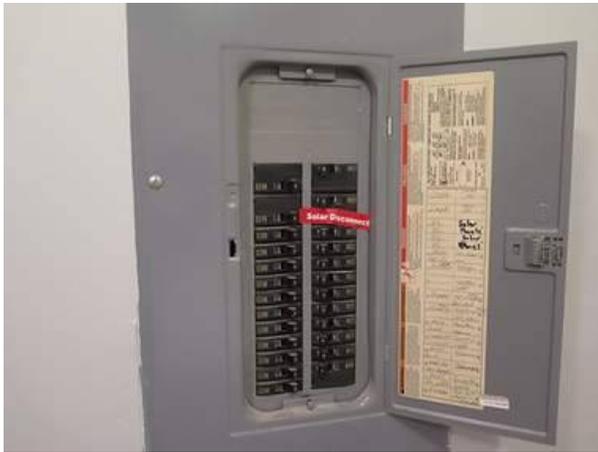
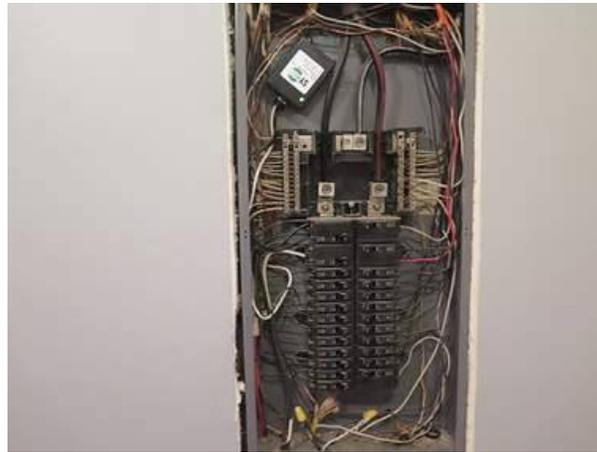
Photos of the service panel located in the laundry.

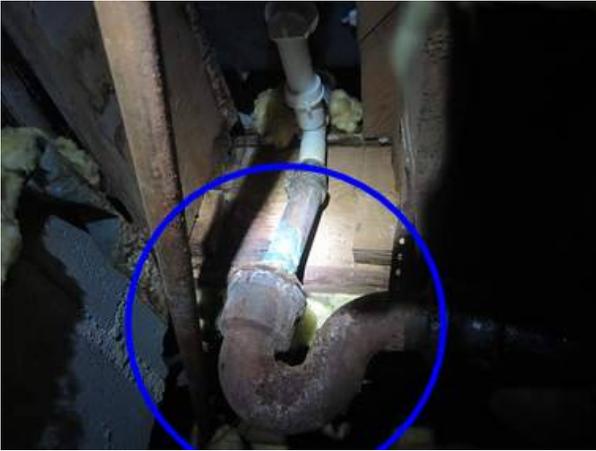
Photo 52-1

Significant corrosion was found in some drain and/or waste pipes or fittings. This can indicate past leaks, or that leaks are likely to occur in the future. Recommend that a qualified plumber evaluate and repair as necessary.

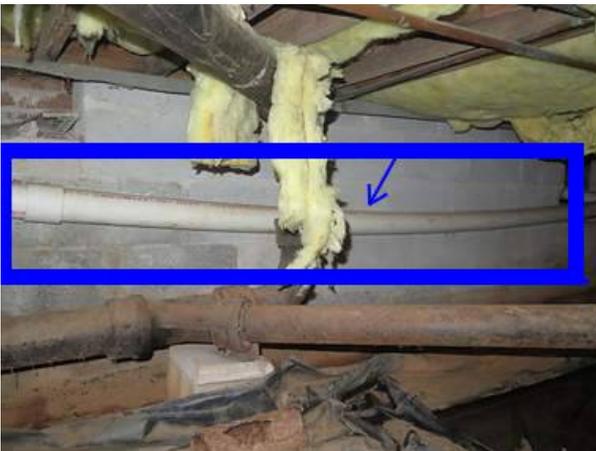
Photo 53-1

One or more waste pipes had a substandard slope. Clogging or leaks can occur as a result. Drain and waste pipes should be sloped 1/4 inch per foot of length if less than 3 inches in diameter, or 1/8 inch per foot of length for larger diameters. Recommend that a qualified plumber repair per standard building practices.

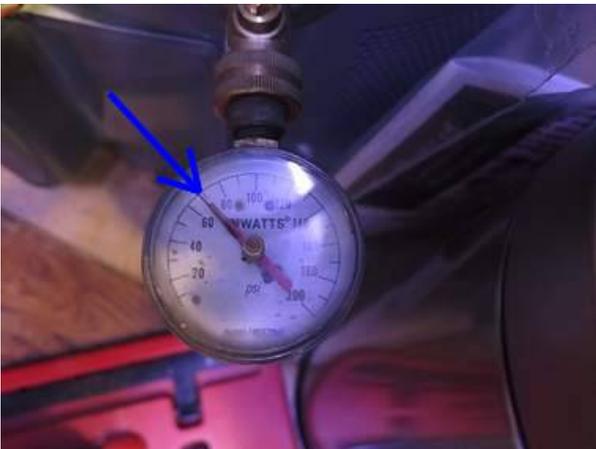
Photo 54-1

General picture of the water pressure as tested. 40-80 PSI is considered the normal range for water pressure in a home, and most plumbers recommend 50-60 PSI.

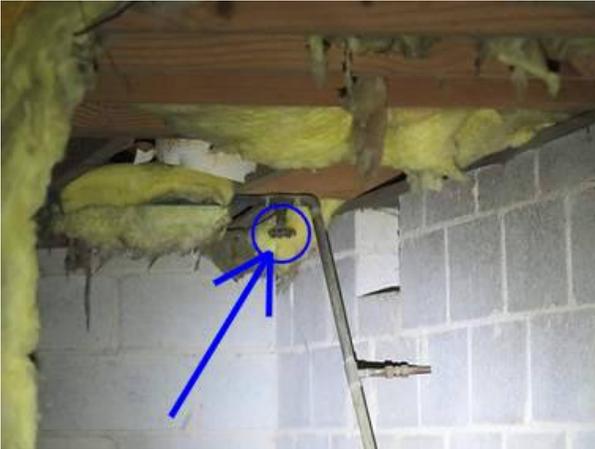
Photo 55-1

- 55) **i** What appeared to be the main water shut-off valve was located in the crawl space. This is an inconvenient location at best, and may prevent the water from being turned off in a timely manner in the event of a plumbing emergency. Consider having a qualified plumber relocate the shut-off valve to a more convenient location, such as in a closet or a cabinet under a sink.

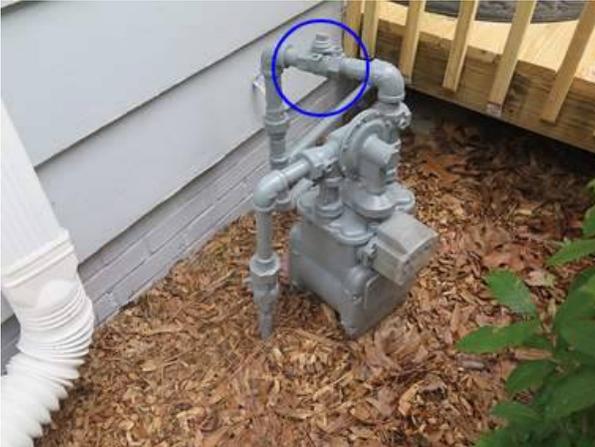
Photo 56-1

- 56) **i** Photo of the main natural gas shut-off valve adjacent to the meter along the right side of the home.

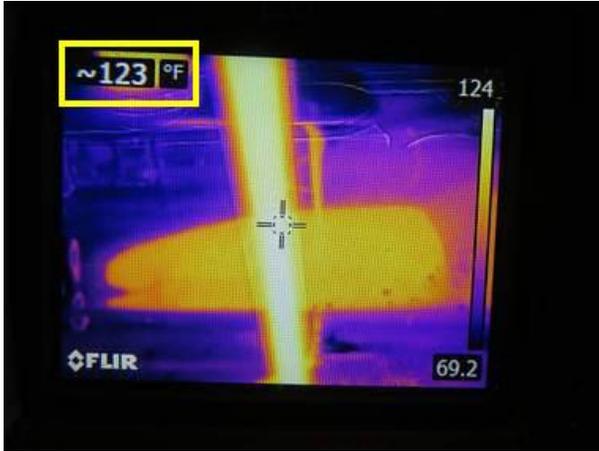
Photo 57-1

- 57) **+** The hot water temperature was greater than 120 degrees Fahrenheit. This is a safety hazard due to the risk of scalding. The thermostat should be adjusted so the water temperature doesn't exceed 120 degrees. If the water heater is powered by electricity, a qualified person should perform the adjustment, since covers that expose energized equipment normally need to be removed. For more information on scalding dangers, visit:

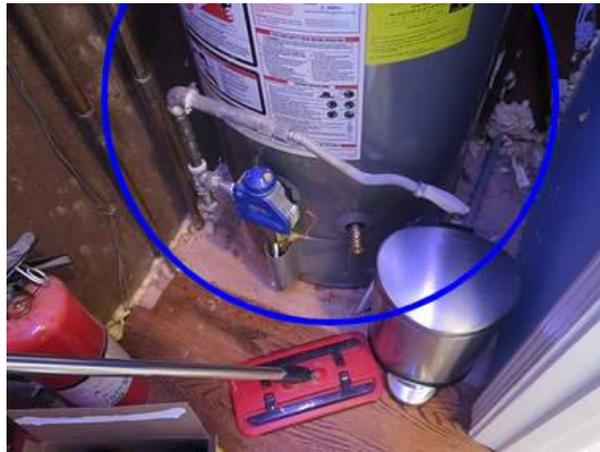
Photo 58-2

58) **i** A water heater was installed in or over a finished living space or in an area where leaking can cause damage, and no catch pan or drain was installed. Catch pans and drains prevent water damage to finished interior spaces below if or when the water heater leaks or is drained. If concerned, consult with a qualified contractor about installing these. Note that drain lines for catch pans are usually installed below the floor level and are difficult at best to install in an existing home. 510.7

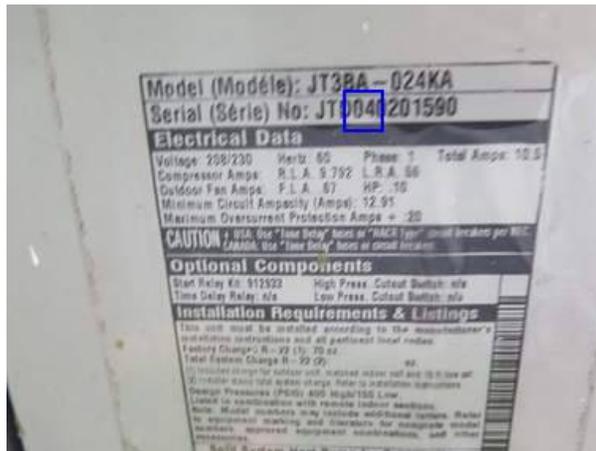
Photo 59-2

The estimated useful life for most heat pumps and air conditioning condensing units is 10-15 years. This unit appeared to be beyond this age and/or its useful lifespan and may need replacing or significant repairs at any time. Recommend budgeting for a replacement in the near future.

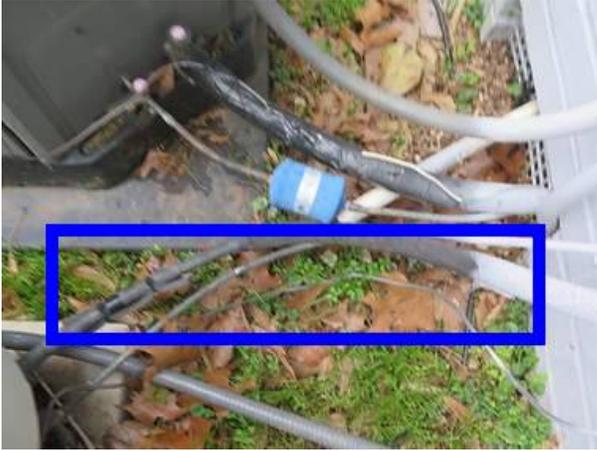
Photo 60-1

Insulation on the heat pump or air conditioning condensing unit's refrigerant lines was deteriorated or missing in some areas. This may result in reduced efficiency and increased energy costs. Recommend that a qualified person replace or install insulation as necessary.

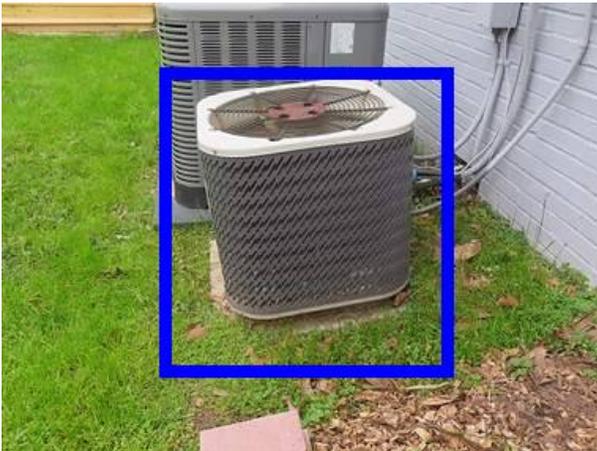
Photo 61-1

The pad for the heat pump or air conditioning condensing unit was not level. This unit requires adequate support. The compressor may be damaged if this unit is tilted 10 degrees or more. Also, the pad should elevate the unit above the soil to prevent corrosion. Recommend that a qualified person repair as necessary.

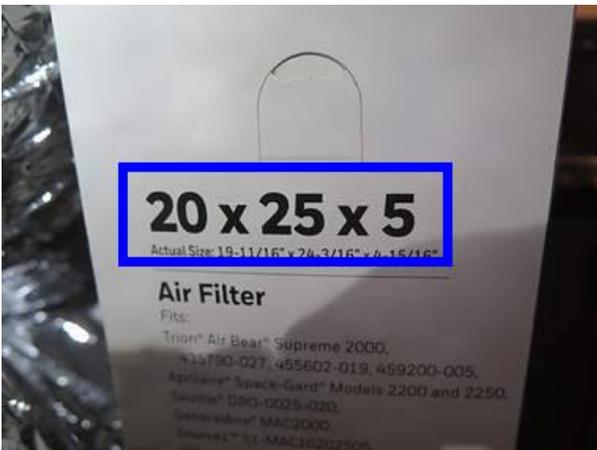
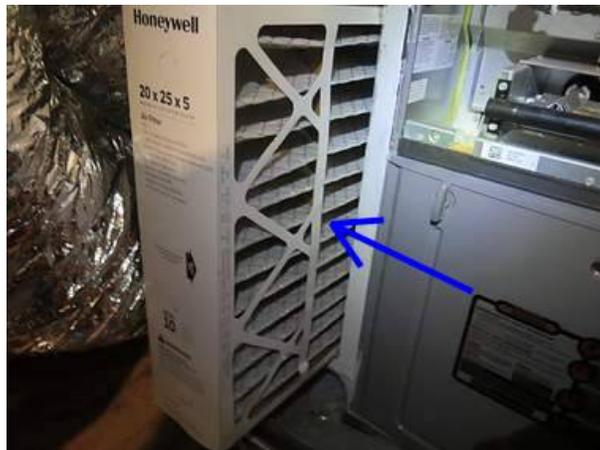
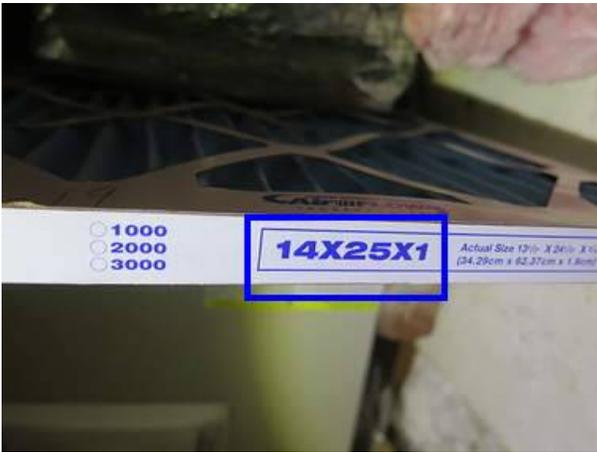
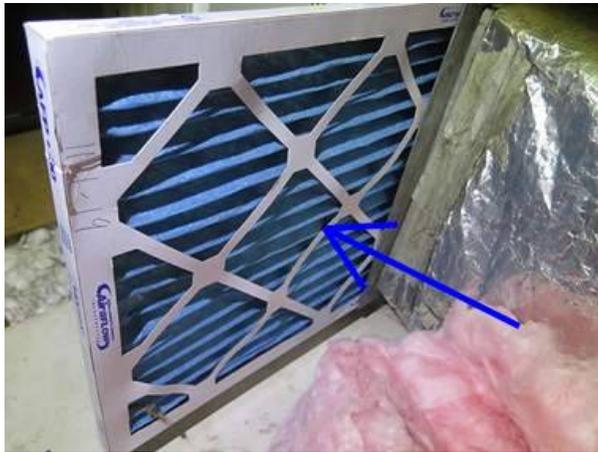
NOTE filter size - 14x25x1 and/or 20x25x5

Recommend replacing or washing HVAC filters upon taking occupancy depending on the type of filters installed. Regardless of the type, recommend checking filters monthly in the future and replacing or washing them as necessary. How frequently they need replacing or washing depends on the type and quality of the filter, how the system is configured (e.g. always on vs. "Auto"), and on environmental factors (e.g. pets, smoking, the frequency of house cleaning, number of occupants, the season).

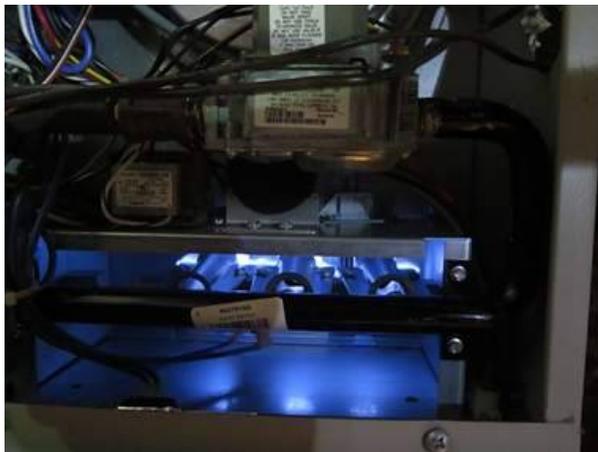
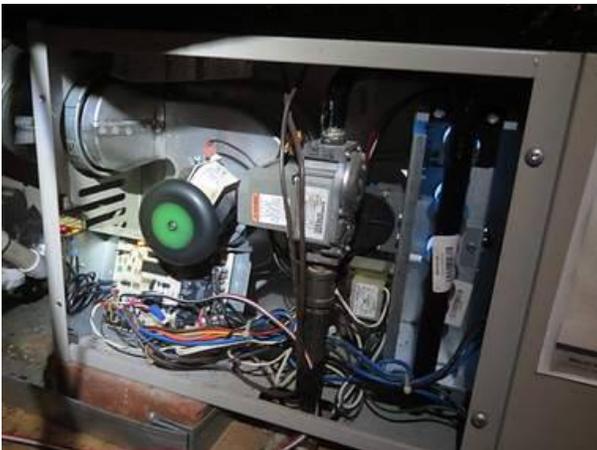
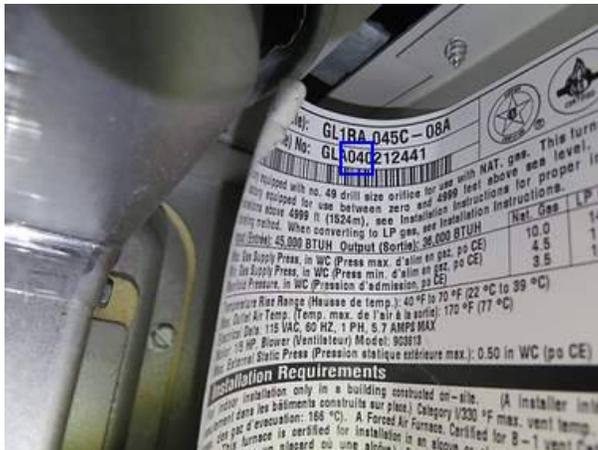
63) **i** The estimated useful life for most forced air furnaces is 15-20 years. This furnace appeared to be at this age and/or its useful lifespan and may need replacing or significant repairs at any time. Recommend budgeting for a replacement in the near future.

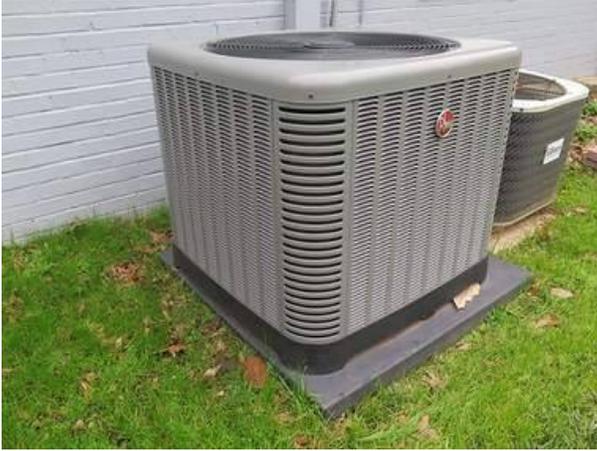
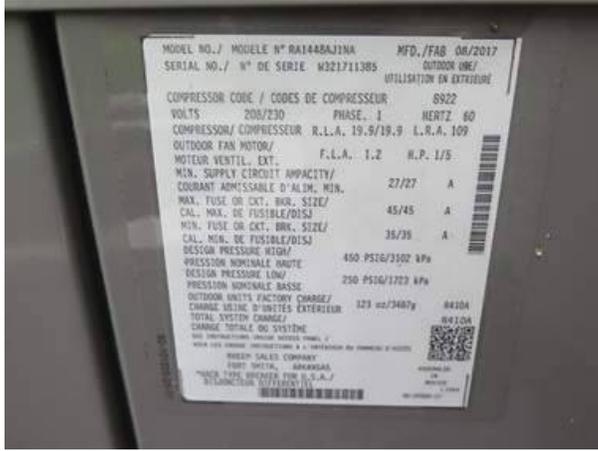
64) **i** The outdoor air temperature was below 65 degrees Fahrenheit during the inspection. Air conditioning systems can be damaged if operated during such low temperatures. Because of this, the inspector was unable to operate and fully evaluate the cooling system.

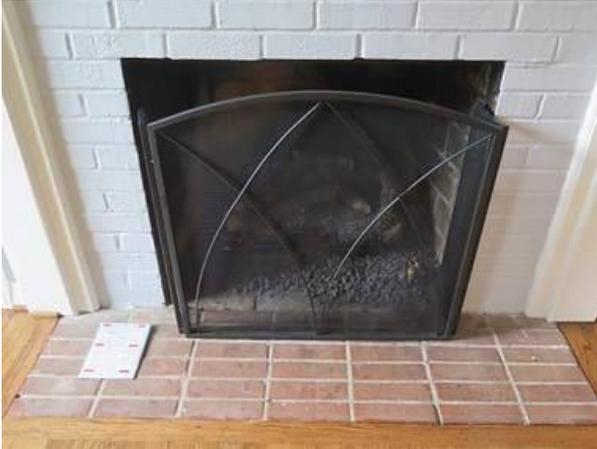
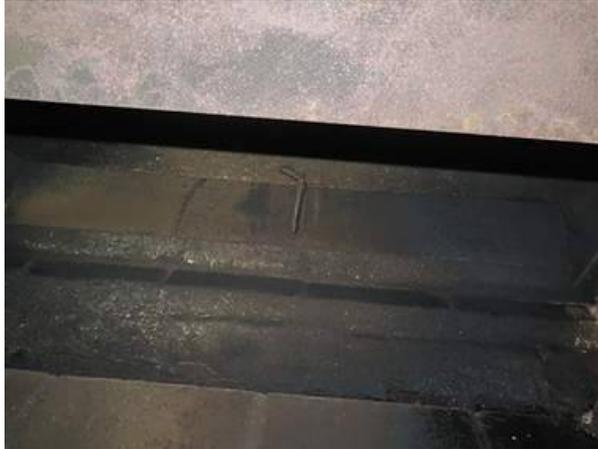
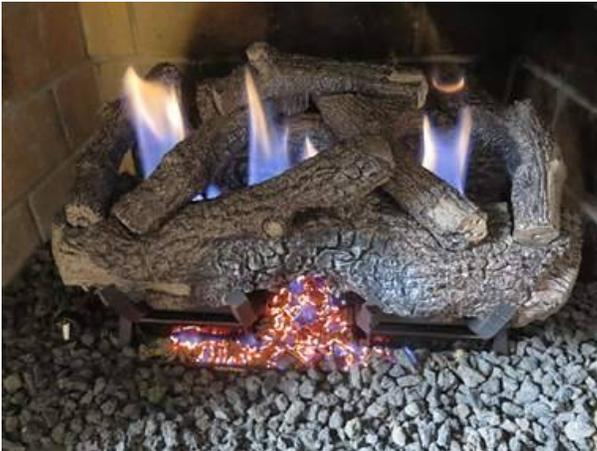
Condition of gas-fired fireplaces or stoves: Required repair, replacement and/or evaluation (see comments below)

Gas fireplace or stove type: Converted wood-burning fireplace

Recommend that the client review all available documentation for gas-fired fireplaces and stoves. Depending on how they are operated (for routine heating versus ambiance), such appliances normally need servicing annually or every few years. Consult with the property owner and/or a qualified specialist to determine if service is needed now.

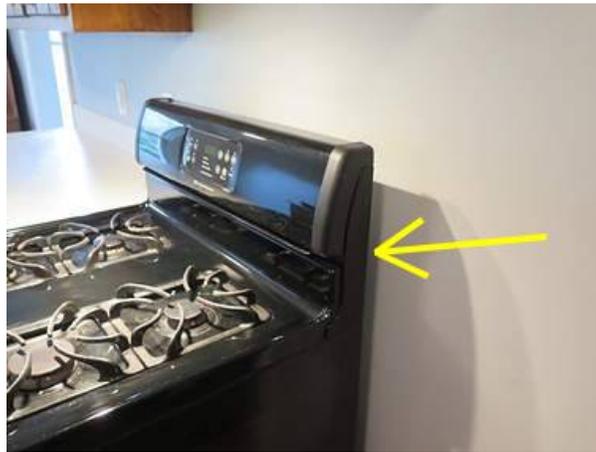
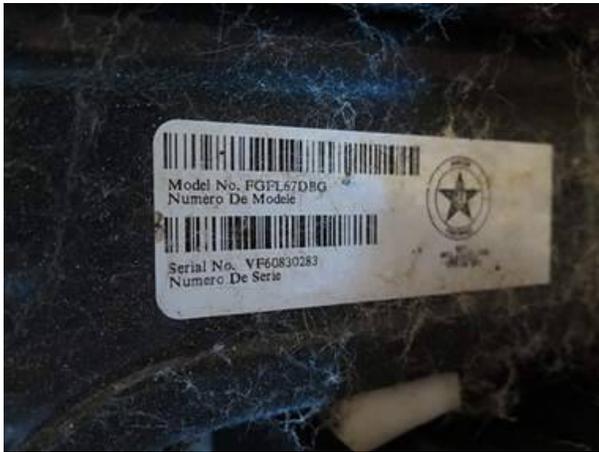
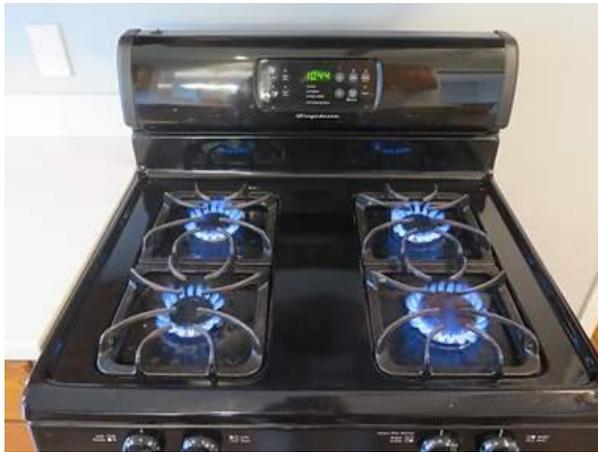
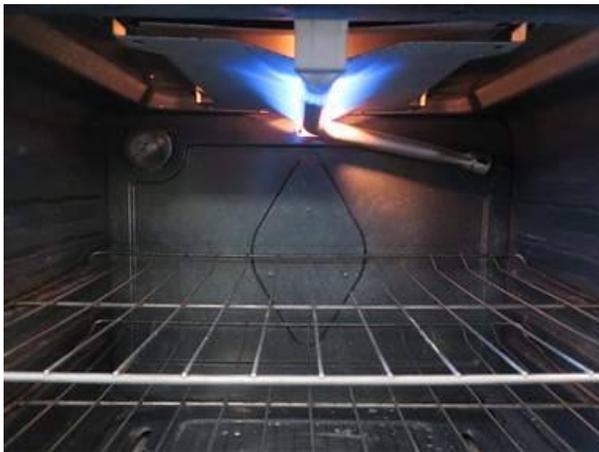
68) 🛠️🔪 The range could tip forward. An anti-tip bracket may not be installed. This is a potential safety hazard since the range can tip forward when weight is applied to the open door, such as when a small child climbs on it or if heavy objects are dropped on it. Anti-tip brackets have been sold with all free-standing ranges since 1985. Recommend installing an anti-tip bracket to eliminate this safety hazard. For more information, visit: <https://www.reporthost.com/?ATB>
