Property Inspection Report

Property address: **6422 Vernon Woods Dr NE
Atlanta GA 30328**

Inspection date: **Saturday, February 1, 2020**

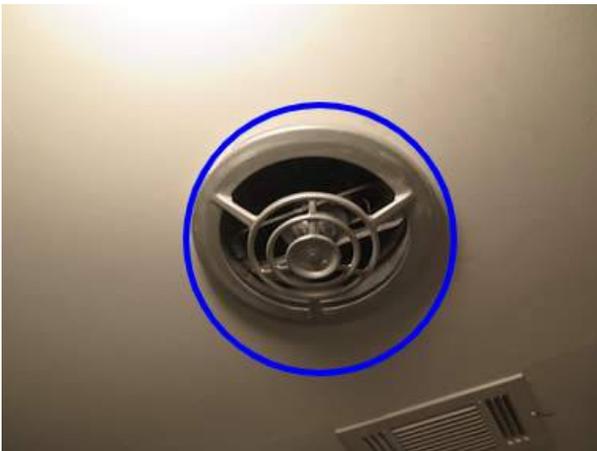
Photo 77-1

The exhaust fan at location(s) #A was noisy or vibrated excessively. Moisture may accumulate and result in mold, bacteria or fungal growth. Recommend that a qualified person clean, repair or replace fans as necessary.

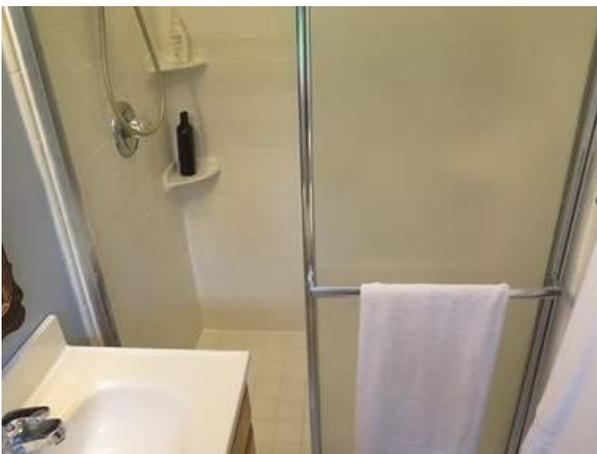
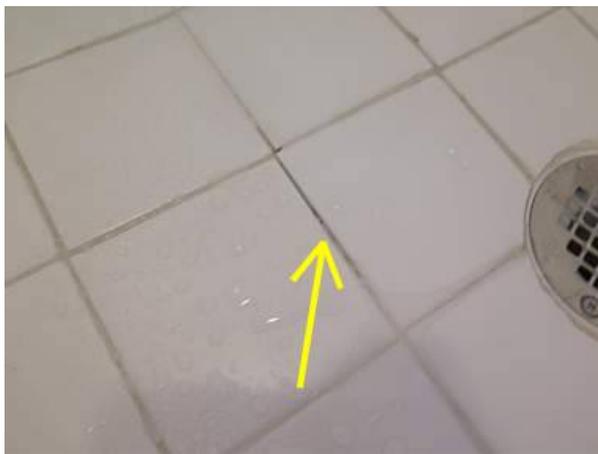
Tile and/or grout in the shower enclosure at location(s) #B and D were deteriorated (e.g. loose or cracked tiles, missing grout) or substandard. Water can damage the wall structure as a result. Recommend that a qualified contractor repair as necessary.

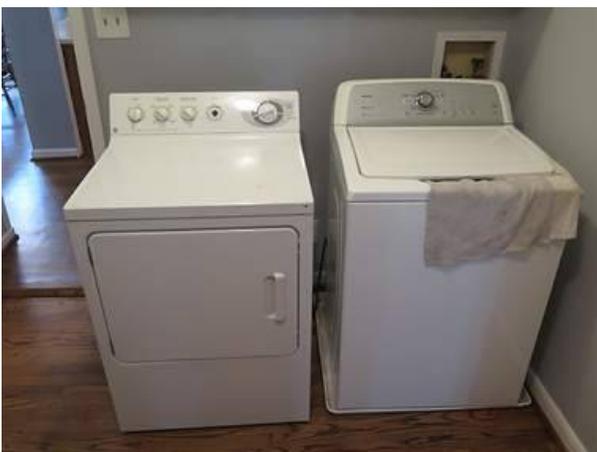
Photo 80-1

Neither the clothes washer or dryer were operated or evaluated. These appliances are excluded from this inspection.

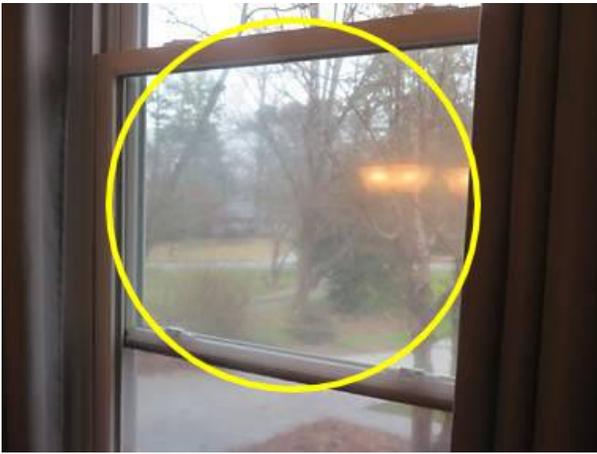
Photo 82-1

Condensation or staining was visible between multi-pane glass in one or more windows. This usually indicates that the seal between the panes of glass has failed or that the desiccant material that absorbs moisture is saturated. As a result, the view through the window may be obscured, the window's R-value will be reduced, and accumulated condensation may leak into the wall structure below. Recommend that a qualified contractor evaluate and repair windows as necessary. Usually, this means replacing the glass in window frames.

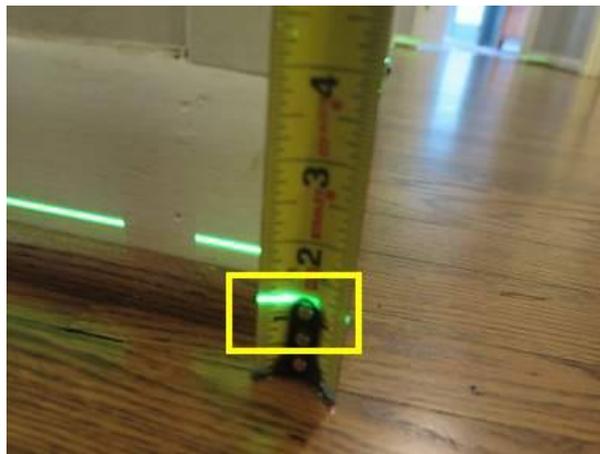
Photo 83-2

83) Floors in one or more areas were not level. This can be caused by foundation settlement or movement of the foundation, posts and/or beams. Significant repairs may be needed to make floors level. Recommend that a qualified contractor and/or engineer evaluate further. Repairs should be performed by a qualified contractor.

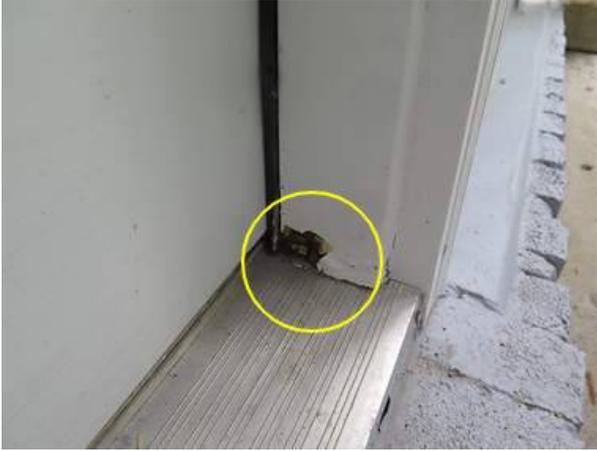
Photo 84-1

84) Fungal rot was found at one or more exterior door jambs. Recommend that a qualified person repair as necessary. All rotten wood should be replaced.

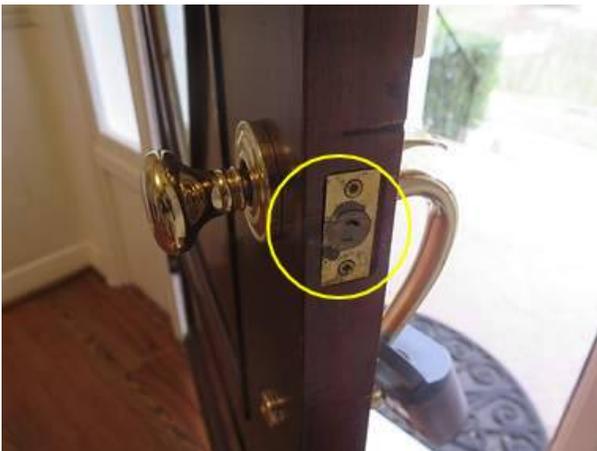
Photo 86-1

Some exterior door hardware, including locksets were inoperable. Recommend that a qualified person repair or replace as necessary.

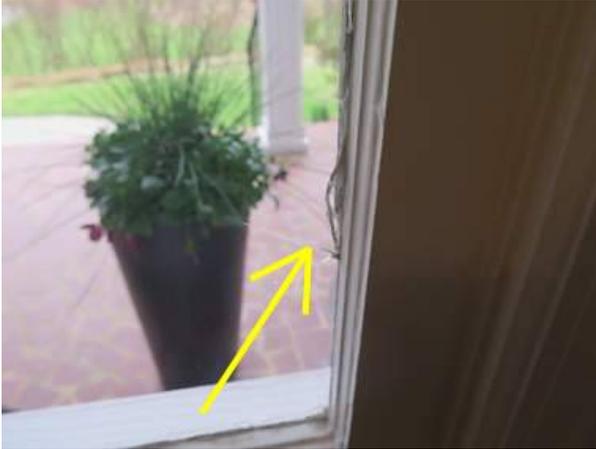
Photo 87-1

Glass in one or more exterior doors was broken. Recommend that a qualified contractor replace glass where necessary.

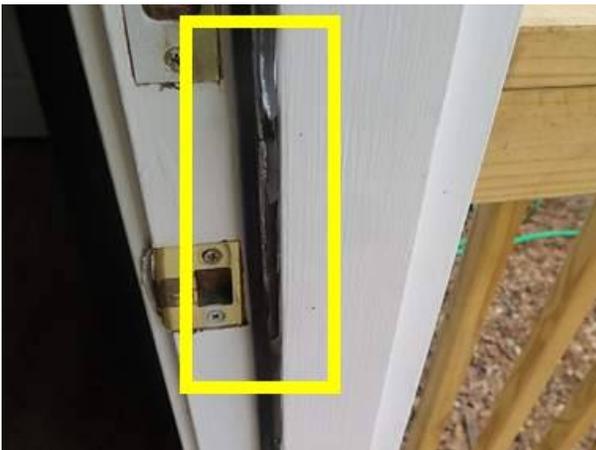
Photo 89-1

Weatherstripping around one or more exterior doors was damaged and/or deteriorated. Water may enter the building, or energy efficiency may be reduced. Recommend that a qualified person repair or replace weatherstripping as necessary.

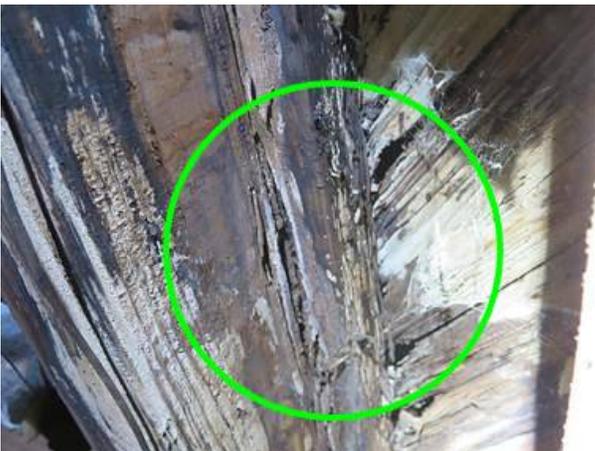
Photo 92-1

Evidence of past infestation of subterranean termites was found at location(s) # in the form of galleries or holes in wood with visible wood damage. Recommend the following:

- Correct any conducive conditions for wood-destroying organisms mentioned in this report.
- Consult with the property owner about any history of infestation.
- Have a state-licensed pest control operator evaluate further and treat as necessary.

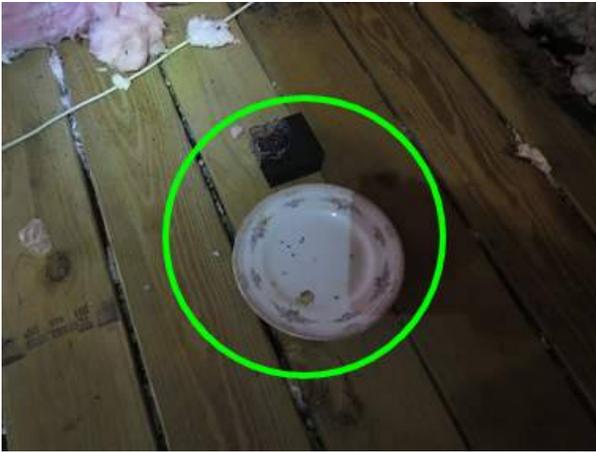
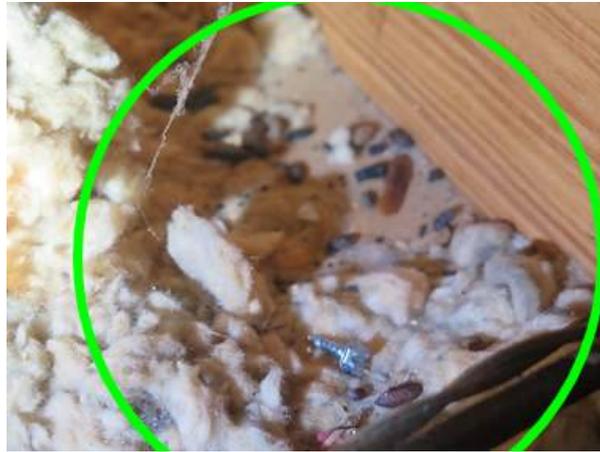
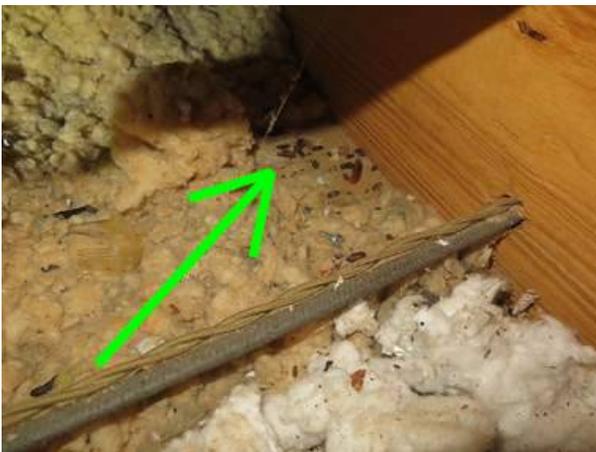
Evidence of rodent infestation was found in the form of feces, traps, poison and/or damaged insulation in the attic. Consult with the property owner about this. A qualified person should make repairs to seal openings in the structure, set traps, and clean rodent waste as necessary. Recommend following guidelines in these Center for Disease Control articles:

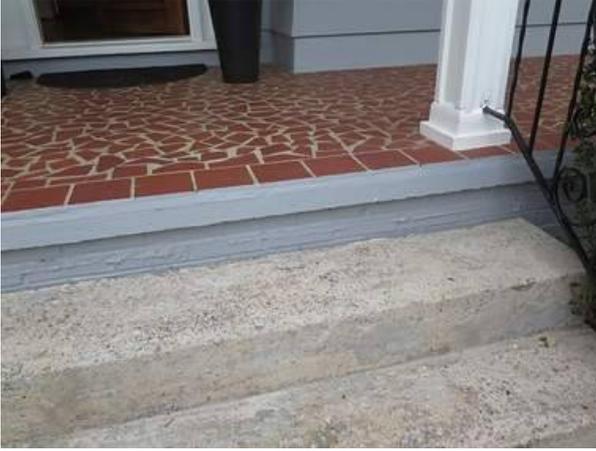
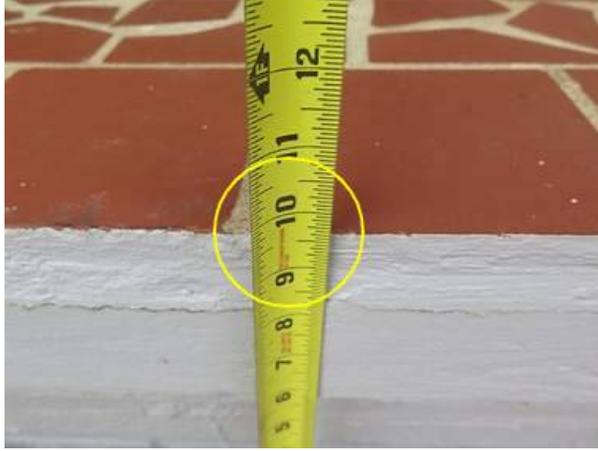
The risers for stairs at one or more locations varied in height and pose a fall or trip hazard. Risers within the same flight of stairs should vary by no more than 3/8 inch. At a minimum, be aware of this hazard, especially when guests who are not familiar with the stairs are present. Recommend that a qualified contractor repair per standard building practices.

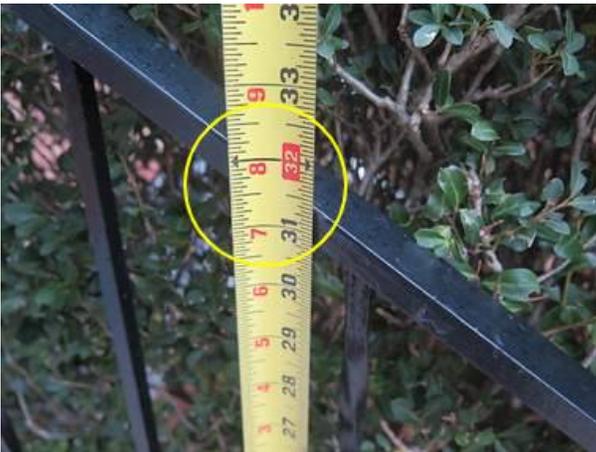
Photo 6-1

Handrails at one or more flights of stairs were too low or too high and pose a fall hazard. Handrails should be located at least 34 inches and at most 38 inches above the nose of each tread/riser. Recommend that a qualified person repair per standard building practices.

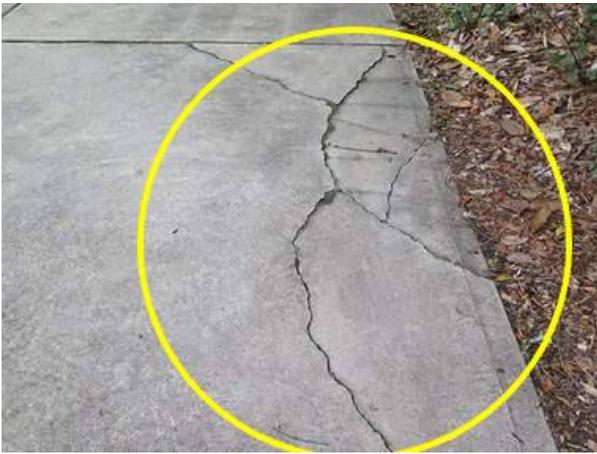
Photo 7-1

Cracks, holes, settlement, heaving and/or deterioration were found in the driveway. Recommend that qualified contractor repair as necessary.

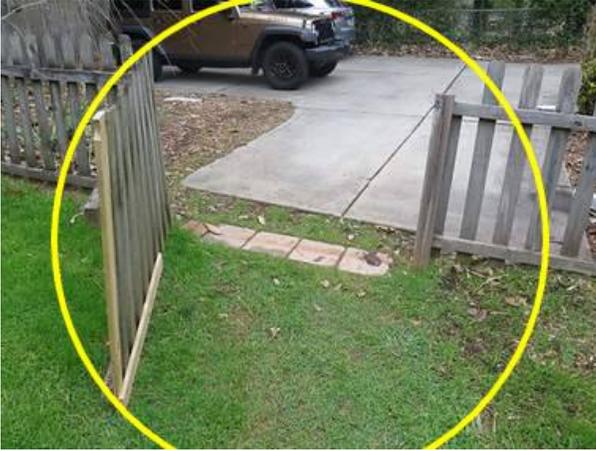
Photo 9-1

One or more fences and/or gates were damaged or deteriorated and need repair.

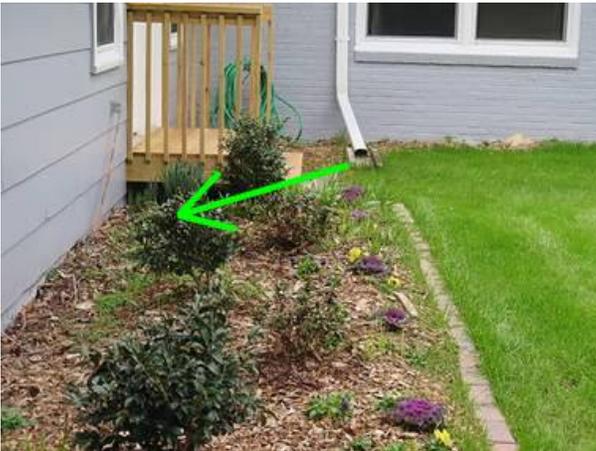
Photo 10-1

The soil or grading sloped down towards building perimeters in one or more areas. This can result in water accumulating around building foundations or underneath buildings. It is a conducive condition for wood-destroying organisms. Recommend grading soil so it slopes down and away from buildings with a slope of at least 1 inch per horizontal foot for at least 6 feet out from buildings.

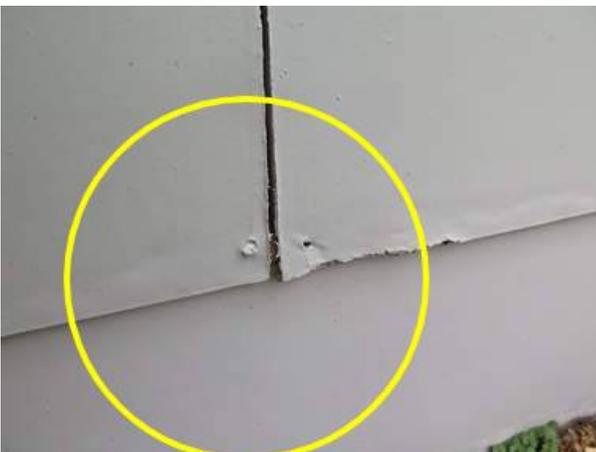
Photo 12-1

Some sections of siding and/or trim were deteriorated and/or damaged. Recommend that a qualified person repair, replace or install siding or trim as necessary.

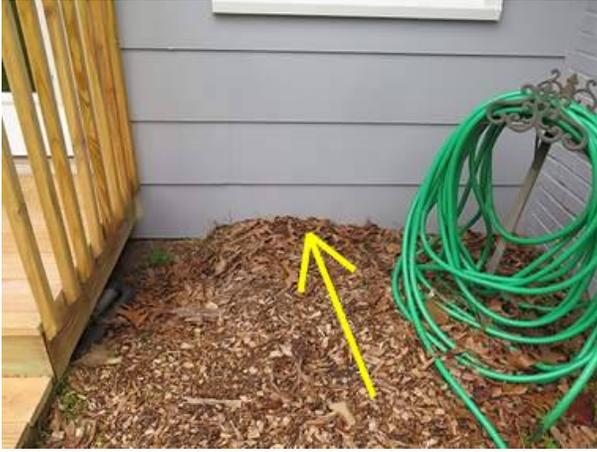
Photo 13-1

13) 🛠️💧 Soil was in contact with or less than 6 inches from siding, trim or structural wood. This is a conducive condition for wood-destroying organisms. Recommend grading or removing soil as necessary to maintain a 6-inch clearance. If not possible, then recommend replacing untreated wood with pressure-treated wood. Installation of borate-based products such as Impel rods can also reduce the likelihood of rot or infestation if soil cannot be removed. Note that damage from fungal rot and/or insects may be found when soil is removed, and repairs may be necessary.

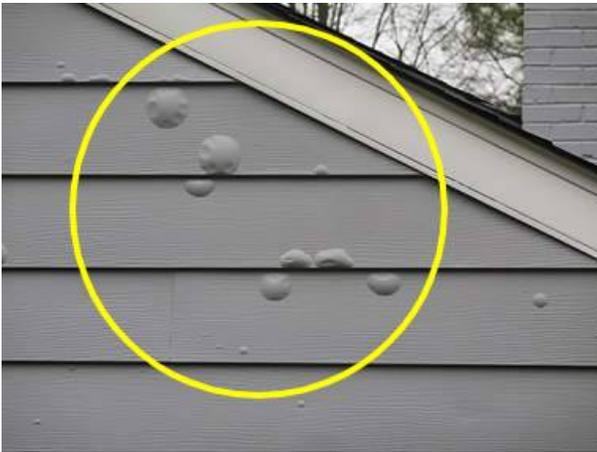
Photo 14-1

14) 🛠️💧 The paint or stain finish in some areas was failing (e.g. peeling, faded, worn, thinning). Siding and trim with a failing finish can be damaged by moisture. Recommend that a qualified contractor prep (e.g. clean, scrape, sand, prime, caulk) and repaint or restain the building exterior where necessary and per standard building practices. Any repairs needed to the siding or trim should be made prior to this.

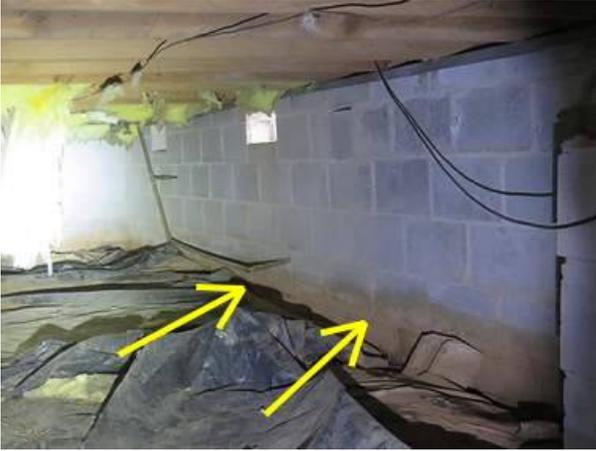
Photo 16-1

16) 🛠️🔍🏠💧 Evidence of prior water intrusion or accumulation was found in one or more sections of the crawl space. For example, sediment stains on the vapor barrier or foundation, and/or efflorescence on the foundation. Accumulated water is a conducive condition for wood-destroying organisms and should not be present in the crawl space. Recommend that the client review any disclosure statements available and ask the property owner about past accumulation of water in the crawl space. The crawl space should be monitored in the future for accumulated water, especially after heavy and/or prolonged periods of rain. If water is found to accumulate, then recommend that a qualified contractor who specializes in drainage issues evaluate and repair as necessary. Typical repairs for preventing water from accumulating in crawl spaces include:

- Repairing, installing or improving rain run-off systems (gutters, downspouts and extensions or drain lines)
- Improving perimeter grading
- Repairing, installing or improving underground footing and/or curtain drains

Ideally, water should not enter crawl spaces, but if water must be controlled after it enters the crawl space, then typical repairs include installing trenches, gravity drains and/or sump pump(s) in the crawl space.

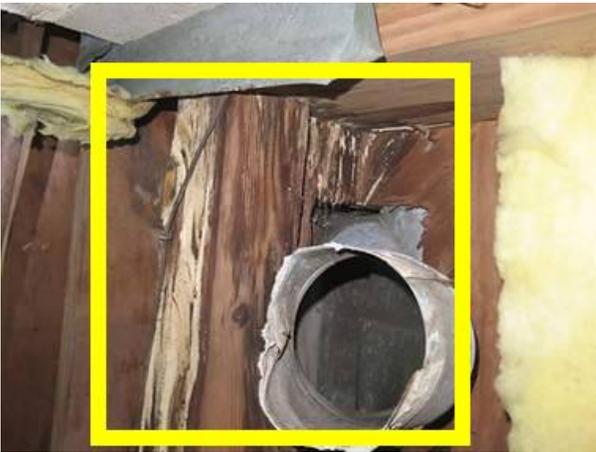
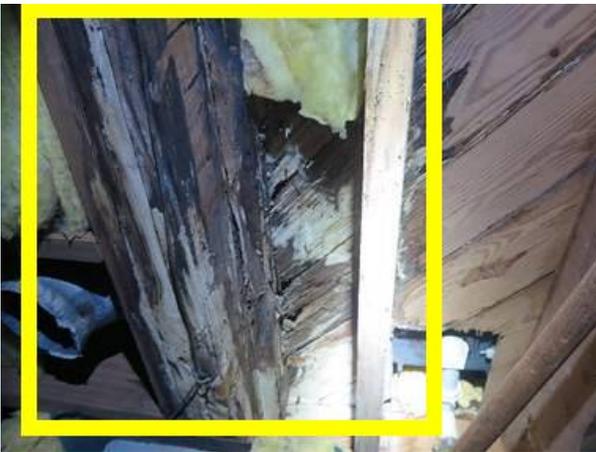
Fungal rot was found at one or more joists, beams and/or sections of floor sheathing. Recommend that a qualified contractor evaluate and repair as necessary. All rotten wood should be replaced.

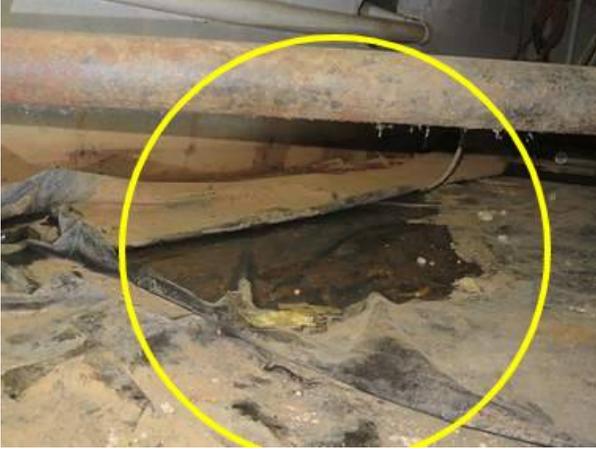
Photo 18-1

Standing water was found at one or more locations in the crawlspace. Water from crawl spaces can evaporate and enter the structure above causing high levels of moisture in the structure. This is a conducive condition for wood-destroying organisms. While a minor amount of seasonal water is commonly found in crawl spaces, significant amounts should not be present.

Rain runoff is the most common cause of wet crawl spaces, but water can come from other sources such as groundwater or underground springs. Recommend that a qualified person correct any issues related to outside perimeter grading and/or roof drainage (see any other comments about this in this report). If standing water persists, then recommend that a qualified contractor who specializes in drainage issues evaluate and repair as necessary.

Typically such repairs include:

- Repairing, installing or improving underground footing and/or curtain drains
- Applying waterproof coatings to foundation walls
- Digging trenches in the crawl space to collect or divert water
- Installing sump pumps

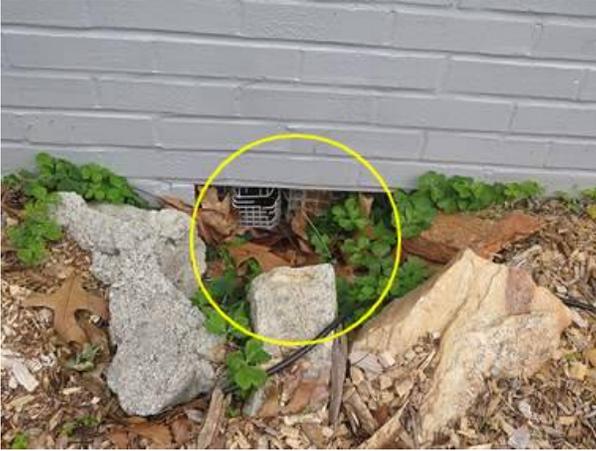
Photo 20-1

One or more crawl space vents were blocked by soil, debris and/or insulation. This restricts ventilation in the crawl space and can result in increased levels of moisture inside. This is a conducive condition for wood-destroying organisms. Materials or items blocking vents should be removed as necessary.

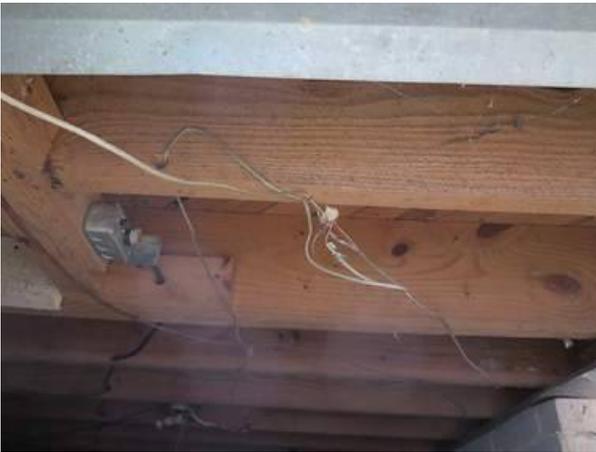
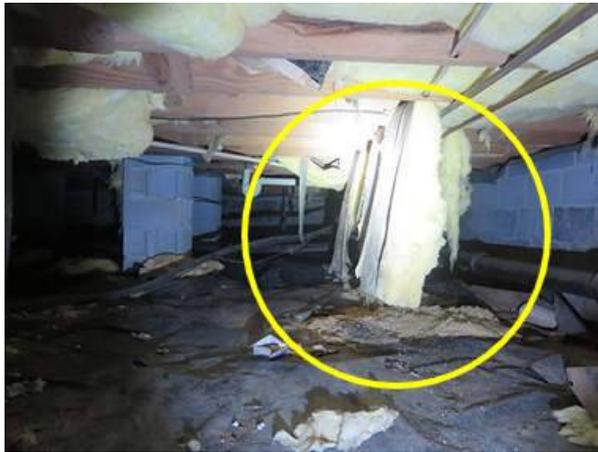
21) 🛠️💧 Under-floor insulation was damaged, missing, or deteriorated in many areas, and will likely result in reduced energy efficiency. A qualified contractor should replace insulation as necessary. Consider having all insulation replaced.

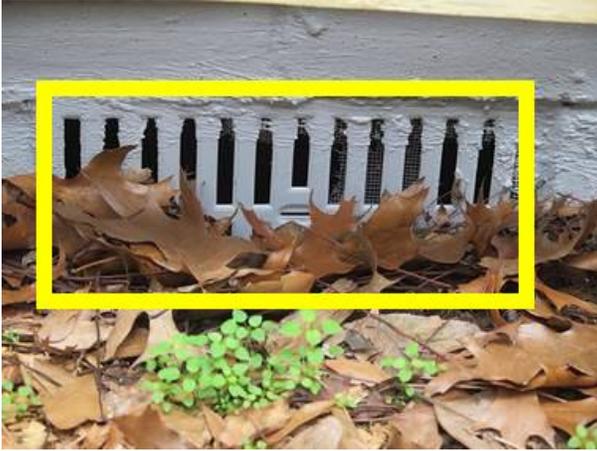
Photo 23-1

23) 🛠️🐭 The screens for one or more crawl space vents were damaged. Vermin or pets can enter the crawl space and nest, die and/or leave feces and urine. Vermin often damage under-floor insulation too. Recommend that a qualified person install or replace screens where necessary using 1/8-inch to 1/4-inch wire mesh.

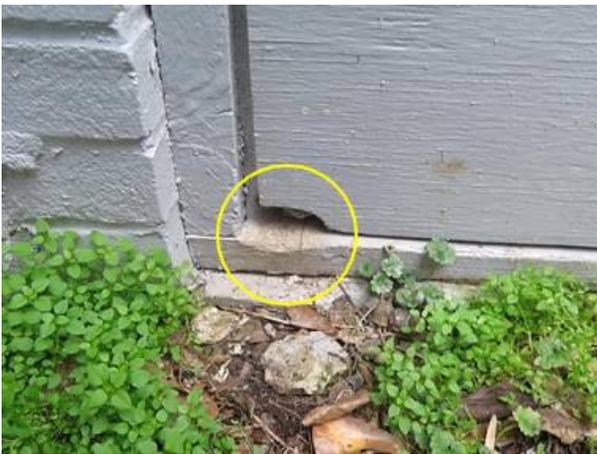
Photo 24-1

24) 🛠️ One or more outdoor crawl space access hatches or doors were missing, damaged, deteriorated or substandard. Water and/or vermin can enter the crawl space. Recommend that a qualified person replace, install or repair hatches or doors where necessary.

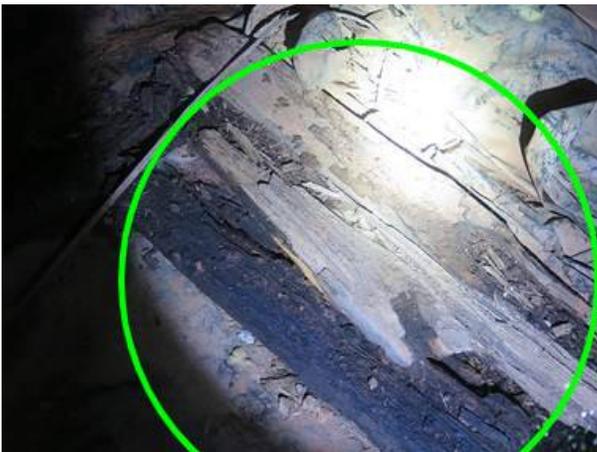
Photo 25-1

25) 🗑️💧 Cellulose material such as scrap wood was found in the crawl space. This is a conducive condition for wood-destroying organisms. Recommend removing all cellulose-based debris or stored items.

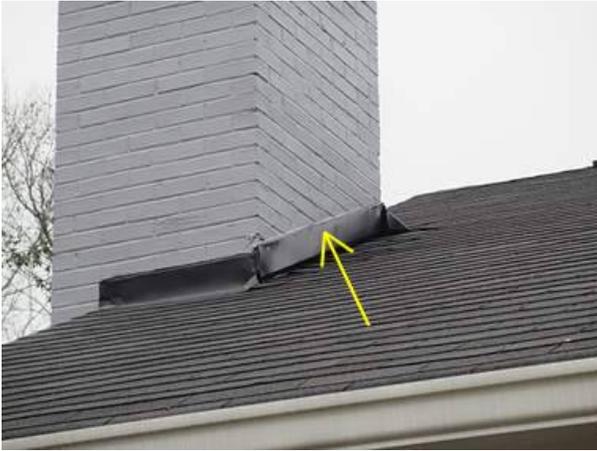
Photo 27-1

27) 🔧💧 Flashings at the base of one or more chimneys were missing counter flashing. Leaks can occur as a result. This is a conducive condition for wood-destroying organisms. Recommend that a qualified contractor evaluate and repair as necessary.

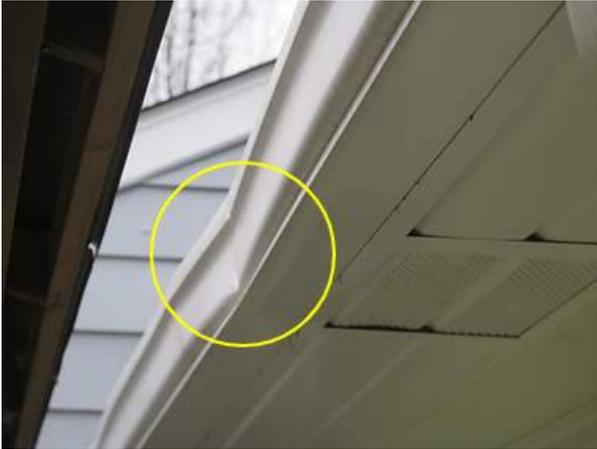
Photo 28-1

28) 🪛💧 One or more gutters were damaged. Rainwater can come in contact with the building's exterior or accumulate around the building foundation as a result. This is a conducive condition for wood-destroying organisms. Recommend that a qualified person repair as necessary.

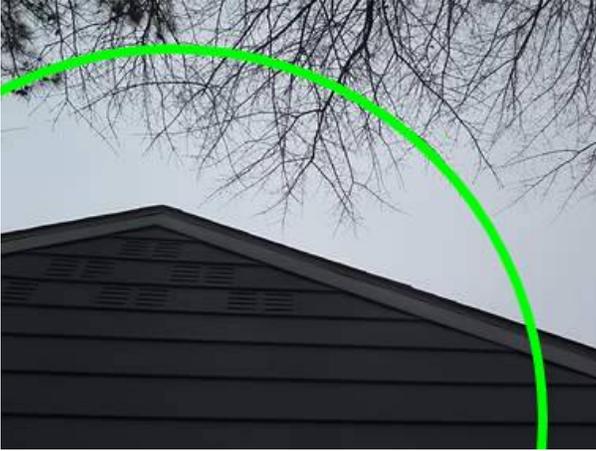
Photo 29-1

29) 🌿💧 Vegetation such as trees, shrubs, and/or vines overhung the roof surface or were in contact with the roof edge. Organic debris such as leaves or needles are likely to accumulate in gutters and on the roof surface. Gutters can overflow and cause water to come in contact with the building exterior or water can accumulate around the foundation. This is a conducive condition for wood-destroying organisms. Vegetation in contact with the roof can damage the roof surface and/or the roof drainage system. Recommend pruning vegetation so as to not be in contact with the roof and to not overhang the roof surface. If vegetation is too tall then it should be pruned at least 10 feet above the roof surface.

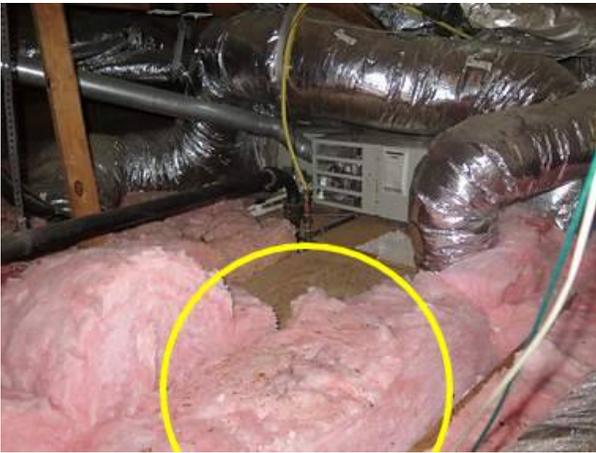
Photo 31-1

There should be continuous flooring present to permit access to service the Heat pump or furnace in the attic.

NOTE A passageway shall have continuous solid flooring not less than 24 inches wide. A level service space not less than 30 inches deep and 30 inches wide shall be present at the front or service side of the appliance. Have a qualified contractor evaluate and repair as necessary.

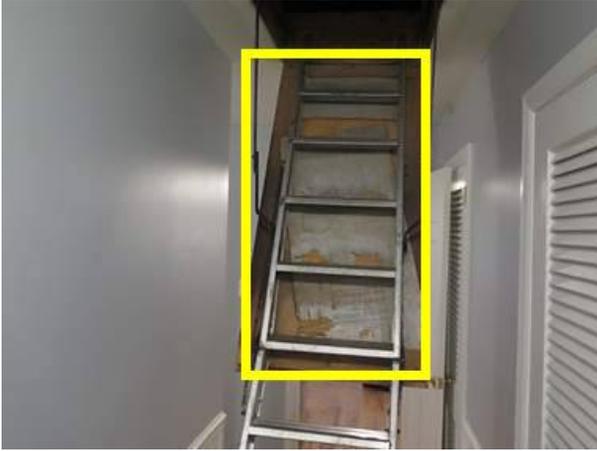
Photo 32-1

The pull-down attic stairs were not insulated. Typically, such stairs that are not insulated also do not have any weatherstripping installed. Recommend that a qualified person install insulation and weatherstripping per standard building practices for better energy efficiency. For more information, visit:

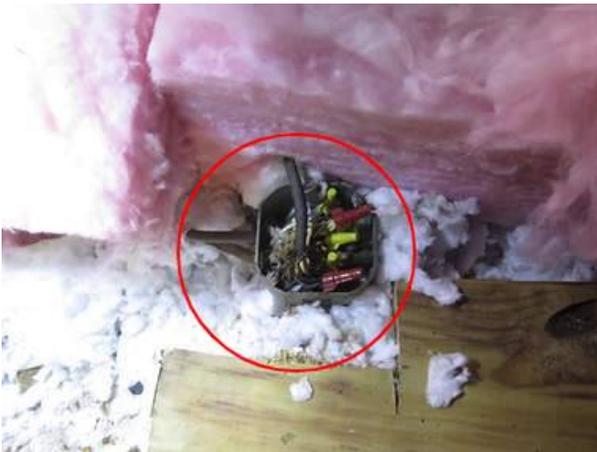
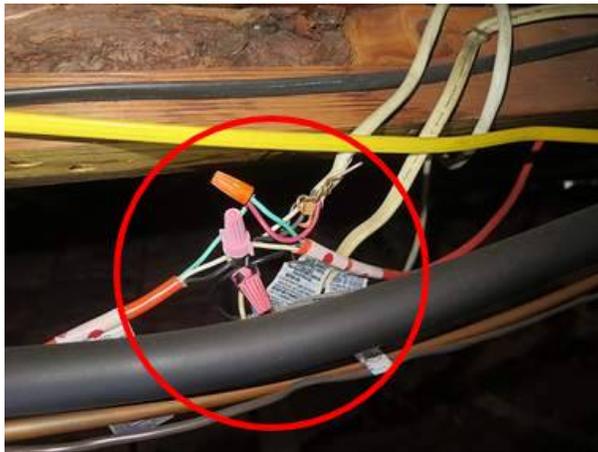
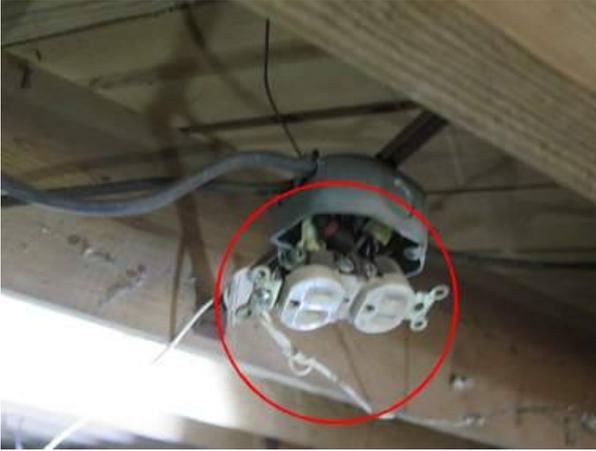
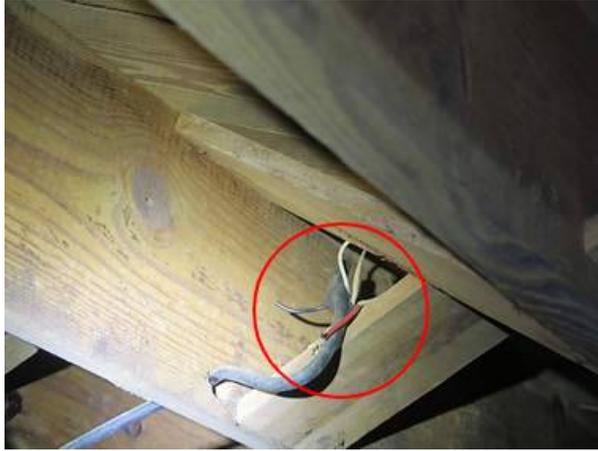
Substandard wiring was found at the attic and/or crawl space. For example, loose wiring, unterminated wires, exposed splices, missing or broken cover plates and/or loose boxes. This is a safety hazard. Recommend that a qualified electrician evaluate and repair as necessary and per standard building practices.

Wiring should be kept at least one inch away from heating ducts and hot water piping. Thermal insulation can be used to separate these materials.

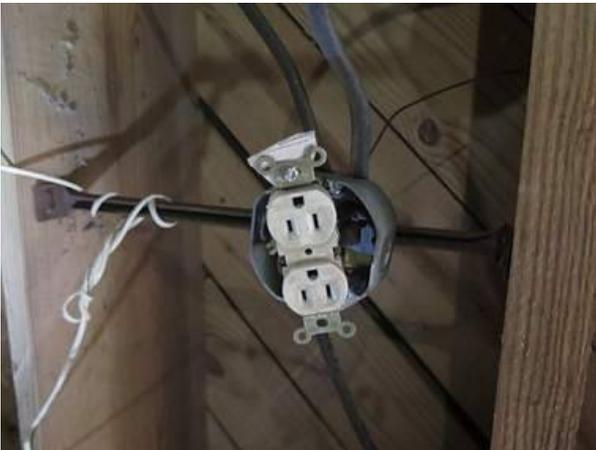
Photo 38-1

One or more electric receptacles at the crawl space had no visible ground fault circuit interrupter (GFCI) protection, or the inspector was unable to determine if GFCI protection was present. If not GFCI-protected, receptacles in wet areas pose a shock hazard. Recommend that a qualified electrician evaluate and install GFCI protection if necessary and per standard building practices. General guidelines for GFCI-protected receptacles include the following locations:

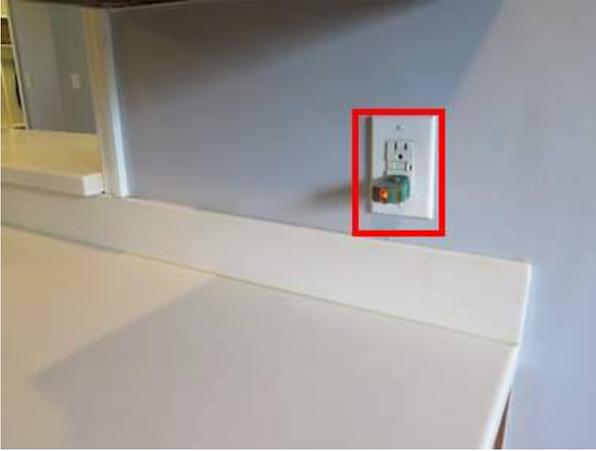
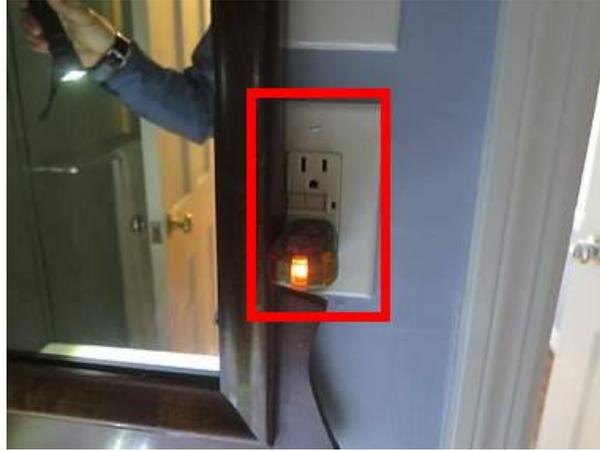
One or more ground fault circuit interrupter (GFCI) receptacles (outlets) wouldn't trip with a test instrument at the kitchen and/or bathroom(s). This is a potential shock hazard. Recommend that a qualified electrician evaluate and repair as necessary.

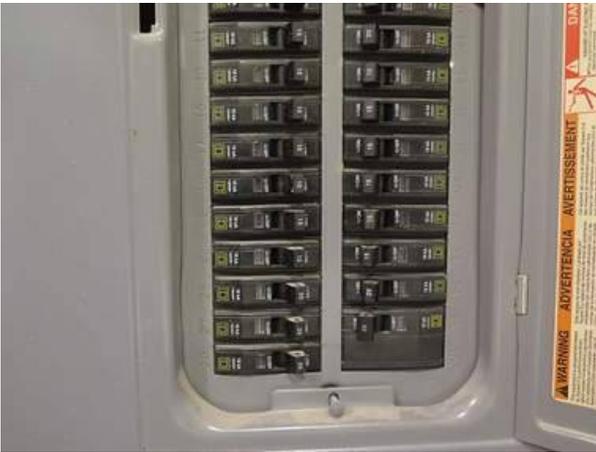
Photo 40-1

40) + No arc fault circuit interrupter (AFCI) breakers were installed for bedroom circuits. These are relatively new devices, and reduce the risk of fire by protecting against overheated or arcing receptacles (outlets) or light fixtures. Consult with a qualified electrician about upgrading circuits to AFCI protection per standard building practices.

They're equipped with sophisticated electronics that can detect an arcing condition (like in a frayed lamp cord), which may not be detected by a standard circuit breaker until after a fire has started. AFCI protection is not just required for new construction; it's now also required where branch-circuit wiring is modified, replaced or extended into existing homes.

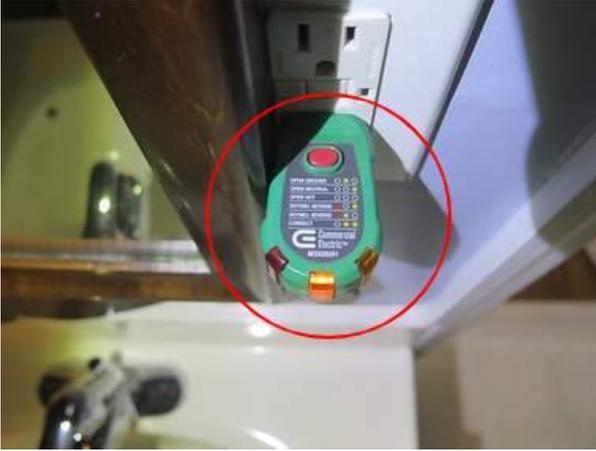
Photo 41-1

41) + One or more ground fault circuit interrupter (GFCI) type receptacles (outlets) had an open ground. GFCI receptacles will work (trip) without a ground; but a 3-slot receptacle on an open ground circuit can result in appliances that require a ground can be used without one. This is a potential shock hazard. Recommend that a qualified electrician upgrade circuits that require GFCI protection (e.g. in wet areas) with grounded wiring per standard building practices.

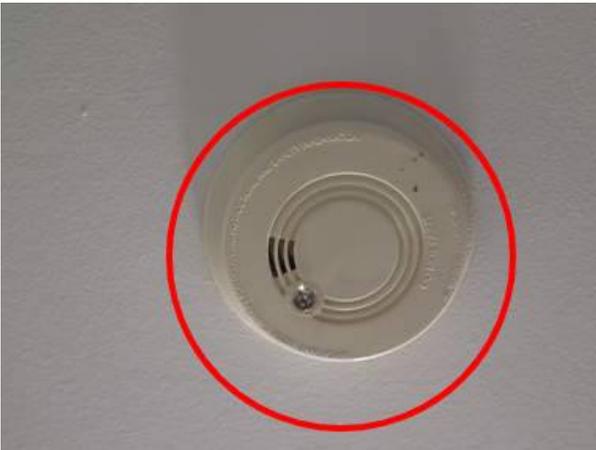
Photo 42-1

Smoke alarms were missing from one or more bedrooms. Additional smoke alarms should be installed as necessary so a functioning alarm exists in each hallway leading to bedrooms, in each bedroom, and on each level. For more information, visit:

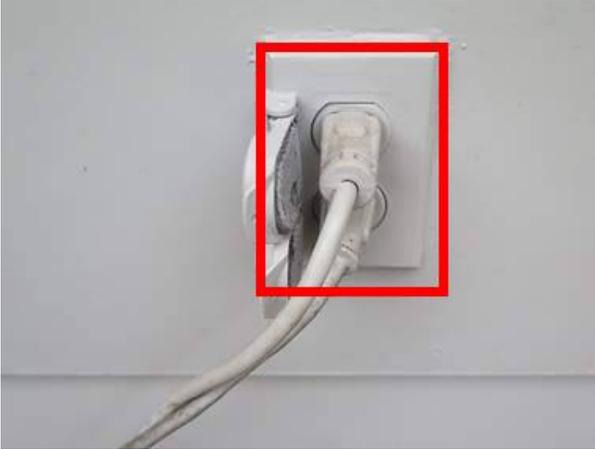
Photo 43-1

One or more exterior receptacle (outlet) covers were substandard or damaged. Outdoor outlets should have watertight covers that allow them to stay covered even with a cord plugged in. This is a potential shock hazard. Special weathertight outlets are required outdoors or where water may contact the outlet. Recommend that a qualified person replace covers where necessary.

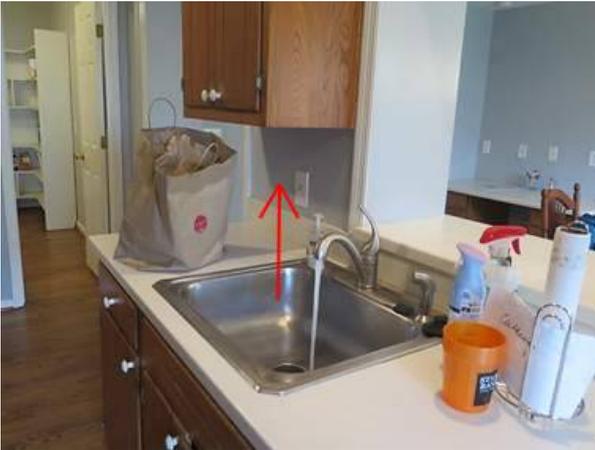
Photo 44-1

Few receptacles (outlets) were installed in one or more areas by modern standards. This can result in "octopus" wiring with extension cords, which is a fire hazard. In modern construction, electrical outlets should be located so that there is an outlet within six feet horizontally of any point along the wall (in finished living spaces). Translated, this means there should be an outlet every twelve feet along the wall. Above kitchen counters, modern codes require outlets spaced so that no point on the counter is more than two feet from a receptacle. Consult with a qualified electrician about upgrading circuits with additional receptacles per standard building practices.

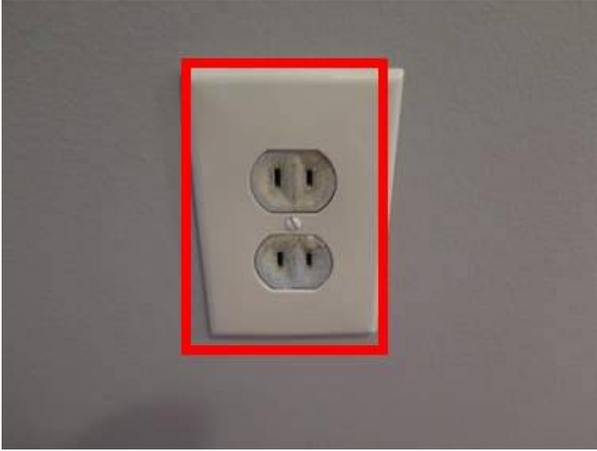
Photo 45-1

2-slot receptacles (outlets) rather than 3-slot, grounded receptacles were installed in one or more areas. These do not have an equipment ground and are considered unsafe by today's standards. Appliances that require a ground should not be used with 2-slot receptacles. Examples of such appliances include computers and related hardware, refrigerators, freezers, portable air conditioners, clothes washers, aquarium pumps, and electrically operated gardening tools. The client should be aware of this limitation when planning use for various rooms, such as an office. Upgrading to grounded receptacles typically requires installing new wiring from the main service panel or sub-panel to the receptacle(s), in addition to replacing the receptacle(s). Consult with a qualified electrician about upgrading to 3-wire, grounded circuits.

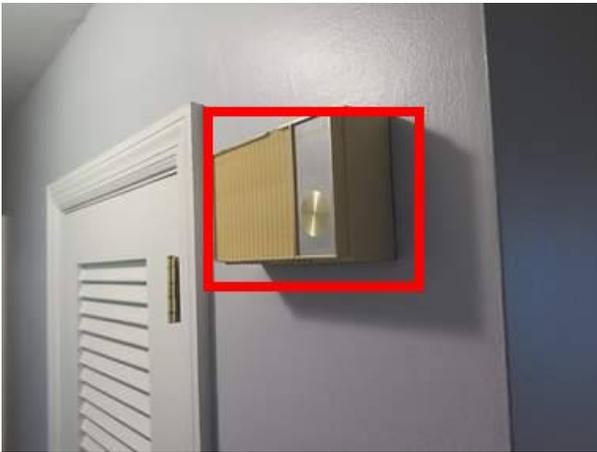
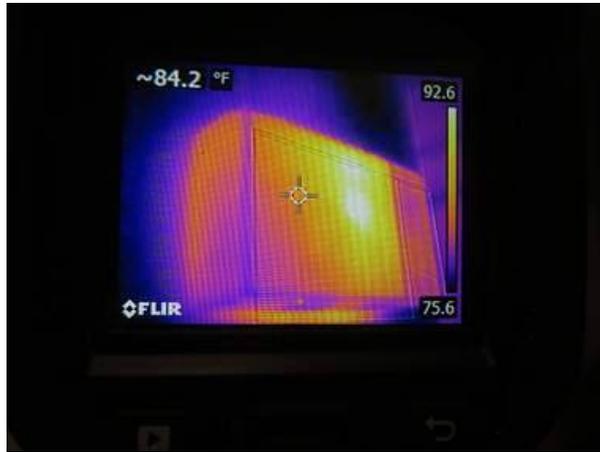
The front and/or back door's doorbell appeared to be malfunctioning. Recommend that a qualified person repair as necessary.

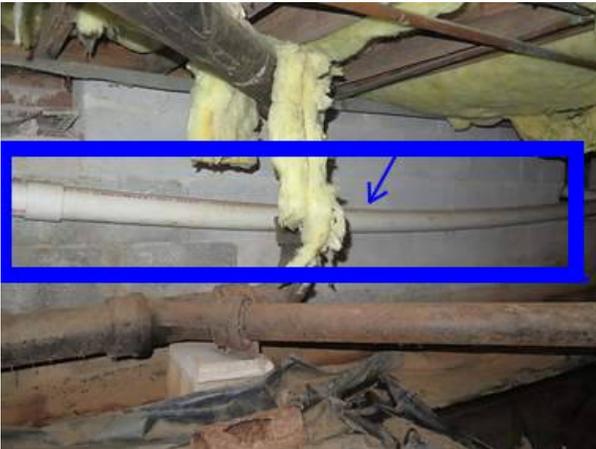
Photo 53-1

53) 🛠️ One or more waste pipes had a substandard slope. Clogging or leaks can occur as a result. Drain and waste pipes should be sloped 1/4 inch per foot of length if less than 3 inches in diameter, or 1/8 inch per foot of length for larger diameters. Recommend that a qualified plumber repair per standard building practices.

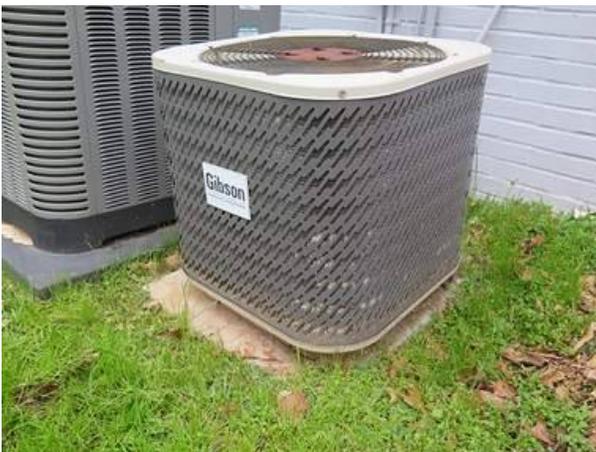
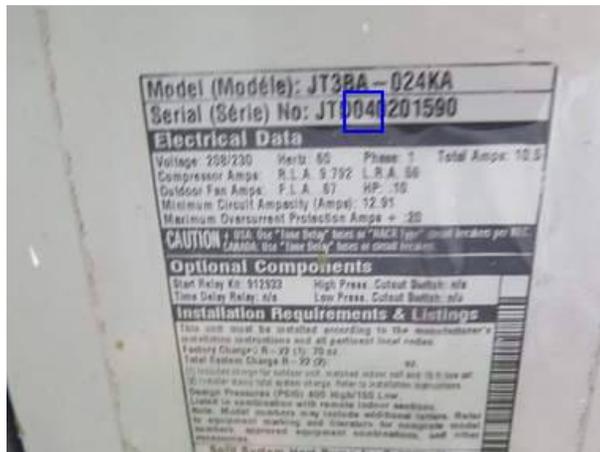
59) The estimated useful life for most heat pumps and air conditioning condensing units is 10-15 years. This unit appeared to be beyond this age and/or its useful lifespan and may need replacing or significant repairs at any time. Recommend budgeting for a replacement in the near future.

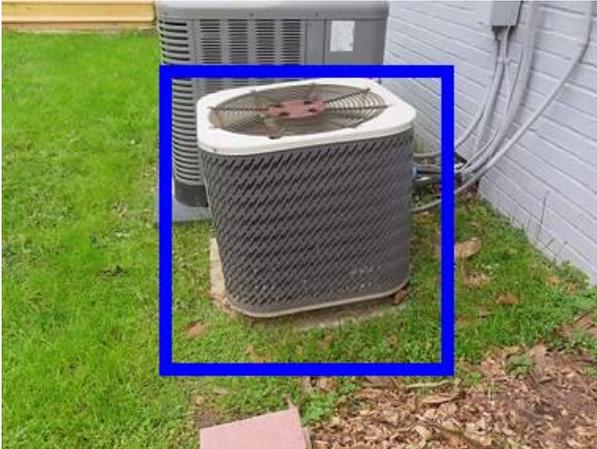
Photo 61-1

61) 🛠️ The pad for the heat pump or air conditioning condensing unit was not level. This unit requires adequate support. The compressor may be damaged if this unit is tilted 10 degrees or more. Also, the pad should elevate the unit above the soil to prevent corrosion. Recommend that a qualified person repair as necessary.

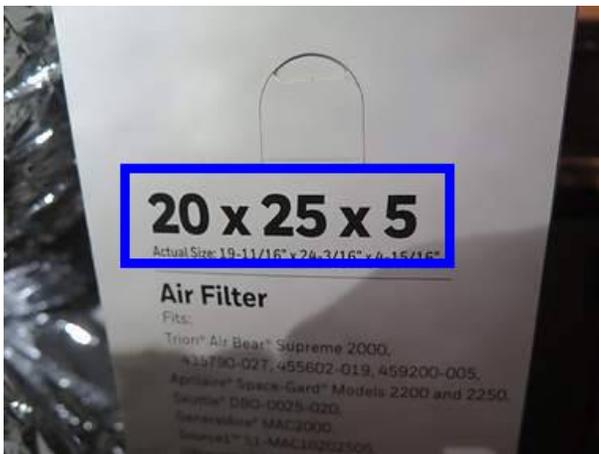
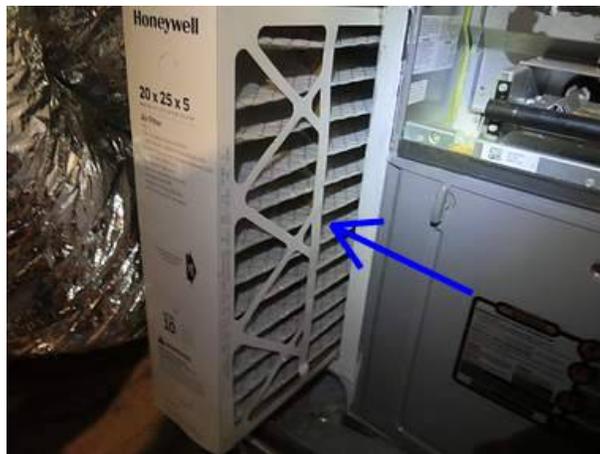
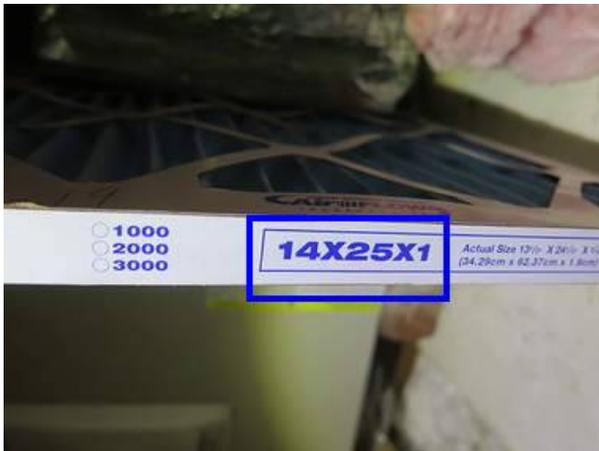
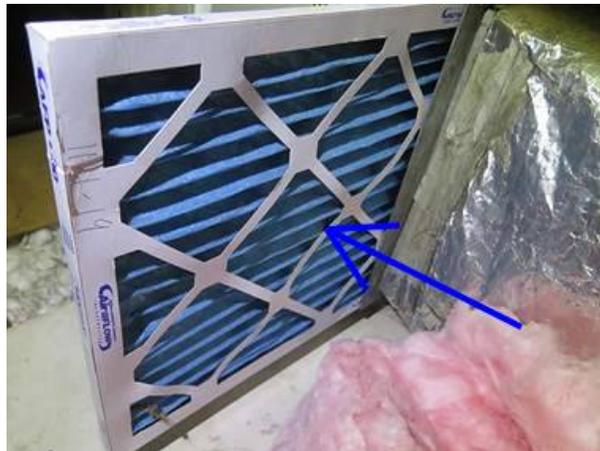
62) 🛠️ Recommend replacing or washing HVAC filters upon taking occupancy depending on the type of filters installed. Regardless of the type, recommend checking filters monthly in the future and replacing or washing them as necessary. How frequently they need replacing or washing depends on the type and quality of the filter, how the system is configured (e.g. always on vs. "Auto"), and on environmental factors (e.g. pets, smoking, the frequency of house cleaning, number of occupants, the season).

NOTE filter size - 14x25x1 and/or 20x25x5

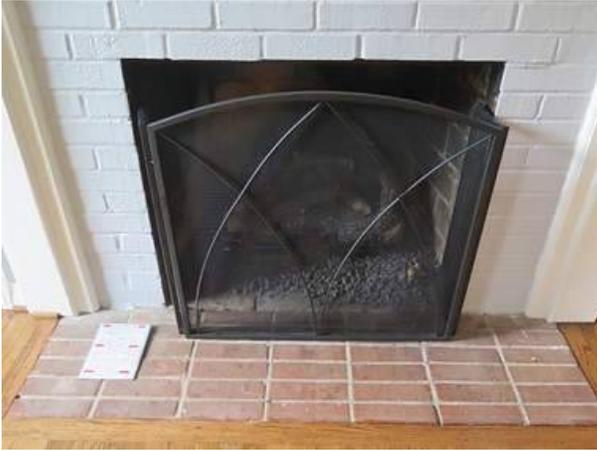
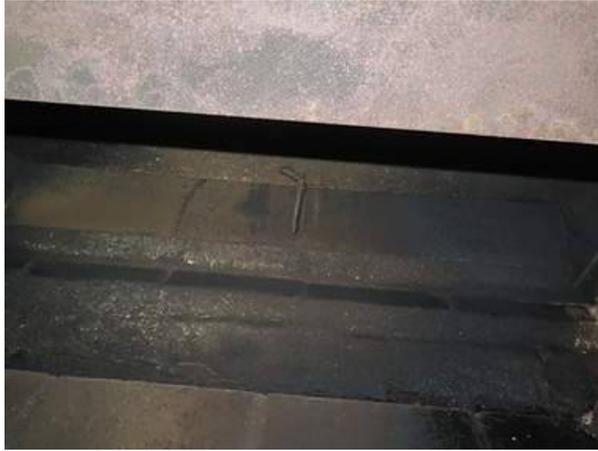
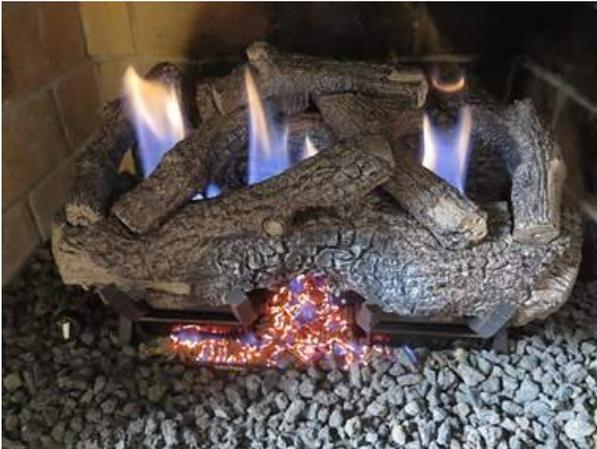
Recommend that the client review all available documentation for gas-fired fireplaces and stoves. Depending on how they are operated (for routine heating versus ambiance), such appliances normally need servicing annually or every few years. Consult with the property owner and/or a qualified specialist to determine if service is needed now.
