Property Inspection Report

Property address: **6422 Vernon Woods Dr NE
Atlanta GA 30328**

Inspection date: **Saturday, February 1, 2020**

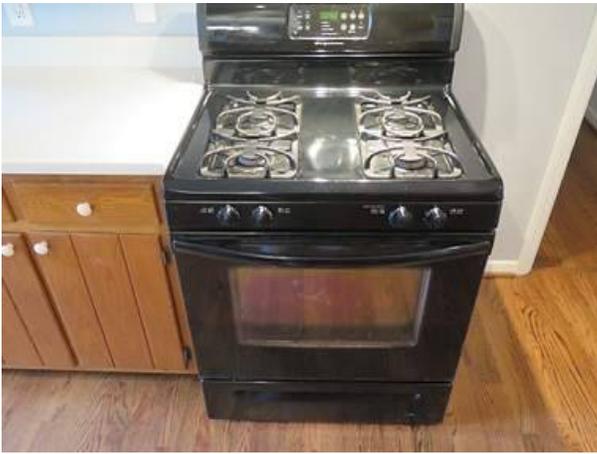
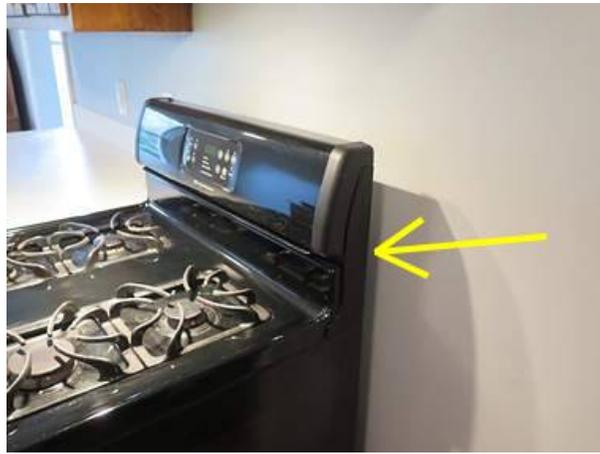
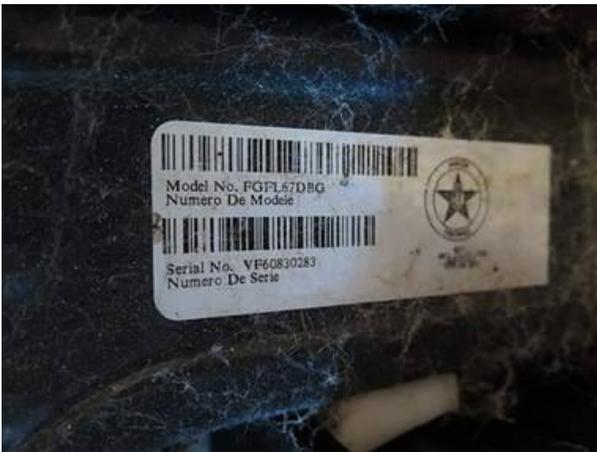
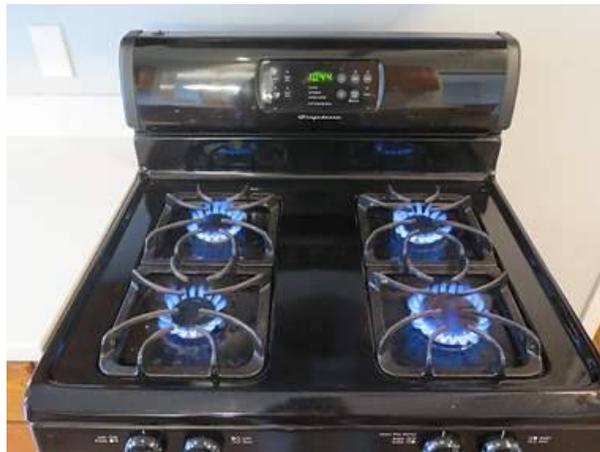
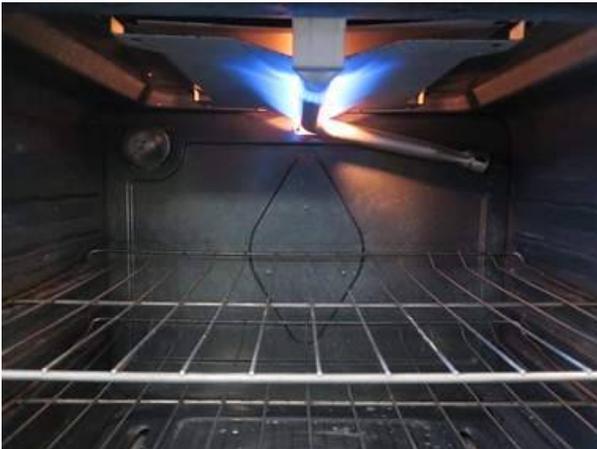
The range could tip forward. An anti-tip bracket may not be installed. This is a potential safety hazard since the range can tip forward when weight is applied to the open door, such as when a small child climbs on it or if heavy objects are dropped on it. Anti-tip brackets have been sold with all free-standing ranges since 1985. Recommend installing an anti-tip bracket to eliminate this safety hazard. For more information, visit: <https://www.reporthost.com/?ATB>

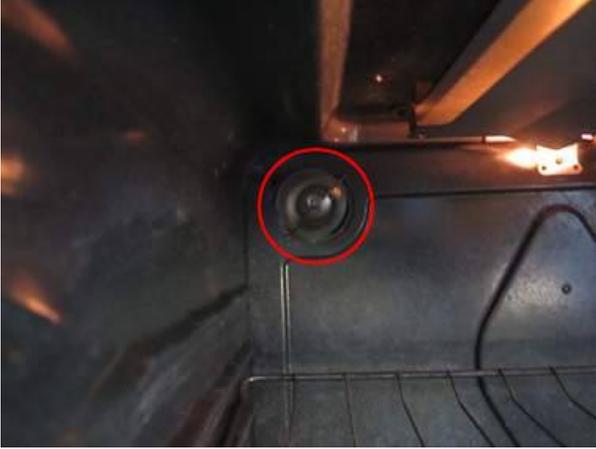
Photo 69-1

69) 🛠️ The oven light was inoperable. Recommend replacing bulb or that repairs are made, if necessary, by a qualified person.

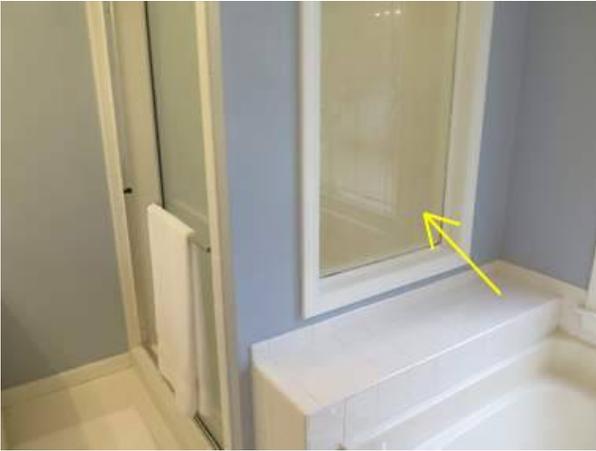
Photo 76-1

The inspector was unable to verify that the glass used in the shower enclosure at location(s) #B was approved safety glass. Glazing that is not approved safety glass, located in areas subject to human impact, is a safety hazard. Standard building practices generally require that approved safety glass be used in swinging and sliding doors except where "art glass," jalousie windows or glazing smaller than a 3-inch opening is used. Recommend that a qualified contractor evaluate further to determine if glazing is approved safety glass, and replace glass if necessary, and per standard building practices.

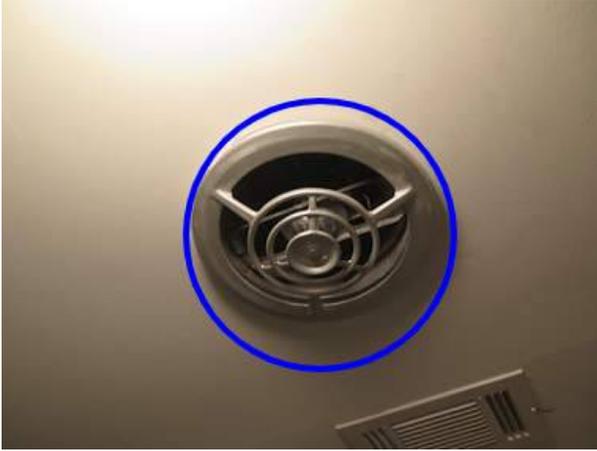
Photo 77-1

The exhaust fan at location(s) #A was noisy or vibrated excessively. Moisture may accumulate and result in mold, bacteria or fungal growth. Recommend that a qualified person clean, repair or replace fans as necessary.

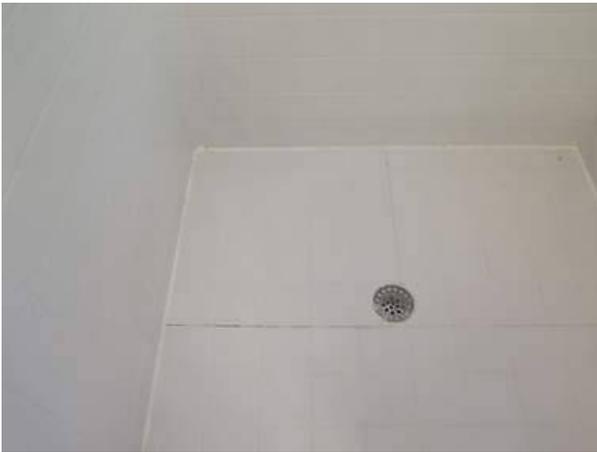
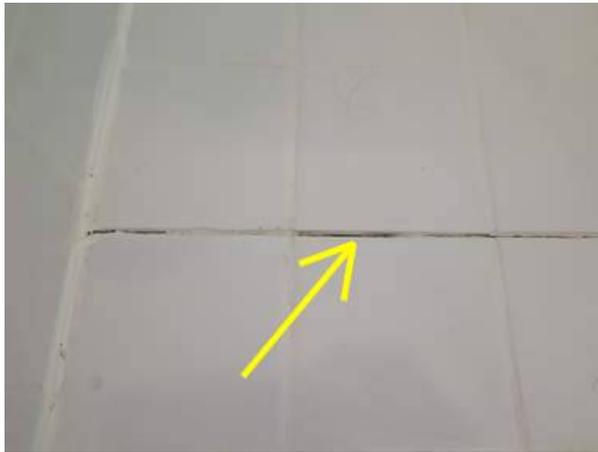
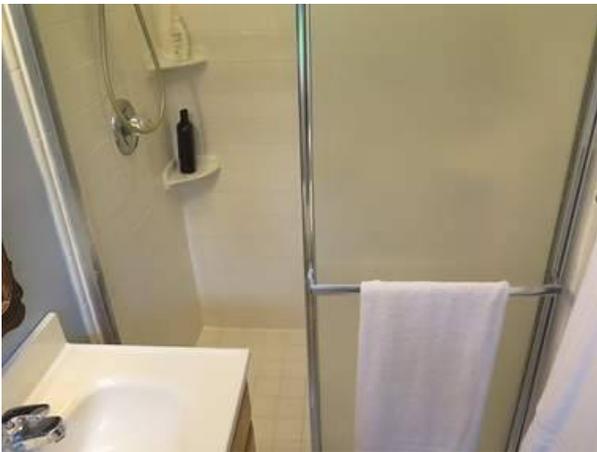
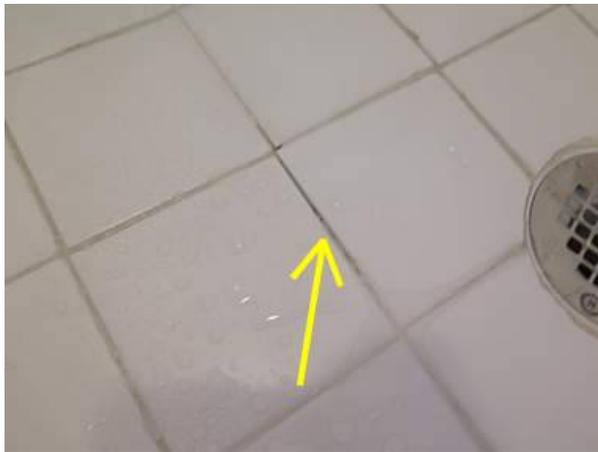
Tile and/or grout in the shower enclosure at location(s) #B and D were deteriorated (e.g. loose or cracked tiles, missing grout) or substandard. Water can damage the wall structure as a result. Recommend that a qualified contractor repair as necessary.

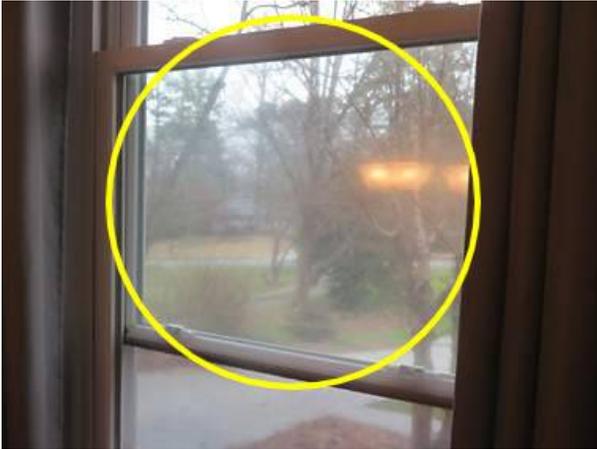
Photo 82-1

Condensation or staining was visible between multi-pane glass in one or more windows. This usually indicates that the seal between the panes of glass has failed or that the desiccant material that absorbs moisture is saturated. As a result, the view through the window may be obscured, the window's R-value will be reduced, and accumulated condensation may leak into the wall structure below. Recommend that a qualified contractor evaluate and repair windows as necessary. Usually, this means replacing the glass in window frames.

Be aware that evidence of failed seals or desiccant may be more or less visible depending on the temperature, humidity, sunlight, etc. Windows or glass-paneled doors other than those that the inspector identified may also have failed seals and need glass replaced. It is beyond the scope of this inspection to identify every window with failed seals or desiccant.

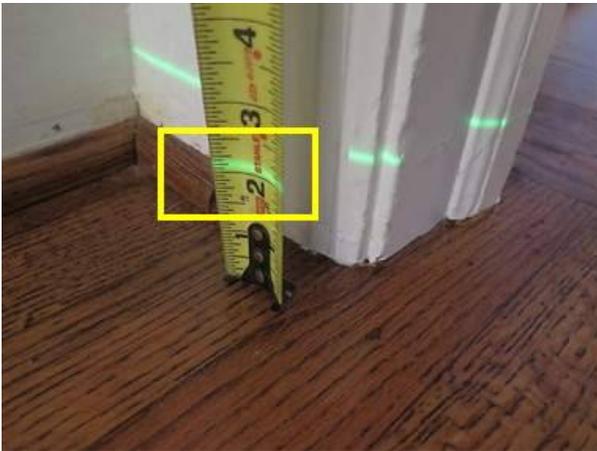
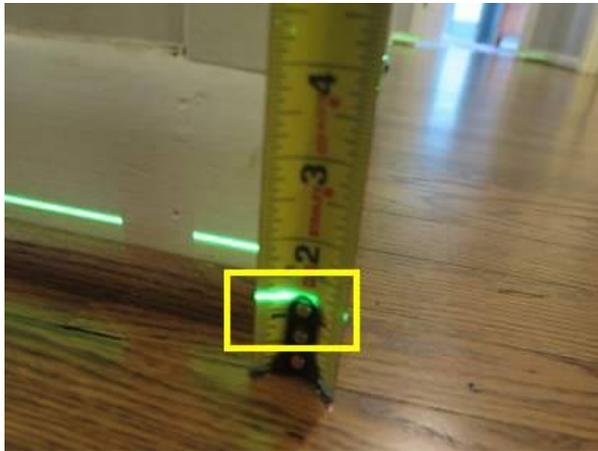
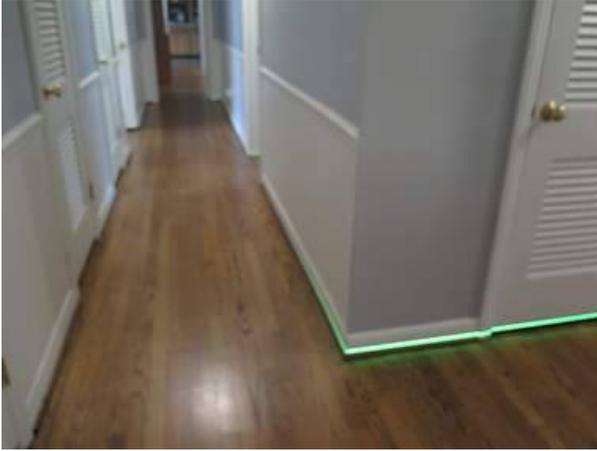
Floors in one or more areas were not level. This can be caused by foundation settlement or movement of the foundation, posts and/or beams. Significant repairs may be needed to make floors level. Recommend that a qualified contractor and/or engineer evaluate further. Repairs should be performed by a qualified contractor.

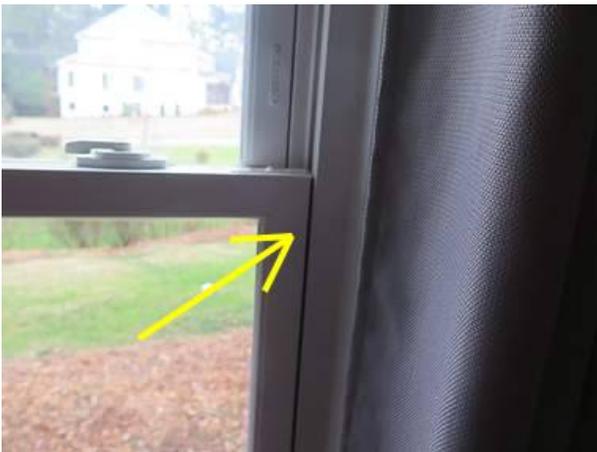
Photo 85-1

85) 🛠️ One or more windows that were designed to open and close were stuck shut. Recommend that a qualified person repair windows as necessary so they open and close easily.

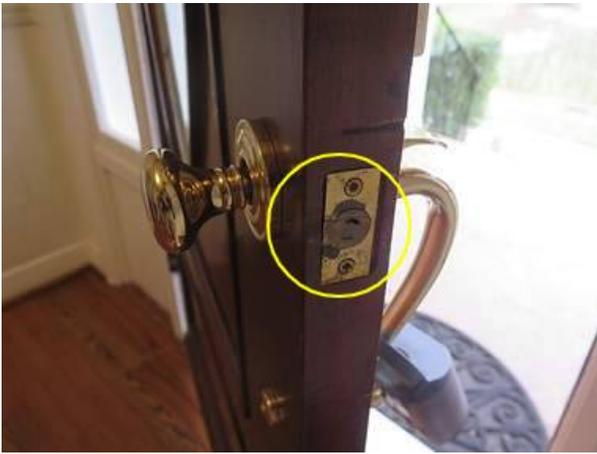
Photo 86-1

86) 🛠️ Some exterior door hardware, including locksets were inoperable. Recommend that a qualified person repair or replace as necessary.

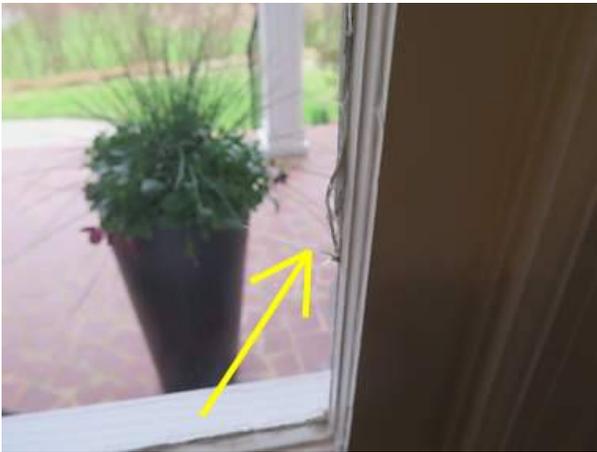
Photo 87-1

87) 🛠️ Glass in one or more exterior doors was broken. Recommend that a qualified contractor replace glass where necessary.

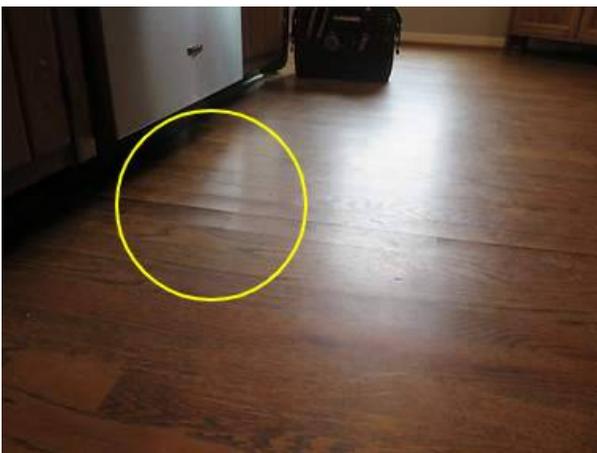
Photo 88-1

88) 🛠️ Wood flooring in one or more areas was significantly worn, deteriorated or damaged. Recommend that a qualified contractor refinish wood flooring as necessary.

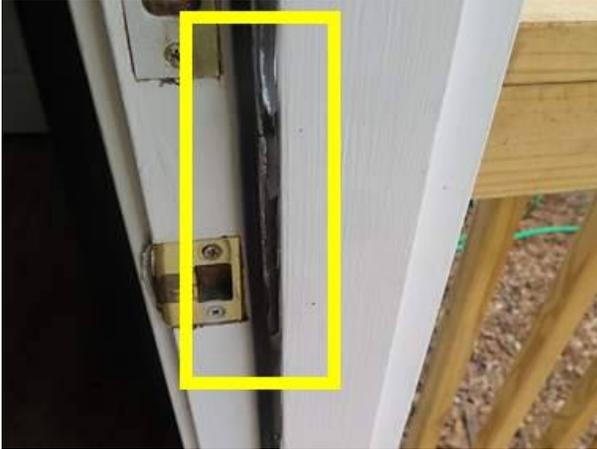
Photo 89-1

89) 🛠️ Weatherstripping around one or more exterior doors was damaged and/or deteriorated. Water may enter the building, or energy efficiency may be reduced. Recommend that a qualified person repair or replace weatherstripping as necessary.

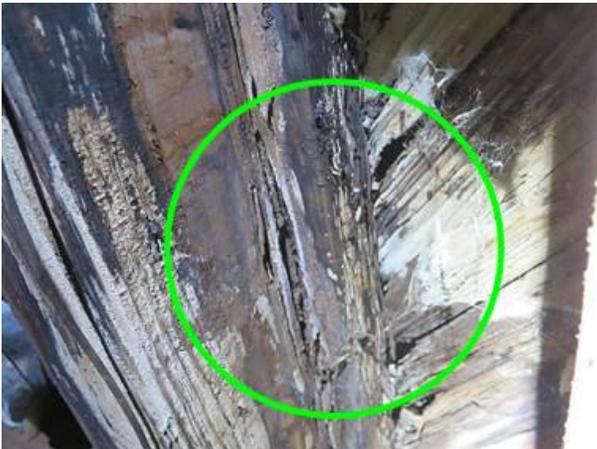
Photo 92-1

92) 🔍🪲 Evidence of past infestation of subterranean termites was found at location(s) # in the form of galleries or holes in wood with visible wood damage. Recommend the following:

- Correct any conducive conditions for wood-destroying organisms mentioned in this report.
- Consult with the property owner about any history of infestation.
- Have a state-licensed pest control operator evaluate further and treat as necessary.
