Property Inspection Report
3715 Valleyway Road

Property Address:
3715 Valleyway Road
Cumming, Georgia 30040

Inspection Date:
February 8th, 2020

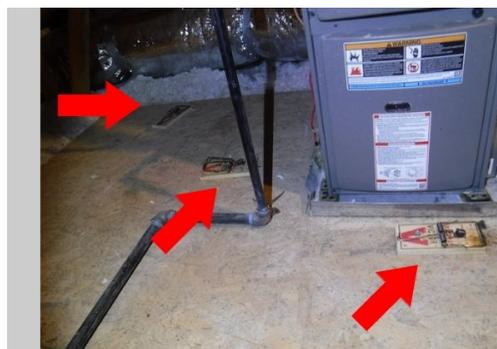
Description:	Rodents
Location:	Main Attic and Both Attic Entries in Large Garage
Condition:	Rodent Activity Noted
Explanation:	Rodent tunnels, paths, and traps indicate past or present activity. Rodents can chew wiring and stored items, displace insulation and cause damage to other attic components. The third picture shows a path through the insulation.
Suggested Action:	Consult a pest control specialist for further evaluation and eradication.
Significance:	Needs Pro Repair

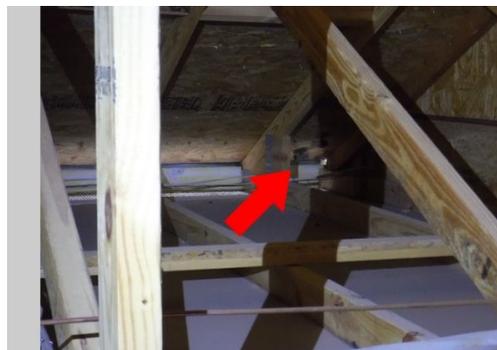
Description:	Wasp Nests
Location:	Single Garage, Front
Condition:	Wasps Nests Observed
Explanation:	Wasp nests were observed in the attic.
Suggested Action:	Consult a pest control contractor for evaluation and remediation.
Significance:	Safety Concern

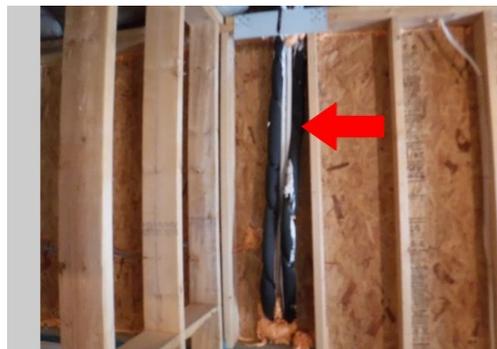
Description:	Refrigerant Line Insulation
Location:	Basement, Back Left Side
Condition:	Refrigerant Line Insulation Damaged/missing/constricted
Explanation:	The refrigerant line will produce excessive condensation if not properly insulated. The condensation will drip from the pipe, creating copper stains and increasing moisture levels. Tape used to hold the insulation can be installed too tight, thus constricting the foam insulation and will also cause dripping.
Suggested Action:	Replace where damaged. Ensure proper sealing at the coil.
Significance:	Needs Handy Repair

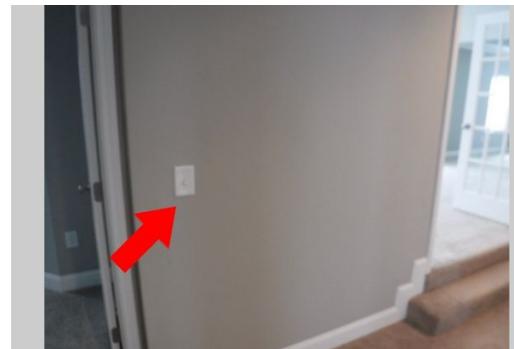
Description:	Light Switch
Location:	Upstairs Hallway Between Back Bedrooms
Condition:	Attic Light Switch
Explanation:	This turns on the attic light.
Suggested Action:	Use as needed.
Significance:	Courtesy Information

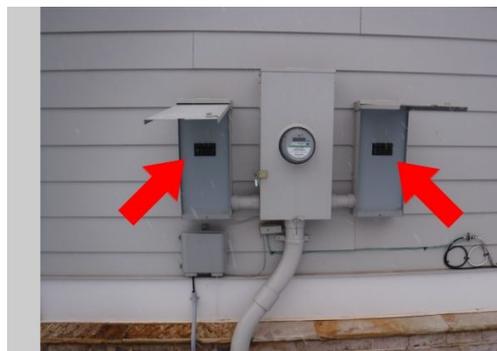
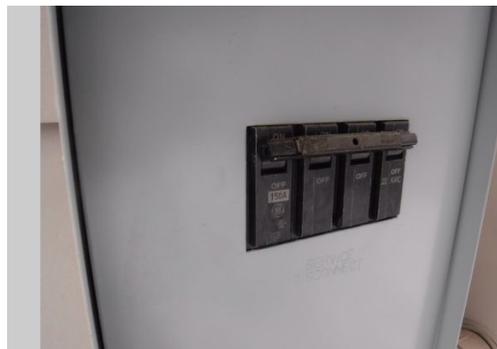
Description:	Main Electrical Disconnect
Location:	Right Side of Home
Condition:	Information Regarding Main Disconnect and Location
Explanation:	Many insurance companies are requesting a photo of the electrical main disconnect, so it is provided here as a courtesy. This single breaker will cut off all power to the house in case of emergency.
Suggested Action:	Use as needed.
Significance:	Courtesy Information

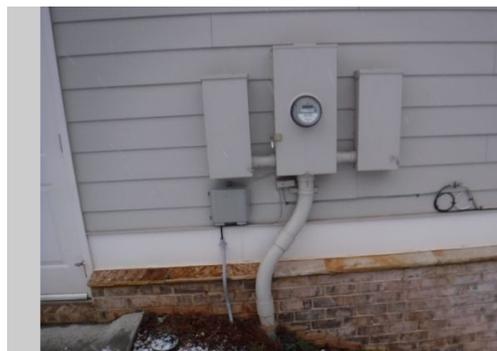
Description:	Ground Service Entry
Location:	Right Side of Home
Condition:	Information on Location of Service Entry, Power Meter, Etc.
Suggested Action:	Use as needed.
Significance:	Courtesy Information

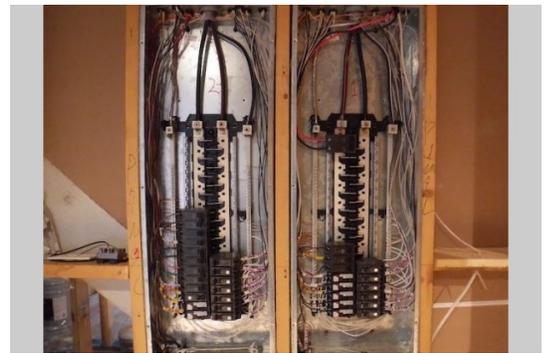
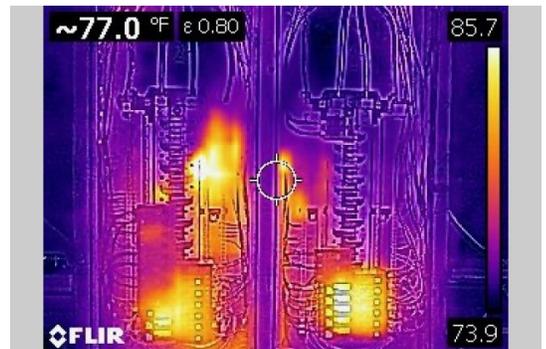
Description: Main Electrical Panels
Location: Basement, Front Left Room
Condition: Information Regarding Panel Wiring
Explanation: Many insurance companies are requesting a photo of the electrical panel interior components, so it is provided here as a courtesy.
Suggested Action: Use as intended.
Significance: Courtesy Information

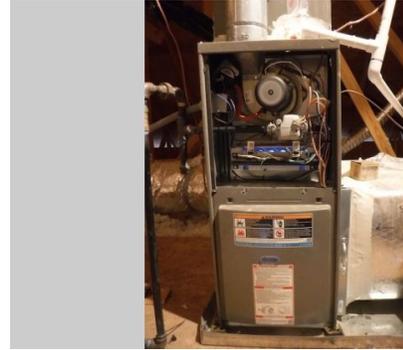
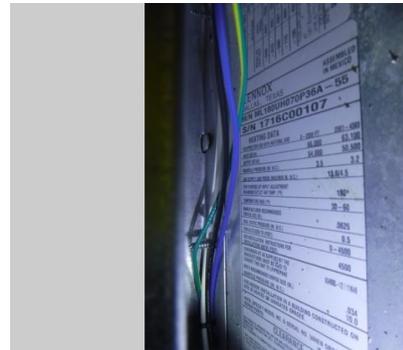
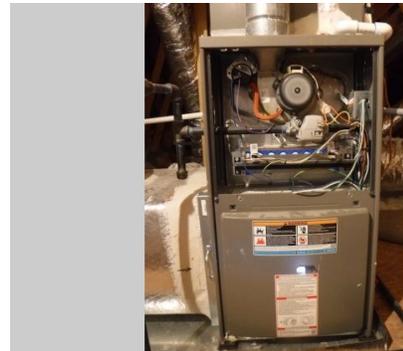
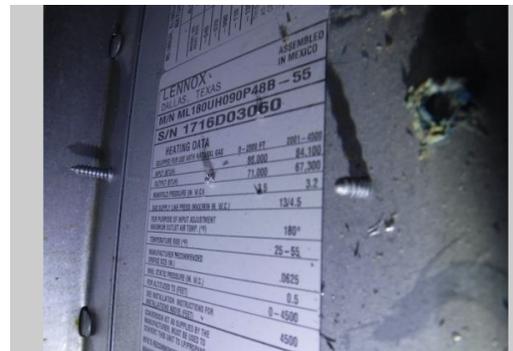
Description: Lennox - 2016 and 2016
Location: Attic
Condition: Data Tag and Filter Information
Explanation: Change air filters on a regular basis. Filters will be located on the left and/or right side. Size: 16x25x1
Suggested Action: Use as needed.
Significance: Courtesy Information

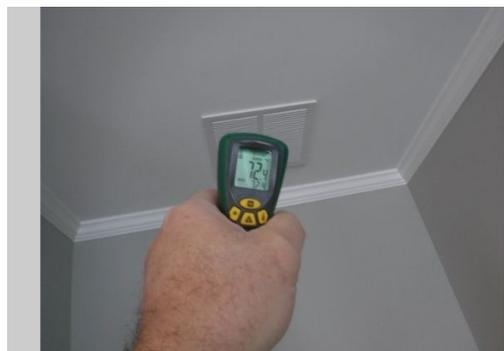
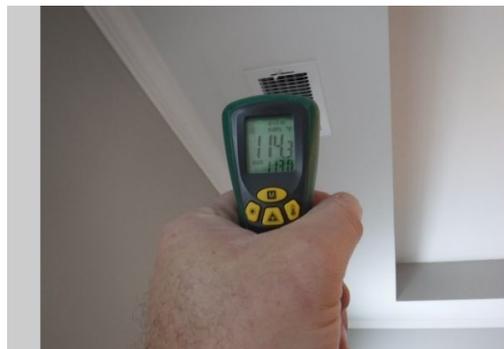
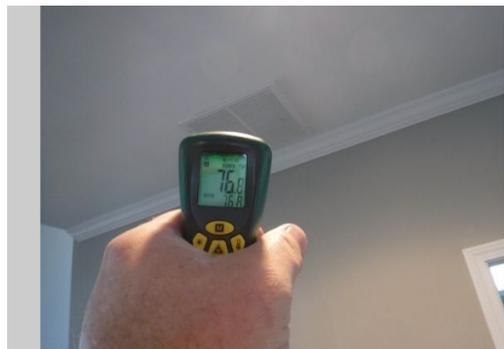
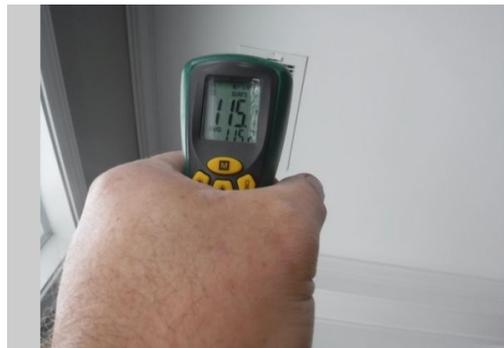
Description:	Temperature Differentials
Location:	Upper and Main Levels
Condition:	Heating Performing Adequately
Explanation:	Temperature differentials should be a minimum of 12 to 20 degrees between the registers that force air out and the return air vents that draw air inward.
Suggested Action:	Use information as needed.
Significance:	Courtesy Information

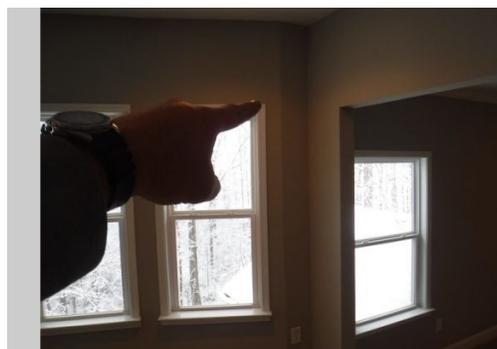
Description:	Wall Crack
Location:	Master Bedroom
Condition:	Abnormal Wall Cracks Present
Explanation:	Abnormal cracks indicate unusual movement of the structure, which can be caused by foundation or framing problems. These conditions can indicate deficiencies. The cracking is thin, less than 1/8th inch and not displaced.
Suggested Action:	Have a drywall/paint contractor repair. Monitor for any further cracking. If cracking continues, consult a qualified contractor to provide repair specifications
Significance:	Needs Pro Repair

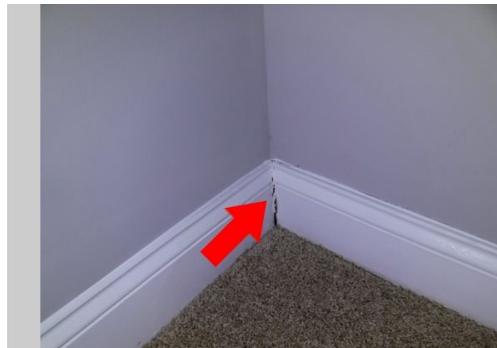
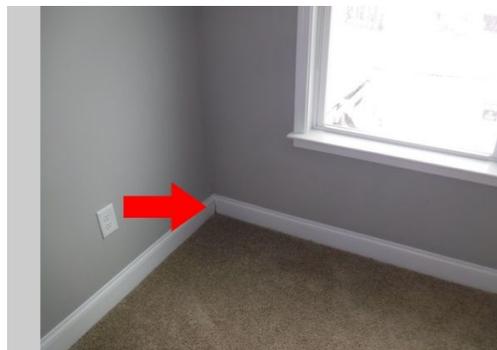
Description:	Wall Baseboard
Location:	Upstairs Front Right Bedroom
Condition:	Crack Noted
Explanation:	A crack was noted at the butts of two baseboards. This appears to be an expansion/contraction situation of the baseboards and caulking. No other cracking or activity was noted in this area.
Suggested Action:	Have a qualified contractor or handy person repair and repaint the cracked area and monitor for subsequent movement. Obtain a second opinion from a structural engineer as desired.
Significance:	Needs Handy Repair

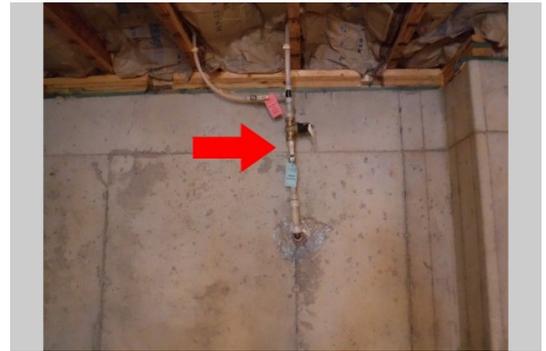
Description:	Main Water Shut Off
Location:	Basement, Front of Home
Condition:	Location of Water Shut-off
Explanation:	The main water valve will shut down the water to all of the interior supply line locations. This valve is used for maintenance and in the event of leakage.
Suggested Action:	Use as needed.
Significance:	Courtesy Information

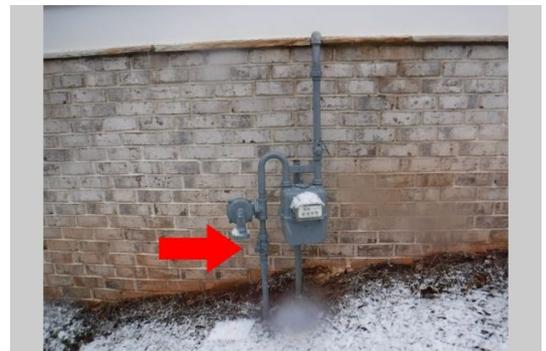
Description:	Main Gas Shut Off
Location:	Left Side of Home
Condition:	Gas Shut Off Valve Location Information
Explanation:	In the event of a gas leak or fire, this is where the gas flow may be turned off.
Suggested Action:	Use as needed.
Significance:	Courtesy Information

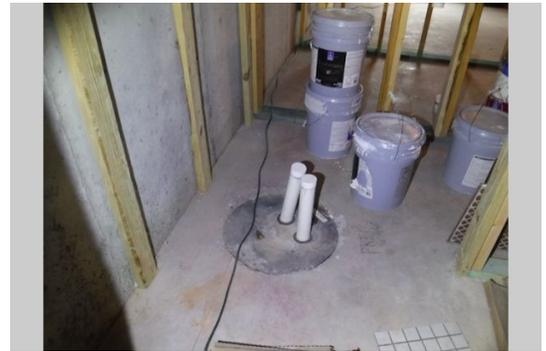
Description:	Sewage Ejector
Location:	Basement Under Stairs
Condition:	Sewage Ejection Pump Location Information
Explanation:	This appears to be a sewage ejection pump and are typically installed if the basement level plumbing sits below the sewer line at the street. In this instance it becomes necessary to pump the waste up so that it may appropriately drain toward the main sewer line at the street.
Suggested Action:	Confirm with seller or plumber. Use as needed.
Significance:	Courtesy Information

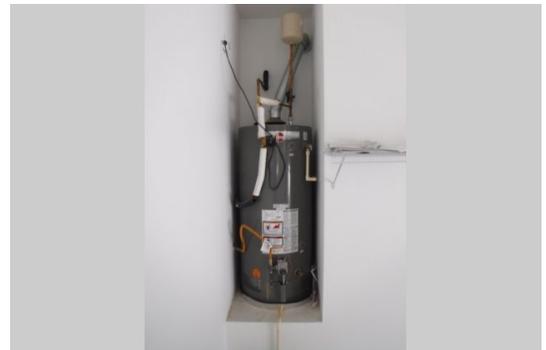
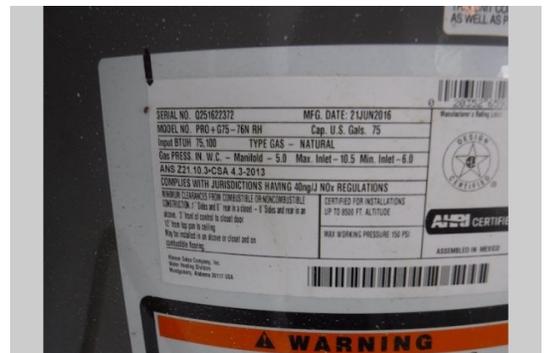
Description:	75 Gallon; 4 Years Old; Gas
Location:	Main Garage
Condition:	Data Tag -- Age and Size
Suggested Action:	Use as needed.
Significance:	Courtesy Information

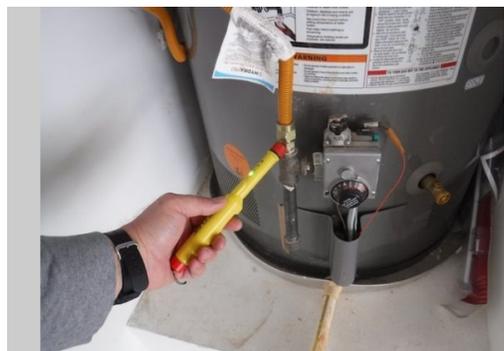
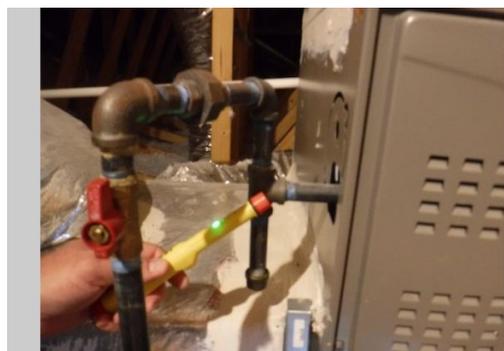
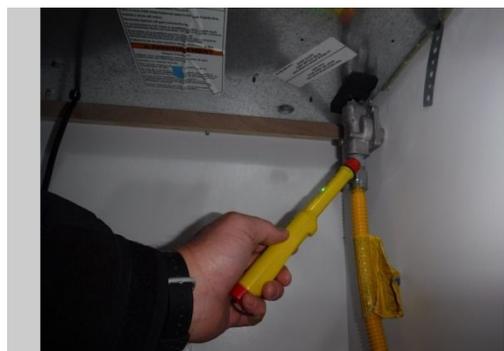
Description: Gas Leak Detection Test
Location: Water Heater, Furnace, Gas Regulator
Condition: Leak Detection Performed - OK
Explanation: Gas leak detection performed at the water heater, furnaces and gas regulator under cooktop.
Suggested Action: Courtesy information.
Significance: Courtesy Information
