Inspection Report

Property Address:
580 Kearny St
Alpharetta GA 30022

Residential Inspector of America
Inspector: Todd Rymer
3276 Buford Dr., Ste. 104-306
Buford, GA 30519
770.476.4963

Date: 2/10/2020	Time: 01:00:00 PM	Report ID: 021020TR287
Property: 580 Kearny St Alpharetta GA 30022	Customer: Bassem and Majd Elkhayat	Real Estate Professional: Rebecca Nelson Keller Williams (Roswell) Mansell Rd

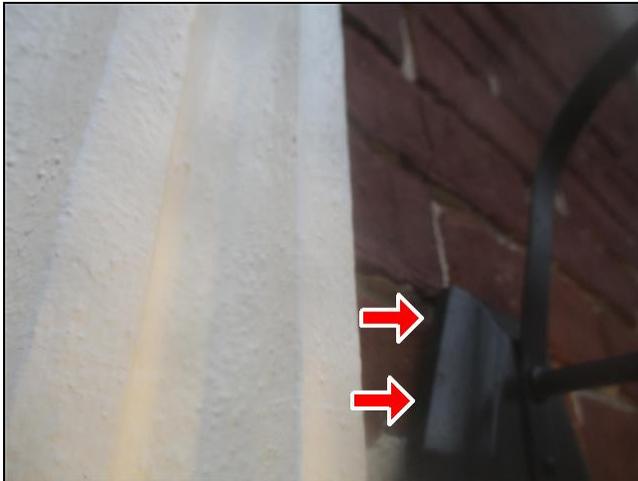
1.0 Item 3(Picture) Seal gap

(2) Seal vertical gaps between brick veneer and lap siding around the home. See example photos. This will help prevent any possible water leaks into the wall cavity behind siding.
-

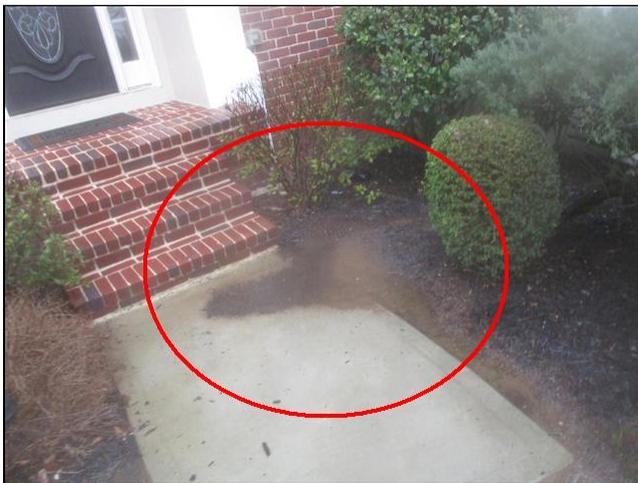
1.4 Item 5(Picture) Ponded water near front entry

- 🔧 (1) The garden area formed by the front wall of the house, and the side walk from the driveway to the front landing, may prohibit quick drainage of run off water. These garden areas often are slow to drain and can cause water entry in the basement.
- 🔧 (2) Minor cracking in driveway. Patch as needed.
- 🔧 (3) Poor drainage/erosion concerns observed on both the right and left sides of the home and near the front entry. See photos. Improvements would be required to improve drainage at these locations. Consult with a landscape professional for solutions/resolve all concerns before closing.

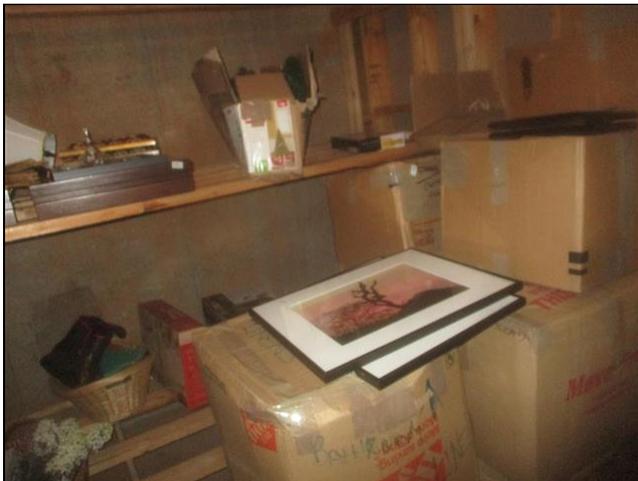
3.0 Item 1(Picture) Stored items

(2) Basement is mostly finished limiting visual inspection of the floor, walls and ceiling areas. Not all insulation was removed from between floor joist and along rim joist. Stored items in some locations of the unfinished basement limited visual inspection of the floor and walls.

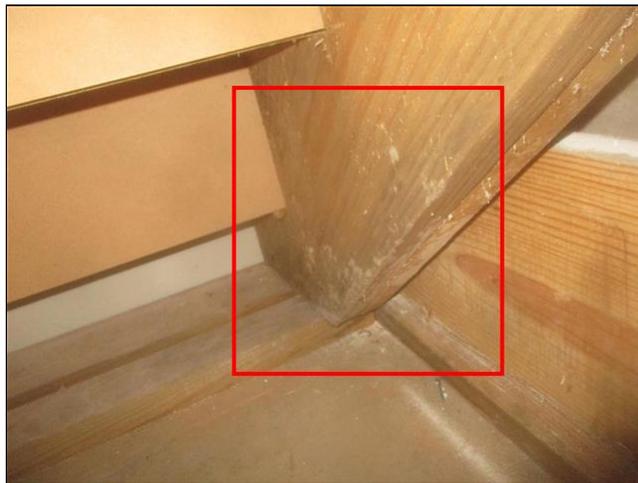
3.0 Item 5(Picture)

👁️ (3) Signs of a small amount of surface type mold or suspected mold growth is present on the unfinished basement under the stairs. See photos. The underlying cause of mold problems is normally moisture or high humidity. A visual inspection cannot determine the extent of the mold problem or if any health hazards exist. Mold testing is recommended and can be completed if desired. Resolve all mold concerns prior to closing. Please click [HERE](#) for more information on mold testing.

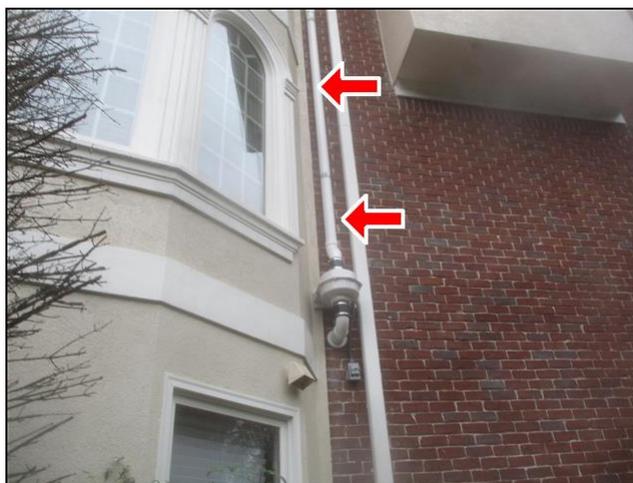
5.4 Item 1(Picture)

Radon mitigation system not included with the inspection. Functionality of system is unknown. Inquire with the owner for more information.

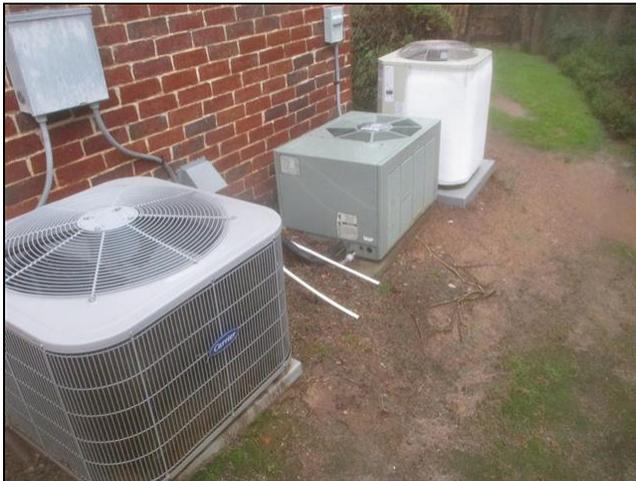
6.6 Item 1(Picture)

The older a/c unit uses the older R-22 type of refrigerant gas (freon) that is being phased out of production and will likely be expensive and difficult to find in the near future. The newer type of freon does not mix with the older type.

The older a/c unit for the home may need replacing in the near future due to its age. A/c units for the home include 1997 model, a 2015 model and a 2019 model.

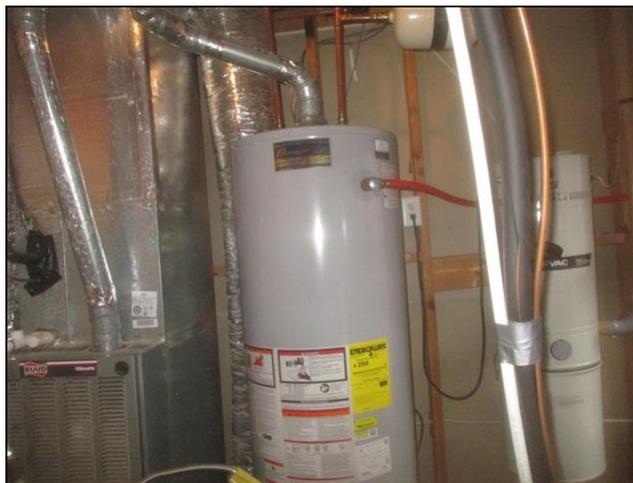
8.3 Item 1(Picture)

Water heaters generally last 10-12 years before needing replacement. Water heater is a 2018 model.
