Atlanta Property Inspections, Inc.

HOME INSPECTION REPORT

2324 Blackberry Court, Snellville, GA 30078
Inspection prepared for: Mai Hue Welshams
Date of Inspection: 11/16/2019 Time: 9:30 AM
Age of Home: 21 Years Old (1998) Size: 2270 SF
Weather: Sunny, Damp Soil, 45 Degrees

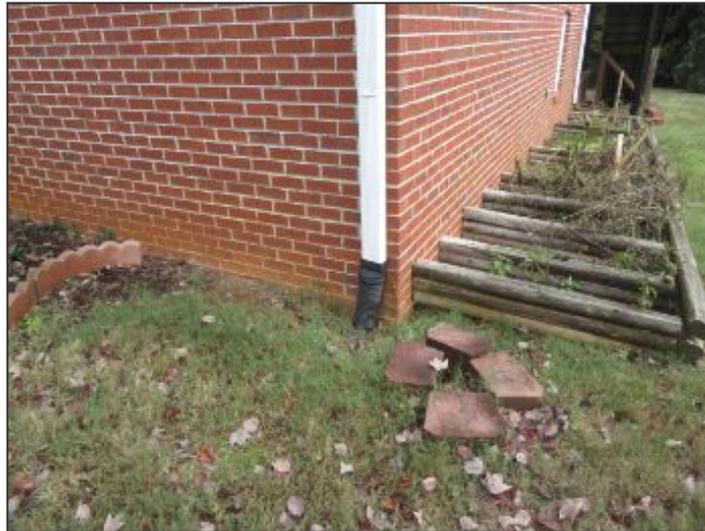
- The yard has a gentle slope overall;
- The overall condition of the exterior grading and drainage appears to be adequately sloped and maintained. No concerns were observed, continue to maintain good drainage conditions as needed.
- **POSITIVE FEATURE!**
Several downspouts have been extended into underground drain pipes for improved drainage around the perimeter of the foundation (see photo). Continue to monitor these drain pipes and clean as needed.

Underground downspouts present for improved drainage

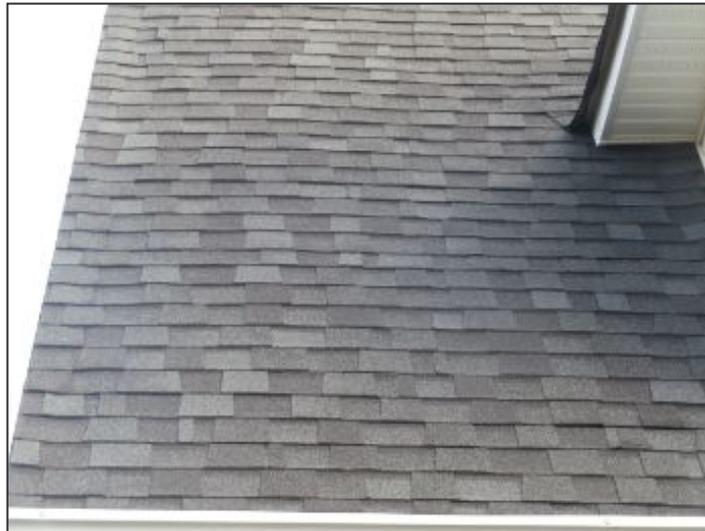
This roof has architectural or profile shingles; this attractive and slightly more expensive shingle is a significant upgrade from traditional roof shingles. It also has a longer warranty period of 25-35 years and should provide an extended lifespan when compared to traditional roof shingles. This type of shingle also performs better in storms and when exposed to hail.

Architectural shingles present

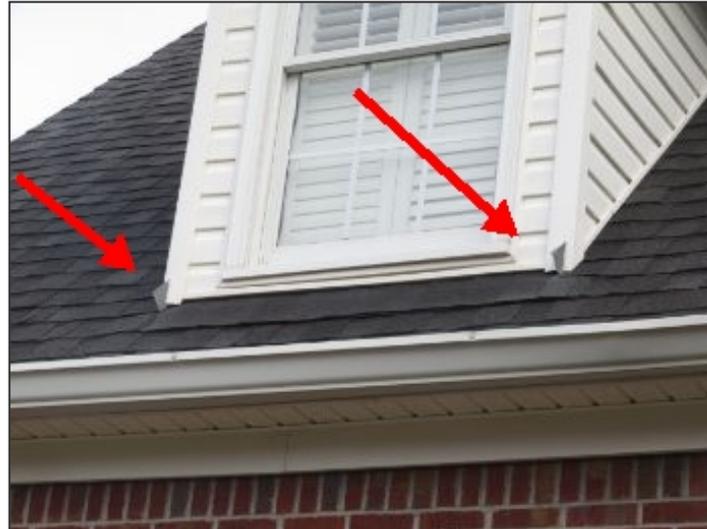
• **Good flashing details were noted at the intersecting walls (see photo).**

Good flashing details at dormer intersections

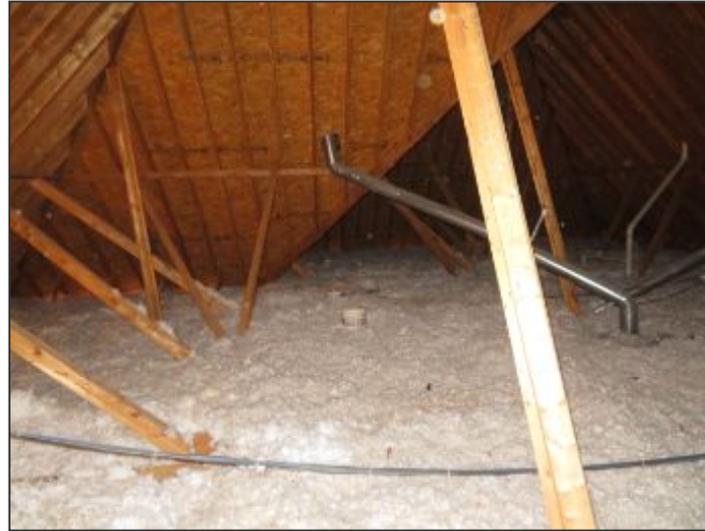
• **The attic entry door does not have full weatherstripping at the perimeter of the doorway to prevent heat loss and heat gain at this doorway location. For improved energy efficiency, it is suggested that weatherstripping be installed to fully seal this door.**

View of attic space

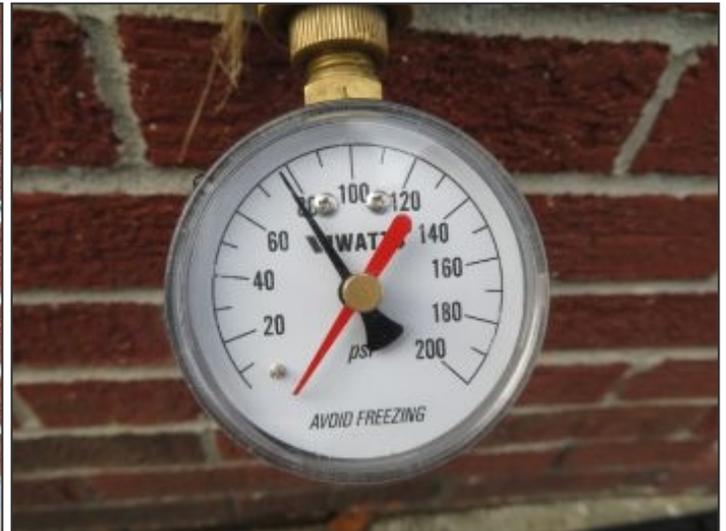
Water pressure at 78 PSI

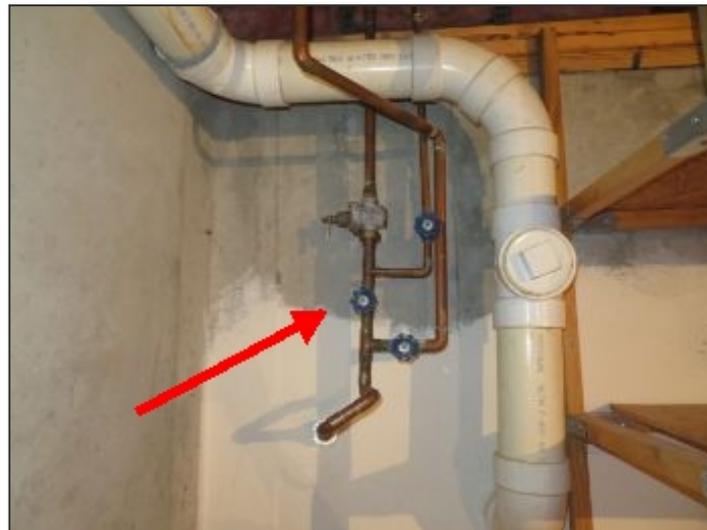
Main water cut-off handle located in basement

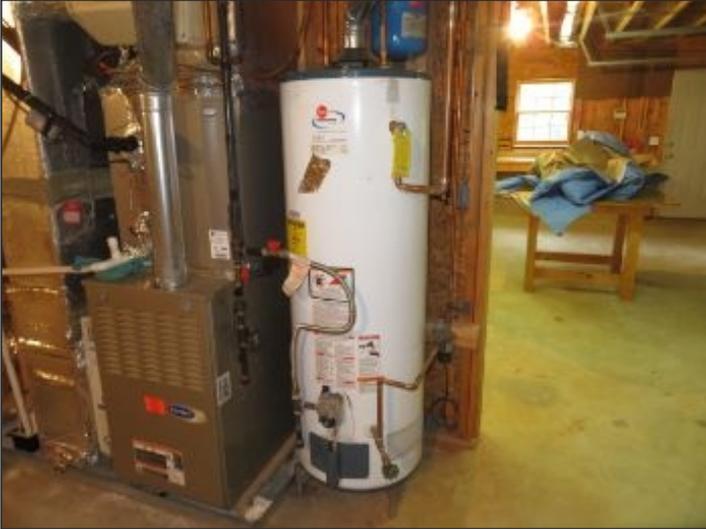
- ~~BUDGET FOR REPLACEMENT:~~
Due to the advanced age of this aging gas water heater, client should budget for replacement of the water heater tank soon. The water heater tank is at, or past, the normal expected lifespan of 10 years.

Water heater located in basement

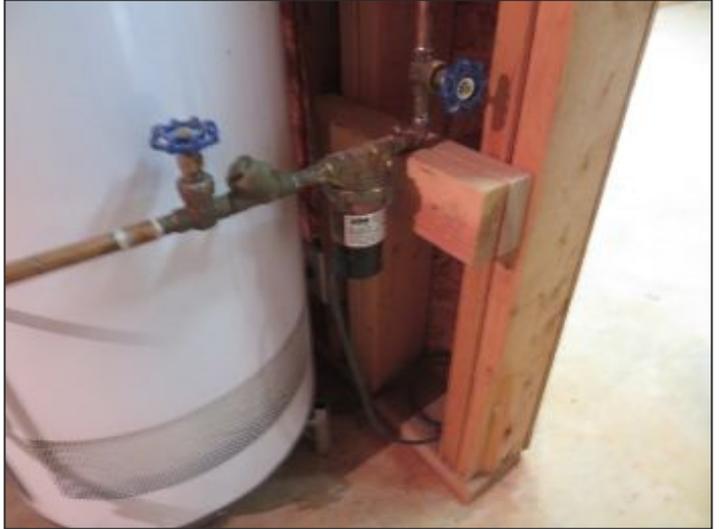
Recirculating pump present at water heater

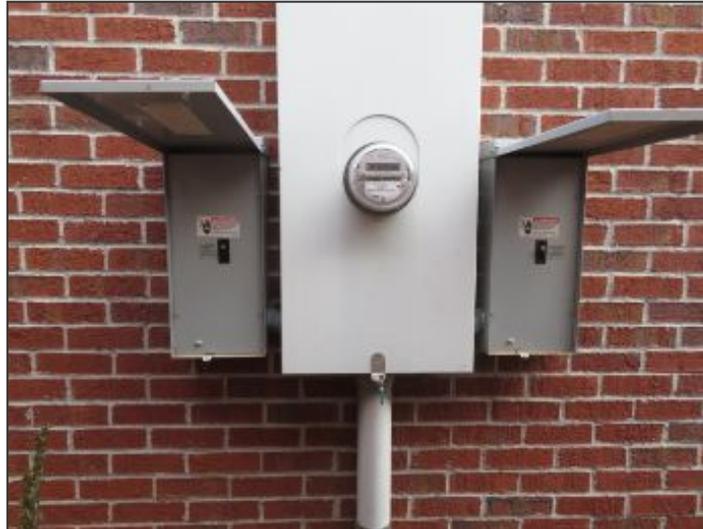
- **The electrical service is underground - 110/220 volt;**
- **Two 150 amp main breakers are located at the exterior meter location; appears serviceable, no concerns were noted.**
- **The electrical grounding consists of a single ground rod near the electrical meter. The electrical service and grounding appears serviceable; no concerns were noted.**

Main electrical disconnects at exterior meter

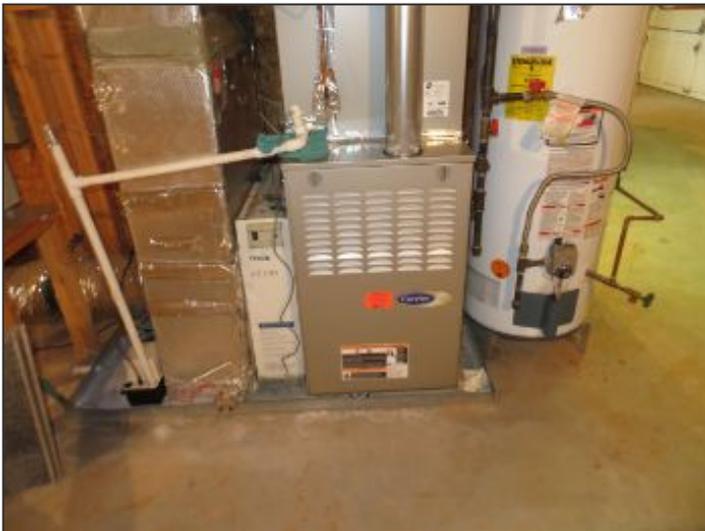
• **The heating system appears serviceable; the heating system was operated and was found to be functioning normally during a limited visual inspection, no significant concerns were noted. Continue to maintain the system and have it serviced regularly.**

Main floor furnace located in basement

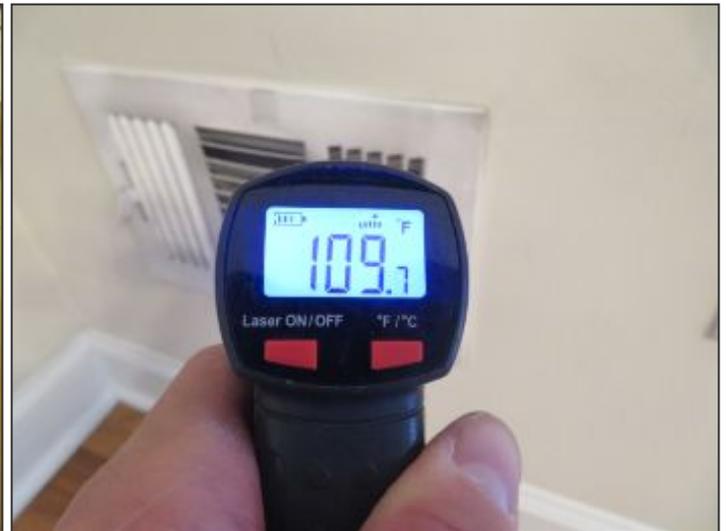
Good temps during testing of main floor furnace

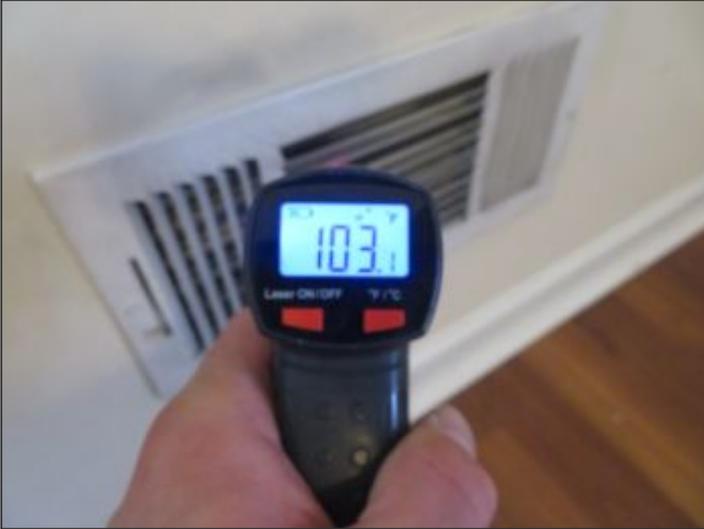
Good temps during testing of second floor furnace

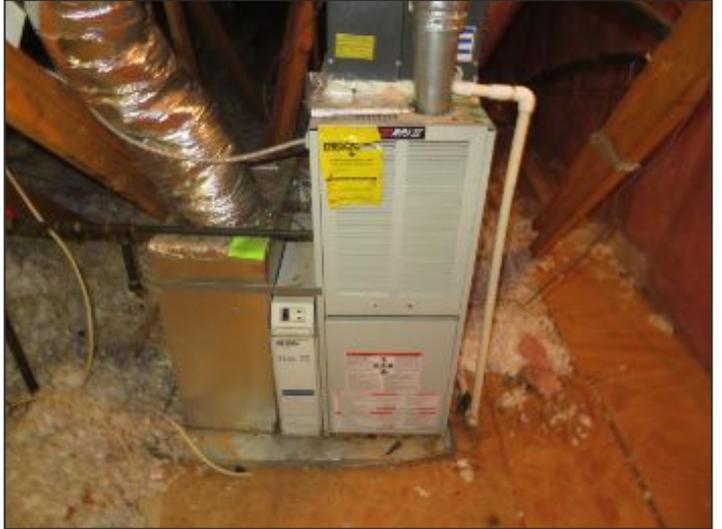
Second floor furnace located in attic

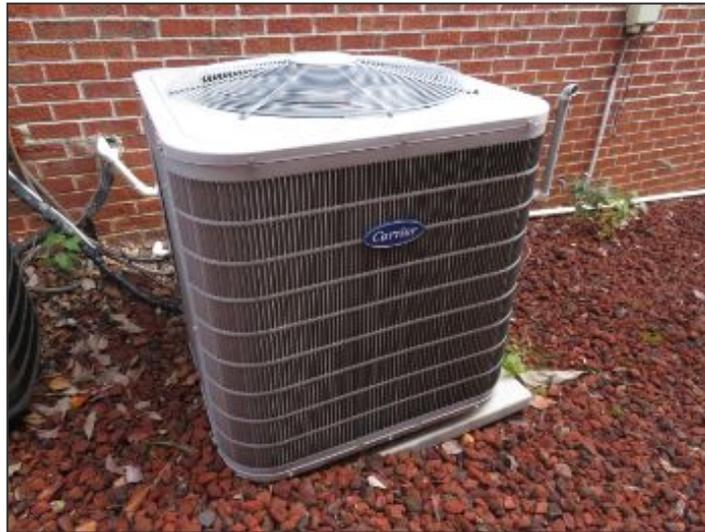
Main floor AC unit

We are unable to inspect the cooling system due to cold weather. The outside temperatures have dropped below 60 degrees during the day or during the previous overnight hours. Due to concerns regarding possible damage to the unit, the air conditioner was not operated and could not be fully inspected during this cold weather inspection. This inspection is limited to a visual inspection and a quick start up to insure the unit is functional.

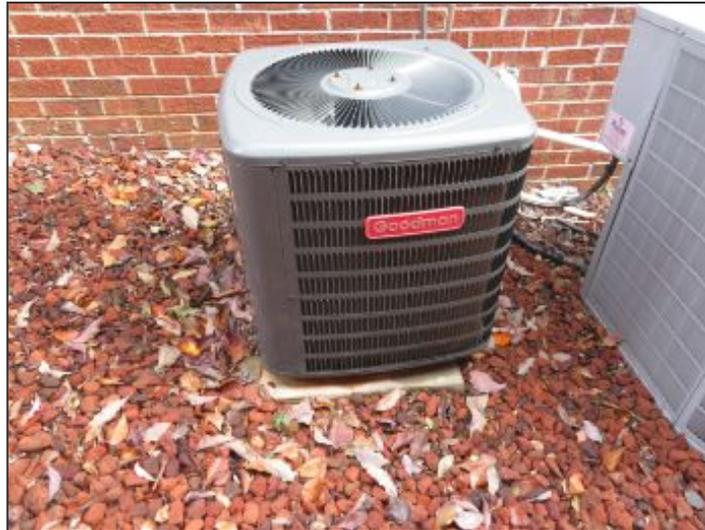
Second floor AC unit

We are unable to inspect the cooling system due to cold weather. The outside temperatures have dropped below 60 degrees during the day or during the previous overnight hours. Due to concerns regarding possible damage to the unit, the air conditioner was not operated and could not be fully inspected during this cold weather inspection. This inspection is limited to a visual inspection and a quick start up to insure the unit is functional.
