Atlanta Property Inspections, Inc.

HOME INSPECTION REPORT

310 Marshy Pointe, Johns Creek, GA 30097
Inspection prepared for: Greg Smith & Natalie Smith
Date of Inspection: 2/26/2020 Time: 1:30 PM
Age of Home: 20 Years Old (2000) Size: 8460 SF
Weather: Cloudy, Damp Soil, 50 Degrees

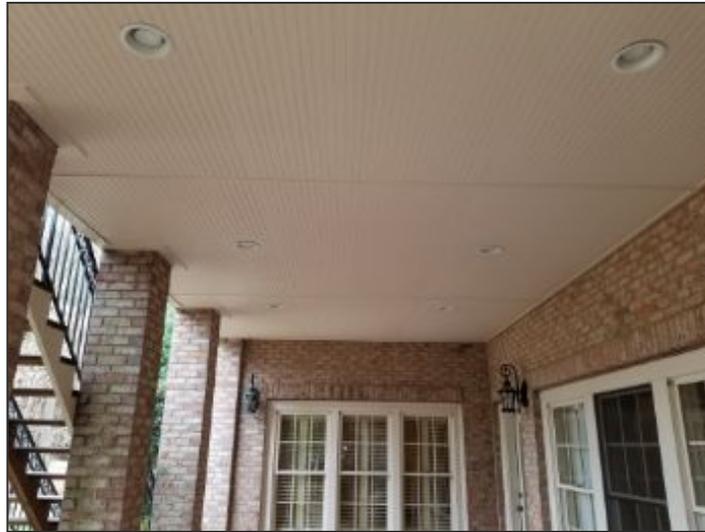
- A wood deck is present at the rear.
- Metal guard railings are present.
- **The rear deck appears to be serviceable, no concerns were noted.**
- **LIMITED INSPECTION: The rear deck has been covered underneath the joists with a ceiling drainage system. The deck framing components and the deck ledger connection are not visible for inspection.**

Covered ceiling below deck

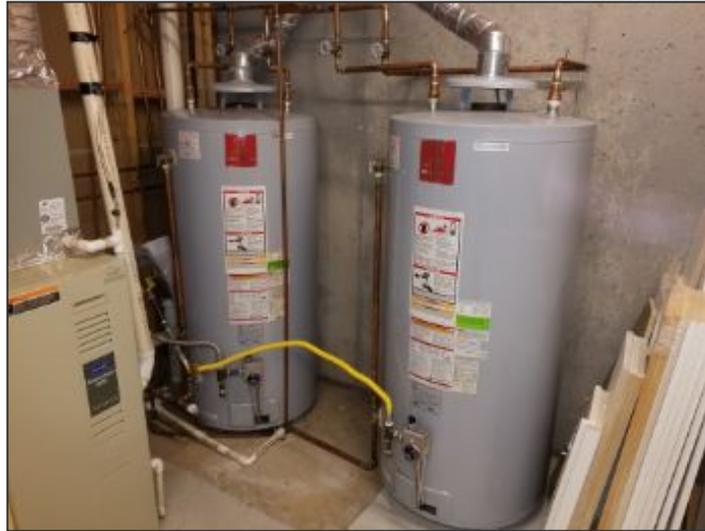
• The expansion valve appears to be leaking based on water dripping out of the exterior end of the drain pipe. Replacement of the **expansion tank** is recommended soon. Expansion valves often leak due to excessively high water pressure or advanced age.

Water heaters located in basement

Due to this active leak, further evaluation and correction is recommended by a professional plumber to determine the full scope of repair needs and costs, the expansion valve may need replacement.

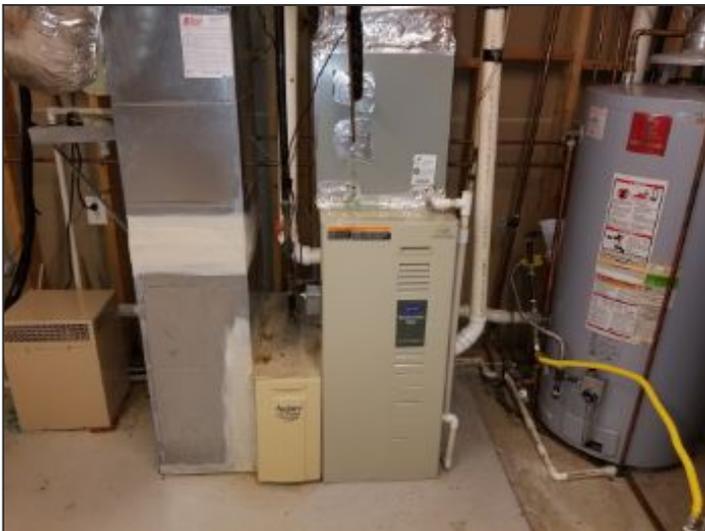
Main floor furnace located in basement mechanical room

HEAT EXCHANGER INSPECTION ADVISED:

Due to the advanced age of the system, a full heat exchanger inspection is advised by a professional HVAC contractor and to provide written certification that the heat exchanger is in good working condition and is safe to operate. Additional heat exchanger inspections are advised each year for as long as this older furnace is in service.

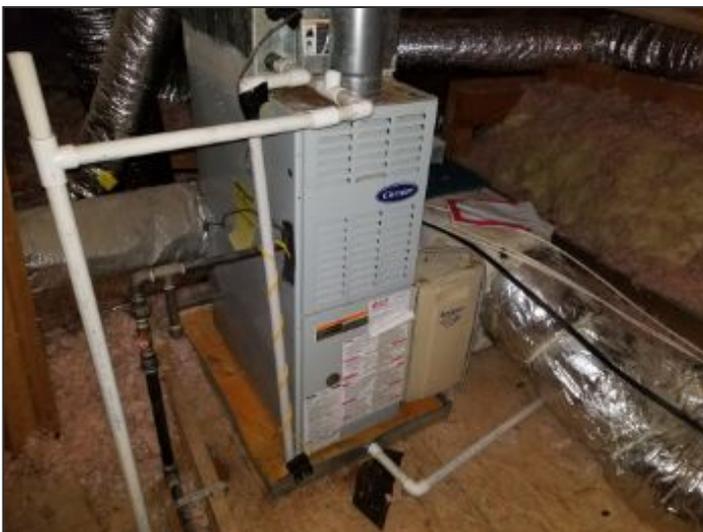
Master bedroom furnace located in lower attic

HEAT EXCHANGER INSPECTION ADVISED:

Due to the advanced age of the system, a full heat exchanger inspection is advised by a professional HVAC contractor and to provide written certification that the heat exchanger is in good working condition and is safe to operate. Additional heat exchanger inspections are advised each year for as long as this older furnace is in service.

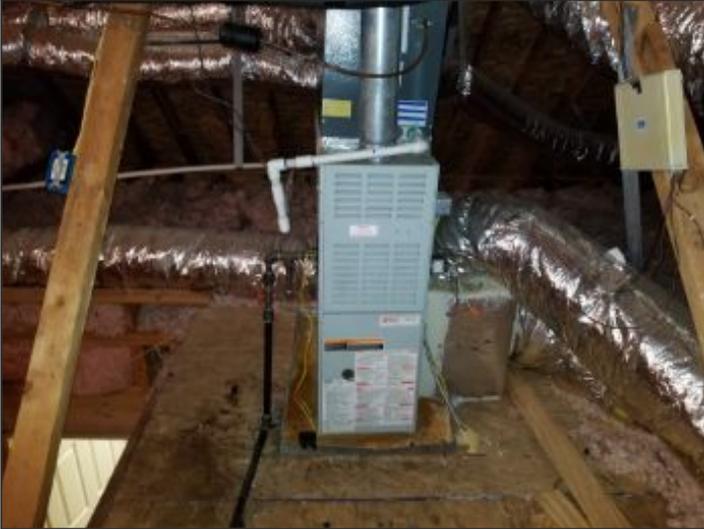
Second floor furnace located in upper attic

HEAT EXCHANGER INSPECTION ADVISED:

Due to the advanced age of the system, a full heat exchanger inspection is advised by a professional HVAC contractor and to provide written certification that the heat exchanger is in good working condition and is safe to operate. Additional heat exchanger inspections are advised each year for as long as this older furnace is in service.

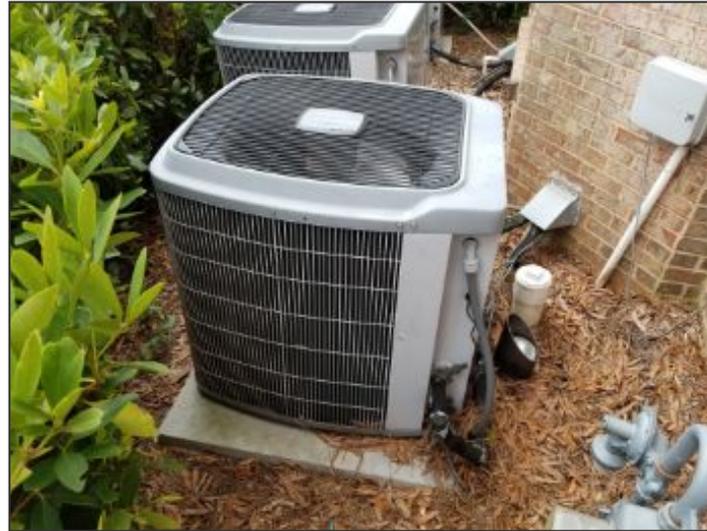
Due to the advanced age of this AC unit, client should budget for replacement soon which is expected to be a major expense. Based on the available manufacturing date on the equipment, the AC unit is at or past the normal expected lifespan of 12-15 years.

Main floor AC unit

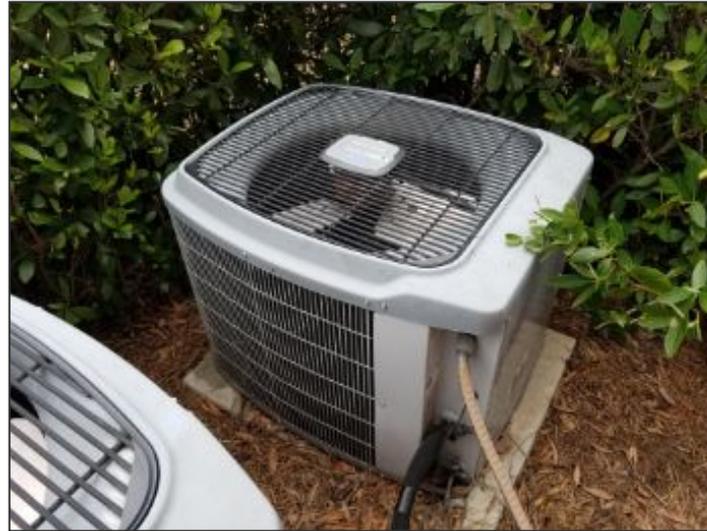
Due to the advanced age of this AC unit, client should budget for replacement soon which is expected to be a major expense. Based on the available manufacturing date on the equipment, the AC unit is at or past the normal expected lifespan of 12-15 years.

Master bedroom AC unit

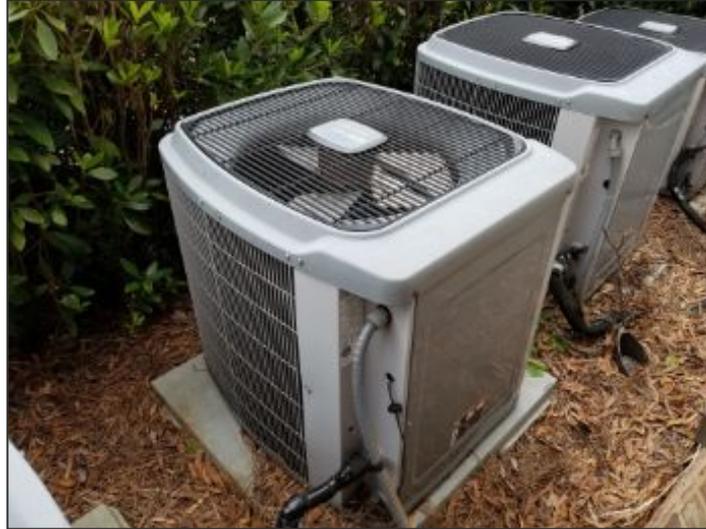
Due to the advanced age of this AC unit, client should budget for replacement soon which is expected to be a major expense. Based on the available manufacturing date on the equipment, the AC unit is at or past the normal expected lifespan of 12-15 years.

Second floor AC unit
