**Amerispec**  
**PO Box 350**  
**Loganville, GA 30052**  
**Jess.Hodges@AmeriSpec.biz**

Doc #:	202002-16978	Inspector:	Zach Flory
Date:	2/25/2020		
Dwelling Address:	1250 Spring Oak Way Cumming GA 30041		
Client Name:	Alexander Garland		
Client's Agent:	Leiah Clark

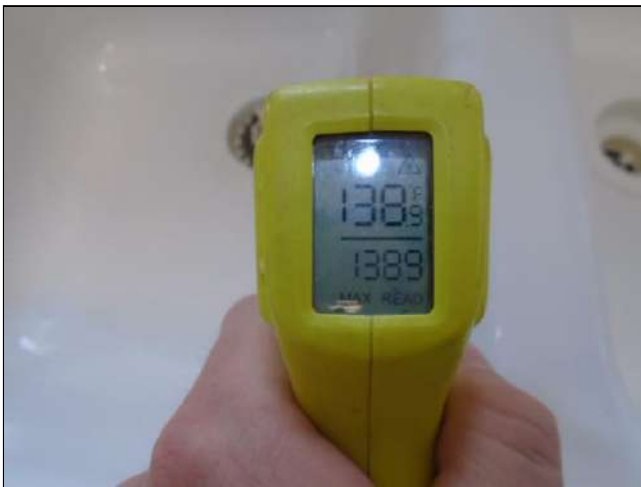
**10.5 Overflow Pan / Drain Line****Comments:** Serviceable**10.6 Hot Water Temperature****Comments:** Review

The water temperature at time of inspection was 138 degrees, which is not within the normal operating range of 110 to 130 degrees. Recommend having a qualified professional adjust temperature to between 110 and 130 degrees for safety.

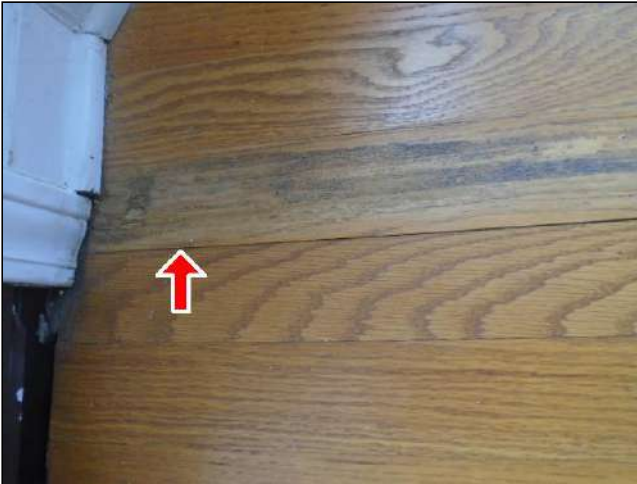
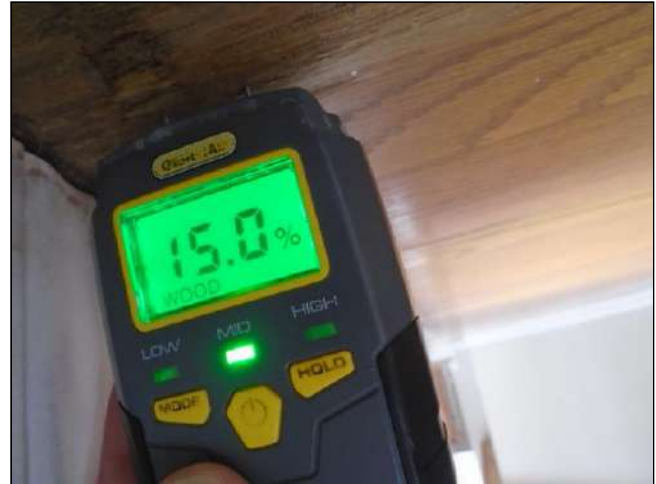
(1) Water damaged floor observed at the rear entry door. An elevated level of moisture was detected using an electronic moisture meter indicating recent or active leaks. A qualified contractor is needed for further review to determine the source of the moisture and to perform necessary corrections prior to close.

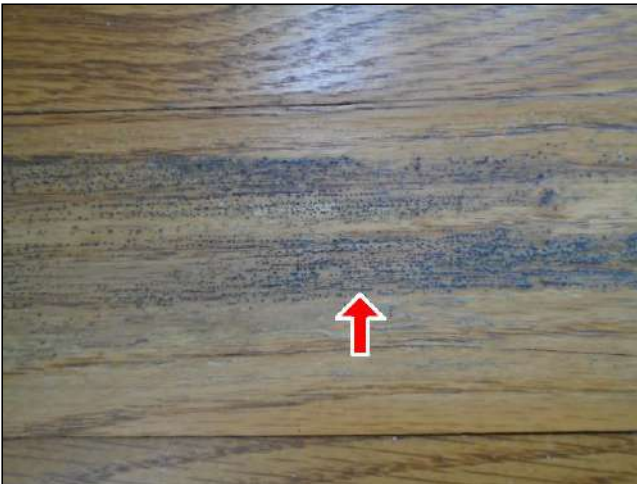
(2) Stains, discoloration, growth and/or evidence of moisture observed in the kitchen floor at the rear entry door. These conditions may indicate fungal growth and were discovered during the home inspection. Because certain types of fungal growth may be toxic and result in adverse health effects, it is strongly recommended that an environmental inspection be performed by a qualified professional to determine the presence of, and types of, fungal growth in the house and that corrective measures be taken to limit moisture inside the home. Remediation of any areas affected by fungal growth should be performed by a qualified professional prior to close.

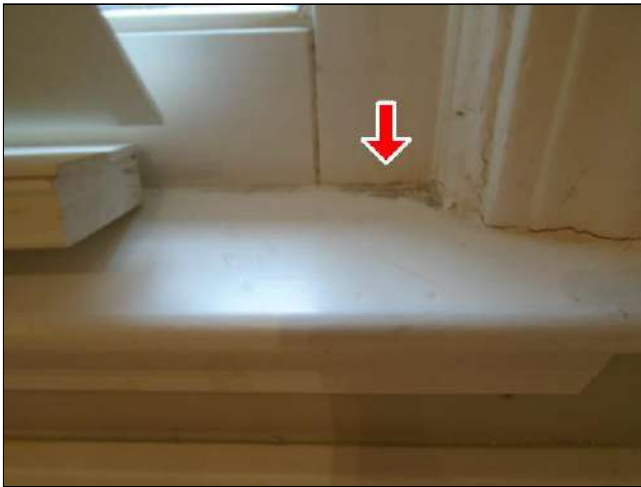
(2) Moisture damaged trim and/or sill observed in the master bathroom, no moisture was detected at the time of inspection. Recommend further evaluation by a qualified contractor for repairs or replacement as needed, prior to close.

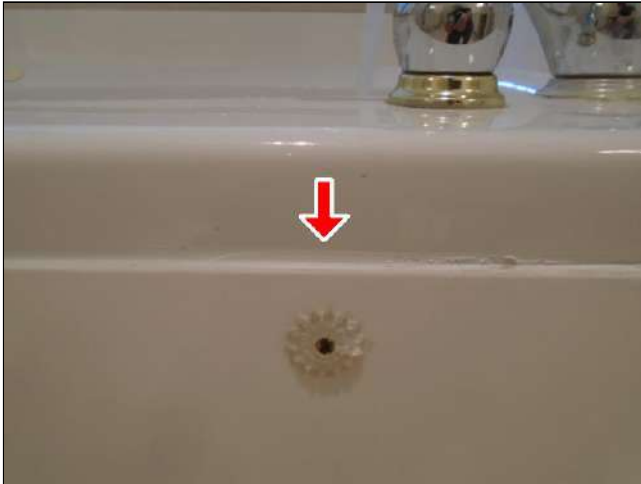
(2) Access for the hydro-massage tub pump was caulked in and could not be removed without damaging materials at the time of inspection. The inspector is unable to verify conditions of the pump or other concealed items in this location. Recommend review for corrections by a licensed contractor as needed prior to close.

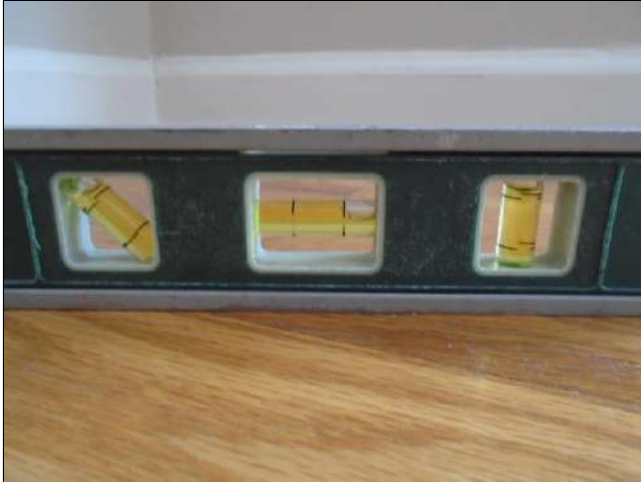
Floor is sloped/uneven in the dining room. Unable to determine cause. Suggest further review by a qualified contractor prior to closing for corrections as needed.

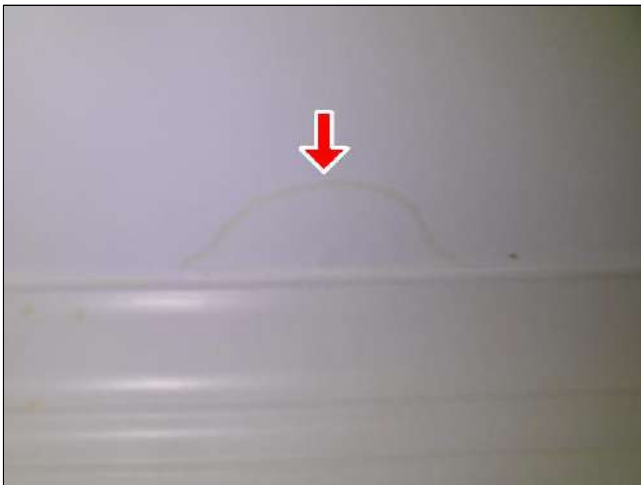
Stains observed on ceiling in the upstairs hallway. The inspector probed stains with a moisture detector, which showed no moisture present at time of inspection. Client is advised to consult seller to determine the source of staining and verify that corrections have been made or have reviewed by a qualified contractor for corrections prior to close.

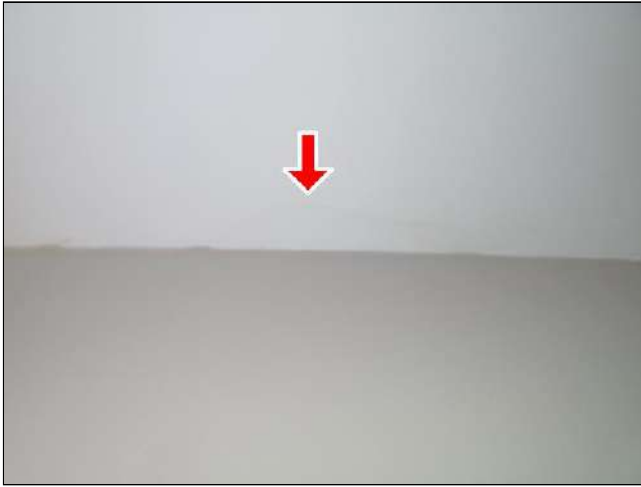
Stains observed on ceiling in the right bedroom at the hall door. The inspector probed stains with a moisture detector, which showed no moisture present at time of inspection. Client is advised to consult seller to determine the source of staining and verify that corrections have been made or have reviewed by a qualified contractor for corrections as needed.

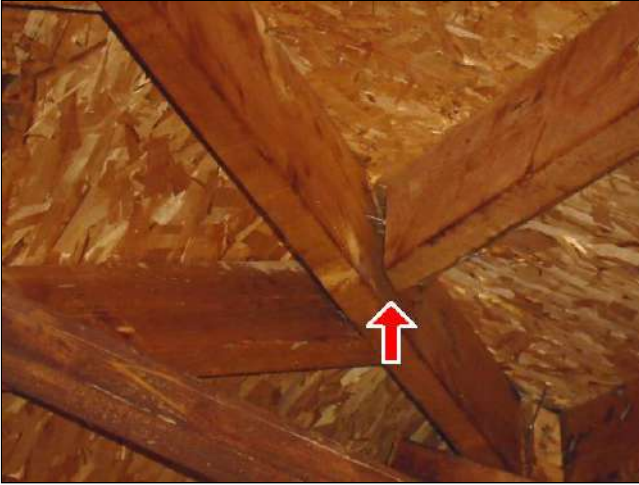
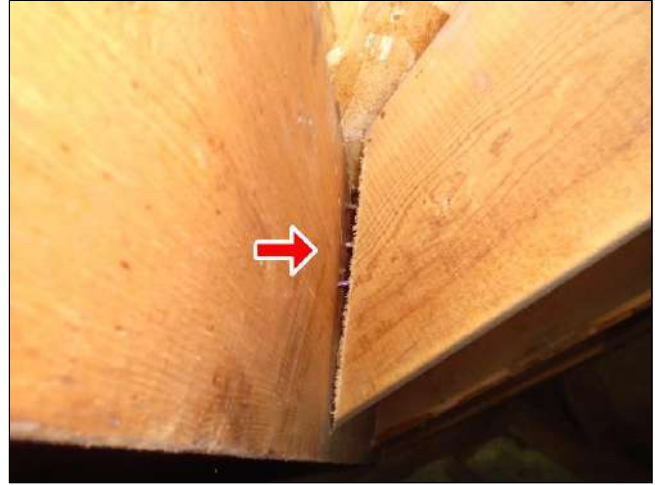
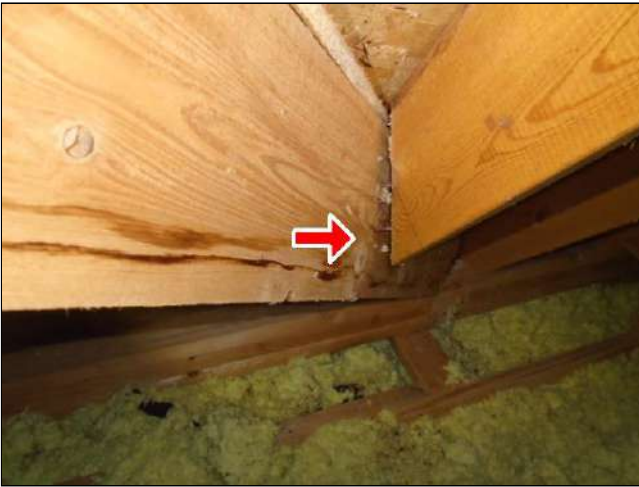
Improperly cut, poorly joined rafters noted, we are unable to determine the effect these will have on the structural integrity of the roof system. We recommend review by a licensed structural engineer or other qualified professional for further evaluation and repair or replacement, as necessary, prior to close.

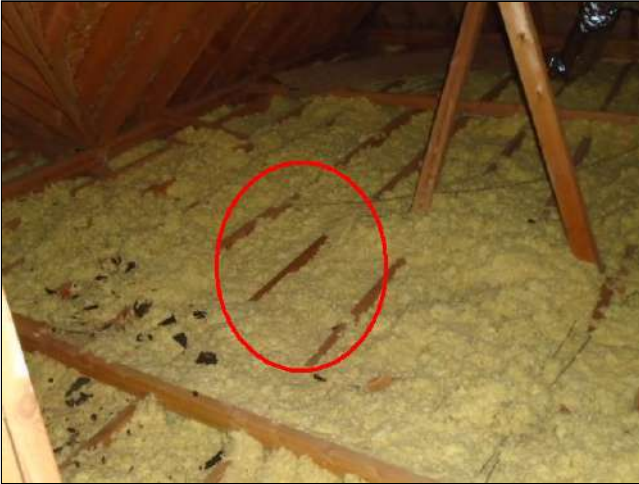
(1) Insulation has been compressed and displaced in several areas of the attic. A licensed general contractor will need to properly place/replace the insulation to prevent temperature loss from the conditioned side.

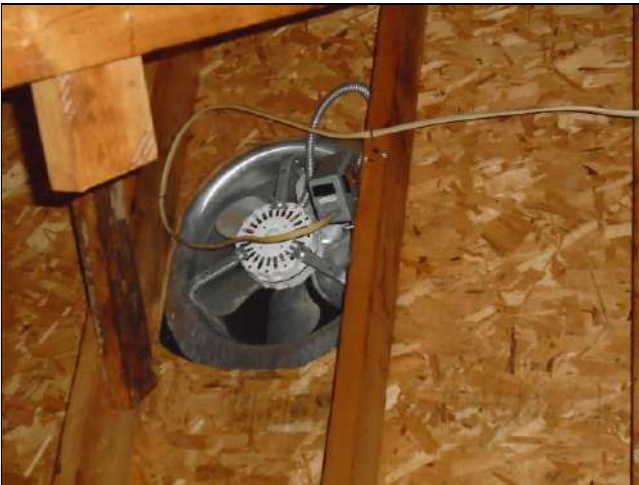
The attic fan(s) were not accessible or the attic temperatures were too low to view the fan(s) in operation; recommend consulting seller's to ensure proper operation.

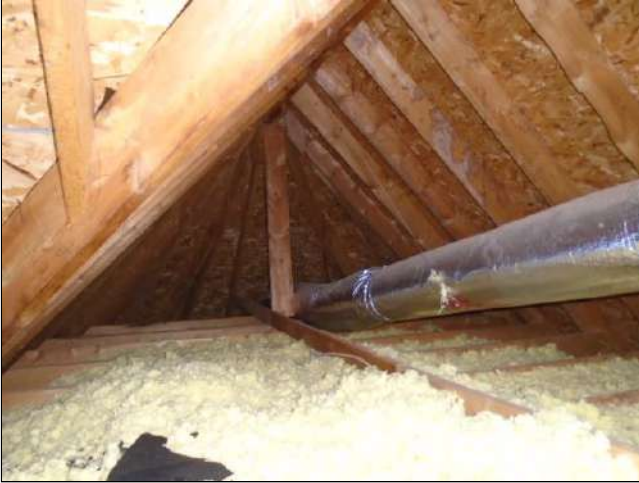
(2) Access to portions of the attic were blocked or not accessible. We were unable to view the attic to note possible evidence of leaking, the amount and type of insulation, the condition of the components, etc. There was a limited review of these areas in the attic.
