Inspection Report

Property Address:
2567 Briars N Dr
Atlanta GA 30360

Avalon Home Inspections

Date: 1/27/2020	Time: 10:00:00 AM	Report ID: 28737TS
Property: 2567 Briers N Dr Atlanta GA 30360	Customer: Craig Dixon	Real Estate Professional: Barbara Neuman Keller Williams Peachtree Road

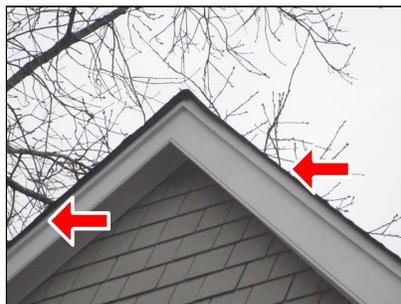
1.1 Item 2(Picture)

The metal drip edge is missing along rake/eaves. Moisture or water could leak in to attic when raining. A qualified roofing contractor should inspect and repair as needed.

Recent changes in code require installation of drip edge flashing when roof is replaced. This change is not retroactive on shingles installed prior to 2012.. This also supports edge of roof shingles and covers the "builder gap" between fascia board and roof sheathing.

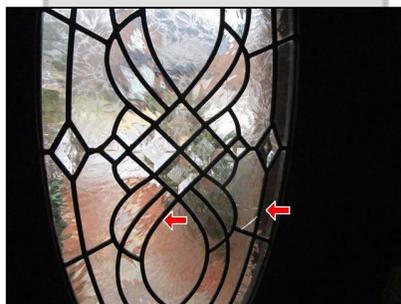
2.1 Item 2(Picture)

(2) The entry door front of home has a cracked glass pane. A repair or replacement is needed. A qualified contractor should inspect and repair as needed.Item 1(Picture) Item 2(Picture)

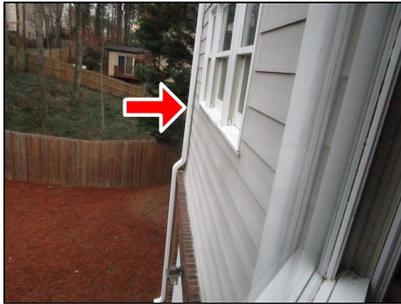
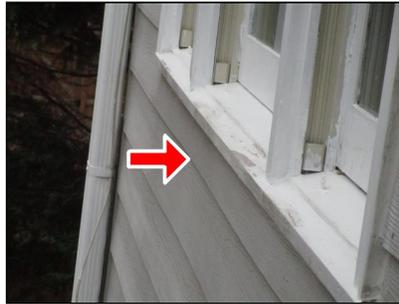
(2) The wood trim is peeling paint at some windows around home. This is a maintenance issue to prevent water intrusion into home. A qualified contractor should prep and paint.Item 1(Picture) Item 2(Picture)

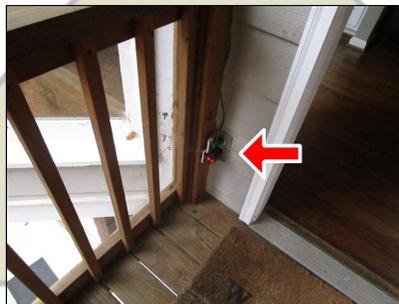
2.7 Item 2(Picture)

At least One GFCI (Ground Fault Circuit Interrupter) outlet at the rear of home did not trip when tested (defective). This is a safety issue that needs to be corrected. A qualified licensed electrical contractor should perform repairs that involve wiring. Item 1(Picture) Item 2(Picture)

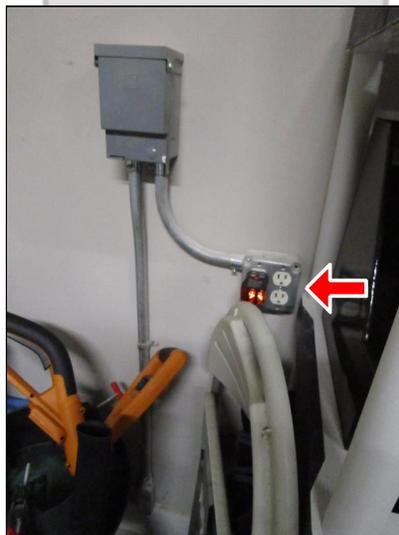
3.6 Item 2(Picture)

At least One GFCI (Ground Fault Circuit Interrupter) outlet at the garage did not trip when tested (defective). This is a safety issue that needs to be corrected. A qualified licensed electrical contractor should perform repairs that involve wiring. Item 1(Picture) Item 2(Picture)

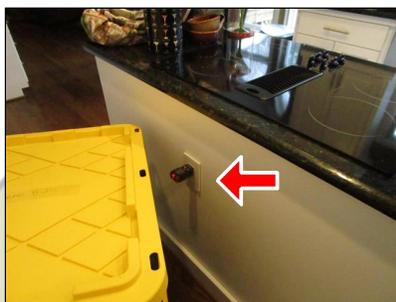
4.8 Item 2(Picture)

At least one GFCI (Ground Fault Circuit Interrupter) outlet at the kitchen island did not trip when tested (defective). This is a safety issue that needs to be corrected. A qualified licensed electrical contractor should perform repairs that involve wiring. Item 1(Picture) Item 2(Picture)

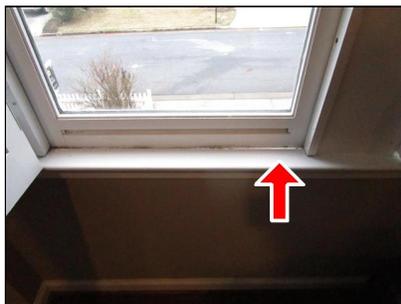
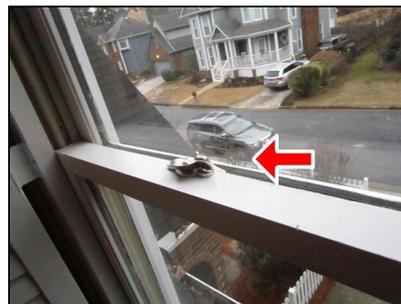
(1) One window stuck or painted shut at the master bedroom. A repair may be needed. A qualified contractor should inspect and repair as needed. Item 1(Picture) Item 2(Picture) Item 3(Picture)

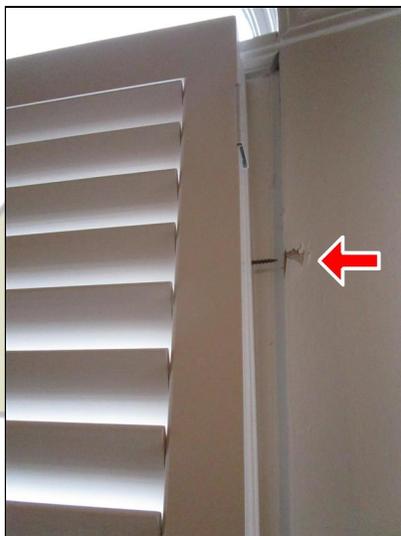
5.5.B Item 5(Picture)

(2) One window plantation shutter has pulled loose at window frame at the master bedroom. A repair may be needed. A qualified contractor should inspect and repair as needed. Item 4(Picture) Item 5(Picture)

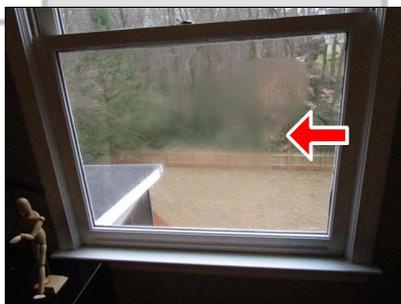
5.5.B Item 7(Picture)

(3) One window is cloudy (lost seal) at the guest bedroom. In order to correct the cloudy appearance of glass, a replacement of glass pane or the unit will be necessary. A qualified contractor should inspect and repair as needed. Item 6(Picture) Item 7(Picture)

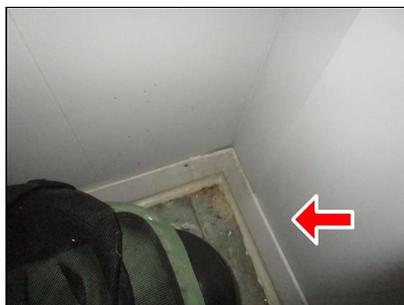
7.0 Item 6(Picture)

(4) There is a professional water intrusion system installed in the basement. I recommend getting warranty information from seller. I would also recommend have contractor come back out and verify the system is working properly. This is for your information. Item 5(Picture) Item 4(Picture)

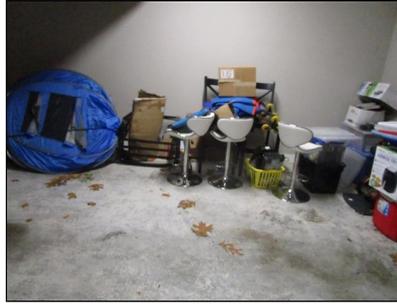
3.1 Item 2(Picture)

Some walls were obstructed with stored items. Stored items can obstruct damage that would of been otherwise noticed. This is FYI. Item 1(Picture) Item 2(Picture)

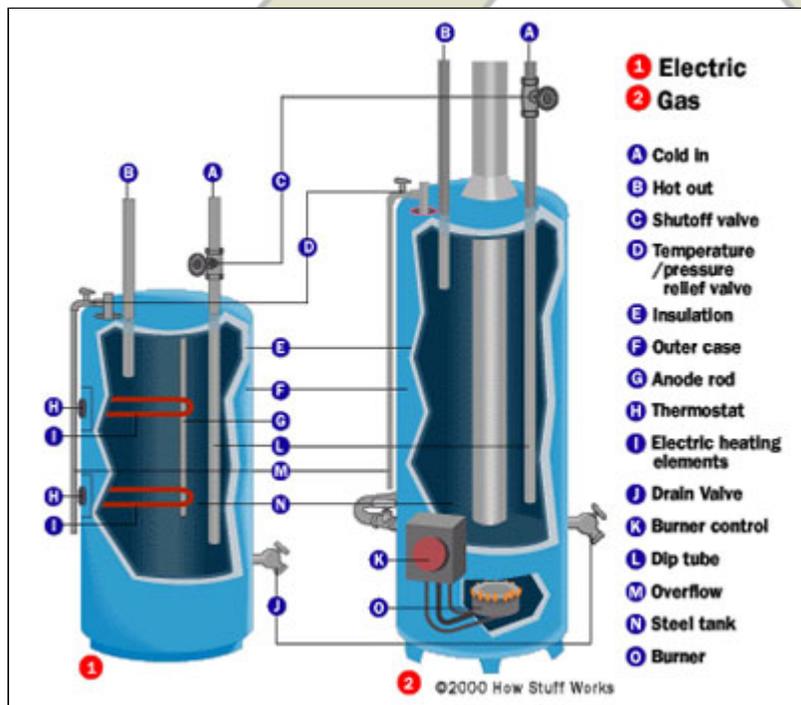
8.2 Item 1(Picture)

(1) Average useful lifespan of water heater in Georgia is 14 Years. If water heater is over this age, buyer should budget for replacement. This is FYI.

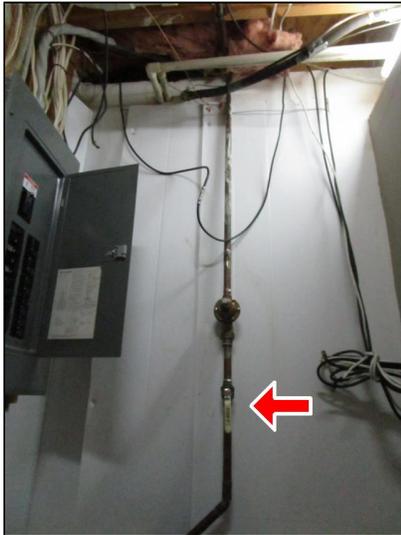
8.3 Item 1(Picture)

The main shut off is the lever located in the basement. This is for your information. Item 1(Picture) Item 2(Picture)

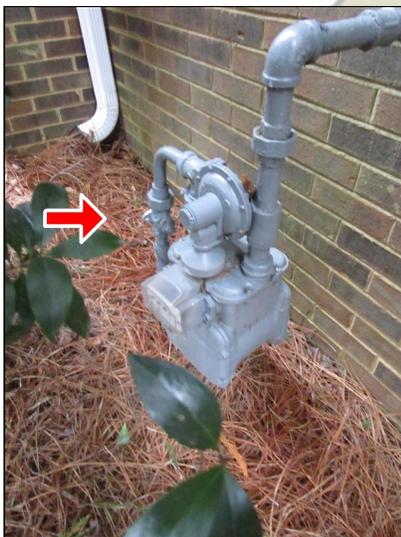
8.5 Item 1(Picture)

The main fuel shut off is at gas meter outside.Item 1(Picture)

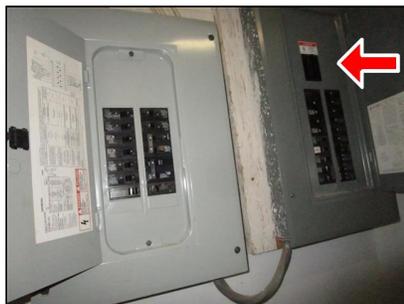
9.6 Item 1(Picture) main shut off

The main panel box is located at the basement.Item 1(Picture)

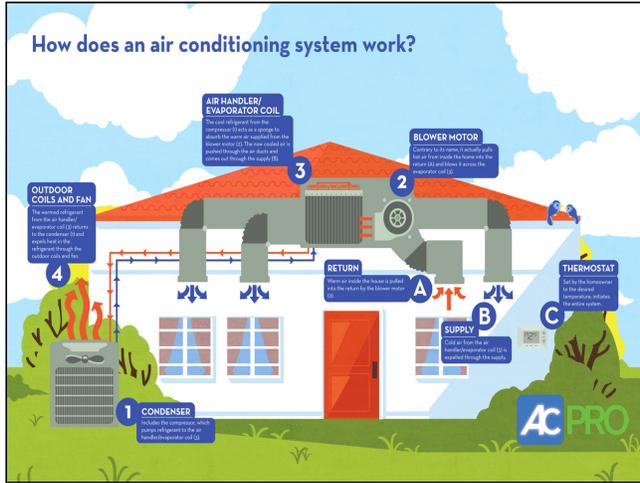
10.10 Item 1(Picture)

(1) Average lifespan of Air Conditioner in Georgia is 15 Years.If unit is above this age, buyer should budget for replacement. This is FYI.

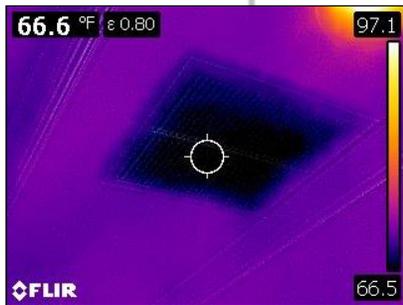
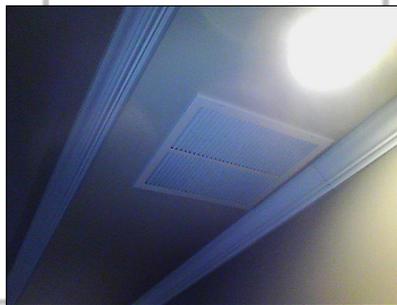
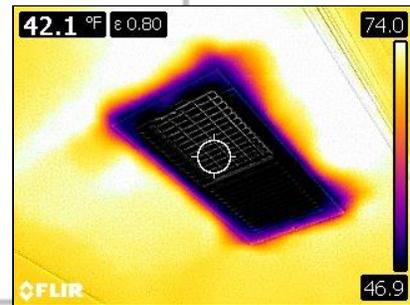
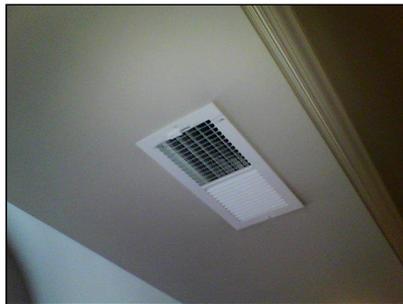
(3) The ambient air test was performed by using thermometers at the 3rd level and 2nd level air handler to determine if the difference in temperatures of the supply and return air are between 14 degrees and 22 degrees which indicates that the unit is cooling as intended. The supply air temperature on your system read 42 and 67 degrees, and the return air temperature was 67 degrees. This indicates that the unit is cooling properly.

Despite test results(cooling properly or not cooling properly), as with all mechanical systems the inspector does not warrant its future operation. HVAC systems should be serviced annually. Per disclosure from seller, if unit has not been serviced in the last year it is highly recommended that a licensed HVAC contractor perform an exhaustive evaluation of systems. Item 4(Picture) Item 5(Picture) Item 6(Picture) Item 7(Picture)

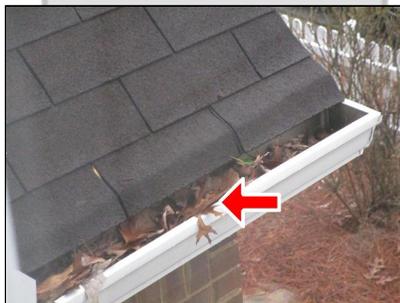
1.4 Item 4(Picture)

(2) The gutters need cleaning of debris at virtually all areas where gutters are installed. Gutters that drain poorly or clogged can lead to many costly problems such as deterioration of fascia, soffit or roof edge. It can also cause gutters to pull loose and lead to possible water intrusion. A qualified person should clean as needed. Item 3(Picture) Item 4(Picture)

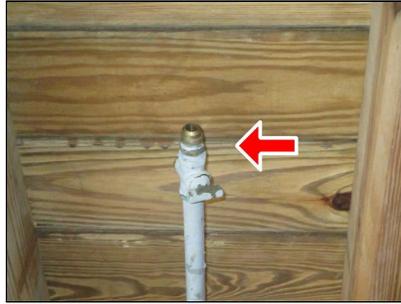
8.4 Item 5(Picture)

(3) The gas line is missing a cap and can be turned on inadvertently at the rear deck. This is a safety issue and should be repaired. A qualified contractor should inspect and repair as needed. Item 4(Picture) Item 5(Picture)
