**National Property Inspection, Cumming GA DBA  
National Property Inspections**

**Sally , 10620 Montclair Way, Johns Creek, GA, 30097**

Inspection Date:  
02/25/2020

## GENERAL INFORMATION

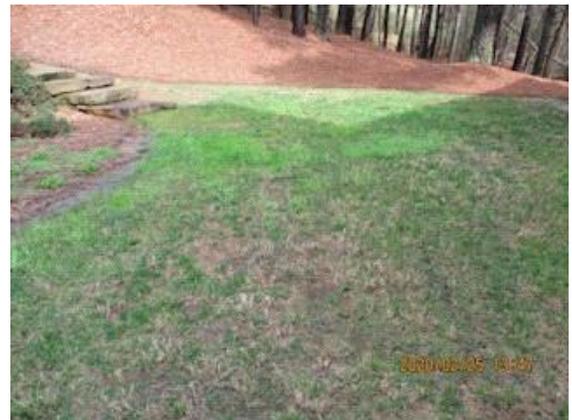
Water puddling in the yard. Ponding water could cause moss in summer and/or ice in winter, both of which are slip hazards. It could also lead to damage to the surfaces themselves, particularly freeze/thaw damage. Ponding against the house could lead to water penetration into the building and damage to the foundation and sub grade areas.

Grading / Drainage: yard water puddling

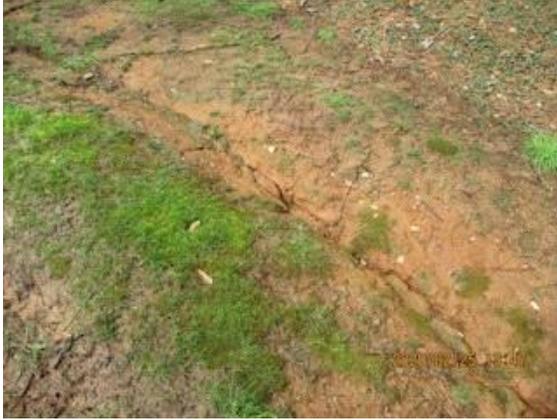
Grading / Drainage: Soil erosion noticed

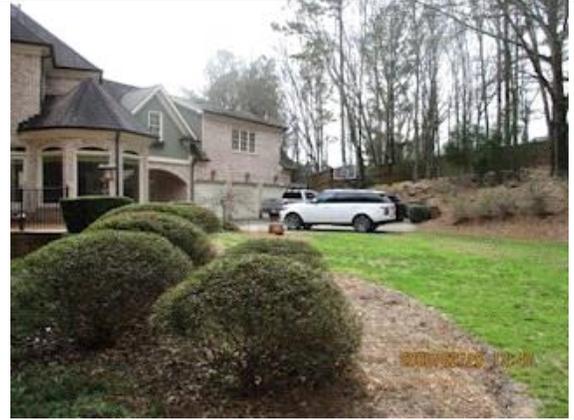
Negative slope noted at rear perimeter of the home. May cause drainage problems/water intrusion during rainfall. The current condition may contribute to water intrusion.

Grading / Drainage: Near level grading at the back of the property, may pose slow drainage problem

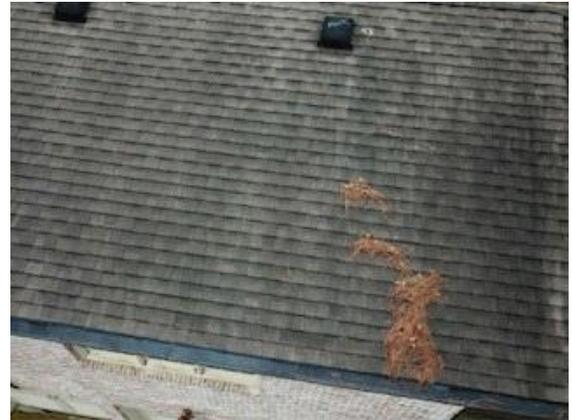
Roofing: debris on roof

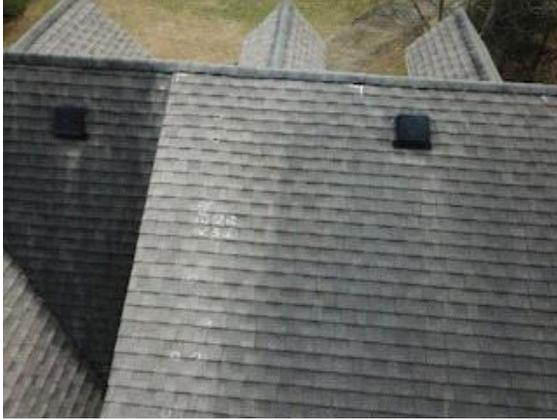
Roof appear to be original to the building which is 15-16 years old. Roof start to have wear typical to its age. Recommend an annual inspection to prevent further deterioration and leakage

Roofing: Roof was exhibiting sign of aging, surface discoloration

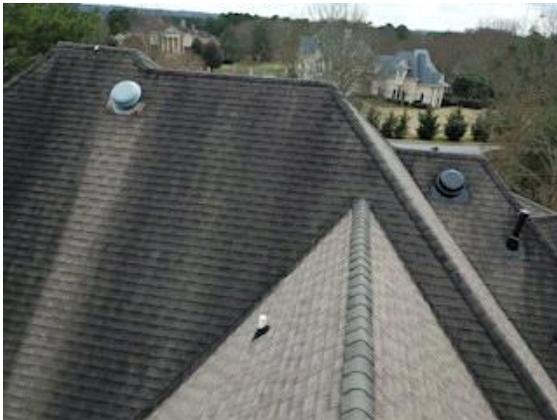
Roofing: Roof was exhibiting sign of aging, surface discoloration

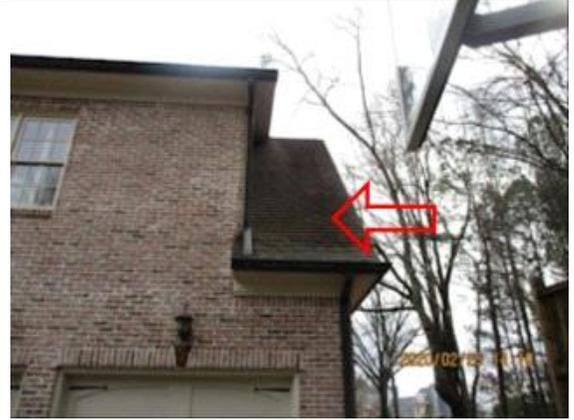
Evidence of moss/mildew growth. Moss /algae would decompose the roofing materials. Properly installed zinc strips (along peak of roof) release zinc-ions that inhibit growth of organisms that could cause ugly roof stains. These organisms include algae, fungus, mold and moss that not only cause stains but can, and often do, damage the roof.

Roofing: moss / algae growth on the roof surface

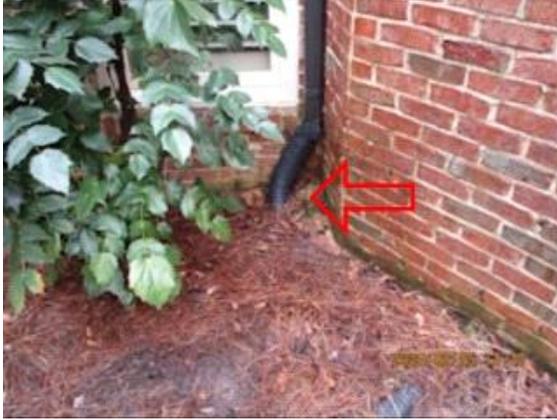
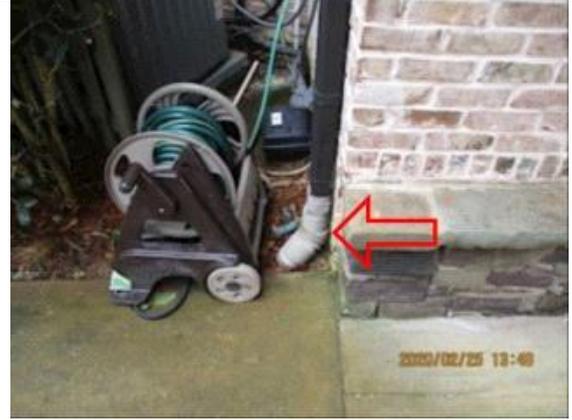
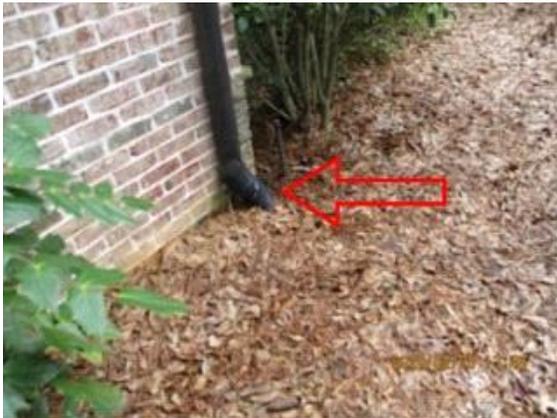
Downspout(s) noted which were currently discharging below grade. Unable to determine where the subsurface drain pipe terminate. The subsurface extension could become clogged and unable to perform the drainage functions. Recommend redirecting downspouts above grade where possible to reduce the risk of overflowing weeping tiles or drains below grade, which could contribute to water intrusion into the home.

Gutters/Down Spouts: Downspout draining into subsurface, unable to locate the drainage outlet

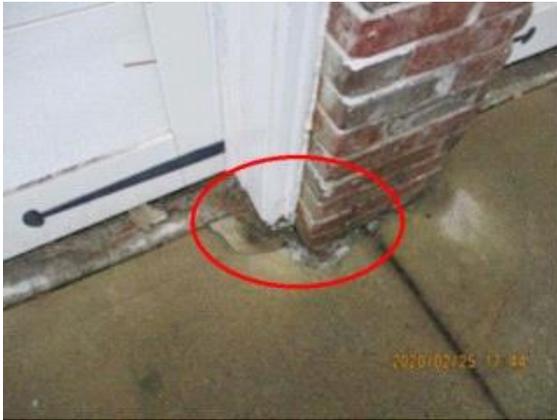
Wood trim outside the overhead door have water damages near the bottom

Garage/Carport: wood trim outside rotten near the bottom

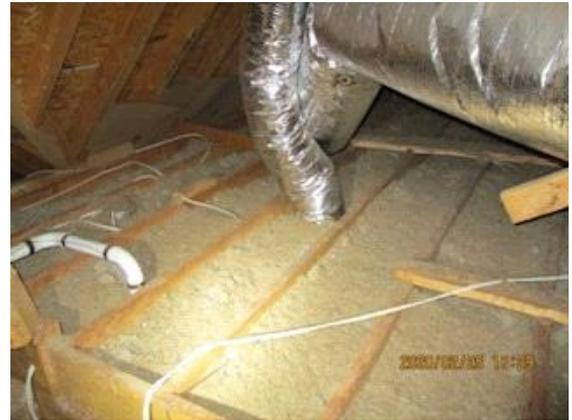
Loose-fill Cellulose insulation present, approximately 5-6 inches deep, estimated R value 17-21. Current standard for attic insulation is recommended to be R40 in value. You may wish to look at upgrading the insulation level in the near future.

Attic Insulation: insufficient blown in insulation materials

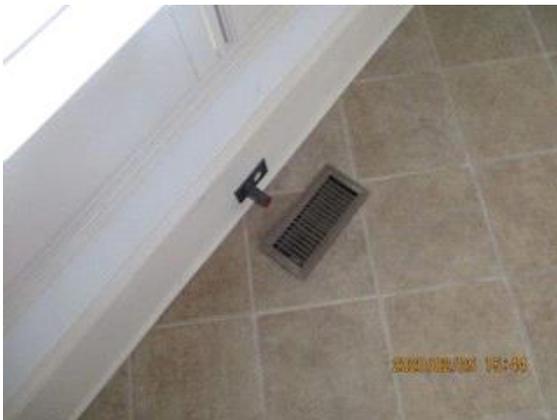
One of the wall electrical outlet have no power

Laundry Facilities: baseboard outlet has no power

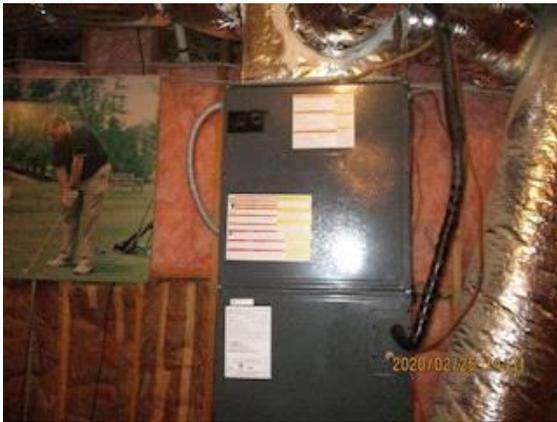
Heating 1 basement :

The heat pump system was a split system with the air handler located in the house and the condenser located outside. The system was working within industry standards with the supply air temperature reading at least 14-20 degrees hotter than the return air. The test results are measured using a digital thermometer. The thermostat and blower were checked and are working as designed.

Heat Exchanger - Unable to detect cracks/holes without dismantling unit.

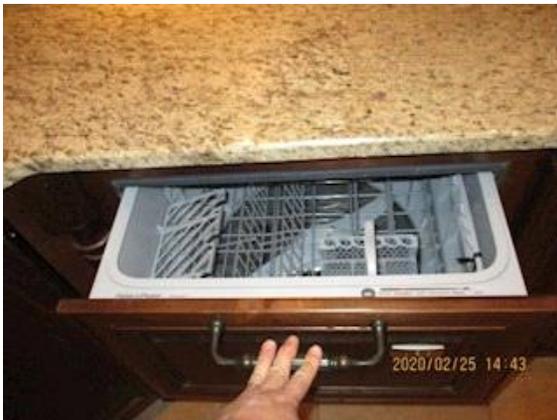
Dishwasher not screwed properly secured into the cabinet

Kitchen @ basement : dishwasher not securely mounted into the cabinet

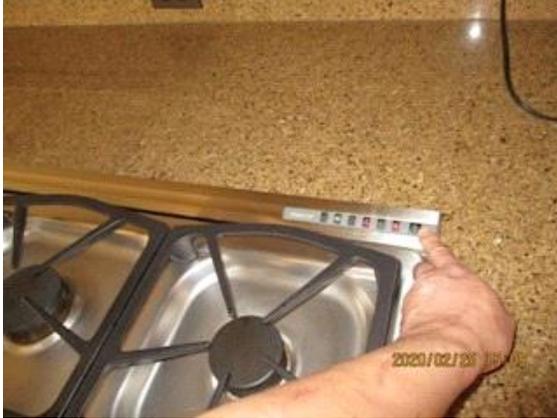
Kitchen @ main level : exhaust fan not operational

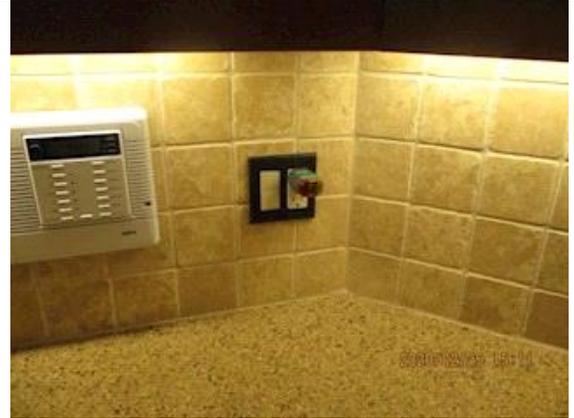
Kitchen @ main level : Electrical outlets at the countertop have no power

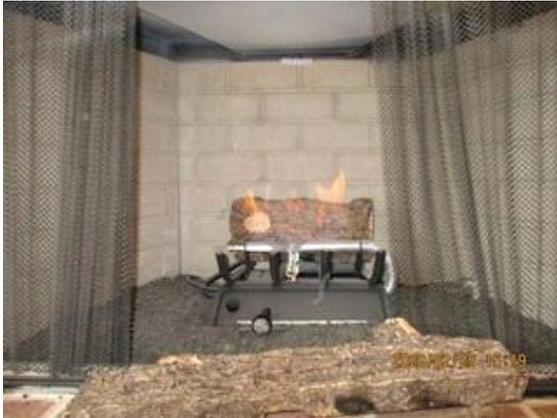
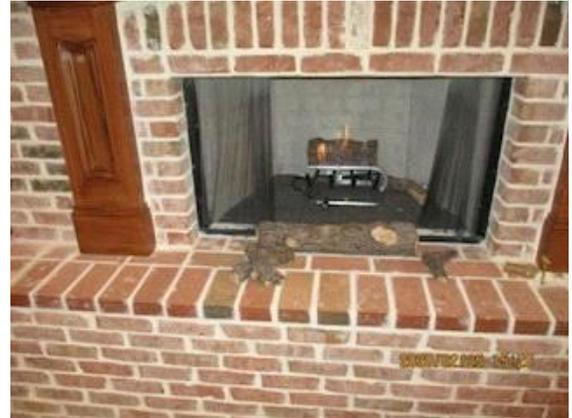
Fireplace/Stove:

Recommend annual cleaning - Fireplace design and soot / creosote buildup, in most cases, prevents view of chimney liner / cracks.

Before using, recommend fireplace, flue and chimney be cleaned and reinspected.

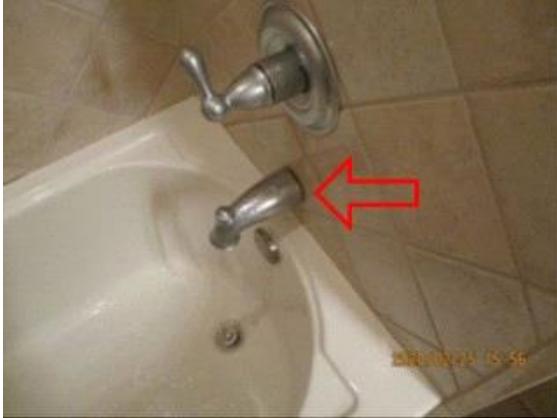
Bathtub spout was separating from the shower tile wall. Recommend caulking around the tub spout to prevent water infiltration into the wall substrate

upper front left bathroom : bathtub spout need caulking

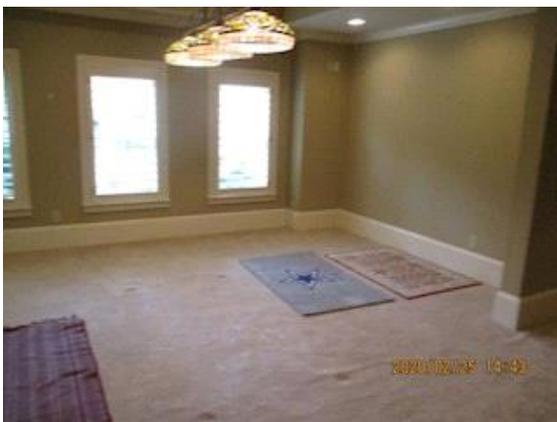
Basement grand room :

Carpet was buckled. Recommend re-stretching to prevent trip/fall hazard.

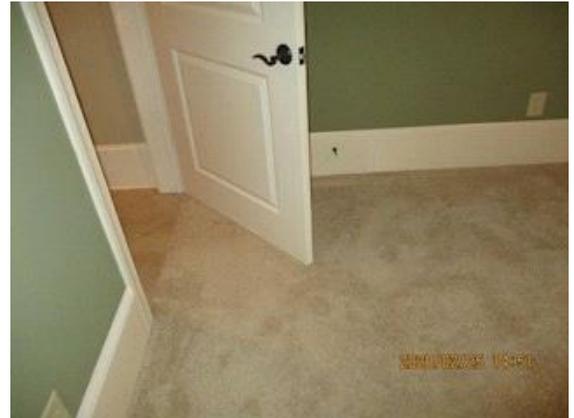
Door was dragging on the carpet

Basement bedroom : door dragging on carpet

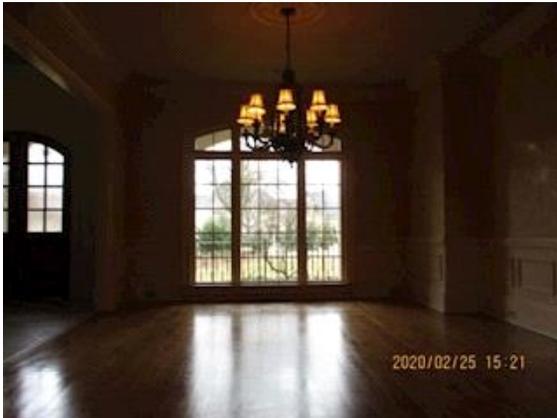
Dining room :

No power at the wall outlet. Recommend further evaluation by a qualified electrical contractor

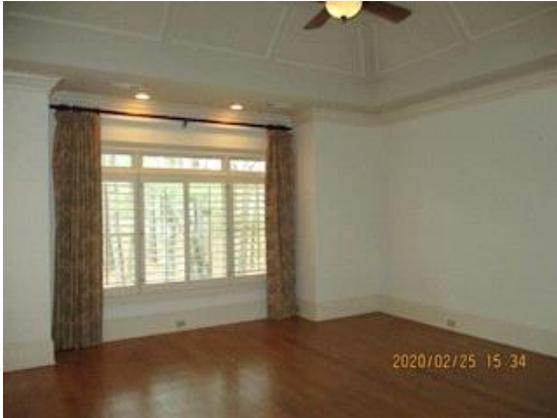
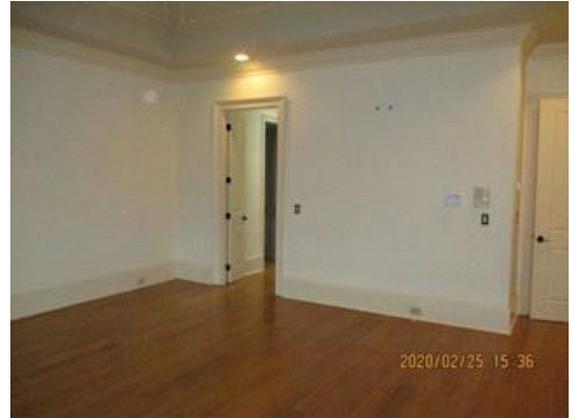
master bedroom :

No window screen

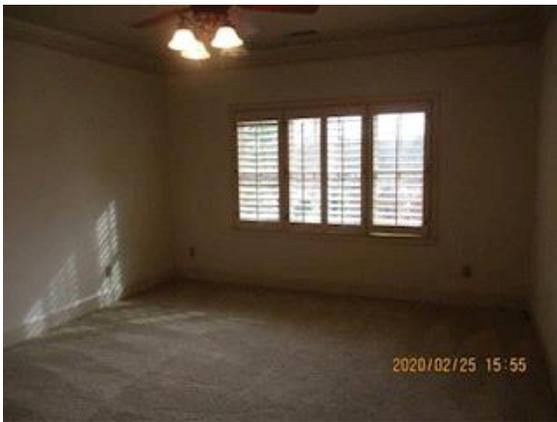
upstairs front left room :

Ceiling repair noticed. Suspected previous roof leakage. Recommend further evaluation by a qualified contractor

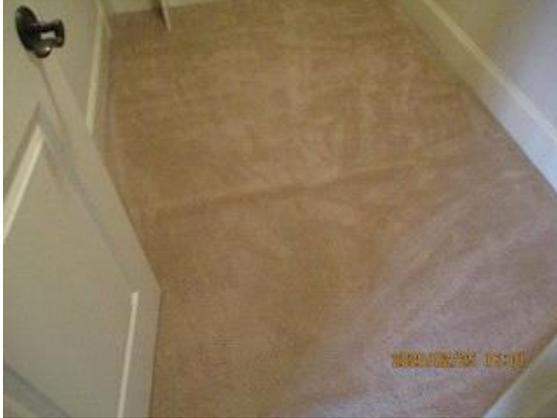
Carpet was buckled. Recommend re-stretching to prevent trip/fall hazard.

upstair front middle room : carpet buckled

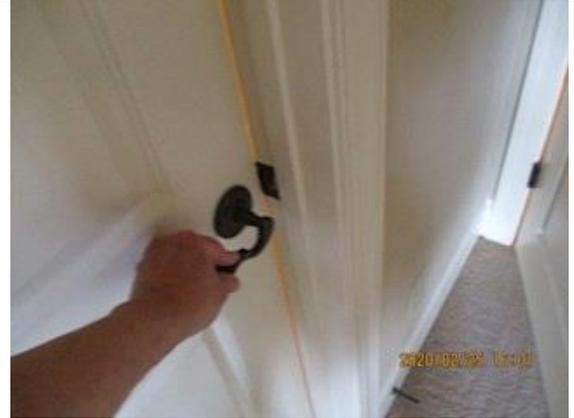
Closet door did not operate properly. Adjust and/or repair as necessary.

upstair front middle room : closet door could not engaged properly

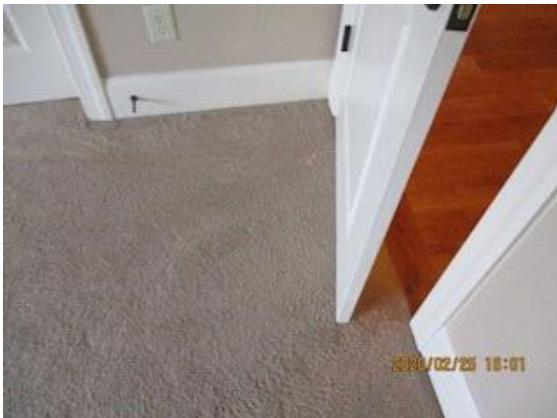
upstair front middle room : door dragging on carpet

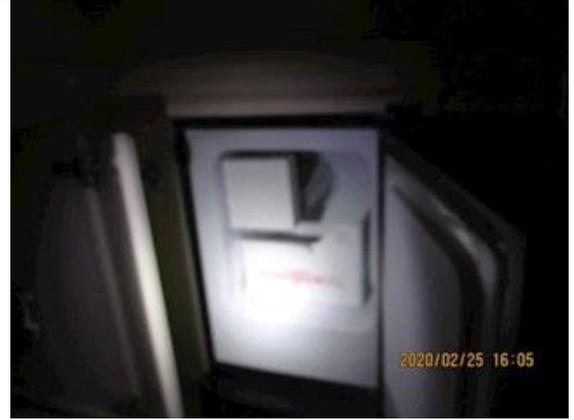
upstairs front right room : ice maker not functioning

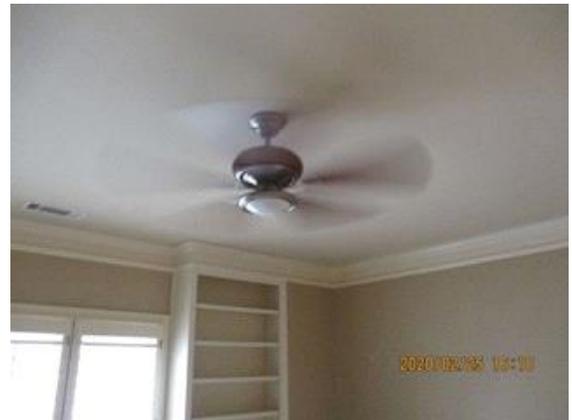
Ceiling light fixture not working at time of inspection. Checking/changing burned out/missing light bulbs is beyond the scope of this general home inspection. Recommend that light bulb(s) be replaced at any inoperable light and rechecked for proper operation before the close of escrow.

upstairs rear room : ceiling light fixture not functioning
