Property Inspection Report

Property address: **1741 Liberty Pkwy NW
Atlanta GA 30318**

Inspection date: **Friday, January 24, 2020**

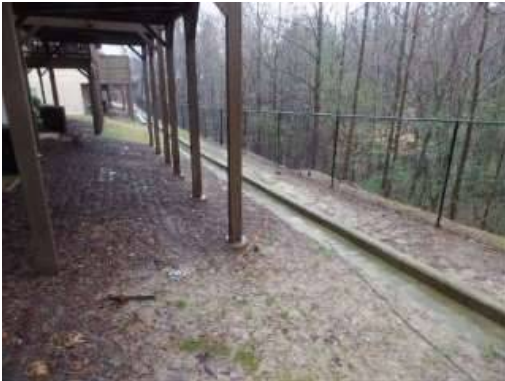
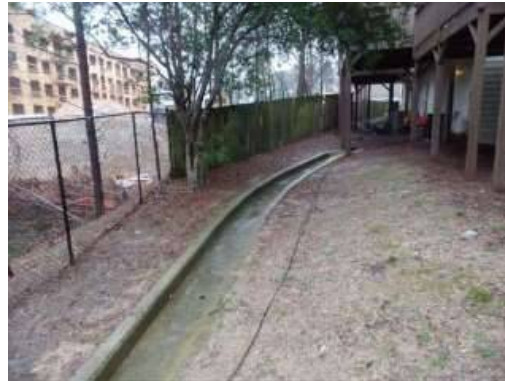
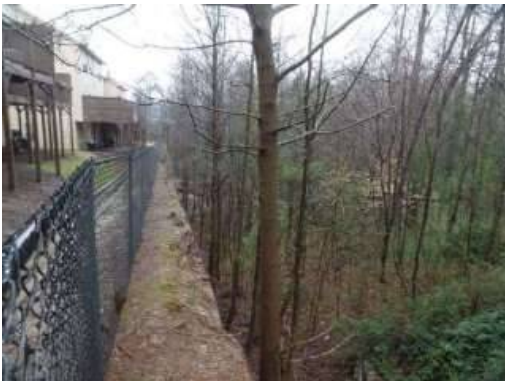
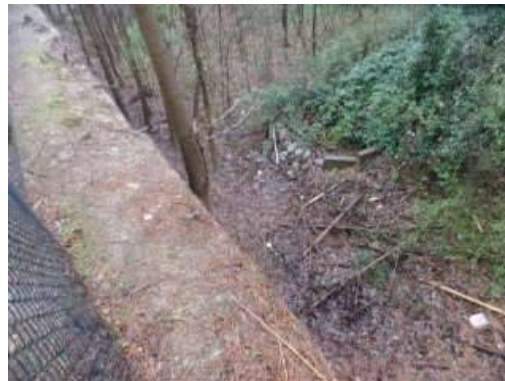
CLIENT SHOULD BE AWARE THAT THE RETAINING WALL BEHIND THE SUBJECT UNIT WAS NOT EVALUATED AND IS EXCLUDED FROM THIS REPORT. LARGE RETAINING WALL HAD A STEEP VERTICAL DROP AND BOTH THE SOIL ABOVE AND FENCE AT TOP SHOULD BE MONITORED REGULARLY TO ENSURE FUNCTIONALITY. MONITOR AS NECESSARY.

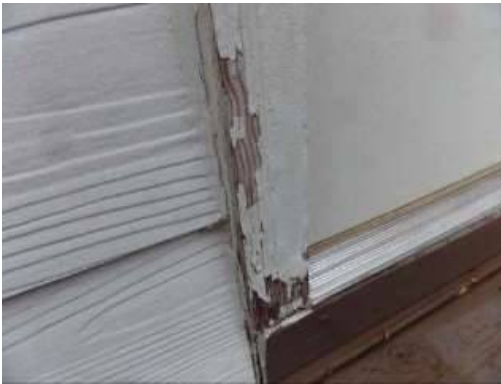
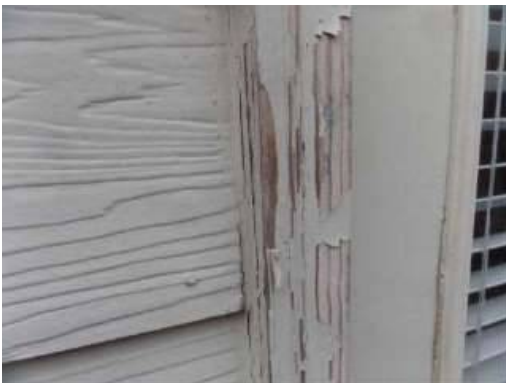
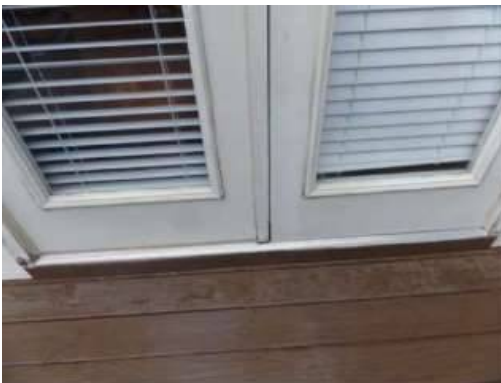
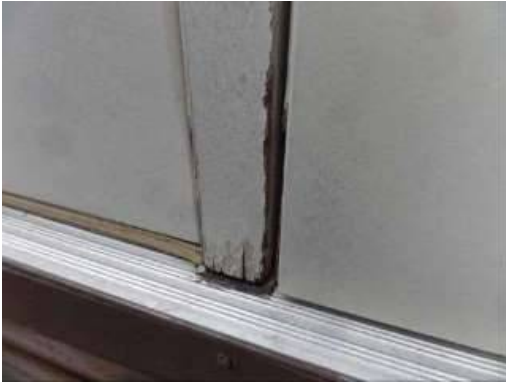
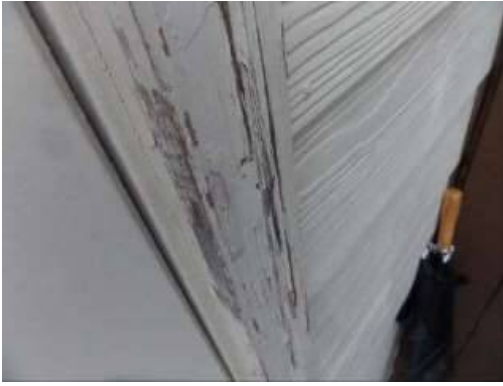
The paint or stain finish in some areas was failing (e.g. peeling, faded, worn, thinning). Siding and trim with a failing finish can be damaged by moisture. Recommend that a qualified contractor prep (e.g. clean, scrape, sand, prime, caulk) and repaint or restain the building exterior where necessary and per standard building practices. Any repairs needed to the siding or trim should be made prior to this.

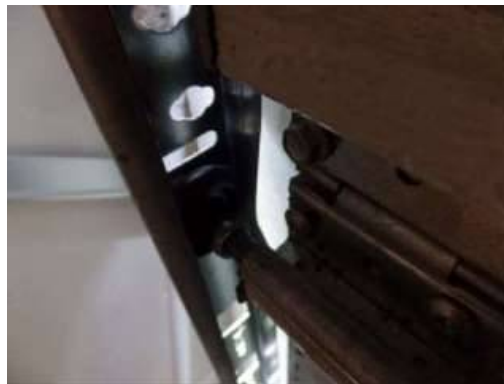
Photo 10-2

One or more garage vehicle doors were DIFFICULT or unable to open or close. Vehicle doors should open and close smoothly and easily. A qualified person should evaluate and repair as necessary. This may require lubrication or repair to hardware such as rollers or brackets.

THE LEFT VERTICAL TRACK (AS VIEWED FROM INSIDE) WAS BENT AT A SPOT ABOUT 3 FEET HIGH. A QUALIFIED CONTRACTOR SHOULD INSPECT/EVALUATE AND REPAIR OR REPLACE AS NECESSARY.

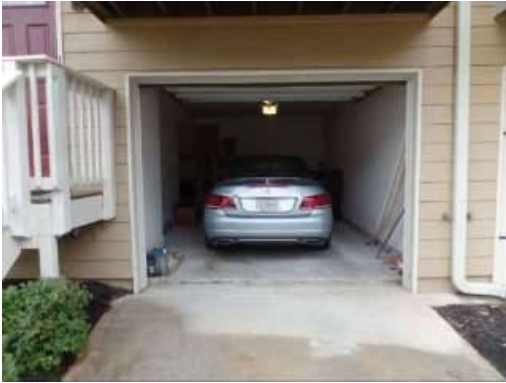
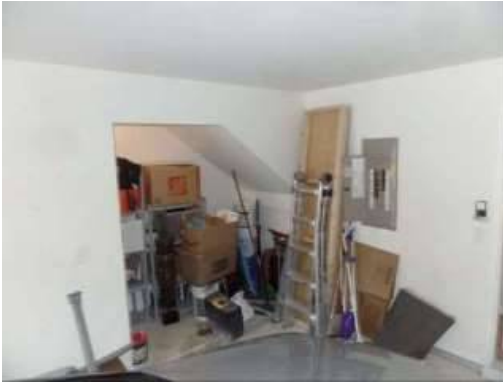
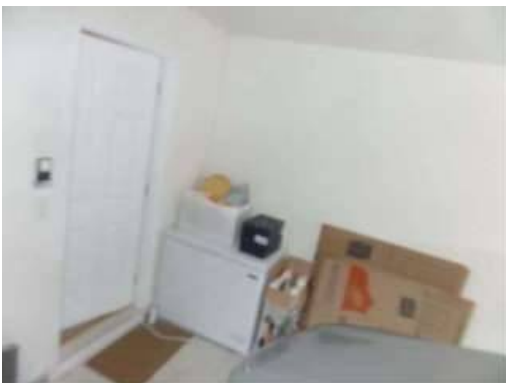
14) **EXCLUDED** - Some areas of the garage were covered with car(s) and/or stored items making it impossible to view around the sides and/or in the middle or both. These areas are excluded from the report.

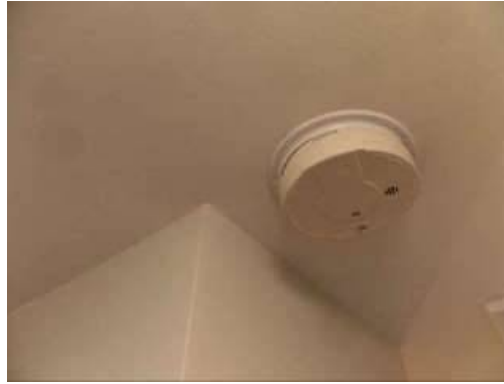
Photo 17-2

Based on the age of this structure and the appearance of existing smoke alarms, the alarms may have been installed more than 10 years ago. According to [National Fire Protection Association](https://www.nfpa.org/101), aging smoke alarms don't operate as efficiently and often are the source for nuisance alarms. Older smoke alarms are estimated to have a 30% probability of failure within the first 10 years. Newer smoke alarms do better, but should be replaced after 10 years. Unless you know that the smoke alarms are new, replacing them when moving into a new residence is also recommended by NFPA. For more information, visit: <https://www.reporthost.com/?SMKALRMLS>

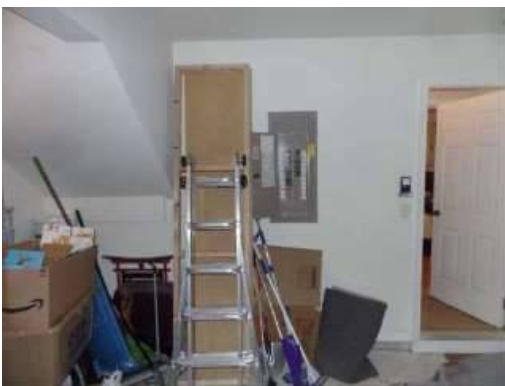
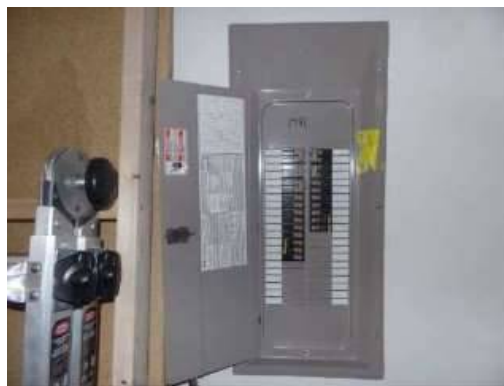
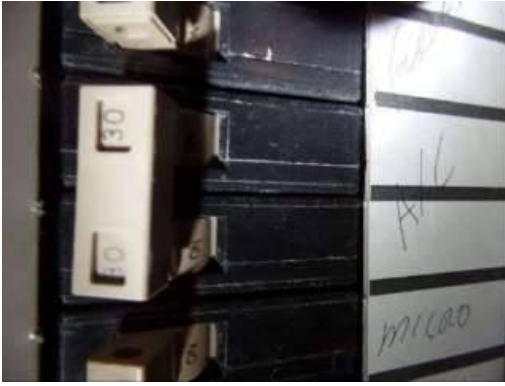
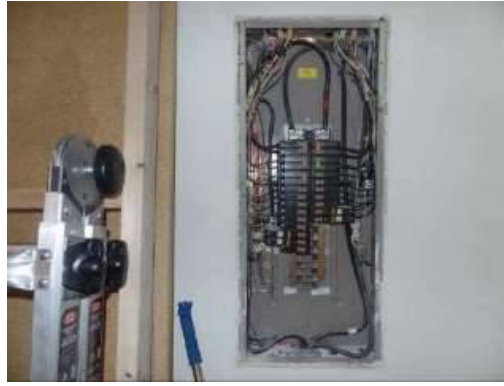
General pictures of service panel(s)

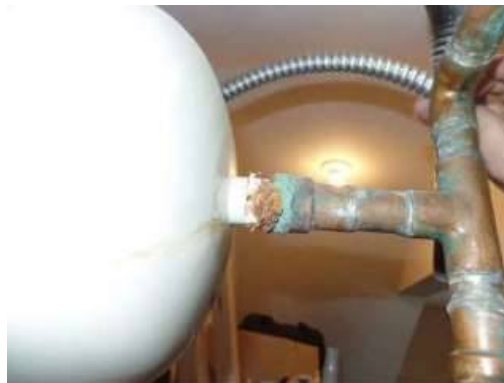
Photo 21-2

Significant corrosion or rust was found at the supply pipes or fittings. This can indicate past leaks, or that leaks are likely to occur in the future. Recommend that a qualified plumber evaluate and replace components or make repairs as necessary.

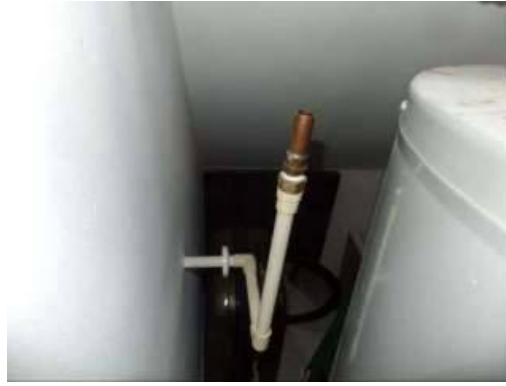
Photo 22-2

No drain line was installed for the temperature-pressure relief valve. Drain lines are normally installed to prevent water from accumulating if/when the valve eventually leaks, and to prevent scalding if someone is standing next to the water heater when the valve opens. Recommend that a qualified plumber install a drain line so it drains outside and per standard building practices. WHAT WAS LIKELY THE PREVIOUSLY CONNECTED DRAIN LINE IN 2ND PHOTO.

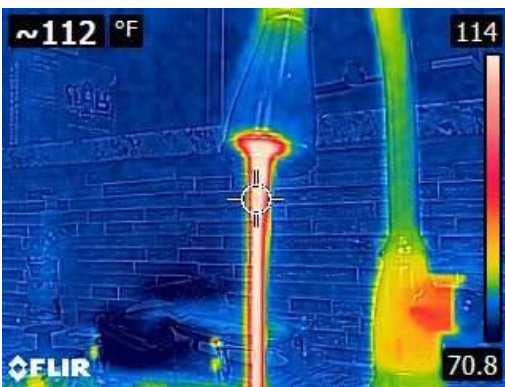
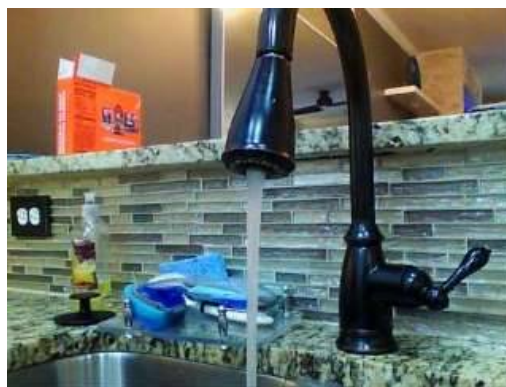
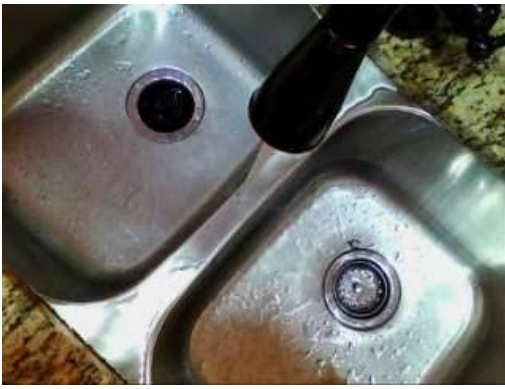
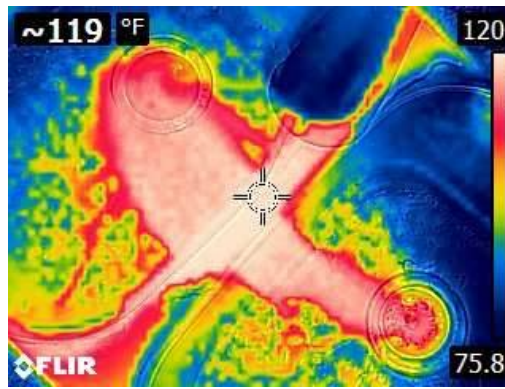
25) Infrared photo(s) of water at sink.

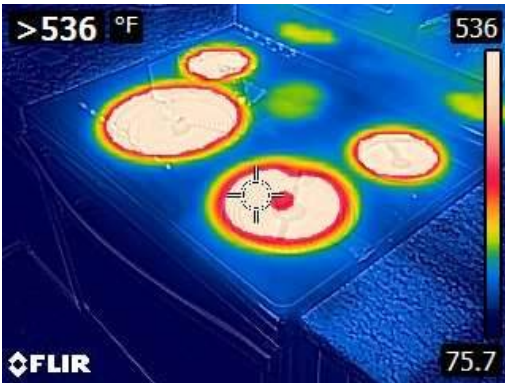
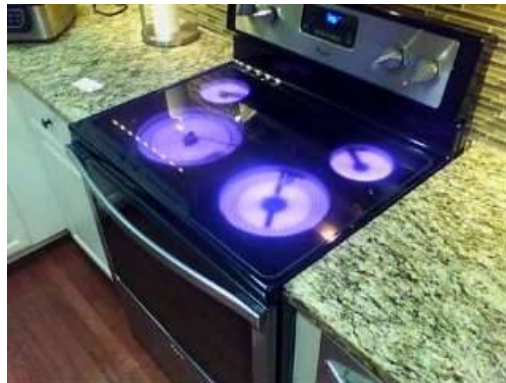
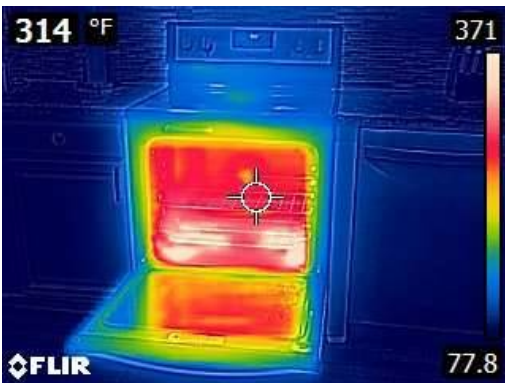
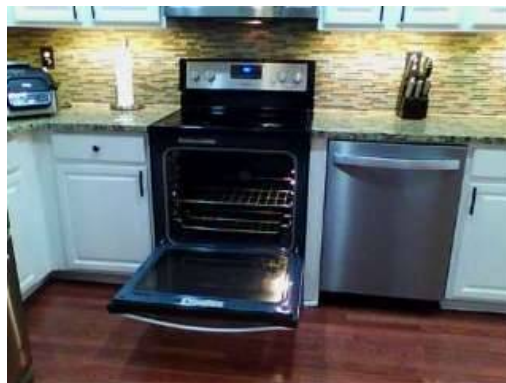
General photo(s) of Range/Cooktop.

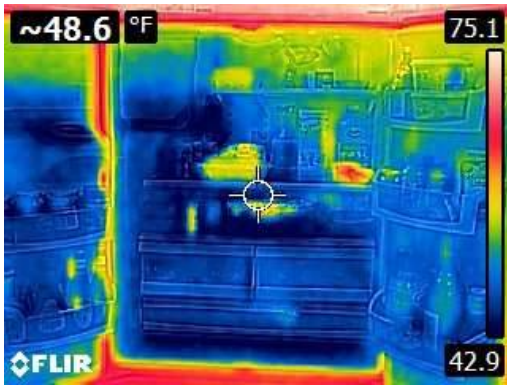
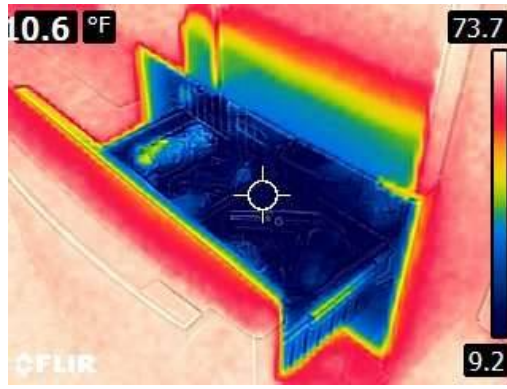
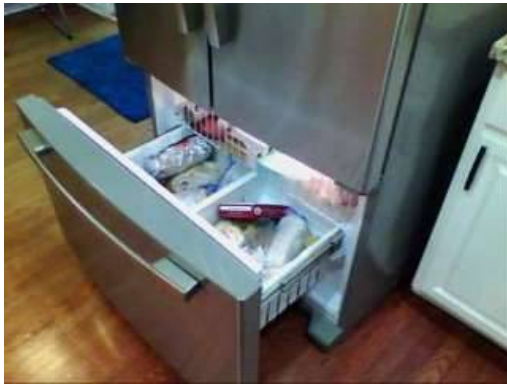
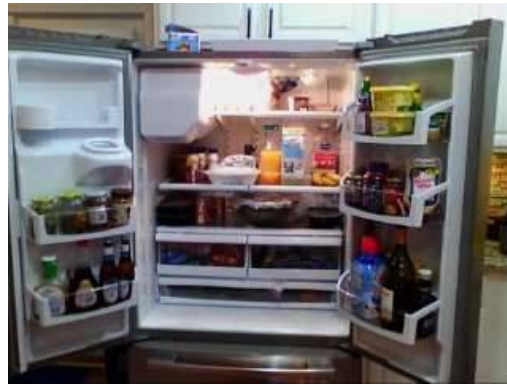
General photo(s) of Refrigerator.

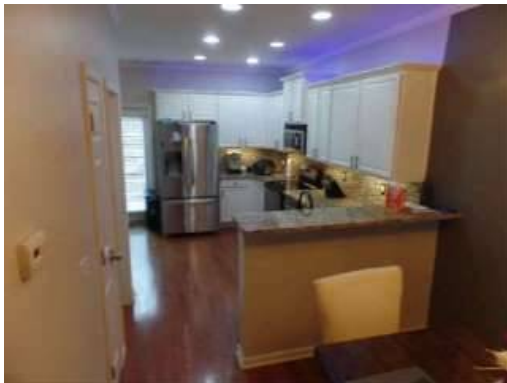
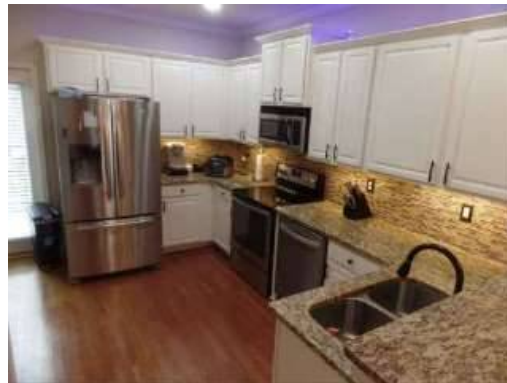
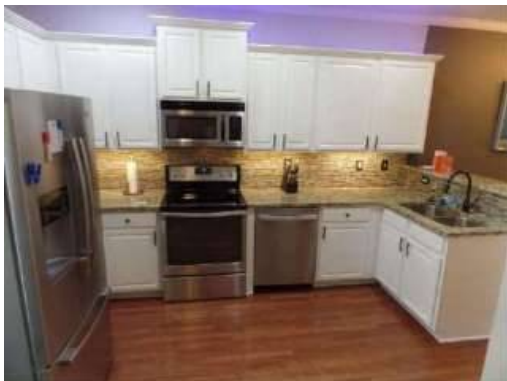
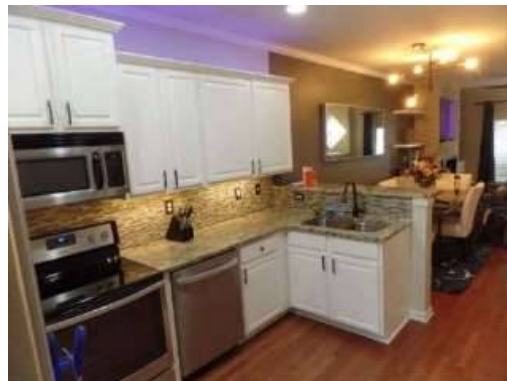
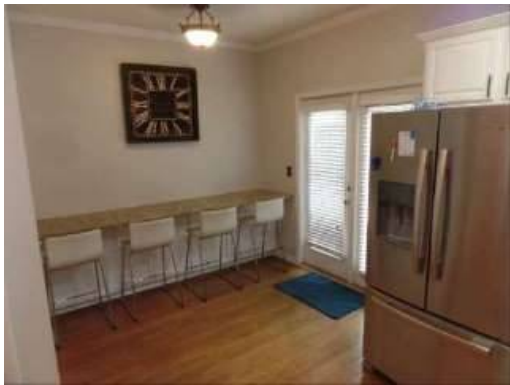
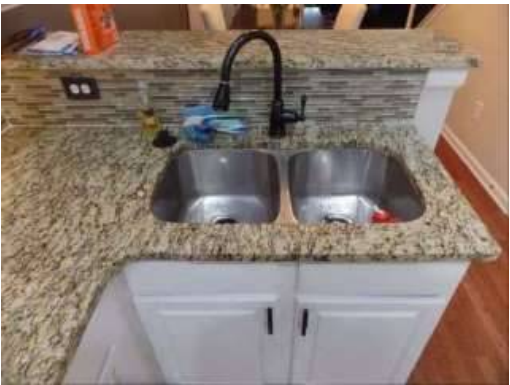
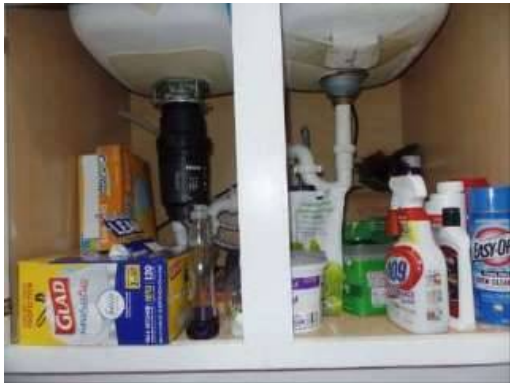
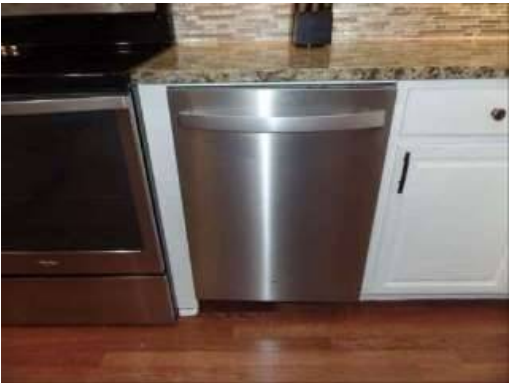
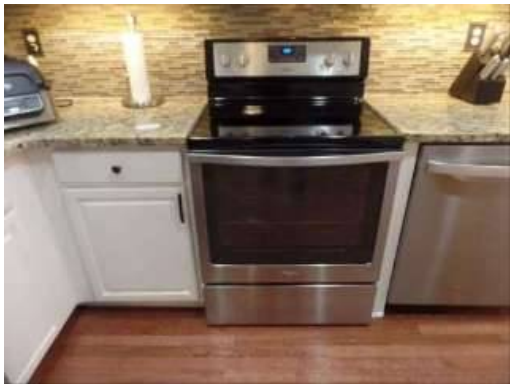
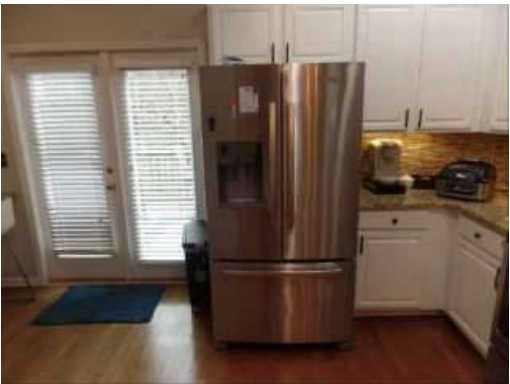
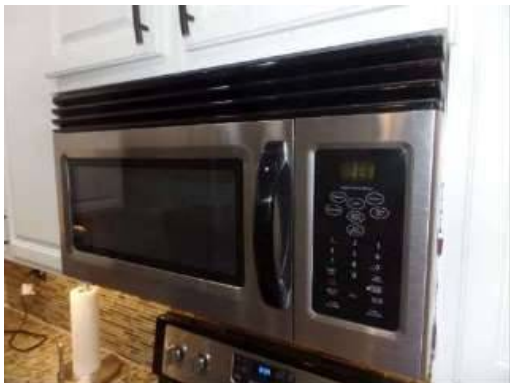
General pictures of kitchen

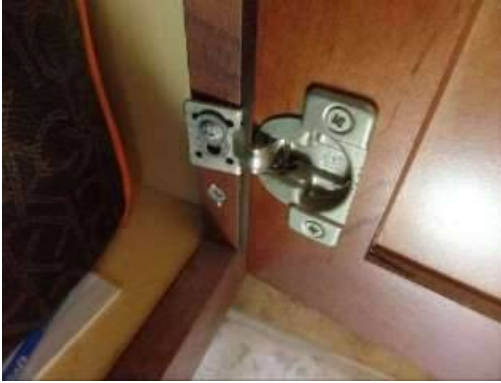
Photo 32-2

One or more cabinets, drawers and/or cabinet doors at location(s) #A and/or MASTER were damaged or deteriorated. Recommend that a qualified person repair or replace as necessary.

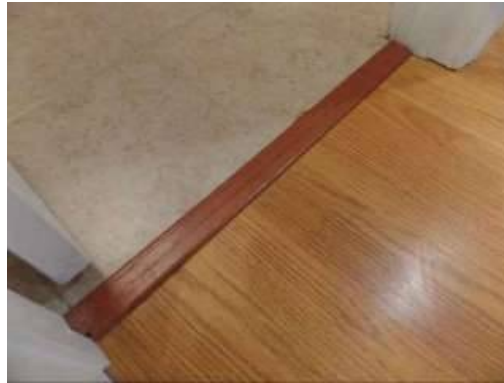
Photo 36-2

Tile, stone and/or grout in the flooring at location(s) #D and/or 1ST FLOOR was deteriorated (e.g. loose or cracked tiles, missing grout) or substandard. Water can damage the sub-floor as a result. Recommend that a qualified contractor repair as necessary.

THRESHOLD WAS LOOSE AT THE TIME OF INSPECTION

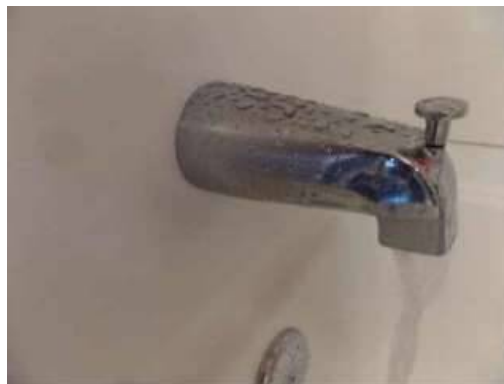
Photo 37-2

Caulk was missing around the base of the bathtub spout, or there was a gap behind it, at location(s) #A, B and/or BOTH TOP BATHROOMS. Water may enter the wall structure behind the bathtub. Recommend that a qualified person repair as necessary to eliminate the gap. For example, by installing or replacing caulk if the gap is small enough. For larger gaps, a shorter spout nipple or an escutcheon plate can be installed.

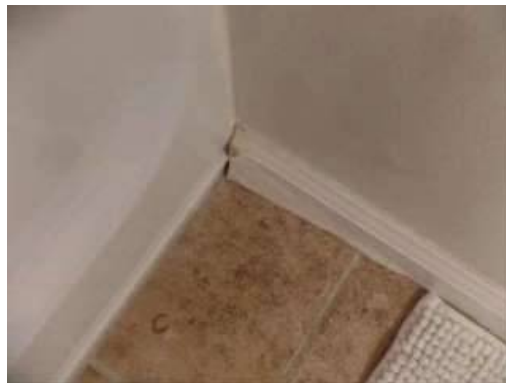
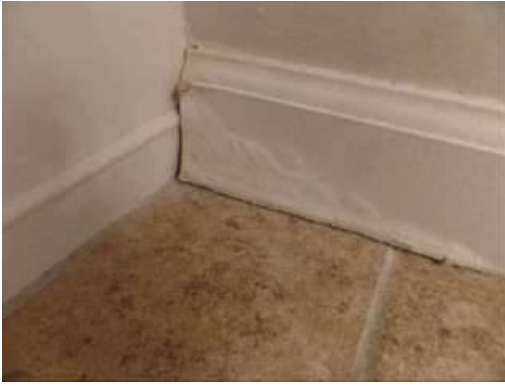
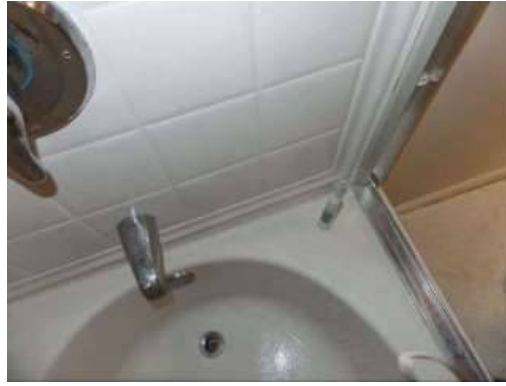
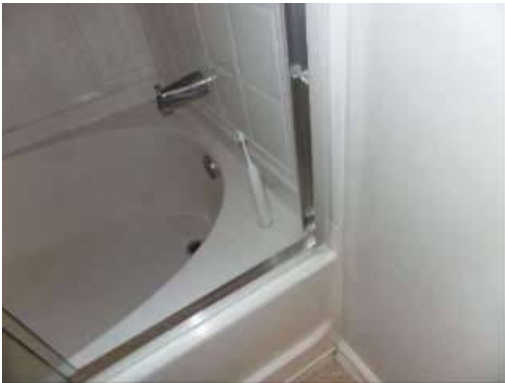
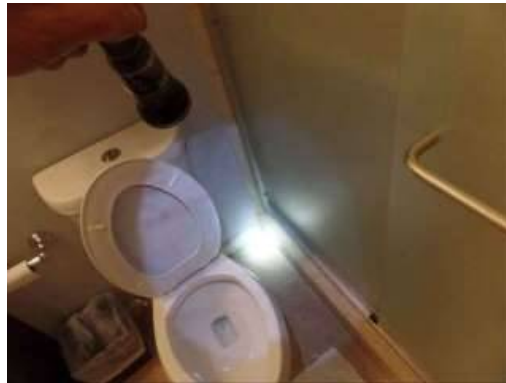
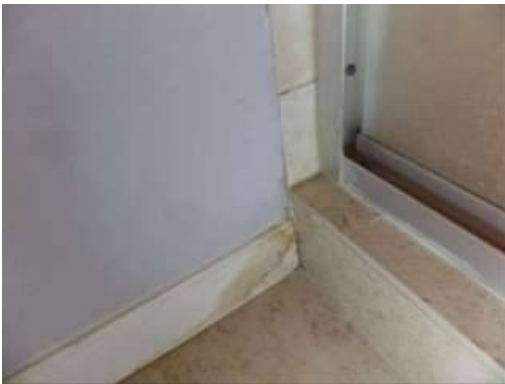
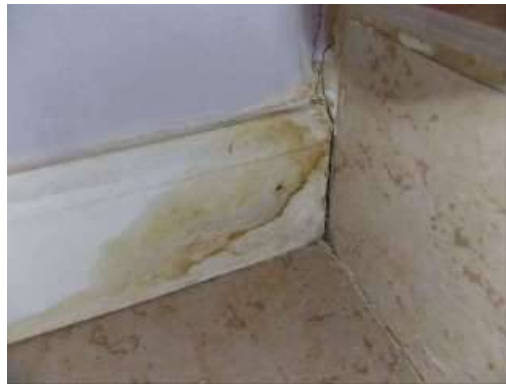
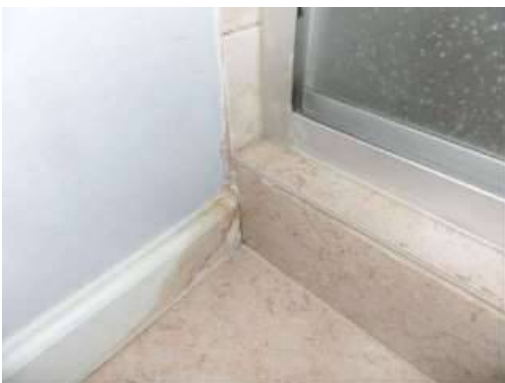
The wall by the shower at location(s) #A, B, D, MASTER, FRONT and/or 1ST FLOOR was water-damaged. Recommend that a qualified person repair as necessary.

TRIM DETERIORATED AND/OR DISCOLORED WHICH INDICATES PROLONGED WATER EXPOSURE. AT SLIDING DOORS CAULK/SEALANT SHOULD BE APPLIED AT METAL FRAME. REPAIR MAINTAIN AS NECESSARY.

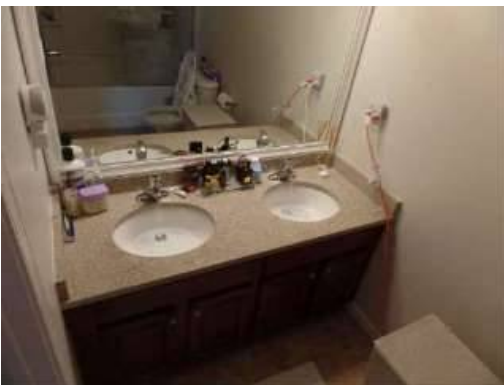
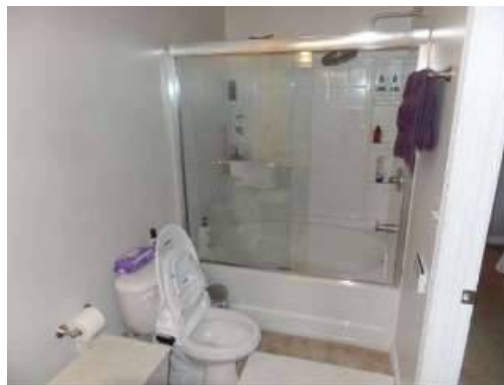
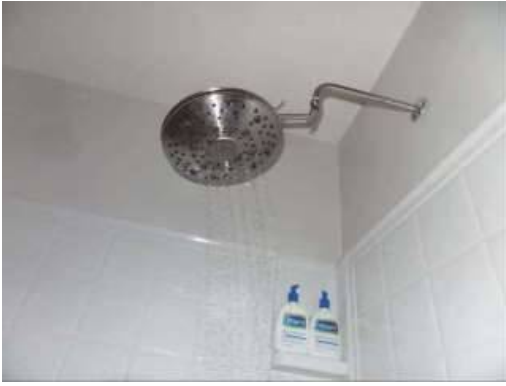
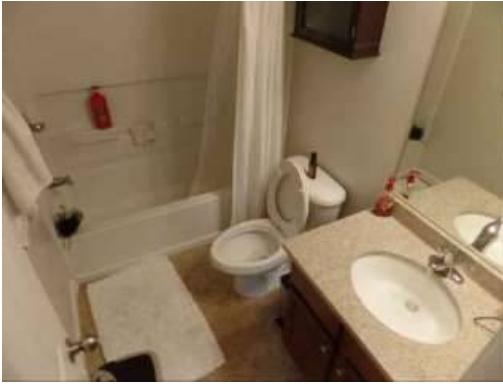
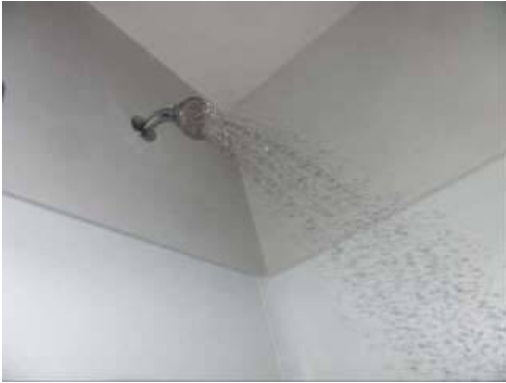
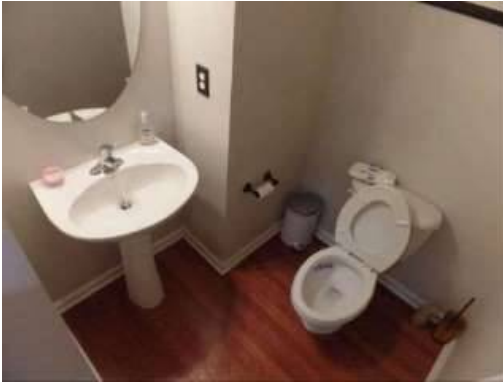
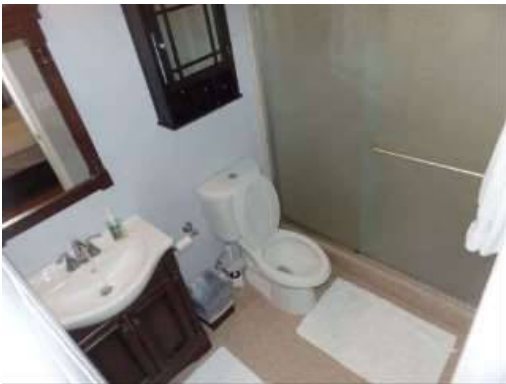
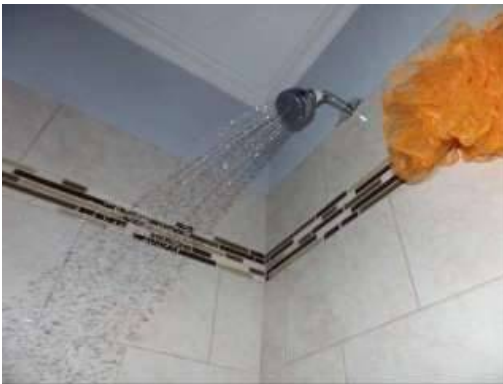
General pictures of bathroom(s)

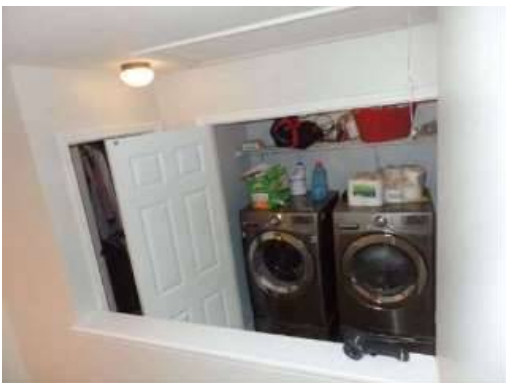
Photo 44-1

General photo(s) of Laundry Area. The washer and dryer are excluded from this report and any comments are provided as a courtesy.

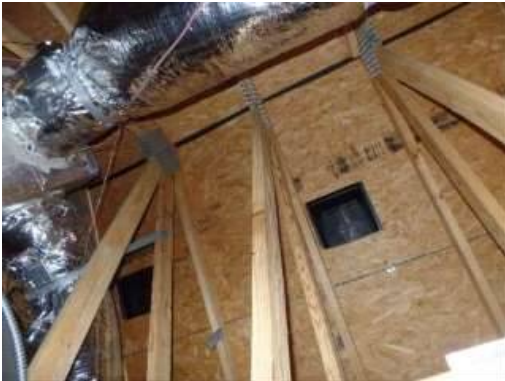
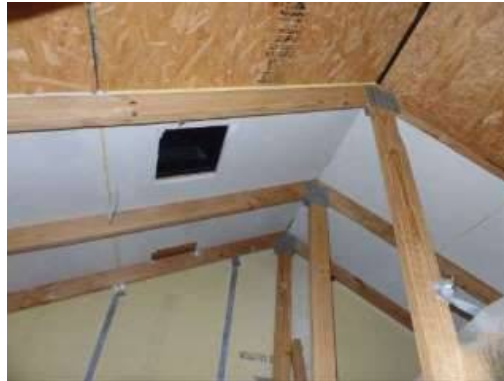
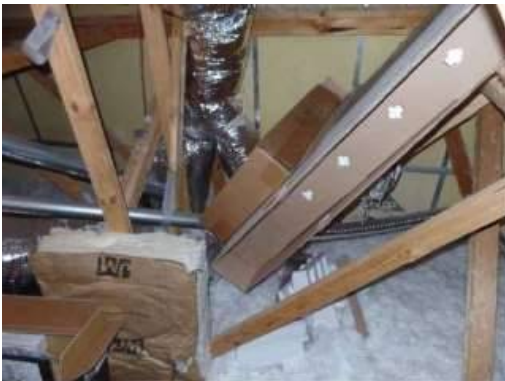
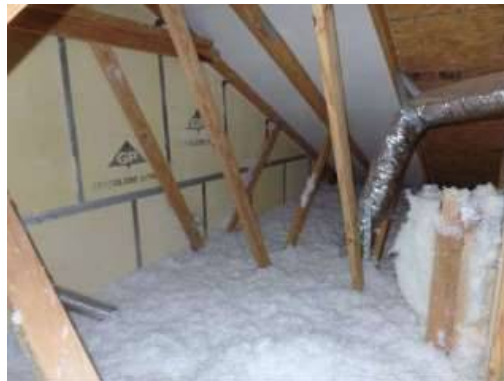
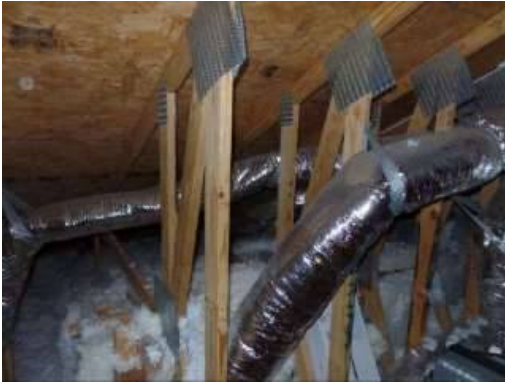
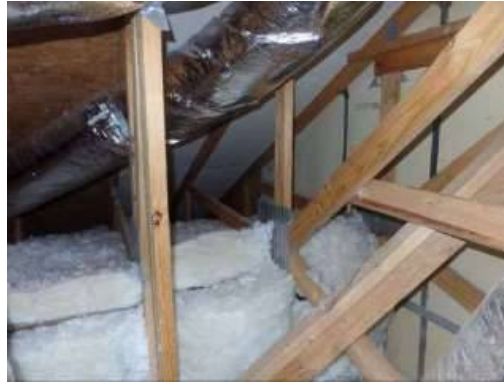
46) **i** General pictures of attic and roof structure

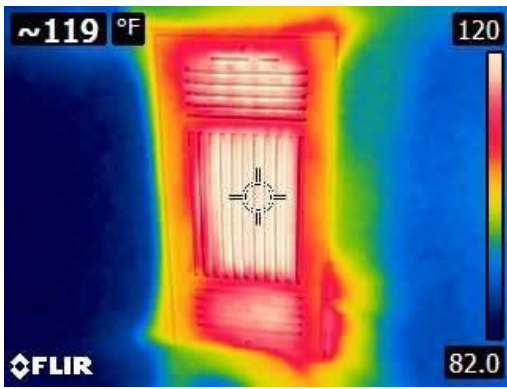
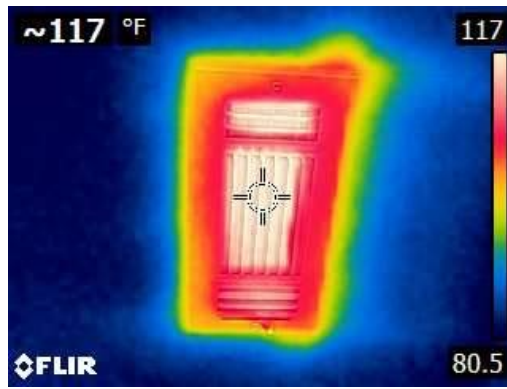
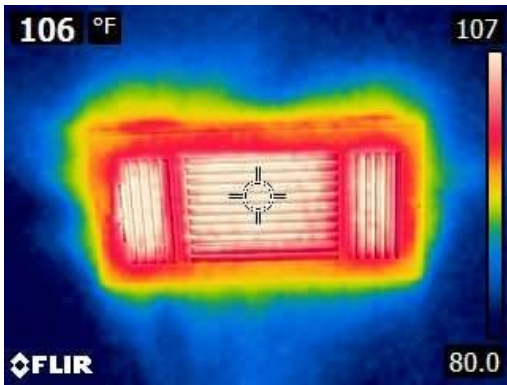
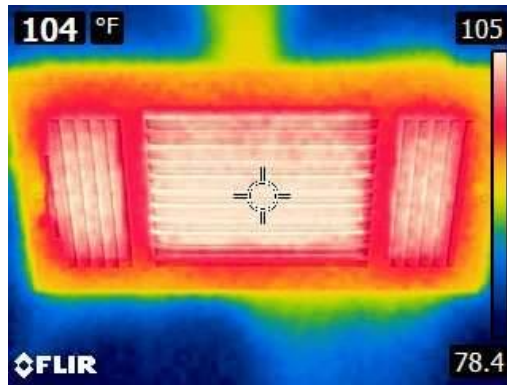
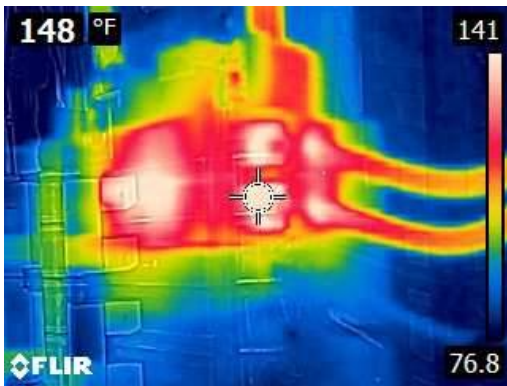
HEAT MODE REQUIRED A LOT OF TIME TO TURN ON AND WHEN ELECTRIC PANEL WAS SCANNED THE BREAKER TEMPERATURE WAS ELEVATED.

A QUALIFIED CONTRACTOR SHOULD INSPECT/EVALUATE AND REPAIR OR REPLACE AS NECESSARY.

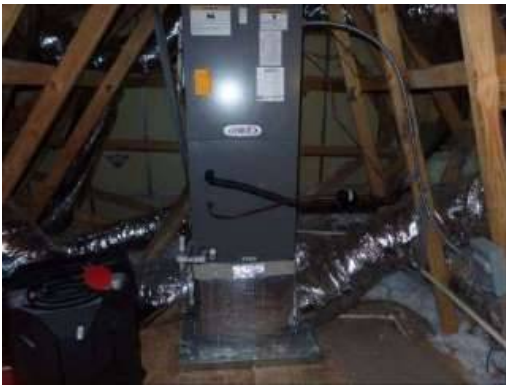
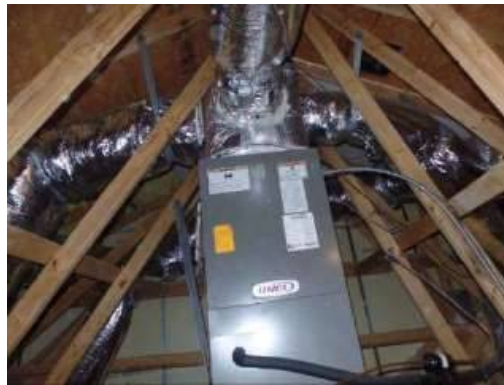
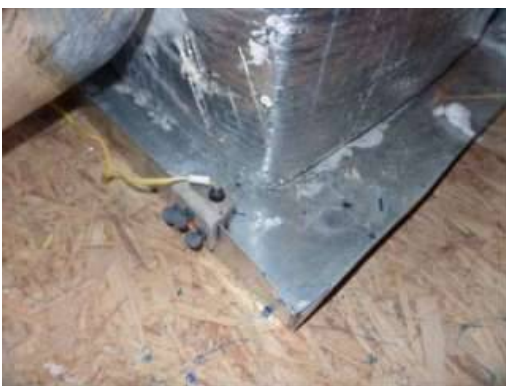
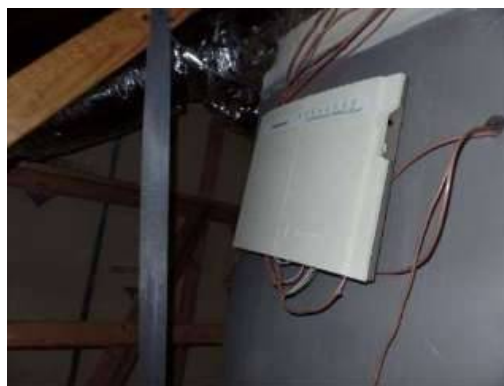
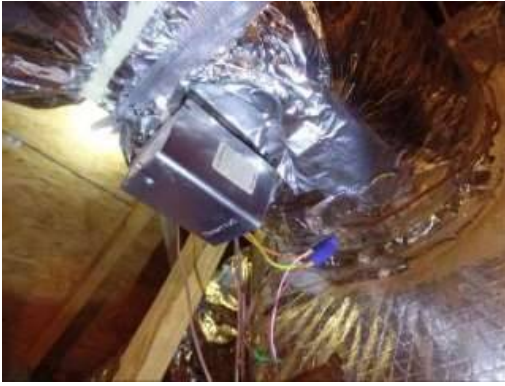
54) ⓘ General photo(s) of HVAC system.

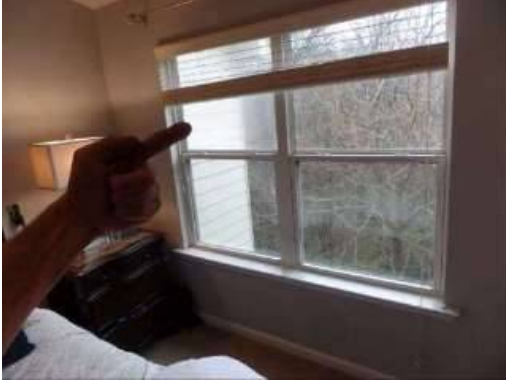
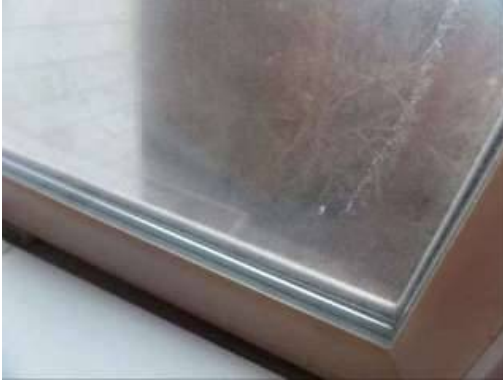
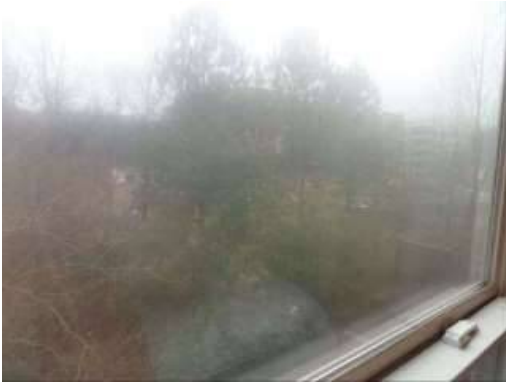
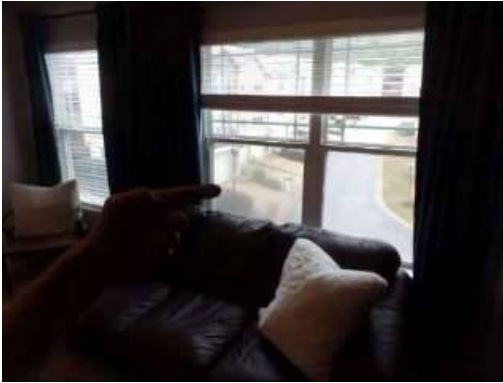
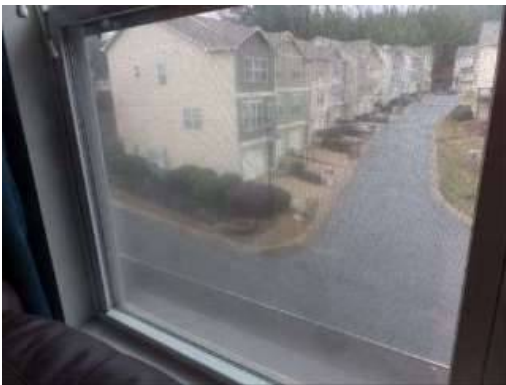
Condensation or staining was visible between multi-pane glass in MULTIPLE windows. This usually indicates that the seal between the panes of glass has failed or that the desiccant material that absorbs moisture is saturated. As a result, the view through the window may be obscured, the window's R-value will be reduced, and accumulated condensation may leak into the wall structure below. Recommend that a qualified contractor evaluate and repair windows as necessary. Usually, this means replacing the glass in

FOR EXAMPLE AT BOTH UPSTAIRS BEDROOMS

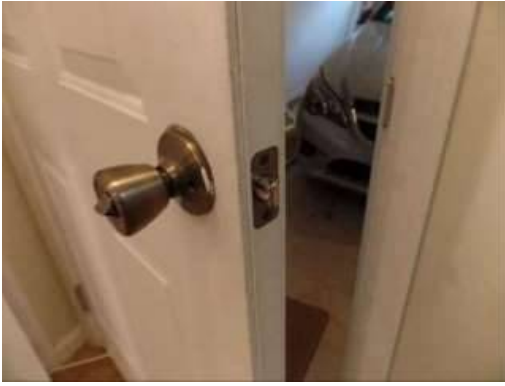
Photo 57-1

One or more exterior doors wouldn't latch. Recommend that a qualified person repair as necessary.

FOR EXAMPLE AT GARAGE DOOR

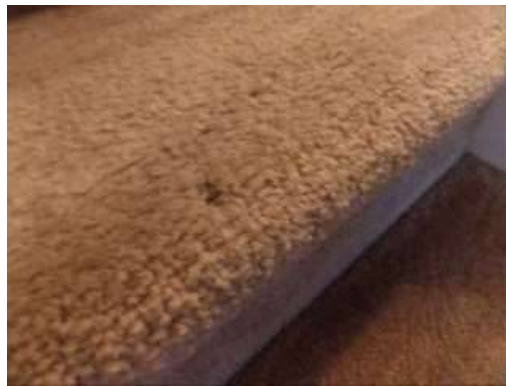
Photo 58-2

Carpeting in one or more areas was damaged or deteriorated. Recommend that a qualified contractor replace as necessary. FOR EXAMPLE AT STAIRS

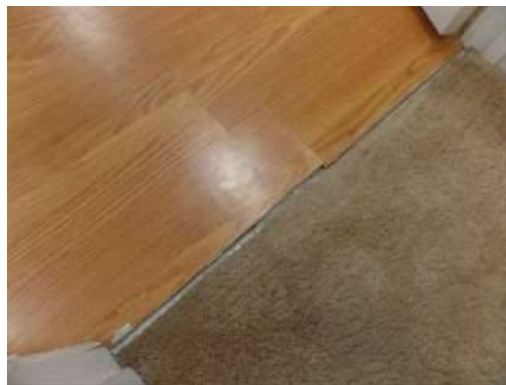
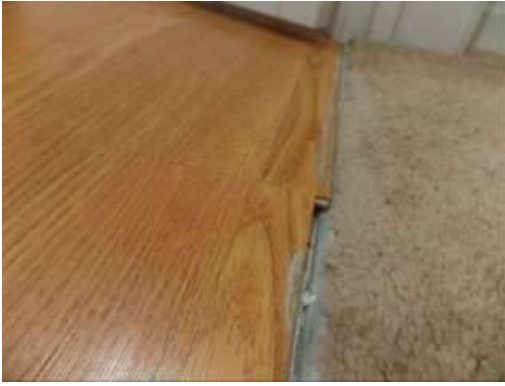
LAMINATE FLOOR AT LOWEST LEVEL WAS MISSING A DOORWAY THRESHOLD AT THE TIME OF INSPECTION. A QUALIFIED CONTRACTOR SHOULD INSPECT/EVALUATE AND REPAIR OR REPLACE AS NECESSARY.

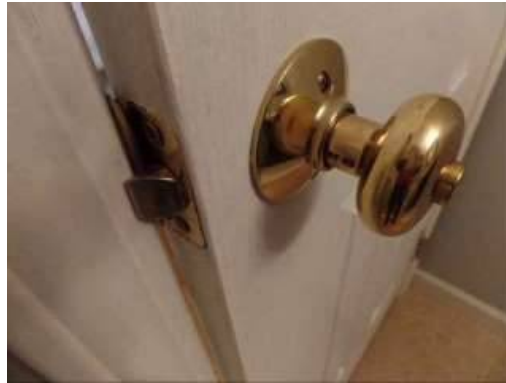
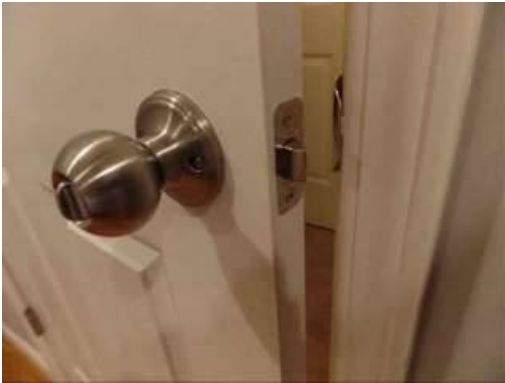
One or more interior doors wouldn't latch or were difficult to latch. Recommend that a qualified person repair as necessary. For example, by adjusting latch plates or locksets. FOR EXAMPLE AT MULTIPLE

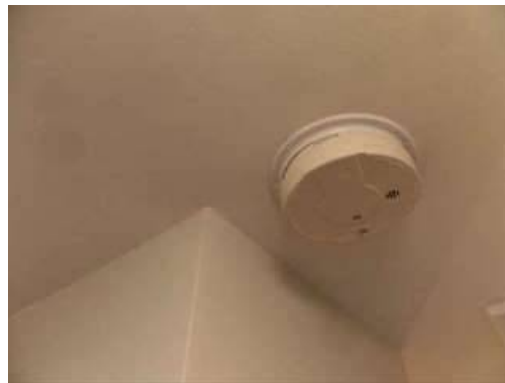
Photo 17-1

Based on the age of this structure and the appearance of existing smoke alarms, the alarms may have been installed more than 10 years ago. According to [National Fire Protection Association](https://www.nfpa.org), aging smoke alarms don't operate as efficiently and often are the source for nuisance alarms. Older smoke alarms are estimated to have a 30% probability of failure within the first 10 years. Newer smoke alarms do better, but should be replaced after 10 years. Unless you know that the smoke alarms are new, replacing them when moving into a new residence is also recommended by NFPA. For more information, visit: <https://www.reporthost.com/?SMKALRMLS>

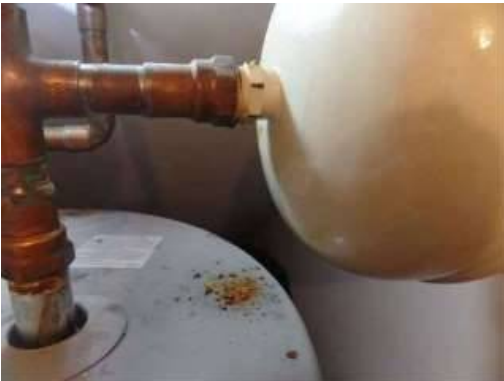
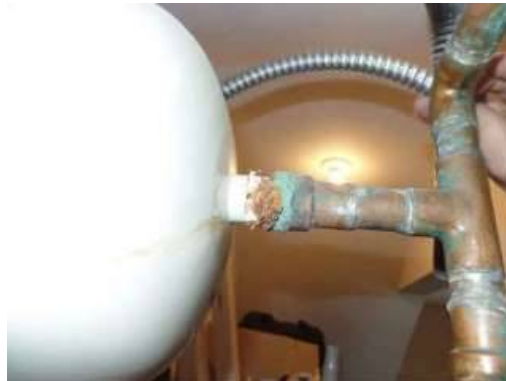
21) 🔧🔍 Significant corrosion or rust was found at the supply pipes or fittings. This can indicate past leaks, or that leaks are likely to occur in the future. Recommend that a qualified plumber evaluate and replace components or make repairs as necessary.

FOR EXAMPLE AT EXPANSION TANK AT TOP OF UNIT

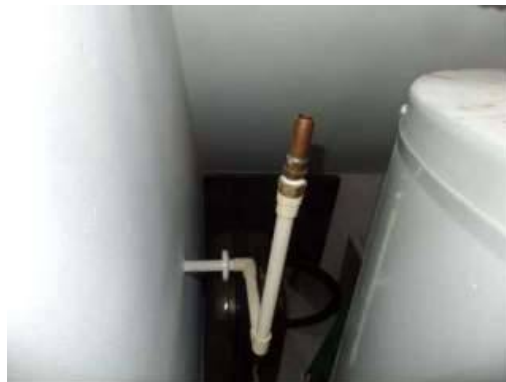
Photo 22-1

22) 🔧🔍 No drain line was installed for the temperature-pressure relief valve. Drain lines are normally installed to prevent water from accumulating if/when the valve eventually leaks, and to prevent scalding if someone is standing next to the water heater when the valve opens. Recommend that a qualified plumber install a drain line so it drains outside and per standard building practices.
WHAT WAS LIKELY THE PREVIOUSLY CONNECTED DRAIN LINE IN 2ND PHOTO.

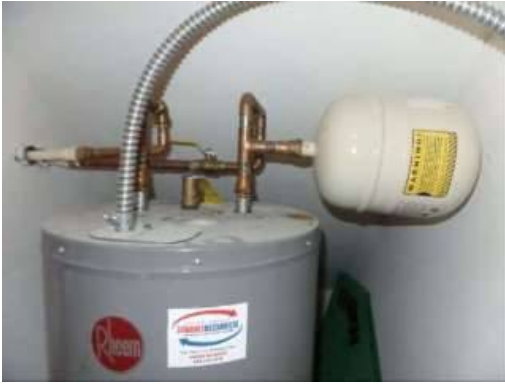
Photo 23-1

23) 🔧🔍 Expansion tank should be supported to prevent stress on the plumbing.

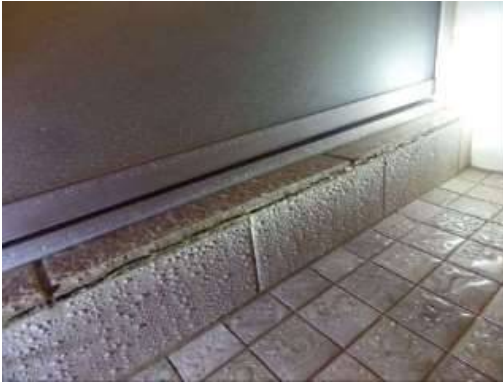
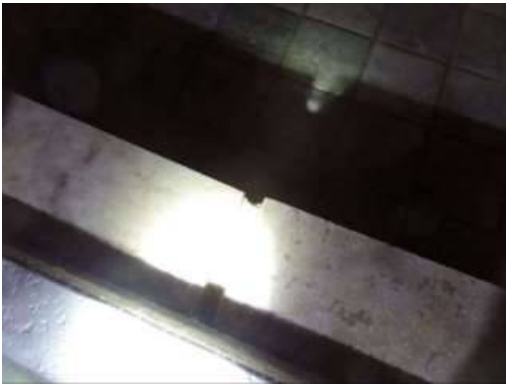
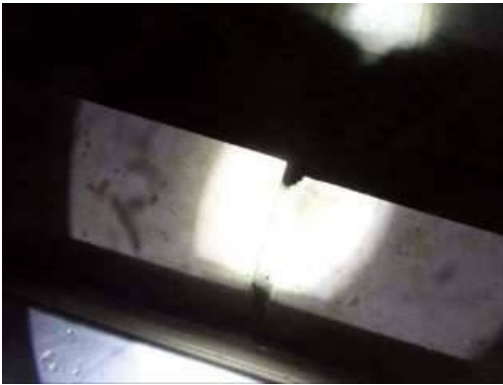
THE FIRST FLOOR SHOWER HAD MULTIPLE SHARP TILE EDGES AT THE ELEVATED BASE OF THE SLIDING GLASS DOORS. THESE SHARP EDGES ARE HAZARDOUS AND COULD CAUSE INJURY TO BARE FEET. A QUALIFIED CONTRACTOR SHOULD INSPECT/EVALUATE AND REPAIR OR REPLACE AS NECESSARY.

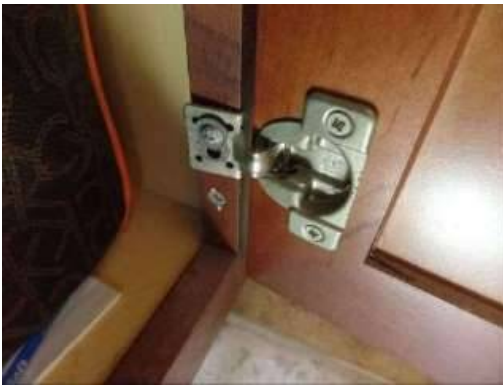
Photo 32-1

One or more cabinets, drawers and/or cabinet doors at location(s) #A and/or MASTER were damaged or deteriorated. Recommend that a qualified person repair or replace as necessary.

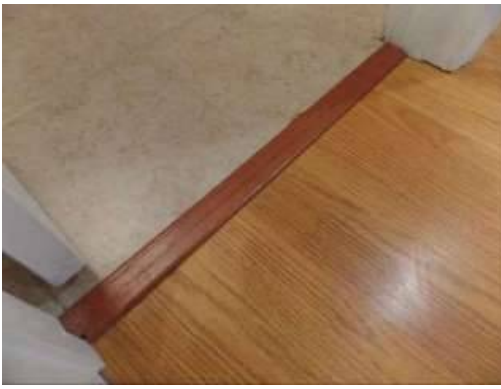
Photo 36-1

Tile, stone and/or grout in the flooring at location(s) #D and/or 1ST FLOOR was deteriorated (e.g. loose or cracked tiles, missing grout) or substandard. Water can damage the sub-floor as a result. Recommend that a qualified contractor repair as necessary.

THRESHOLD WAS LOOSE AT THE TIME OF INSPECTION

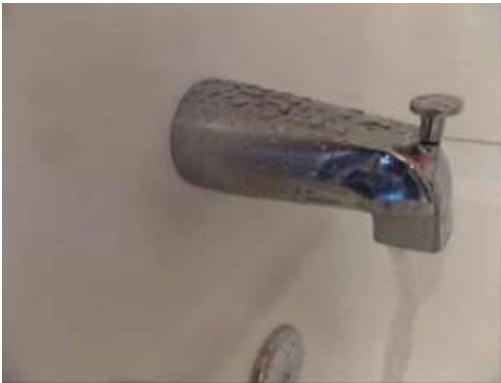
Photo 37-1

Caulk was missing around the base of the bathtub spout, or there was a gap behind it, at location(s) #A, B and/or BOTH TOP BATHROOMS. Water may enter the wall structure behind the bathtub. Recommend that a qualified person repair as necessary to eliminate the gap. For example, by installing or replacing caulk if the gap is small enough. For larger gaps, a shorter spout nipple or an escutcheon plate can be installed.
