Property Inspection Report

Property address: **1741 Liberty Pkwy NW
Atlanta GA 30318**

Inspection date: **Friday, January 24, 2020**

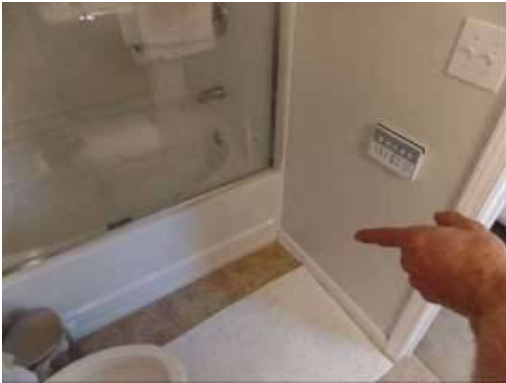
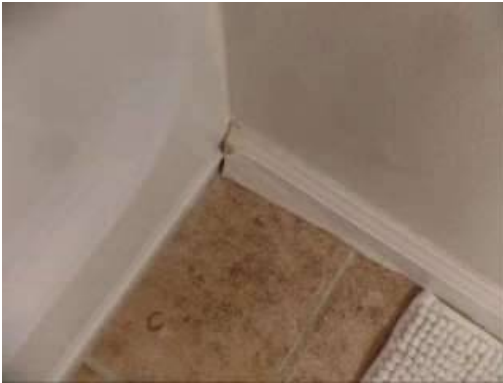
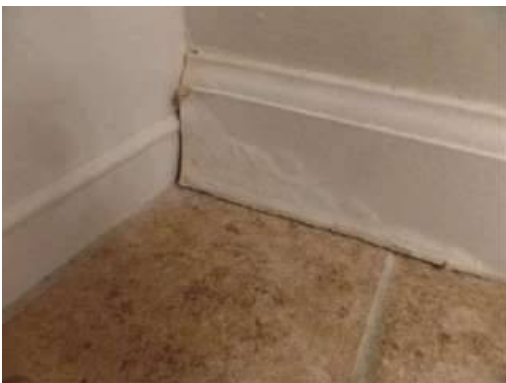
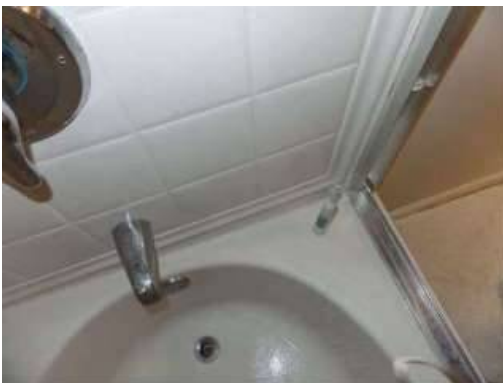
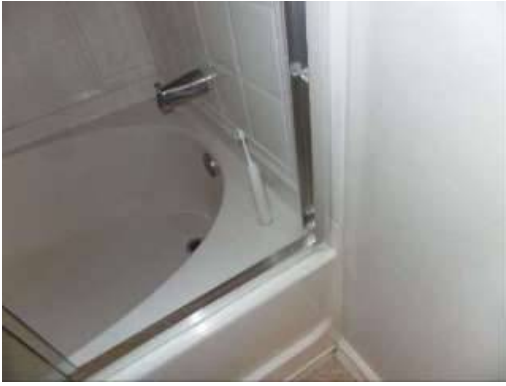
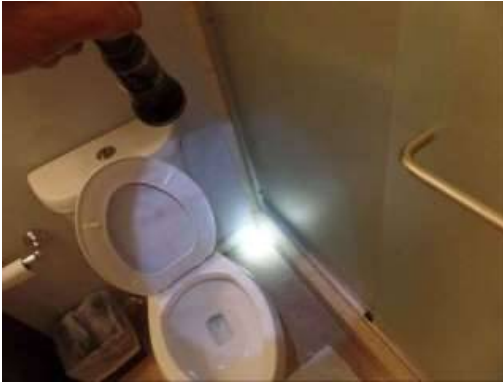
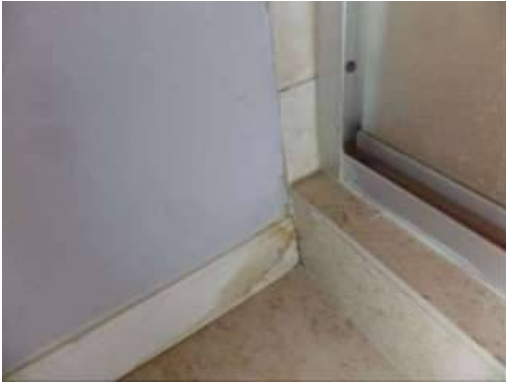
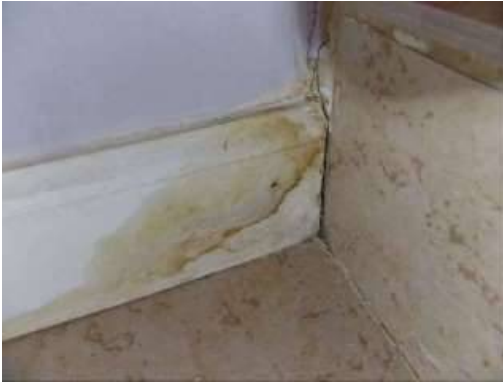
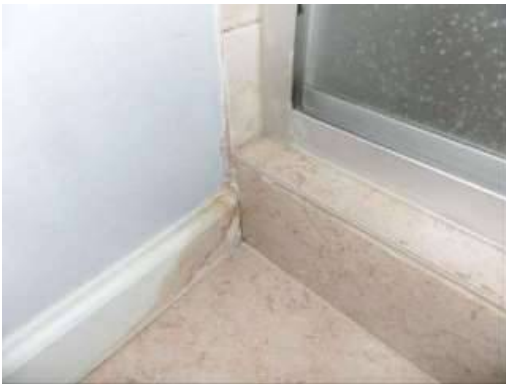
40) 🛠️ The wall by the shower at location(s) #A, B, D, MASTER, FRONT and/or 1ST FLOOR was water-damaged. Recommend that a qualified person repair as necessary.

TRIM DETERIORATED AND/OR DISCOLORED WHICH INDICATES PROLONGED WATER EXPOSURE. AT SLIDING DOORS CAULK/SEALANT SHOULD BE APPLIED AT METAL FRAME. REPAIR MAINTAIN AS NECESSARY.

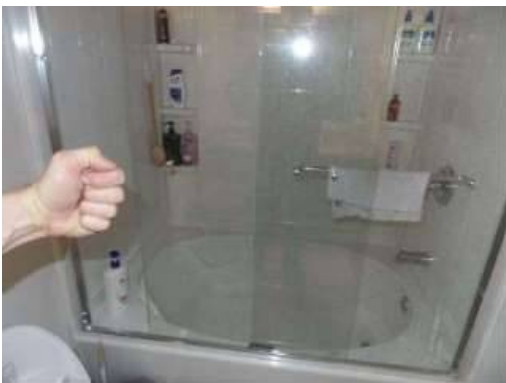
Photo 41-1

THE LEFT SLIDING GLASS DOOR AT MASTER BATHROOM #A WAS DIFFICULT TO OPERATE AT THE TIME OF INSPECTION AND MAY HAVE DAMAGED TRACKS. A QUALIFIED CONTRACTOR SHOULD INSPECT/EVALUATE AND REPAIR OR REPLACE AS NECESSARY.

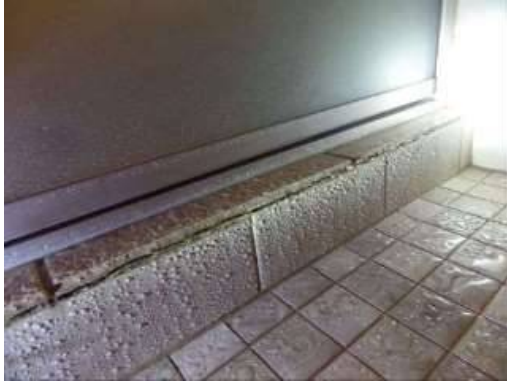
Photo 42-1

ONE OR MORE GAPS WERE PRESENT AT THE TILE GROUT AT THE FIRST FLOOR SHOWER AT THE TIME OF INSPECTION. WATER COULD ESCAPE THE SHOWER ENCLOSURE POSSIBLY CAUSING WOOD ROT AND POTENTIAL BIOLOGICAL GROWTH (MOLD). A QUALIFIED CONTRACTOR SHOULD INSPECT/EVALUATE AND REPAIR OR REPLACE AS NECESSARY.

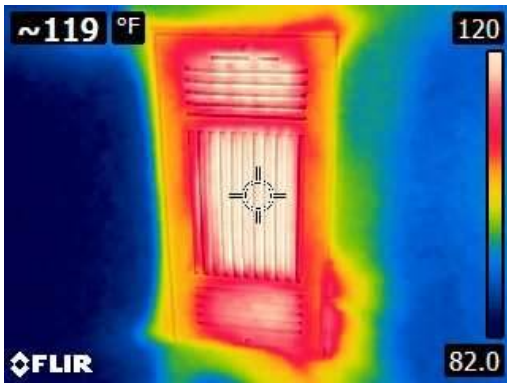
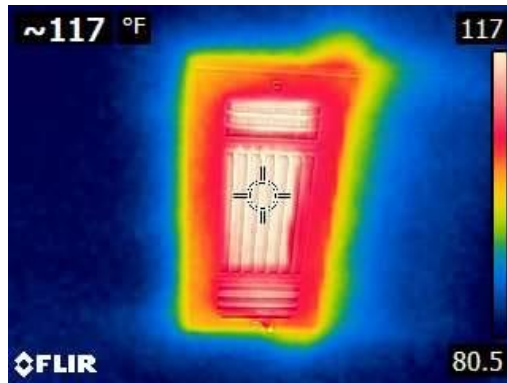
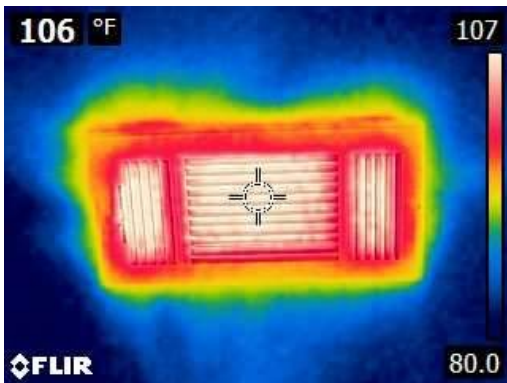
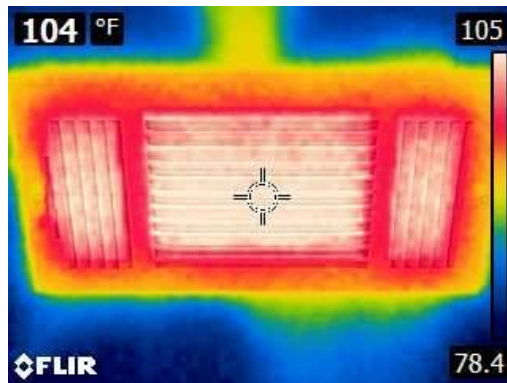
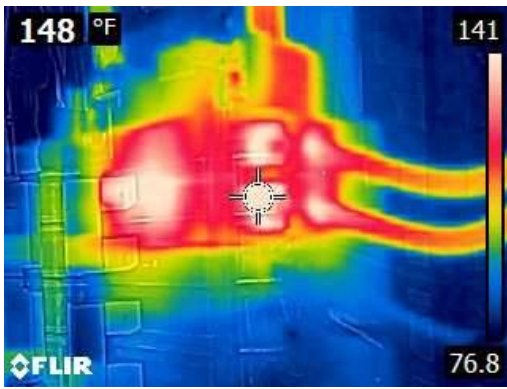
Infrared photo(s) of HVAC system in HEAT mode. HEAT MODE REQUIRED A LOT OF TIME TO TURN ON AND WHEN ELECTRIC PANEL WAS SCANNED THE BREAKER TEMPERATURE WAS ELEVATED. A QUALIFIED CONTRACTOR SHOULD INSPECT/EVALUATE AND REPAIR OR REPLACE AS NECESSARY.

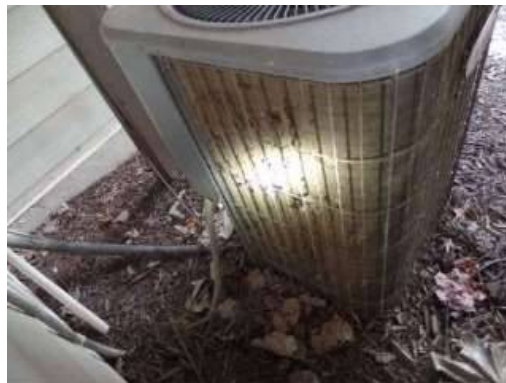
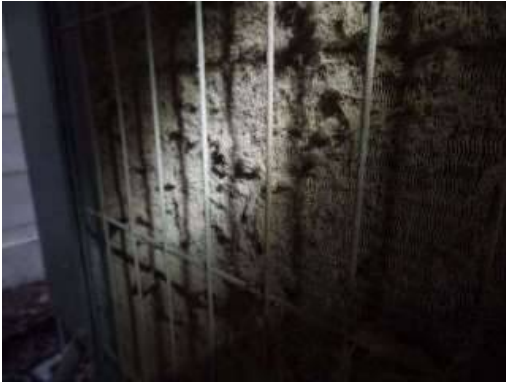
The cooling fins at the air handler evaporator coils were EXTREMELY dirty. Recommend that a qualified person clean fins as necessary.

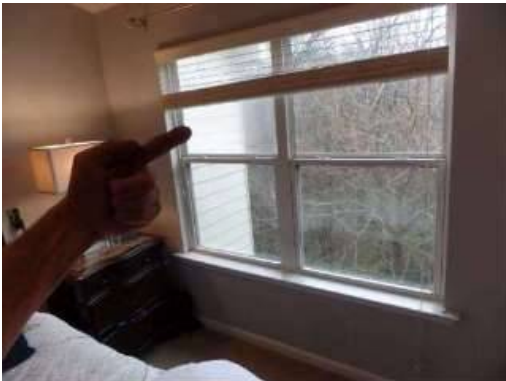
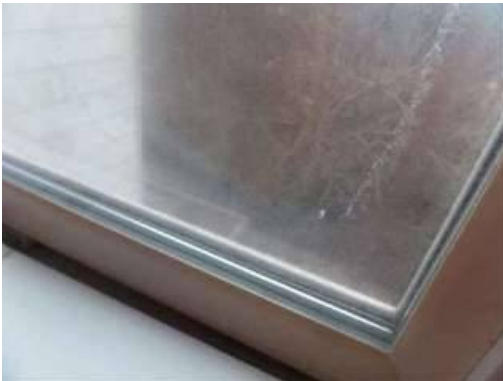
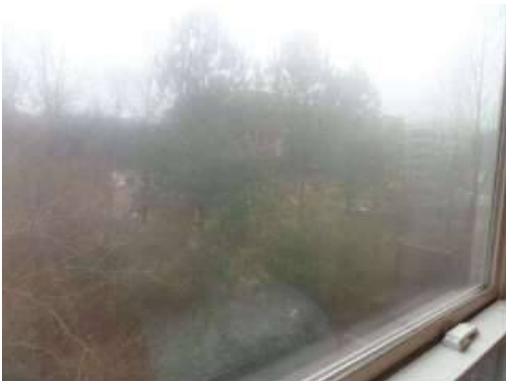
56) 🔨🔍💧 Condensation or staining was visible between multi-pane glass in MULTIPLE windows. This usually indicates that the seal between the panes of glass has failed or that the desiccant material that absorbs moisture is saturated. As a result, the view through the window may be obscured, the window's R-value will be reduced, and accumulated condensation may leak into the wall structure below. Recommend that a qualified contractor evaluate and repair windows as necessary. Usually, this means replacing the glass in window frames.

FOR EXAMPLE AT BOTH UPSTAIRS BEDROOMS

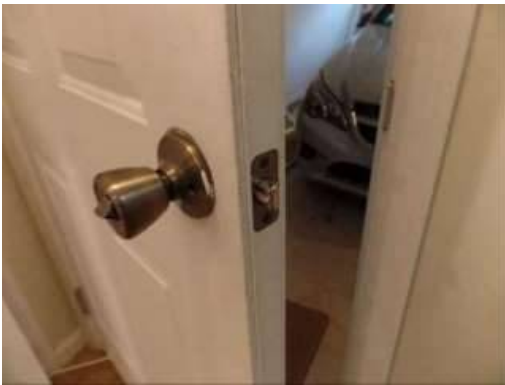
Photo 57-1

One or more exterior doors wouldn't latch. Recommend that a qualified person repair as necessary.

FOR EXAMPLE AT GARAGE DOOR

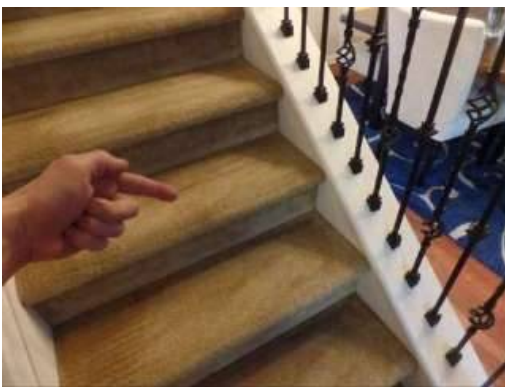
Photo 58-1

Carpeting in one or more areas was damaged or deteriorated. Recommend that a qualified contractor replace as necessary.
FOR EXAMPLE AT STAIRS

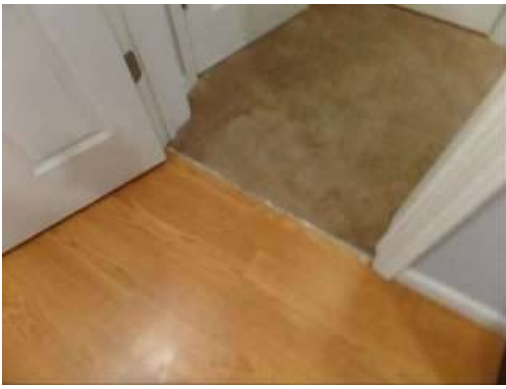
Photo 59-1

LAMINATE FLOOR AT LOWEST LEVEL WAS MISSING A DOORWAY THRESHOLD AT THE TIME OF INSPECTION. A QUALIFIED CONTRACTOR SHOULD INSPECT/EVALUATE AND REPAIR OR REPLACE AS NECESSARY.

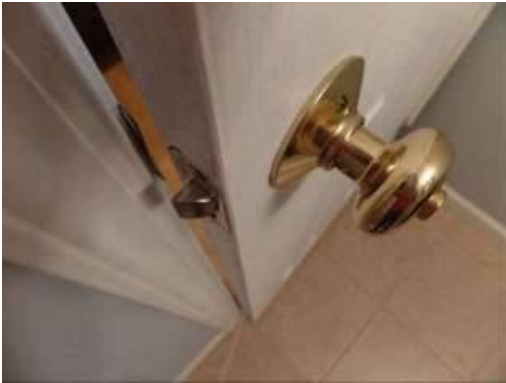
Photo 60-1

One or more interior doors wouldn't latch or were difficult to latch. Recommend that a qualified person repair as necessary. For example, by adjusting latch plates or locksets. FOR EXAMPLE AT MULTIPLE
