Inspection Report

Property Address:
520 Waterview Trail
Alpharetta GA 30022

Champia Real Estate Inspections, LLC

Date: 3/3/2020	Time: 09:02 AM	Report ID: 40838
Property: 520 Waterview Trail Alpharetta GA 30022	Customer: Brett Pancoast	Real Estate Professional: Sherri Godwin Atlanta Communities (Atlanta) InTown Peachtree Rd

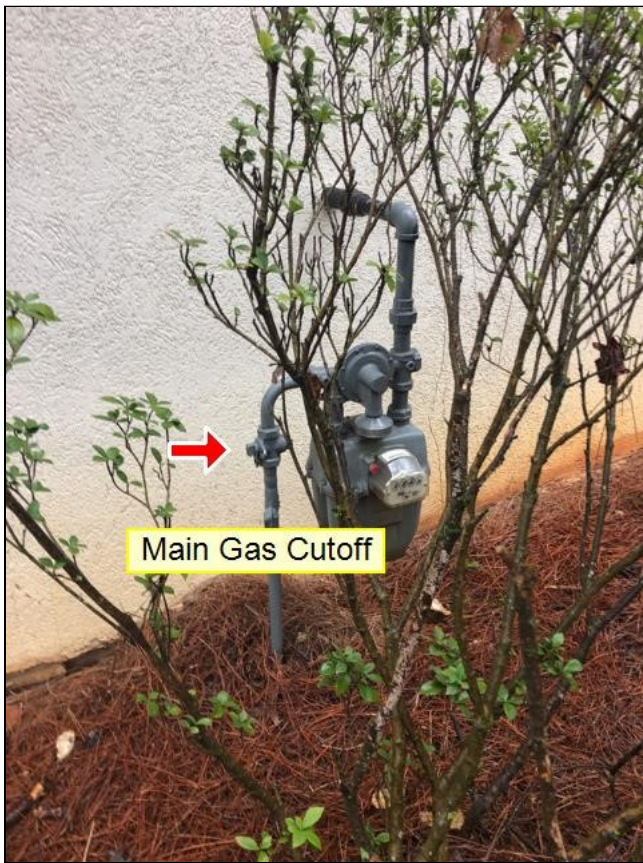
8.1 (1) Gas Main Shutoff locate on left side of house.

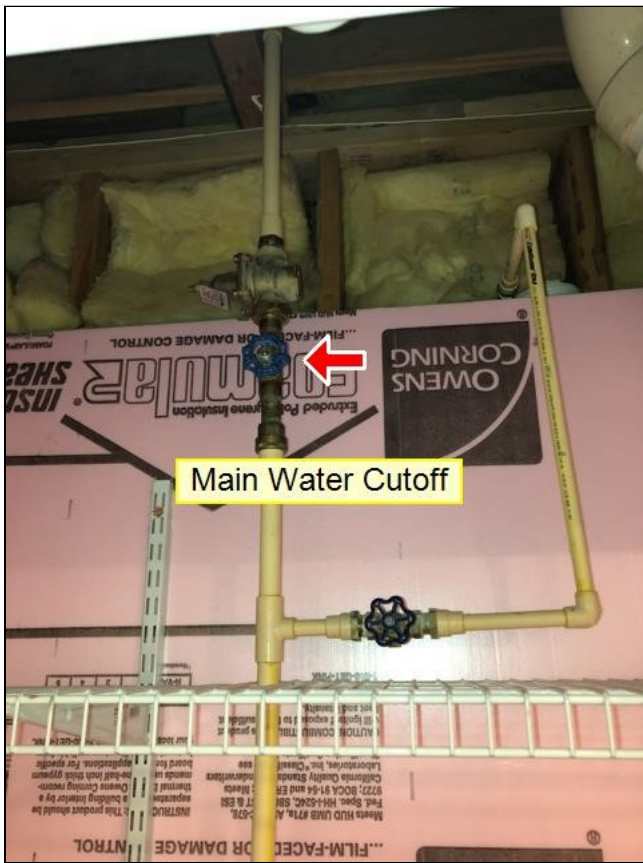
8.2 Location of water main shutoff located in front of basement in closet.

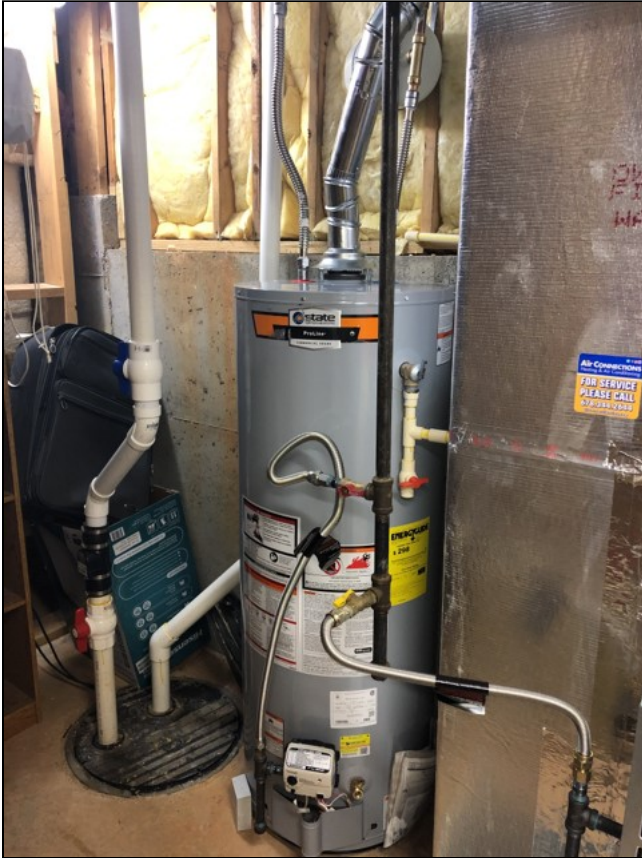
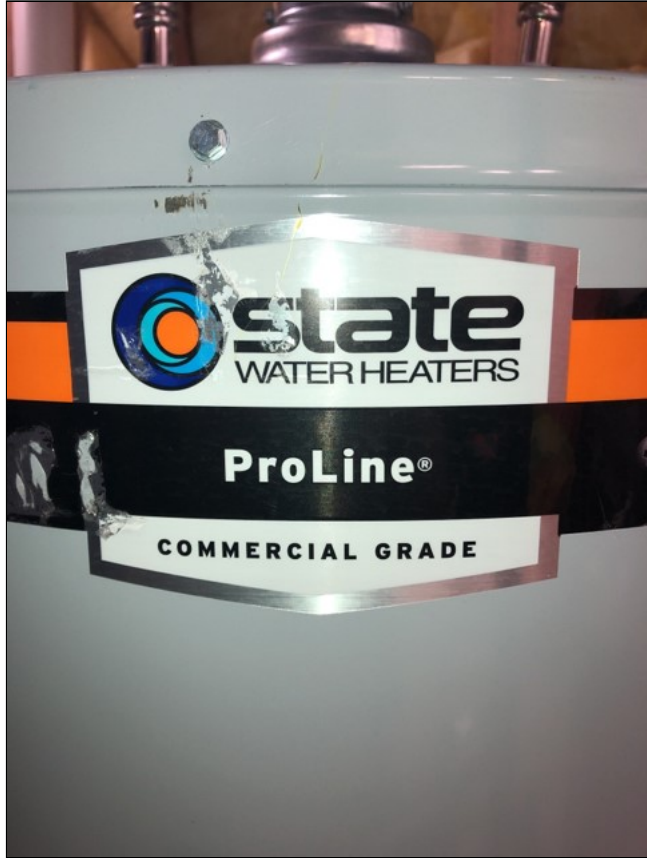
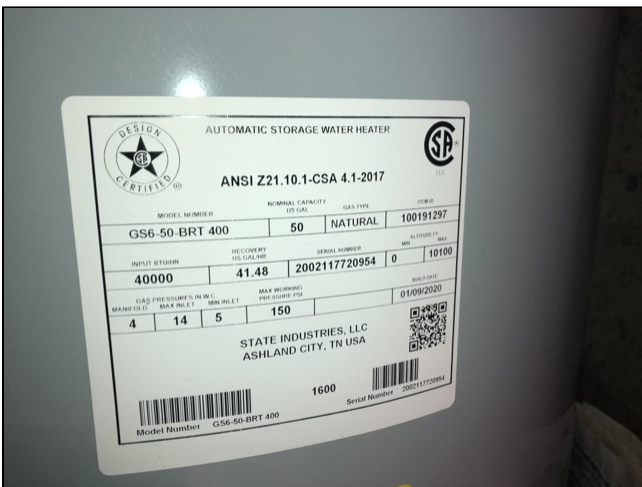
8.3 State gas hot water tank GS6 -50-BRT 400.
 Serial number 2002117720954.
 50 gallon capacity.
 40,000 BTUs per hour.
 Manufactured in 2020.

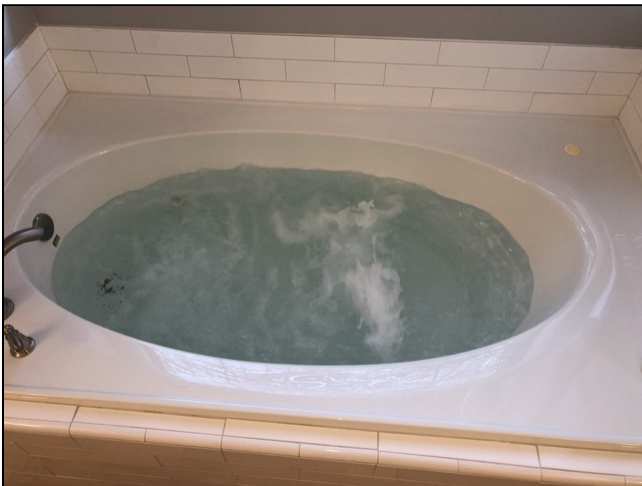
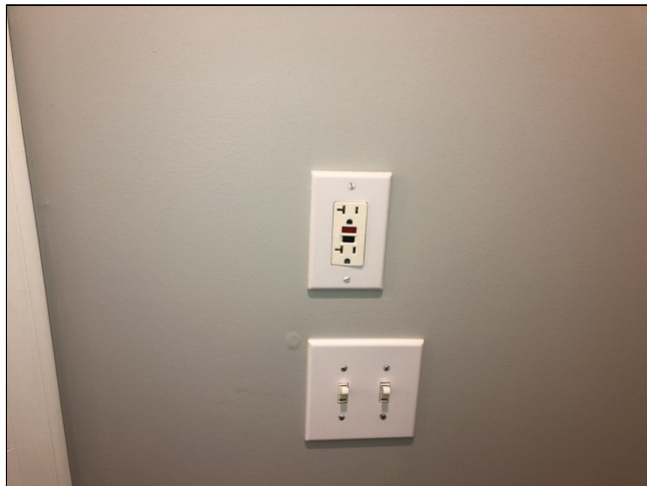
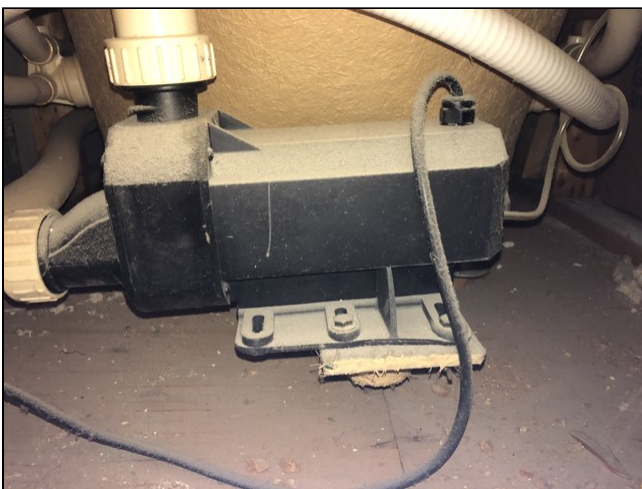
8.6 (3) Spa tub is operational. Pump is protected electrically by GFCI in toilet area. Could not locate a ground lug on pump possibly because outer housing is plastic.

8.6 GFCI protecting Spa tub

8.6 Spa pump motor

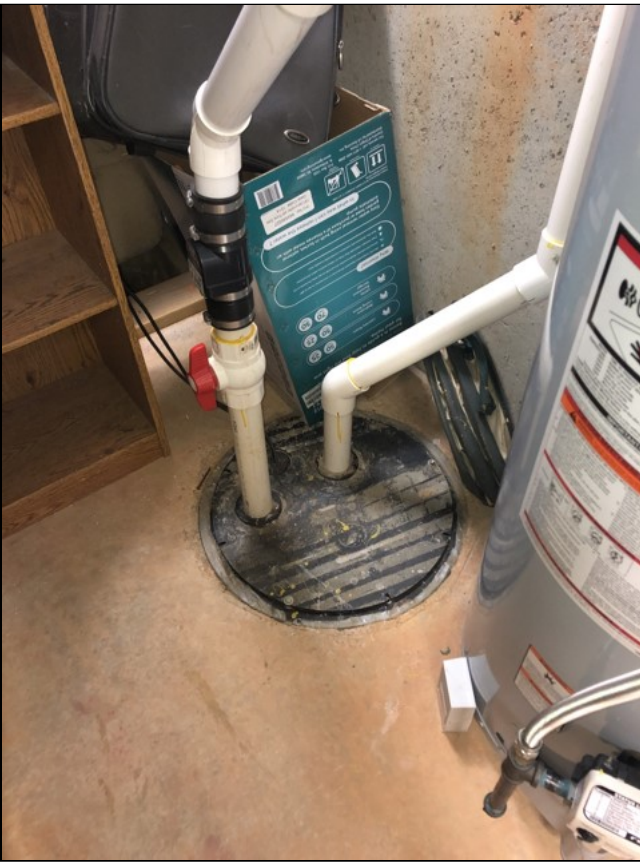
8.9 Sump pump in basement was operational at time of inspection

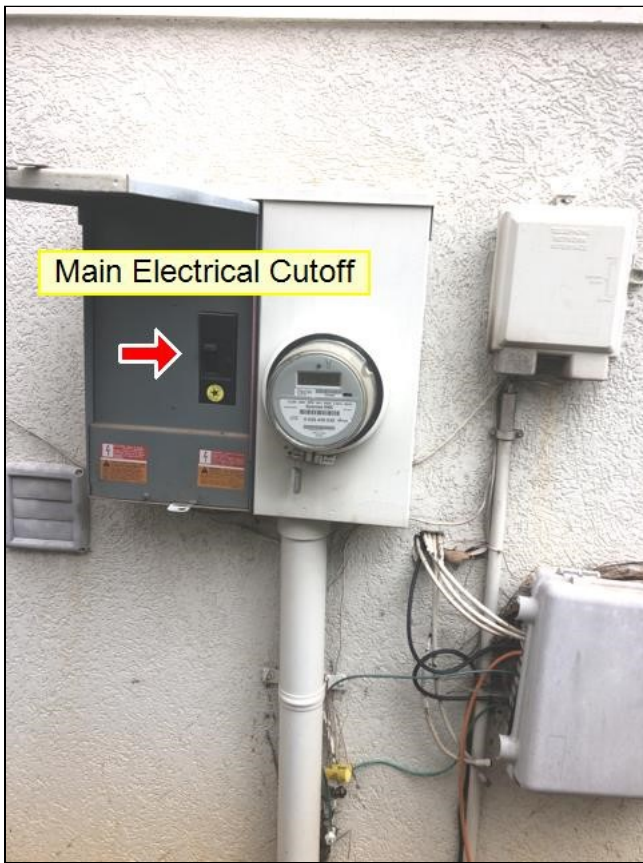
9.1 200 amp electrical disconnect located at meter on left side of house with below ground service.

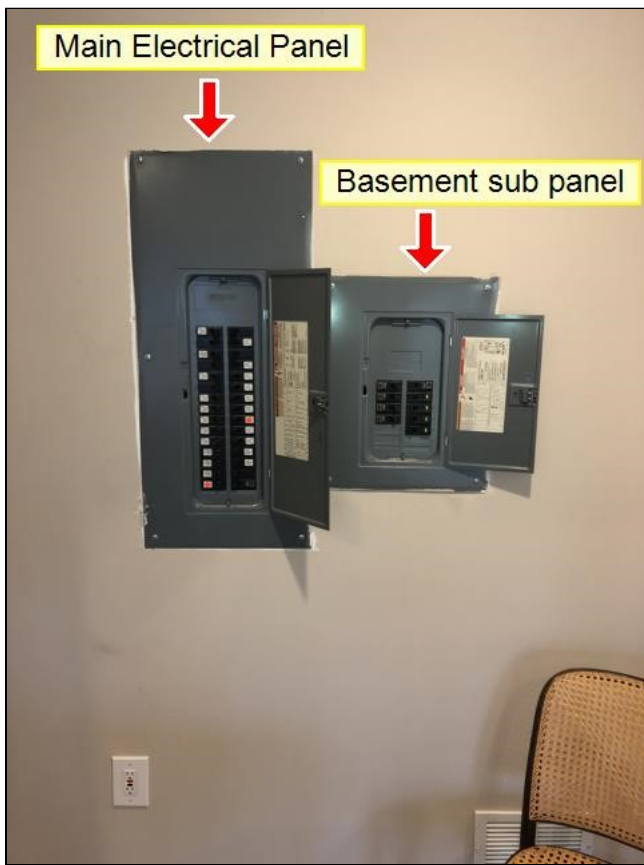
9.2 (1) Electrical panels located in basement.

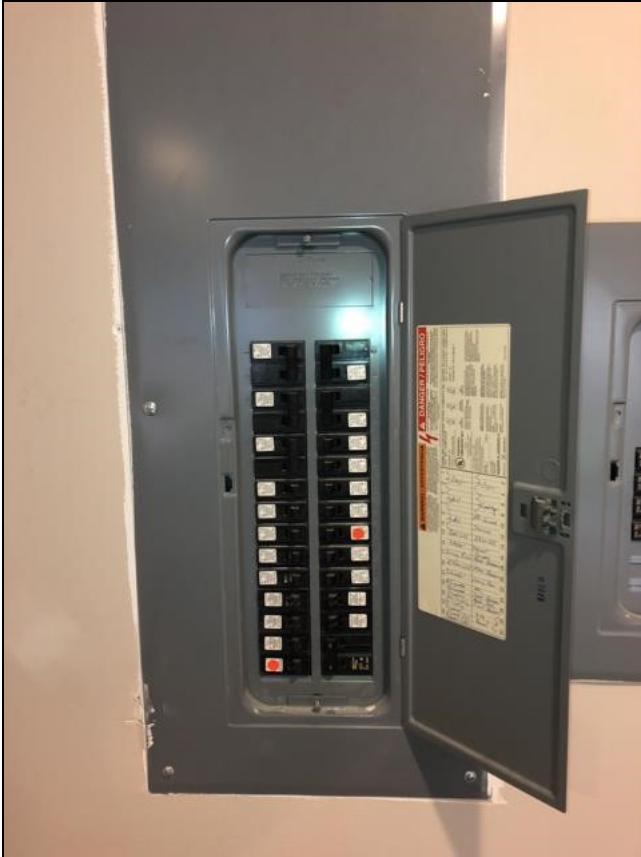
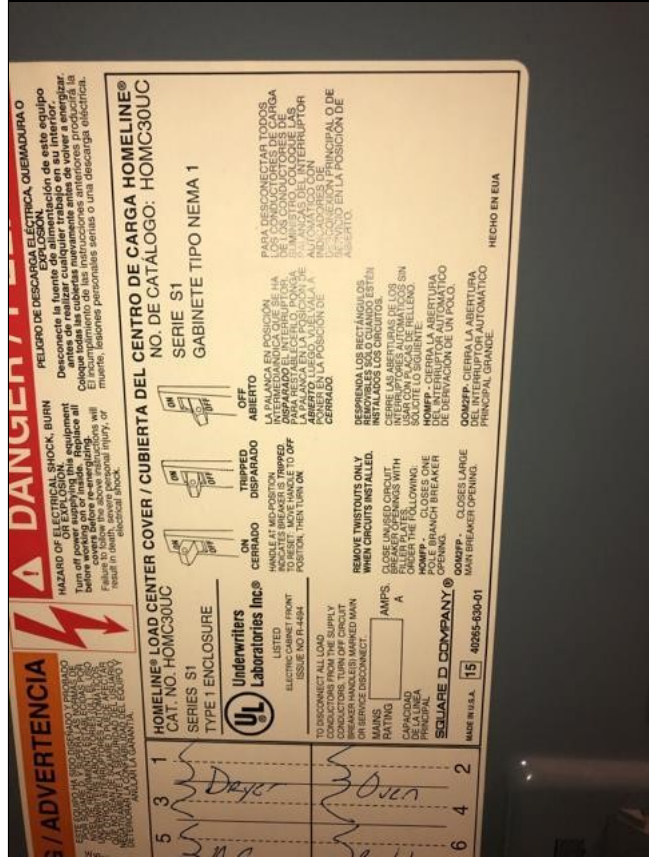
9.2 (2) 200 amp Square D Electrical panel located in basement.

Improper wiring noted with two neutral wires observed under one terminal screw in bus bar. NOTE: Currently accepted construction practices recommends that only one neutral wire per terminal screw at bus bar to ensure circuit can be isolated to work on and to prevent overheating at terminal due to loose connection. Recommend a qualified electrical contractor estimate and make repairs as needed.

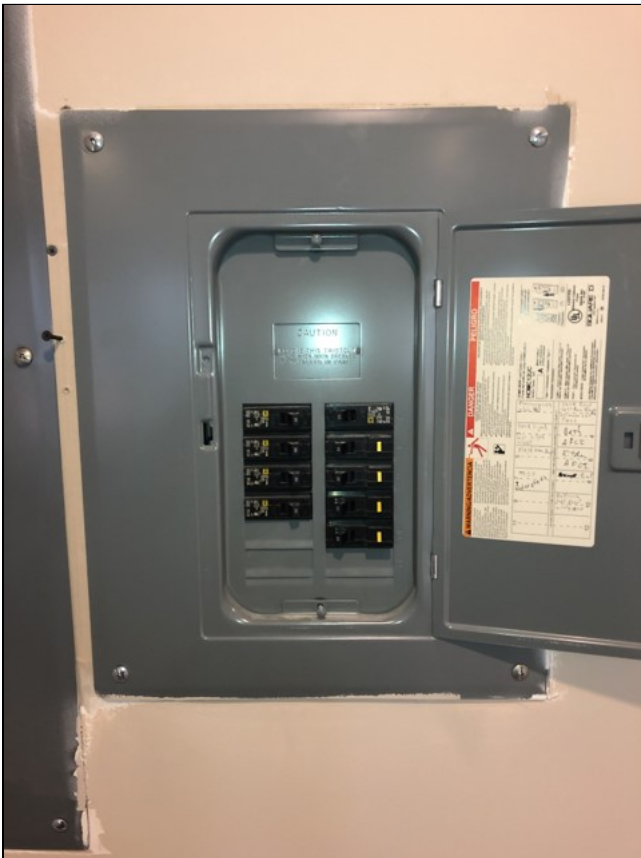
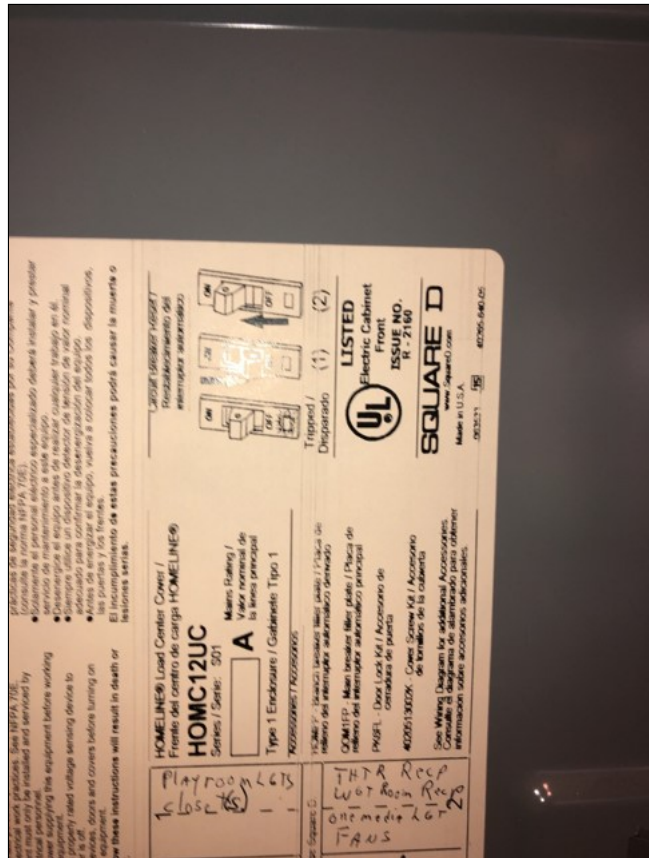
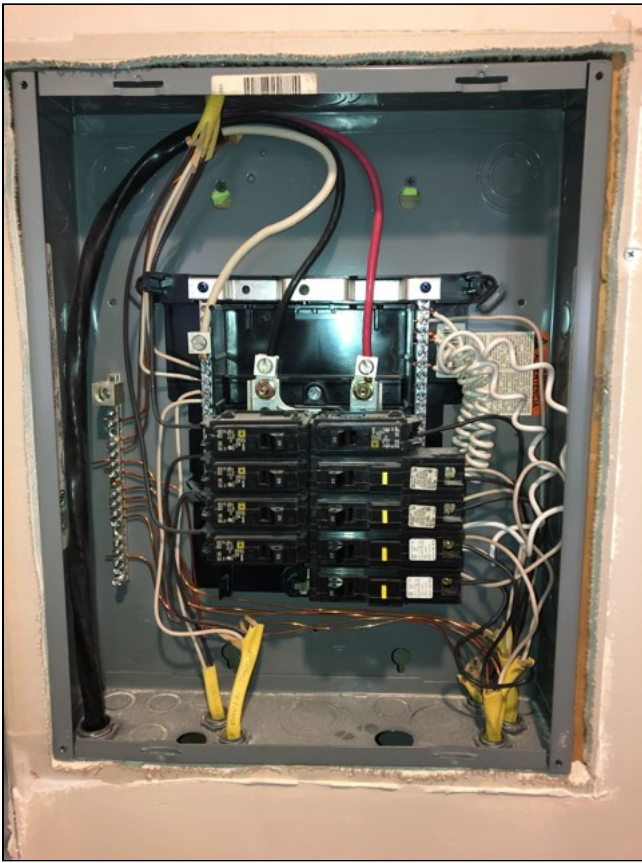
9.2 (3) Square D 125 amp electrical electrical subpanel.

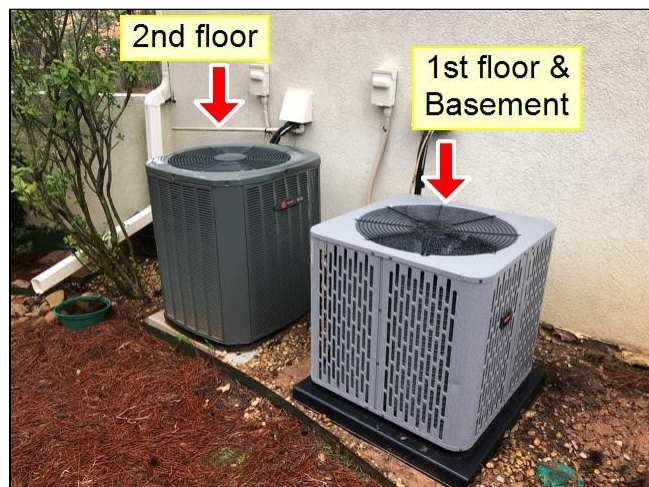
10.1 (1) AC condensers located on left side of house.

Cooling system not tested. When overnight temperatures are below 60 F cooling/air conditioning systems are not tested to avoid damage to the AC condenser. Recommend to consult with a licensed HVAC contractor for evaluation and establish a regular maintenance schedule.

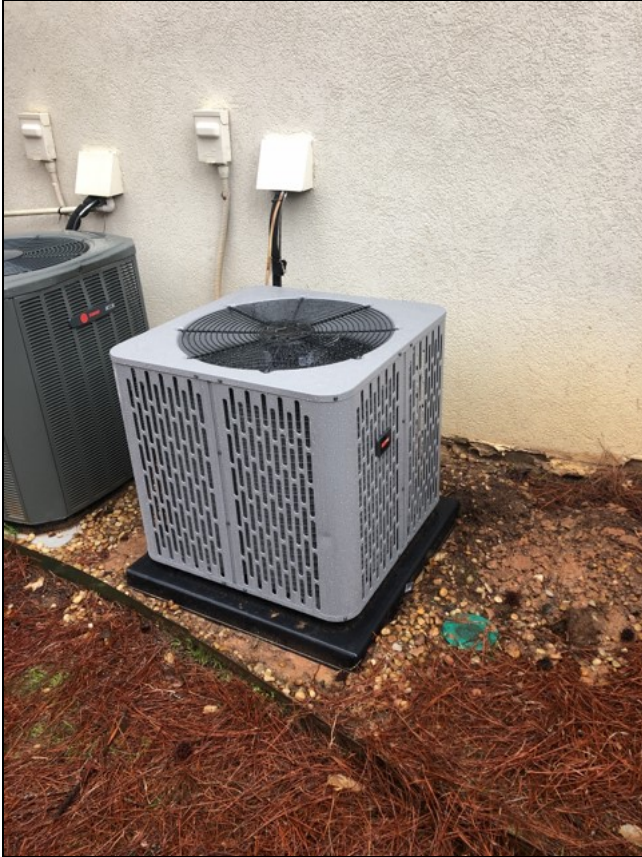
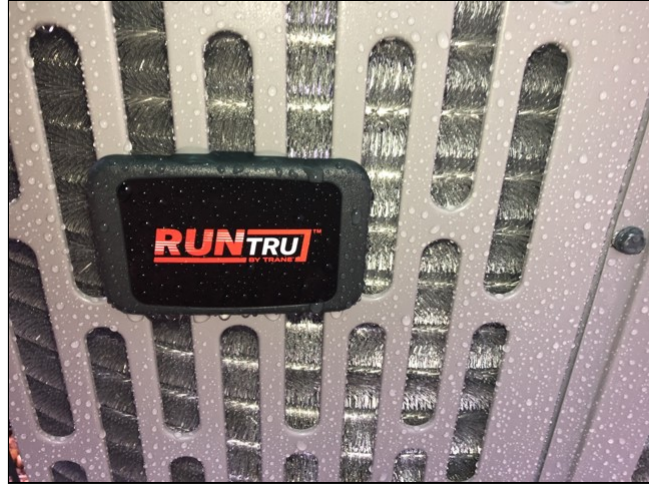
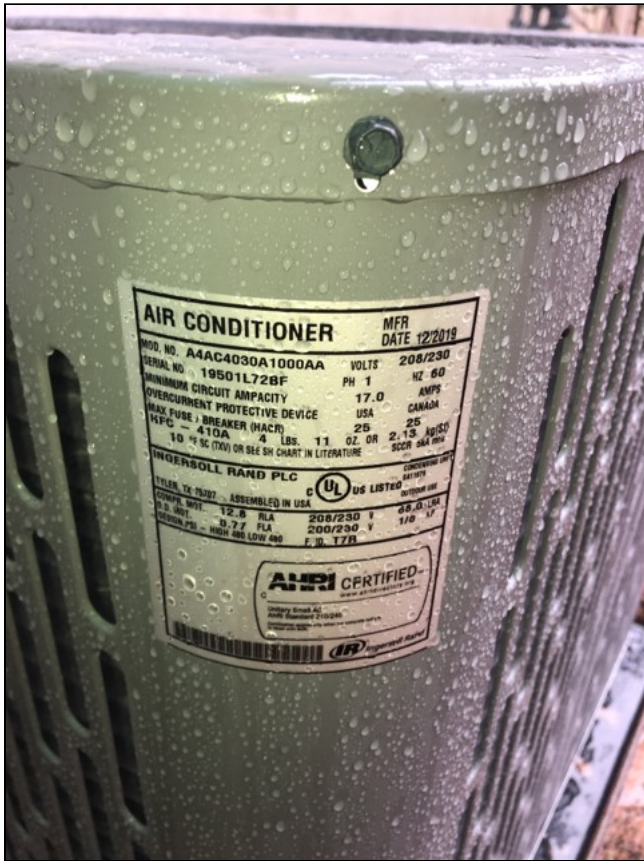
10.1 (2) Run-Tru (Trane) AC condenser
Model number A4AC4030A1000AA.

2 1/2 ton unit.

Manufactured in 2019. The system is 1 years old. NOTE: The typical life expectancy of AC or heat pump unit is 10-12 years. Recommend annual service to maintain AC or heat pump unit and to make repairs as needed.

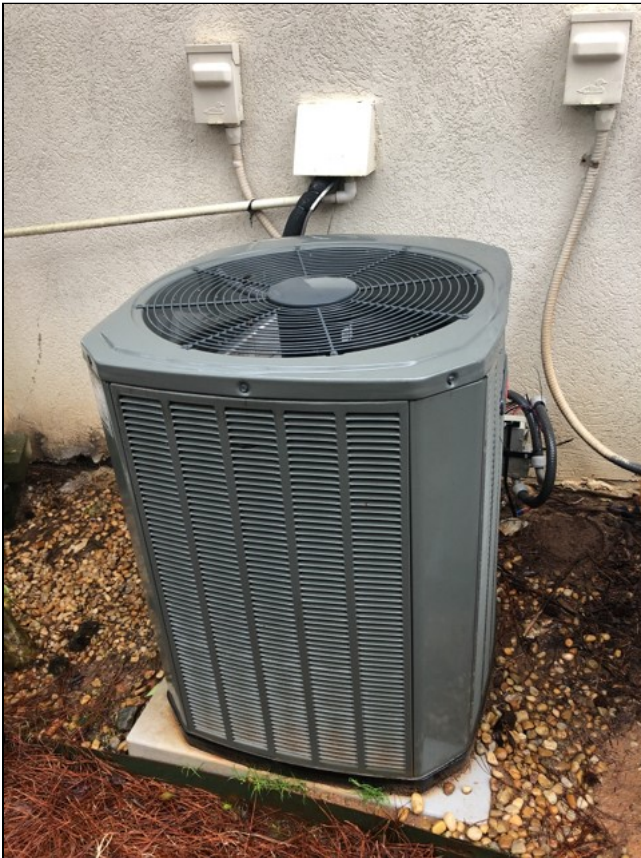
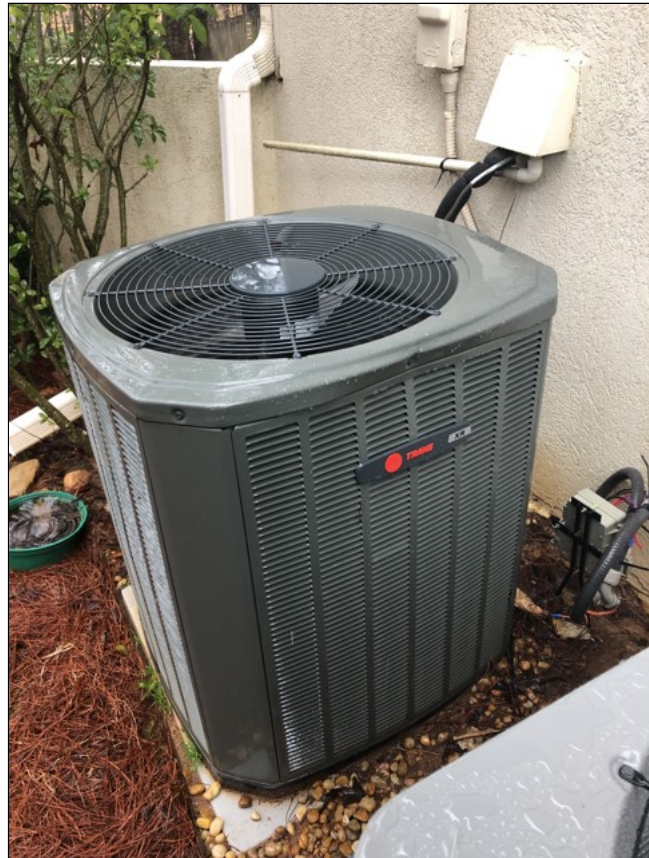
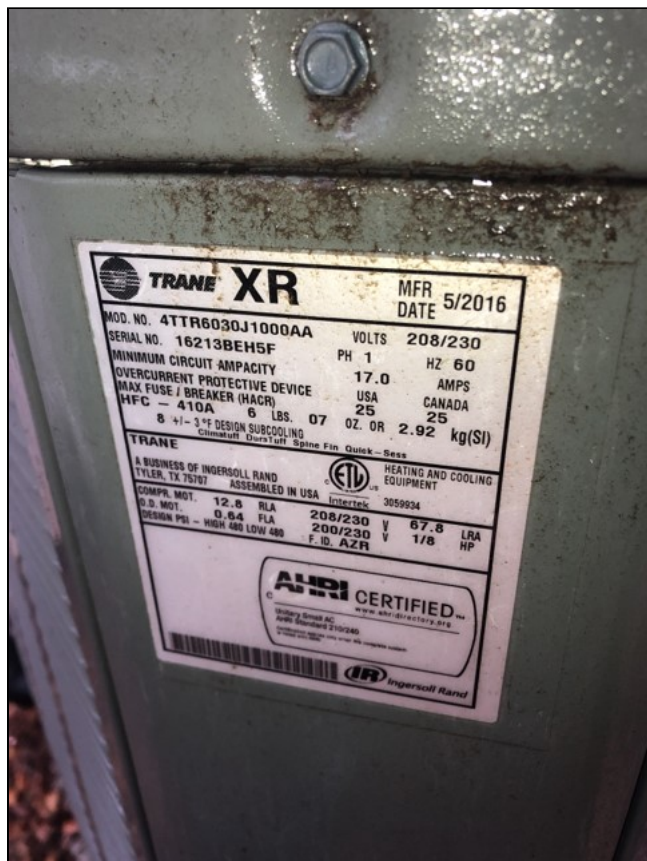
10.1 (3) 2ns floor Trane AC condenser

2 1/2 ton unit.

Manufactured 2016. The system is 4 years old. NOTE: The typical life expectancy of AC unit is 10-12 years. Recommend annual service to maintain AC unit and to make repairs as needed.

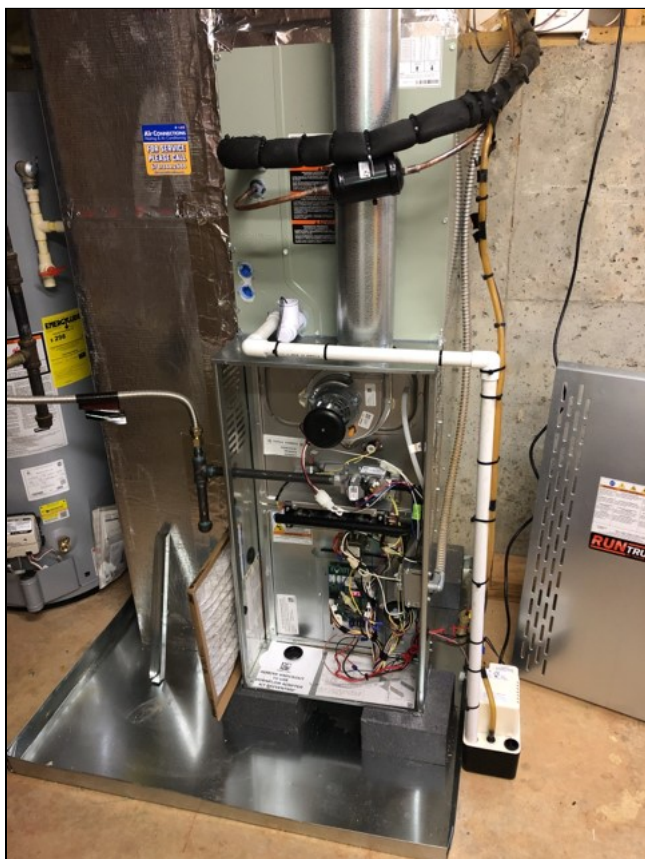
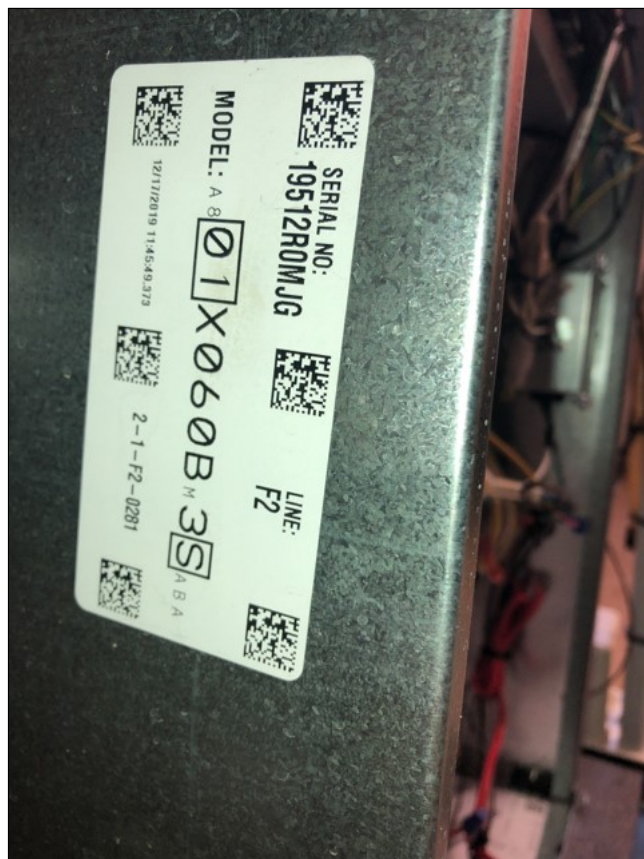
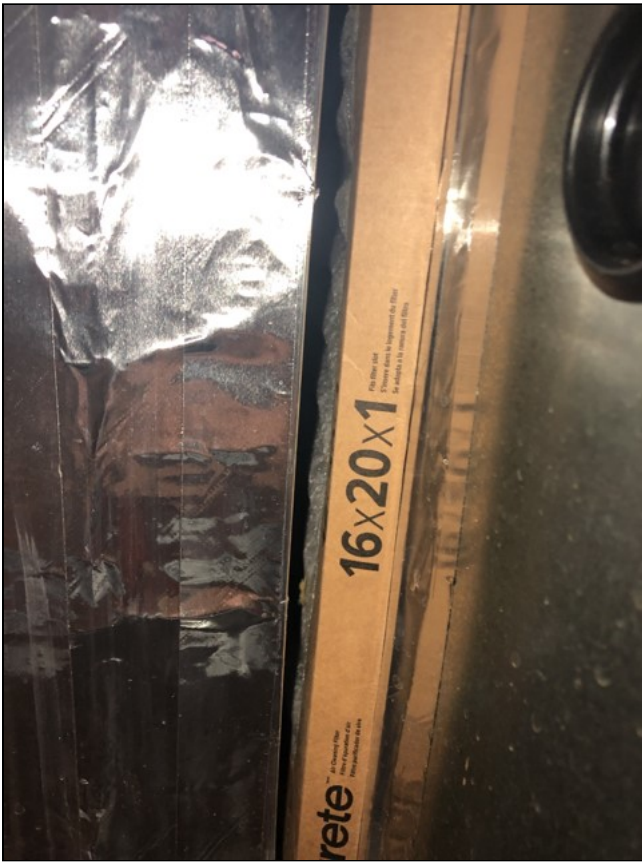
10.2 (1) Run-Tru furnace for first and second floor located in basement.

Manufactured in 2019. The system is 1 years old. NOTE: The typical life expectancy of furnaces is 15 - 20 years. Recommend annual service to maintain furnace and to make repairs as needed.

Filter size is 16 x 20 x 1. Filter was clean at time of inspection.

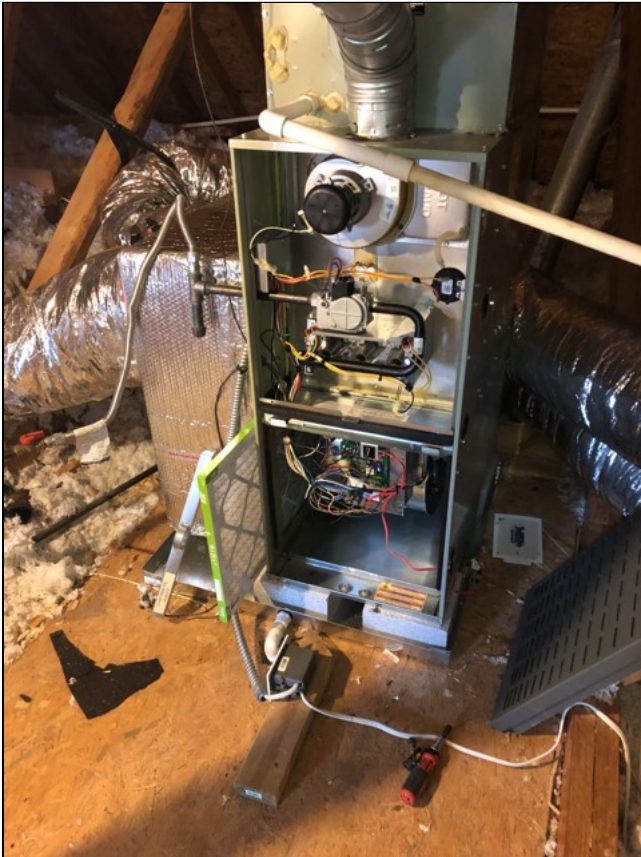
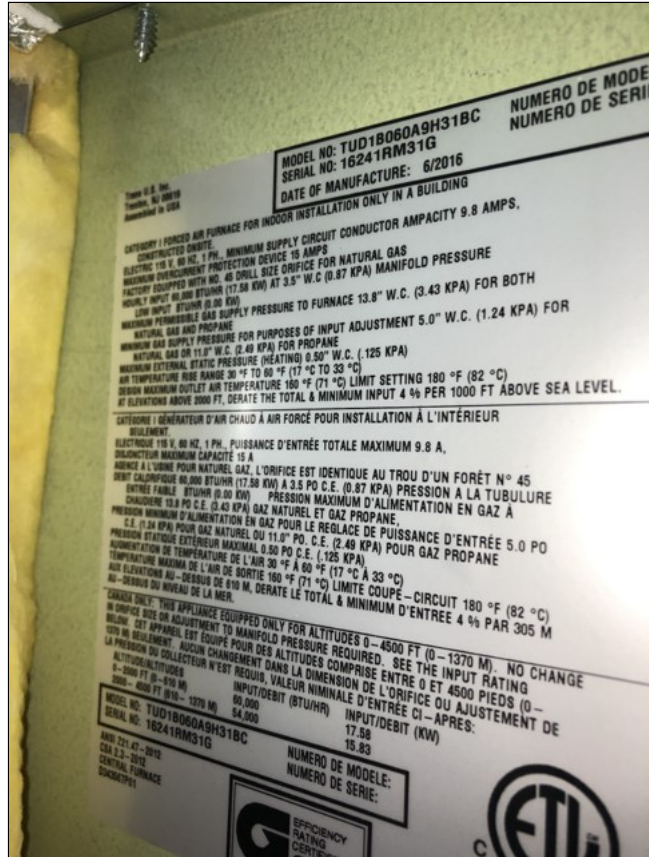
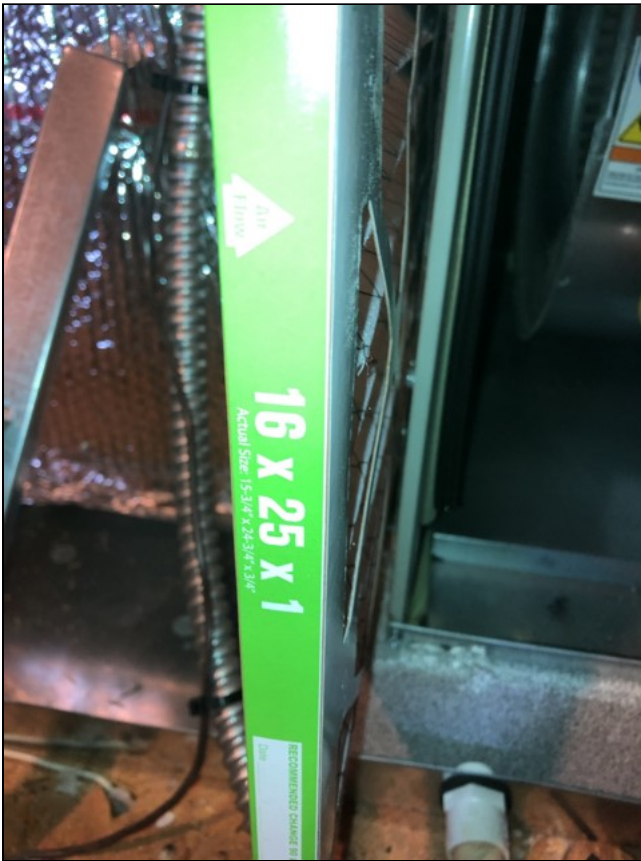
10.2 (2) Trane furnace for second floor located in attic.

Recommend annual service to maintain furnace and to make repairs as needed.

filter size is 16 x 25 x 1 filter was clean at time of inspection.
