Inspection Report

Property Address:
5580 Buck Hollow Dr
Alpharetta GA 30005

Date: 2/21/2020	Time: 09:00:00 AM	Report ID: 022120DM612
Property: 5580 Buck Hollow Dr Alpharetta GA 30005	Customer: Riggs Goodman	Real Estate Professional: Julie Barnes Coldwell Banker

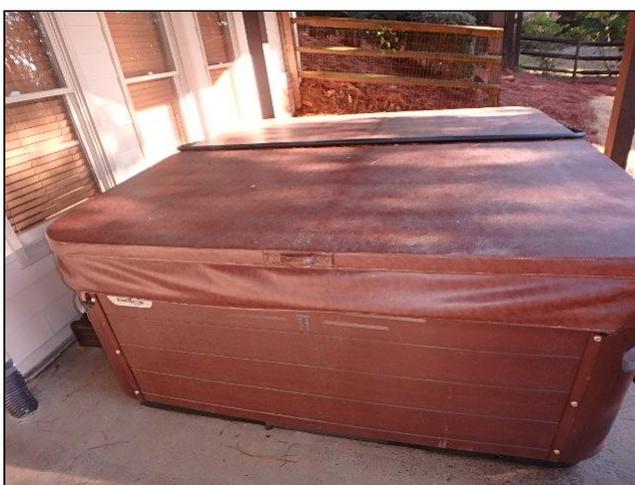
1.5

🔧 (3) The hot tub is outside the scope of a typical inspection. Consult with a specialist to evaluate as needed.

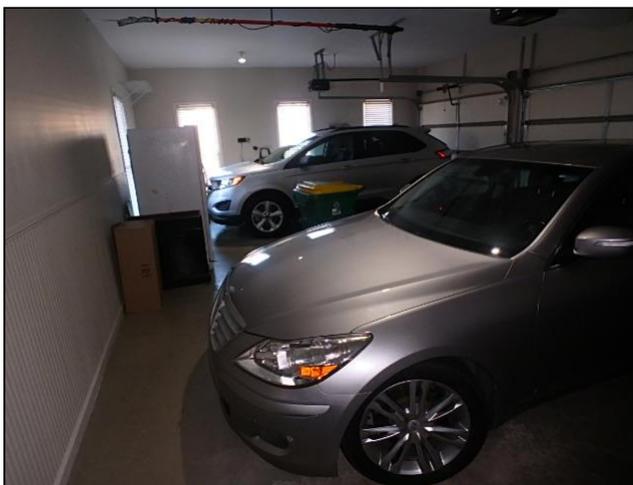
2.1

Garage inspection was limited due to the amount of stored items being in the garage at the time of the inspection. See photo(s). Buyer should resolve all concerns prior to closing.

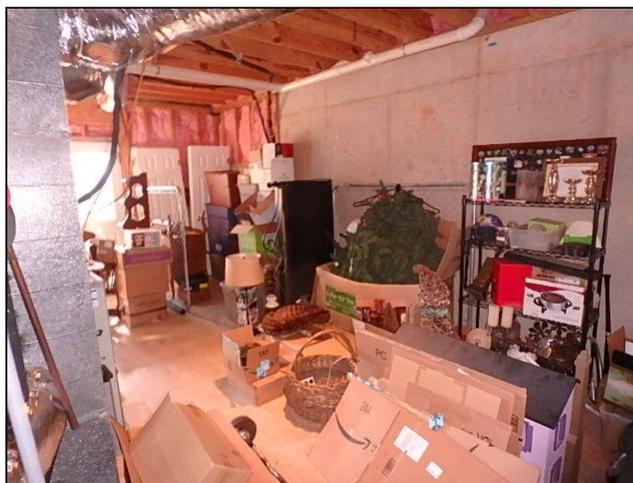
3.0

(1) Many stored items in the basement limiting visual inspection of the floor and walls. Insulation was not removed from between all floor and rim joist. It is possible that some concealed defects may be revealed when stored items are removed.

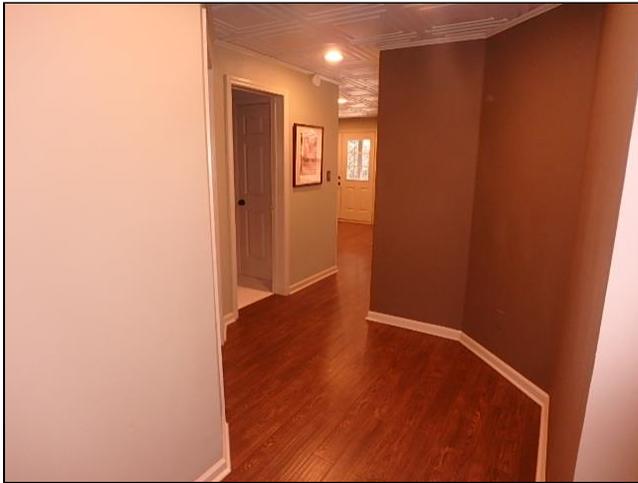
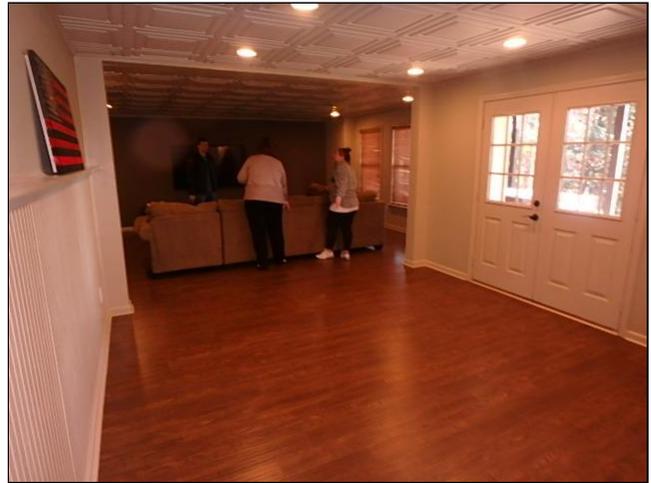
3.0

(2) Basement is mostly finished limiting visual inspection of the floor, walls and ceiling areas. Not all insulation was removed from between floor joist and along rim joist. A select few ceiling tiles were removed for inspection of space between drop ceiling and floor frame.

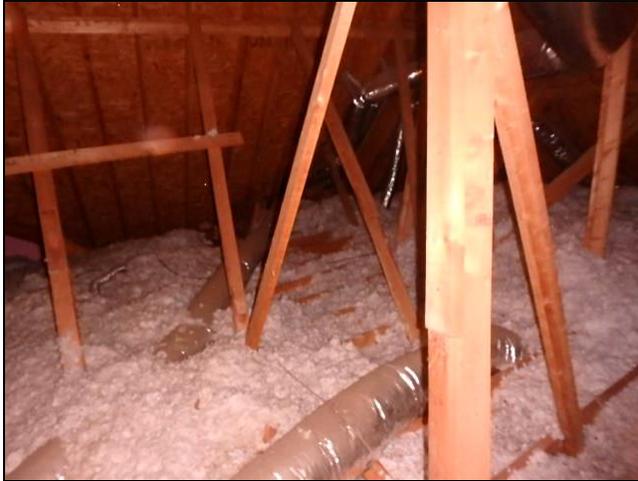
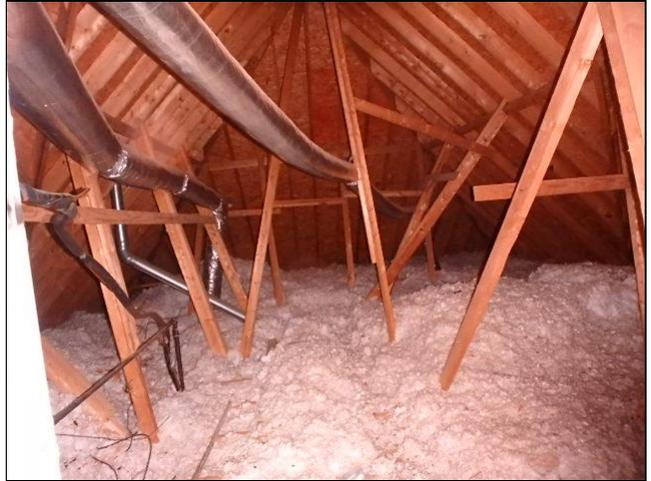
3.4

(2) Views of attic framing and insulation. Attic space entered and inspected from the closest locations possible.

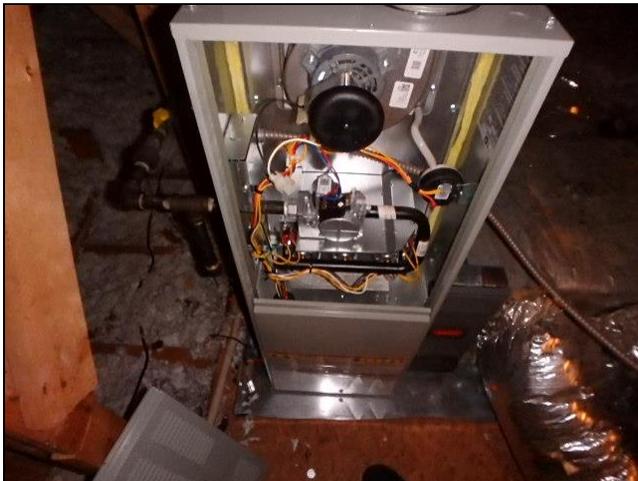
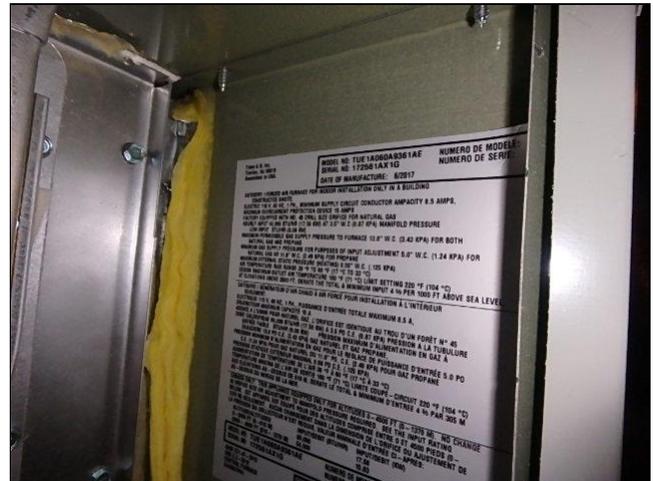
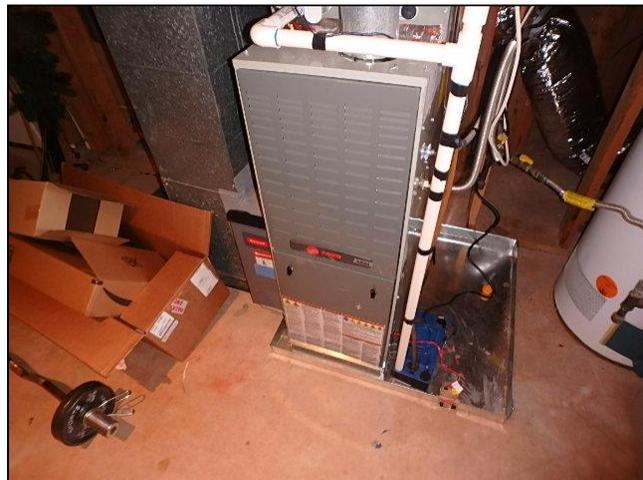
6.0

🔧 Have an hvac tech service the heating and cooling equipment to clean the blower motor, the evaporator coils, the condensing coils, the electrical contacts, check refrigerant levels, check size of units compared to size of home and ascertain that the heat exchangers are not cracked and the equipment is safe to operate and functioning properly. Most of internal parts of the hvac system are concealed from view, and our inspection is visual and is intended to check the function of the systems. This inspection does not make any assessment of the internal parts of the air duct system, since it is not visible. Therefore, an hvac tech should evaluate for any concealed defects or hazards in the system. Furthermore, manufacturers recommend annual maintenance and servicing to keep the system working at peak efficiency.

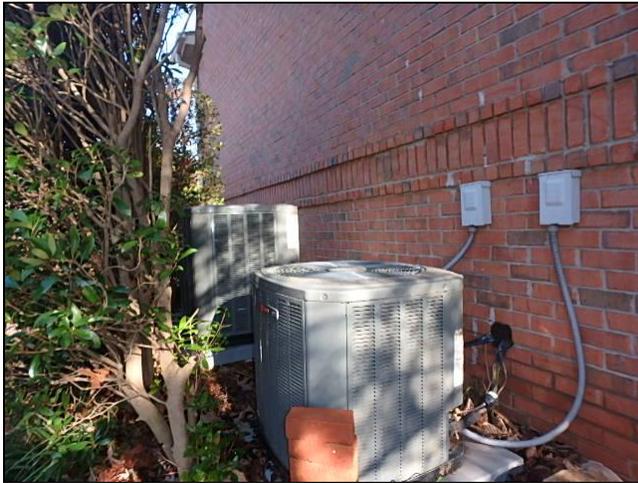
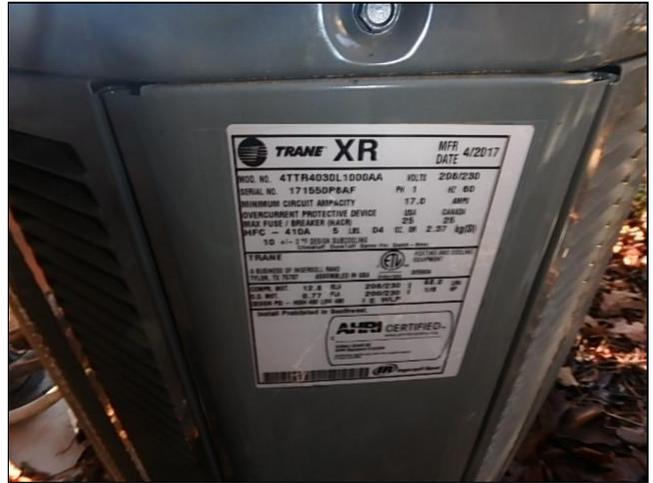
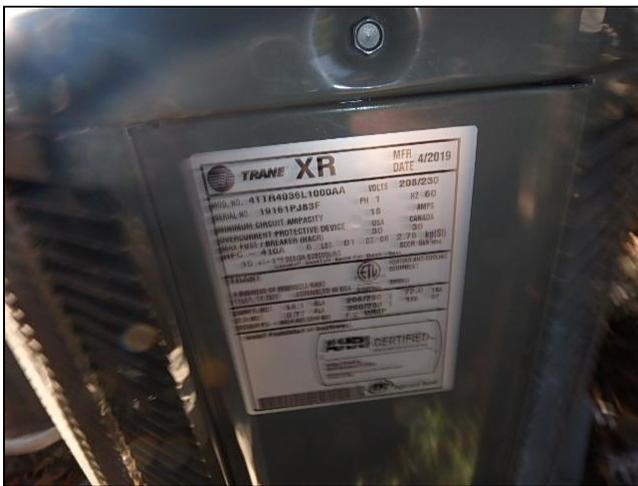
6.6

(1) Along with servicing the heating unit(s), hvac tech should check refrigerant levels in the a/c system to ensure that the systems are working at peak efficiency. This inspection is visual and checks the operation of the system(s). Unit was not disassembled.

🔧 (2) Gaps found in the insulation wrapping around the refrigerant pipes from the a/c units where these pipes pass through the basement. See photos. Have re-wrapped with more insulation to prevent condensate from dripping on the floor.

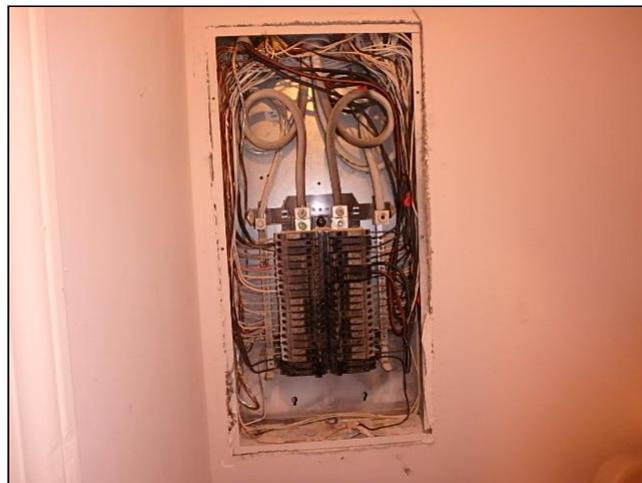
7.2

(1) View of panel. Panel was inspected for function (not code compliance) and building codes and standards have changed over the years.

🔧 (2) Replace missing screws at panel cover.

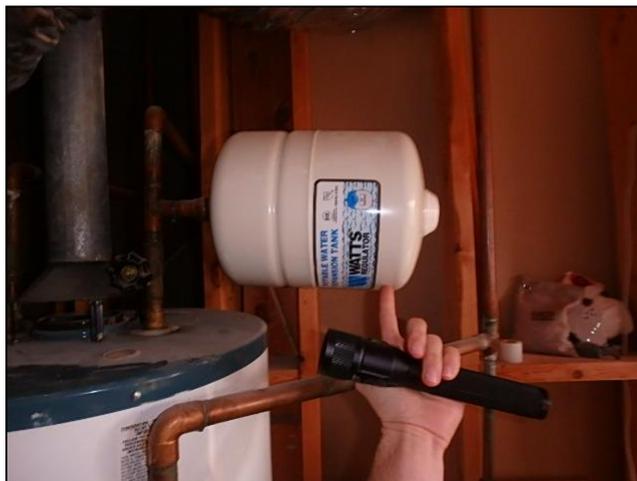
8.3

🔧 (2) Better support needed for expansion tank. A strap attached to framing is typically adequate. This will relieve any stress on the supply pipe joints. See photo.

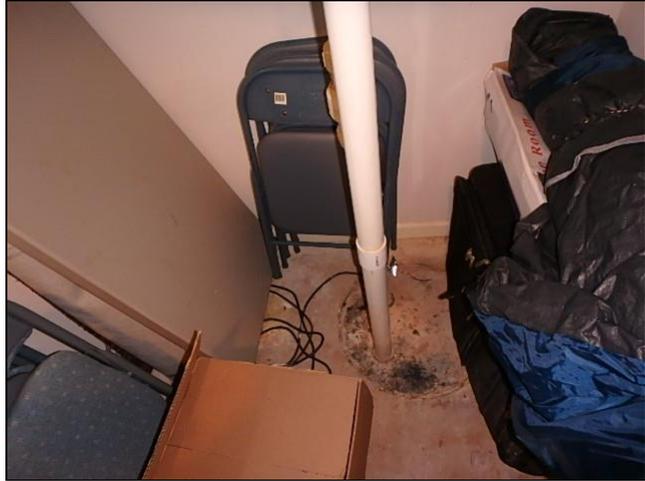
8.7

Occasional sealant maintenance will be needed around pump lid and where pipes pass through lid to prevent sewer gas odors in living space.

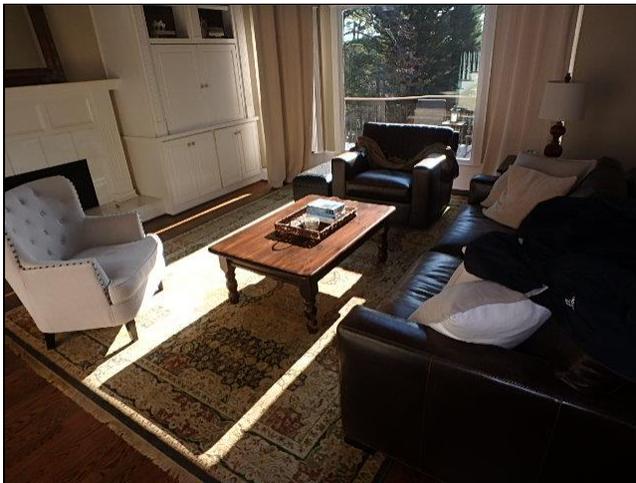
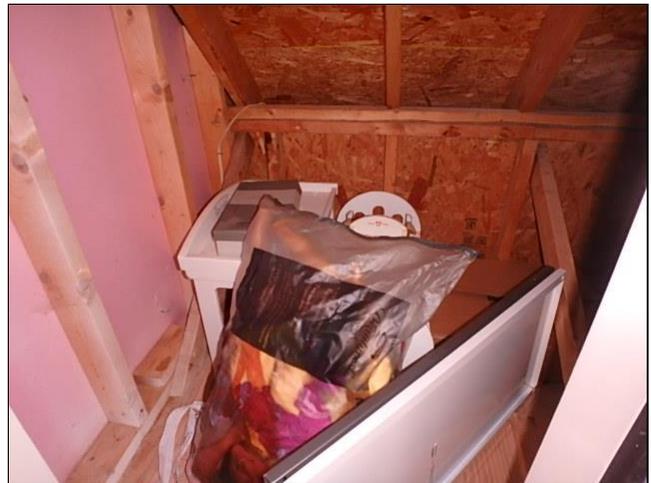
9.1

Many stored items were in the house during the inspection, somewhat limiting visual inspection of walls, windows, floors, closets, areas under sinks, ect... It is possible that some defect issues may be concealed in areas not accessible or visible during this inspection.
