# Atlanta Property Inspections, Inc.

## HOME INSPECTION REPORT

**3950 Chapel Grove Road, Marietta, GA 30062**  
**Inspection prepared for: Jorge Menendez & Angie Menendez**  
**Date of Inspection: 3/9/2020 Time: 9:30 AM**  
**Age of Home: 15 Years Old (2005) Size: 4915 SF**  
**Weather: Sunny, Damp Soil, 40 Degrees**

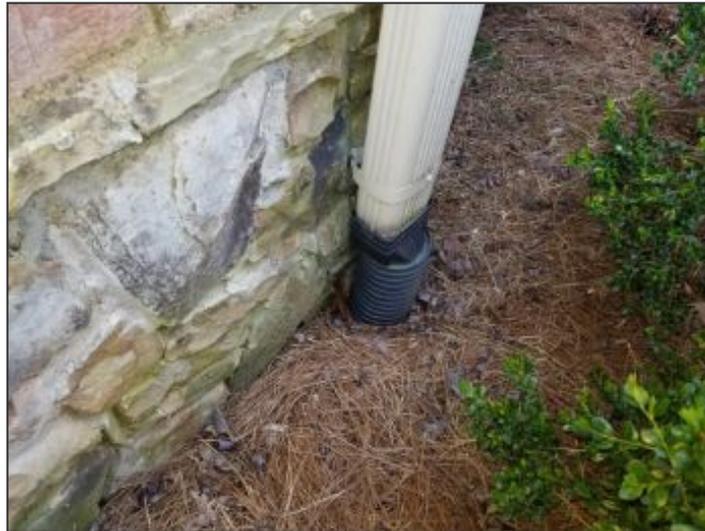
- The yard has a gentle slope overall;
- The overall condition of the exterior grading and drainage appears to be adequately sloped and maintained. No concerns were observed, continue to maintain good drainage conditions as needed.
- **POSITIVE FEATURE!**  
 Several downspouts have been extended into underground drain pipes for improved drainage around the perimeter of the foundation (see photo). Continue to monitor these drain pipes and clean as needed.

Underground downspouts present

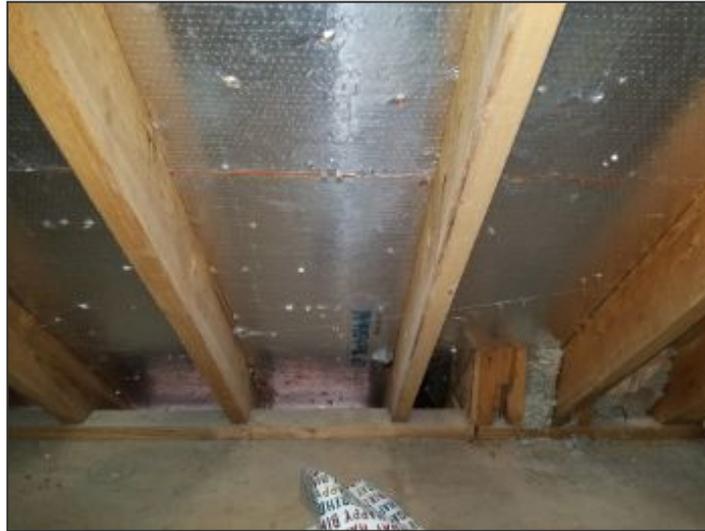
The roof has been framed with TechShield roof decking that contains a foil based coating designed to significantly reduce heat gain into the attic from the hot sun outside (see photo). This type of roof decking can reduce attic temps by up to 30-40 degrees in the hot summer months which can help to reduce air conditioning loads and energy use in the home.

TechShielded roof decking present

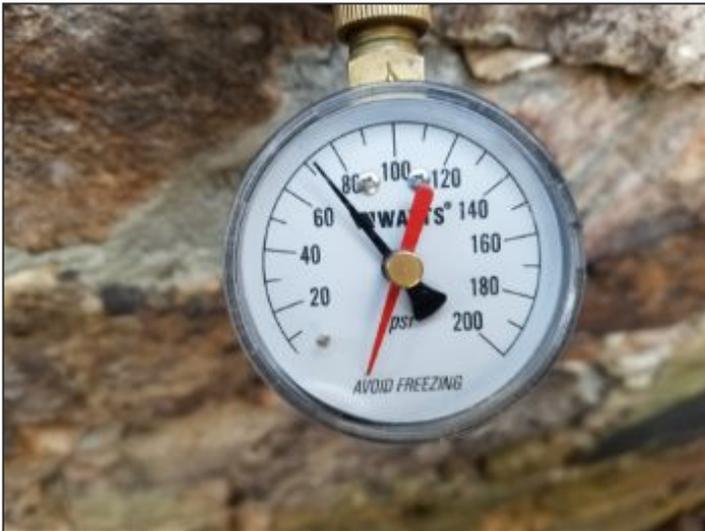
• The supply piping appears to be serviceable, no concerns were noted. A water pressure reading was taken at the rear hose bib and was found to be normal at 71 PSI (see photo).

Water pressure normal at 71 PSI

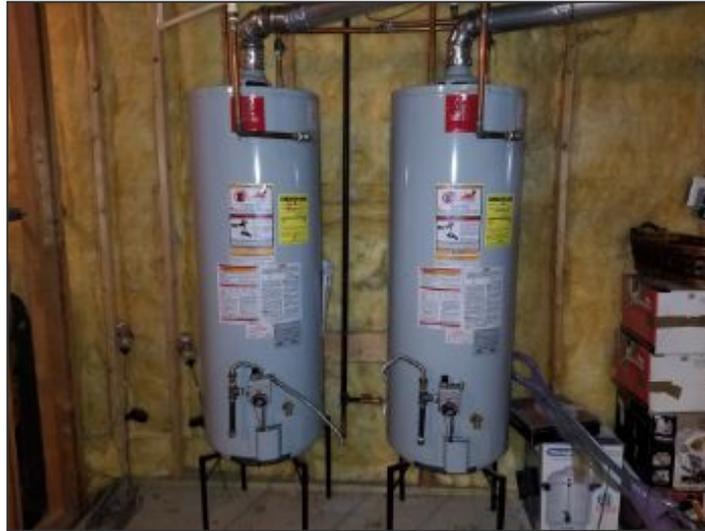
Water heaters located in attic

For these reasons, newer water heater tanks will cost more than replacing water heaters in the past - client should budget for a major expense. It is strongly suggested that client get multiple quotes and check pricing before committing to a new tank.

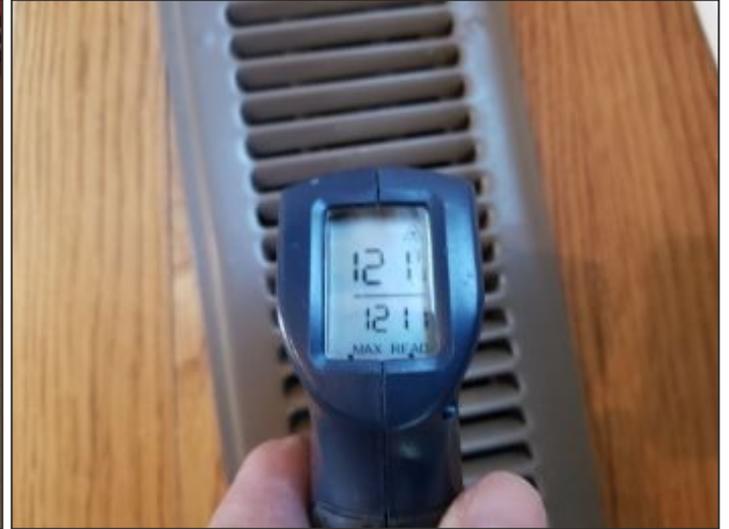
**Good temps during testing of main floor furnace**

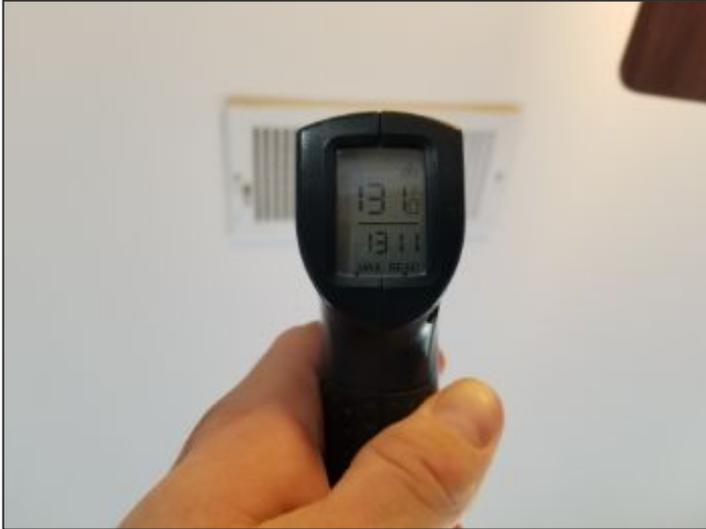
Good temps during testing of second floor furnace

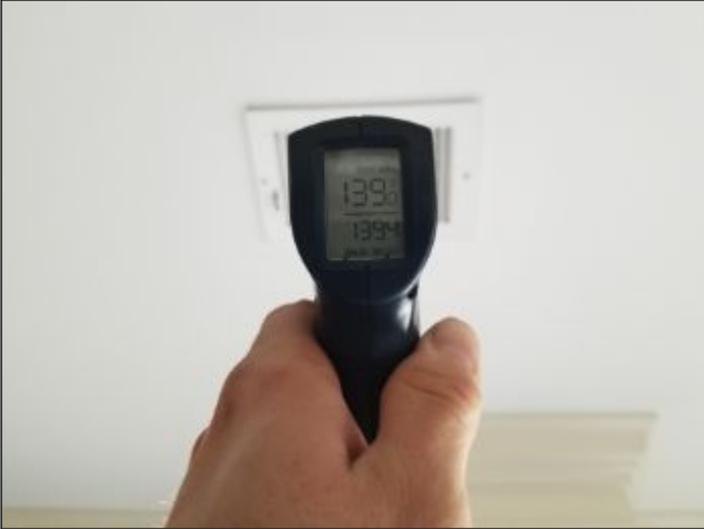
• **The heating system appears serviceable; the heating system was operated and was found to be functioning normally during a limited visual inspection, no significant concerns were noted. Continue to maintain the system and have it serviced regularly.**

**Good temps during testing of master furnace**

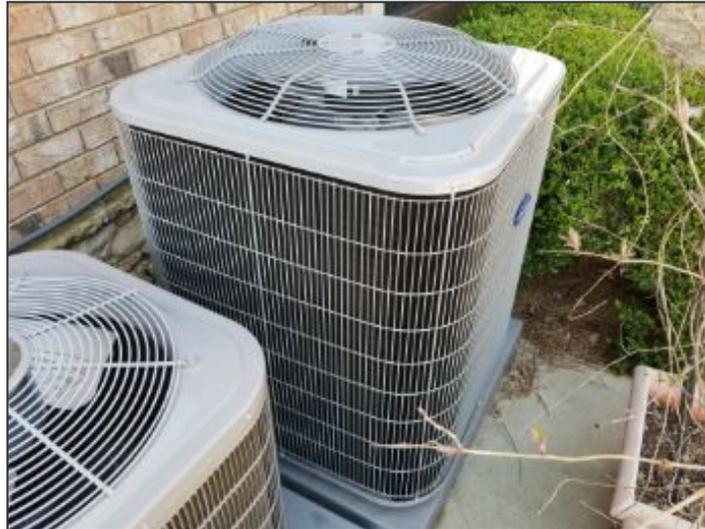
Main floor AC unit

**We are unable to inspect the cooling system due to cold weather. The outside temperatures have dropped below 60 degrees during the day or during the previous overnight hours. Due to concerns regarding possible damage to the unit, the air conditioner was not operated and could not be fully inspected during this cold weather inspection. This inspection is limited to a visual inspection and a quick start up to insure the unit is functional.**

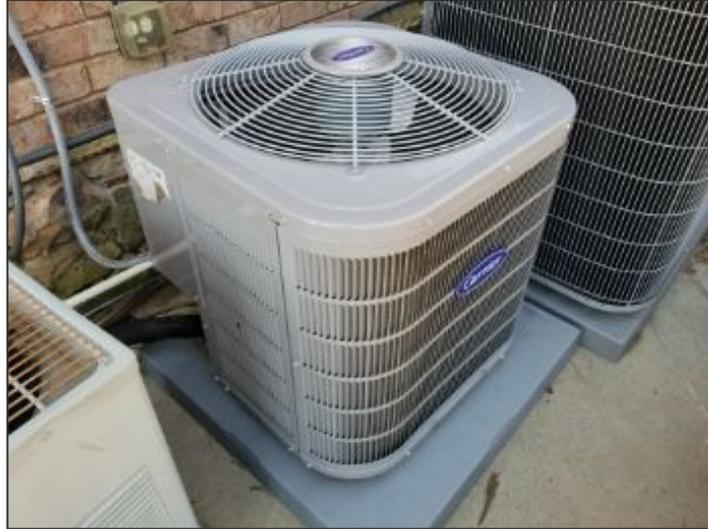
Master bedroom AC unit

**We are unable to inspect the cooling system due to cold weather. The outside temperatures have dropped below 60 degrees during the day or during the previous overnight hours. Due to concerns regarding possible damage to the unit, the air conditioner was not operated and could not be fully inspected during this cold weather inspection. This inspection is limited to a visual inspection and a quick start up to insure the unit is functional.**
