## Property Inspection Report

2475 Rutherford St NW, Atlanta, GA 30318

Date of Inspection: 3/10/2020 Time: 1:00 PM

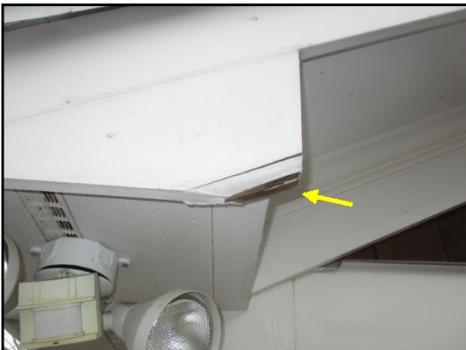
- Moisture damage, wood rot, observed. Recommend review for repair as necessary.

Wood rot observed on the front left corner of the house

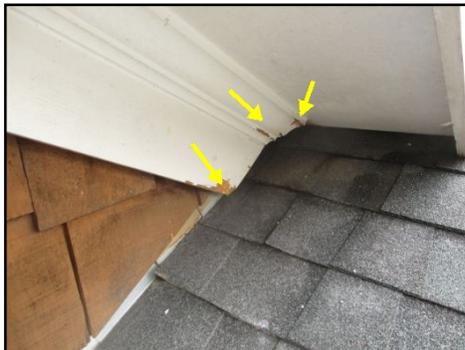
Possible rodent chew marks observed on the front of the house

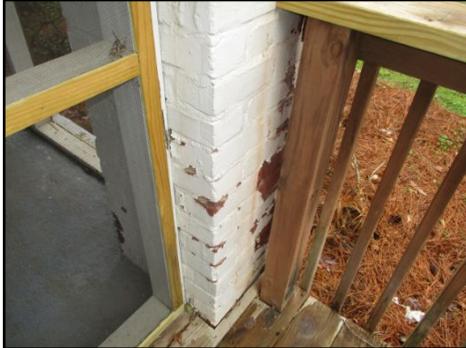
- *Suggest sealing/caulking as part of routine maintenance to prevent further deterioration.*
- *Peeling paint observed, suggest scraping and painting as necessary.*

Peeling paint observed on the brick surface

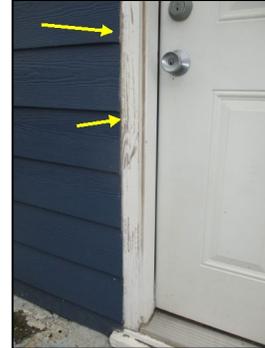
Peeling paint observed on the exterior of the house

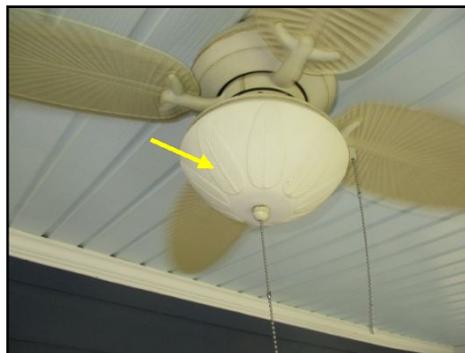
The light on the front porch did not appear to be functional

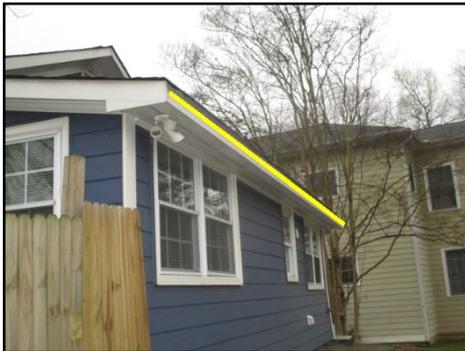
- Significant amounts of debris observed in the gutters. Recommend clearing for safety.
- Missing gutters observed. Recommend further evaluation by a trusted gutter company.

Missing gutters observed on the back of the house

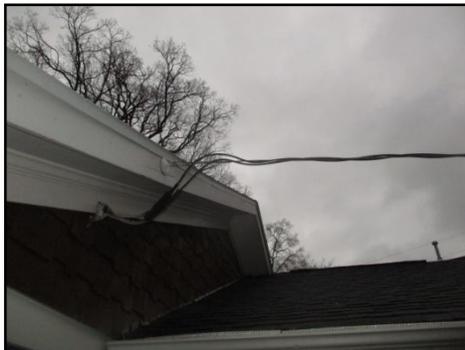
Overhanging power lines

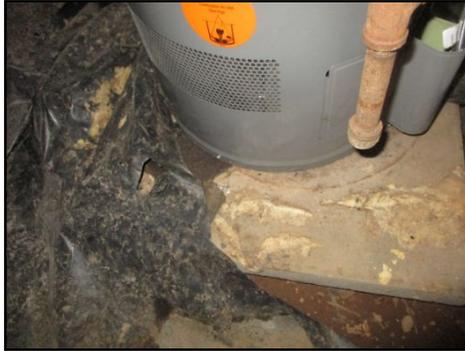
- *Missing drain pan observed below the water heater.*

Missing drain pan observed

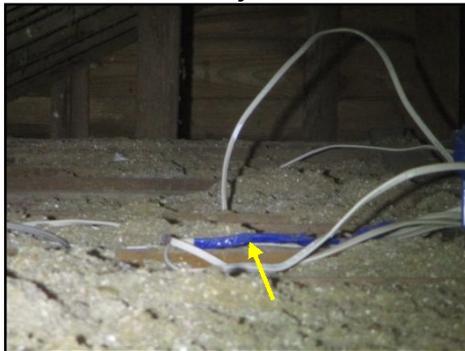
Questionable wire repair observed in the attic space

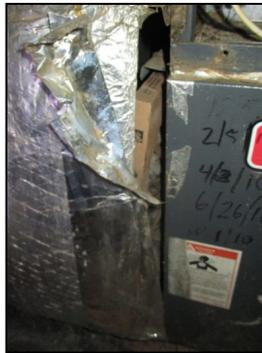
- *Extremely dirty filter observed inside of the gas furnace. Recommend replacing as soon as possible.*

Very dirty filter observed inside of the gas furnace

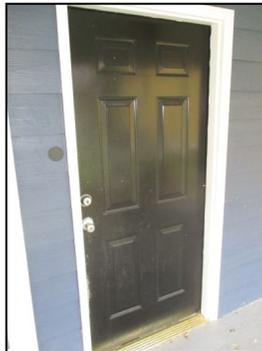
- *No door bell observed at the front door.*

Missing door bell at the front door

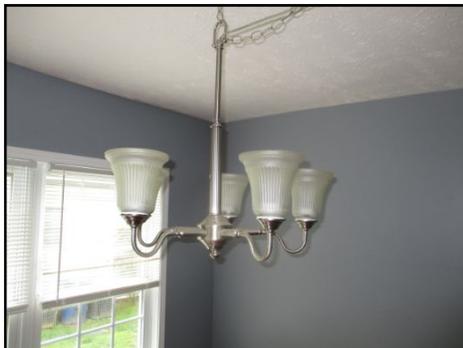
- *The light fixture was not functional in the dining room. Recommend further evaluation by a licensed electrician.*

The light in the living room did not appear to be functional

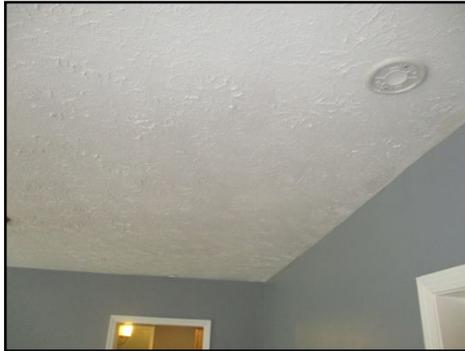
- *Missing smoke detectors observed. Recommend replacing for safety.*

Missing smoke detectors observed

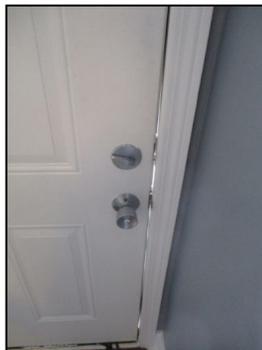
- *Daylight observed around the door near the laundry room. Consider further evaluation by a qualified contractor.*

Daylight observed around the rear door when the dead bolt was not locked

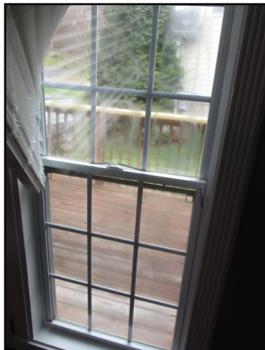
- The 2 windows near the french doors appear to be installed less than 6" off the ground and do not appear to be shatterproof windows. Consider further evaluation by a qualified contractor.
- Hazy window observed. Recommend further evaluation by a qualified contractor.

Hazy window observed on the left side of the house

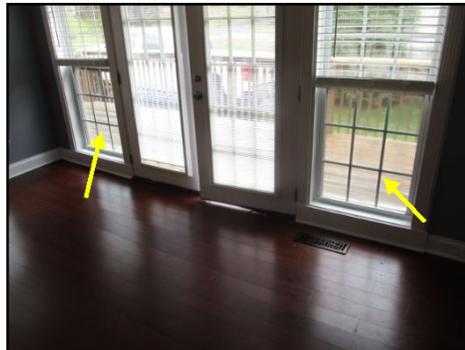
The windows on the left side of the house do not appear to be shatterproof

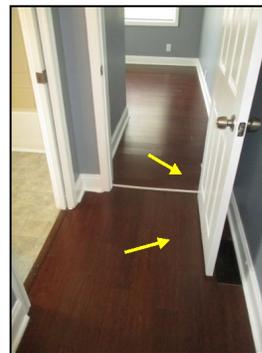
- Unlevel flooring observed throughout the house. Consider further evaluation by a qualified contractor.

Unlevel flooring observed in the rear hallway

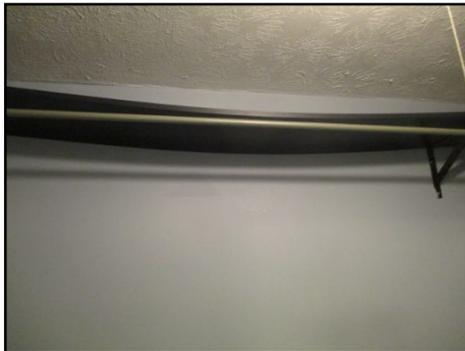
Sagging shelving observed in the master closet

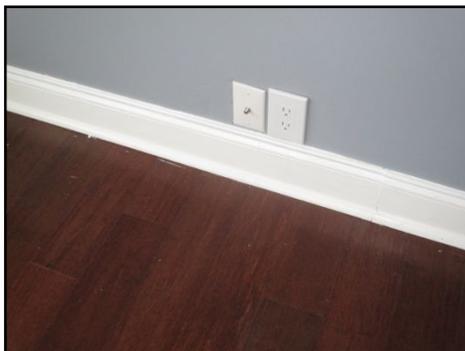
- *The outlet in the rear bedroom was installed less than 6" off of the ground. Recommend further evaluation by a licensed electrician.*

The outlets in the back right bedroom was installed less than 6" off the ground

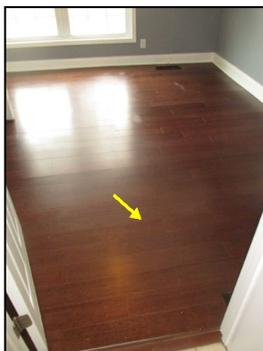
Soft flooring observed in the right middle bedroom Scratches observed on the flooring the bedrooms

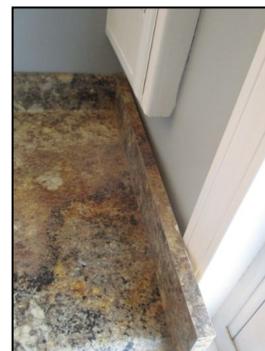
- *Gap observed between the bathroom wall and the back splash. Recommend further evaluation by a qualified contractor.*

Gap observed around the back splash in the rear bathroom

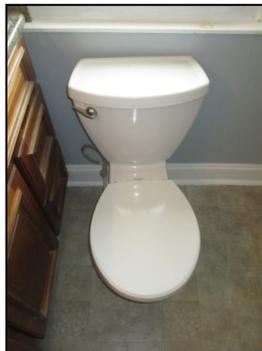
- *Loose toilet observed. Recommend securing the toilet to the floor and caulking around the base.*

Rocking toilet observed in the rear bathroom

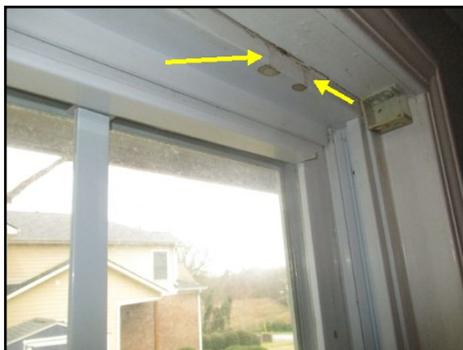
- *Possible leaking window observed in the rear bathroom. Recommend further evaluation by a qualified contractor.*

Water staining observed in the rear bathroom window

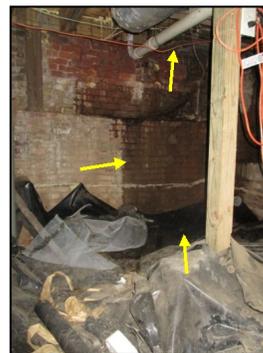
Water leak observed in the crawlspace below the dishwasher

- *Leaking plumbing observed below the dishwasher. Recommend further evaluation by a licensed plumber.*

- *Standing water observed in the crawlspace. Possibly caused by the leaking dishwasher in the kitchen. Recommend further evaluation by a licensed plumbing.*

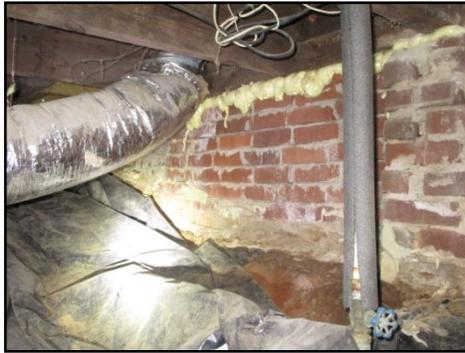
- *Efflorescence observed on the foundation wall. Recommend further evaluation by a trusted foundation specialist.*

Brick walls observed in the crawlspace

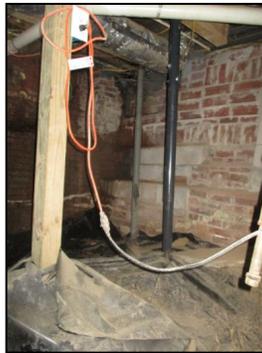
- *Large number of 6x6 post along with a large number of temporary supports observed in the crawlspace. Consider further evaluation by a qualified contractor.*

Temporary supports observed in the crawlspace
