Trademark Home Inspection Co.

Inspection Report

3555 Horizon Ct, Cumming, GA 30041

Date of Inspection: 7/28/2020 Time: 09:00am

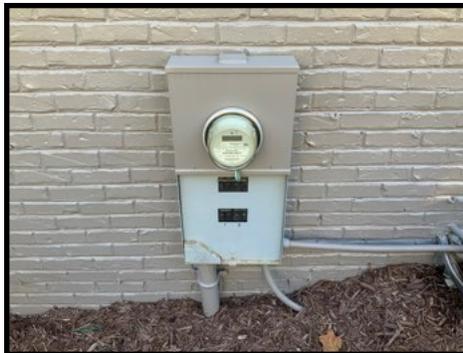
9.1. Main electrical disconnect noted at the meter base.

Electric meter and 200 amp shut off located at the left side of the home

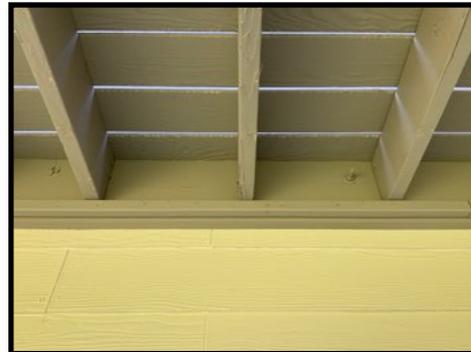
Deck appears to be properly secured and flashed

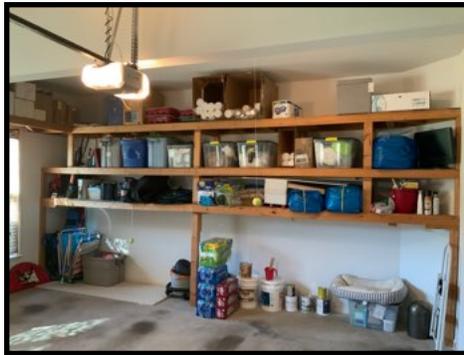
6.1. Limited inspection due to storage of personal property.

Personal storage in the garage

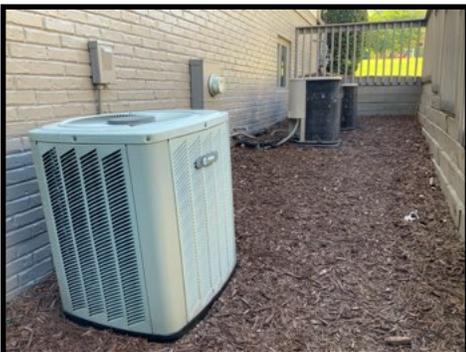
1.1. The Air Conditioning system inside the home was tested and appeared to preform properly. However, the buyer is advised to verify satisfactory operation prior to close. There was a temperature differential of 14 degrees or greater from the supply and return registers which falls within the expected 14-22 degree range.

AC condensers located at the left side of the home

1.2. Due to cooling system being more than 10 years of age, a service review by a licensed HVAC contractor is advised to ensure proper function of all components of the system.

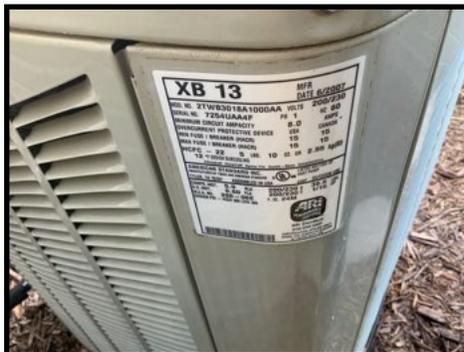
Trane 1.5 ton unit, 2007 model

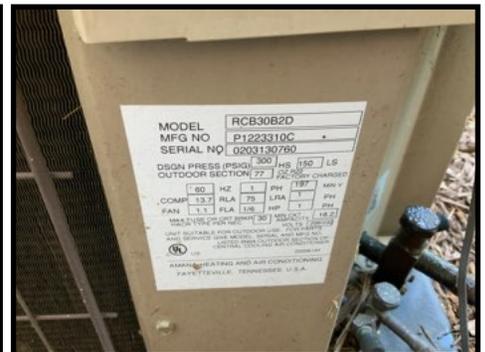
Amana 2.5 ton unit, 2002 model

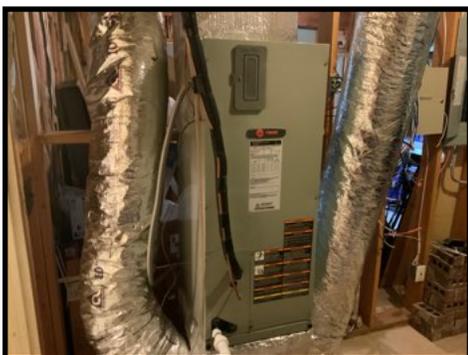
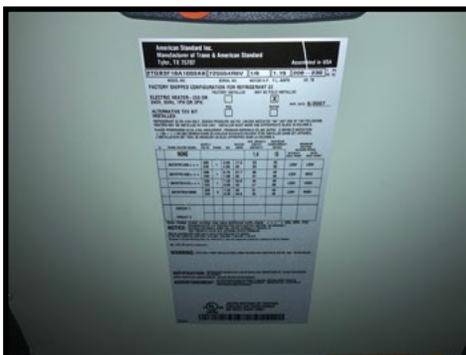
Basement level furnace located in the basement

Trane electric furnace, 2007 model

5.2. The HVAC systems in the home should be fully examined and serviced due to their age. The heat exchangers are not visible as part of this inspection and should be checked by a HVAC tech to ensure they are not damaged and the units are safe to operate. Annual service is recommended on all units over ten years old and all gas fired systems. The systems should be checked to ensure they are sized properly for their installation, to ensure proper operation, and to check the efficiency of the units.

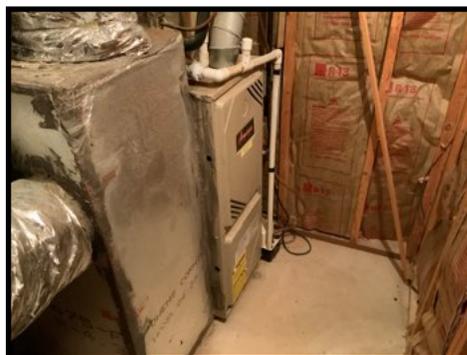
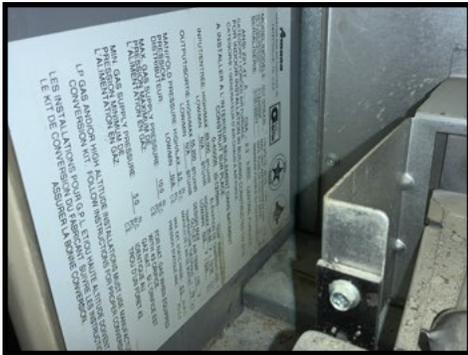
Main level furnace located in the basement

Amana nat gas furnace, 2001 model

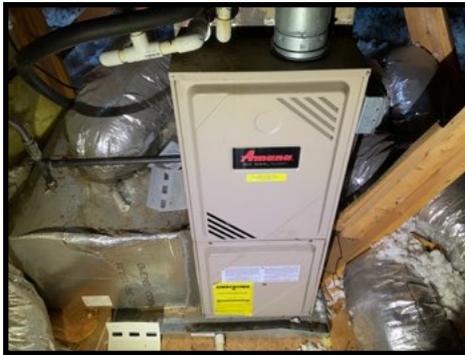
Second floor furnace located in the attic

Amana nat gas furnace, 2001 model

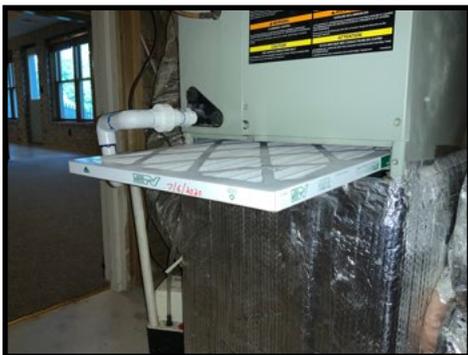
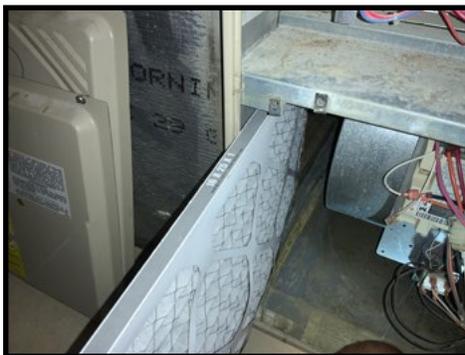
7.1. There it no way to determine the last time the filters were changed and they were dirty at the time of inspection. It is suggested to install new filters once the buyers move into the home.

16x20x1 filter installed at the basement level furnace

16x25x1 filter installed at the main level furnace

16x25x1 filter installed at the furnace

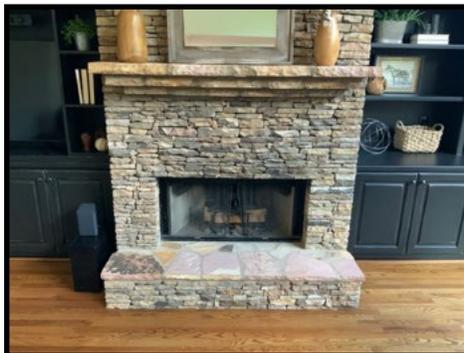
Fireplace located in the living room

9.1. Regular cleaning, inspection, and service are recommended on all fireplaces. The interiors of flues or chimneys are not visible and cannot be fully examined. Firescreens and doors are not fully examined as part of this inspection. Combustion make-up air devices are not visible and are not tested as part of this inspection.

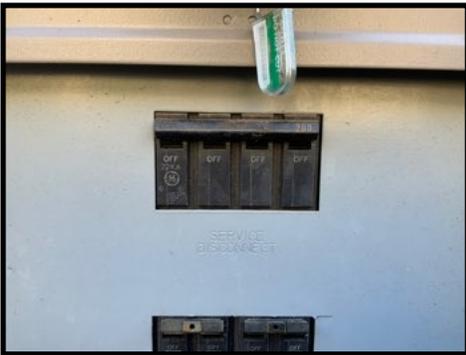
2.1. The main service is approximately 200 Amps.

200 amp service to the home

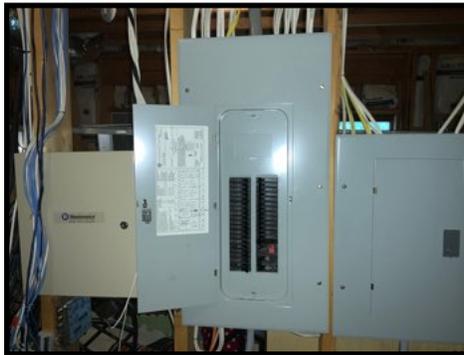
GE panel box located in the basement

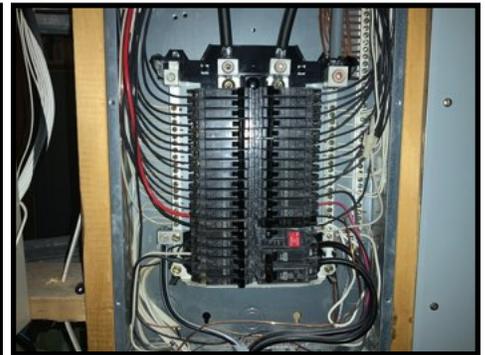
Interior wiring in the main panel

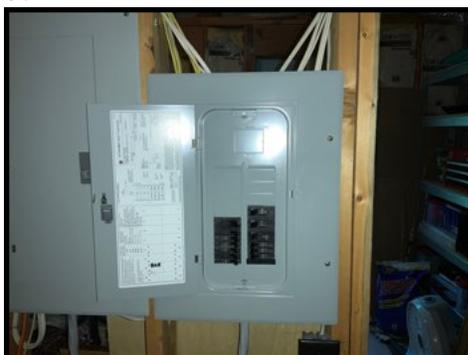
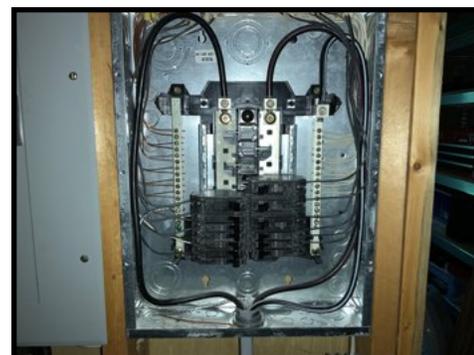
4.1. There is a GE sub panel located in the basement.

GE sub panel located in the basement

Interior wiring in the sub panel

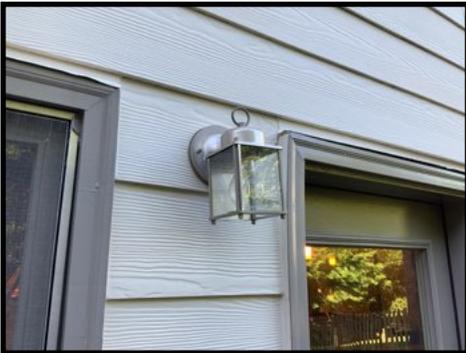
Inoperable light fixture at the rear basement door

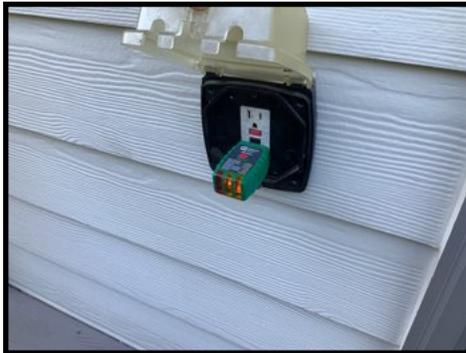
Faulty GFCI outlet at the rear deck

<p>Page 21 Item: 7</p>	<p>Exterior Electrical</p>	<p>7.3. Multiple GFCI outlets around the home did not trip when tested and should be replaced. Have a licensed electrician correct. Exterior outlets may fail over time and should be repaired as needed.</p>
------------------------	----------------------------	--

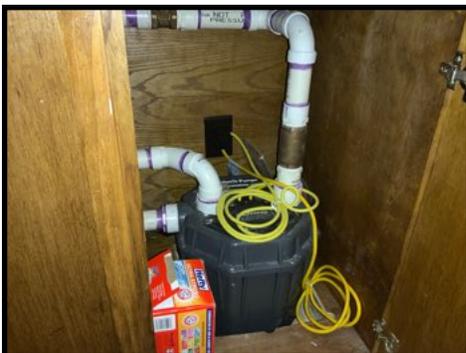
Mini ejector pump located in the wet bar

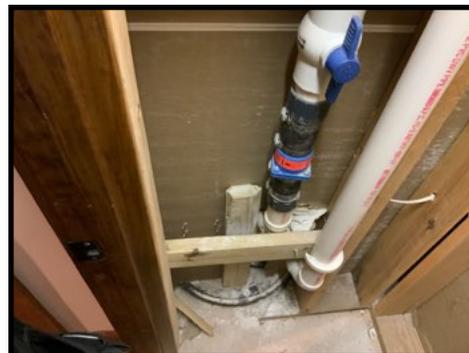
Ejector pump located in the basement

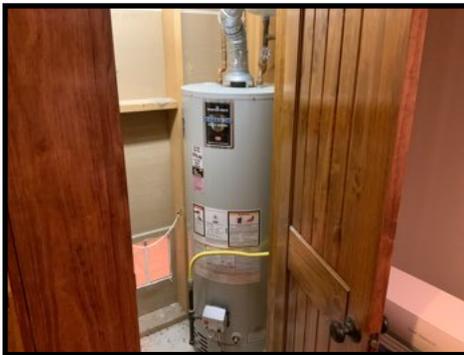
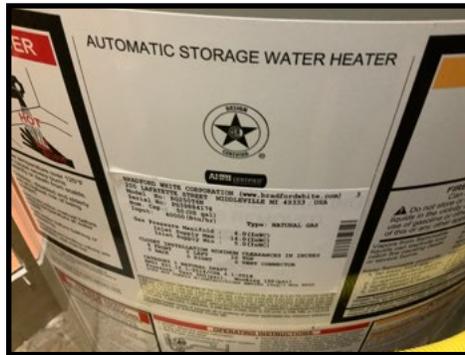
Water heater located in the basement

Bradford White 50 gal nat gas water heater, 2017 model

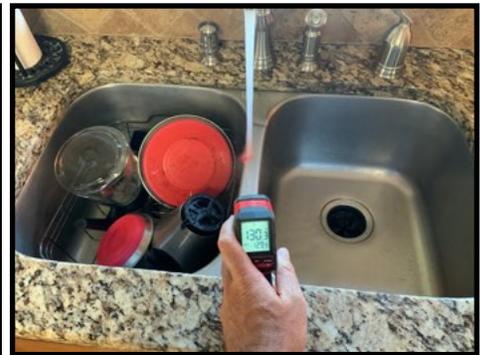
4.1. The current setting of the water heater thermostat resulted in a water temperature at the kitchen sink of ~130 degrees, adjust as desired. Water temperature should not exceed 120 degrees to prevent scalding. Hotter water will scald quicker and should be used with caution.

Hot water temperature reading (130 degrees)

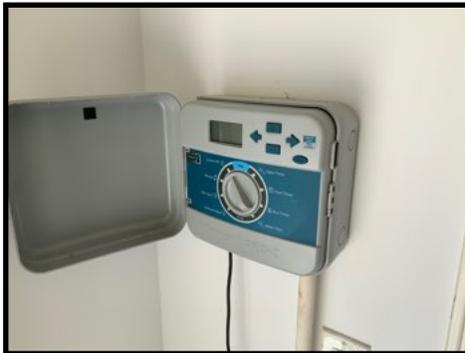
8.2. If the home is equipped with an automatic sprinkle system, it is not included as a part of this inspection. This system is primarily underground and beyond the scope of the home inspection. We recommend further review by a qualified professional, if concerned.

Irrigation system noted, not tested

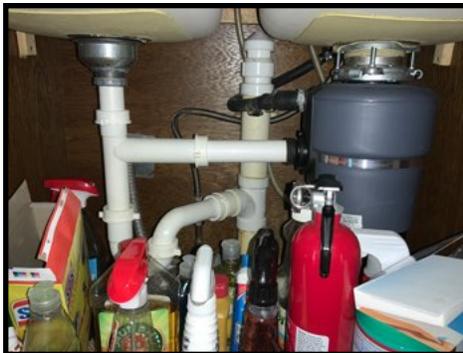
3.2. Limited review due to personal property stored in undersink cabinet.

Kitchen sink drain/disposal serviceable

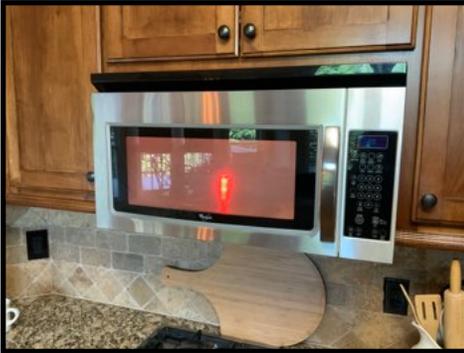
Microwave functional

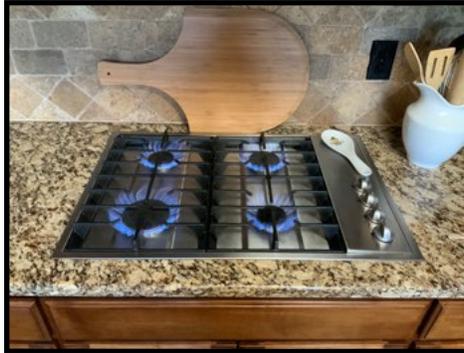
Gas cooktop functional

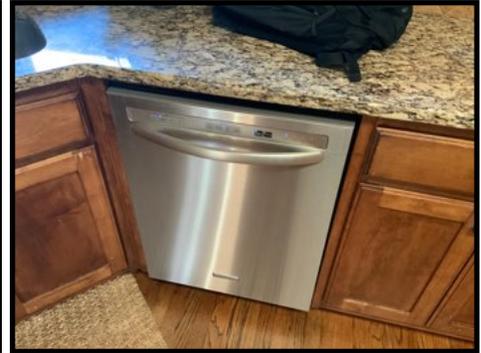
Dishwasher functional

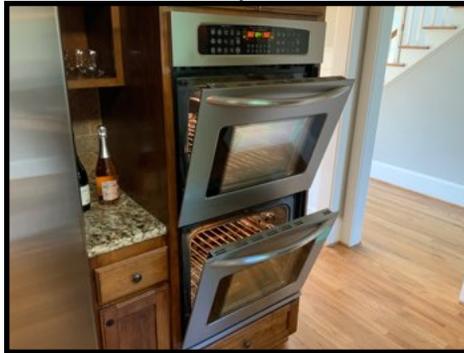
Electric ovens functional

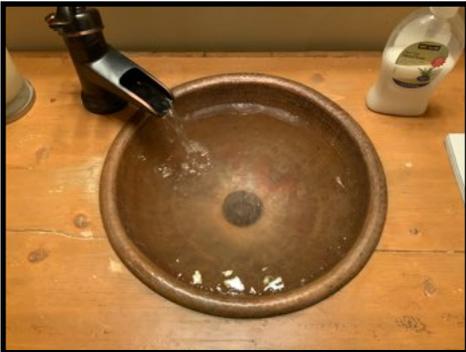
Basement bathroom sink filled and drained

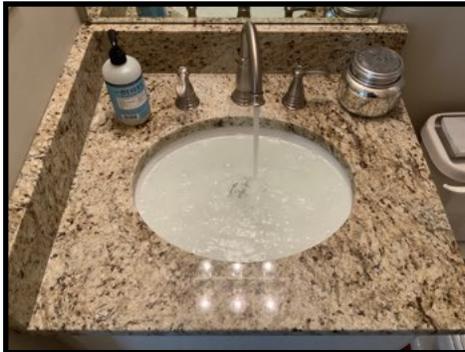
Main level bathroom sink filled and drained

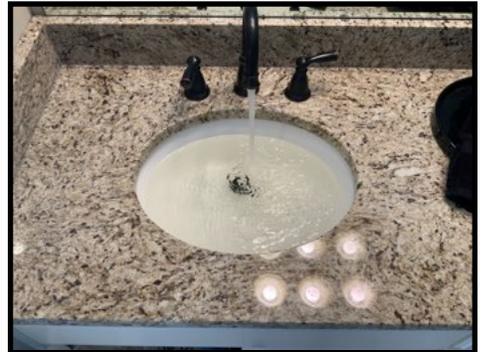
Master bathroom sink filled and drained

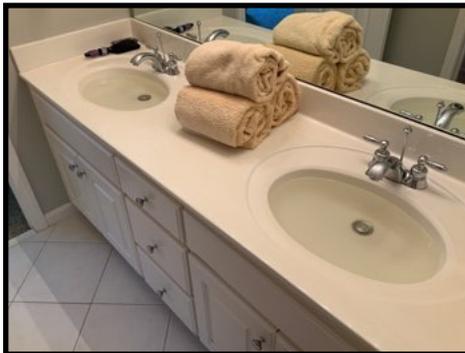
Jack and Jill bathroom sinks filled and drained

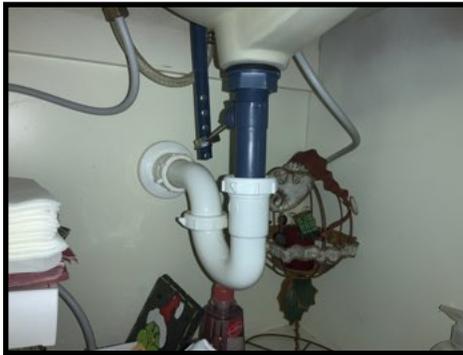
Main level bathroom sink drain serviceable

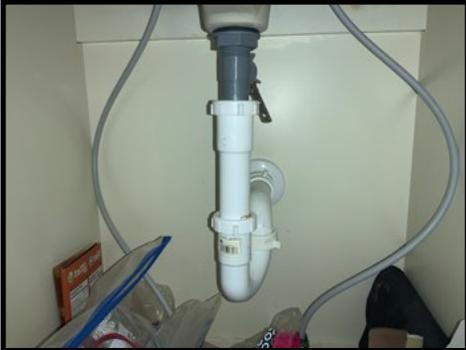
Master bathroom sink drain serviceable

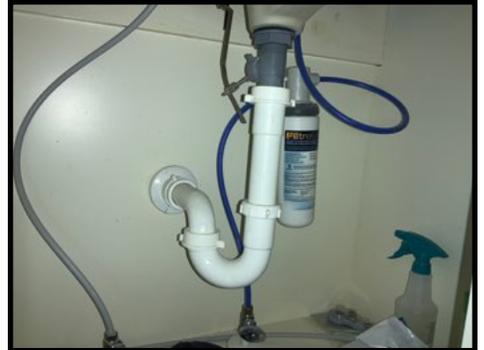
Master bathroom sink drain serviceable

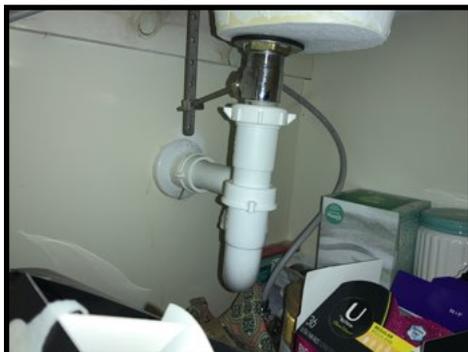
Jack and Jill bathroom sink drain serviceable

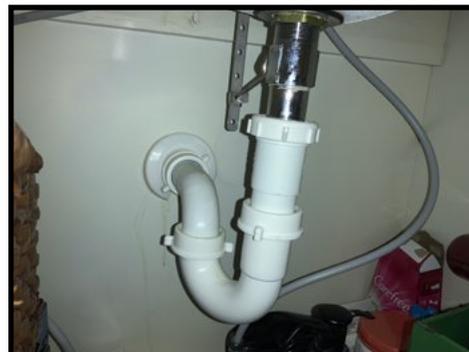
Jack and Jill bathroom sink drain serviceable

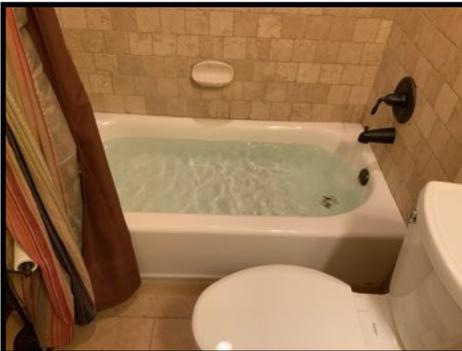
Basement bathroom tub filled and drained

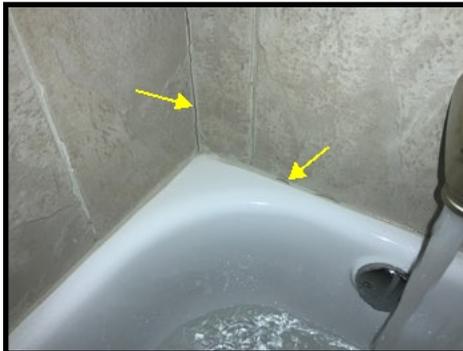
6.1. Suggest all bathroom tub enclosure edges and transitions between dissimilar materials be periodically caulked and sealed to prevent moisture penetration. Any missing/damaged grouting should be replaced as well. Any gaps at the perimeter of the tubs should be caulked. Failure to keep walls and surrounds sealed may cause deterioration and moisture damage to the interior walls and surrounding subflooring.

Clean and re-seal tub enclosures as needed

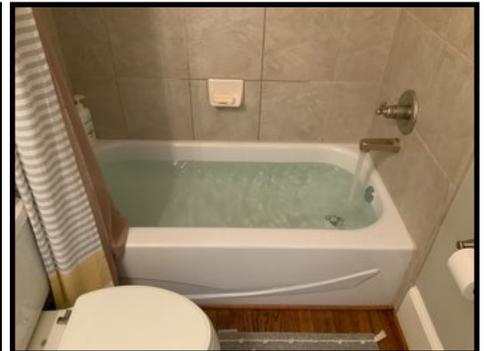
Main level bathroom tub filled and drained

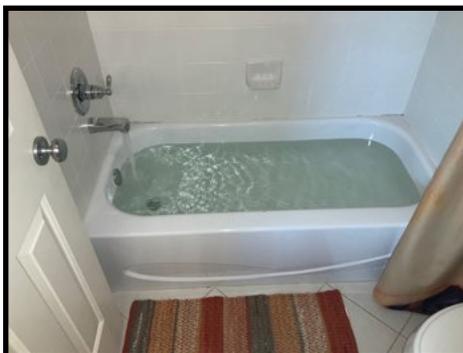
Jack and Jill bathroom tub filled and drained

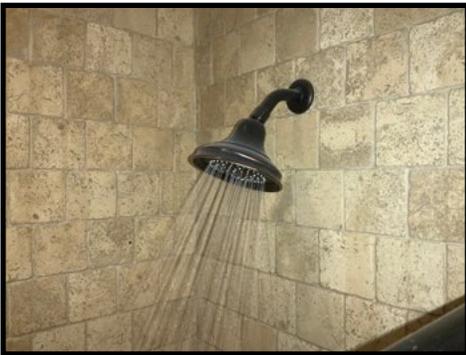
Basement bathroom shower functional

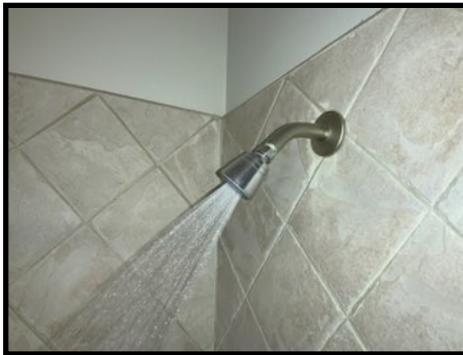
Main level bathroom shower functional

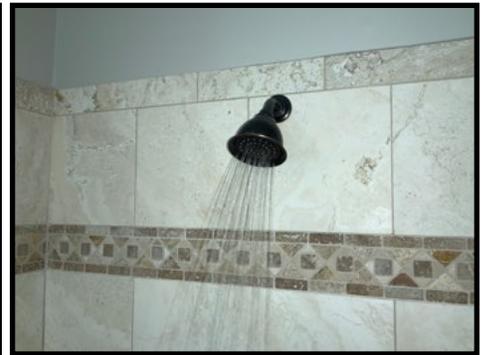
Master bathroom shower functional

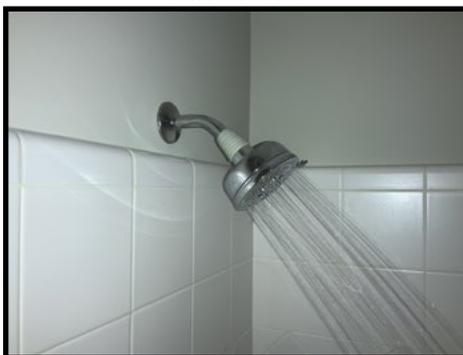
Jack and Jill bathroom shower functional

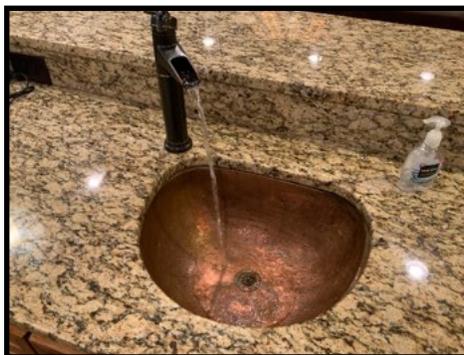
Wet bar sink functional
