Your Inspection Report

1817 West Wesley Road
Atlanta, GA 30327

INSPECTION DATE:
Monday, August 10, 2020

RE: Report No. 35122
1817 West Wesley Road
Atlanta, GA
30327

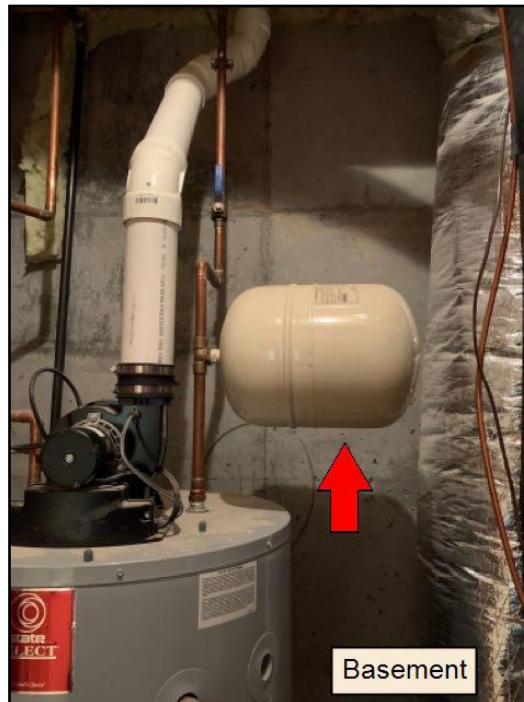
13. Condition: • Poor support of Thermal Expansion Tank

59. *Poor support of Thermal Expansion Tank*
