Inspection Report

Property Address:
8980 Moor Park Run
Duluth GA 30097

Residential Inspector of America, Inc.

Date: 8/1/2020	Time: 01:00:00 PM	Report ID: 080120LQ1092
Property: 8980 Moor Park Run Duluth GA 30097	Customer: Adam Zola	Real Estate Professional: Mike Ross Weichert Realty (Atlanta)

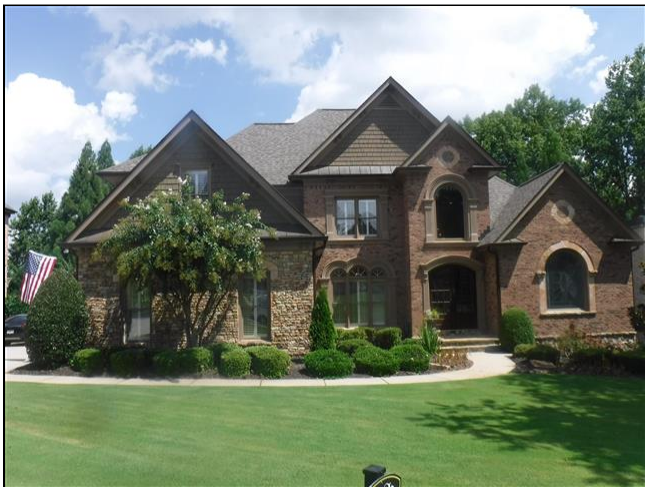
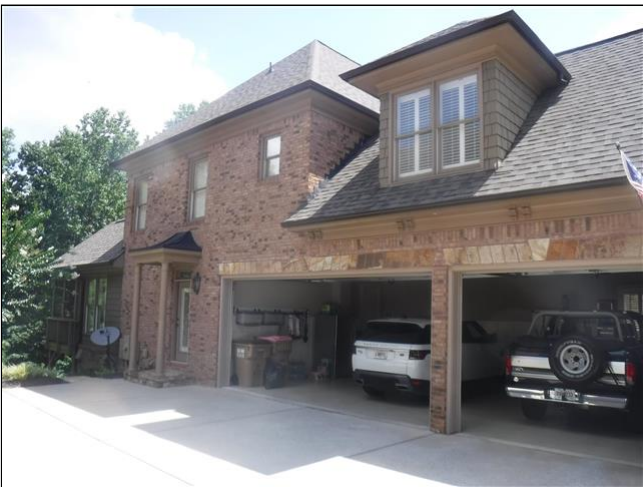
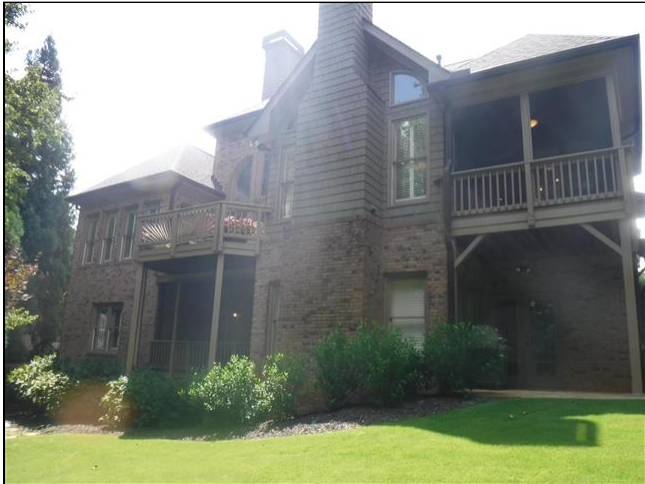
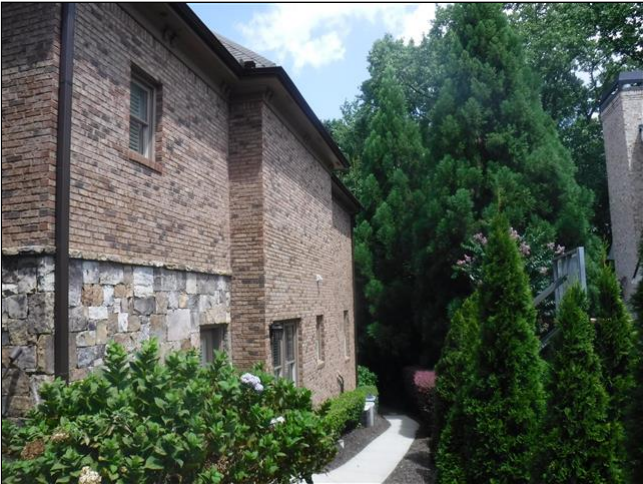
These are photos of the home taken from different angles and are not intended to show any defects.

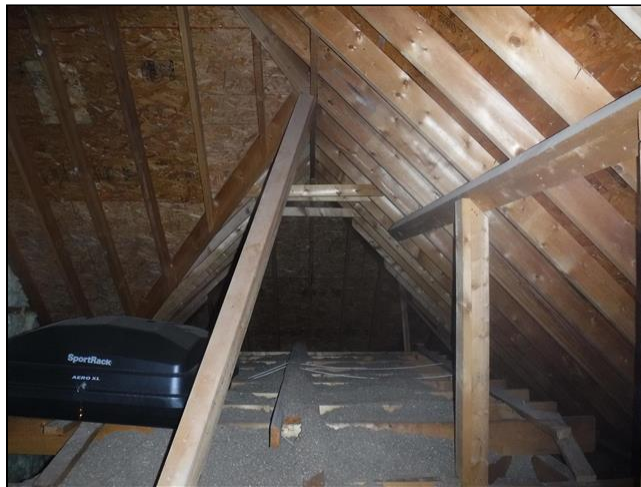
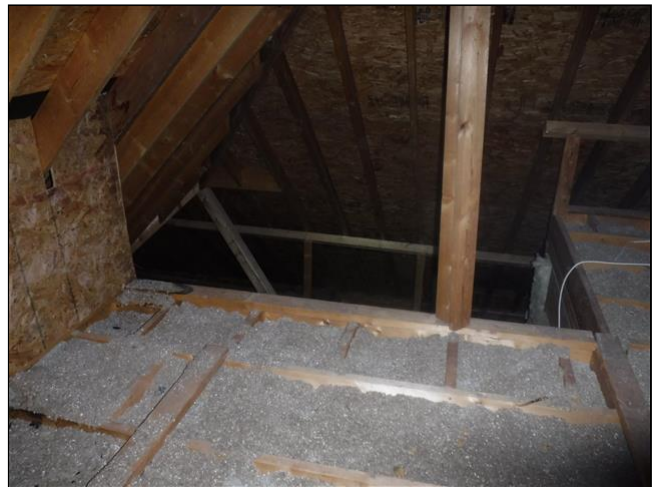
Views of attic framing and insulation. Attic space entered and inspected from the closest locations possible.

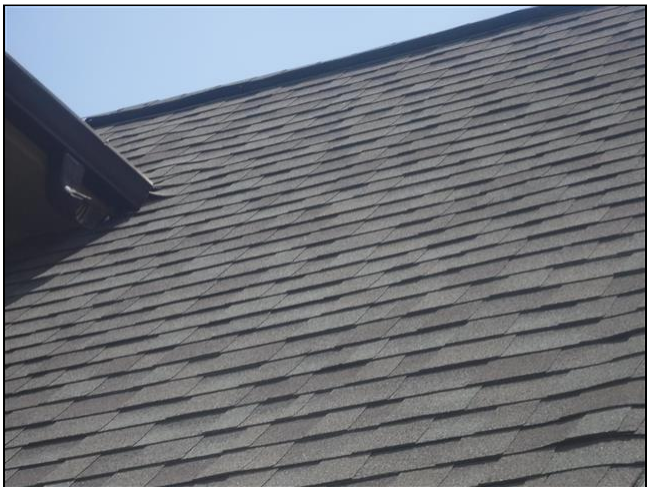
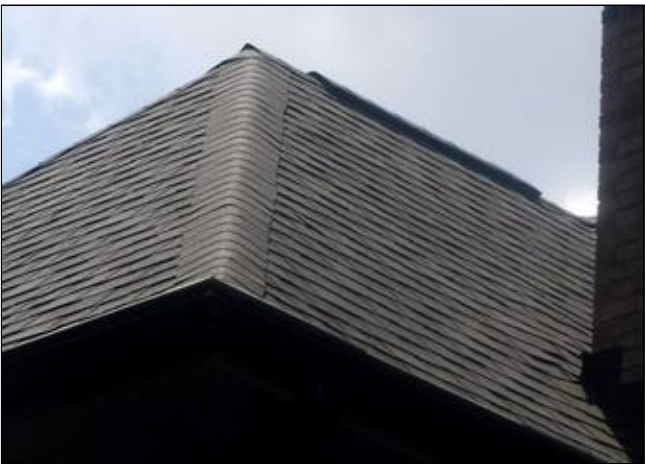
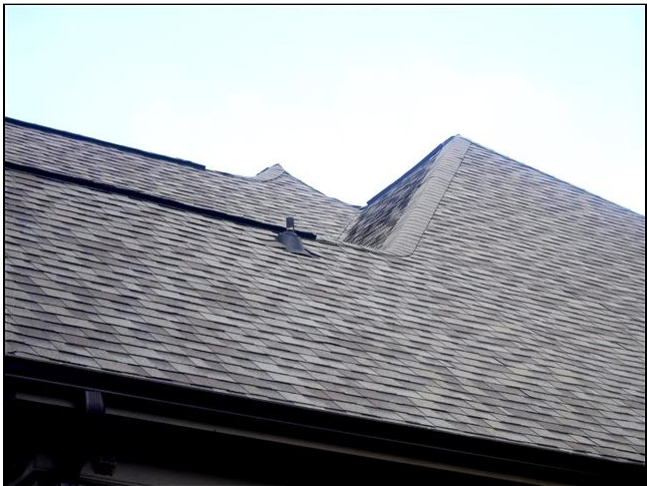
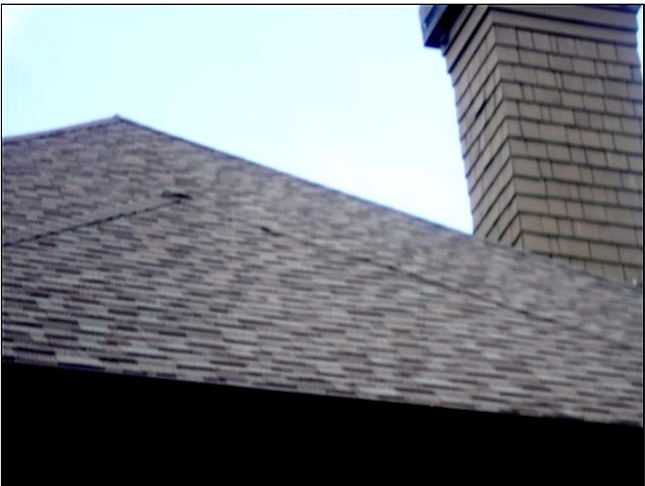
Views of roof.

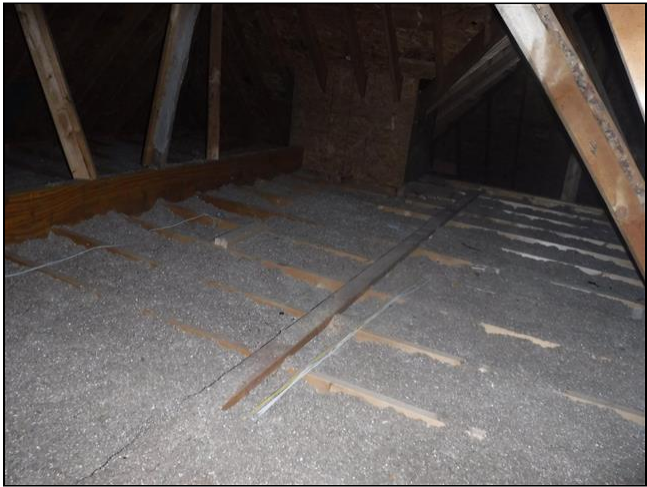
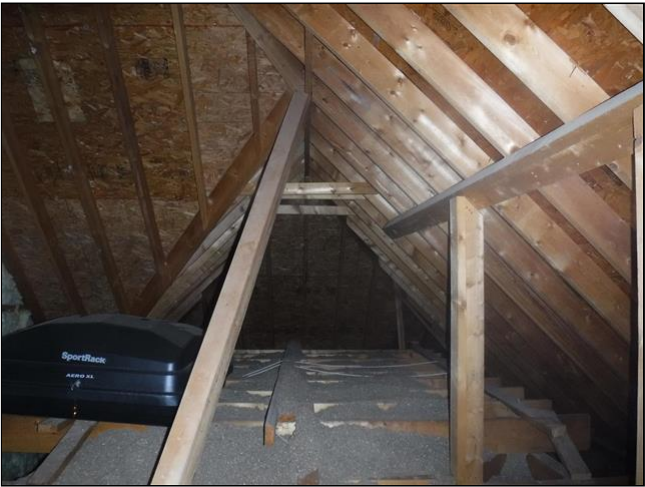
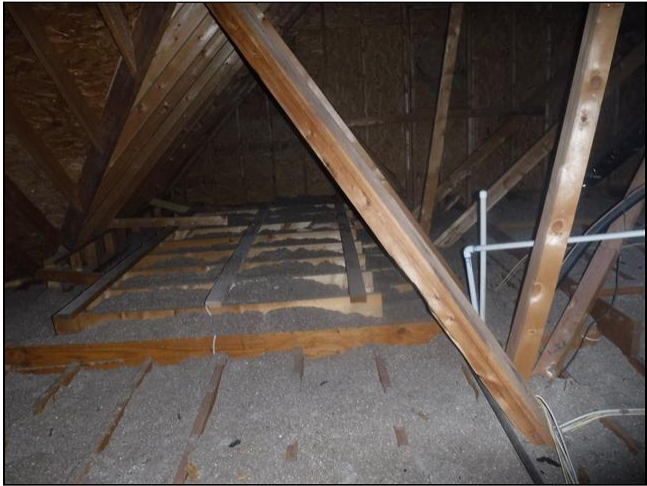
View of insulation in attic.

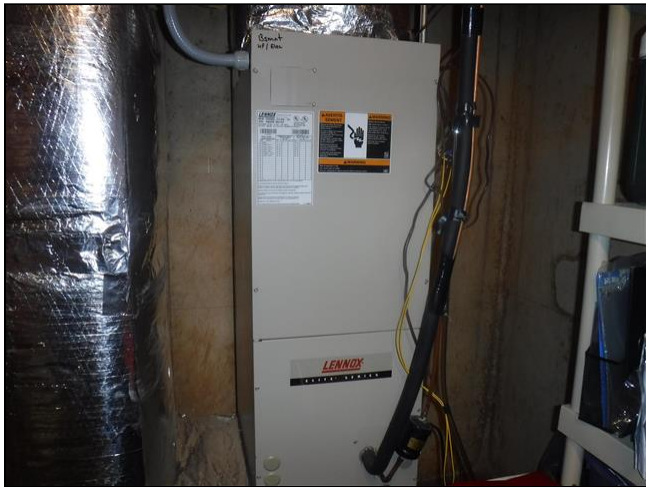
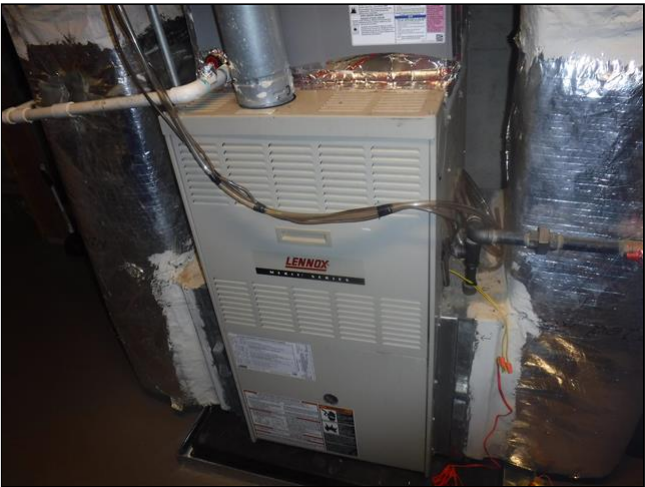
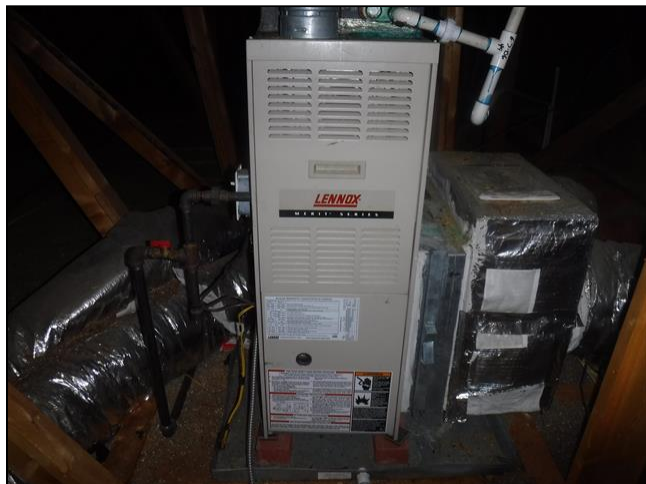
(1) View of furnaces.

🔧 (2) Have an hvac tech service the heating and cooling equipment to clean the blower motor, the evaporator coils, the condensing coils, the electrical contacts, check refrigerant levels, check size of units compared to size of home and ascertain that the heat exchangers are not cracked and the equipment is safe to operate and functioning properly. Most of internal parts of the hvac system are concealed from view, and our inspection is visual and is intended to check the function of the systems. This inspection does not make any assessment of the internal parts of the air duct system, since it is not visible. Therefore, an hvac tech should evaluate for any concealed defects or hazards in the system. Furthermore, manufacturers recommend annual maintenance and servicing to keep the system working at peak efficiency.

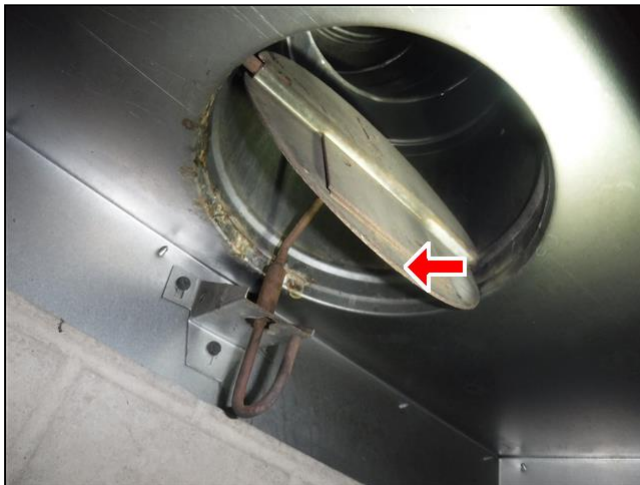
6.5 Item 1(Picture)

C-clamp needed on the damper to prevent it from being closed, since fireplace is using gas logs. This will help prevent carbon monoxide build up in living space.

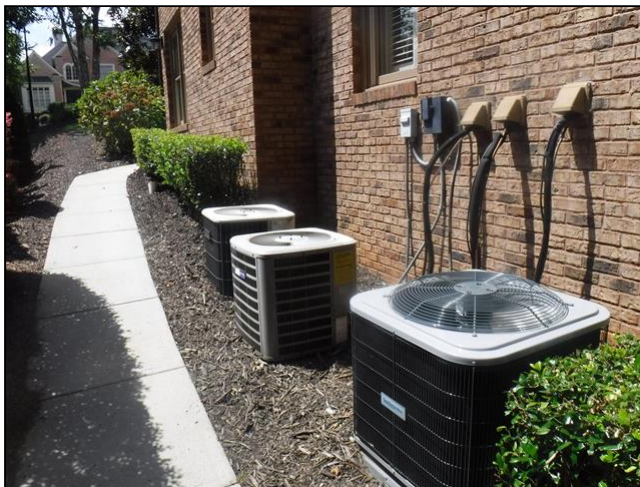
6.6 Item 1(Picture)

(1) View of a/c unit(s) outside.

🔧 (2) Along with servicing the heating unit(s), hvac tech should check refrigerant levels in the a/c system to ensure that the systems are working at peak efficiency. This inspection is visual and checks the operation of the system(s). Unit was not disassembled.

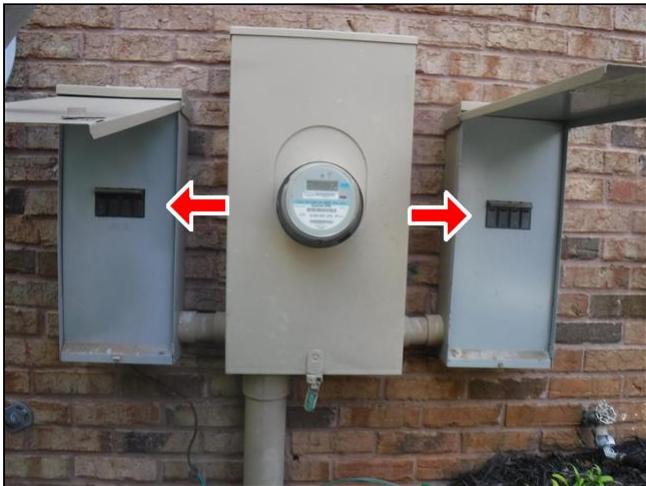
7.0 Item 1(Picture)

Main electrical disconnect location.

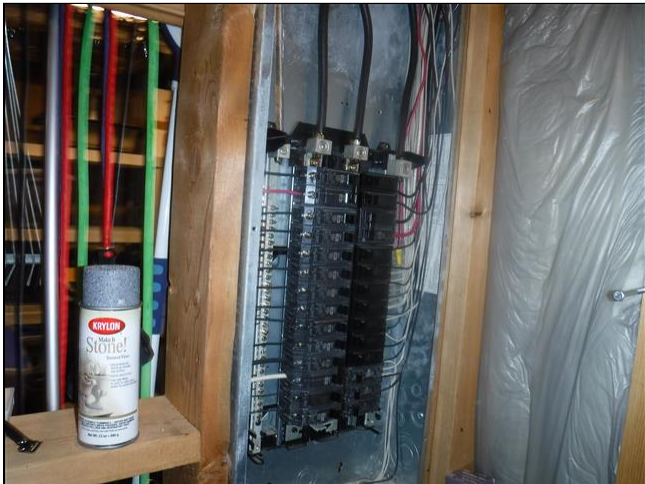
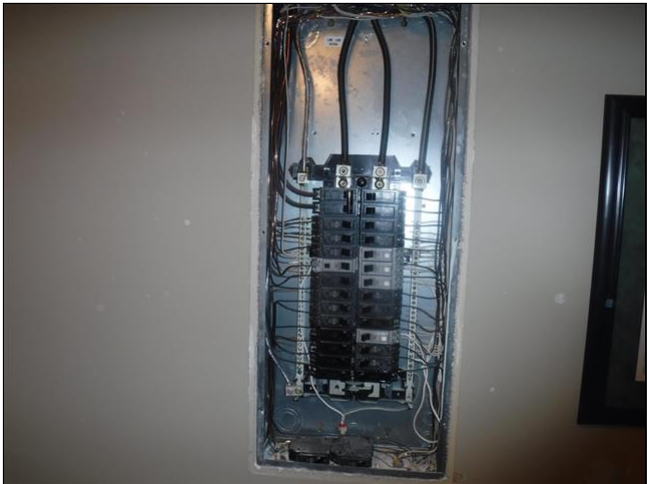
View of panel. Panel was inspected for function (not code compliance) and building codes and standards have changed over the years.

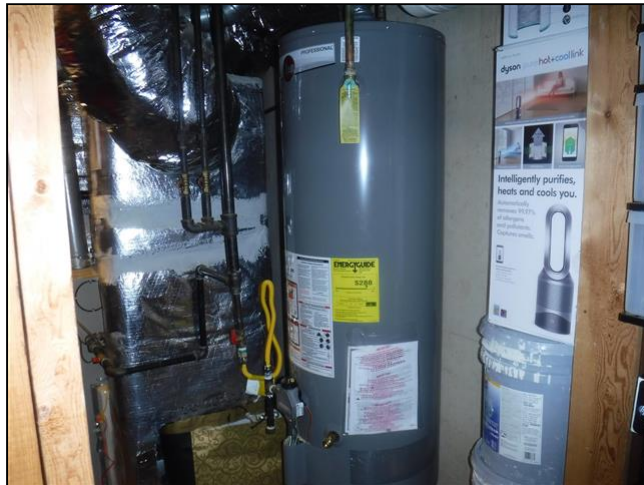
8.3 Item 1(Picture)

(1) View of water heater.

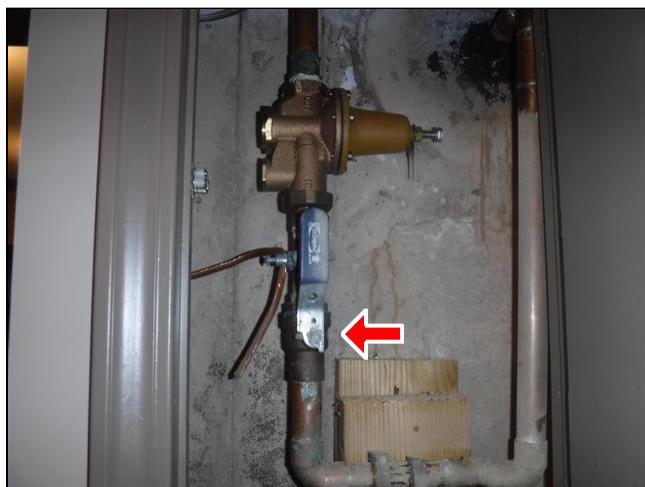
The main water shut off is in the basement.

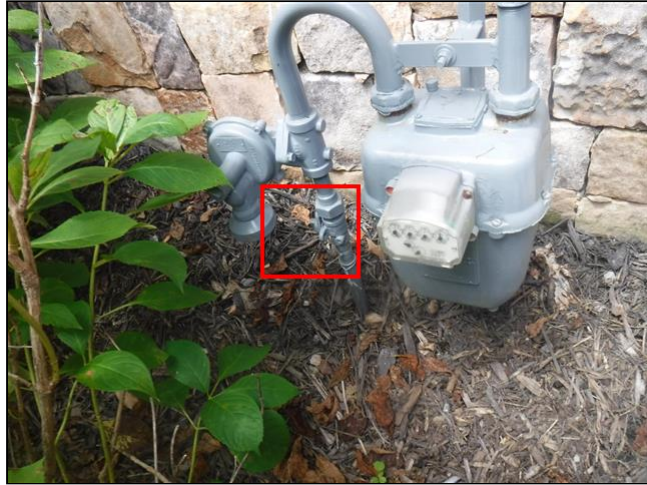
8.6 Item 1(Picture)

Main gas shut off is at the meter.
