Inspection Report

**565 Trowbrook Road
Atlanta, Georgia 30350**

Inspection Date August 21, 2020
Inspector Jay Cao
www.HouseChecked.com
jc@housechecked.com
(678)557-8958
interNACHI Certified Inspector, GA Registered Professional Engineer

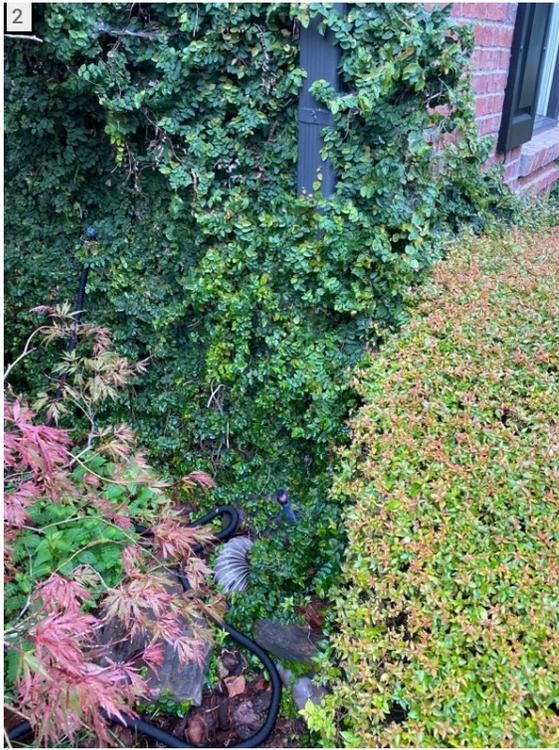
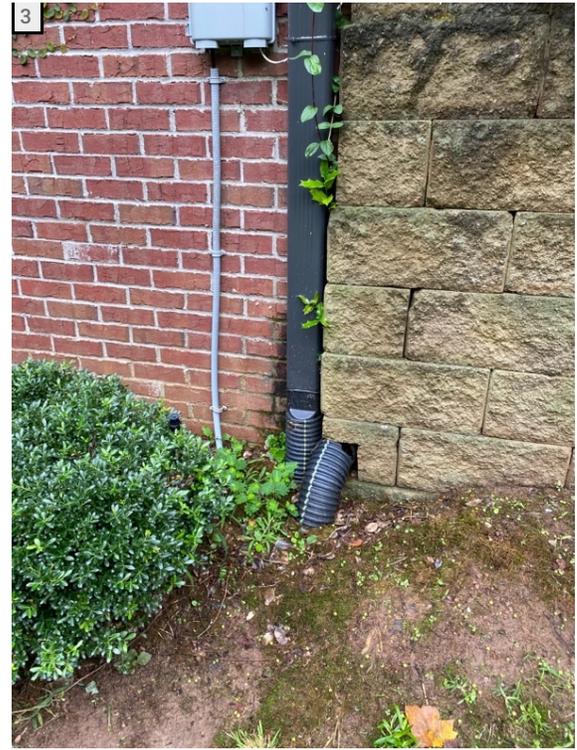
Location Exterior: Ground View

apply to all, too close to house foundation, need to add an extender to diver water at least 4 ft away from house.

all the downspout extenders going into the grade should be checked for clogging, clean as need

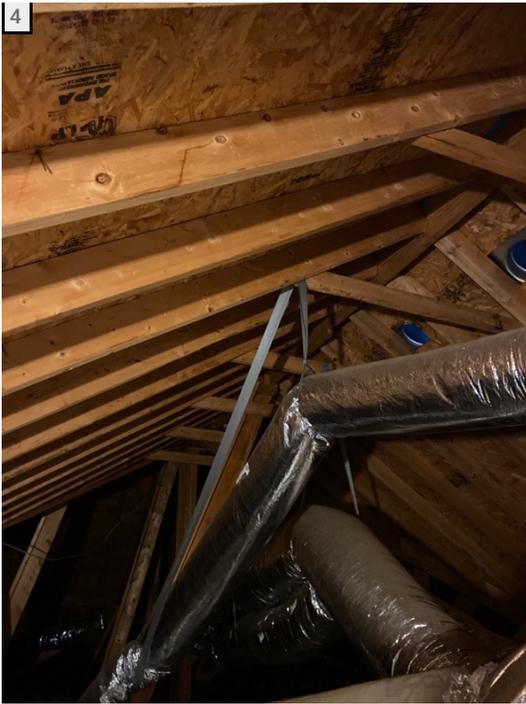
Location Attic

working order

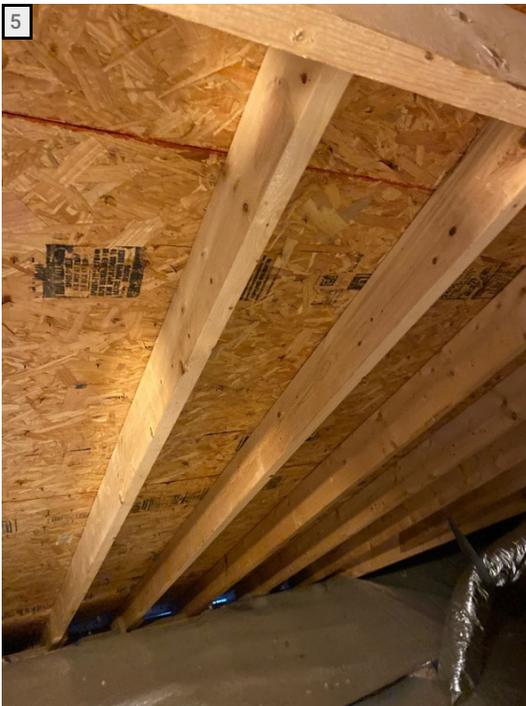
Location Attic

working order

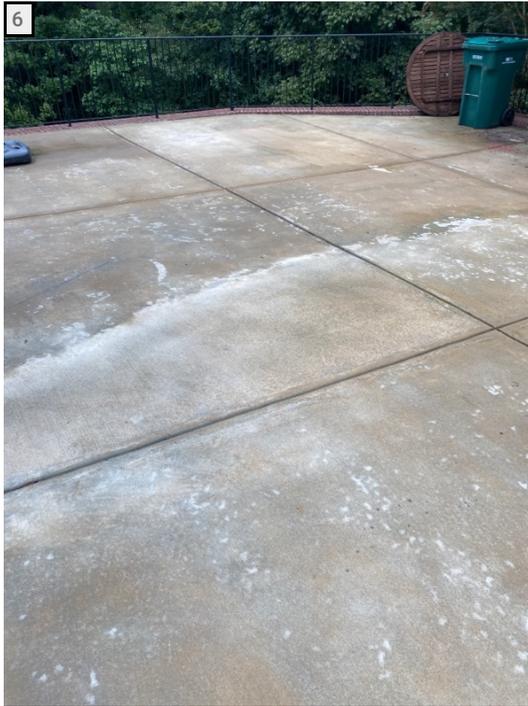
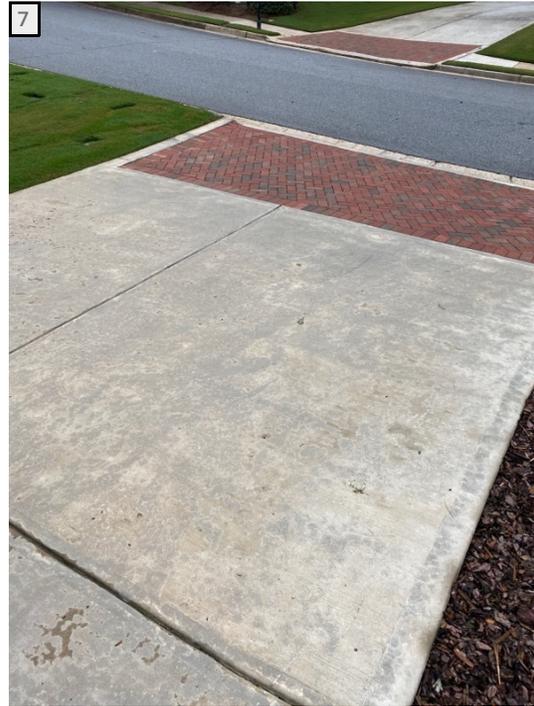
Location Exterior: Ground View

appeared good condition

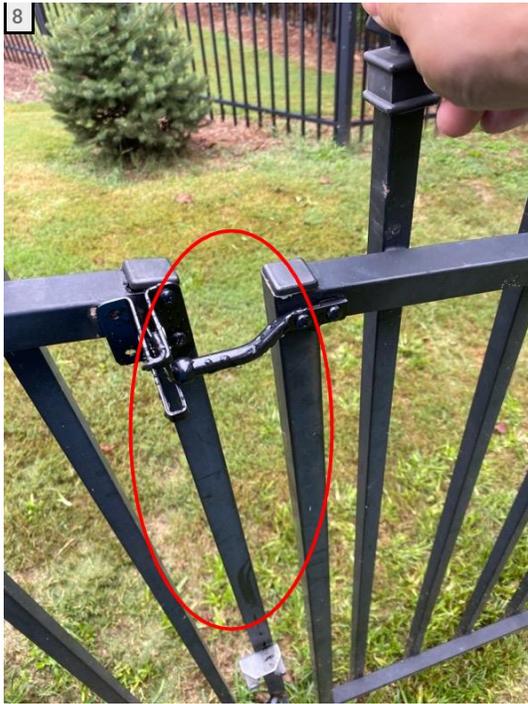
Impact The misalignment makes it difficult to open and close the gate

Suggested Action Have the fence repaired by a fence contractor

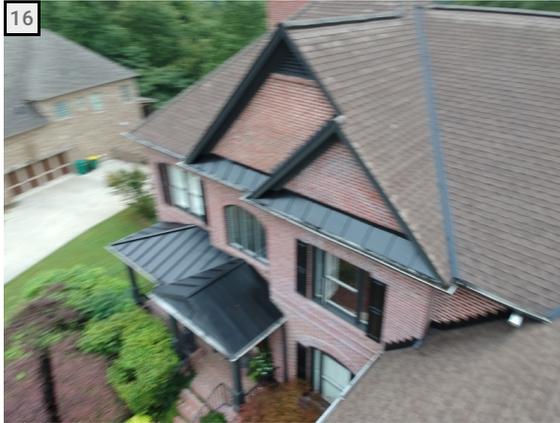
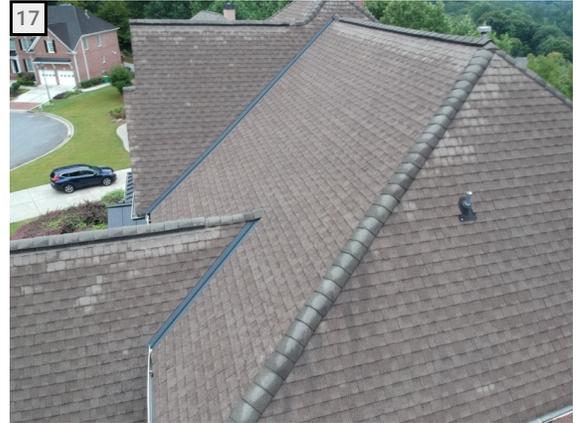
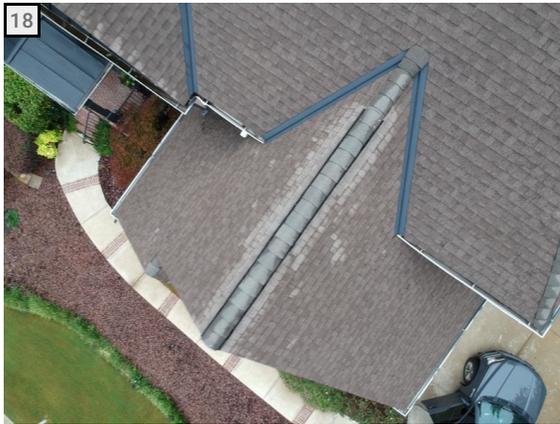
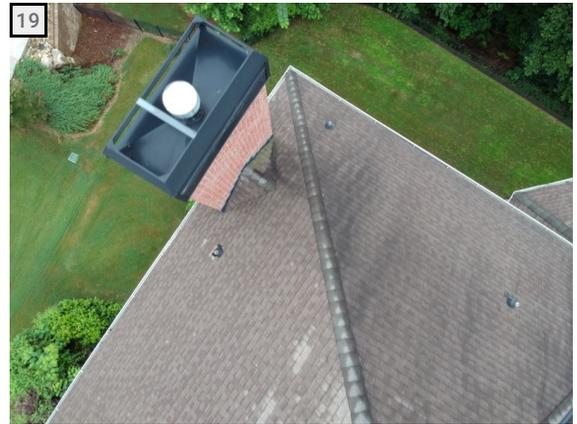
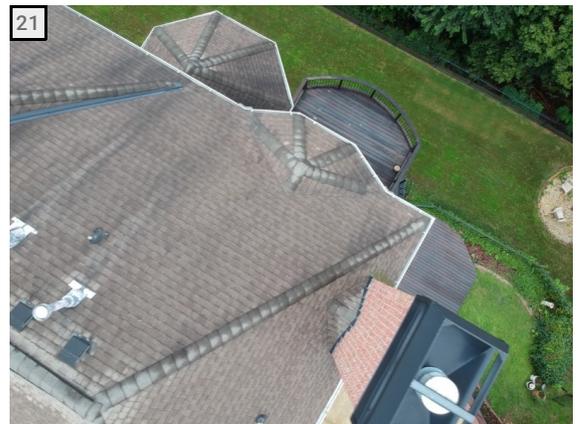
Location Exterior: Roof View

working condition

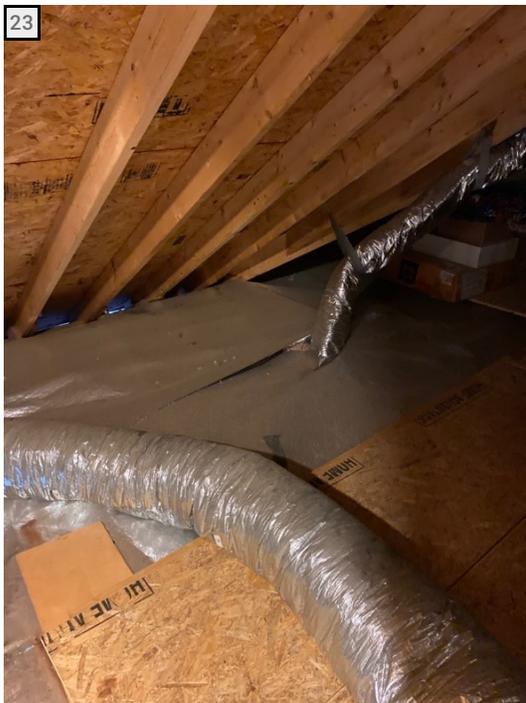
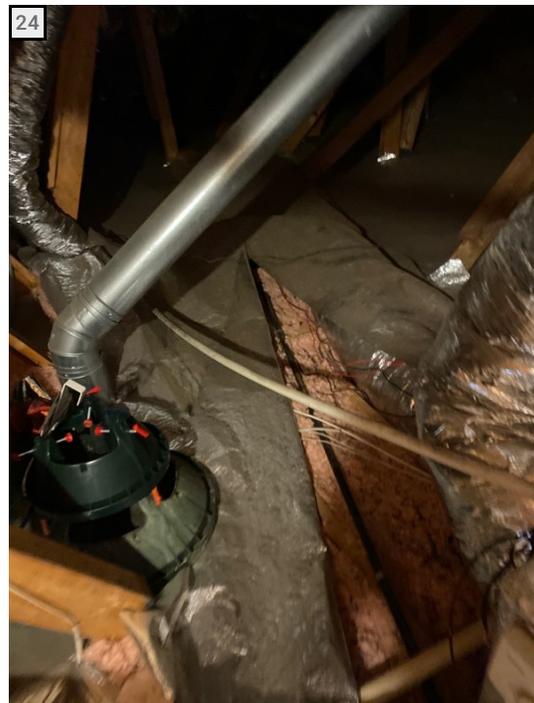
Location Attic

Working order

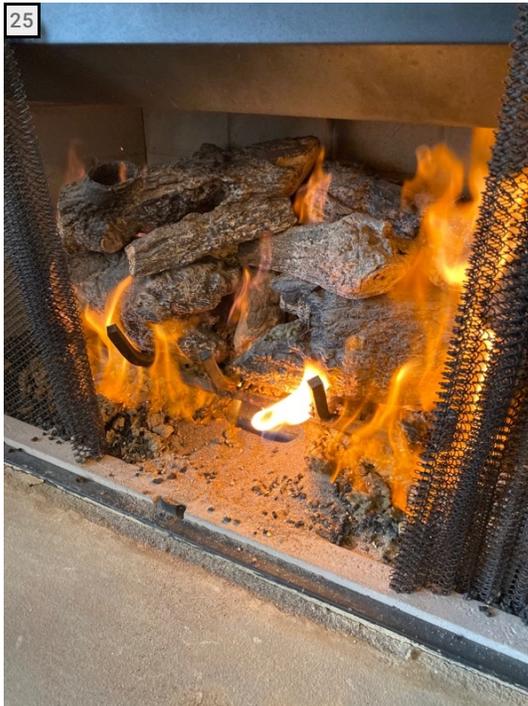
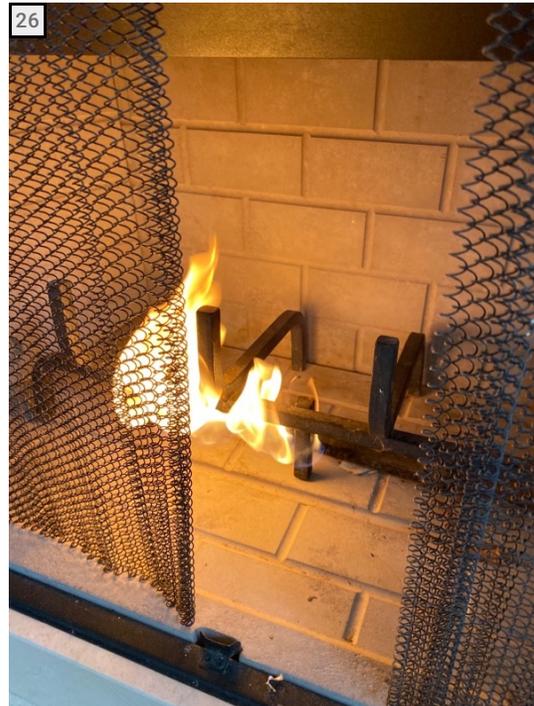
Location Living Room, Family Room

working condition

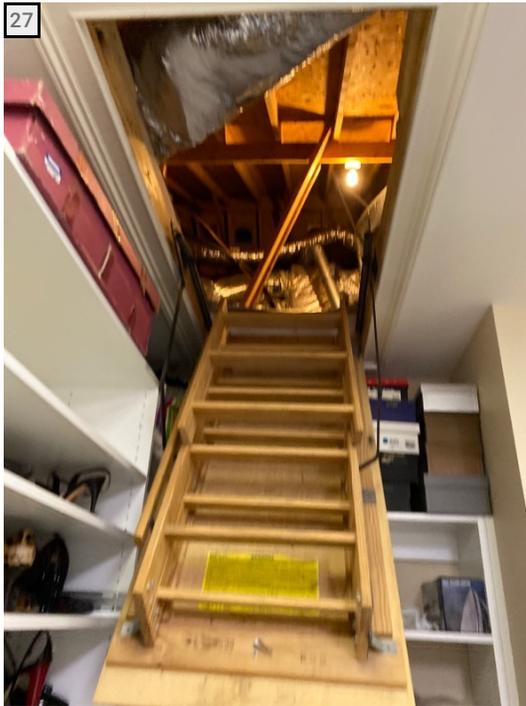
Impact Without insulatiion, the thermal barrier is suboptimized

Suggested Action Adding insulation to the top of the hatch

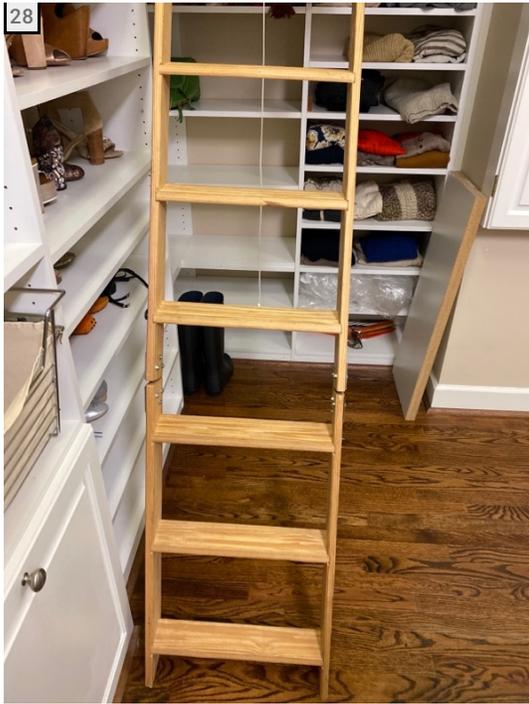
Location Attic

working condition

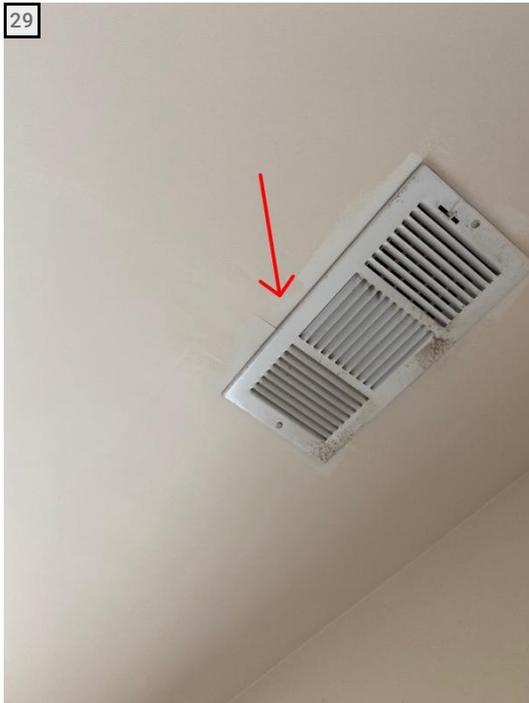
Location 3rd Bedroom

Cracking

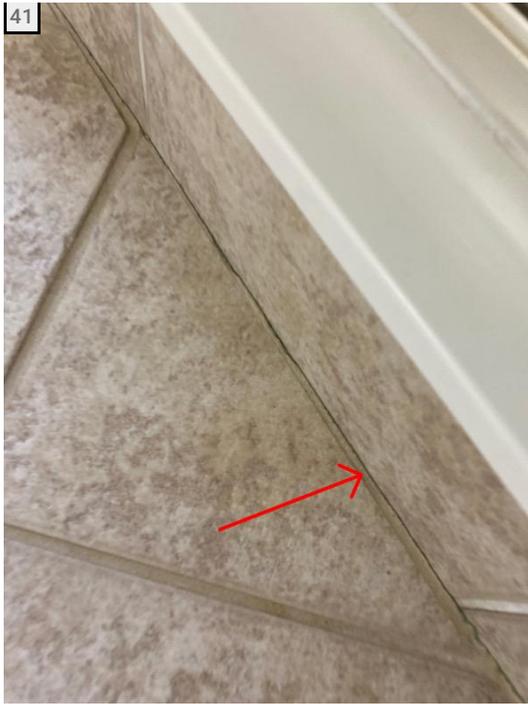
Location 1st Bathroom

tile grout is cracked

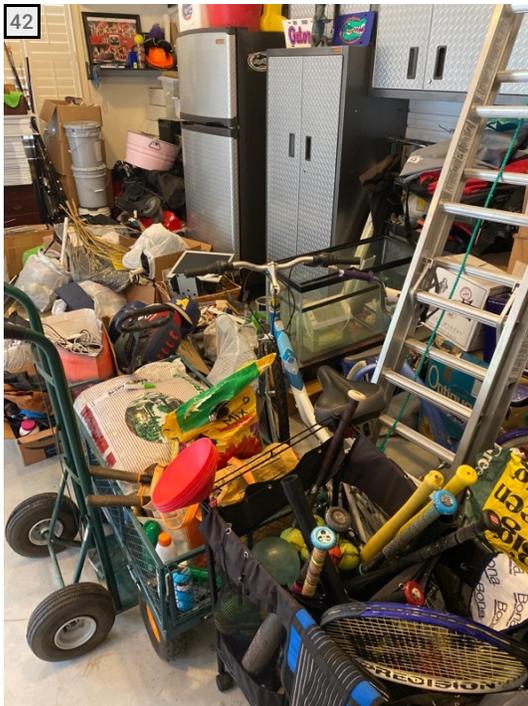
Location Attached Garage

objects on the floor, can't fully inspect the floor

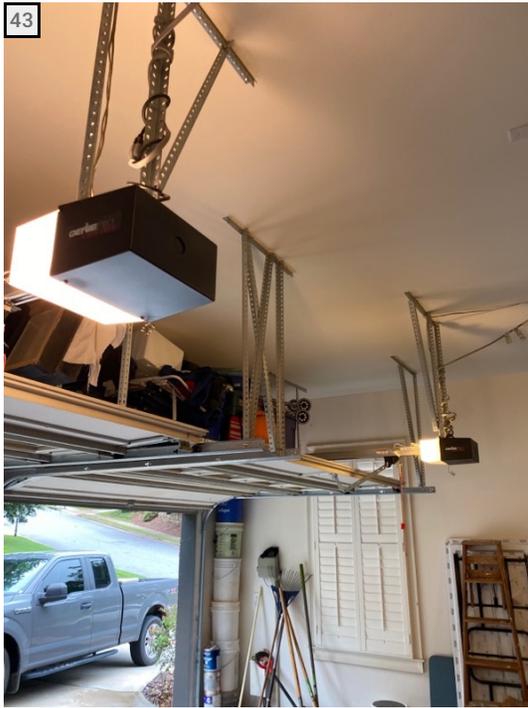
Location Attached Garage

working condition

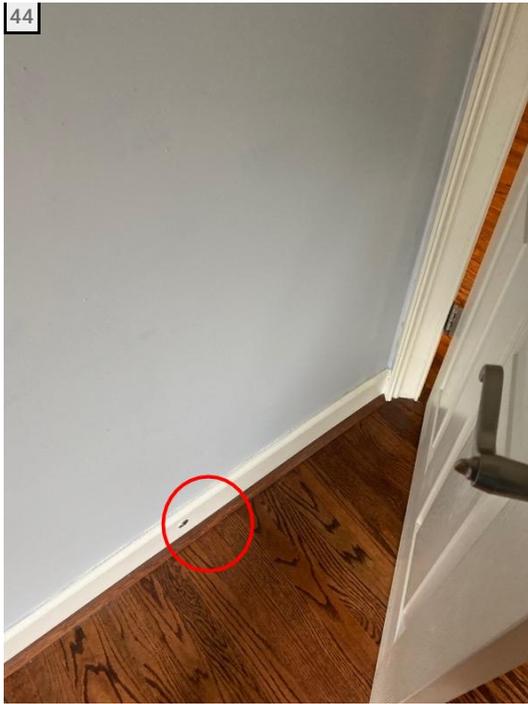
Location 2nd Bedroom

door stopper is missing

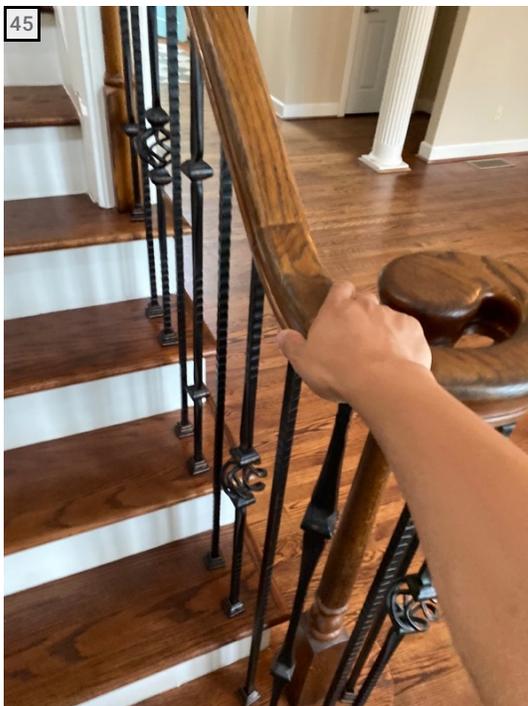
Impact A loose handrail could hinder the stair user an opportunity to stop or reduce the extent of a fall

Suggested Action Resecure the handrail ensuring with either longer screws or relocate the brackets

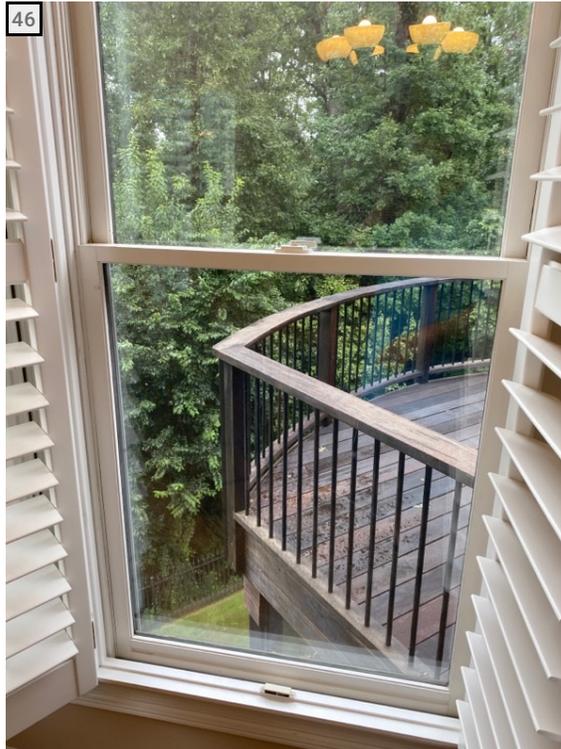
Location Kitchen

a number of representative windows were inspected, some of them are painted shut, or difficult to open.

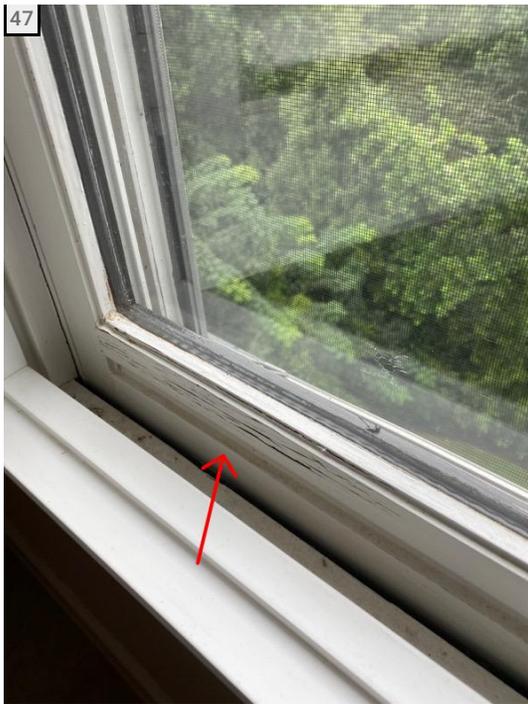
Location 3rd Bathroom

wood rotted

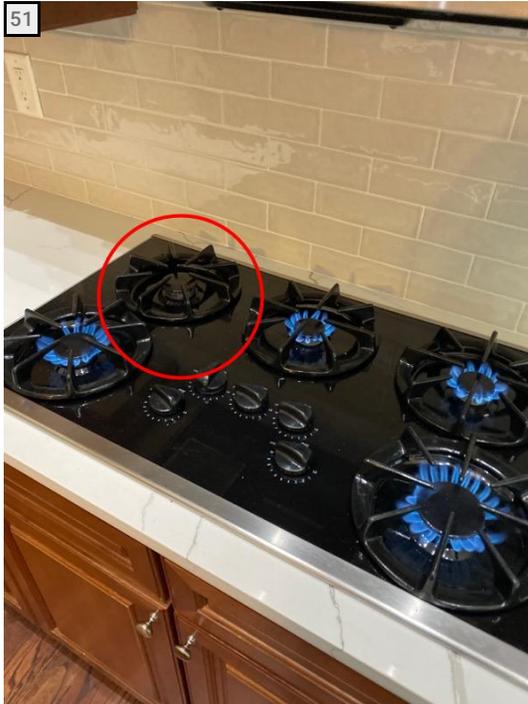
Location Kitchen

one burner can't be ignited.

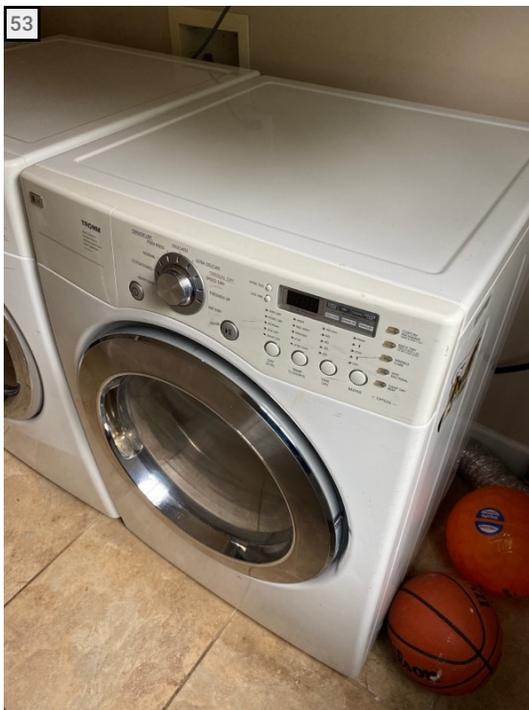
Location Laundry Room / Mudroom

– Dryer

Moderate Concern

has a noise beyond the normal operation

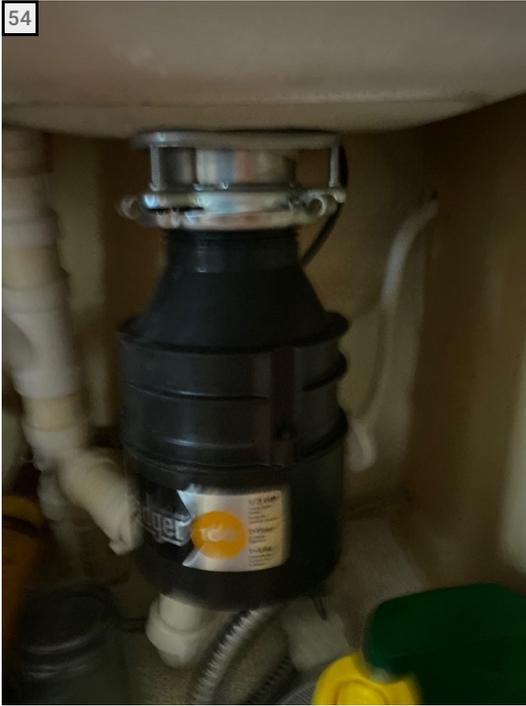
Location Kitchen

✓ Garbage Disposal

In Working Order

working order at the time of inspection

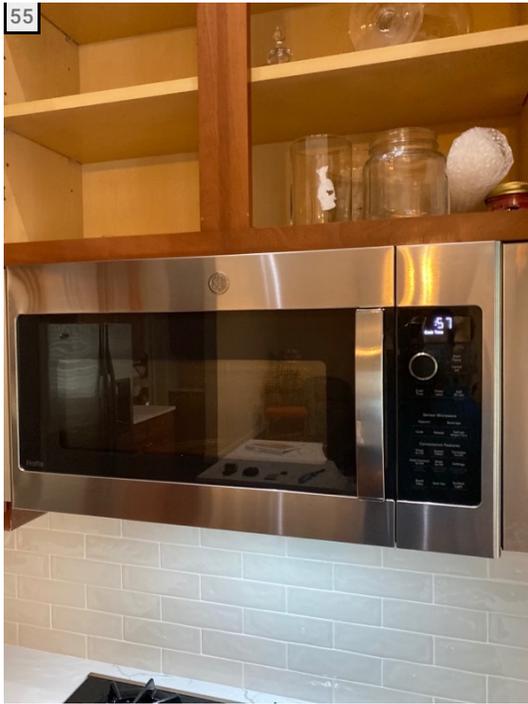
Location Kitchen

✓ **Microwave Oven**

In Working Order

working order

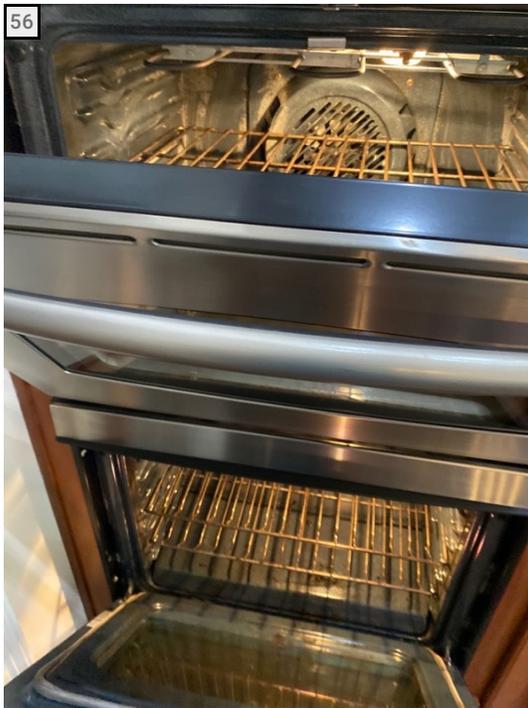
Location Kitchen

✔ **Oven/Range**

In Working Order

working order

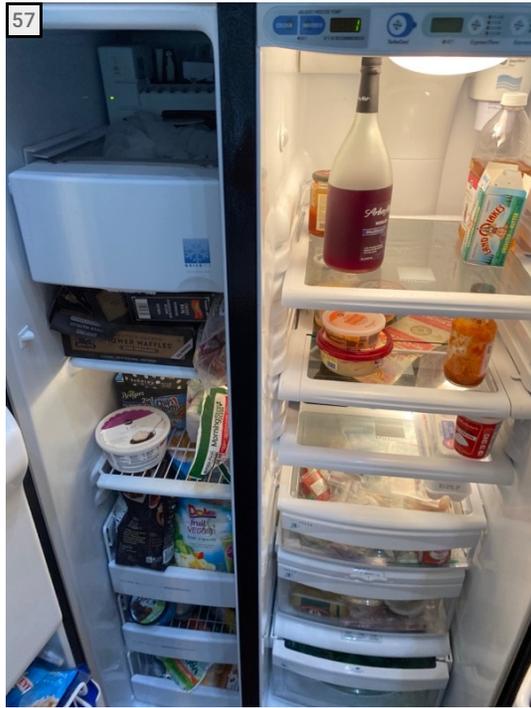
Location Kitchen

✔ **Refrigerator**

In Working Order

working order

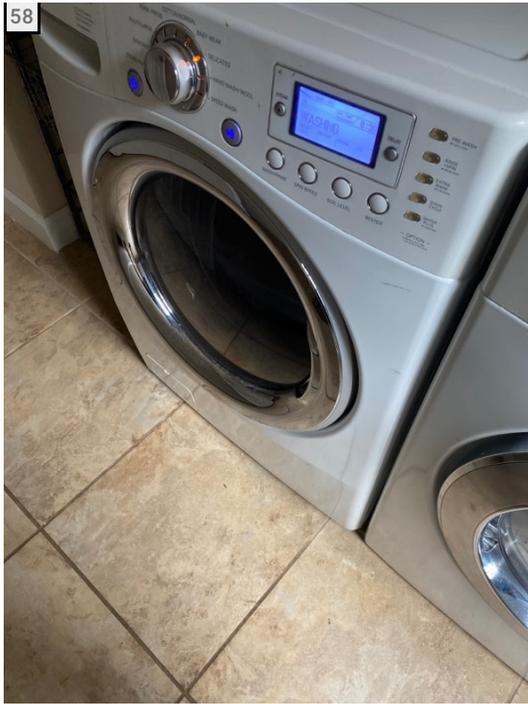
Location Laundry Room / Mudroom

✓ **Washer**

Minor Concern

wet pan is missing

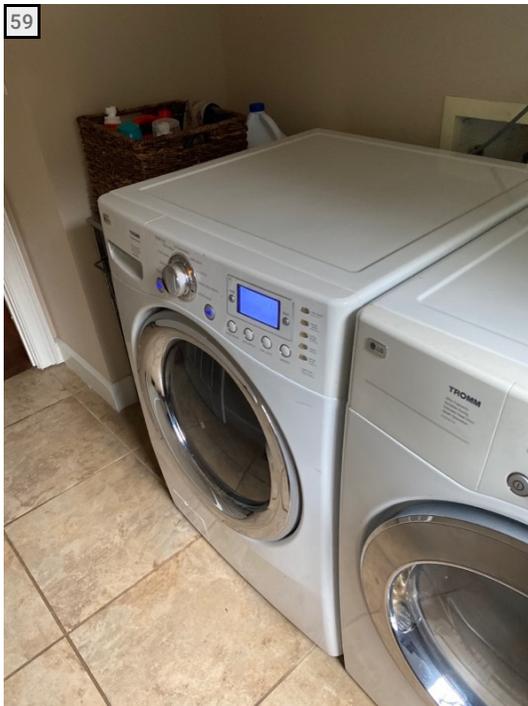
Location Laundry Room / Mudroom

In Working Order

working order

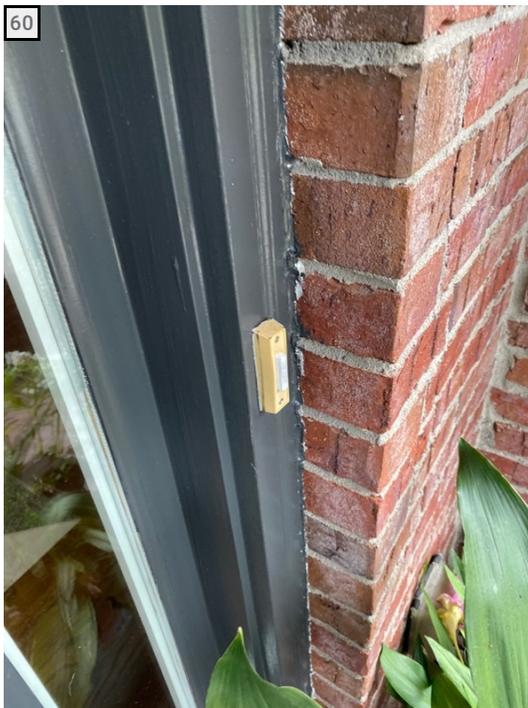
Location Exterior: Ground View

working order

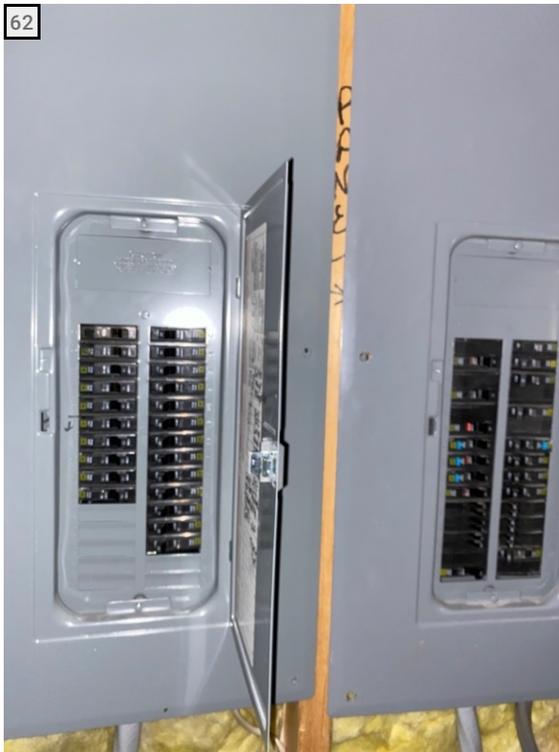
Location Basement

all testable breakers were able to be tested tripping at the time of inspection

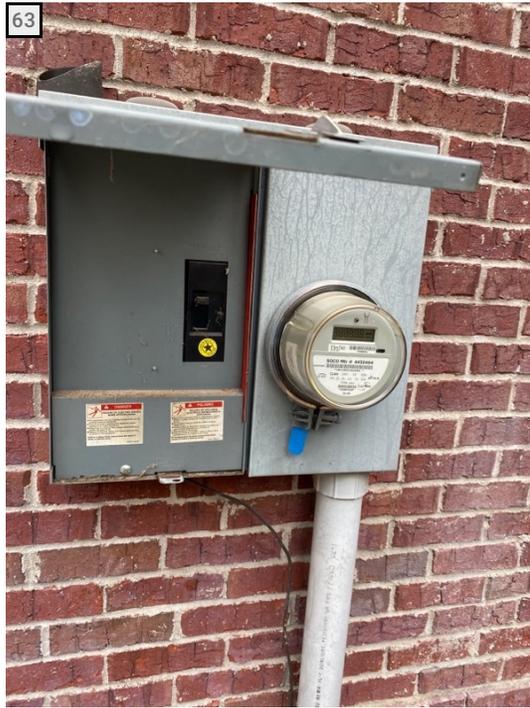
Location Exterior: Ground View

✔ **Electrical service**

In Working Order

200A service main

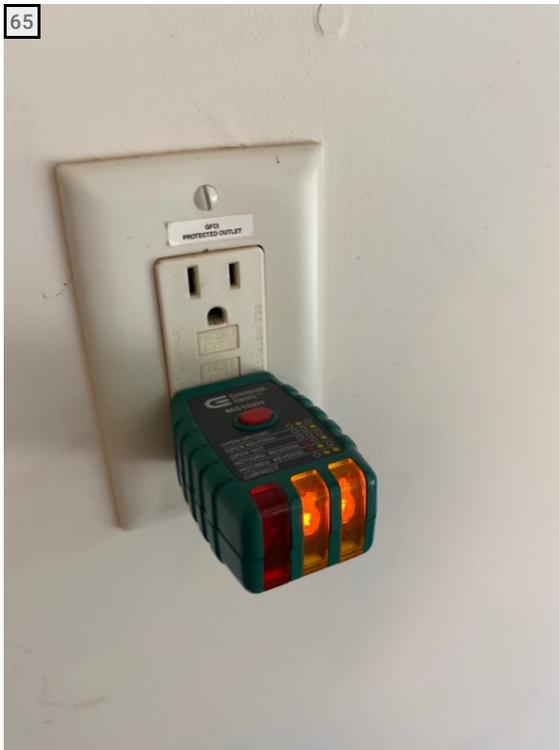
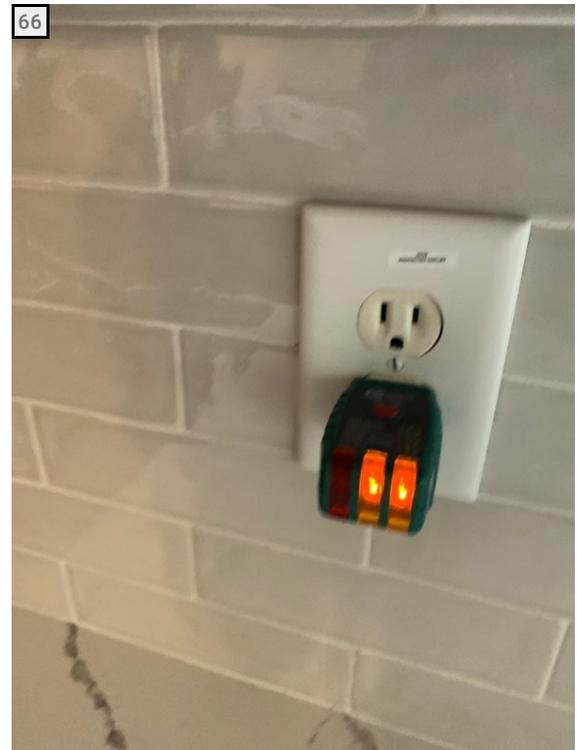
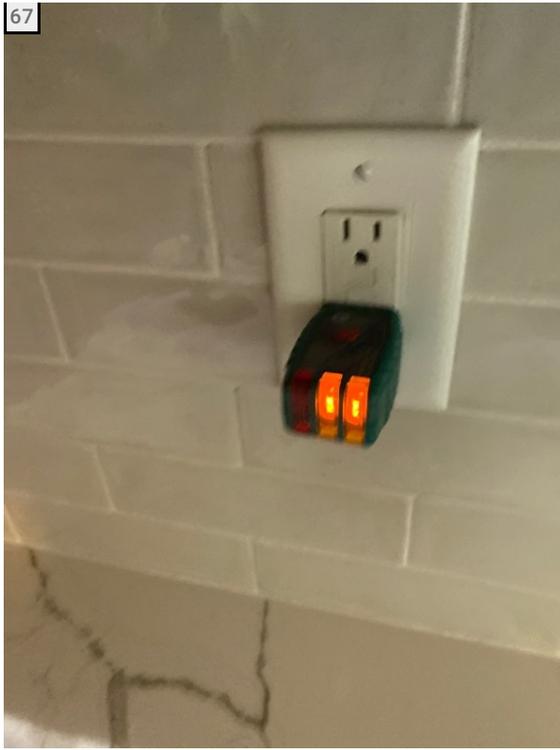
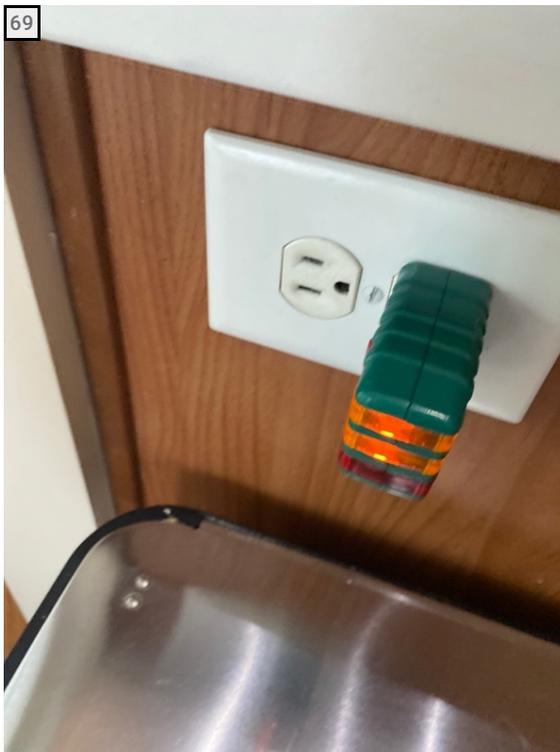
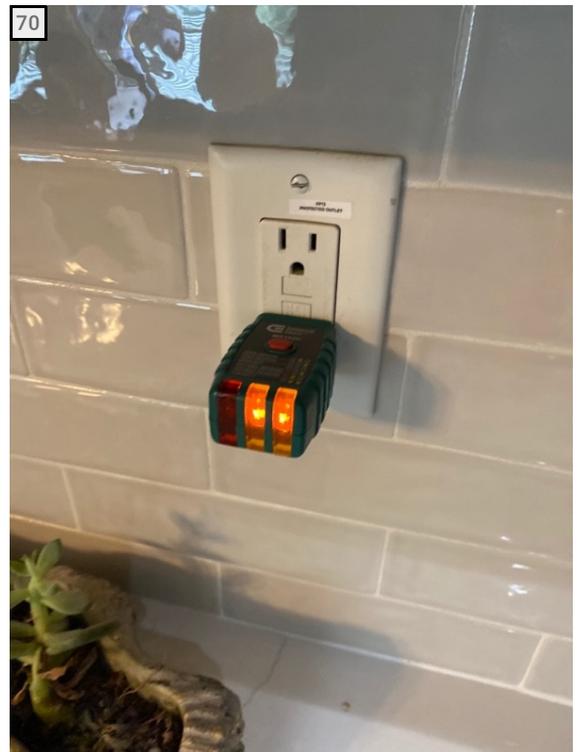
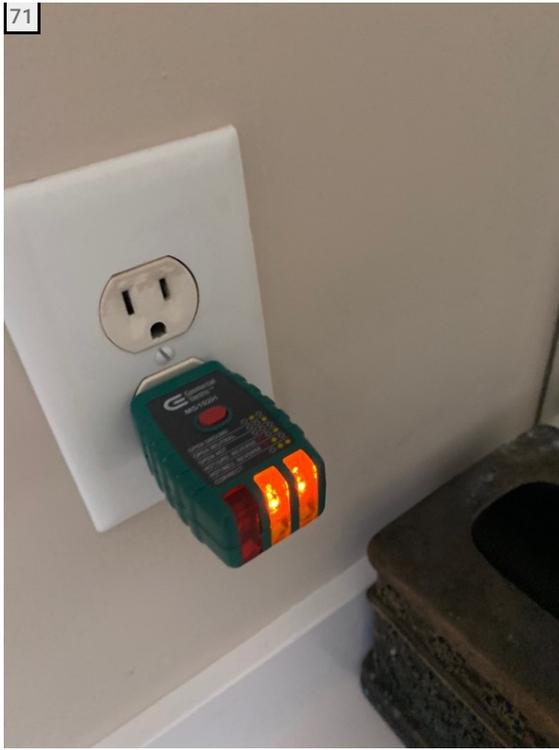
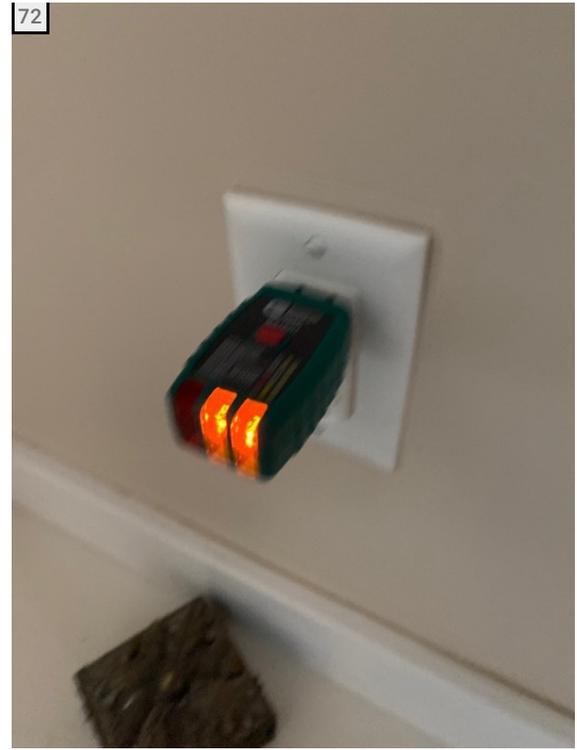
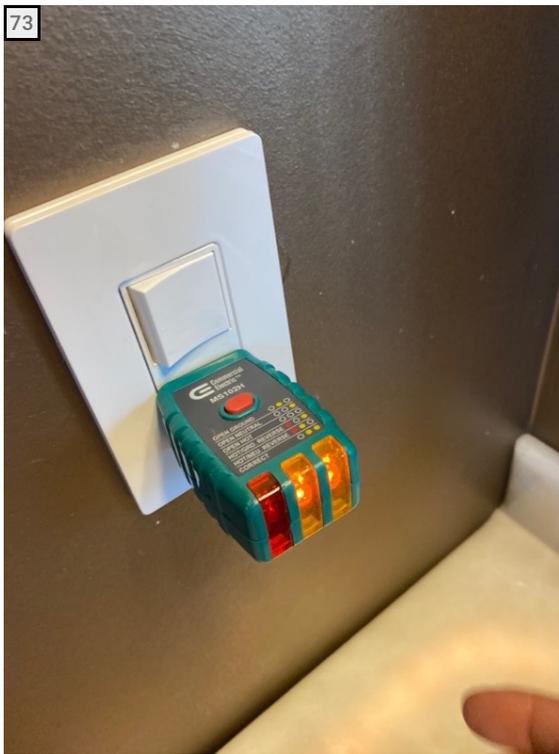
Location Attached Garage, Kitchen, Partial Bathroom, 1st Bathroom

In Working Order

GFCI tested good

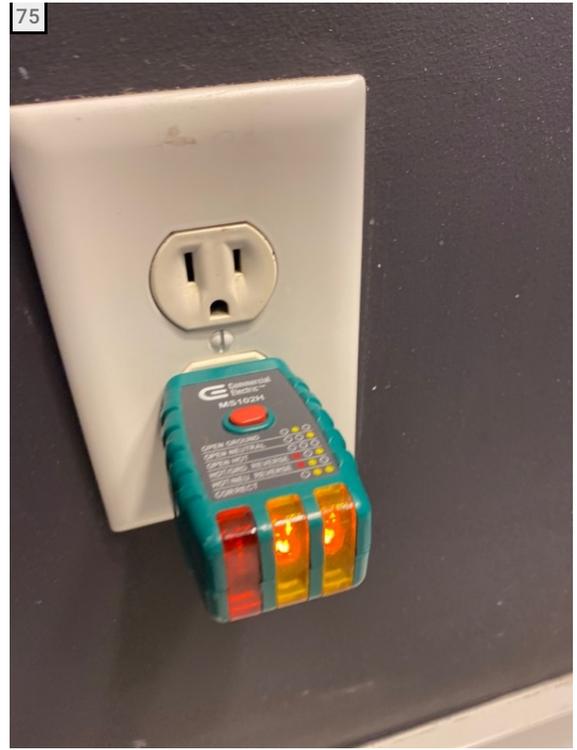
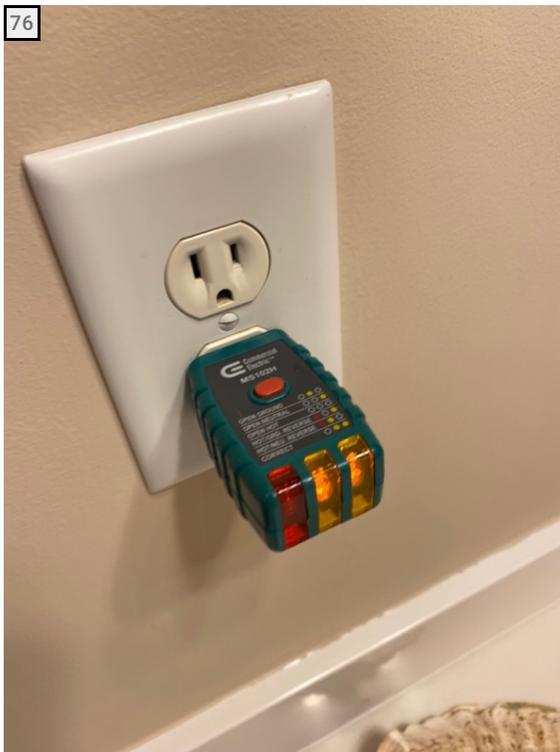
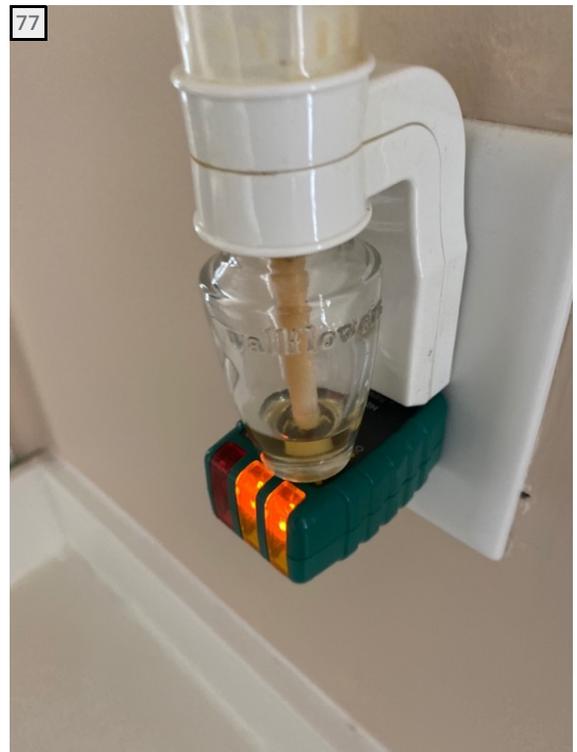
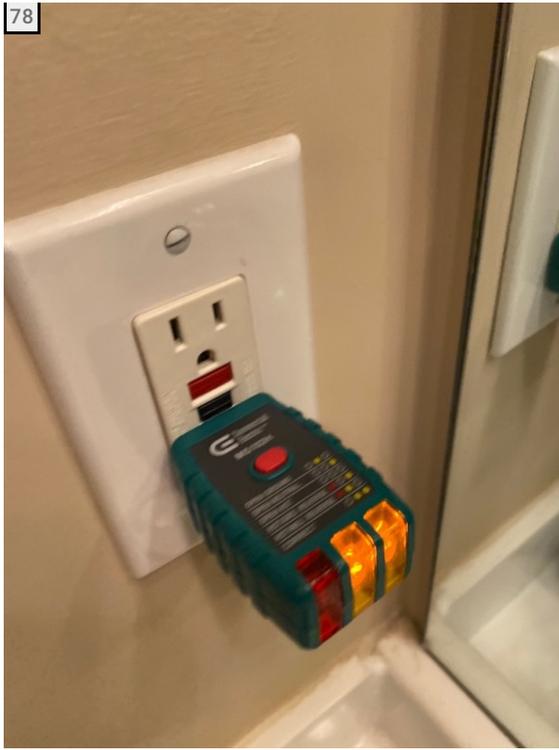
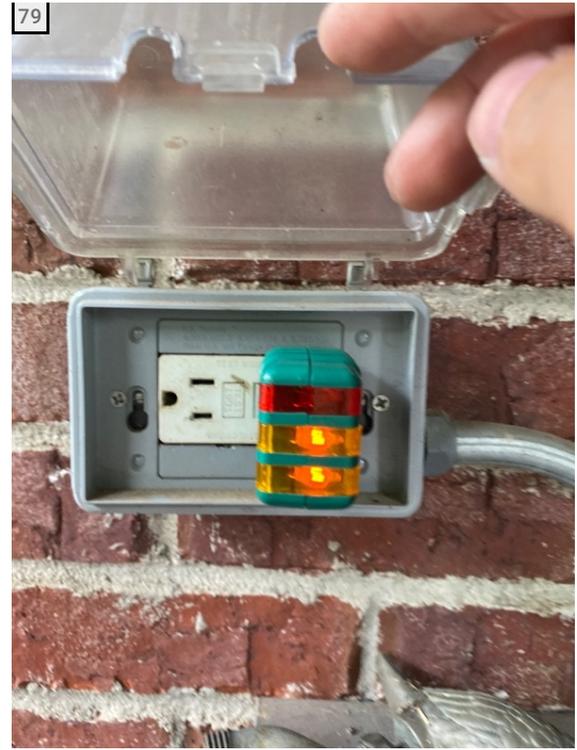
Location Exterior: Ground View, 2nd Bathroom, 3rd Bathroom, 4th Bathroom

In Working Order

GFCI tested good

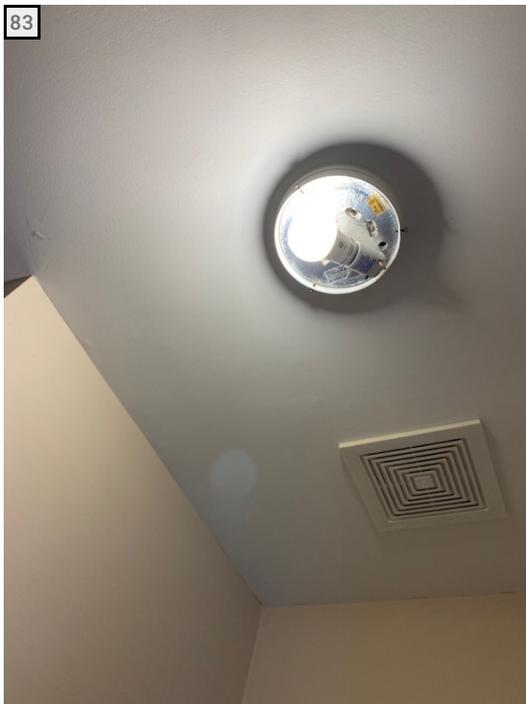
Location 3rd Bathroom

fixture cover is missing

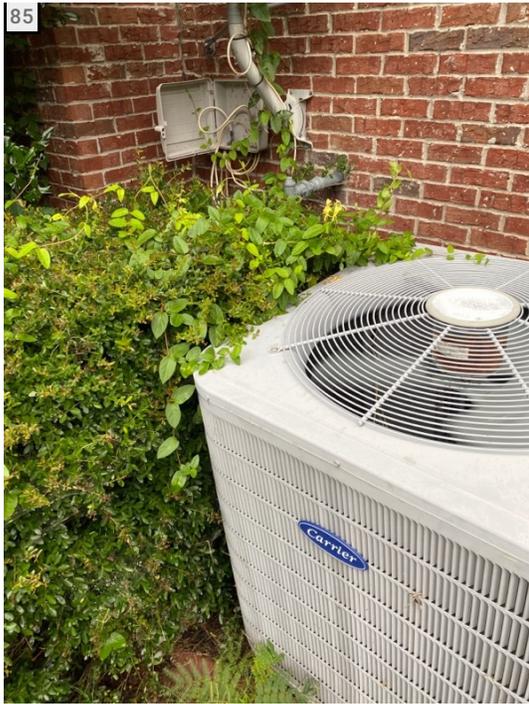
An air conditioner is engineered to remove the heat by having a designed amount of air flow over the condensing coil. If less air flows over the coil, less heat is removed. That means the whole cycle warms up a bit, and your AC works harder to keep your home cool

Suggested Action

Cut back the vegetation

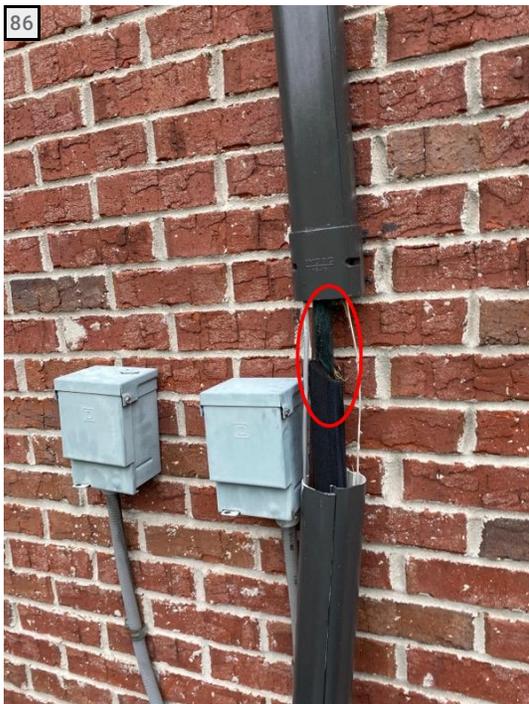
Minor Concern

Insulation is damaged

Without proper insulation the warmer air may create condensation on the suction line which could damage the surrounding area and/or create a slipping hazard. In addition, by warming the refrigerant, operating efficiency is reduced

Suggested Action

Replace the insulation with 3/4 to 1 inch vapor-proof insulation

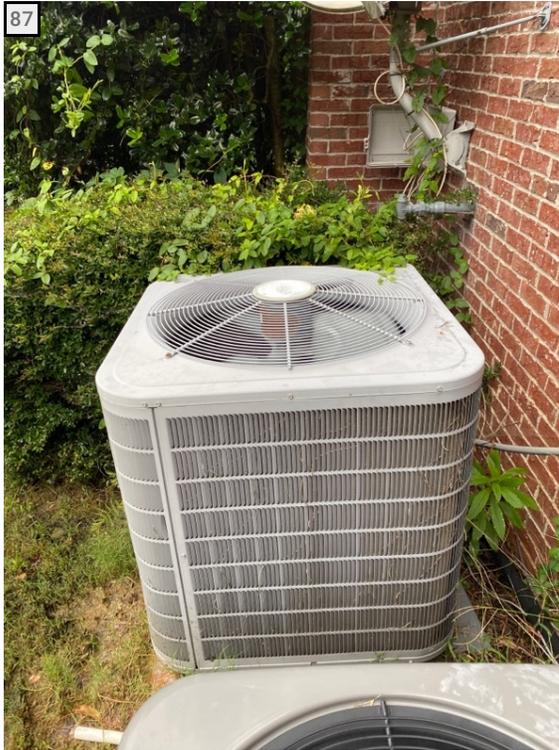
Location Exterior: Ground View

In Working Order

ac cooling appear working at the time of inspection, it did have sufficient cooling, photos were taken at 60F set point

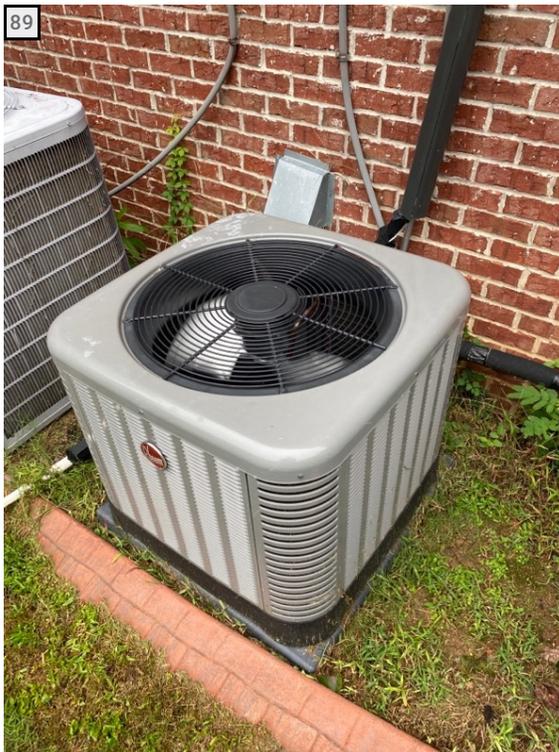
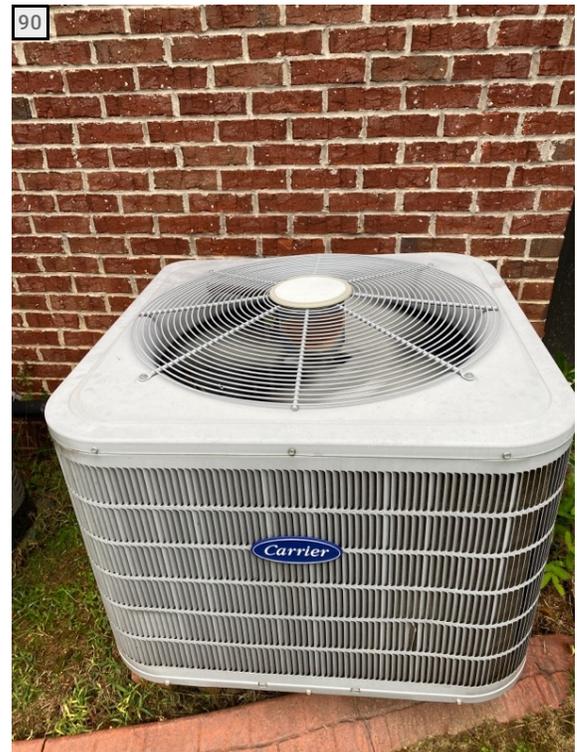
Location Exterior: Ground View

✓ AC-Condenser basement

In Working Order

ac cooling appear working at the time of inspection, it did have sufficient cooling, photos were taken at 60F set point

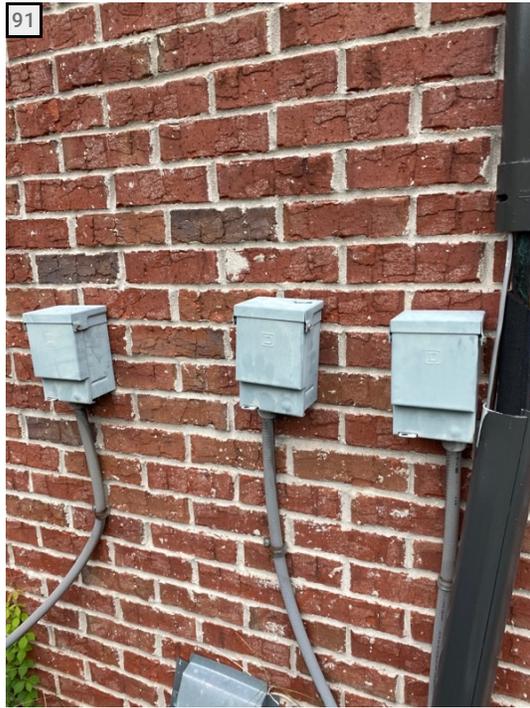
Location Exterior: Ground View

In Working Order

electrical disconnects noted
